Solar Industrial Process Heat (IPH) Project Technical Report October 1982-September 1983

E. L. Harley, W. B. Stine

This document contains a report of the work performed in the Solar Industrial Process Heat Project during FY 1983. The work involved eighteen industrial process heat experiments originally funded by the Department of Energy (DOE) under two separate programs. During FY 1983, eight of the experiments were in the operational phase directly supported by the DOE, seven had been completed previously and the solar equipment had been transferred to the plant owners for continued operation, and three had been discontinued.

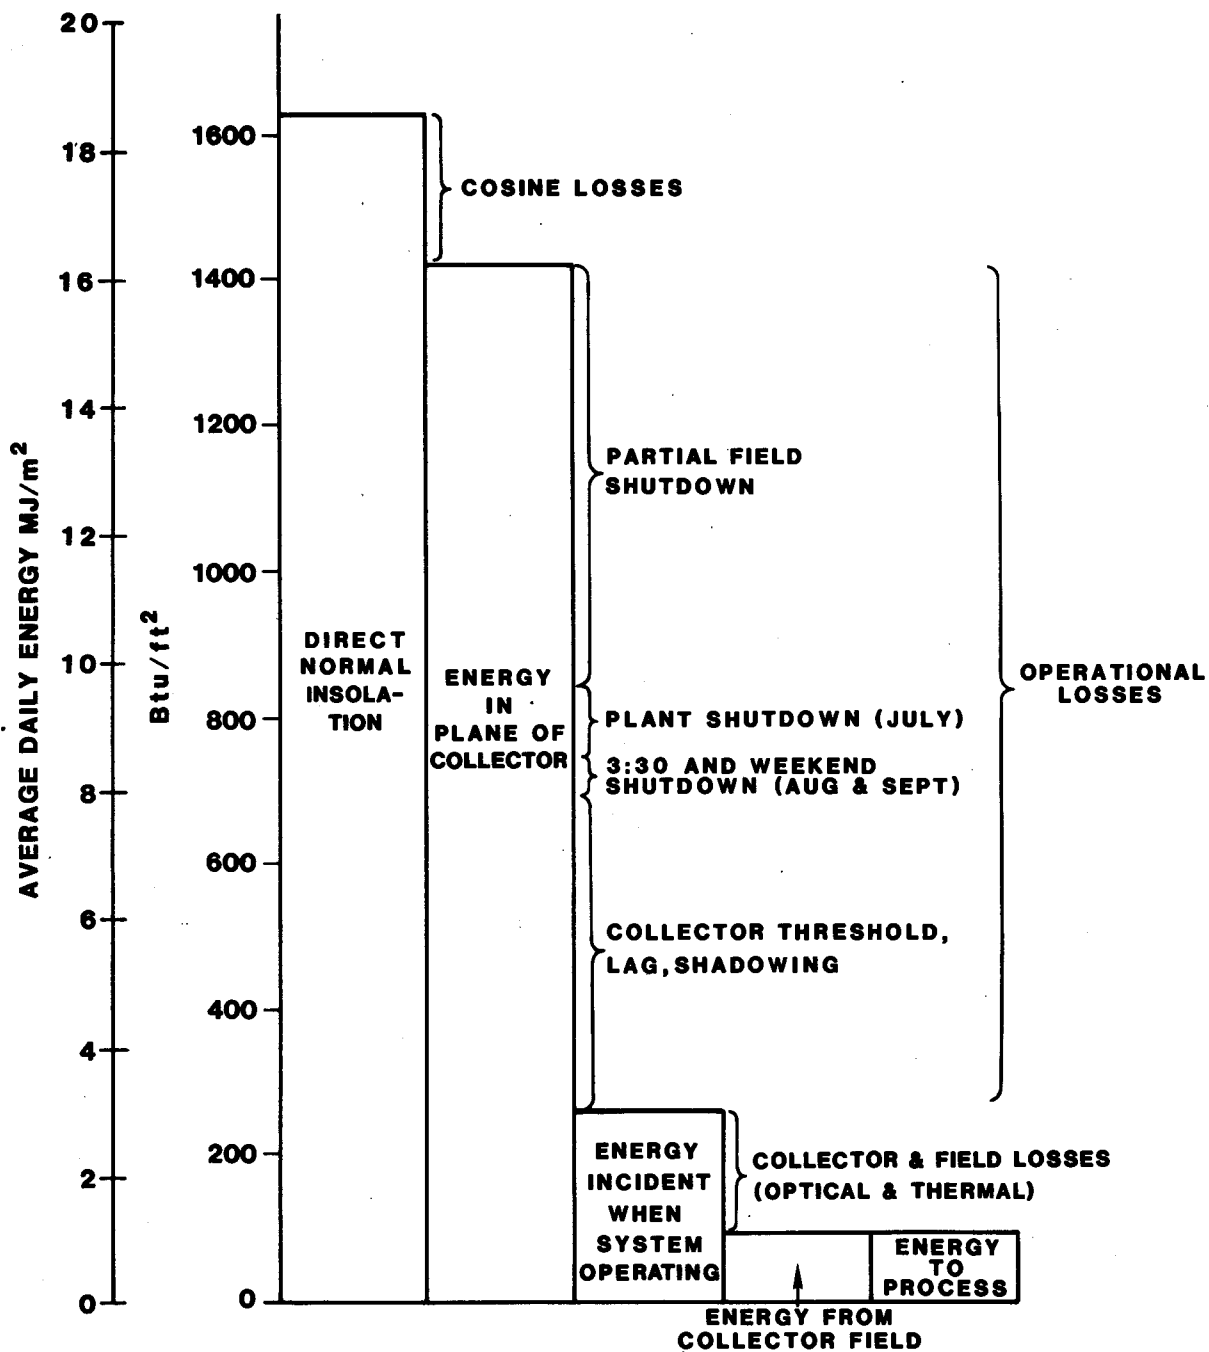
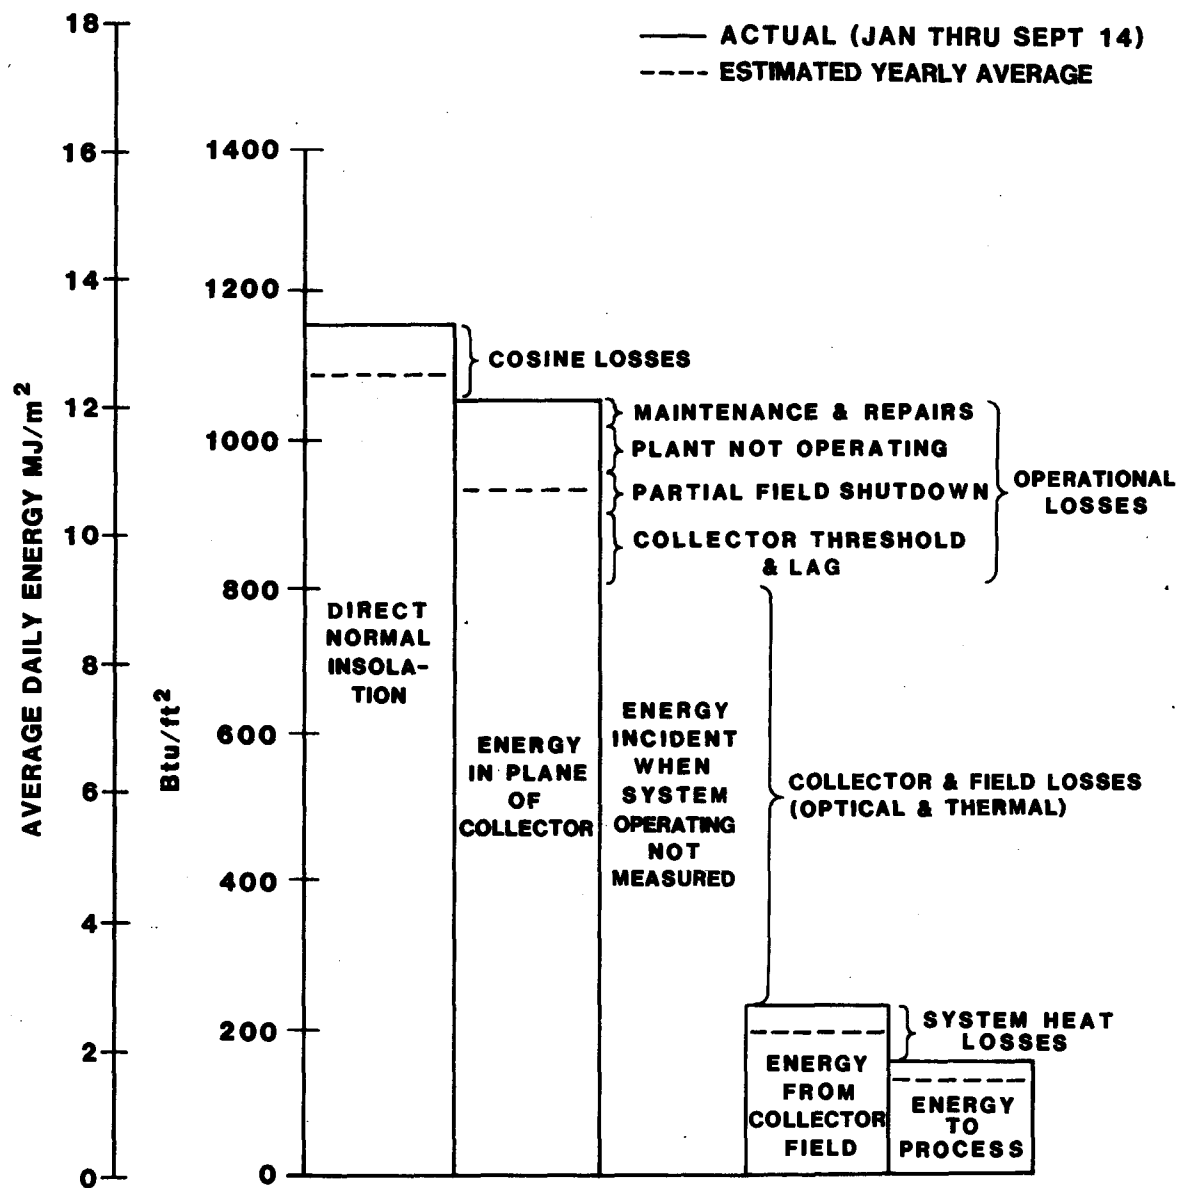
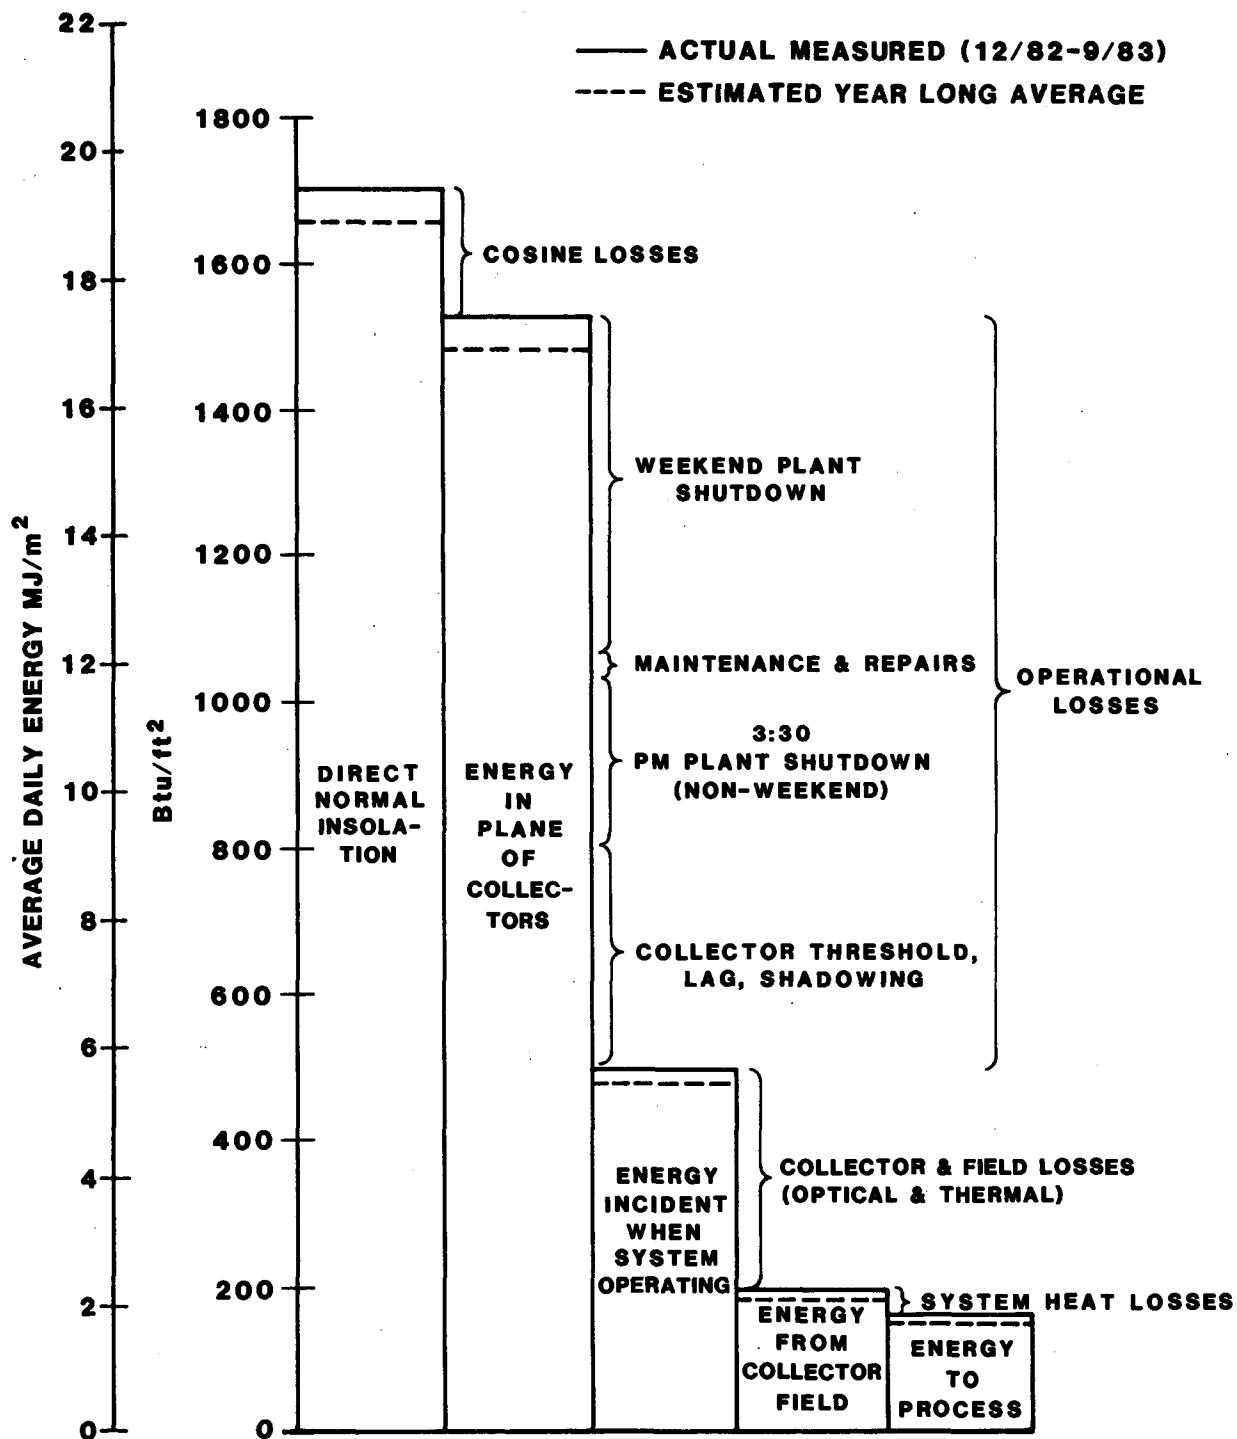
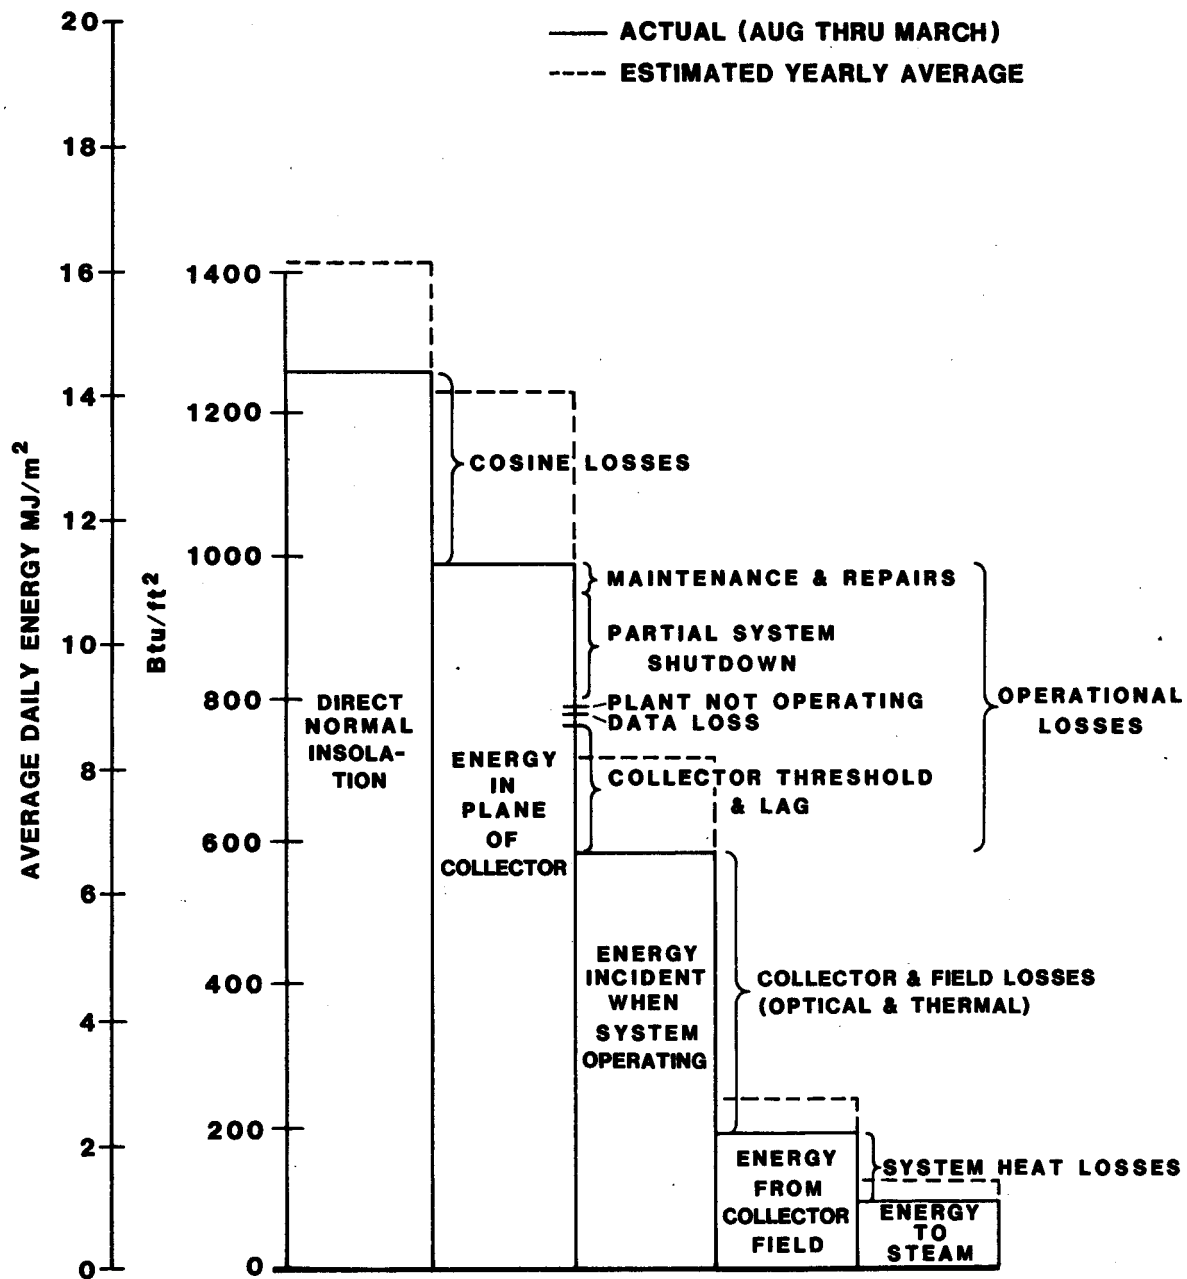
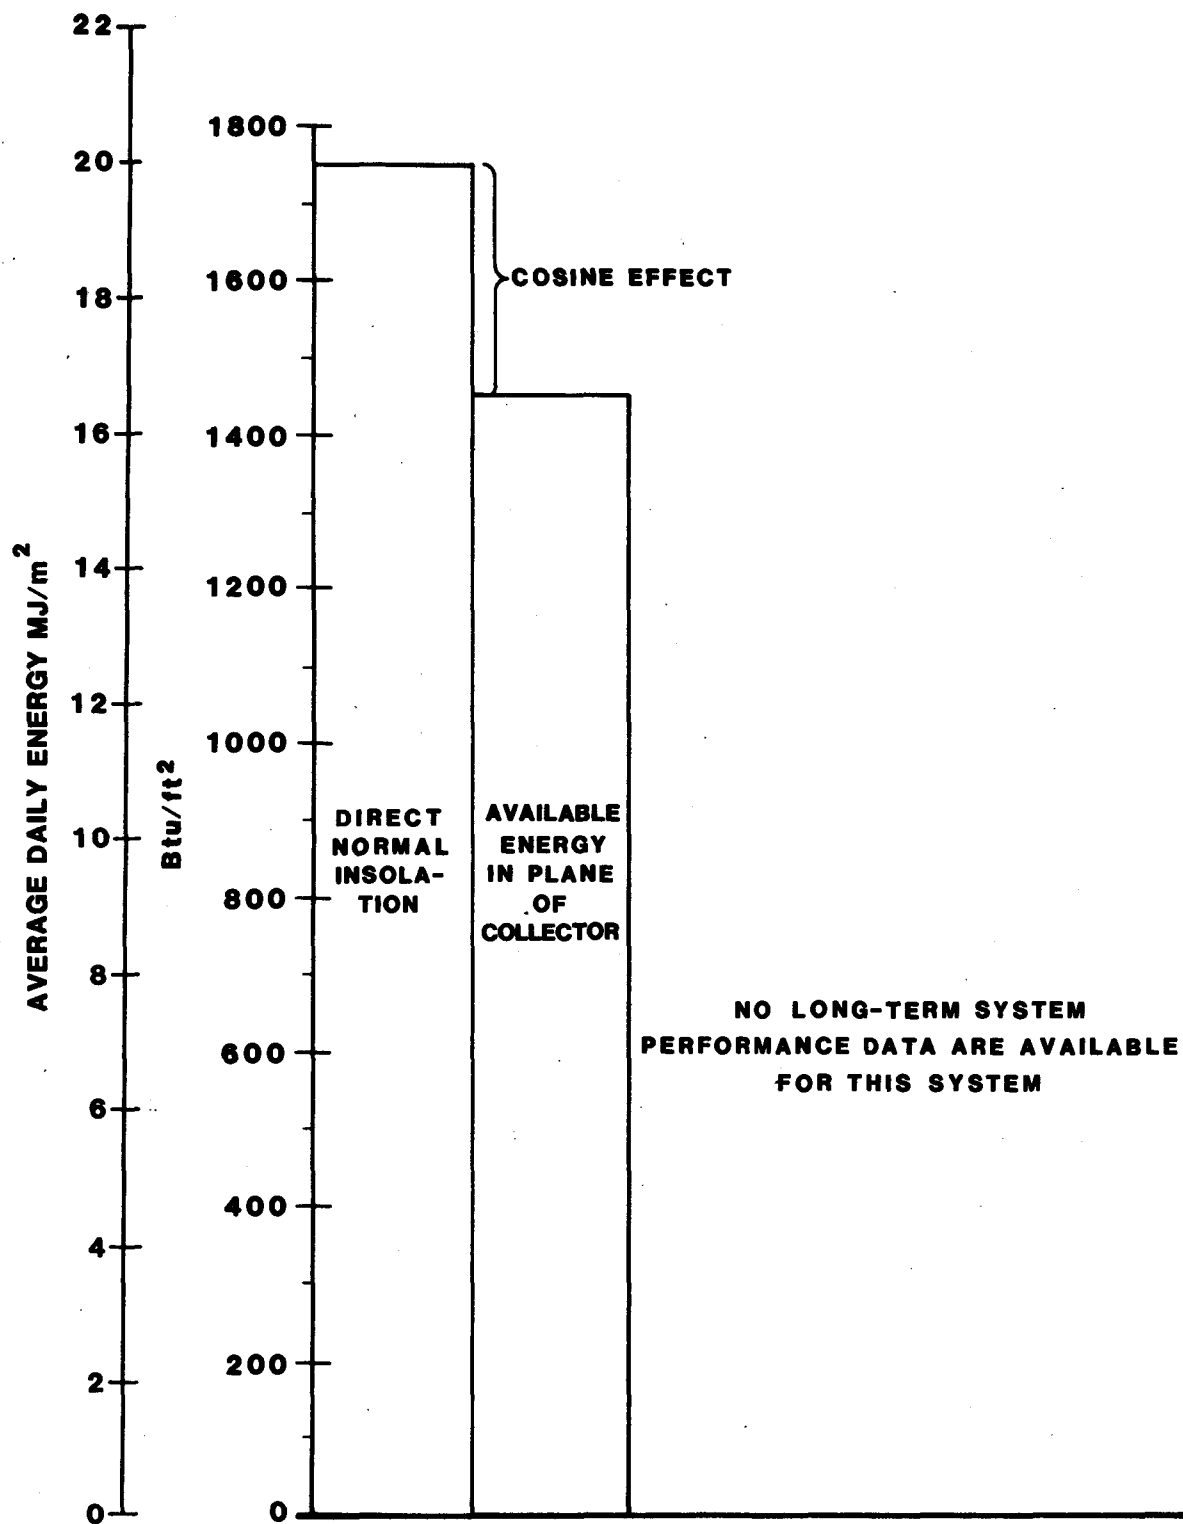
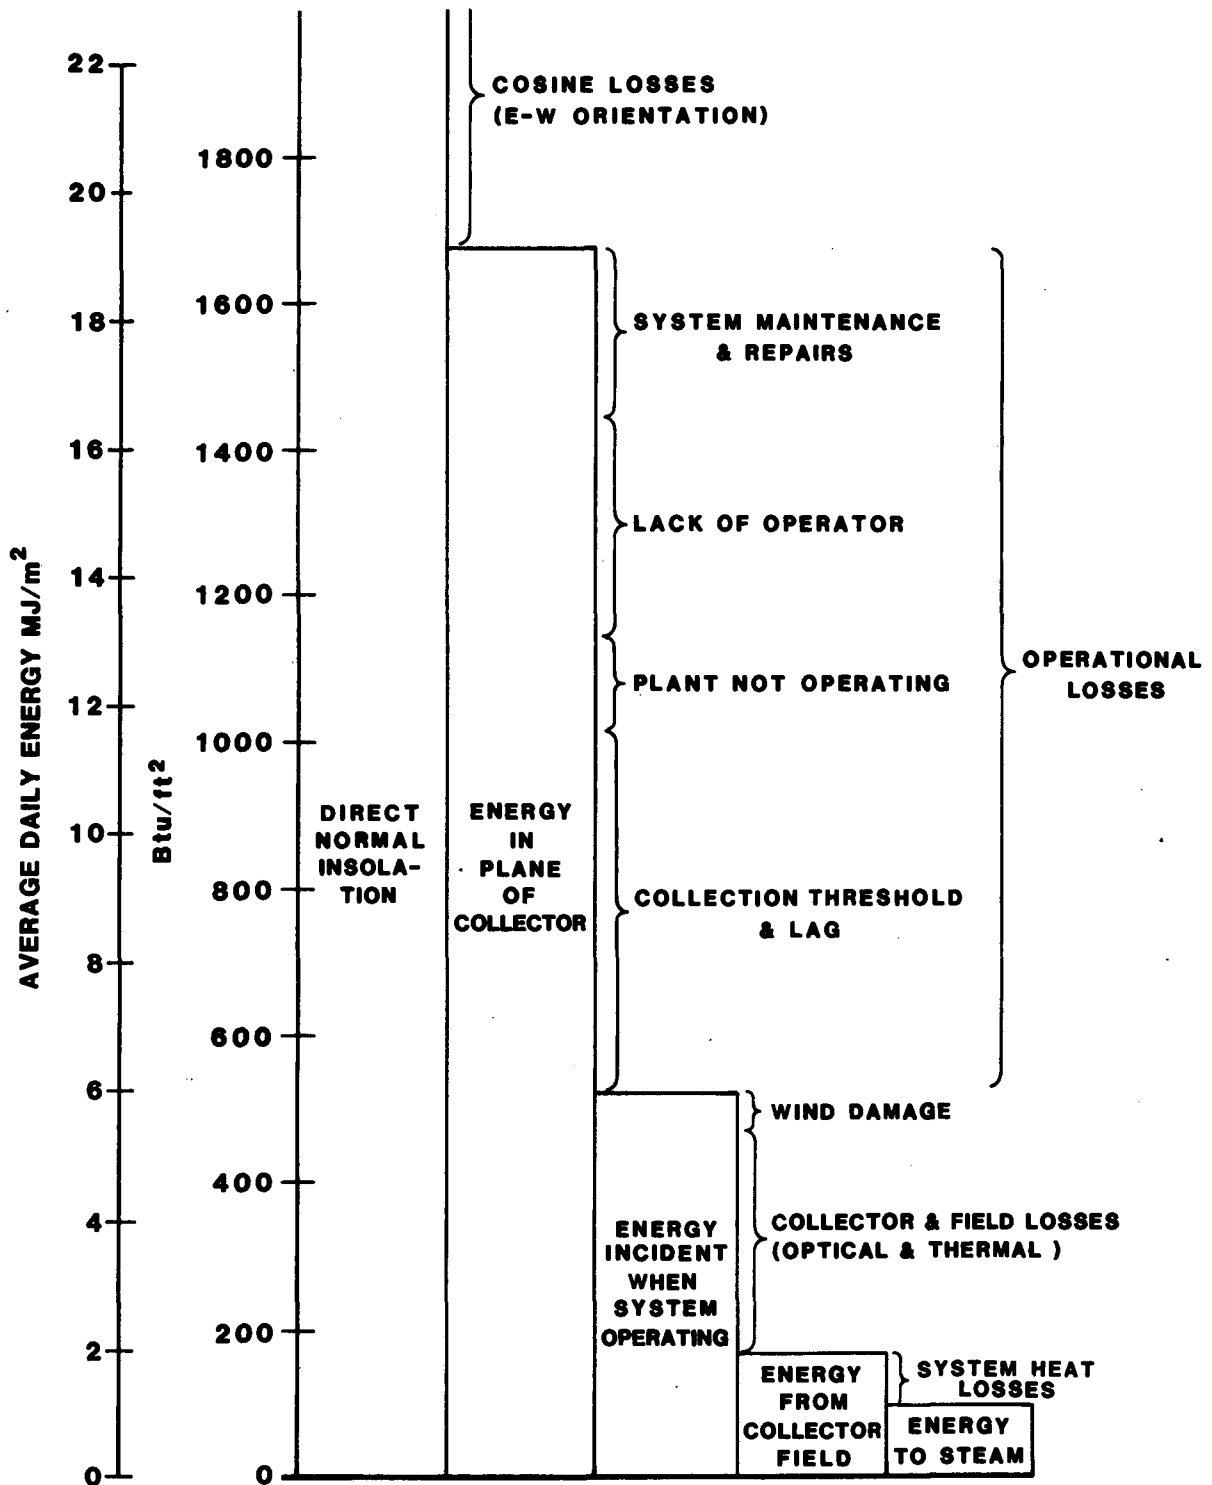
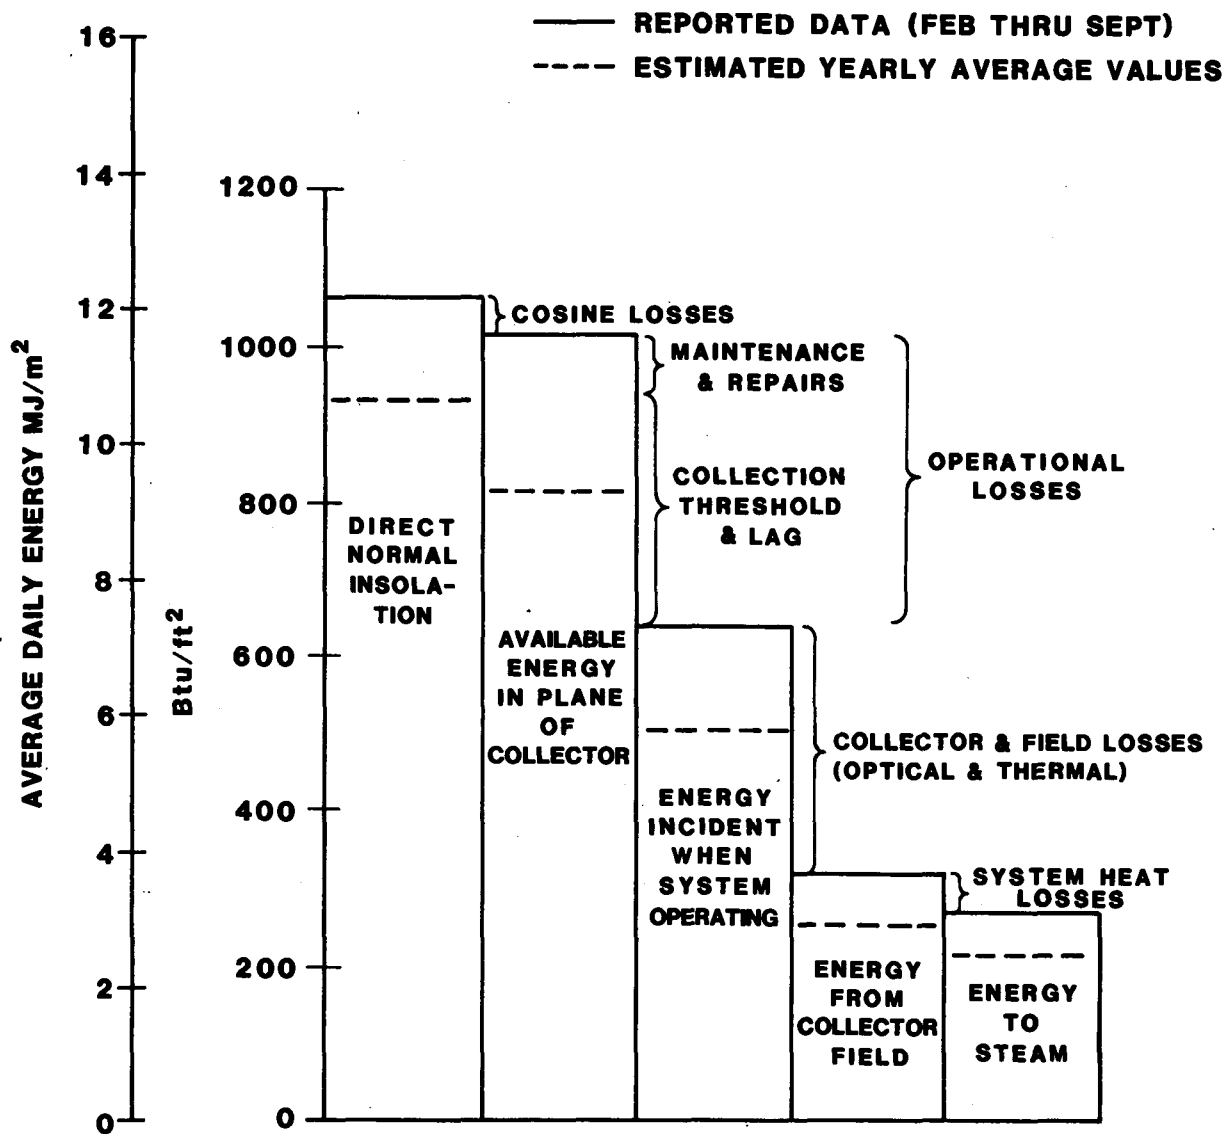
Figure 2-3. System Losses - Caterpillar Tractor Co.

Figure 2-4. System Losses - Dow Chemical Co.

Figure 2-5. System Losses - Home Laundry

Figure 2-6. System Losses - Lone Star Brewery

Figure 2-7. System Losses - Ore-Ida Foods

Figure 2-8. System Losses - Southern Union Refining Co.

Figure 2-9. System Losses - USS Chemicals Co.

Operational losses are high in three systems--Home Laundry, Southern Union Refining Co. and Caterpillar Tractor. High operational losses for Home Laundry occurred because of early afternoon plant shutdown and lack of weekend operation. Caterpillar Tractor has somewhat similar time restrictions on demand due to reductions in work schedules during FY 1983. Demand was also low during operational periods, which required a major portion of the system to be deactivated. High operational losses for Southern Union Refining Co. were caused largely by system failures and occasional unavailability of an operator to turn the system on and to monitor its operation.

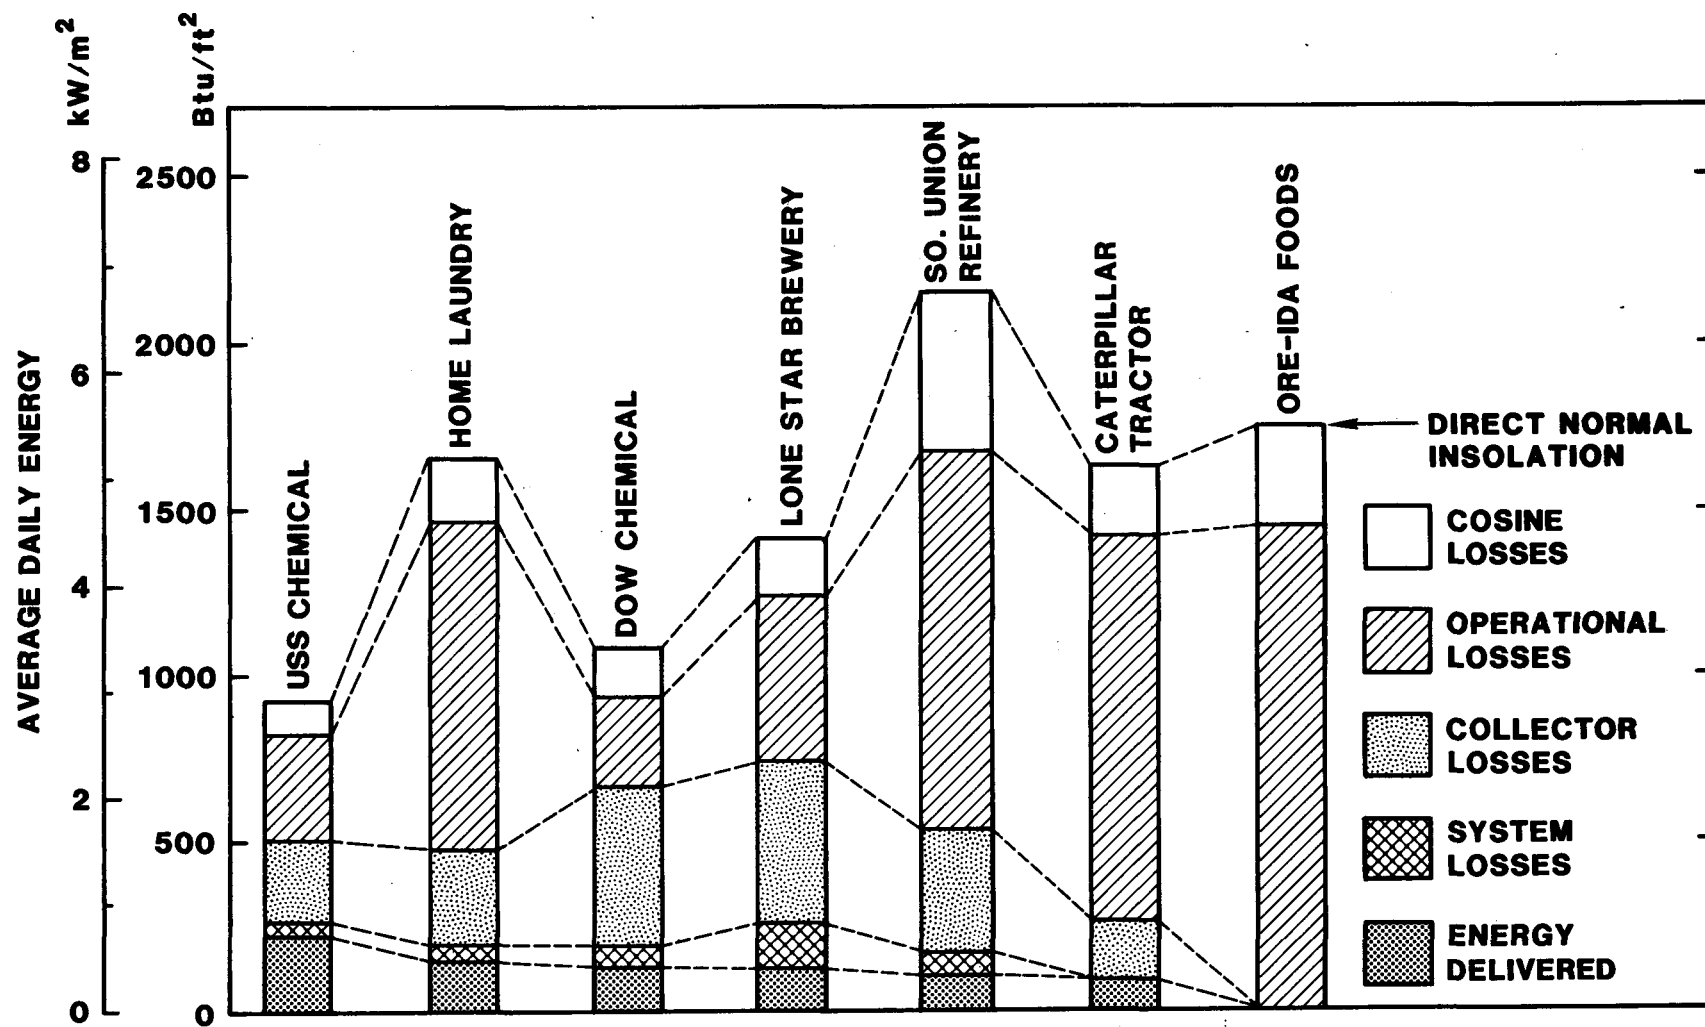
Figure 2-11. Summary Comparison of Measured System Performance

Collector losses are similar for most systems, ranging between 50% and 70% of the energy incident while operating.
