Solar Industrial Process Heat (IPH) Project Technical Report October 1982-September 1983

E. L. Harley, W. B. Stine

This document contains a report of the work performed in the Solar Industrial Process Heat Project during FY 1983. The work involved eighteen industrial process heat experiments originally funded by the Department of Energy (DOE) under two separate programs. During FY 1983, eight of the experiments were in the operational phase directly supported by the DOE, seven had been completed previously and the solar equipment had been transferred to the plant owners for continued operation, and three had been discontinued.

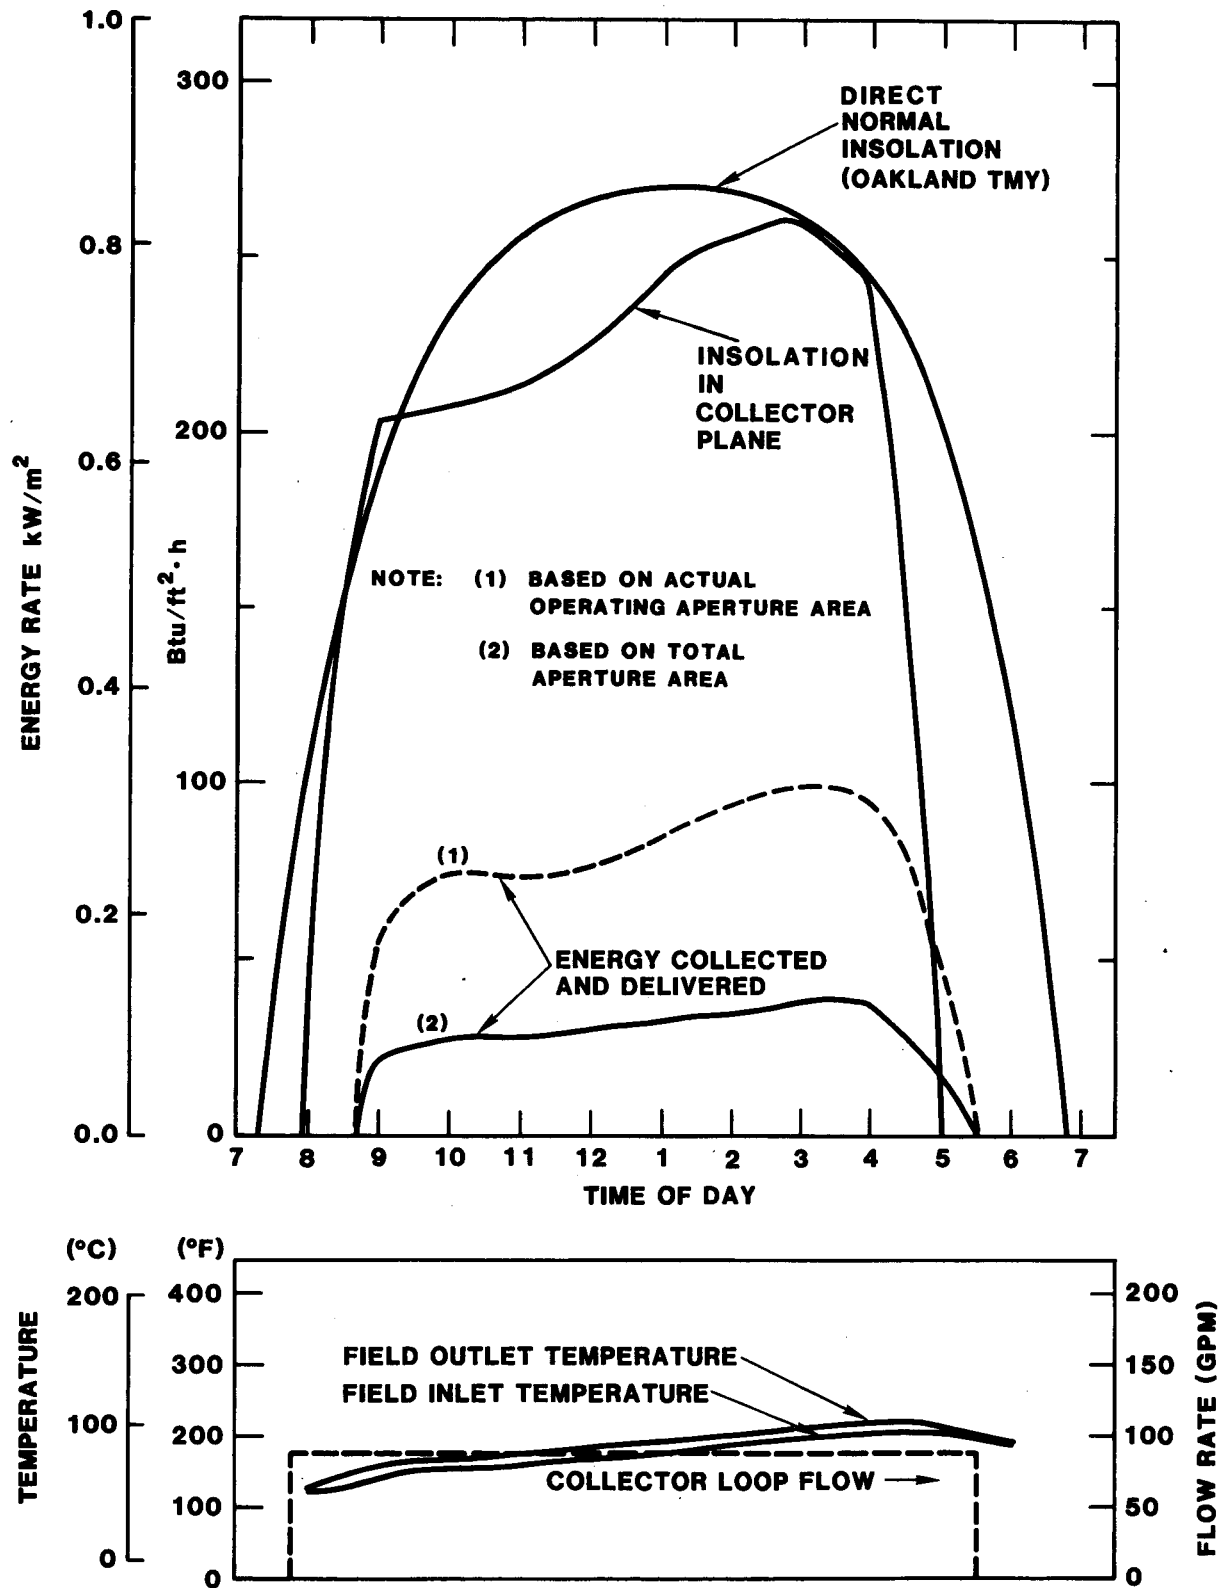
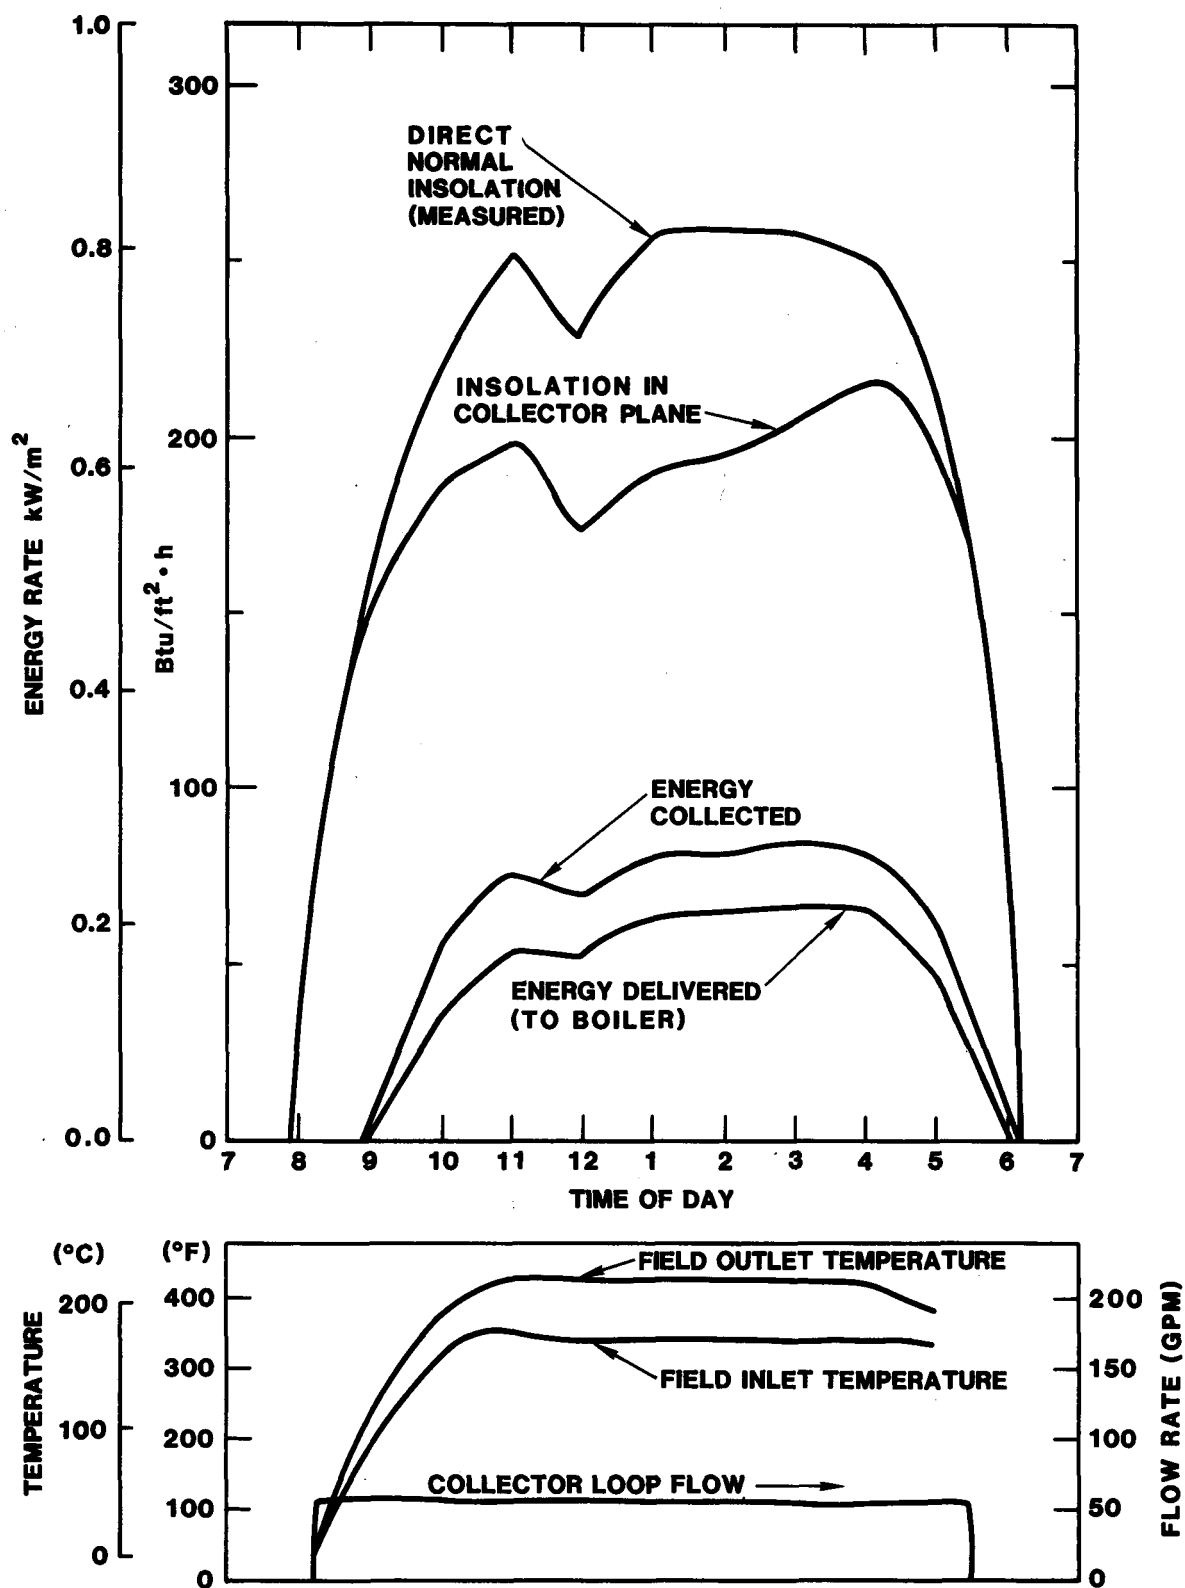
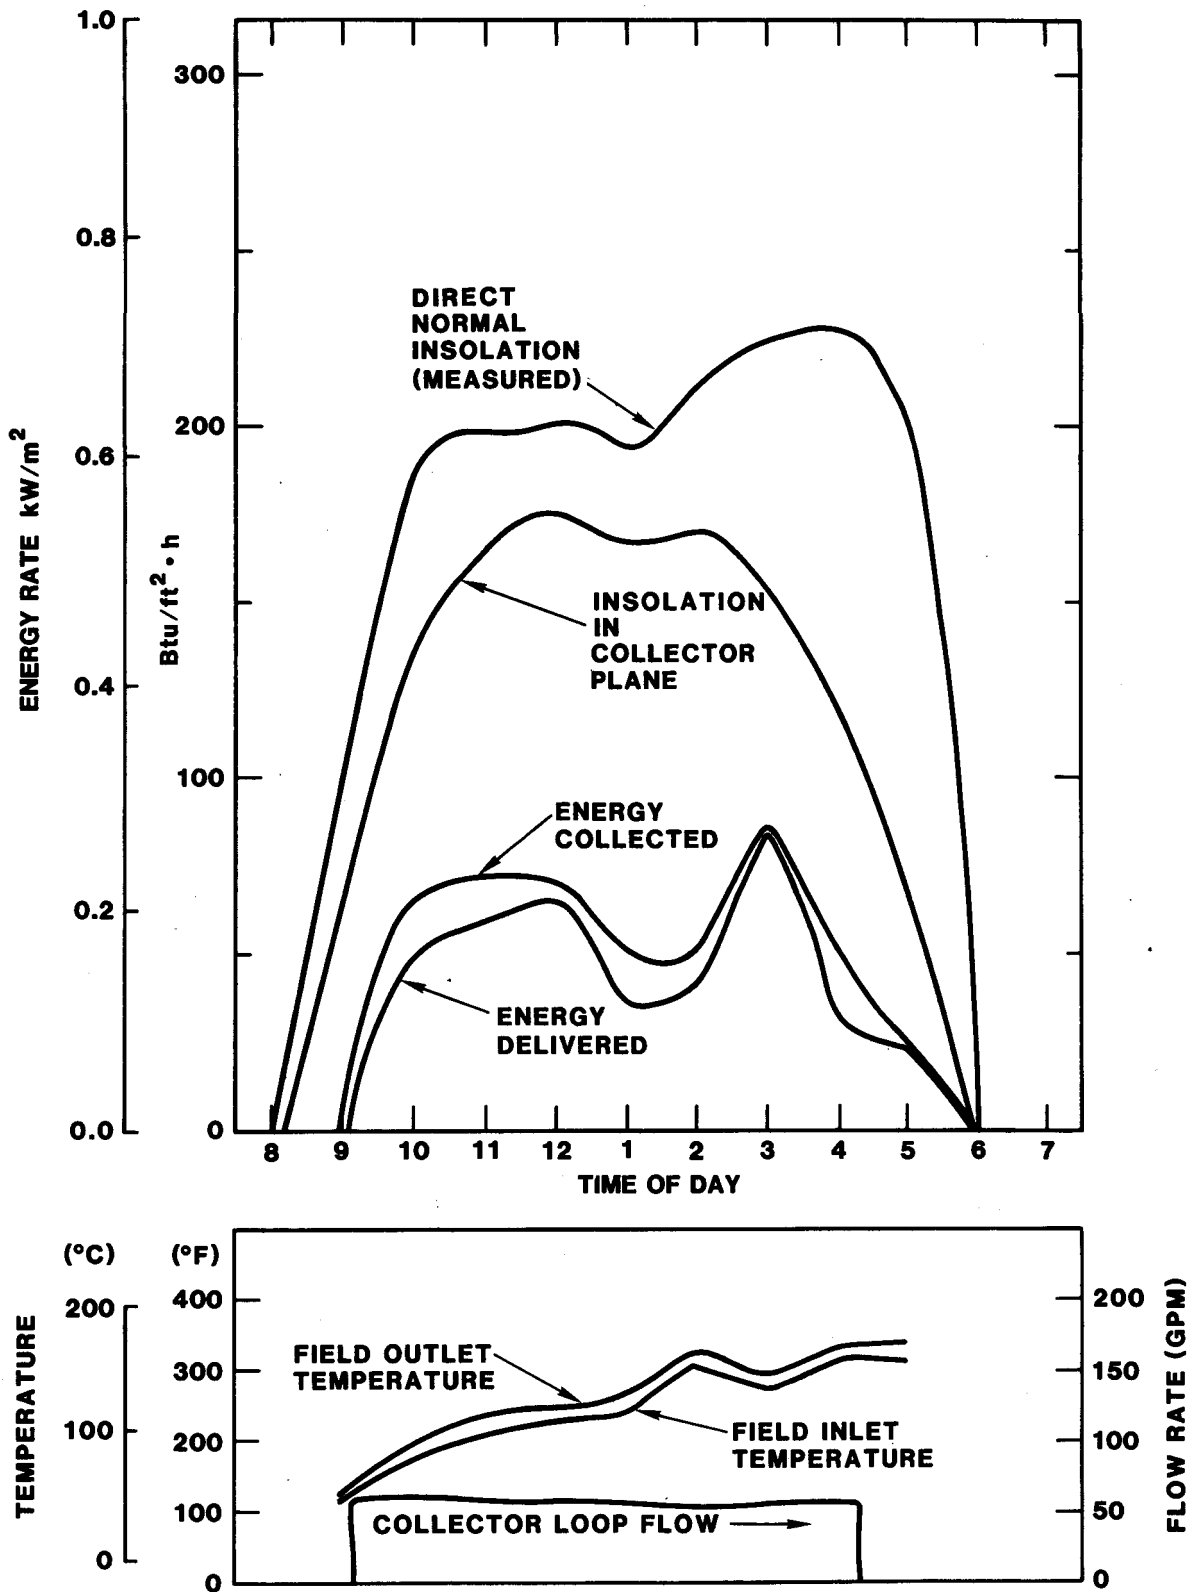
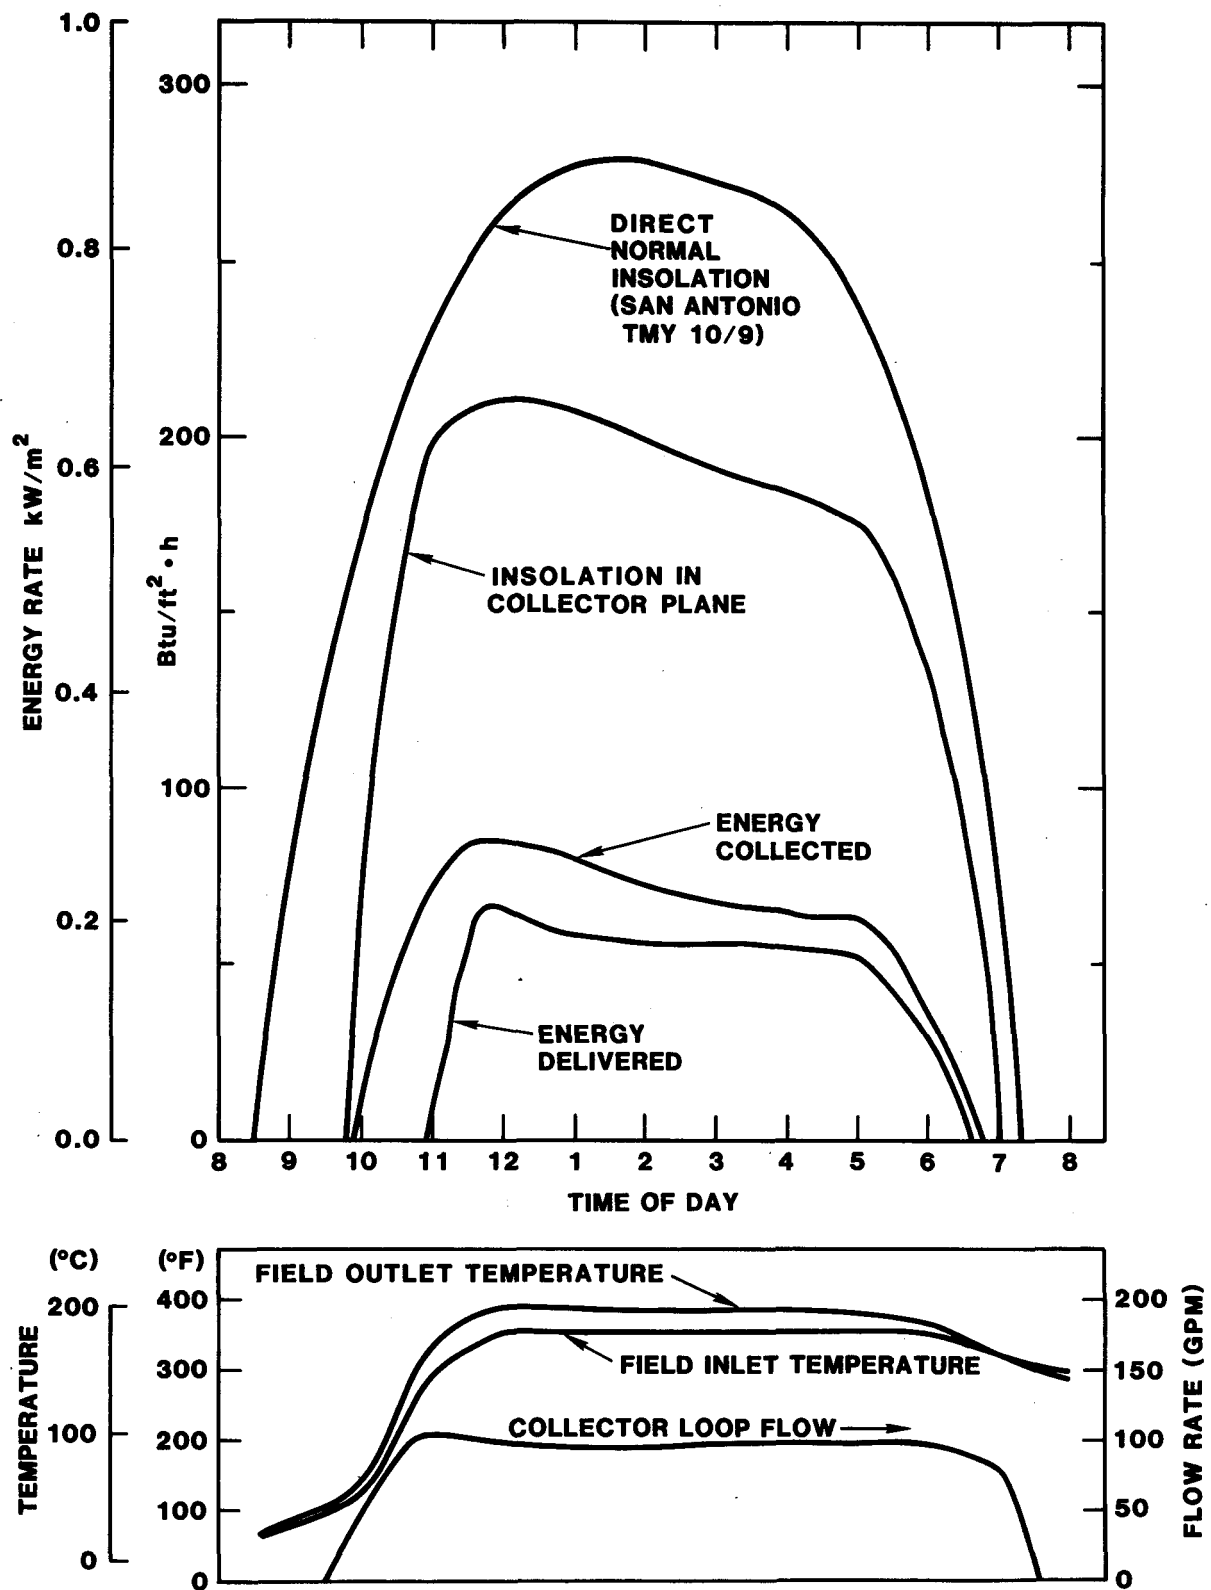
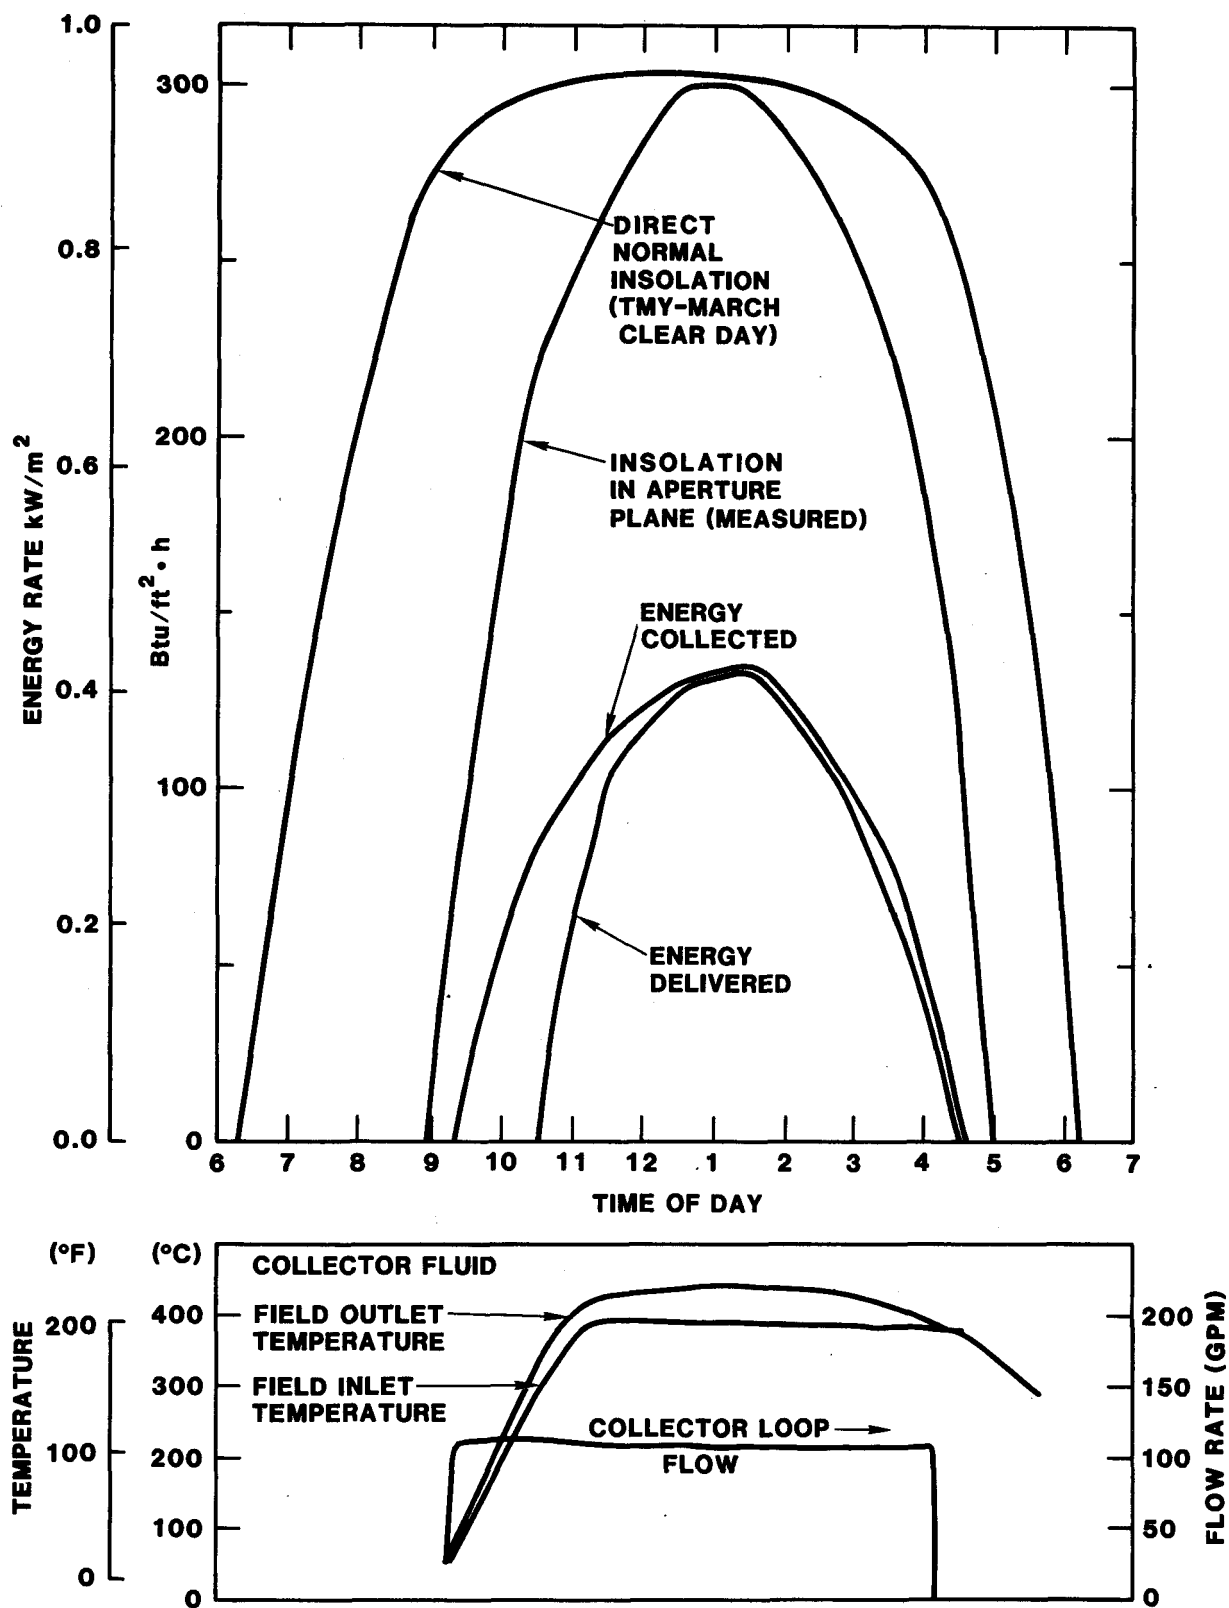
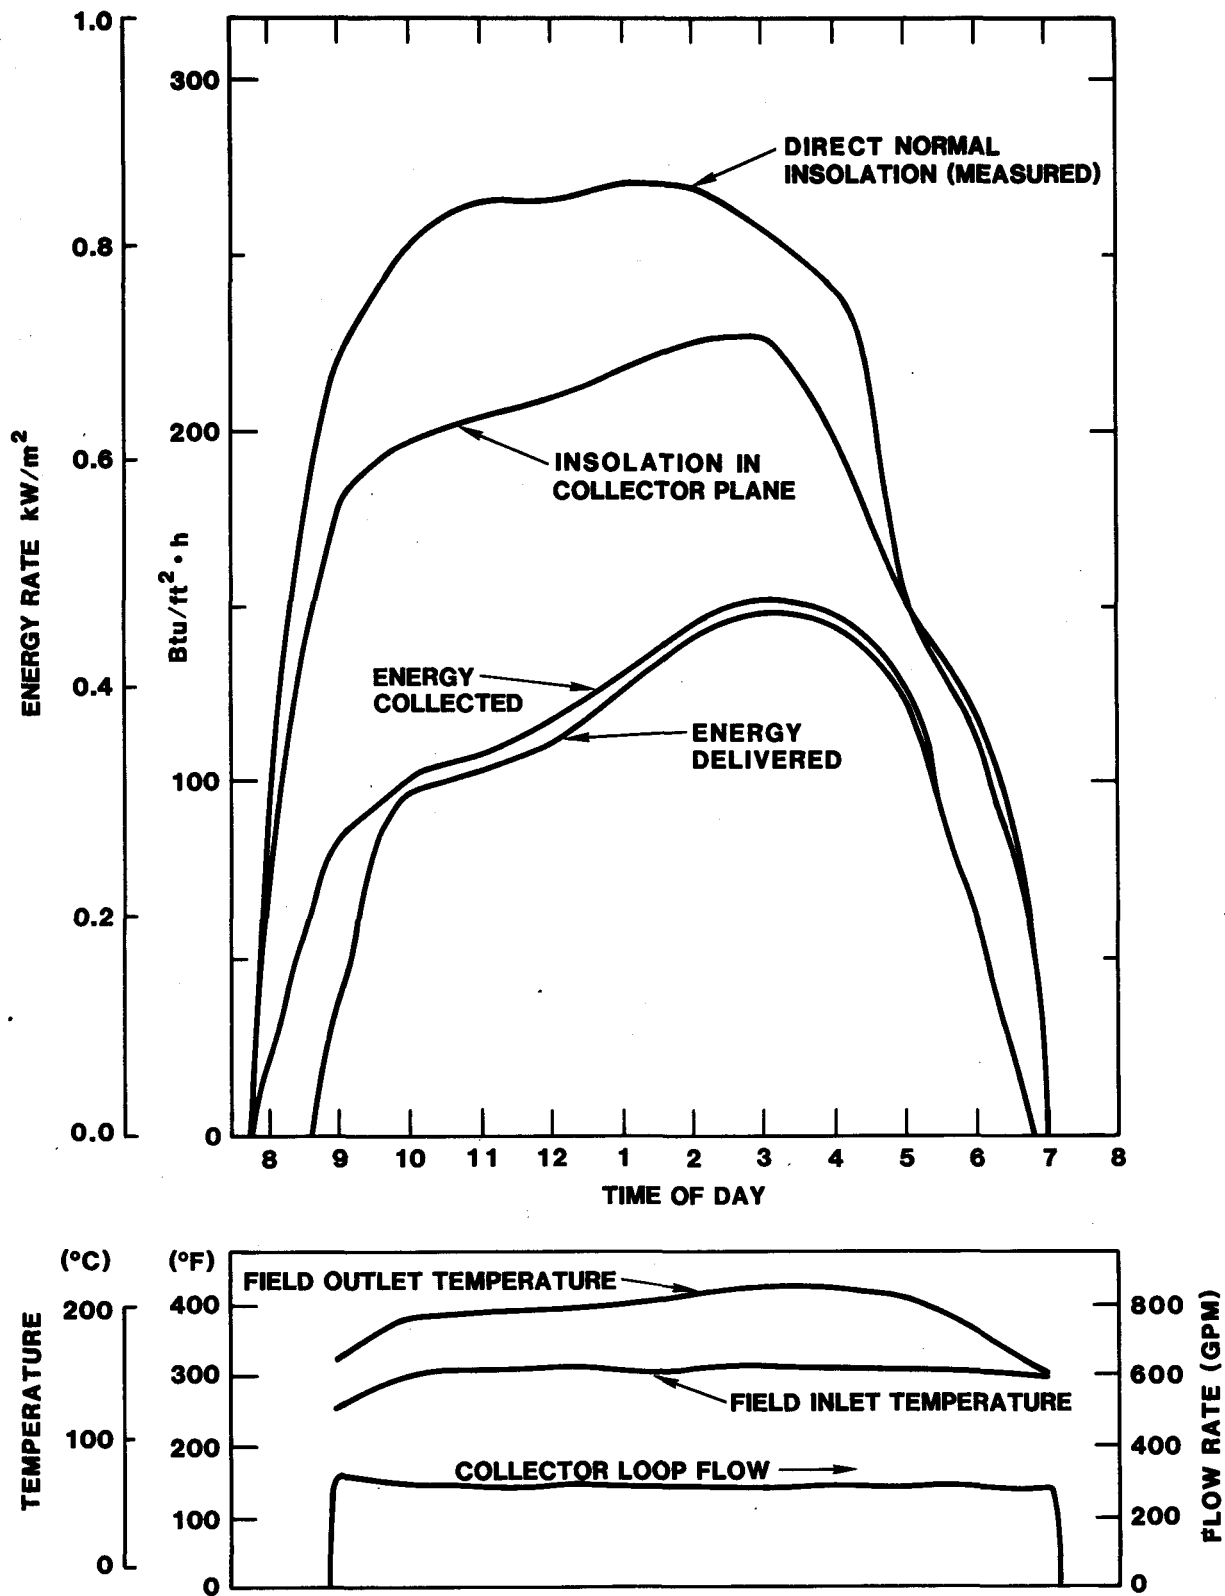
Figure 2-12. Clear-Day Performance - September 11, 1983 - Caterpillar Tractor Co.

Figure 2-13. Clear-Day Performance - March 2, 1983 - Dow Chemical Co.

Figure 2-14. Clear-Day Performance - September 7, 1983 - Home Laundry

Figure 2-15. Clear-Day Performance - October 24, 1983 - Lone Star Brewery

Figure 2-16. Clear-Day Performance - March 10, 1983 - Southern Union Refining Co.

Figure 2-17. Clear-Day Performance - September 8, 1983 - USS Chemicals Co.

An asymmetry in the beam energy incident in the collector plane is evident for most of the systems. It probably is caused by a misalignment of the tracking system, which improves in either the morning or the afternoon, and by offsets of the tracking axes from true north-south for some systems. The dip at noontime for all the systems except Southern Union Refining

Co. is due to their north-south tracking axis orientation, which produces maximum cosine losses at noontime. The Southern Union collectors are oriented in the east-west direction and therefore have the lowest (zero) cosine loss at noon.

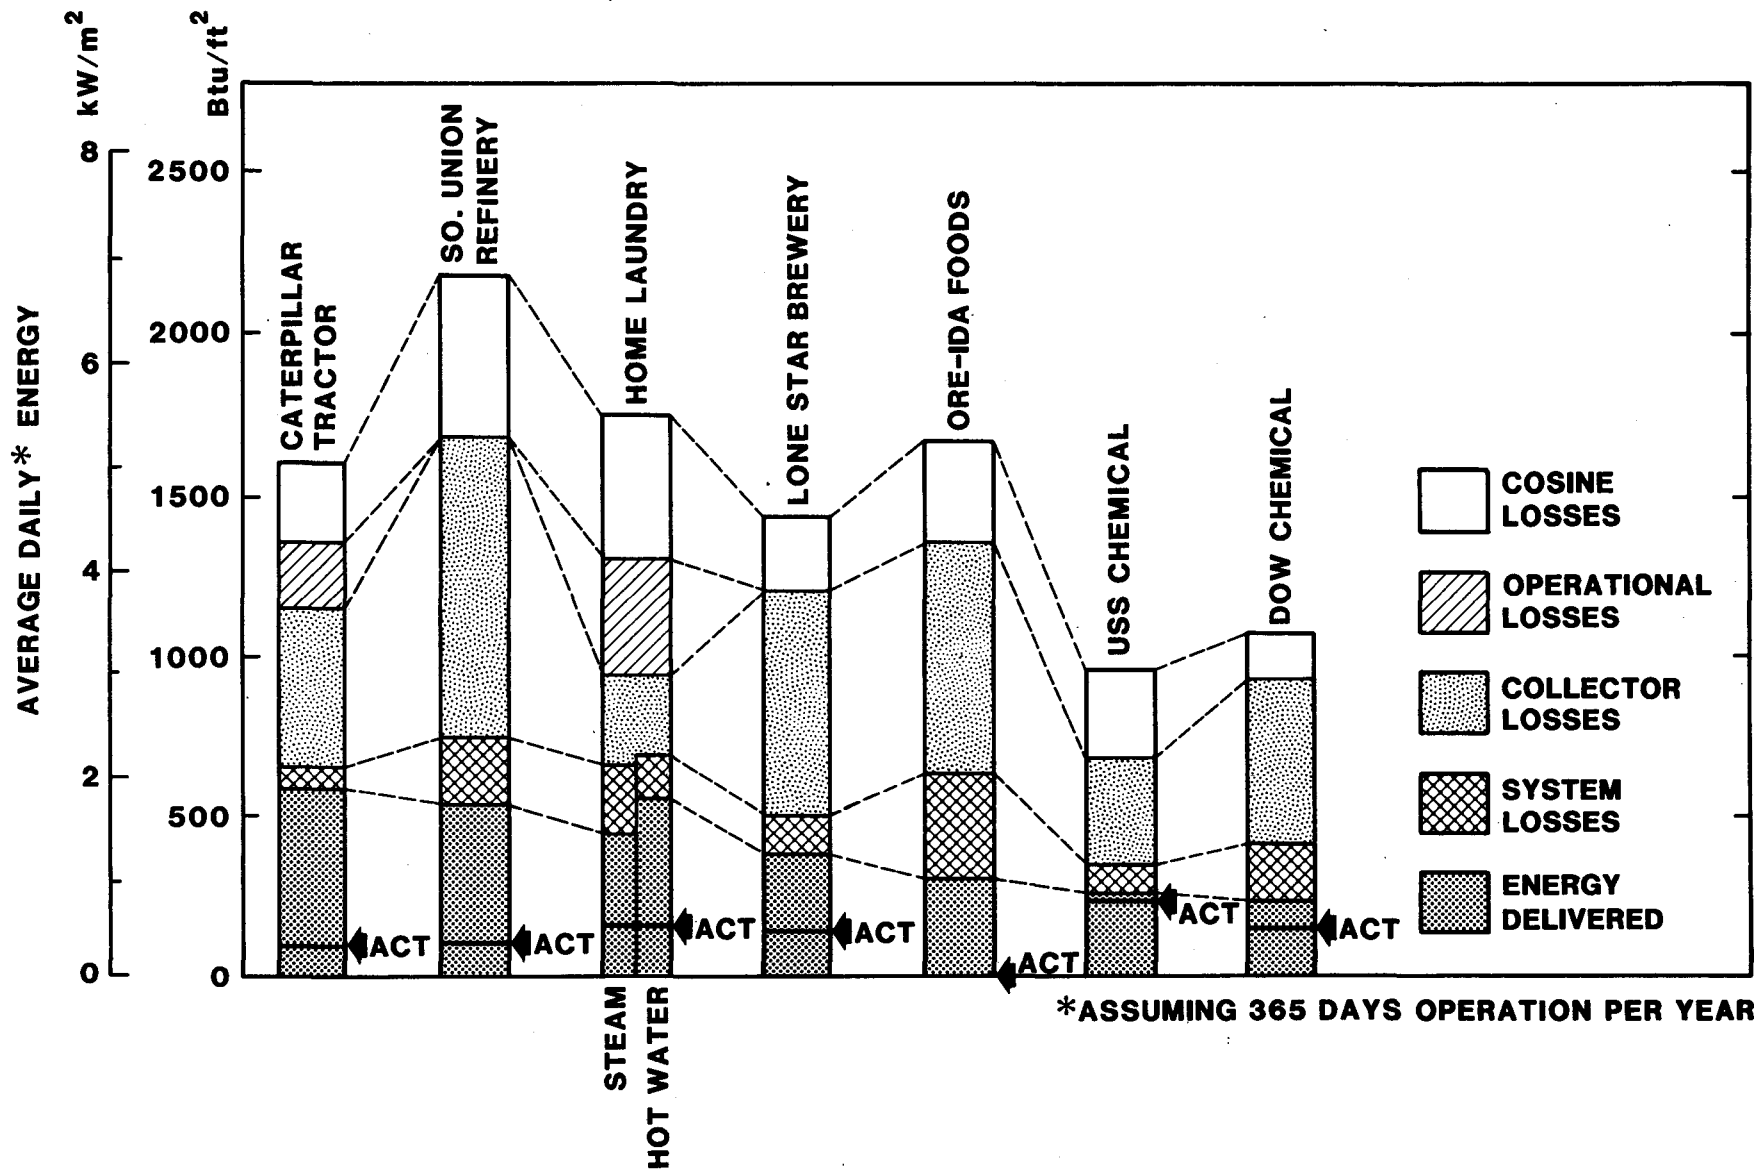
Figure 3-1. Annual Predicted Performance
