Solar Industrial Process Heat (IPH) Project Technical Report October 1982-September 1983

E. L. Harley, W. B. Stine

This document contains a report of the work performed in the Solar Industrial Process Heat Project during FY 1983. The work involved eighteen industrial process heat experiments originally funded by the Department of Energy (DOE) under two separate programs. During FY 1983, eight of the experiments were in the operational phase directly supported by the DOE, seven had been completed previously and the solar equipment had been transferred to the plant owners for continued operation, and three had been discontinued.

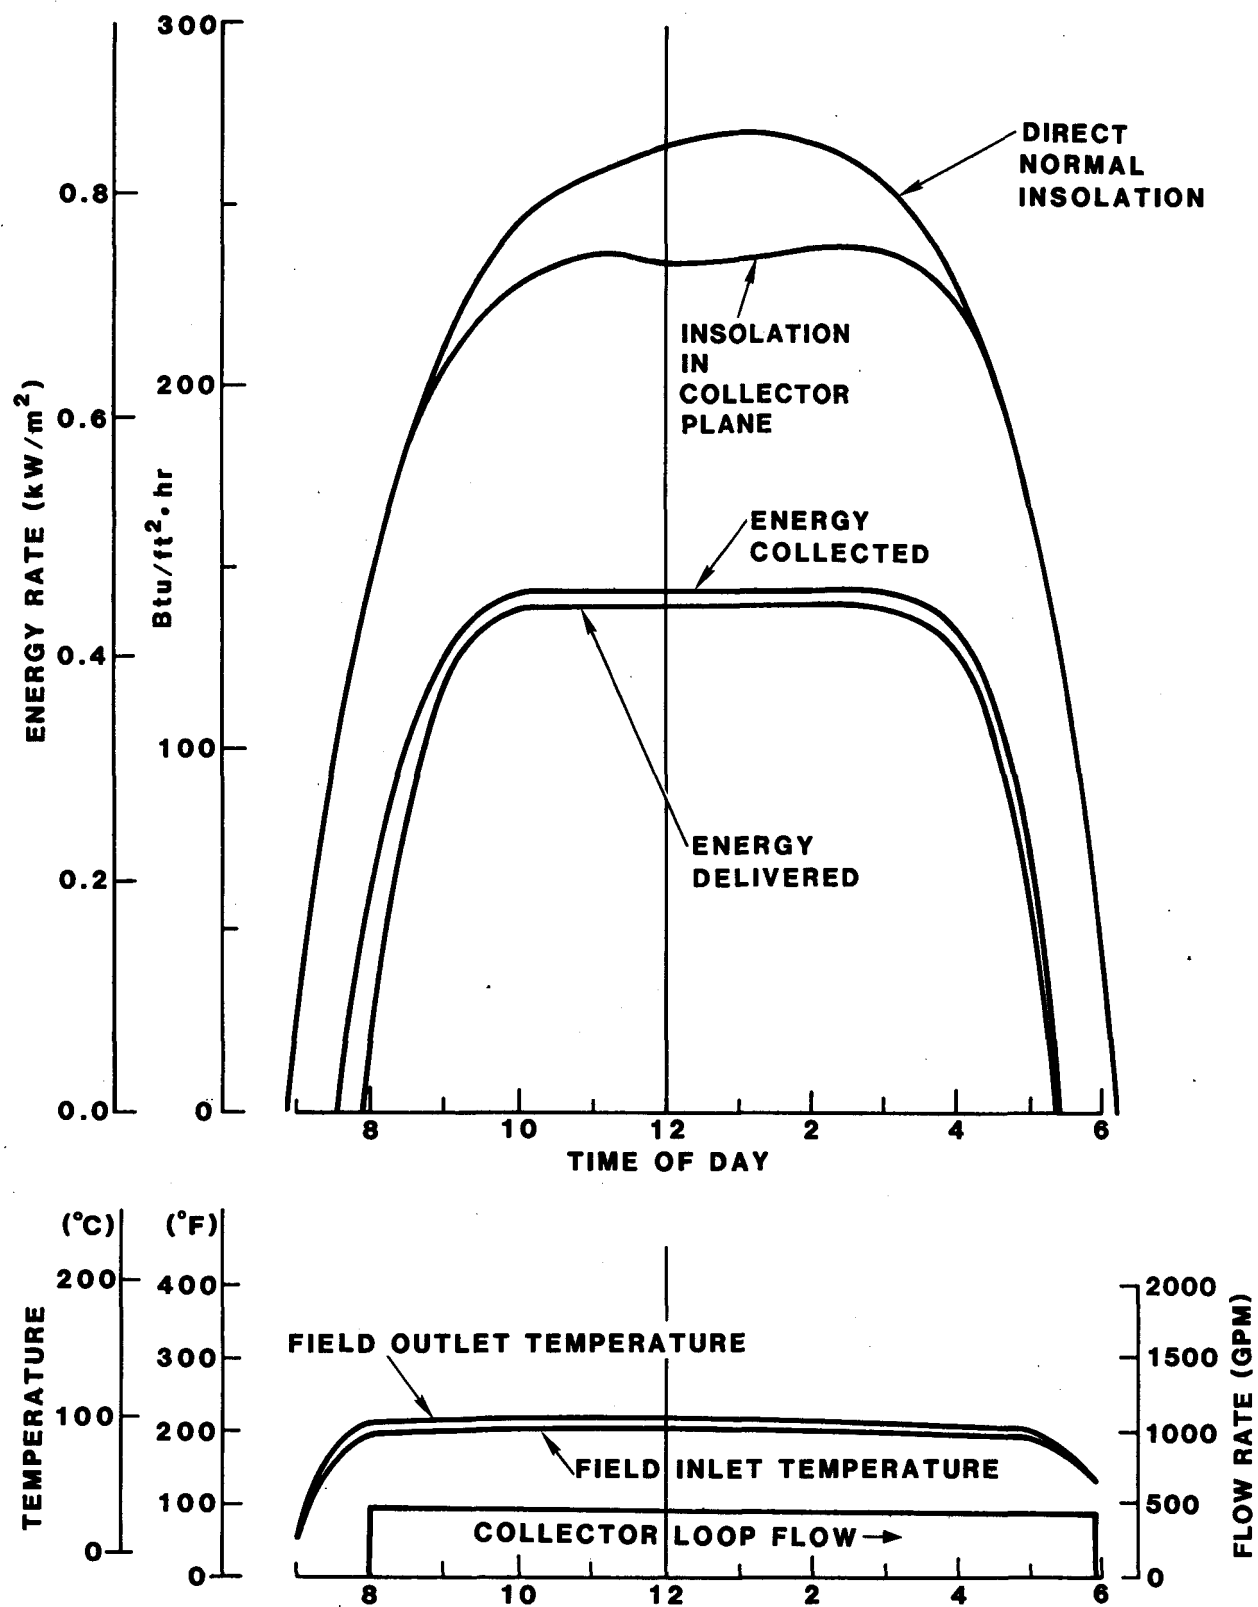
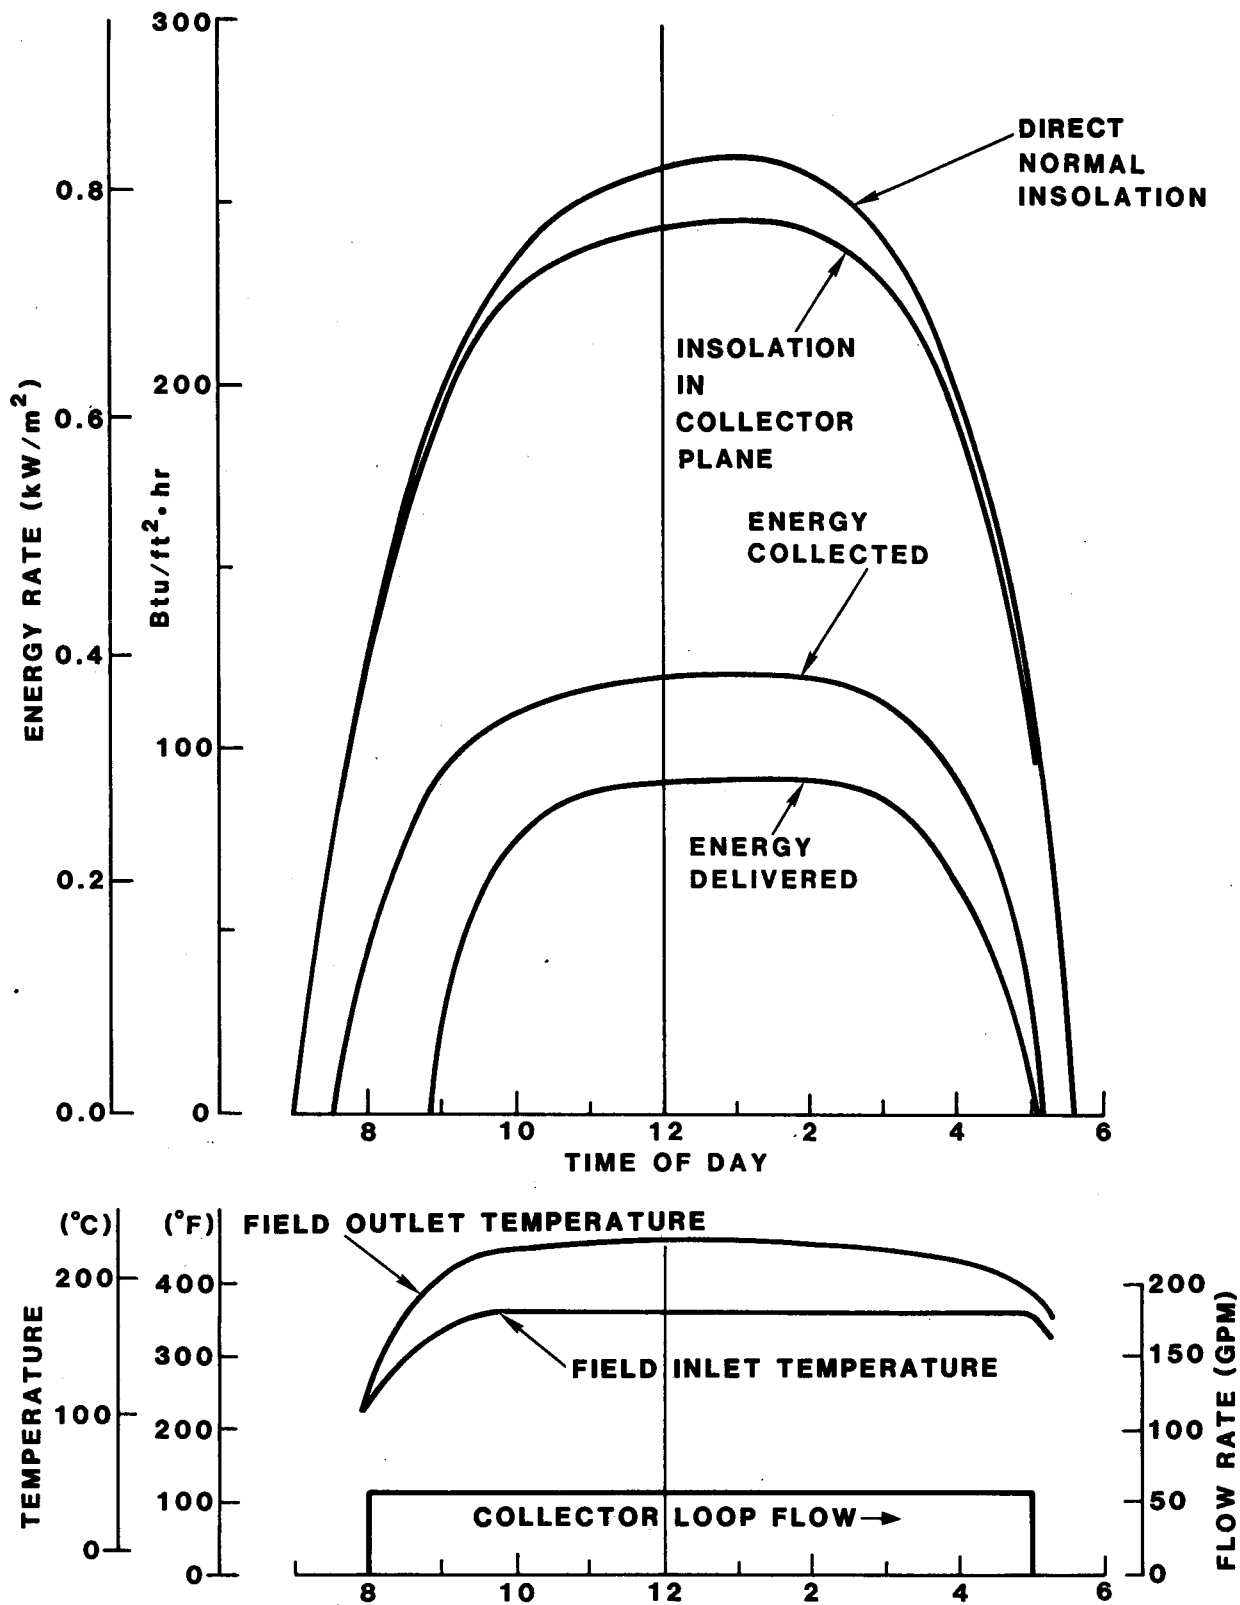
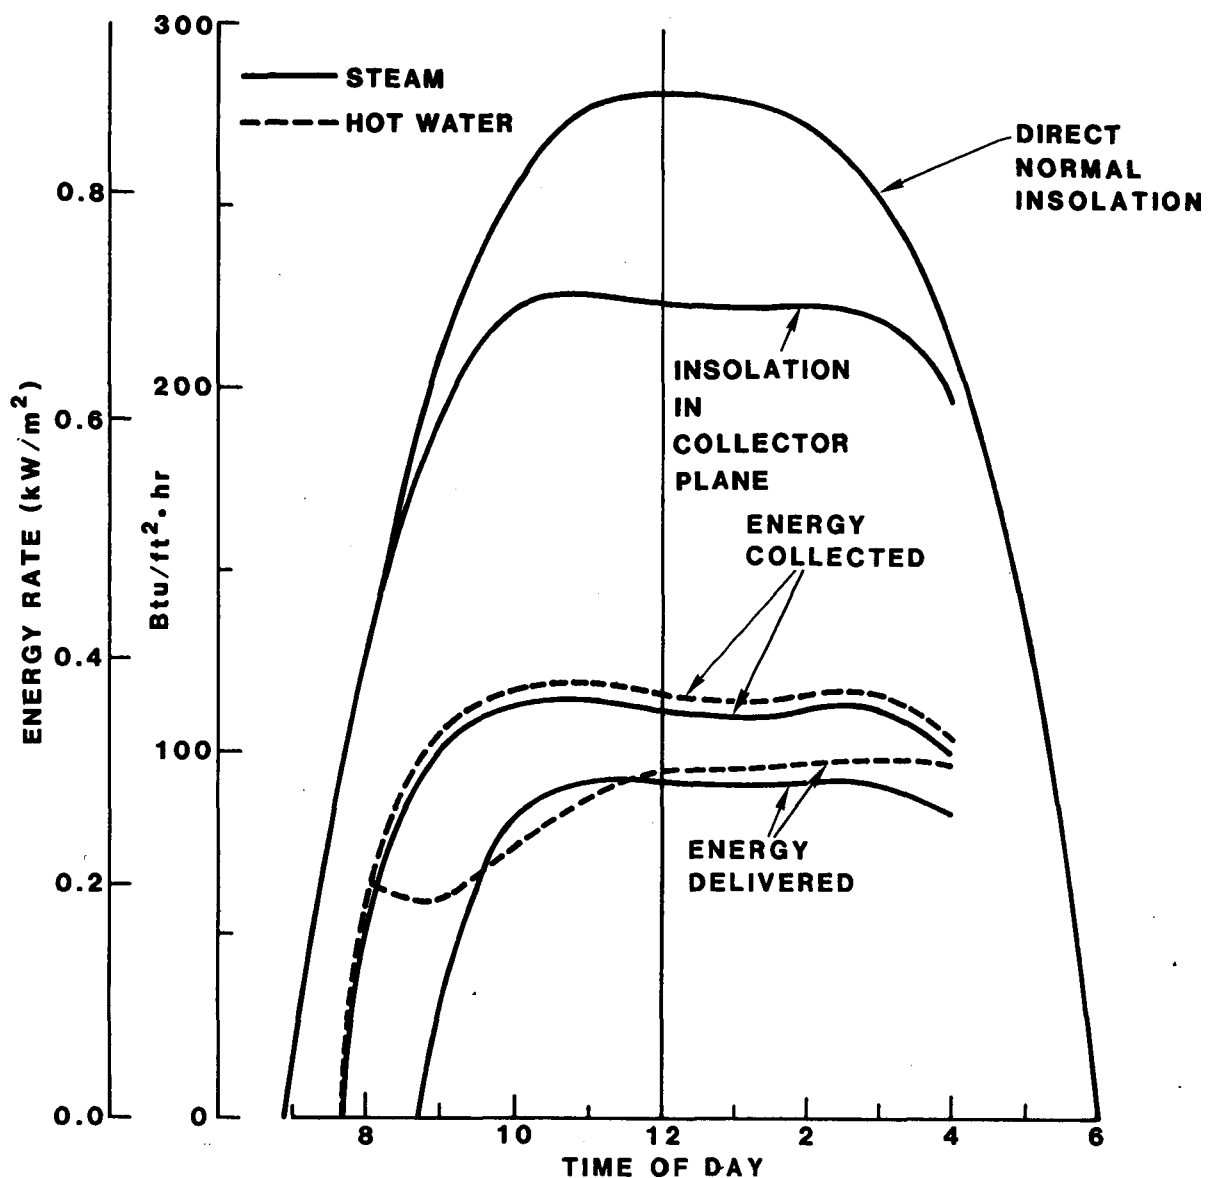
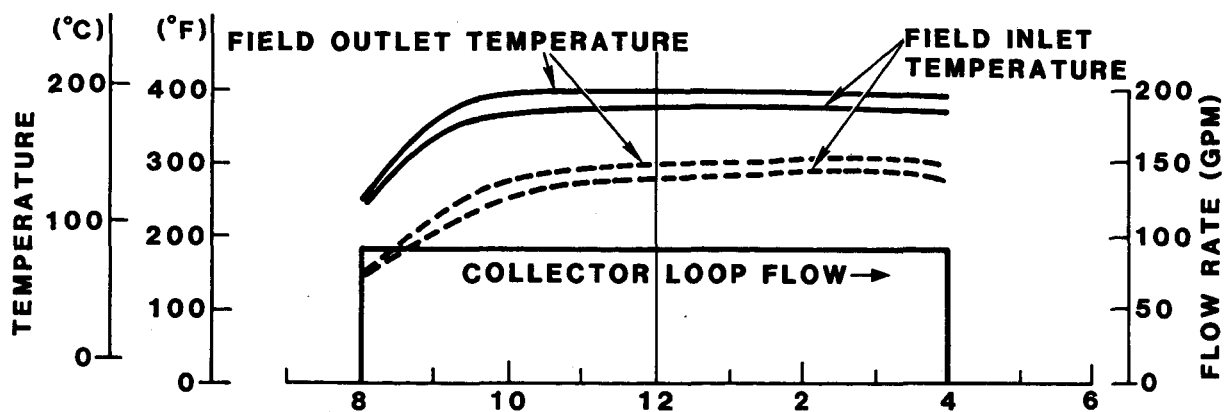
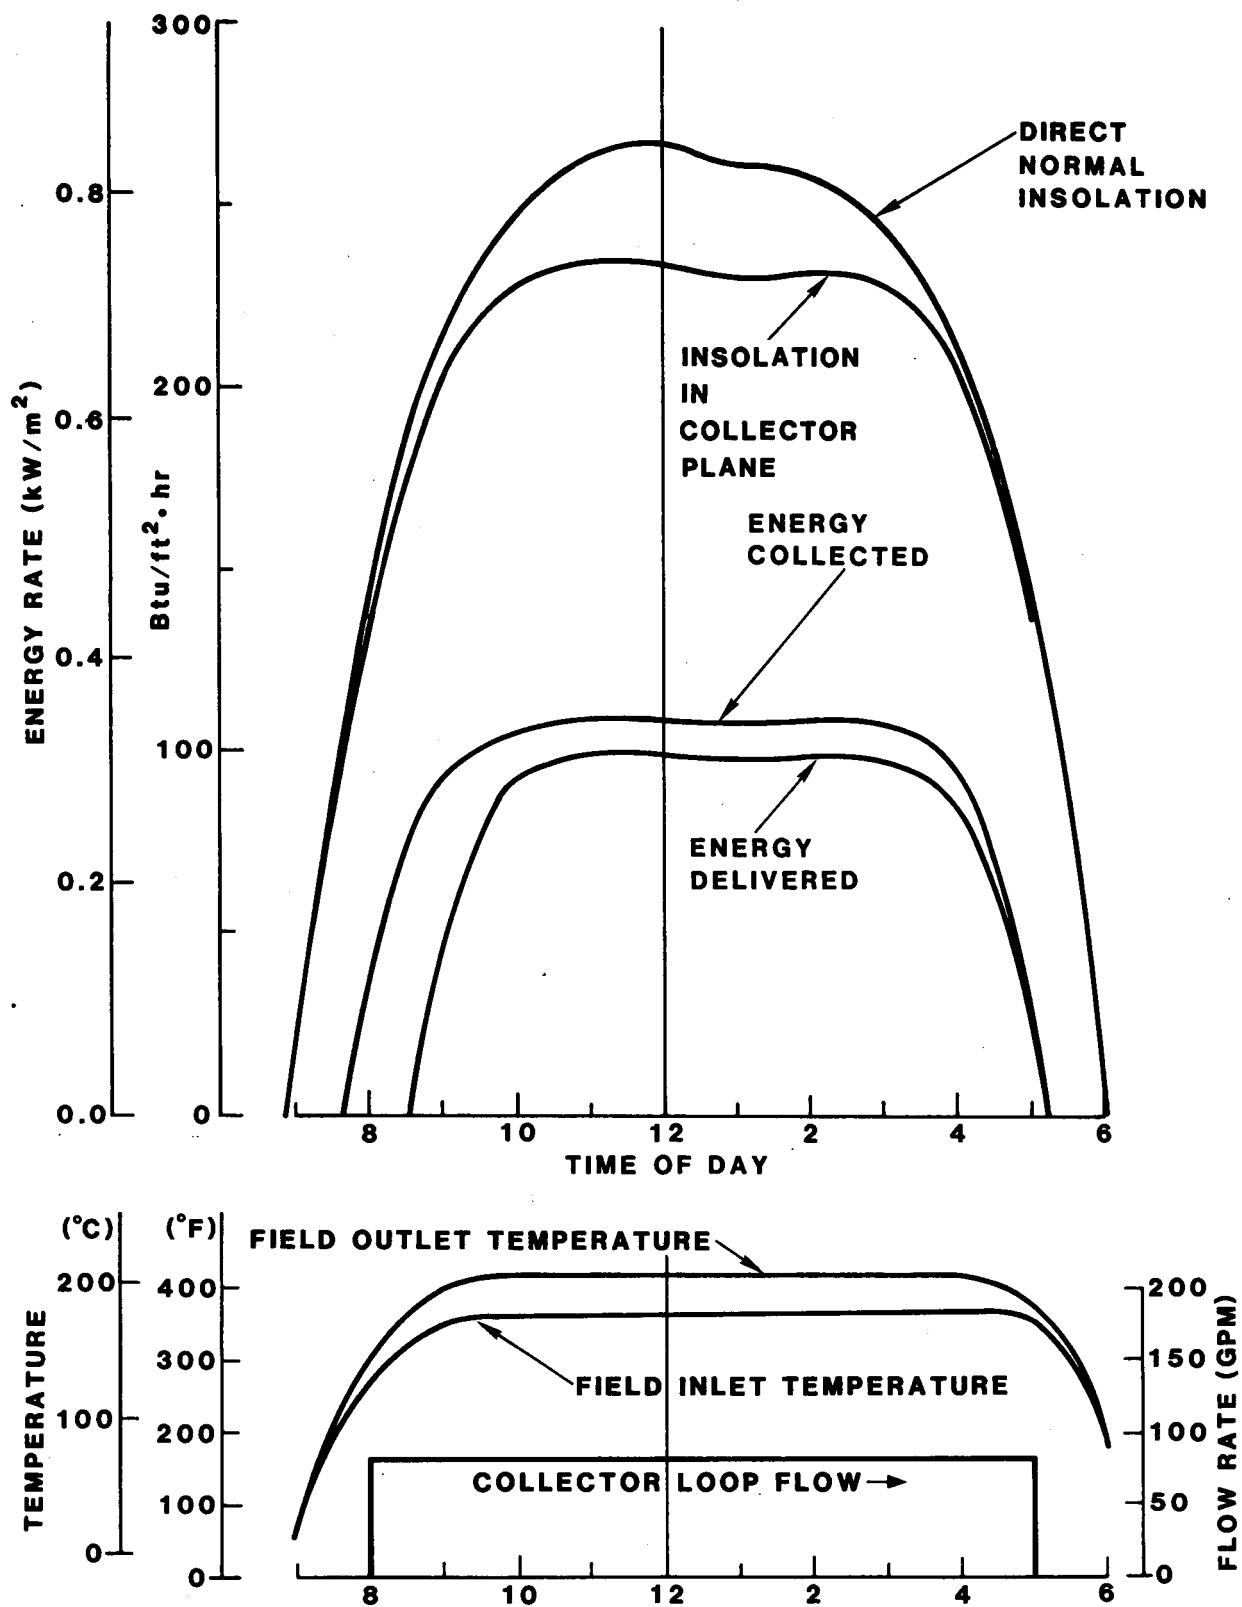
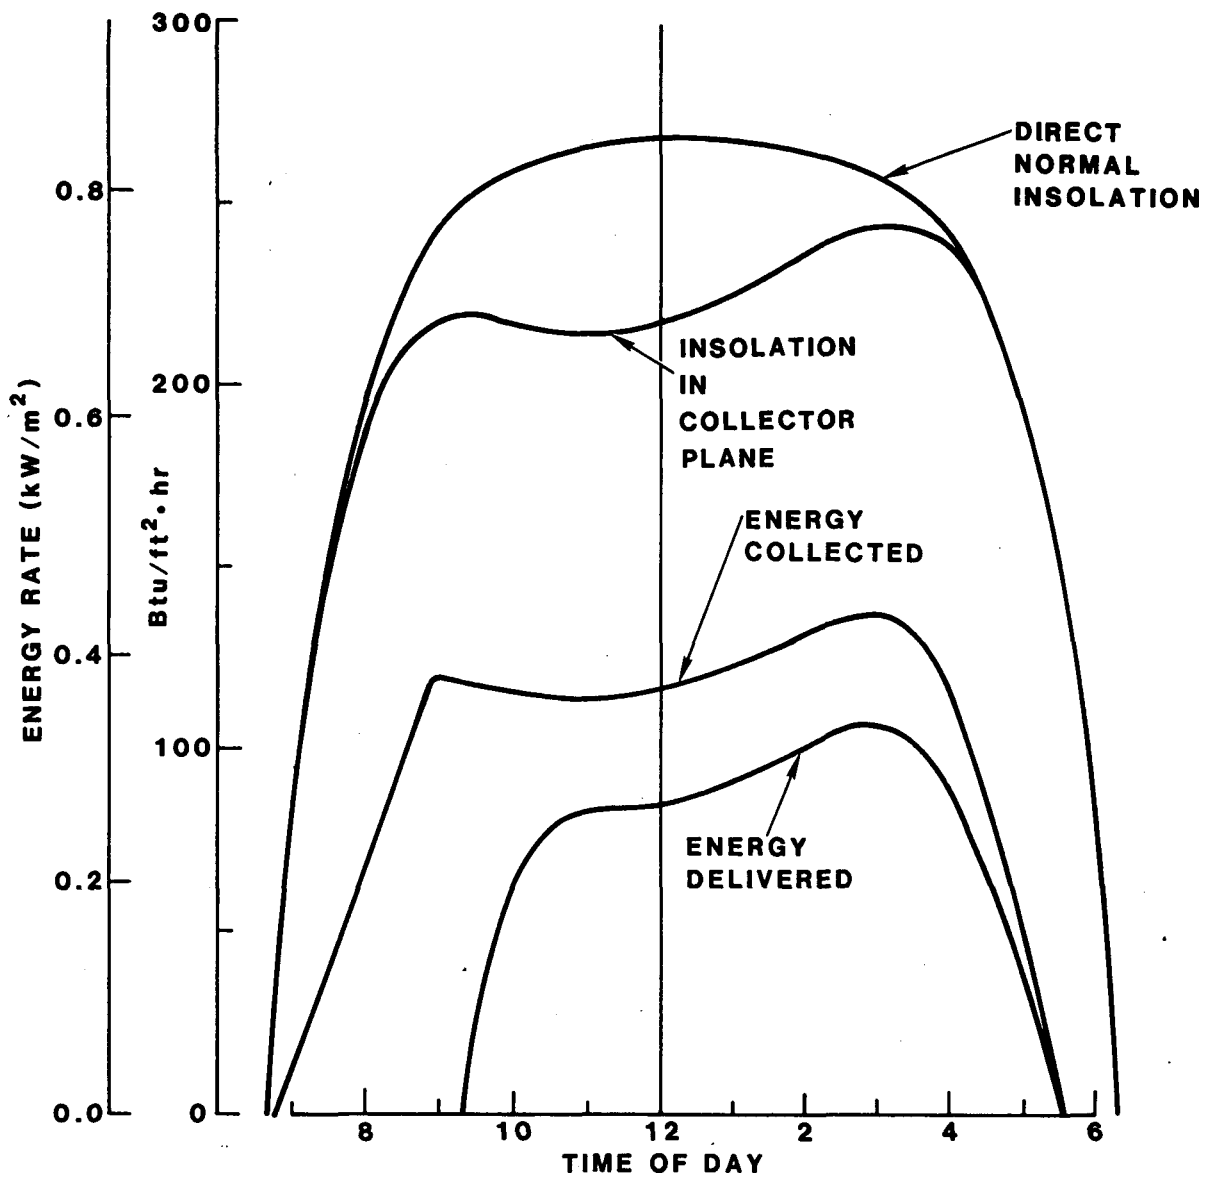
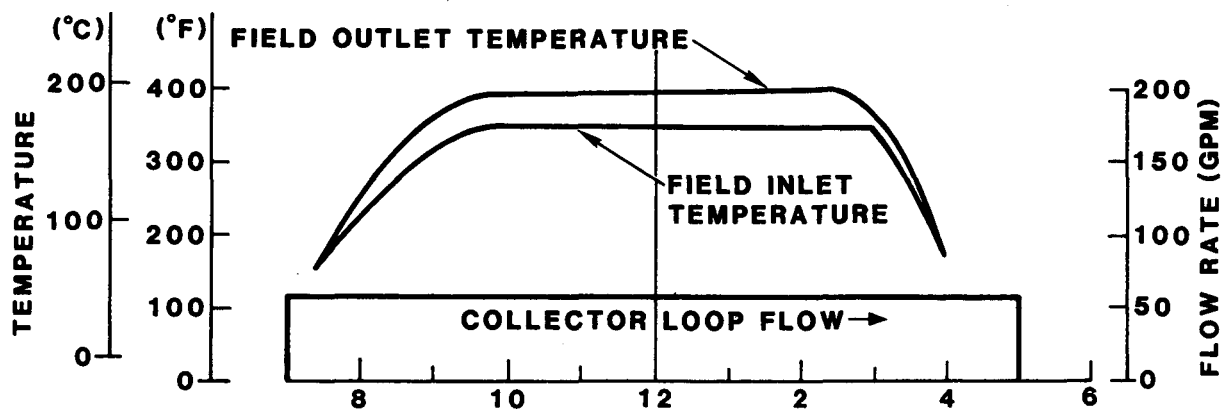
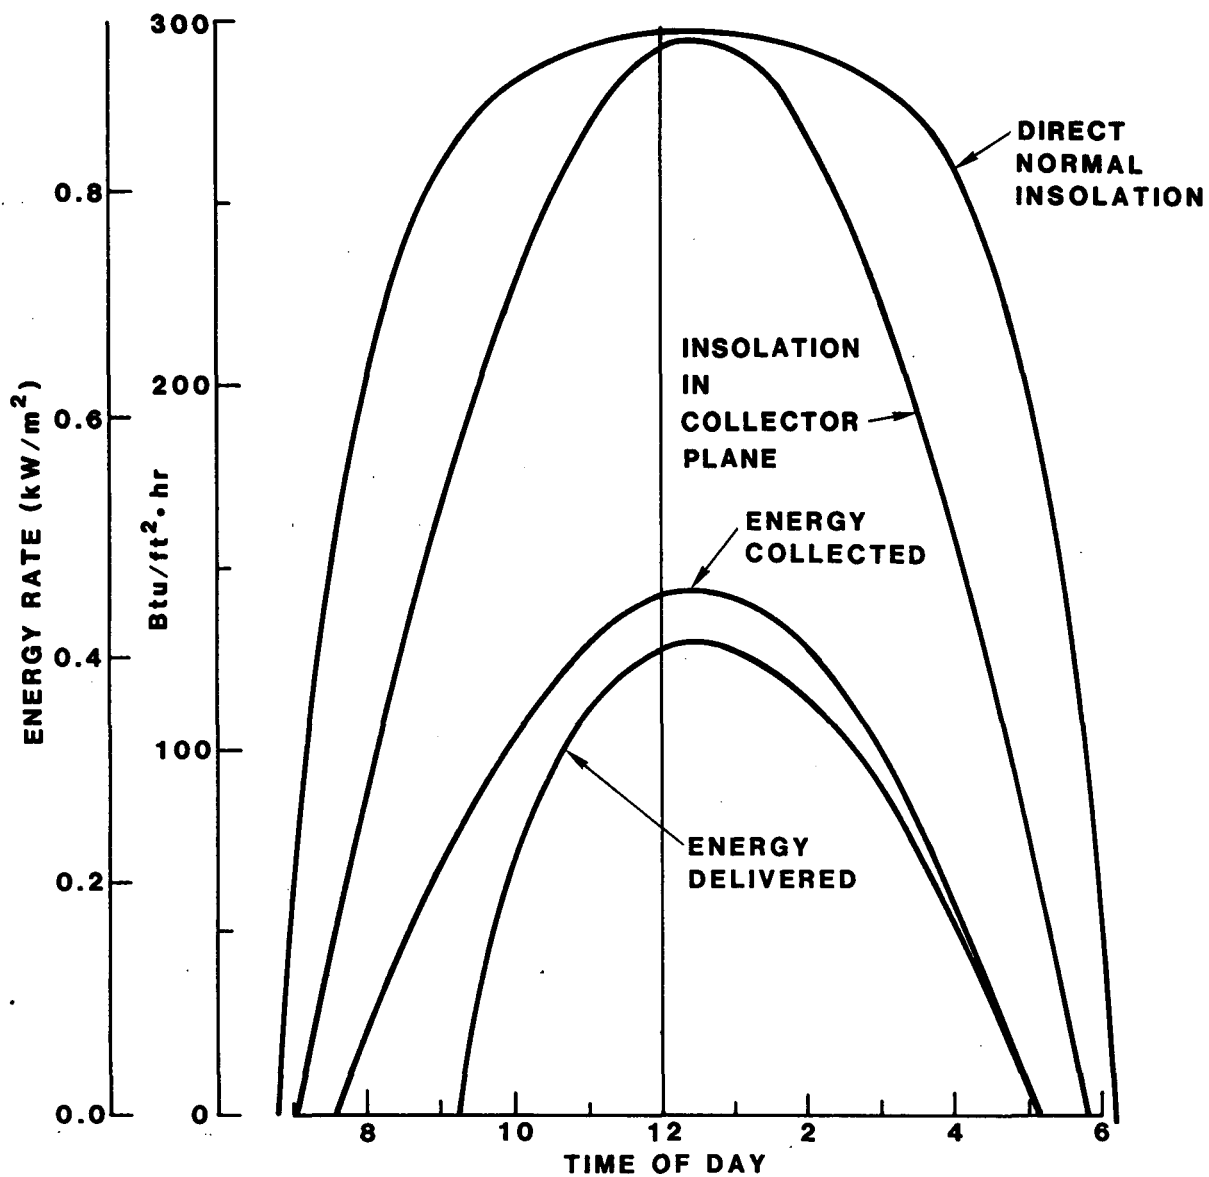
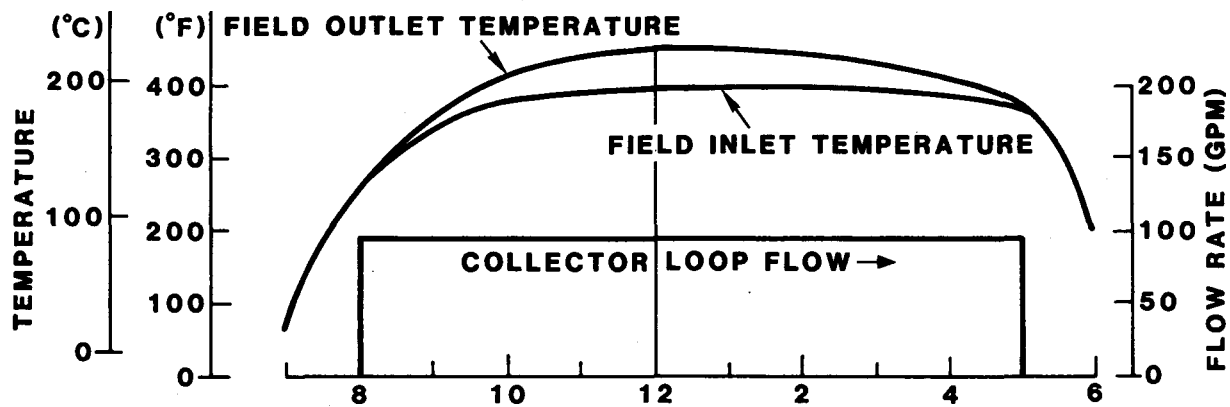
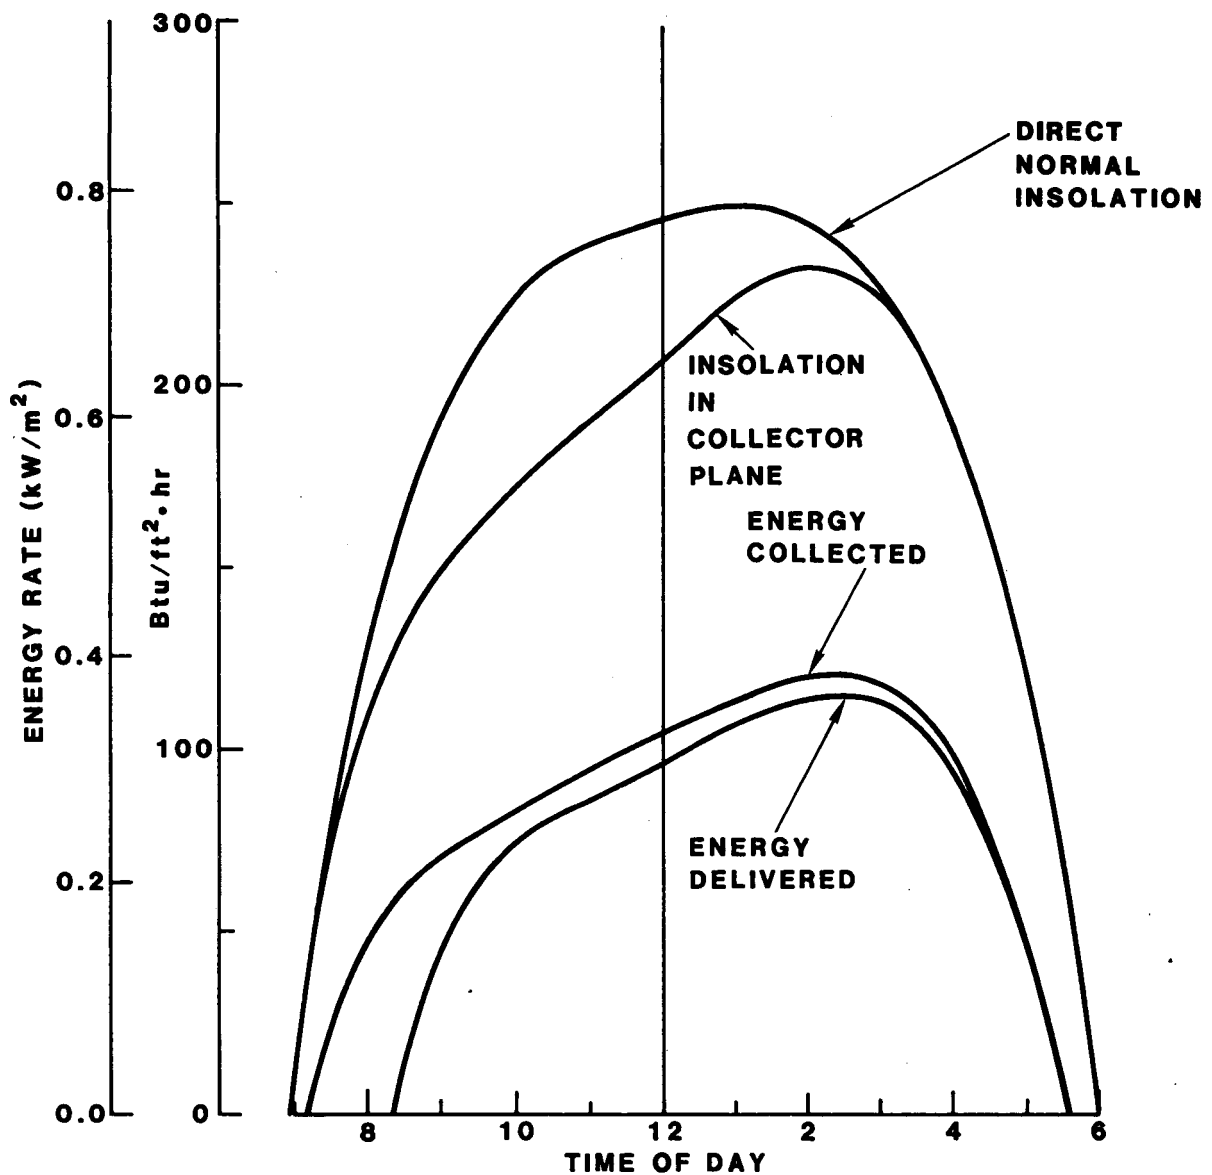
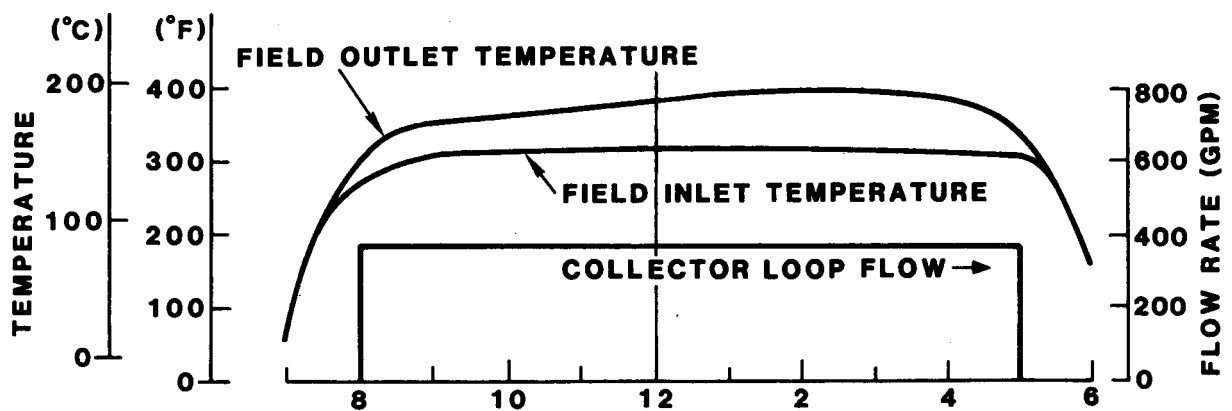
Figure 3-2. Clear-Day Simulation of Caterpillar Tractor for September 1

Figure 3-3. Clear-Day Simulation of Dow Chemical for September 13

Figure 3-4. Clear-Day Simulation of Home Laundry Producing Steam or Hot Water for March 15

Figure 3-5. Clear-Day Simulation of Lone Star Brewery for September 18

Figure 3-6. Clear-Day Simulation of Ore-Ida Foods for September 1

Figure 3-7. Clear-Day Simulation of Southern Union Refining Co. for September 2

Figure 3-8. Clear-Day Simulation of USS Chemicals for September 8

The opposite condition is exhibited by the east-west oriented Southern Union Refining Co. system. With this orientation, the collector apertures are normal to the sun at noon, which results in a "peaked" solar input rather than the more constant daily input of the north-south oriented collectors. However, as mentioned in the previous section, the average daily insolation does not vary as much over the year for the system oriented east-west.

There is an asymmetry between the morning and afternoon radiation in the plane of the collector at Ore-Ida Foods and at USS Chemicals. This asymmetry is caused by the orientation of the collectors, which is 11° from true north at Ore-Ida and 25° from true north at USS Chemicals.

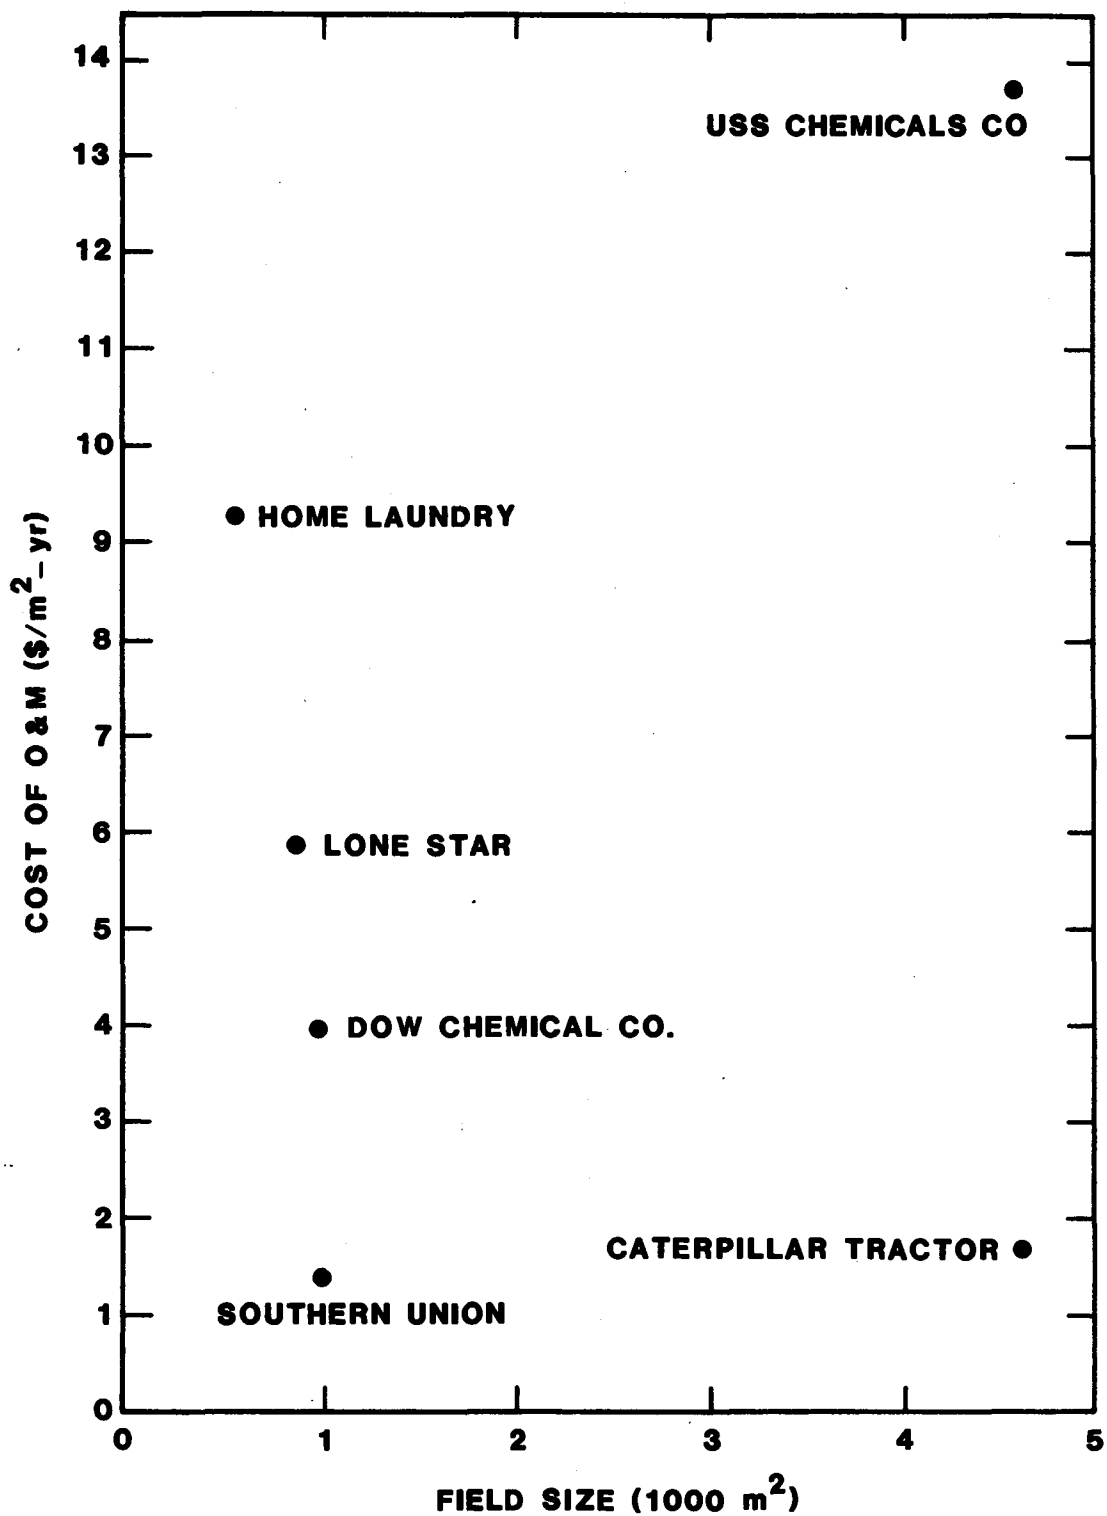
Figure 4-1. Unit Costs of O&M - IPH Experiments
(Actual costs for periods of operation
extrapolated to full-year cost.)
