Observations on the Mechanisms of Fatigue in Eutectic Pb-Sn Solder Joints

D. Tribula, D. Grivas, D. R. Frear and J. W. Morris, Jr.

August 1988

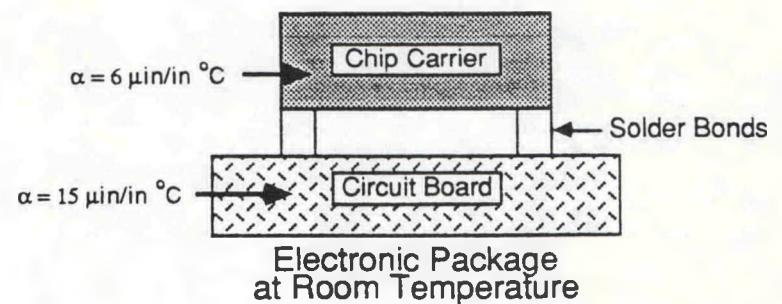
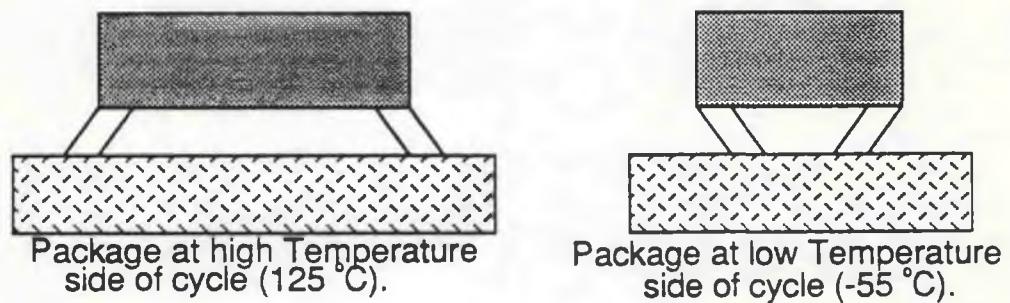
However, the strain is often very nearly a simple shear, as illustrated in Figure 1 for a simple chip-to-substrate contact.

1. Schematic illustration of the shear that develops in a solder joint between a chip and substrate when the device is heated by operating current or a change in ambient temperature.

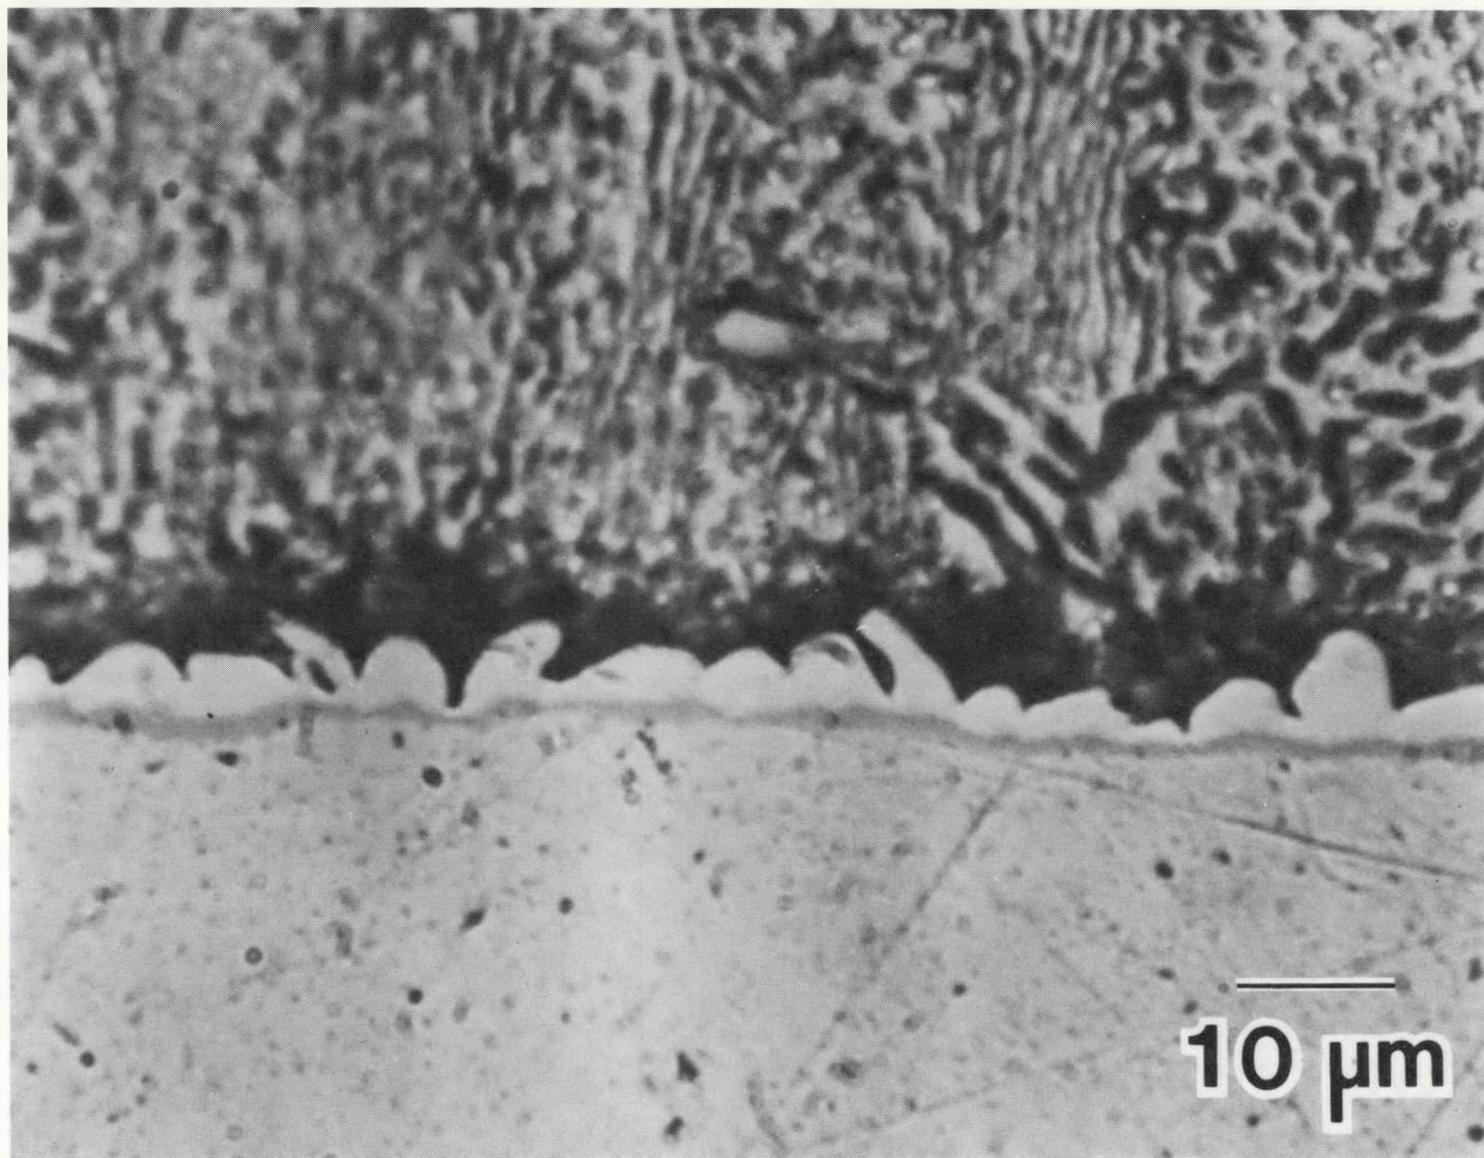
Figure 2

a. The wetted interface. The wetting of Cu by Pb-Sn solder is primarily due to the formation of Cu-Sn intermetallic films at the interface. In the case of 60Sn-40Pb solder the intermetallic layer is a bilayer of two intermetallic films [4,5], as shown in Figure 2. The inner film, adjacent to Cu, is a thin, coherent layer of Cu_3Sn which is relatively uniform in thickness over the surface. The outer film, adjacent to the solder, is a thicker layer of

Cu_6Sn_5 which has an irregular outer boundary that contains rounded protrusions and needle-like whiskers that thrust out into the solder. Almost all of the intermetallic growth occurs while the solder is molten. The thickness of the intermetallic layer depends on the temperature and time of exposure to the molten solder.

2. Optical micrograph showing a cross-sectional view of a 60Pb-40Sn/Cu interface. Two intermetallic layers lie in the interface. The inner is Cu_3Sn , the outer is Cu_6Sn_5 .

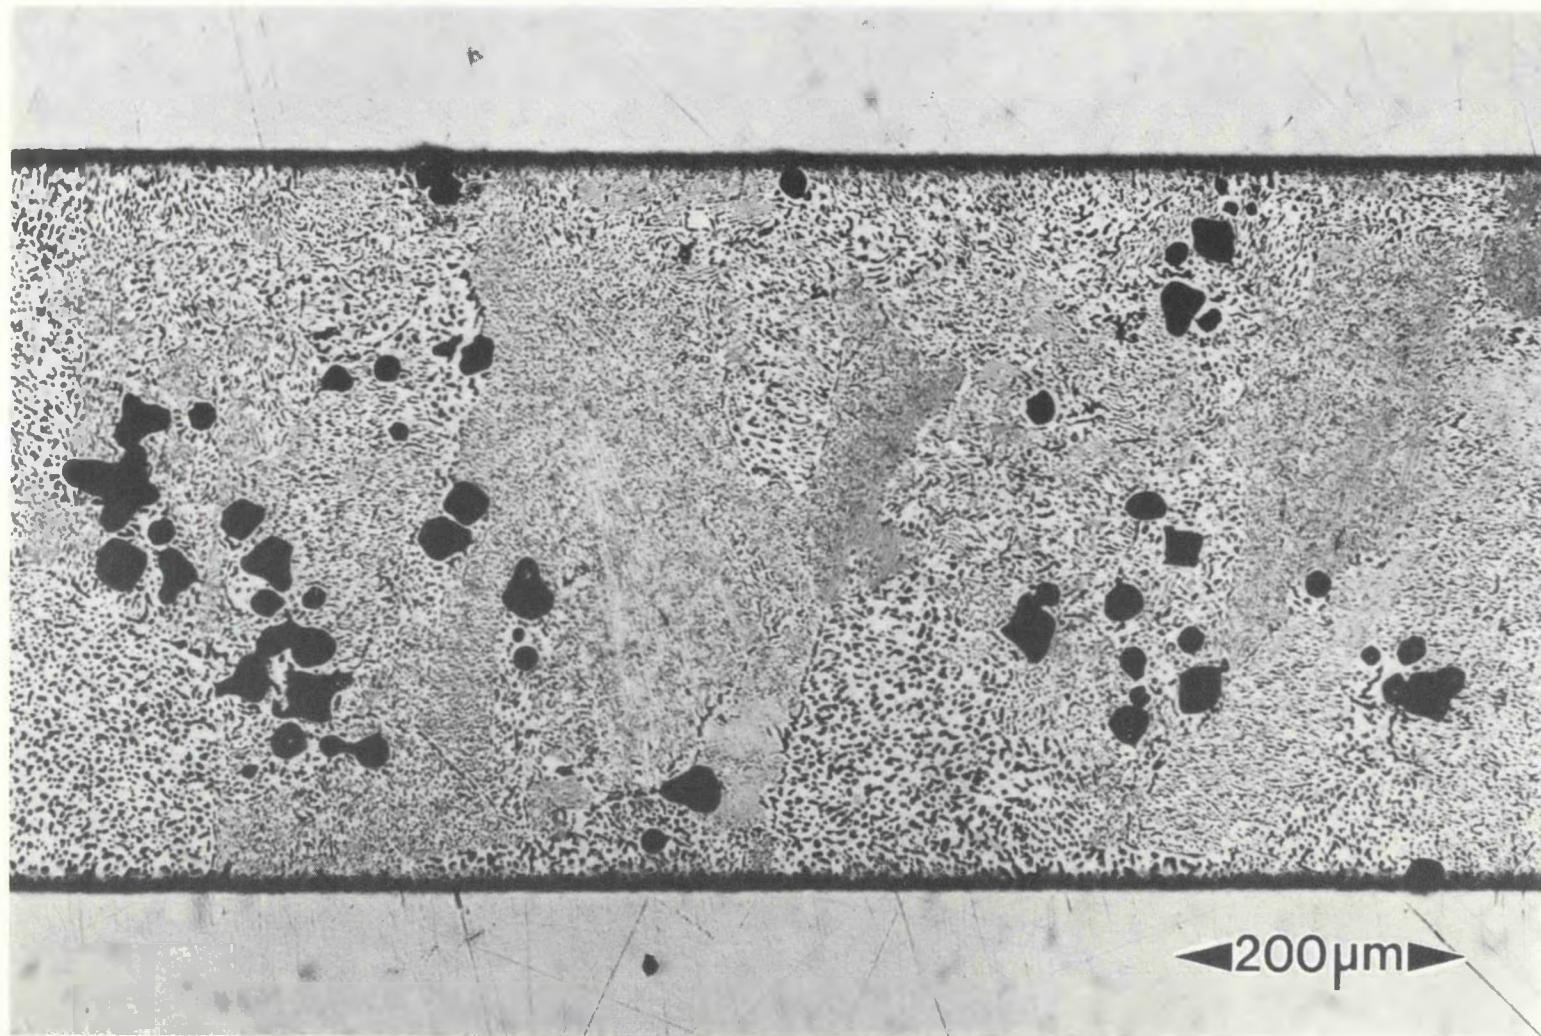
Figure 3

b. The solder phase. The as-solidified microstructure of 60Sn-40Pb solder is illustrated in Figure 3. The typical microstructure includes isolated particles of pro-eutectic Pb-rich phase amongst a eutectic mixture of the Sn-rich and Pb-rich phases. Closer examination reveals that the Pb-rich phase contains small, plate-shaped Sn-rich precipitates [6]. These form during cooling from the eutectic solidification temperature to adjust the composition of the Pb-rich phase to its equilibrium value. The eutectic microstructure usually consists of "colonies" readily distinguished by the uniformity of phase distribution within such a colony and the presence of a "colony boundary". The phase distribution within a colony may be lamellar or globular.

3. Optical micrograph showing a typical as-solidified microstructure of 60Pb-40Sn. The dark phase is Pb-rich. Several distinct colonies appear, separated by colony boundaries.

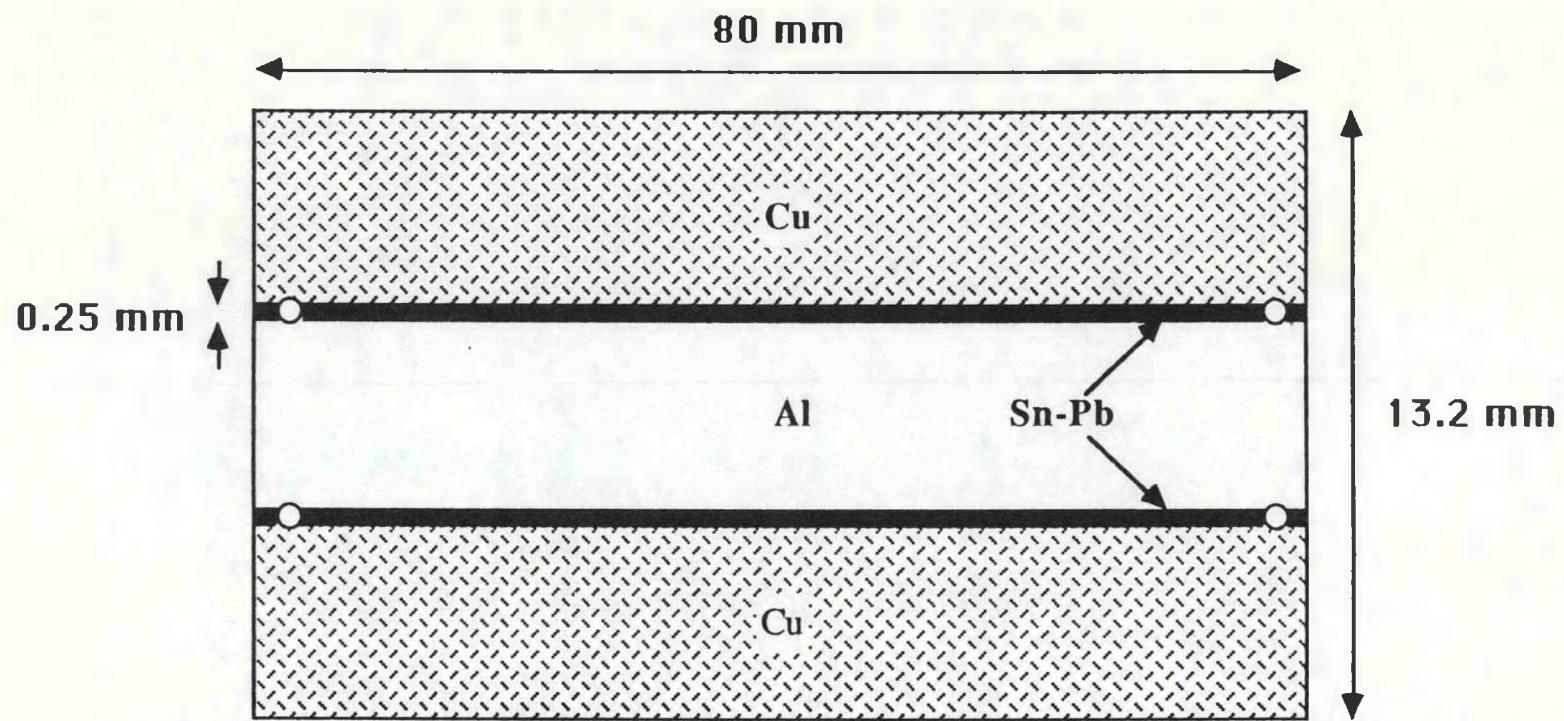
Figure 4
Page 14

The specimen that is diagrammed in Figure 4 was used to investigate the metallurgical mechanisms of thermal fatigue in shear [1]. The specimen is a thin, three-layer sandwich with Cu outer layers and a Cu-coated Al inner layer, joined with solder. When the specimen is heated the thermal expansion difference between the Cu and Al layers imposes a shear strain on the solder whose magnitude increases, for the most part, linearly from the center to the ends of the sample. Samples of this configuration were thermally fatigued by alternate immersion in hot and cold baths. The response of the specimen was monitored by metallographic analysis after exposure to a selected number of thermal cycles. Detailed experimental procedures and results are reported elsewhere [1,7].

4. Diagram of the specimen used for thermal fatigue studies.
5. Sequence of thermally fatigued specimens showing the development of a coarsened band and associated fatigue crack.

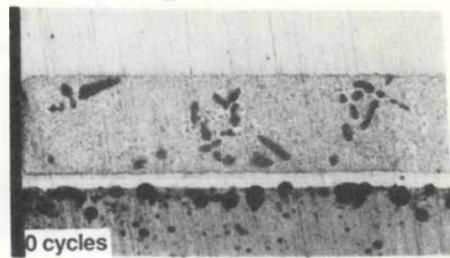
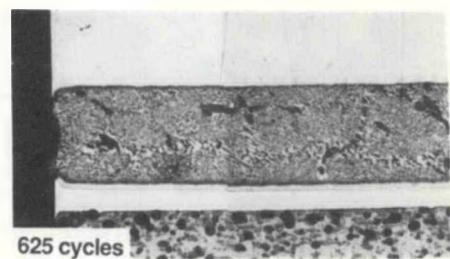
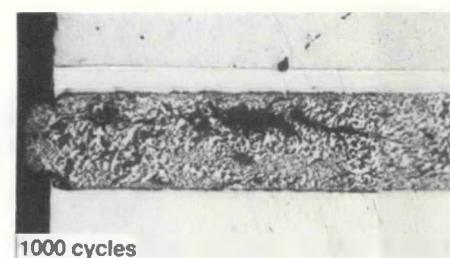
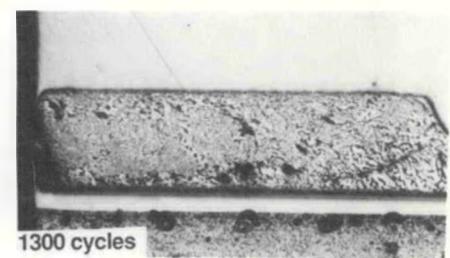
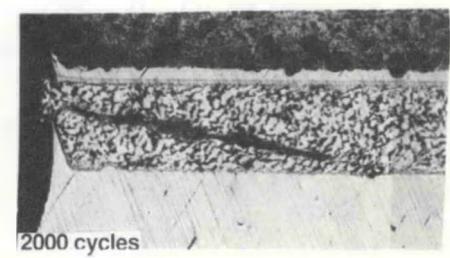
Figure 5

A typical result of these experiments is presented in Figure 5, which illustrates the development of growing thermal fatigue cracks in the high-strain region of specimens that were thermally cycled between -55°C and 125°C to a peak shear of approximately 20%. The first apparent change in the specimen is metallurgical, and is the appearance of a continuous band through the eutectic microstructure within which the Pb- and Sn-rich regions are significantly coarsened with respect to the surrounding material. The band lies along the length of the bar, is slightly offset from the interface and is roughly parallel to the plane of maximum shear. As thermal cycling continues cracks appear within this band and merge

60Sn-40Pb
Thermal Cycle: -55°C \longleftrightarrow 125°C

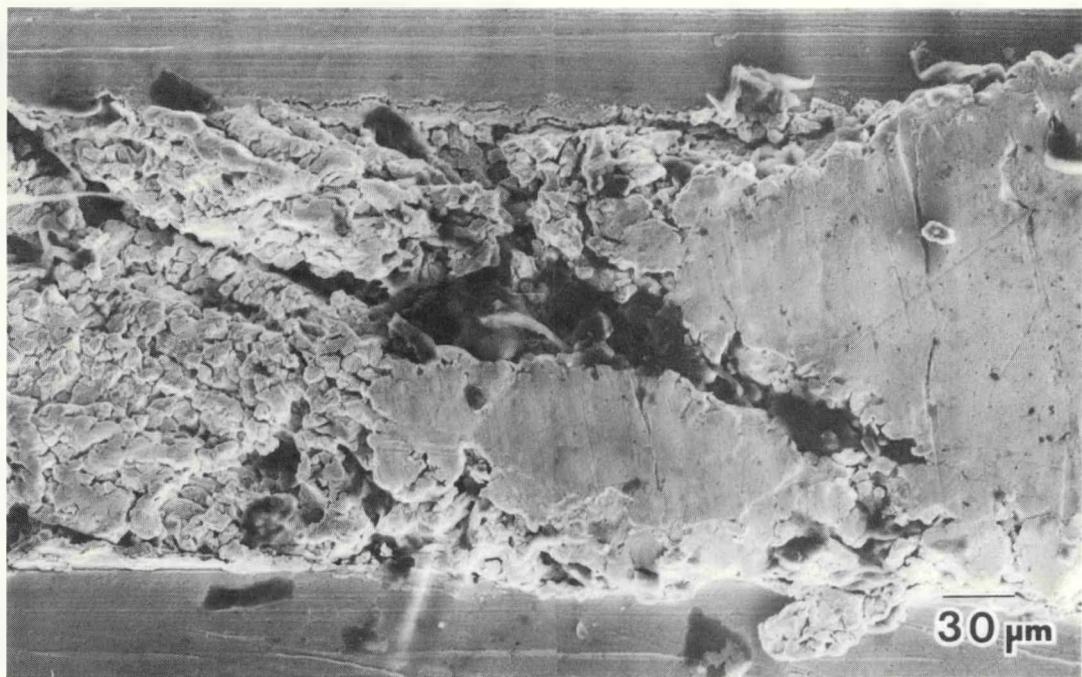
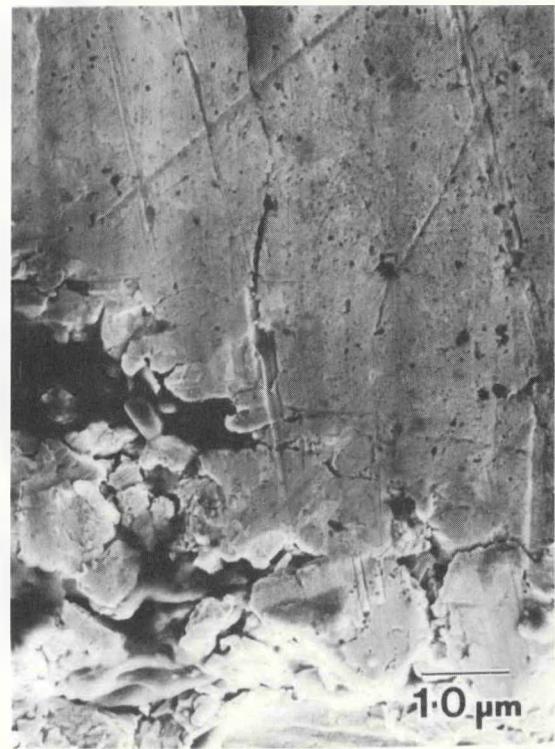
Figure 6

to form a growing thermal fatigue crack. The cracking mechanism, which is illustrated in Figure 6, involves the intergranular fracture of Sn-rich grains followed by the gradual failure of the intermediate Pb-rich material.

6. Optical micrograph of a coarsened band showing the coarse grain structure and intergranular fracture between Sn-rich grains.
7. Sample configuration used for isothermal creep experiments. Due to the slot configuration cut in in sample, when the sample is pulled in tension the solder regions between the slots are strained in nearly simple shear.

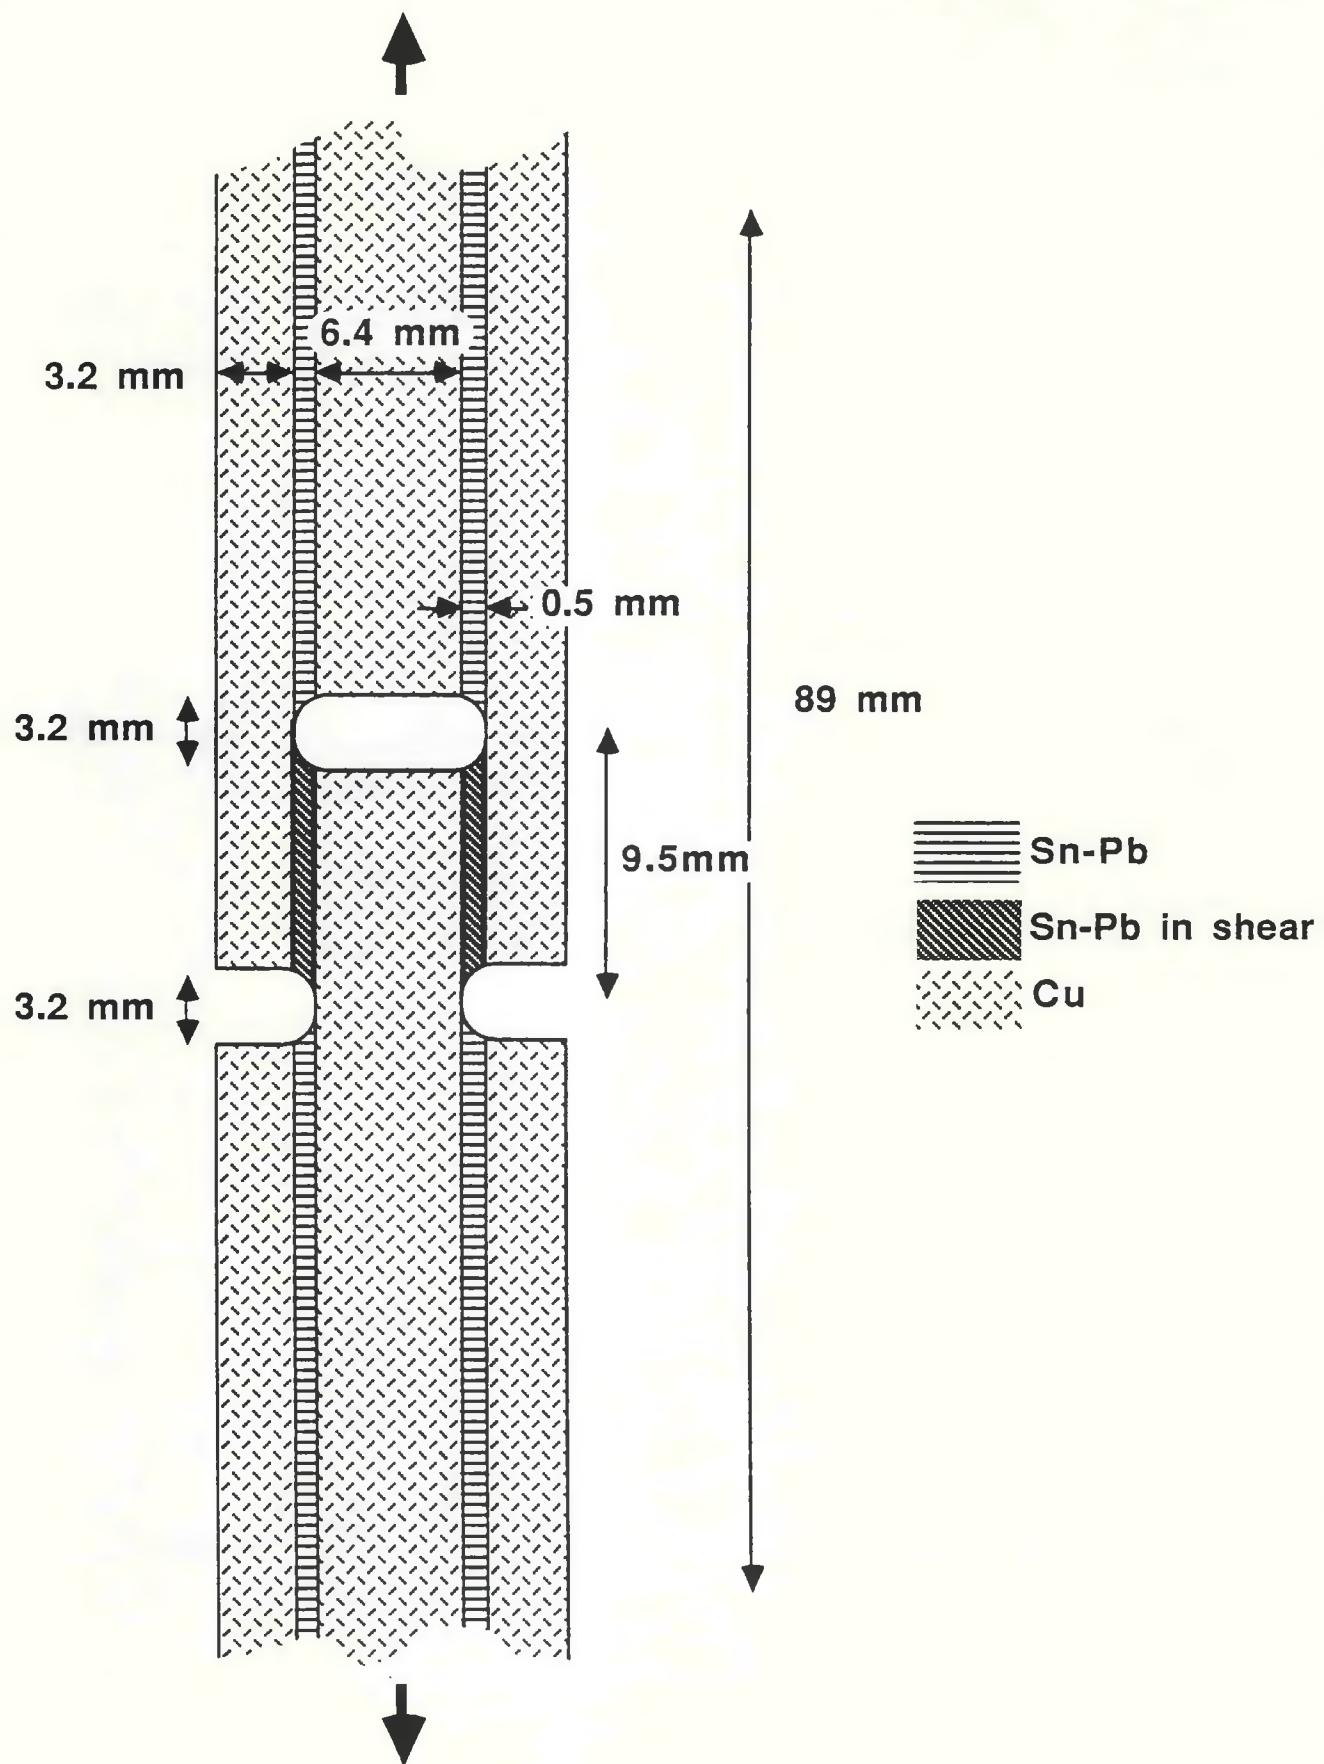
Figure 7

The sample used for the creep (and isothermal fatigue) experiments is diagrammed in Figure 7. It is a thin, three-layer copper sandwich with solder layers between each of the copper plates. The sample is slotted, as shown in the figure, so that the solder material between the slots transmits the load in nearly simple shear when the sample is pulled in tension. Creep experiments are conducted by applying a constant tensile load to the specimen, which imposes a constant nominal shear stress on the central joints that transmit the load. The shear strain in the solder is then measured as a function of time. The tests determine the steady-state creep rate of the solder as a function of the nominal shear stress and temperature for comparison with conventional steady-state creep data. This data will be published elsewhere. In this paper we are mainly concerned with the mechanism of formation of coarsened bands during creep in shear.

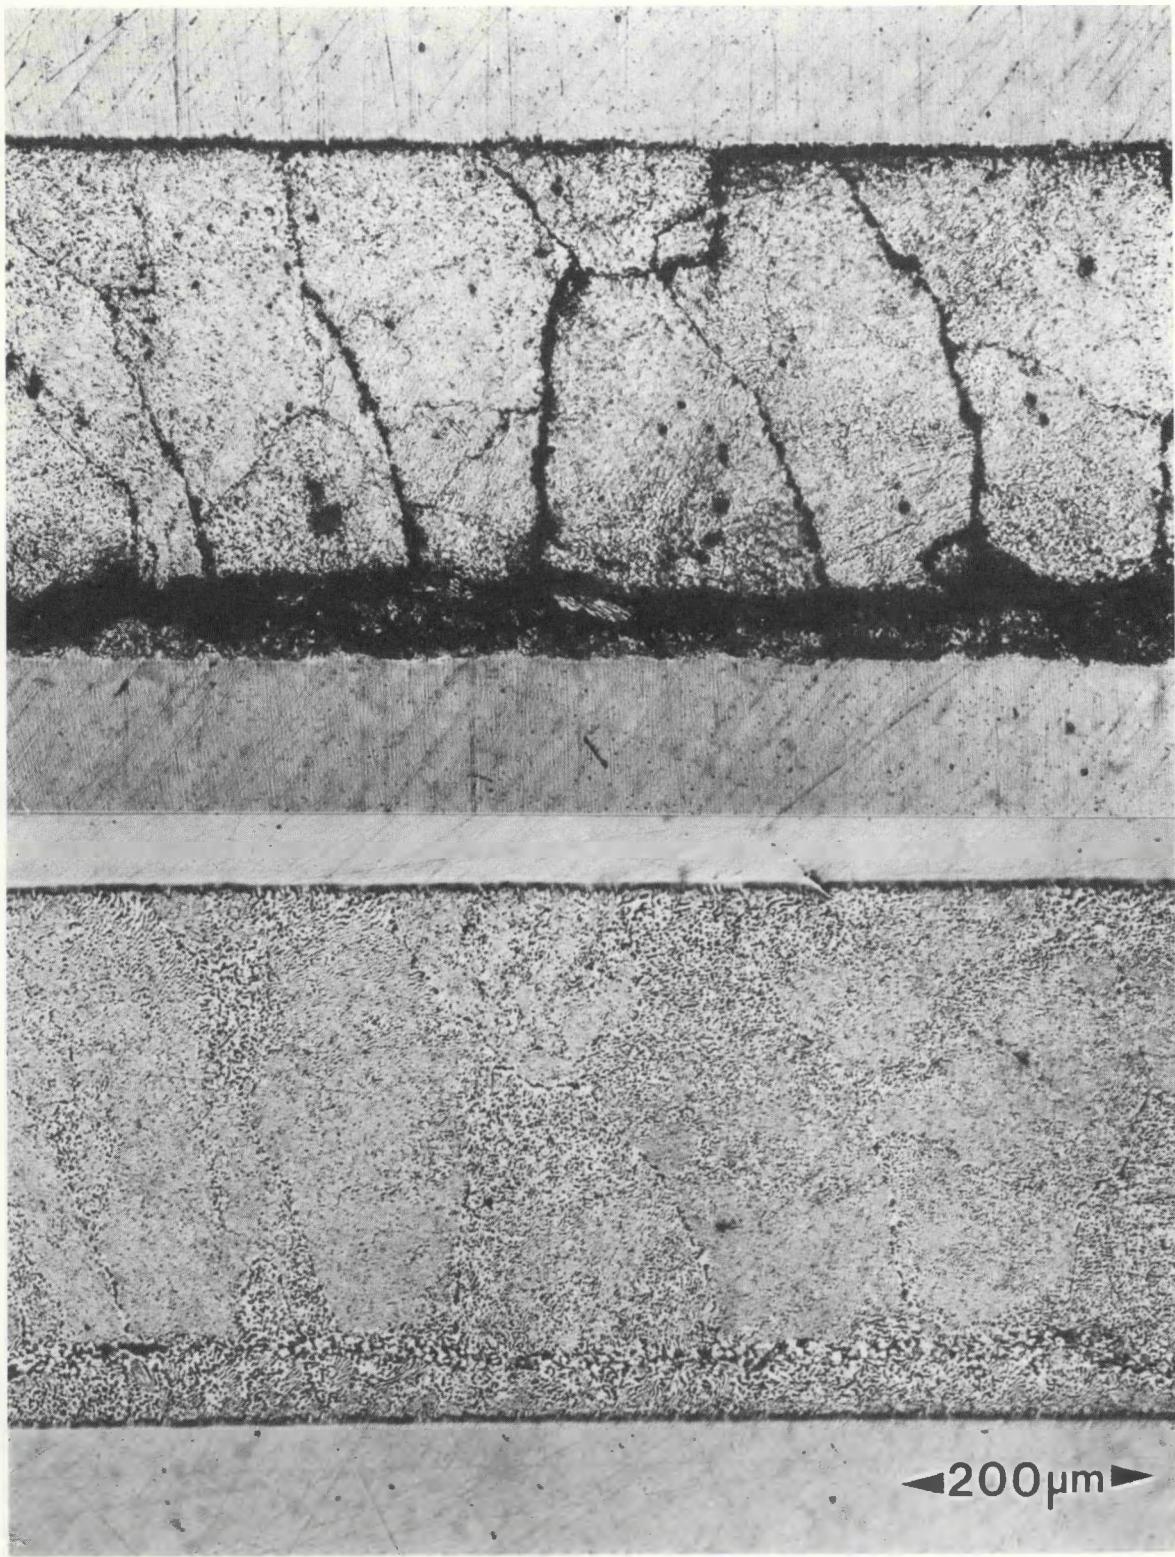
Figure 8

The presence of coarsened shear bands in the crept specimens is documented in Figure 8b, which shows a coarsened band parallel to the wetted interface, note that the coarsened band is nearly straight. A higher magnification photograph, Figure 9, shows that the material within the coarsened band consists of relatively large, equiaxed grains which resemble the grains formed by recrystallization of mechanically worked Pb-Sn eutectics [10,11]. This is the normal microstructure within a coarsened band. Eventually, cracks and cavities form within the bands and, as in thermal fatigue, the fracture initiates through intergranular cracking of Sn-rich grains which induces failure of the nearby Pb-rich material.

8. a. An SEM micrograph of a polished solder joint crept in shear at 75°C at a strain rate of 10^{-5} sec^{-1} . b. The localized deformation is revealed by surface relief on this joint prior to polishing.

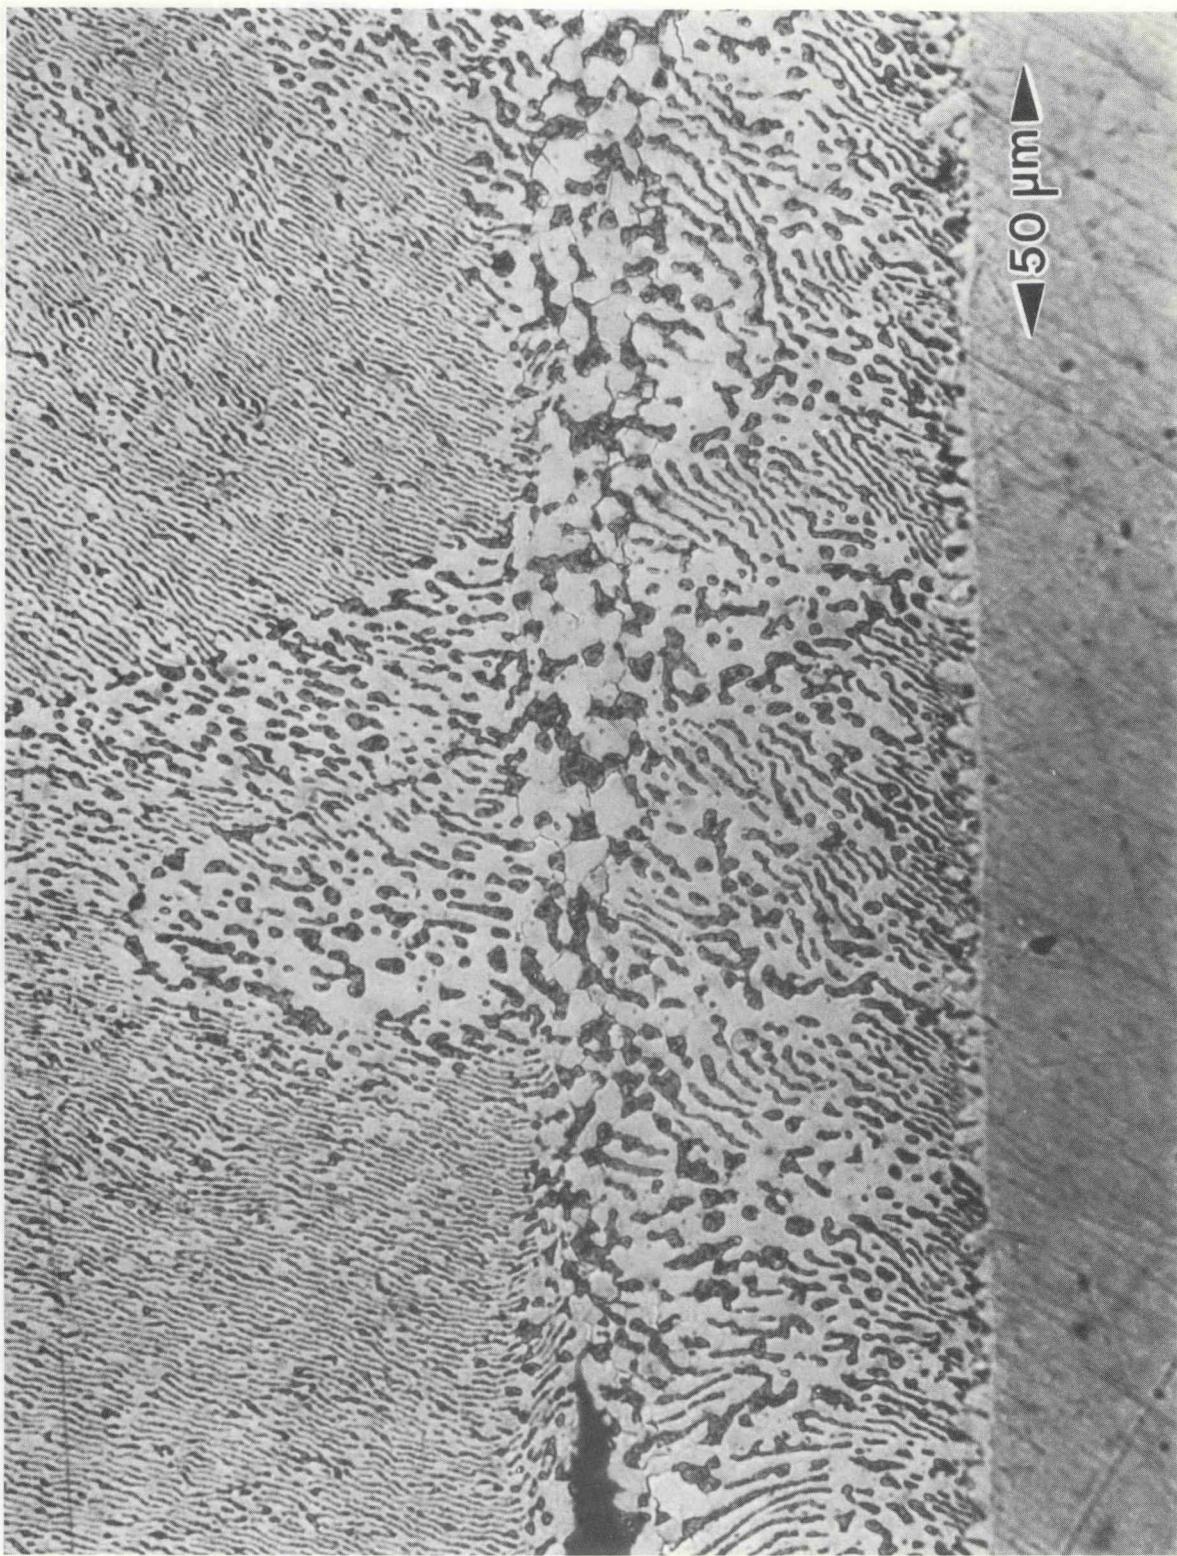
Figure 9

9. Detail of the coarsened band at higher magnification (optical) showing its definition and the presence of equiaxed grains apparently formed by recrystallization.

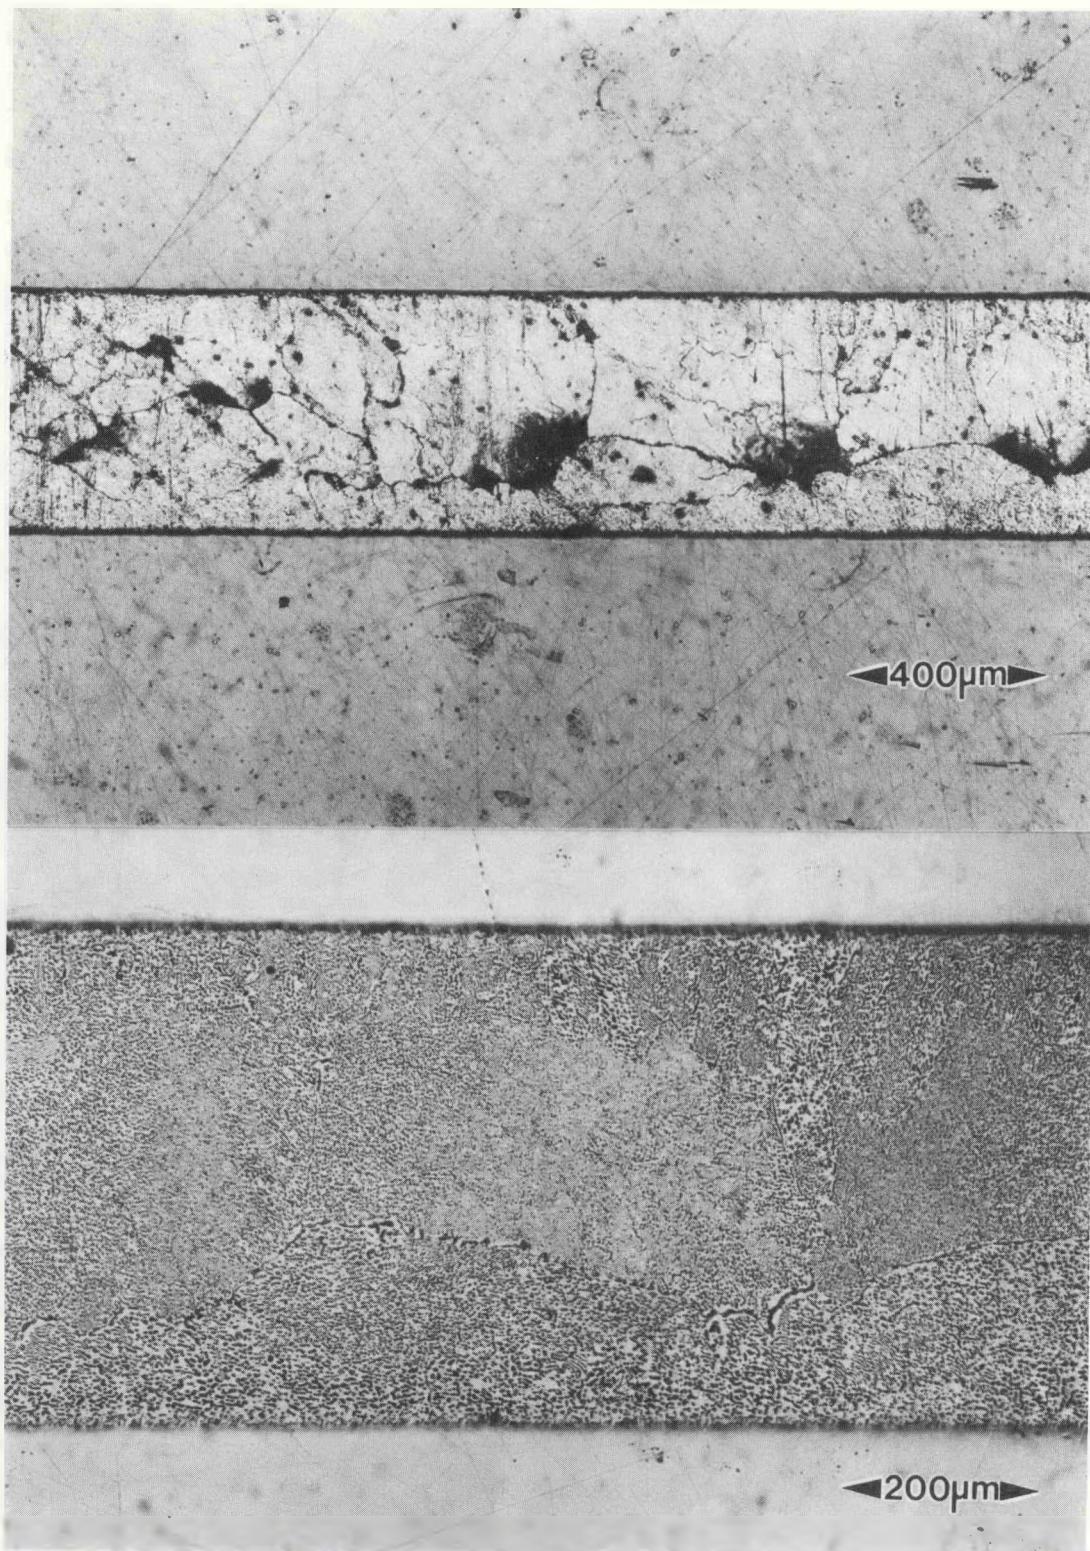
Figure 10

observed at very low creep rates, 10^{-8} sec $^{-1}$ (Figure 10a and b). In this case the parallel deformation band has an irregular shape and follows primarily colony boundaries.

10. a. The shear deformation pattern revealed by surface relief on a specimen crept at a strain rate of 10^{-8} sec^{-1} at 75°C . b. The same specimen after a light polish. Note the correspondence between deformation path and coarsened regions along colony boundaries.

When the rate of deformation is slow the dominant deformation mechanism tends to be colony boundary sliding. In this case the shear band, and hence the coarsened band in the microstructure, tends to follow the colony boundaries. When the shear strain rate is very slow, as it is, for example, in the sample shown in Figure 10, the dominant coarsened band follows the network of colony boundaries that most nearly approximates a plane near the joint interface. In all cases studied to date the secondary shear bands and coarsened bands perpendicular to the joint interface follow colony boundaries.

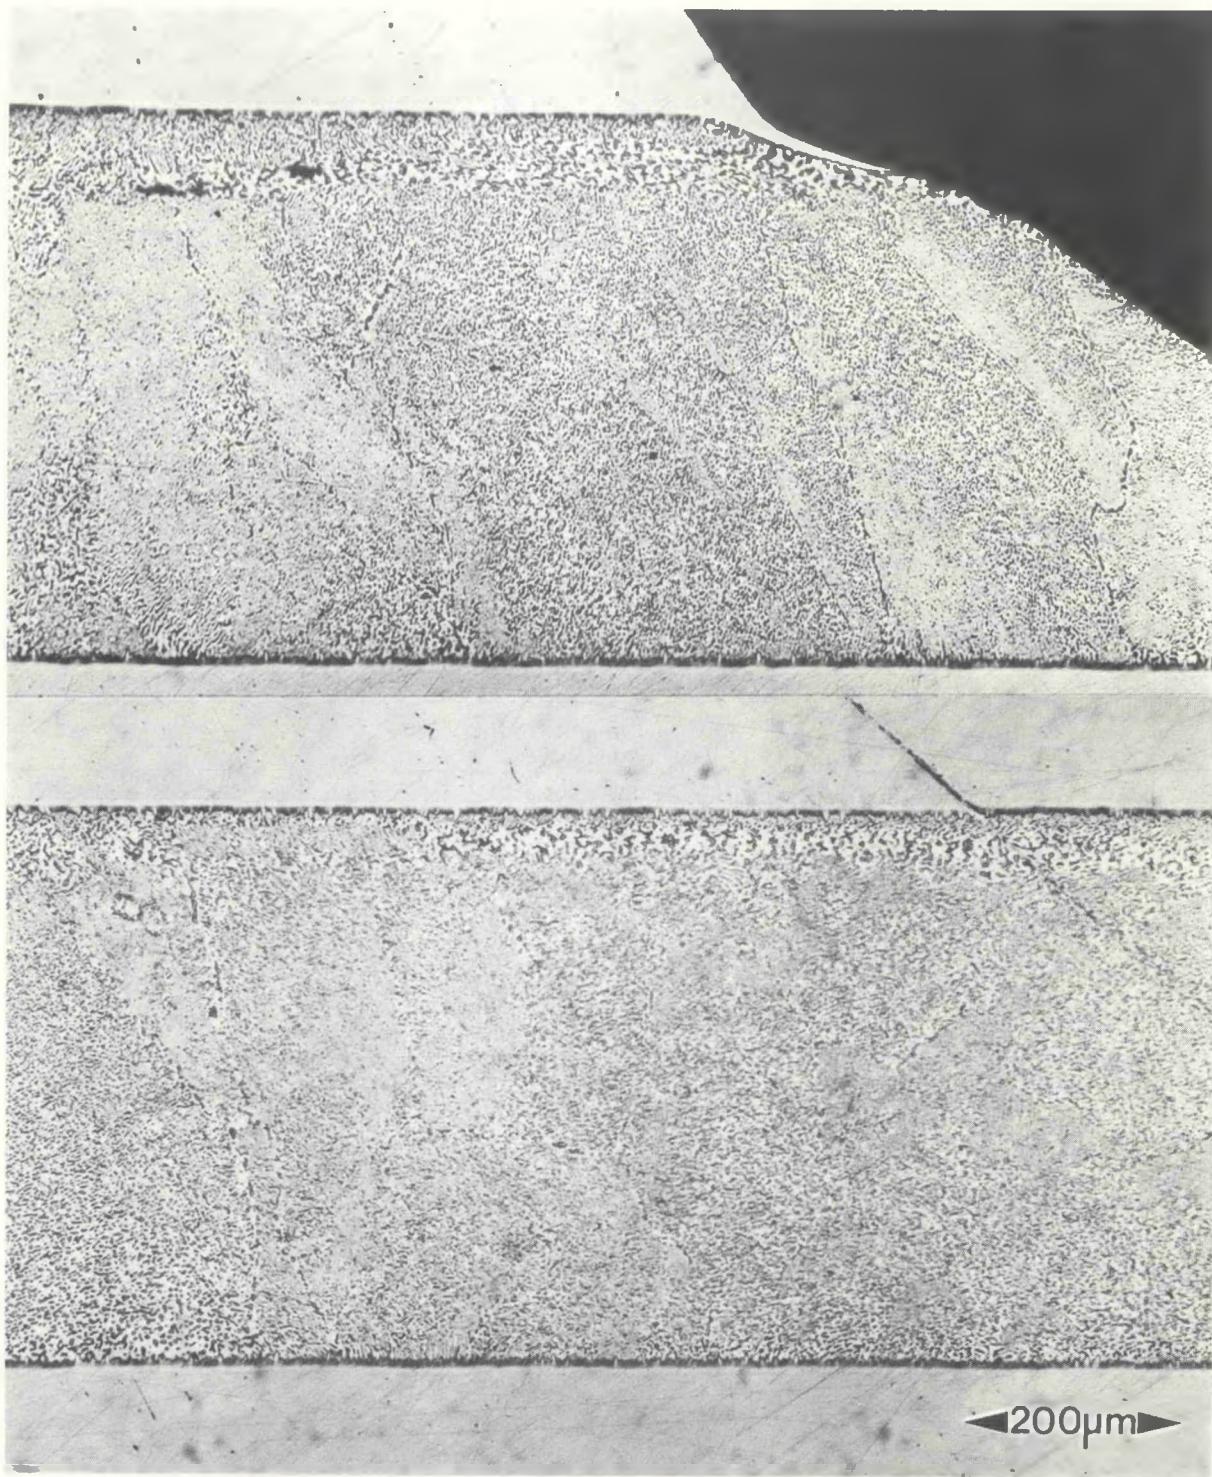
Figure 11

In all cases the parallel deformation band originates at one side of the lateral surface of the solder joint. Finite element analyses [13] suggest that the point of origin is near the principal stress concentration point in the sample. The coarsened band that leads to fracture in the sample is always coincident with the parallel deformation band described above, and forms first at the terminus of the deformation band at the free surface, Figure 11a. It then slowly grows along the deformation band into the sample. Figure 11b, for example, shows the partly developed coarsened band of Figure 11a that terminates in the solder.

11. a. Optical micrograph showing initiation of the coarsened band at a free surface. b. The same coarsened band propagates along the length of the joint terminating within the solder.

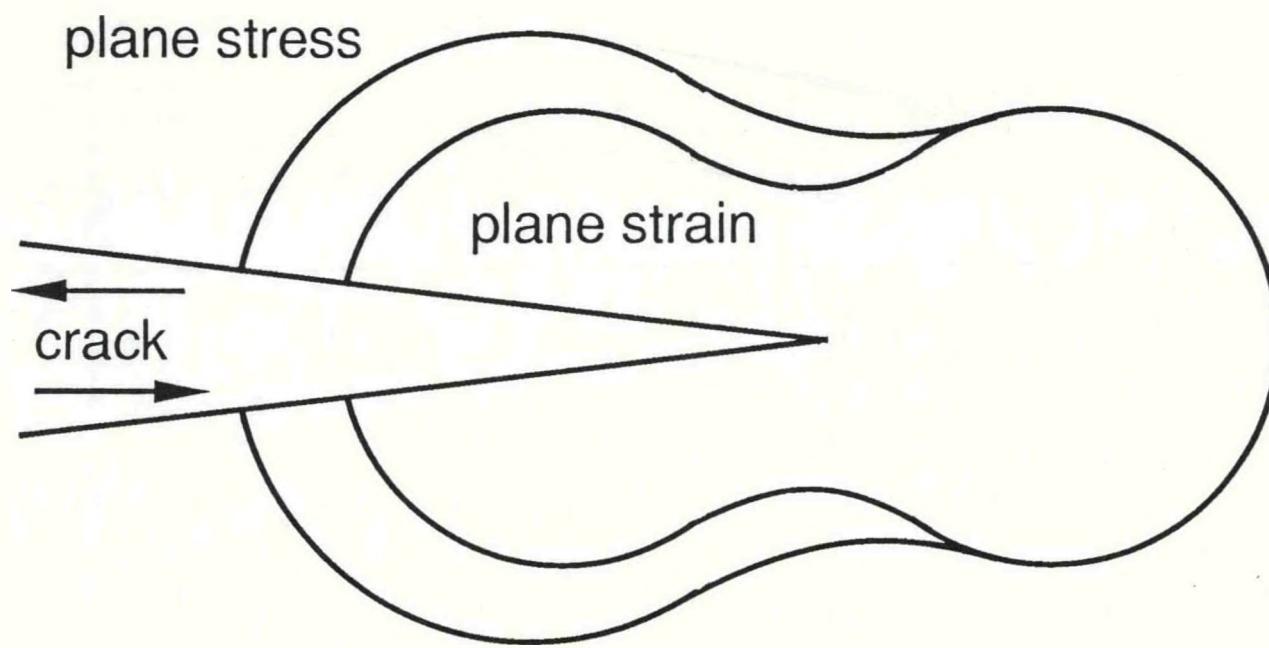
Figure 12
Page 22

12. The plastic deformation field ahead of a mode II crack in a Von Mises material (after McClintock, et al. [17])
