Using Emissivity-Corrected Thermal Maps to Locate Deep Structural Defects in Concrete Bridge Decks

Nancy K. Del Grande
Phillip F. Durbin

This paper was prepared for submittal to the
SPIE Nondestructive Evaluation of Aging Bridges and Highways
Oakland, California
June 6-8, 1995

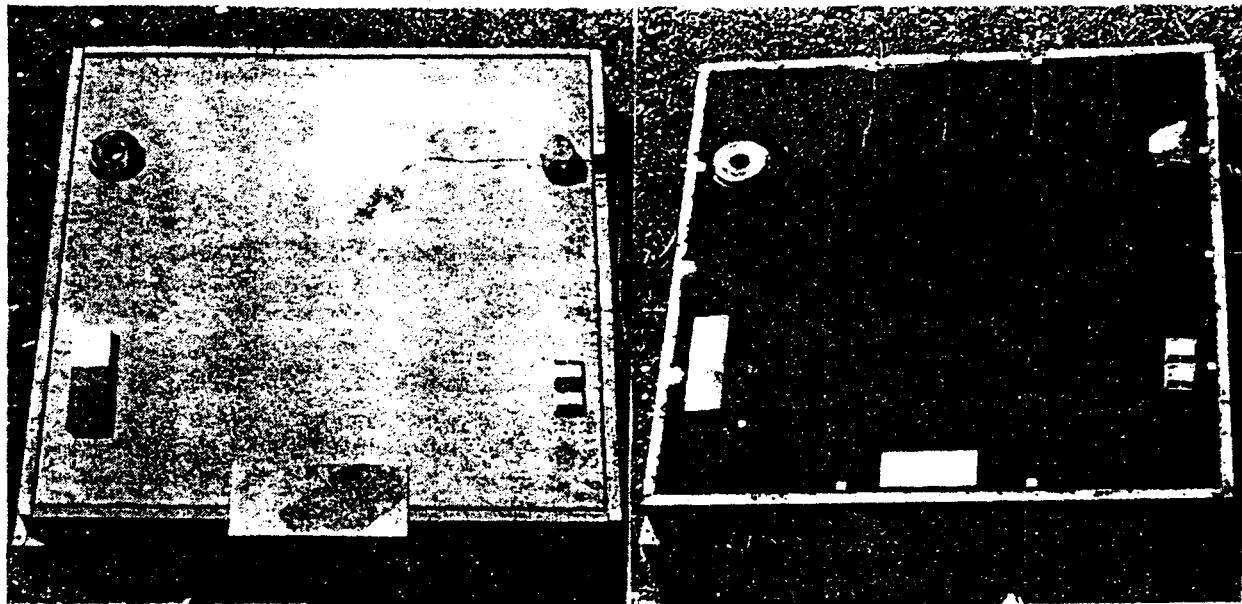
Figure 1. Photos: left, showing concrete slab B with five subsurface styrofoam delamination sites and five clutter sites along perimeter; and right, showing similar concrete slab A covered by 5.1 cm (2 inches) asphalt with a delamination site at the asphalt-concrete interface located at top, center-left, above the same size concrete delamination site #1 at top, center-right.

We mounted the Agema 880 DBIR camera system on a tower platform, overlooking two large concrete test slabs, one of which was covered with a two-in. layer of asphalt. See Figure 1. The DBIR camera detectors were Hg-Cd-Te (at 8-12 μm) and InSb (at 3-5 μm). DBIR images were recorded on the hard drive of the Agema 880 12-bit digital image processing system, which was housed inside a trailer, at the ground station, and backed up for further processing on the SGI workstation.

Figures 1 and 2 show photos of Slab A and Slab B, and the layout of the synthetic delaminations. Two square, 6 feet on-a-side, 7.5 inches thick, concrete test slabs A and B were cast with five variable-size styrofoam implants, 2 inches below the surface, representing synthetic delamination sites in surrogate concrete bridge deck structures. Slab A and Slab B were tested on January 29 with bare, concrete surfaces. During March, Slab A was covered with a 2 inch thick layer of asphalt and had one additional delamination added at the asphalt-concrete interface. During April, both slabs were remeasured to determine the effects of the asphalt cover and of surface clutter. Figure 3 shows Slab B temperature readings which were recorded with thermistors. Tables 1 to 4 apply to the size and depth of the implants and the temperature-differences which were generated.

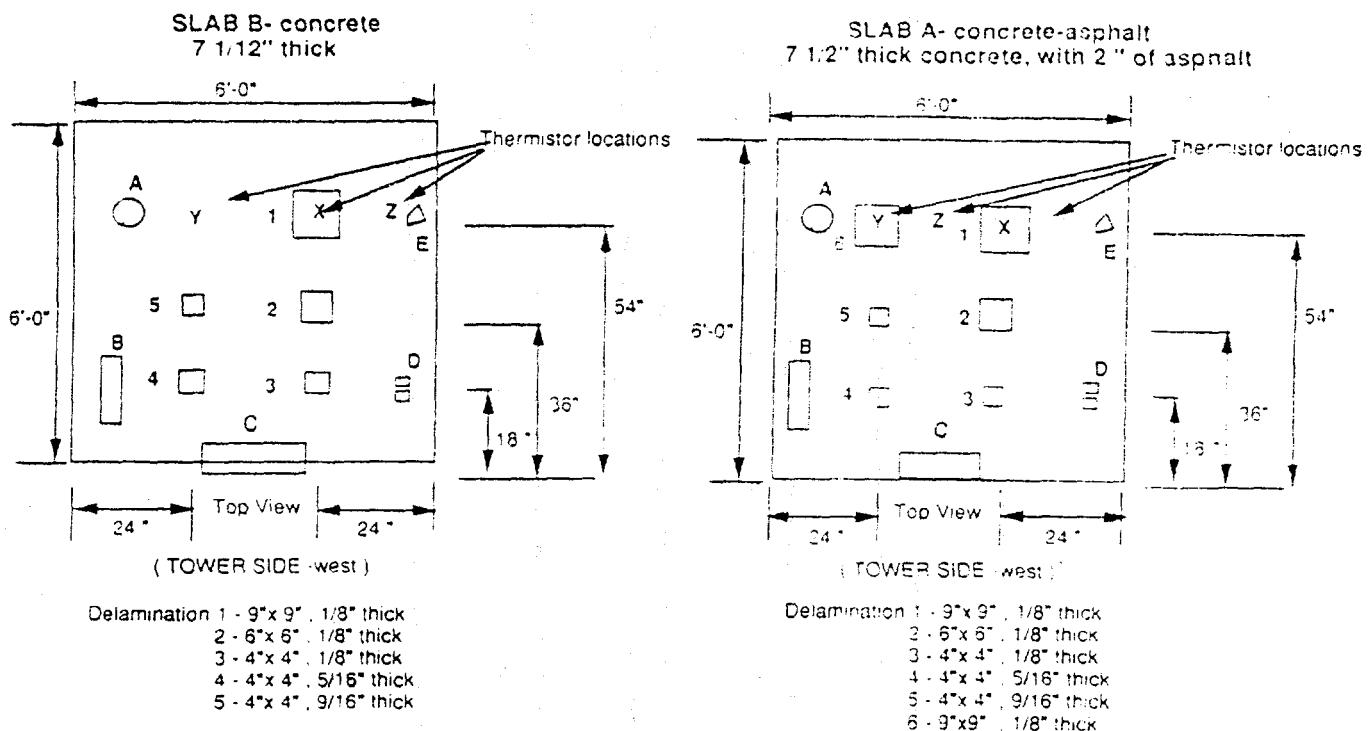
Figure 2. Diagram of concrete slabs used to measure the effects of subsurface delamination sites for a concrete bridge deck.

Table 1. Concrete delamination sites, dimensions and depth beneath concrete surface for Slab A and Slab B before and after resurfacing Slab A with a 2-inch layer of asphalt and placing a delamination at the asphalt/concrete interface. See Figure 2.

The Figure 2 diagrams show thermistor probe sites where we recorded concrete temperatures, e.g., above and below the styrofoam at X, at three shallow depths at Y and at the surface at Z. Also, in Figure 2, are consecutive alphabetic letters shown counterclockwise, along the slab perimeters, which mark the sites of the surface object clutter described below.

- (A) rusty steel pan with hole at center placed at top left side of slab;
- (B) wood painted white at top with grease at bottom placed at bottom left side of slab;
- (C) stainless steel plate placed at bottom center of slab;
- (D) plastic road markers placed at bottom right of slab;
- (E) rock placed at top right of slab.

The pattern of five synthetic delamination sites shown in Figure 2 was apparent from images of Slab A and Slab B taken on January 29 (not shown) and images of Slab B taken on April 12. Slab A and Slab B thermal images were similar in January, but very different in April, since Slab A was overlaid with a 2-in. thick asphalt layer before the tests were conducted in April.

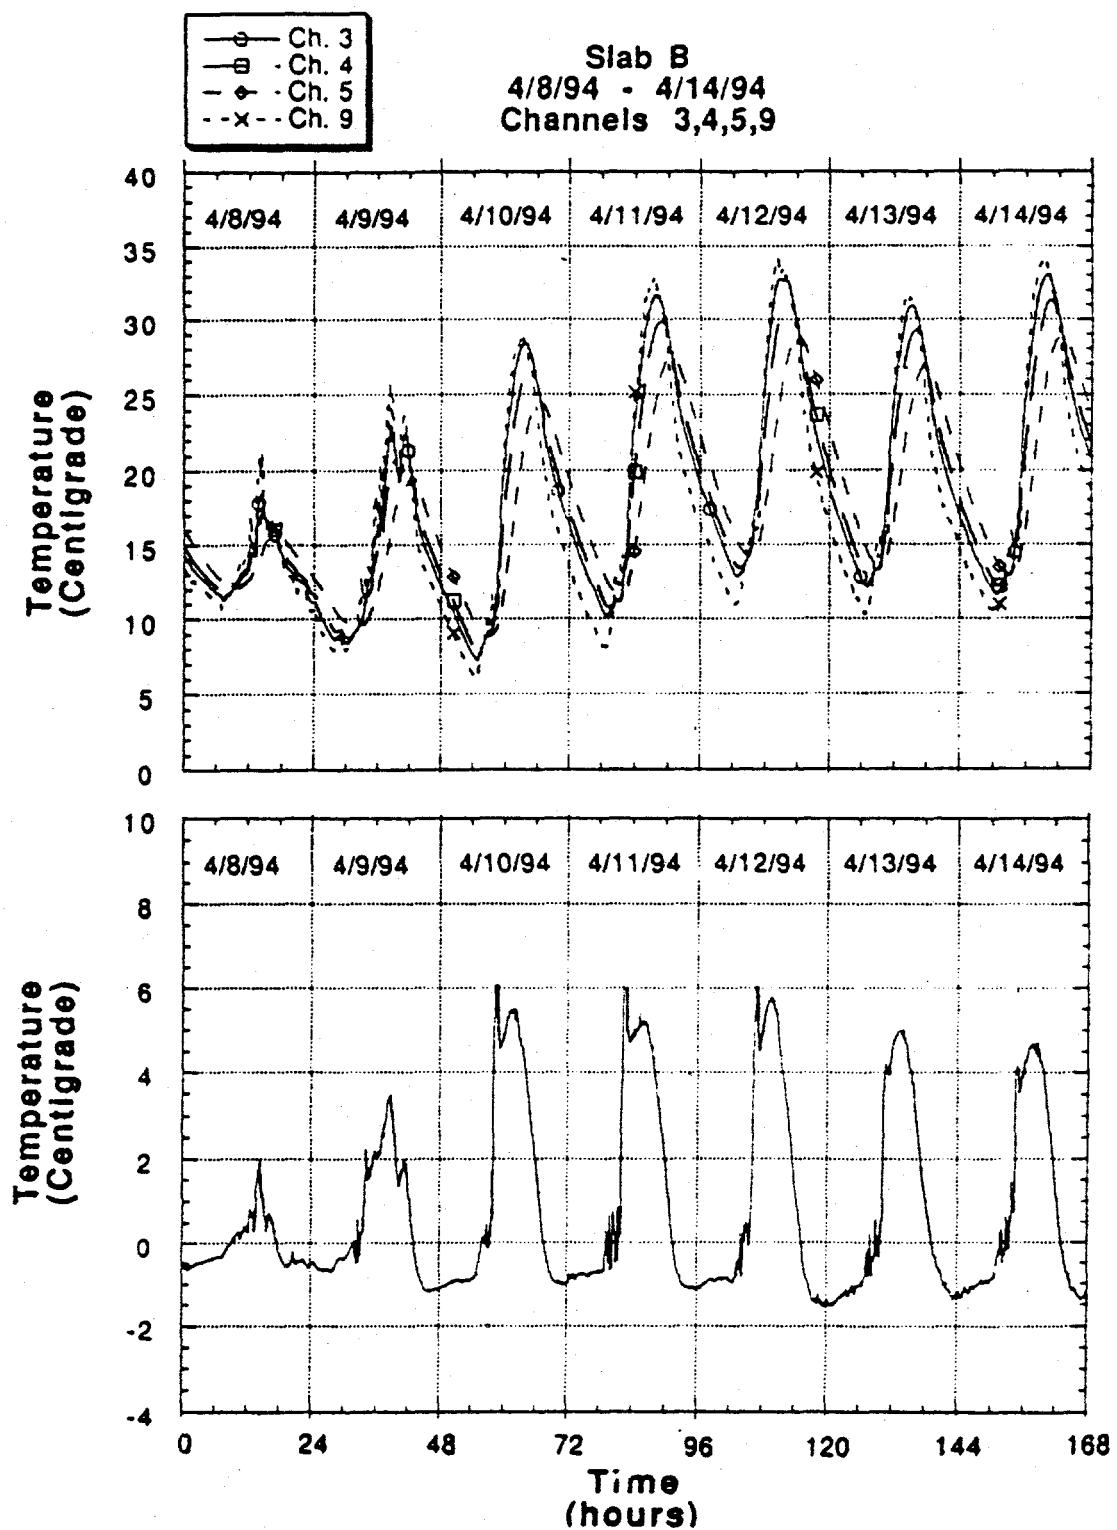
Figure 3. Above: concrete Slab B temperatures, based on thermistor measurements at concrete sites without implants at depths of 1.25 in. (Ch. 3), 2.5 in. (Ch. 4), 6.0 in. (Ch. 5) and 0 in. (Ch. 9). Below: surface temperature differences above the 9-in. square implant (Ch. 10) relative to ambient (Ch. 9) were warmer during the day and cooler at night.

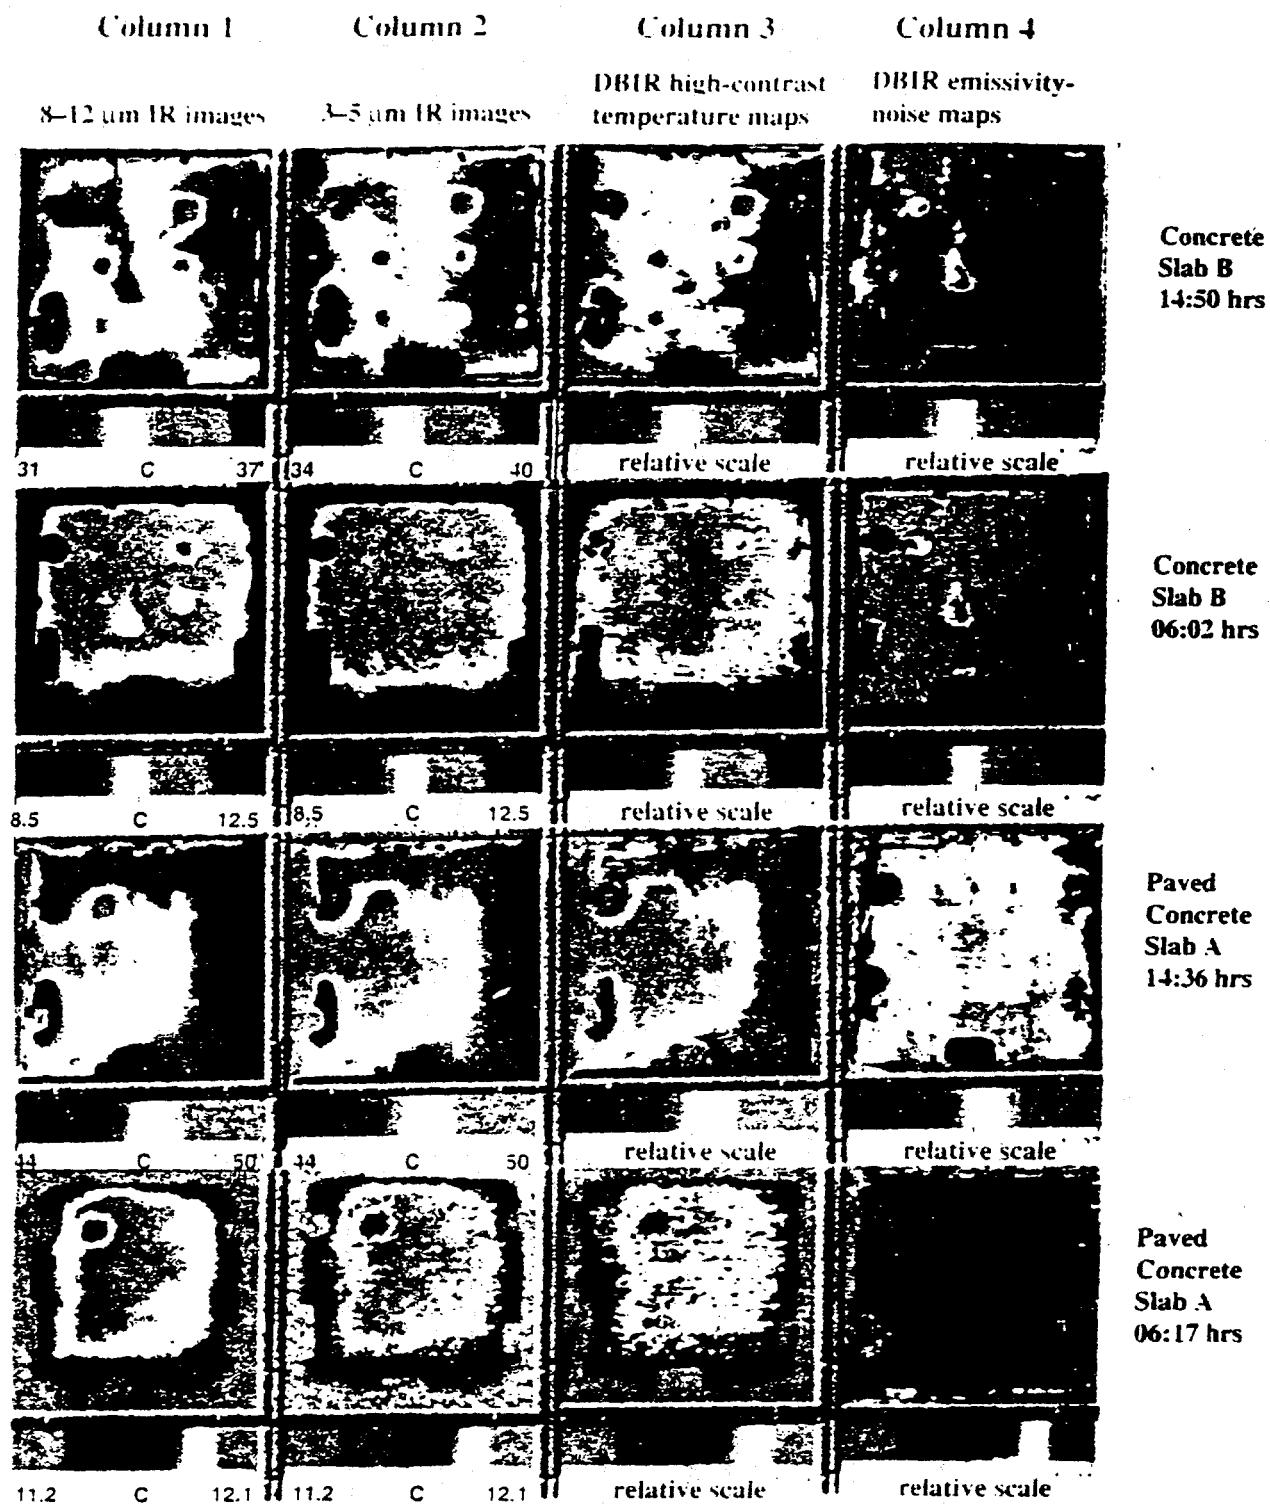
Figure 4. Dual-band infrared (DBIR) images taken April 12, 1994, with a tower-mounted Agema 880 System. Rows 1 and 2 show concrete Slab B at 14:50 and 06:02 respectively. Rows 3 and 4 show paved concrete Slab A at 14:36 and 06:17 respectively. Apparent temperature maps were recorded at 8-12 μm (Column 1) and at 3-5 μm (Column 2). High-contrast temperature maps (Column 3) show both delamination and clutter sites, whereas emissivity-noise maps (Column 4) show only clutter sites.

Figure 4 shows the uncovered, concrete thermal signatures, i.e., Slab B during the day, in Row 1, and night, in Row 2. We note that DBIR thermal imaging depicted emissivity-noise from the concrete compositional differences, e.g., the anomaly near the image centers in Column 4, Rows 1 and 2. This emissivity-noise would not have been distinguished from a delamination site had we used conventional SBIR thermography. We successfully depicted the 4-in. implants, 2-in. deep in bare concrete.

The images shown in Figure 4 look alike when recorded at 8-12 μm LW (Column 1) and 3-5 μm SW (Column 2). They have similar apparent temperature maps, in Columns 1 and Column 2, and high-contrast temperature maps in Column 3. These maps differ significantly from their respective DBIR emissivity-ratio maps in Column 4. Both the high-contrast temperature maps and the emissivity-ratio maps have a relative scale, whereas the apparent temperature maps are scaled in degrees Celsius.

The DBIR emissivity-ratio maps depicted emissivity-ratio variations associated with five large surface clutter objects (along the perimeter) and three small thermistors encased in asphalt-like compounds (across the top, near the center of Slab A). The emissivity maps do not show surface temperature footprints at subsurface delamination sites. Instead, the emissivity maps show emissivity variations from staining, objects, or compositional variations, which apply to Slab B (concrete) or Slab A (asphalt-covered concrete) surfaces shown in Figure 4.

The apparent temperature and DBIR high-contrast temperature maps for the resurfaced (asphalt-covered) Slab A, e.g., see Figure 4, Rows 3 and 4, show one major defect at site (6) for the 9 inch on-a-side synthetic delamination placed at the top, left-of-center, 2-in. depth asphalt-concrete interface. Also, there is a less pronounced indication of a deeper defect at site (1) for the 9 inch on-a-side synthetic delamination placed at the top, right-of-center, 4-inch depth, within asphalt-covered concrete. Corrections to remove a temperature gradient mask, from asphalt density variations, were successful, as shown in Figure 5.

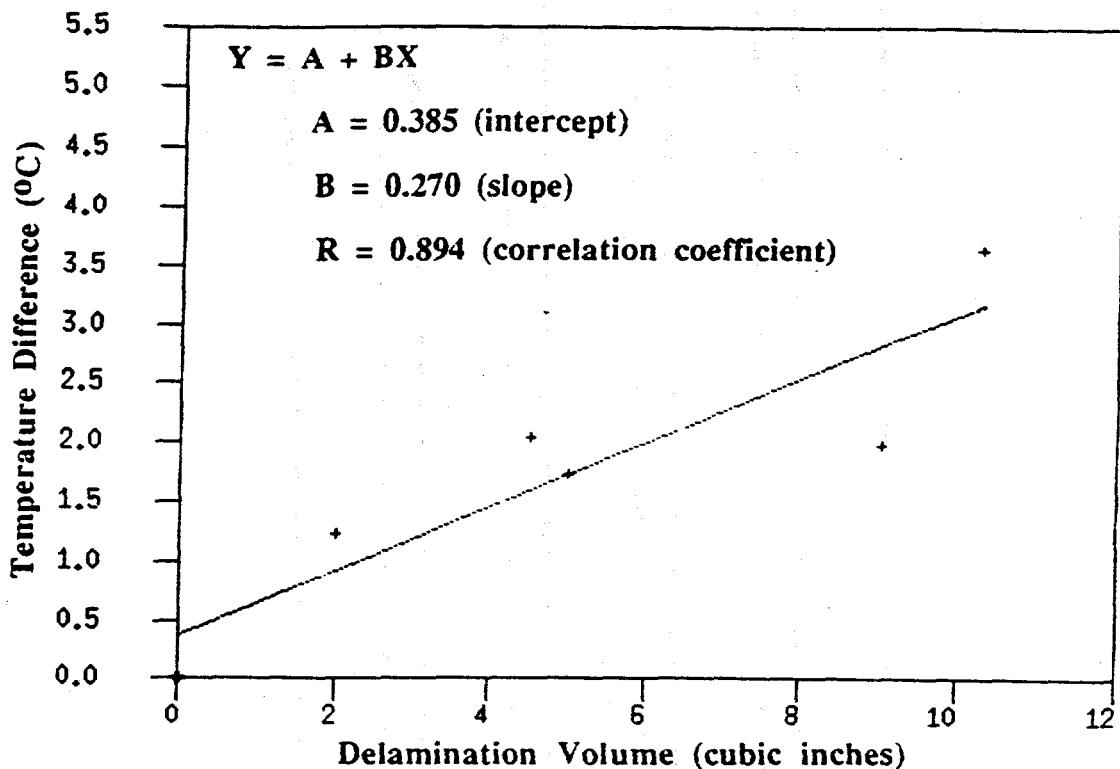
Figure 6. Average daytime (above ambient) minus nighttime (below ambient) concrete temperature differences varied as the styrofoam implant volumes. DBIR data were from the Jan. 29th tests, for Slabs A and B, and the Apr. 12th tests for Slab B.

3.2 Thermal inertia signatures of synthetic delamination sites in concrete, Fig. 6

Previous studies were made of thermal inertia signatures for buried mines.⁷ Sites of disturbed soil above the buried mine had above-ambient temperatures during most of the day, and below-ambient temperatures during most of the night. Similar thermal inertia signatures are expected to tag deteriorated concrete. Within limitations, which have not yet been specified, the daytime, nighttime, and daytime minus nighttime, concrete temperature excursions, e.g., from ambient, for deteriorated concrete, are expected to relate to the volume (or amount) of deteriorated concrete. Figure 6 shows the correlation between the day-night concrete temperature excursions and the volume of the styrofoam implants.

The reason for this is that the bulk thermal properties for defective, delaminated concrete, differ significantly from those of normal concrete. Defective and normal concrete have very different thermal inertia properties. They heat and cool at different rates from their surroundings. The thermal inertia, which is a measure of the resistance to temperature change, will be low for concrete sites with major delaminations affecting the structural integrity of the bridge deck, and high for normal concrete sites. Consequently, the daytime, nighttime, and daytime minus nighttime, temperature excursions from ambient, are expected to increase with the size of the delaminations, and to quantify the amount of deteriorated concrete.
