ORNL/TM-6478

**Structural Model Testing for Prestressed  
Concrete Pressure Vessels:  
A Study of Grouted vs Nongrouted  
Posttensioned Prestressing  
Tendon Systems**

HTGR BASE TECHNOLOGY PROGRAM  
Prestressed Concrete Nuclear Pressure  
Vessel Development (189a 01331)

Concrete Structures Testing — Milestone 7b

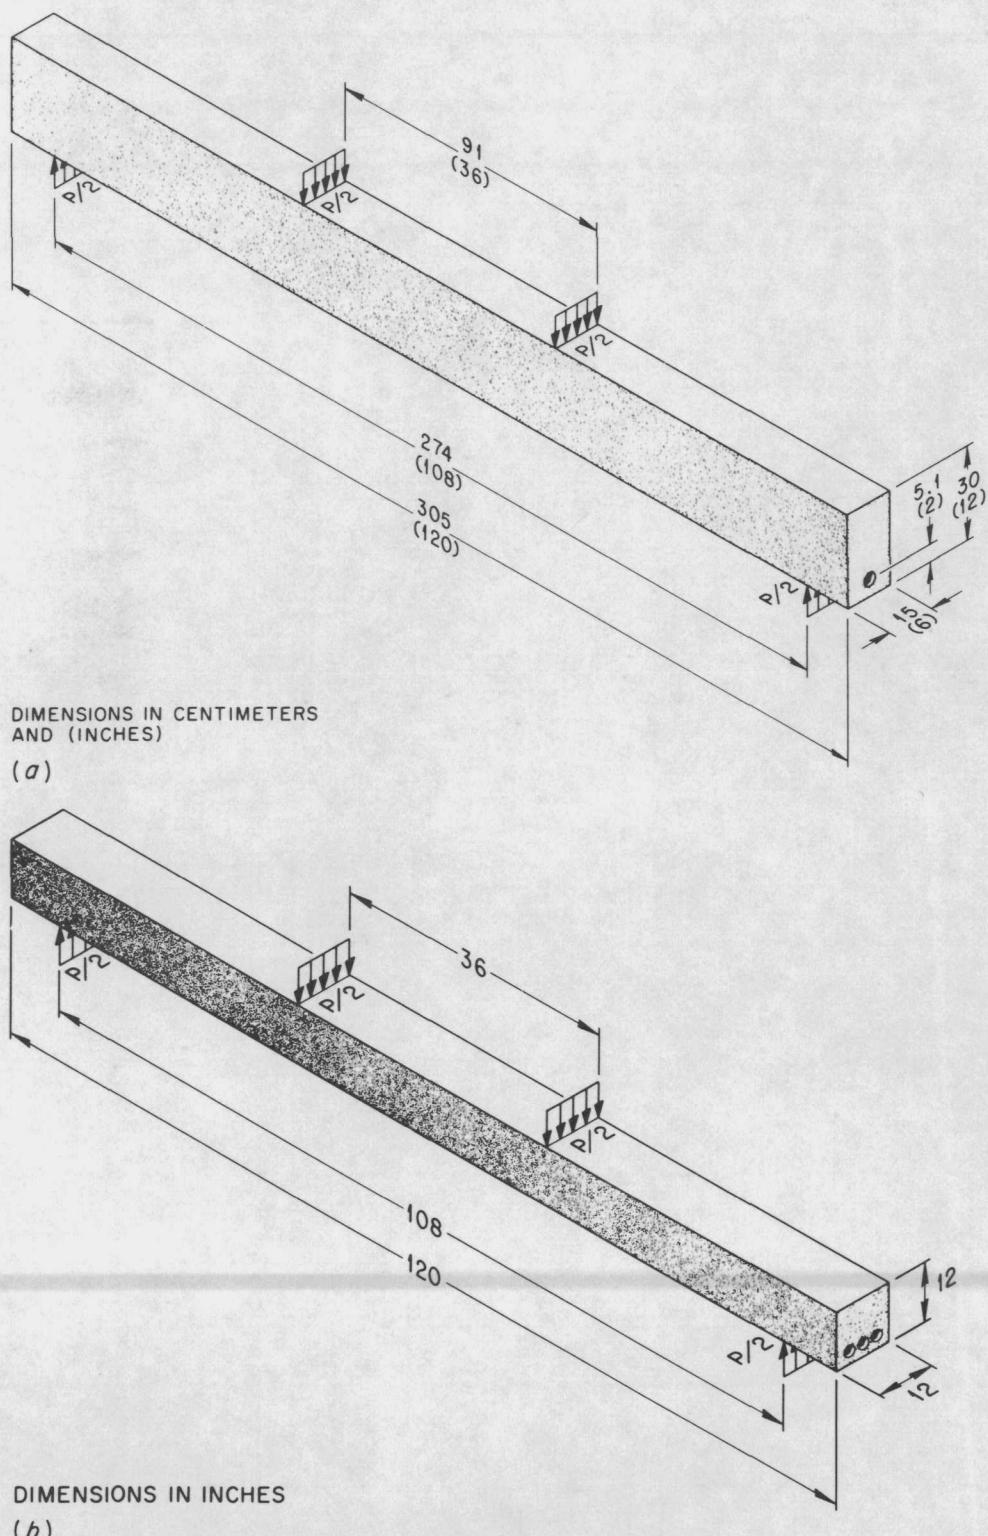
Fig. 1. Flexure test specimen geometries. (a) 0.15 m wide, 0.30 m deep, 3.1 m long; (b) 0.30 m wide, 0.30 m deep, 3.1 m long.

The relative structural performance under static, dynamic, and cyclic loading conditions of grouted and nongrouted posttensioned structures was evaluated by testing in flexure simple beam members\* either 0.15 m wide by 0.30 m deep by 3.1 m long or 0.30 m wide by 0.30 m deep by 3.1 m long, such as shown in Figs. 1(a) and (b), respectively. The 0.15-m-wide beams were cast in the steel mold shown in Fig. 2(a) and the 0.30-m-wide beams were cast in the plywood mold shown in Fig. 2(b). Analysis results for these beam geometries are contained in Appendix A.

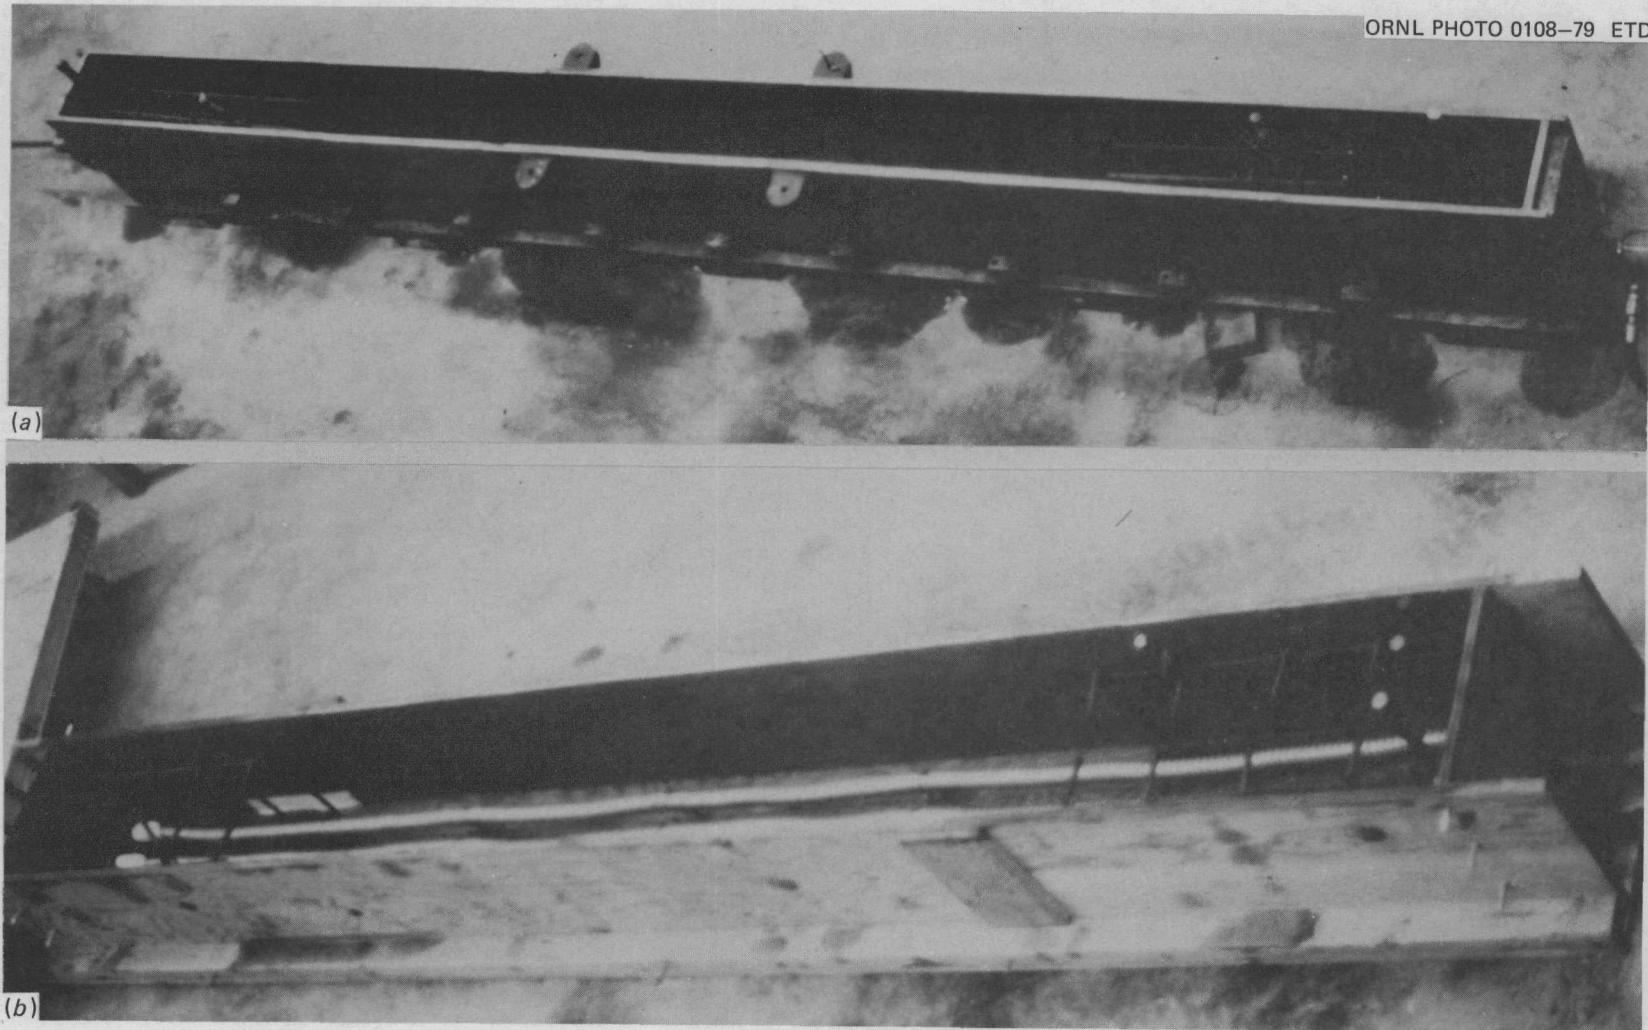
Fig. 2. Molds for flexure specimen fabrication. (a) 0.15-m-wide, 0.30-m-deep, 3.1-m-long specimens; (b) 0.30-m-wide, 0.30-m-deep, 3.1-m-long specimens.

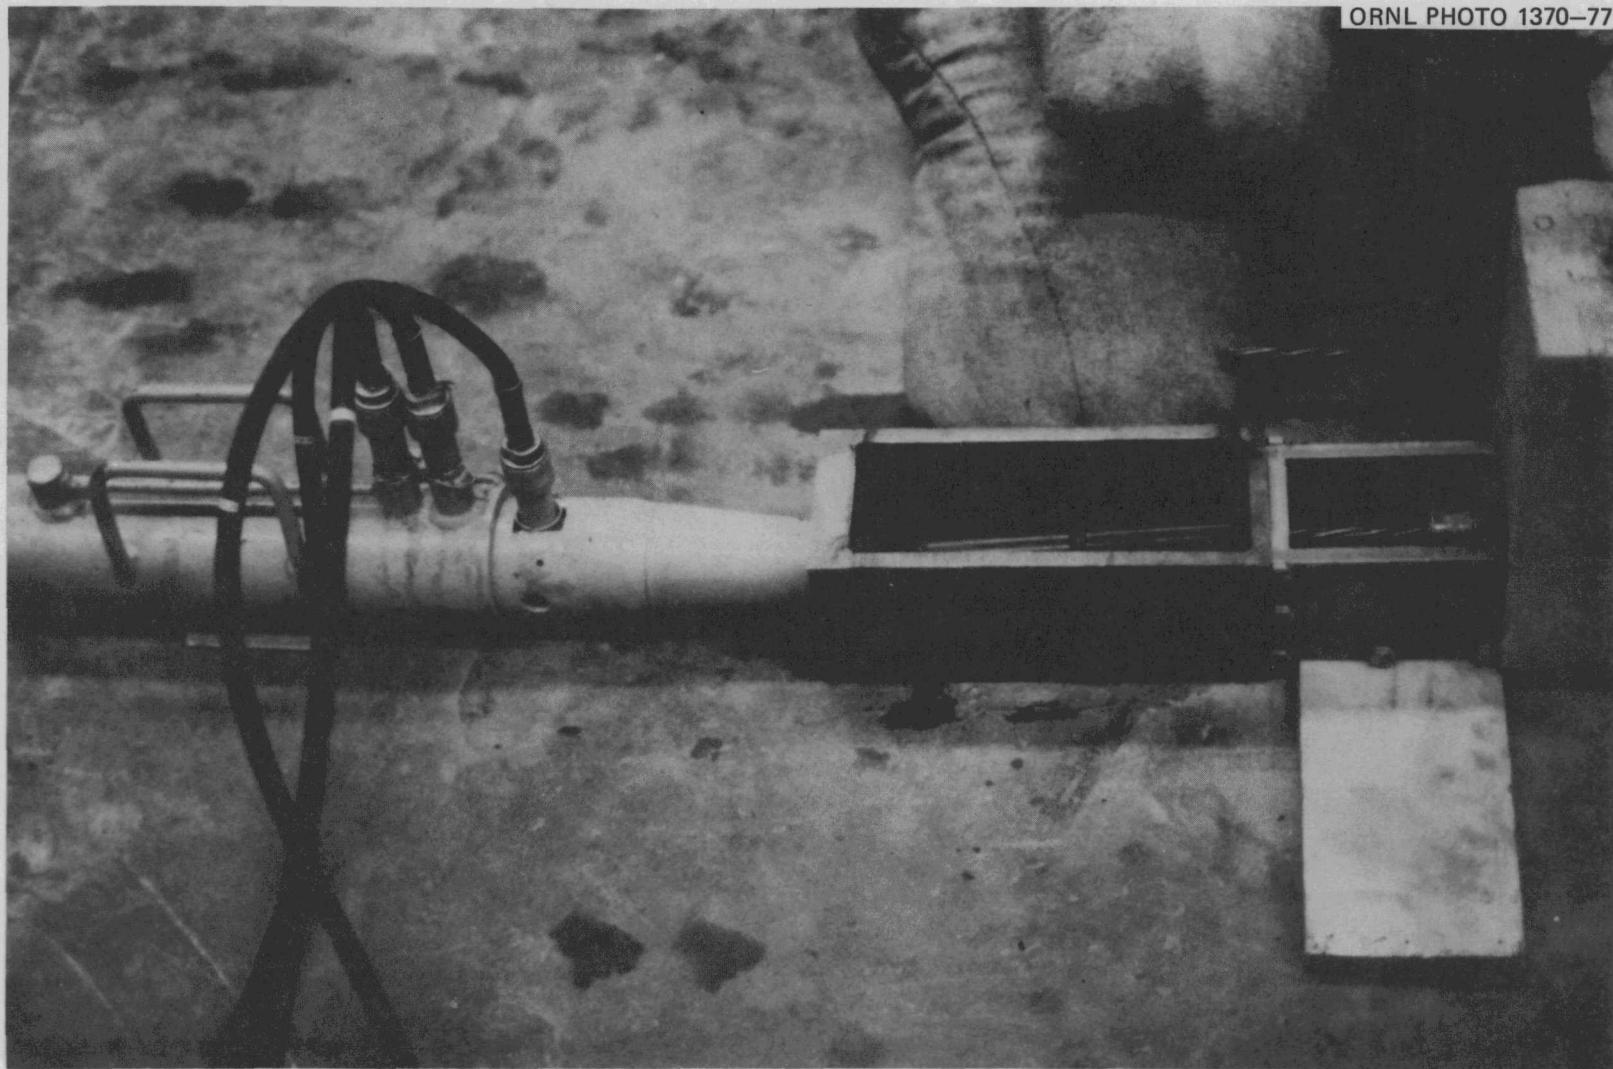
Fig. 4. Prestressing strand posttensioning setup.

and the reaction plate, which had been cast into the beam; releasing the ram pressure; and retensioning the strand and noting the ram pressure\* at which the shim washers first became loose. If posttensioning values were not correct,<sup>†</sup> the procedure was repeated with shims added or subtracted to obtain correct values. Table 4 presents posttensioning levels for each of the beams tested in this test series.

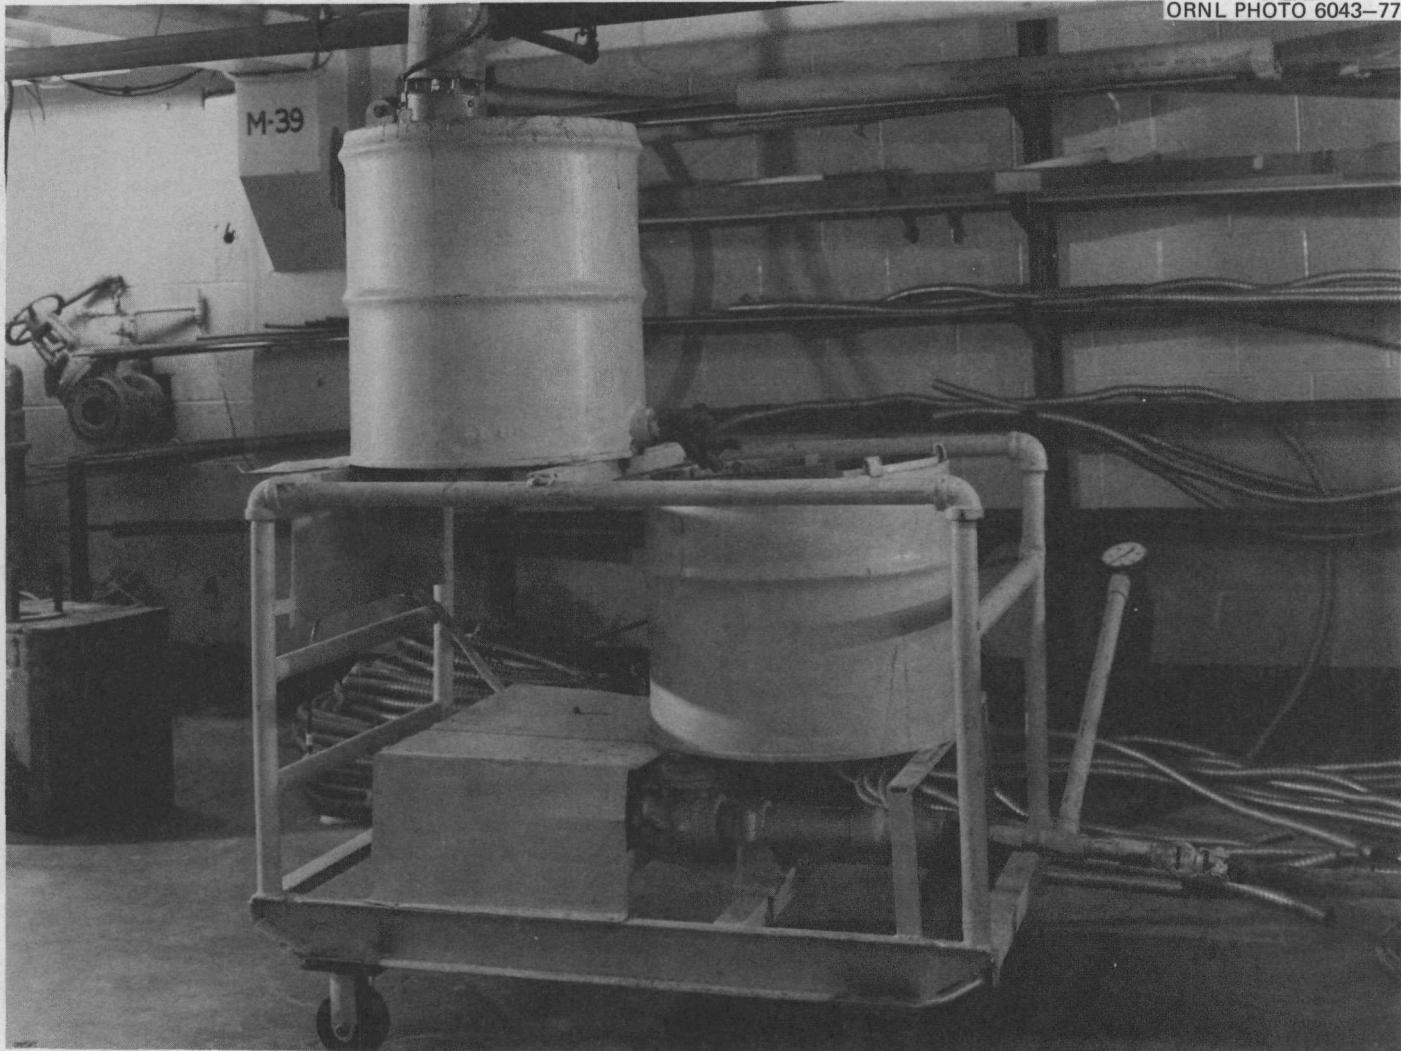
Fig. 5. Grout pump.

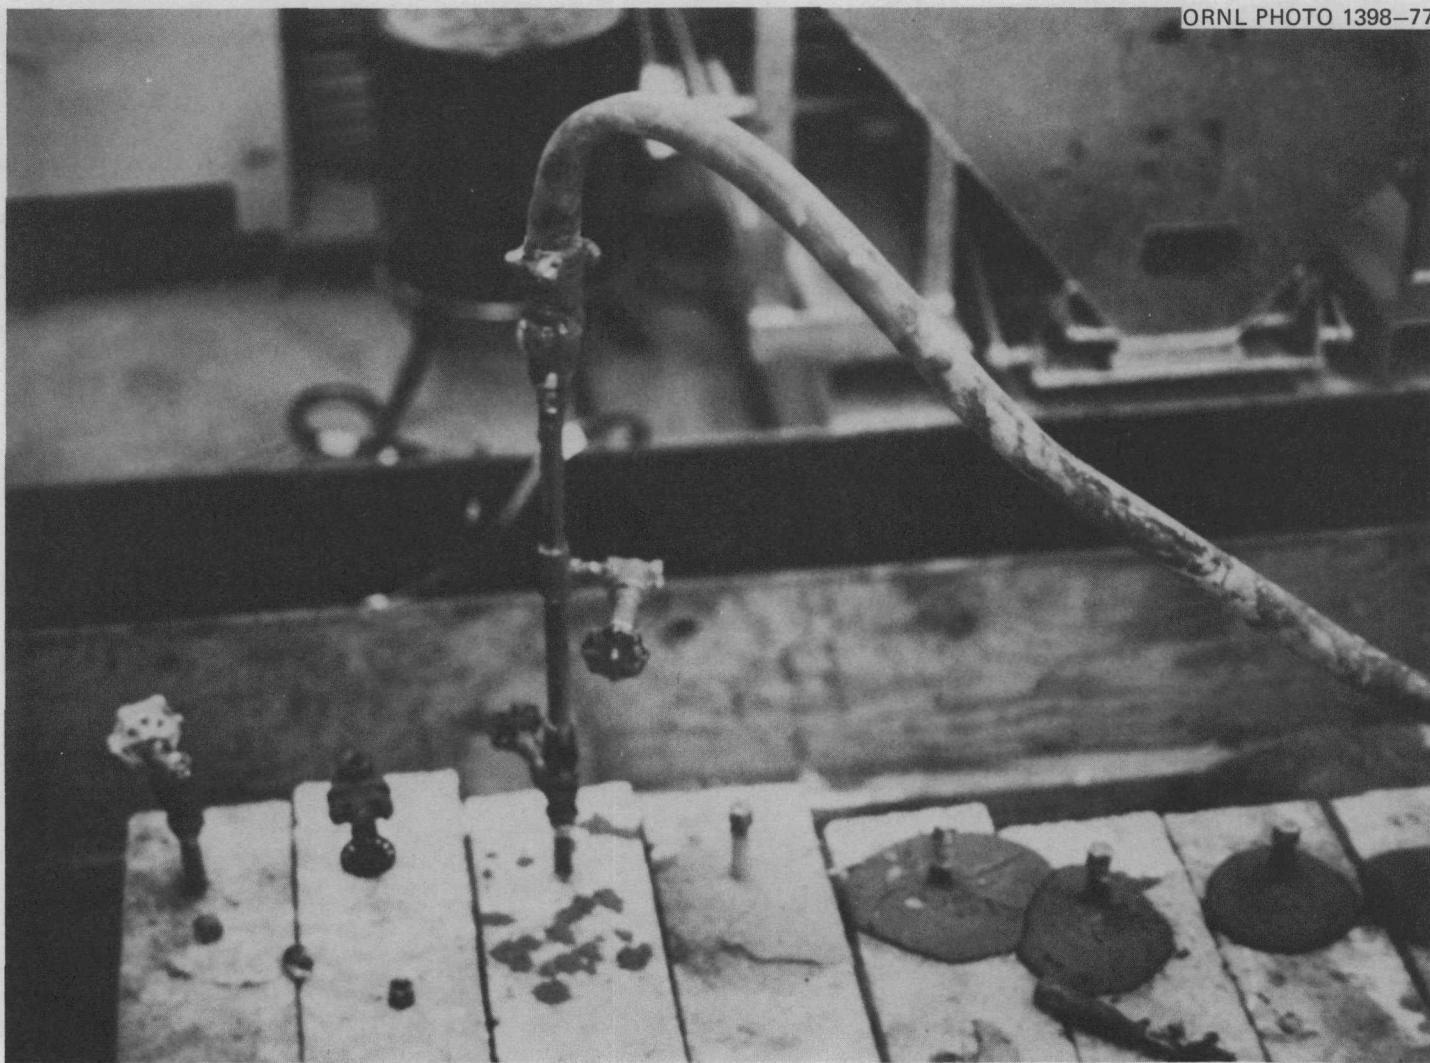
Fig. 6. Grouting of prestressed concrete beam.

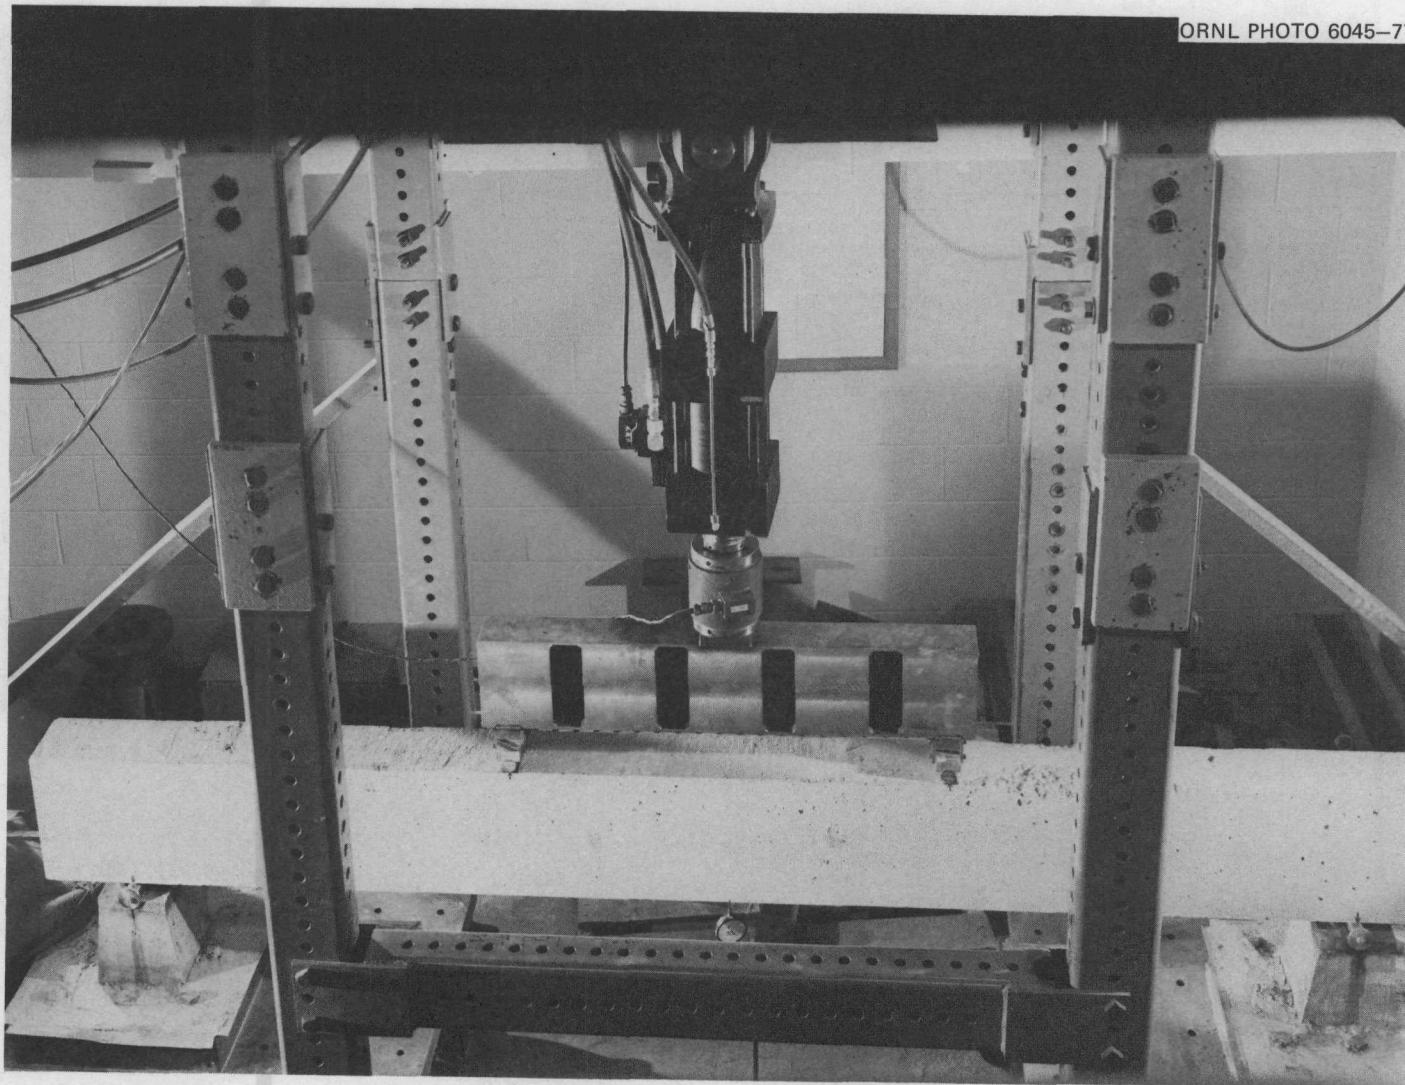
Fig. 7. Flexure test setup.

Dynamic flexure tests were conducted using the same test setup as for the static flexure tests. Nominal prestressing levels of 60% ultimate strand strength were used for both the grouted and nongROUTed tendon beams. The test procedure was the same as for the static tests, except loading rates of 0.074, 0.74, 7.4, and 74 kN/sec were used and cracks were only marked for the slowest loading rate. Grouted tendon load-centerline deflection curves for beams loaded at rates of 0.074, 0.74, 7.4, and 74 kN/sec are presented in Figs. 10 (G4), 21 (G10), 22 (G5), and 23 (G8), respectively. NongROUTed load-centerline deflection curves for beams loaded at rates of 0.074, 7.4, and 74 kN/sec are presented in Figs. 17 (NG15), 24 (NG11), and 25 (NG12), respectively. Photographs of each of the beams after testing have been overlaid on the appropriate load-centerline deflection curves. Table 4 presents maximum load level, centerline deflection at maximum load, and type of beam failure for each of these beams. Figure 26 presents a summary of the effects of loading rate on the load-centerline deflection behavior of the grouted and nongROUTed tendon beams. Results indicate no significant difference (<8%) in ultimate load capacities for either grouted or nongROUTed tendon beams for the range of loading rates investigated. The load capacities of the beams were anticipated to increase as the loading rate increased,<sup>9,10</sup> but this trend was not apparent because the stiffness and capacity of the testing machine were apparently not sufficient to apply a truly dynamic loading effect, and results were thus within the static domain. However, there was a trend for the beam centerline deflections at ultimate load to increase as the loading rate increased for both types of beams.

After conduction of the prestressing bond transfer length tests, each of the beams was statically loaded to failure in the test fixture shown in Fig. 7. Testing procedures were identical to those used for the static flexure test specimens. Load-centerline deflection curves for the shrinkage-compensating cement, polymer-silica cement, and commercially grouted beams with one anchorage removed are shown in Figs. 53 (G17), 54 (G20), and 55 (G9), respectively. These figures also show photographs of the particular beams after testing. A summary of the results, including those for a grouted tendon beam in which a simulated anchorage failure has not been induced, are presented in Fig. 56. As anticipated, the beams having one anchorage removed and grouted with shrinkage-compensating cement and conventional grout failed by tendon pull-out\* at 58 and 51% of the ultimate load of a grouted tendon beam

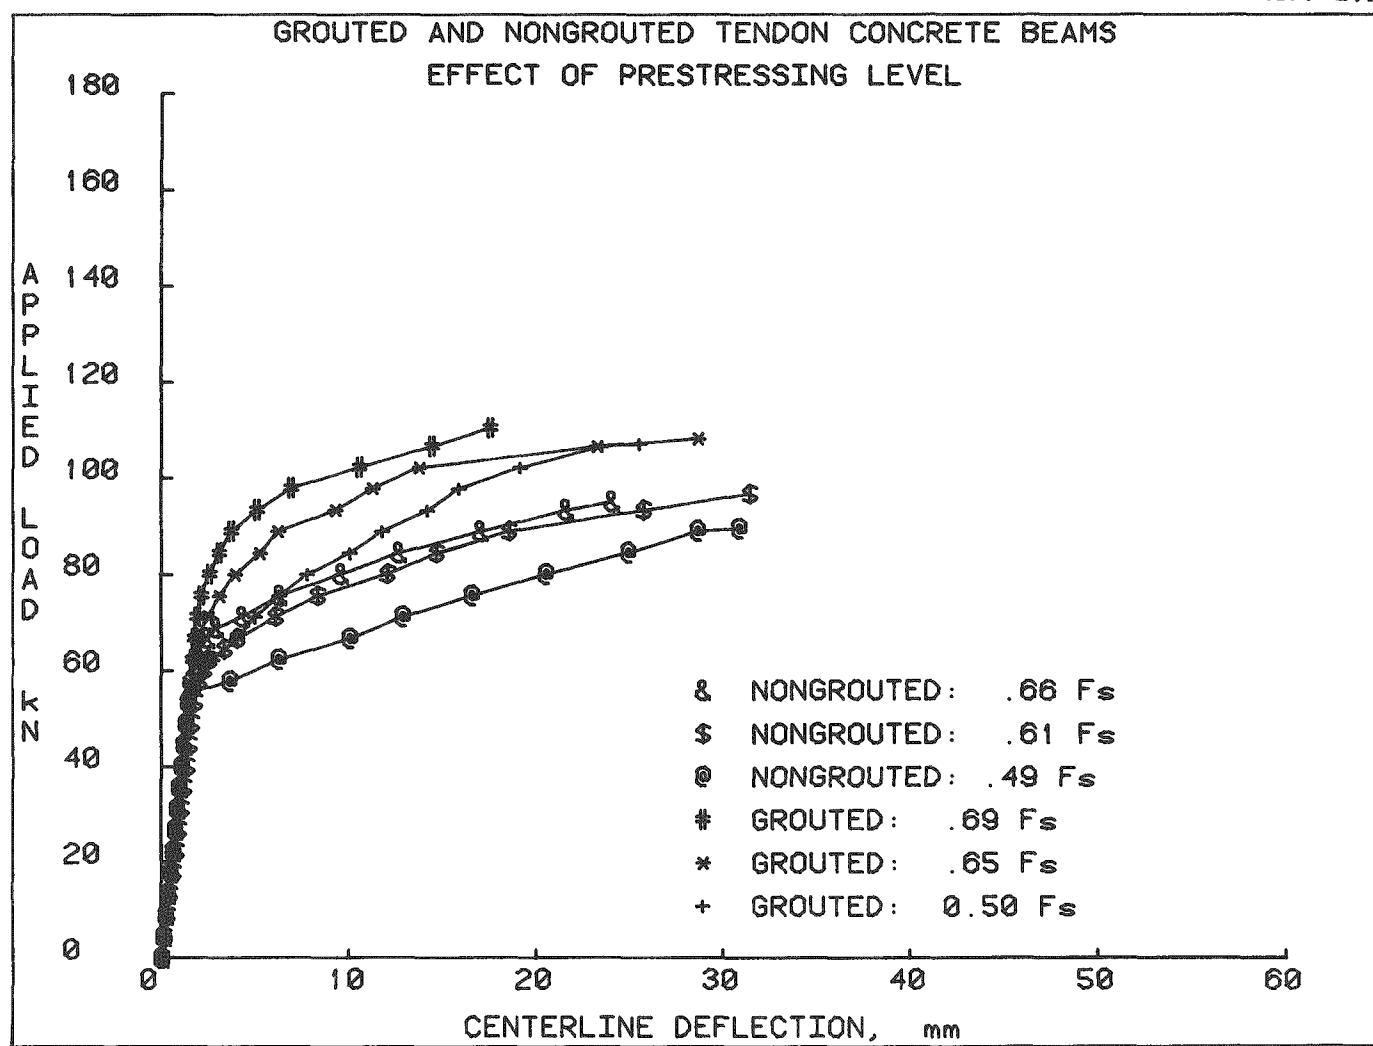
Fig. 20. Effect of prestressing level on beam performance.

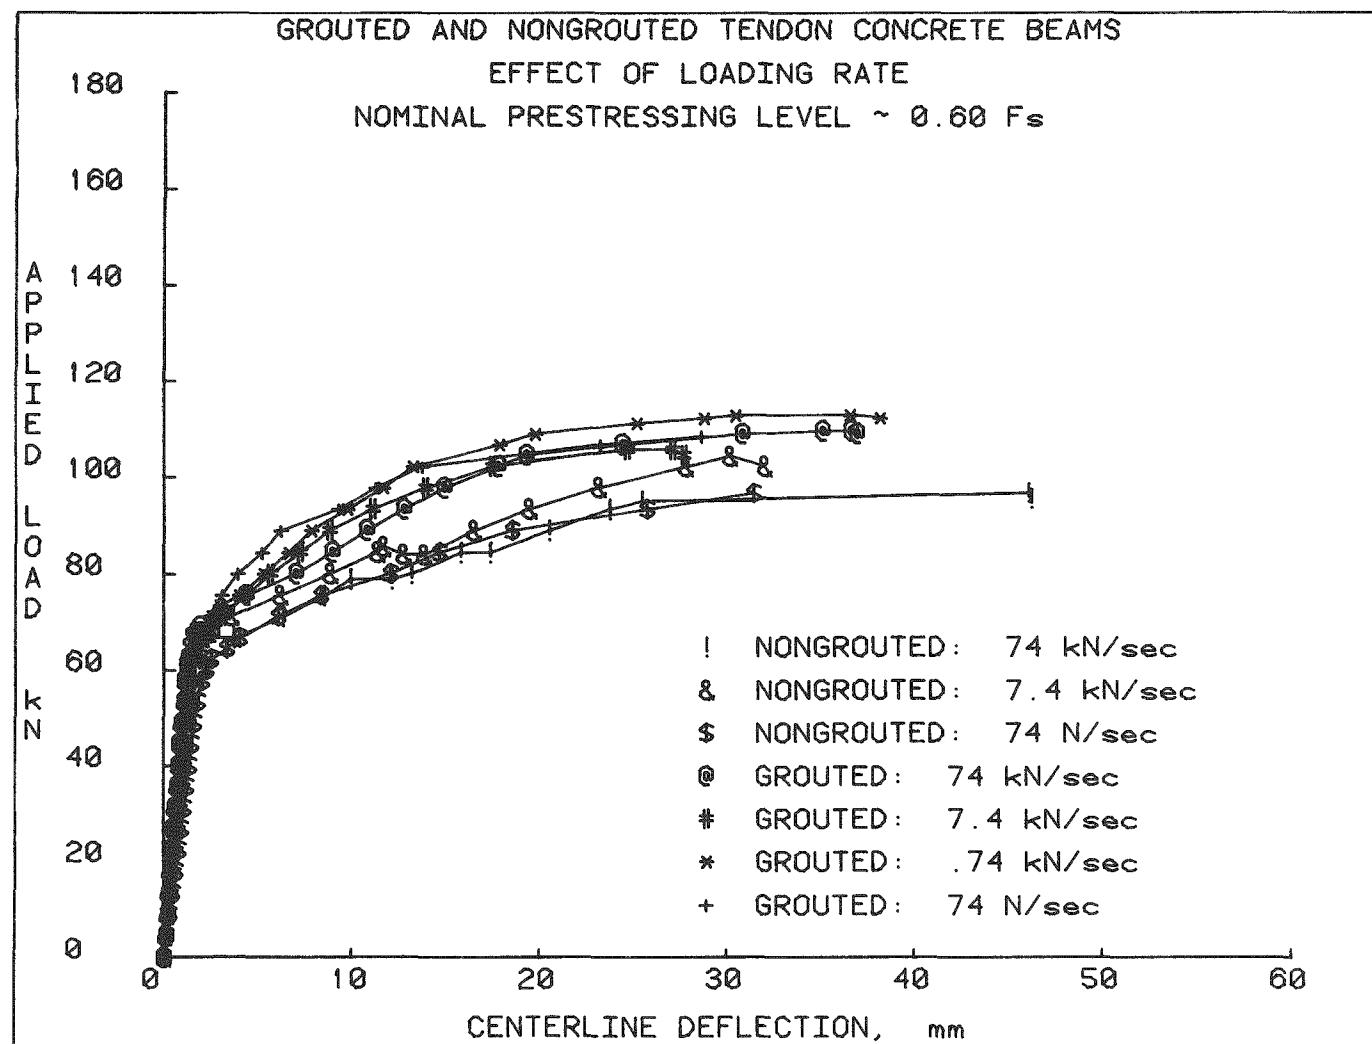
Fig. 26. Effect of loading rate on beam performance.

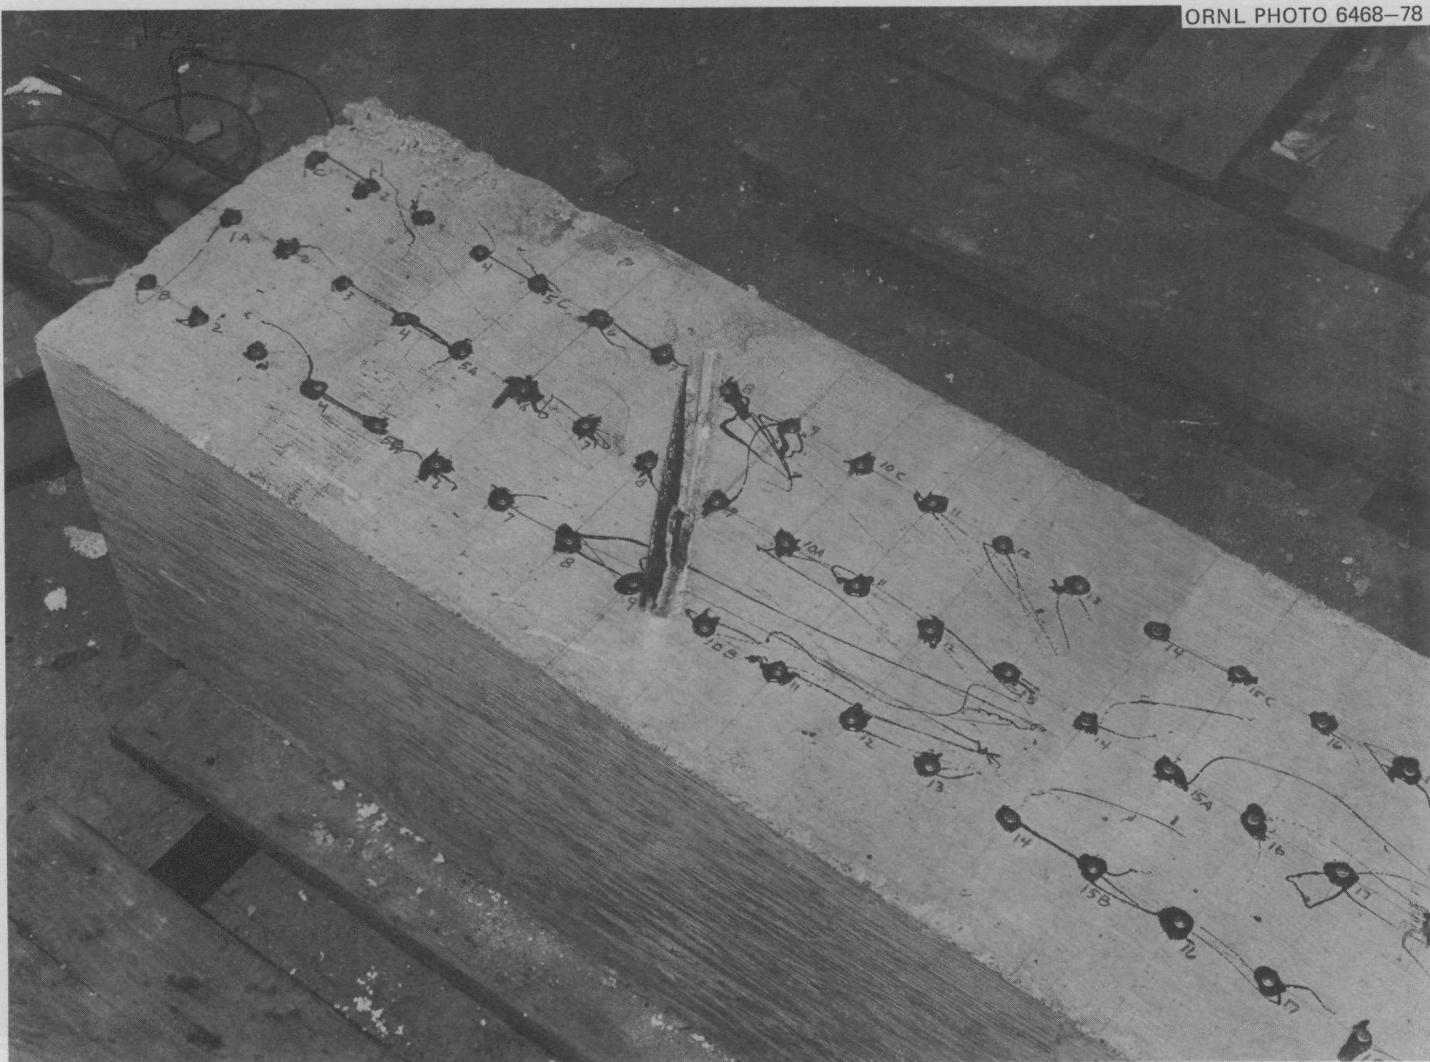
Fig. 30. Simulated failed tendon test specimen.

Simulated tendon failures were induced (1) in the nongROUTed tendon beam by overtensioning the center strand sufficiently so that a shim restraining the wedge anchorage could be removed and the load released, and (2) in the grouted tendon beam by using a grinder to slowly cut the central tendon, which was exposed by a slot (Fig. 30) that had been precast into the beam at a distance 406 mm from one end (failure located in the shear region of the beam). Beams were tested by loading to failure at a rate of 74 N/sec using the static flexure test fixture. Extent of crack propagation was noted as a function of load for each beam. Load-centerline deflection curves for the control specimens and the specimens with a simulated tendon failure are presented in Figs. 31 (LGC) and 32 (LGF) for the grouted tendon beams and in Figs. 33 (LNGC) and 34 (LNGF) for the nongROUTed tendon beams, respectively. Each of these curves also has a photographic overlay showing the beams after testing. Figure 35 presents a summary of results for the simulated tendon failure test series. As noted in Appendix A, analysis results predicted failure very close to the 245-kN capacity of the testing machine; thus, both grouted beams and the nongROUTed control beam could not be loaded to failure because their ultimate load capacity exceeded the testing machine capacity. The nongROUTed beam with the simulated tendon failure was loaded to failure. Some results that can still be derived are (1) a tendon failure occurring in a nongROUTed tendon beam is more critical than a tendon failure in a corresponding grouted tendon beam and (2) for the beam geometry of the investigation, both the grouted and nongROUTed beams with simulated tendon failure exhibited reduced cracking loads and increased deflections for the same load levels after cracking. Also, after first cracking, deflections of nongROUTed beams were greater than those of companion grouted beams at the same load level.

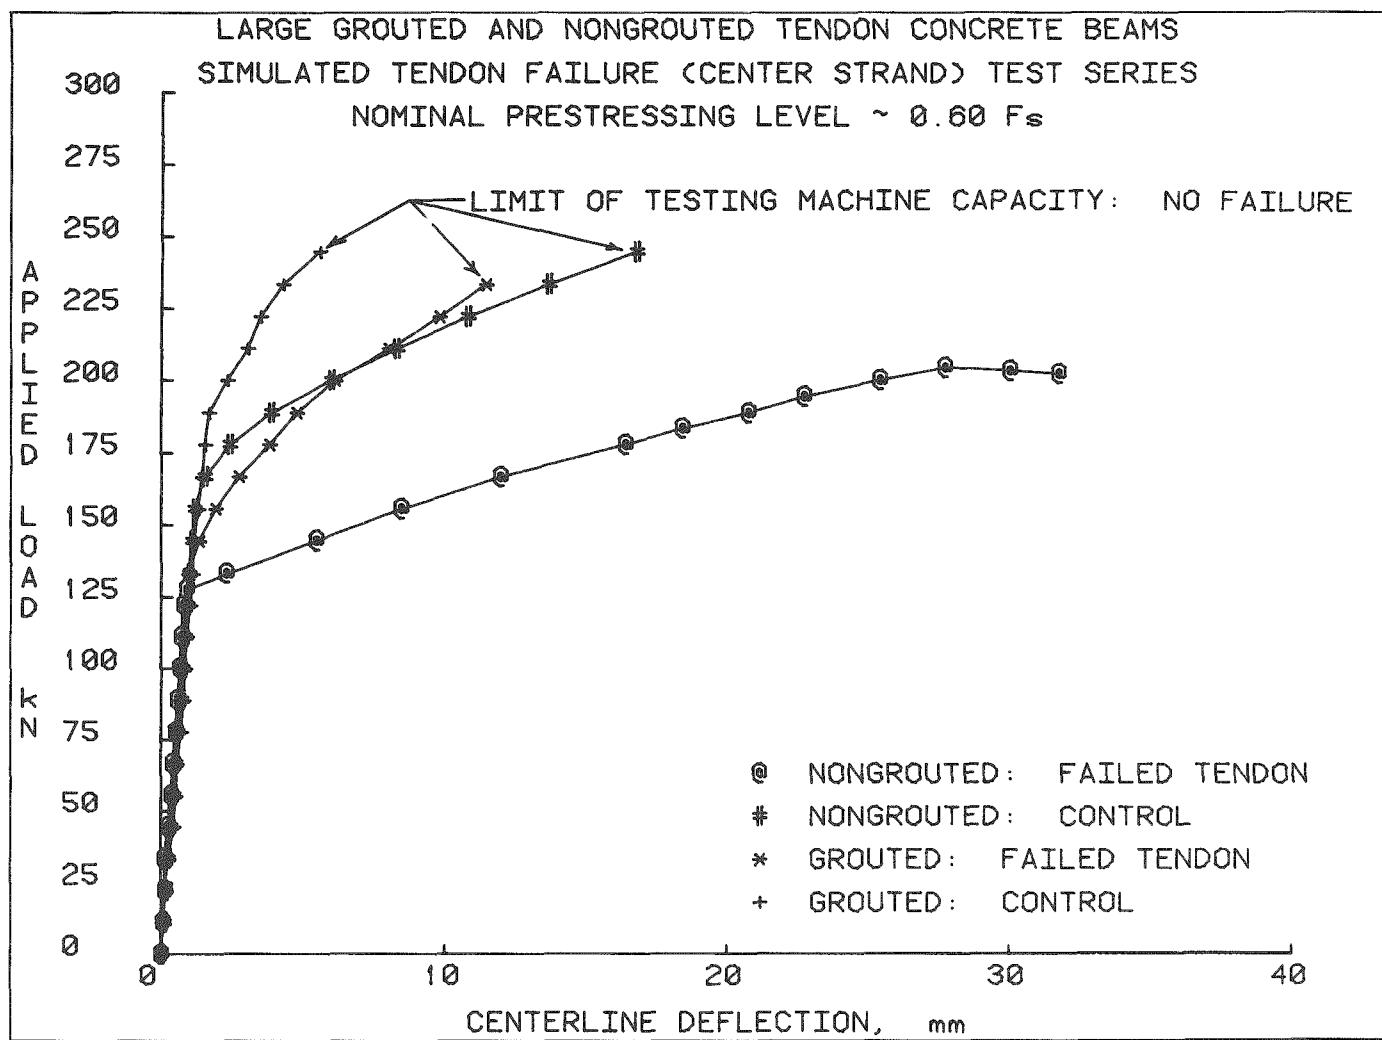
Fig. 35. Effect of simulated tendon failure on beam performance.

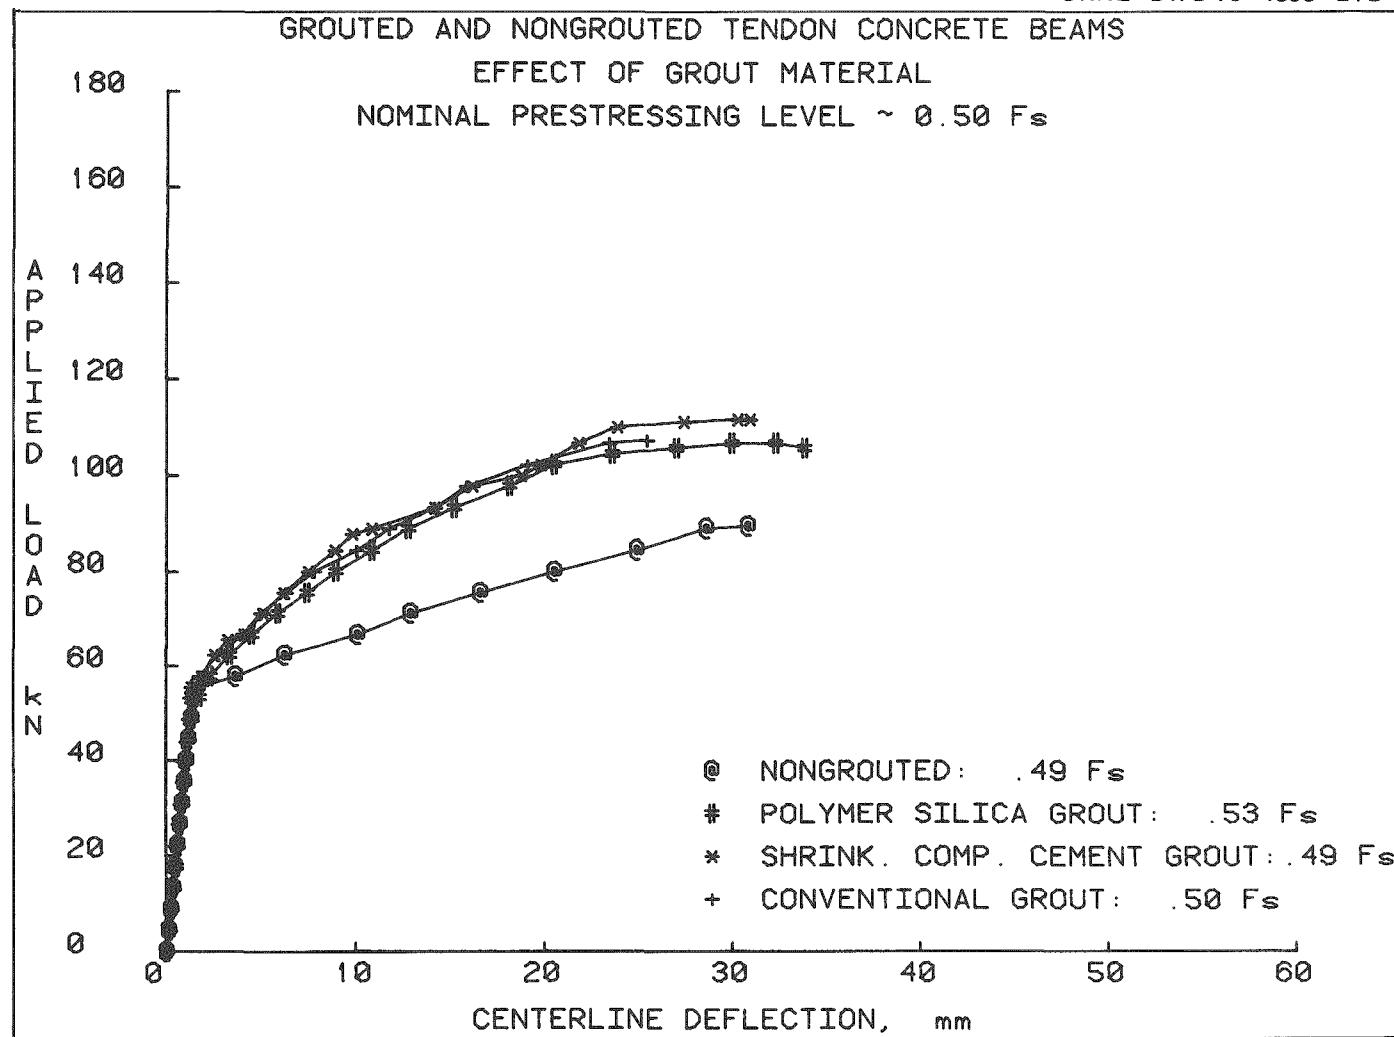
Fig. 49. Effect of grout material on beam performance —  $F_s = 0.50$ .

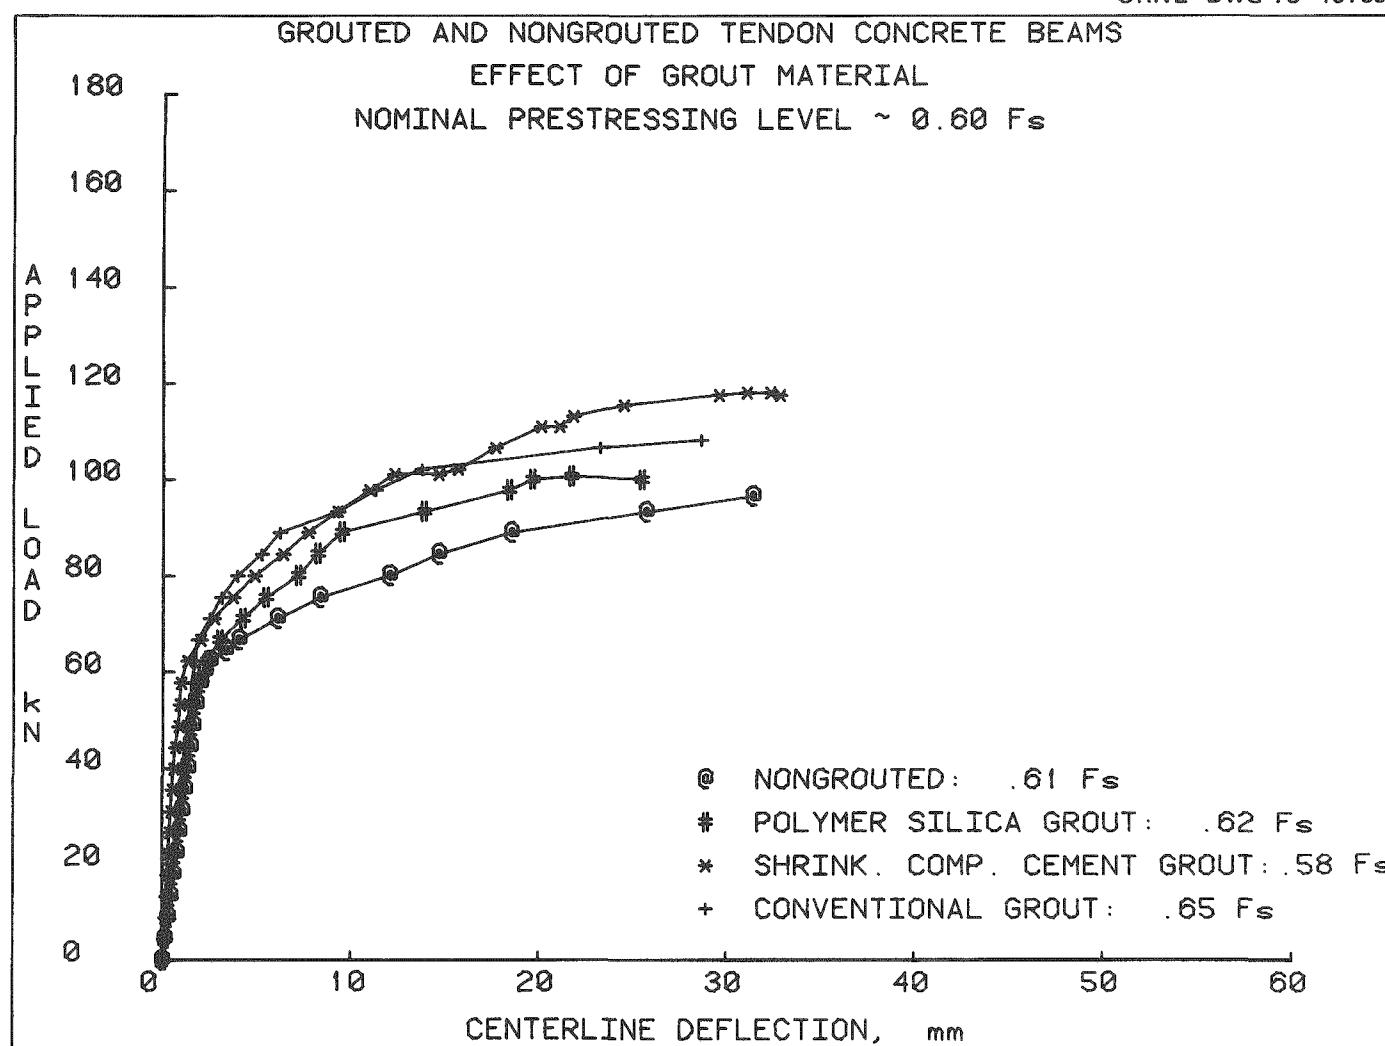
Fig. 50. Effect of grout material on beam performance —  $F_s = 0.60$ .

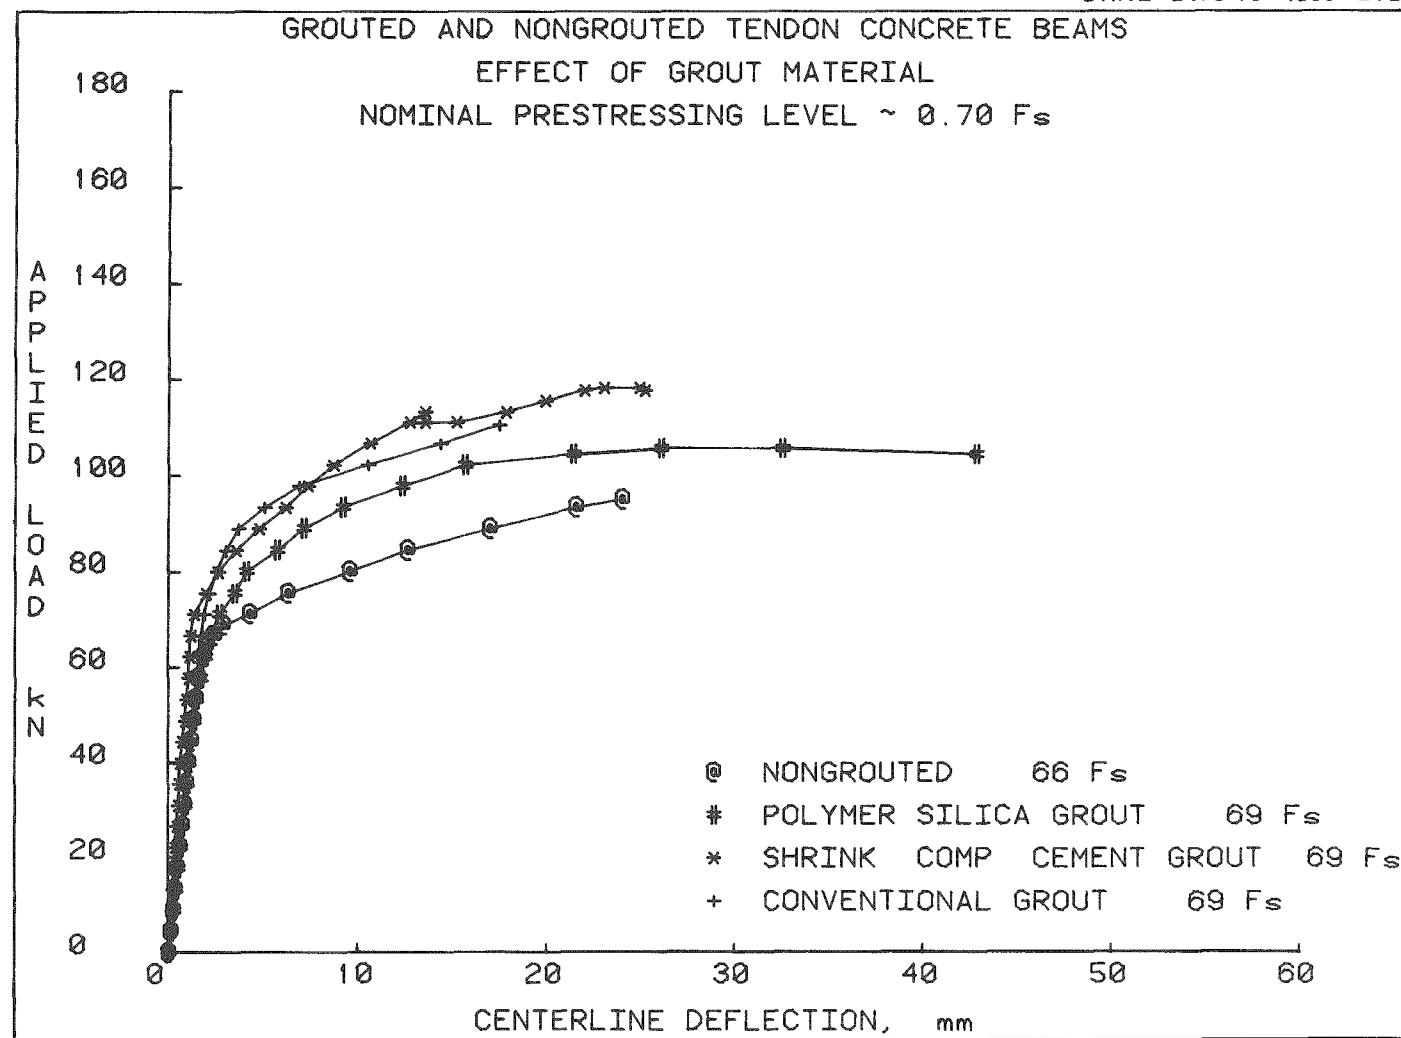
Fig. 51. Effect of grout material on beam performance —  $F_s = 0.70$ .

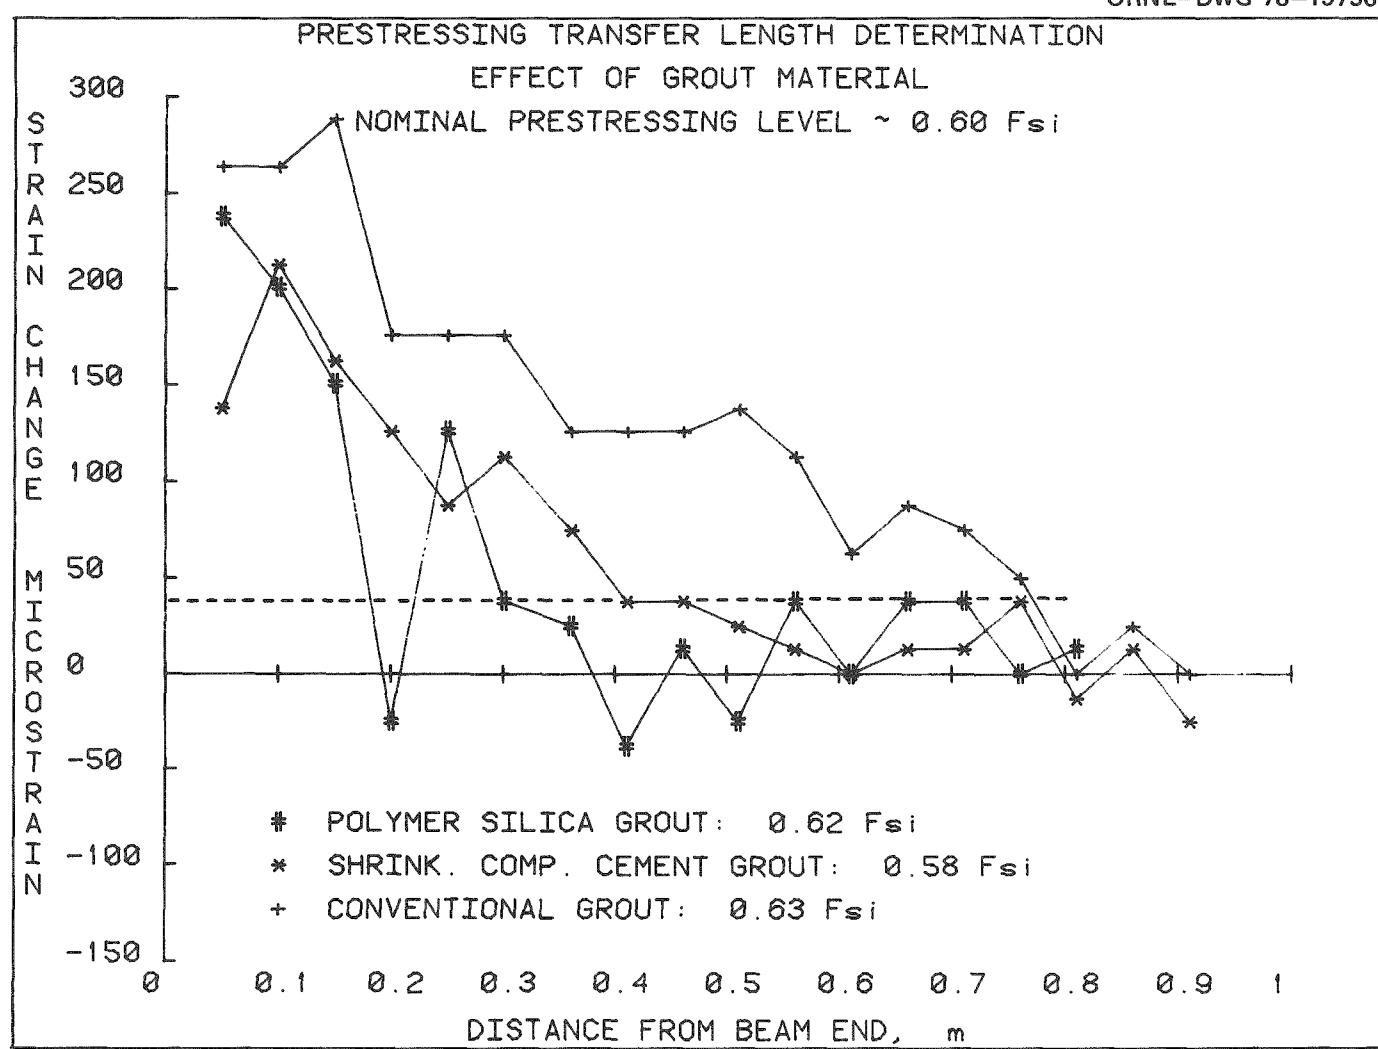
Fig. 52. Effect of grout material on prestressing transfer length.
