ORNL/TM-6478

**Structural Model Testing for Prestressed  
Concrete Pressure Vessels:  
A Study of Grouted vs Nongrouted  
Posttensioned Prestressing  
Tendon Systems**

HTGR BASE TECHNOLOGY PROGRAM  
Prestressed Concrete Nuclear Pressure  
Vessel Development (189a 01331)

Concrete Structures Testing — Milestone 7b

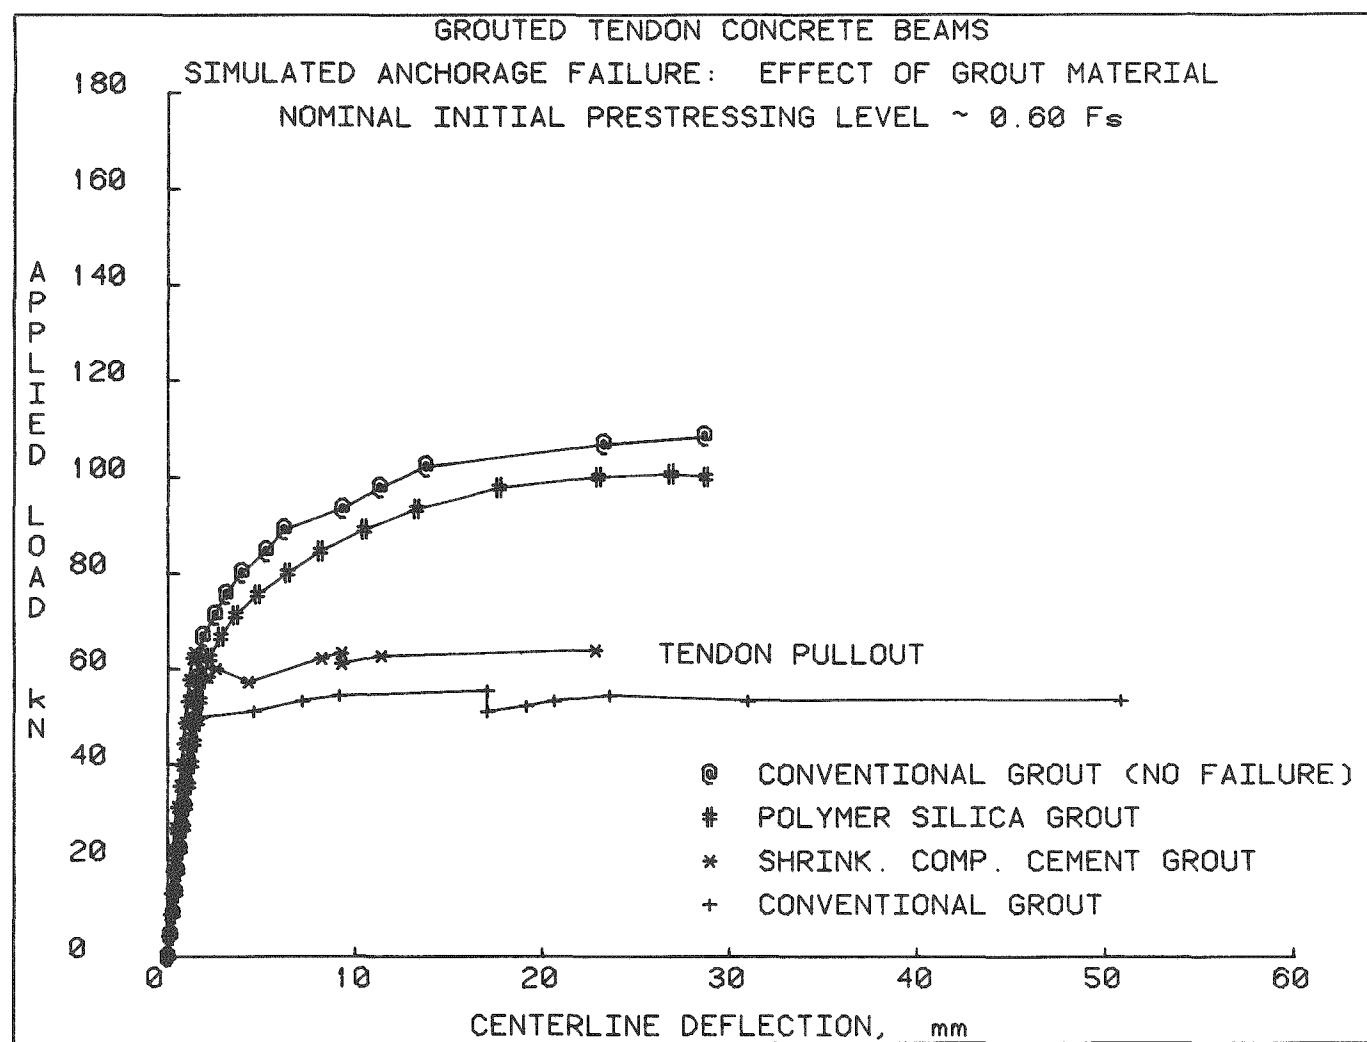
Fig. 56. Simulated anchorage failure: effect of grout material.

having nonfailed anchorages. However, the polymer-silica grouted beam with one anchorage removed was able to attain 93% of the ultimate load of the control beam and failed by concrete compression rather than tendon pull-out. Results thus indicate improved bond characteristics of the polymer-silica cement materials.

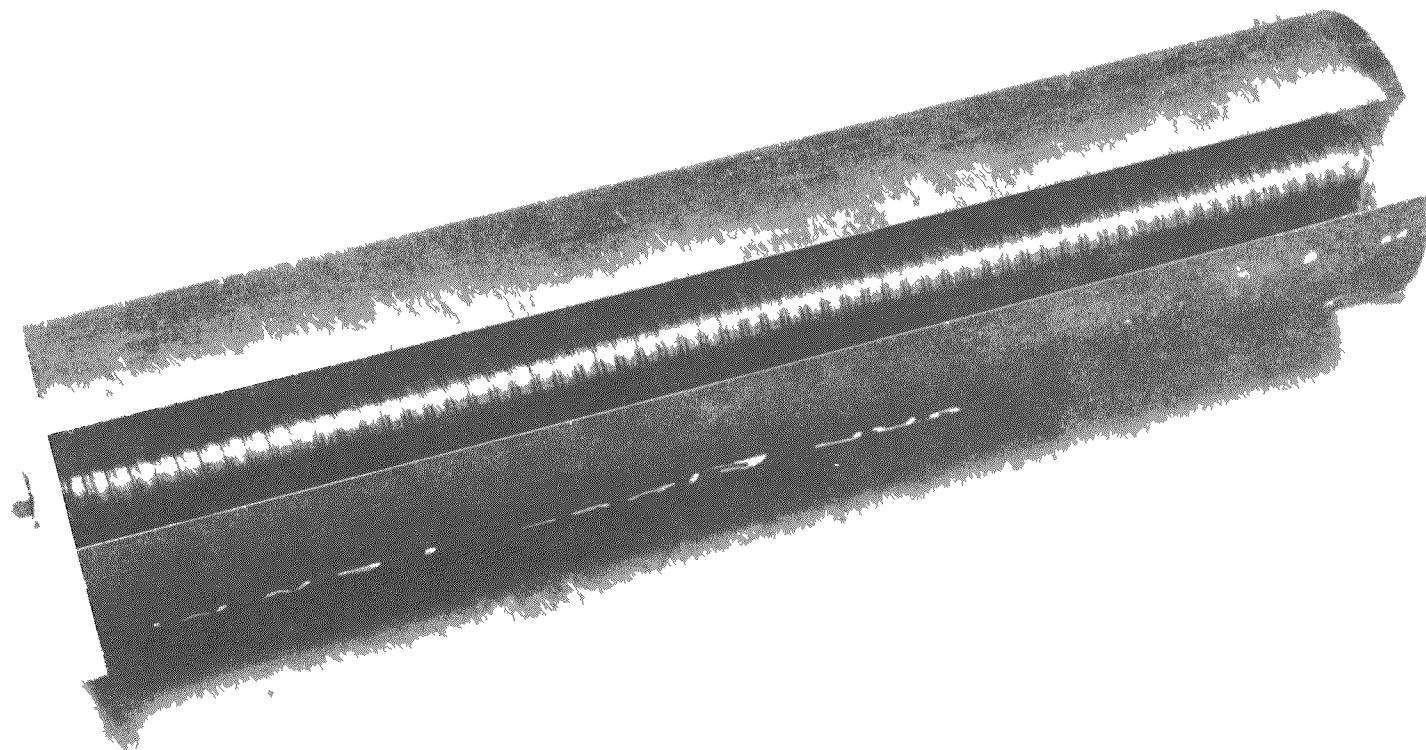
Fig. 57. Bond pull-out test specimen mold.

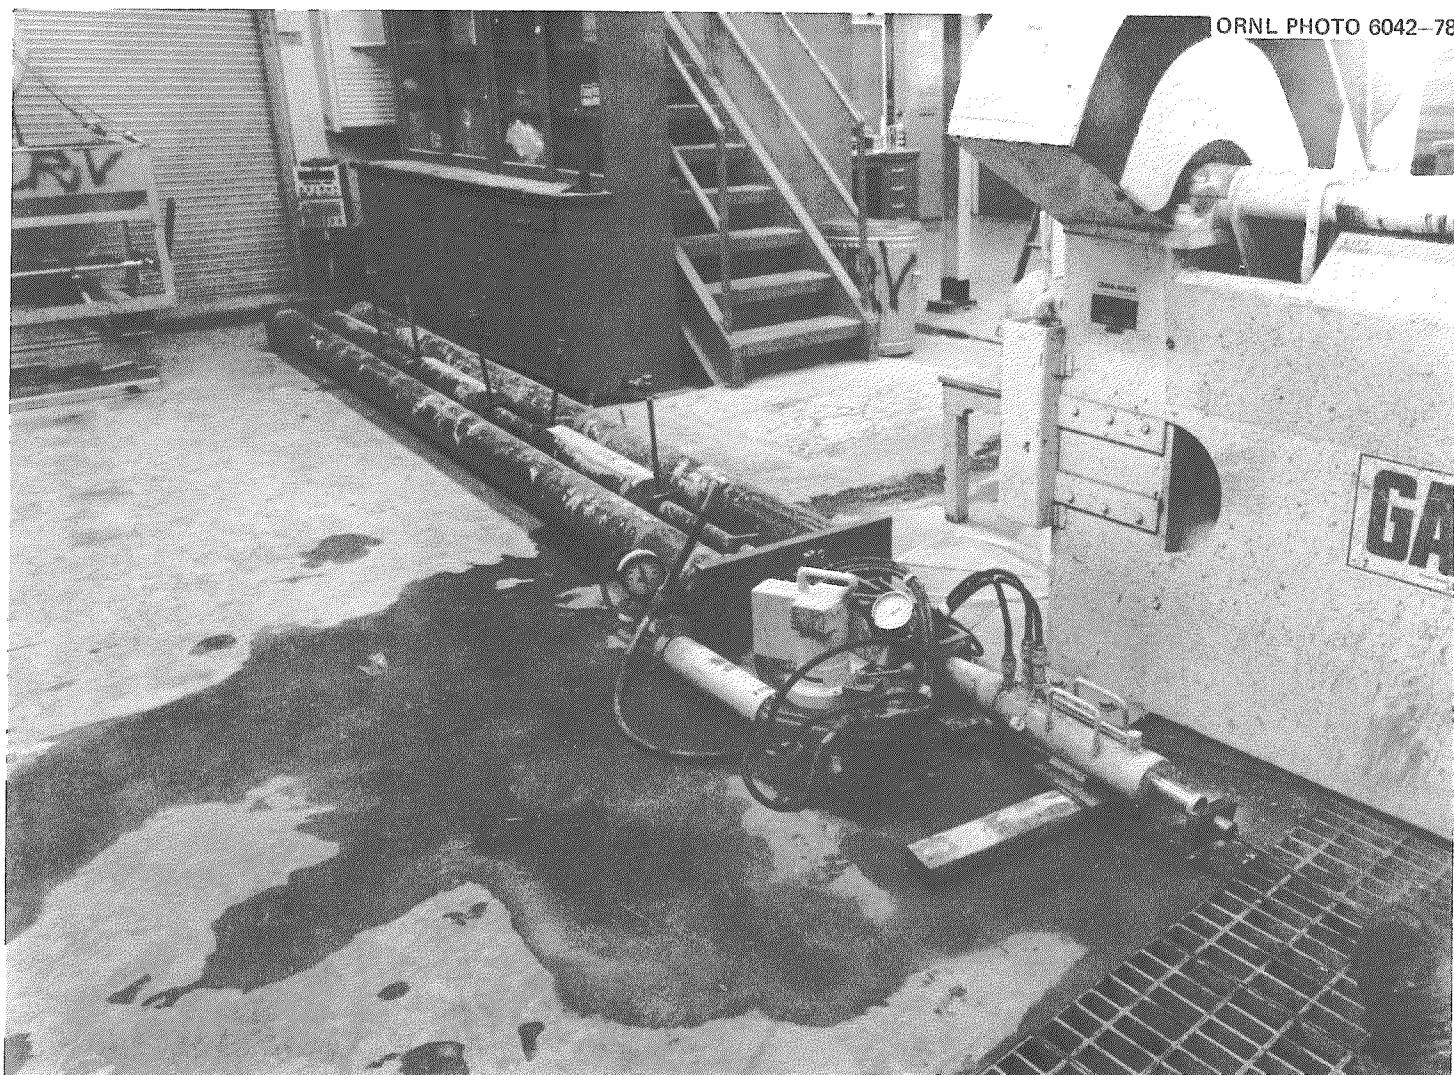
Fig. 58. Tensioning fixture for bond pull-out specimens.

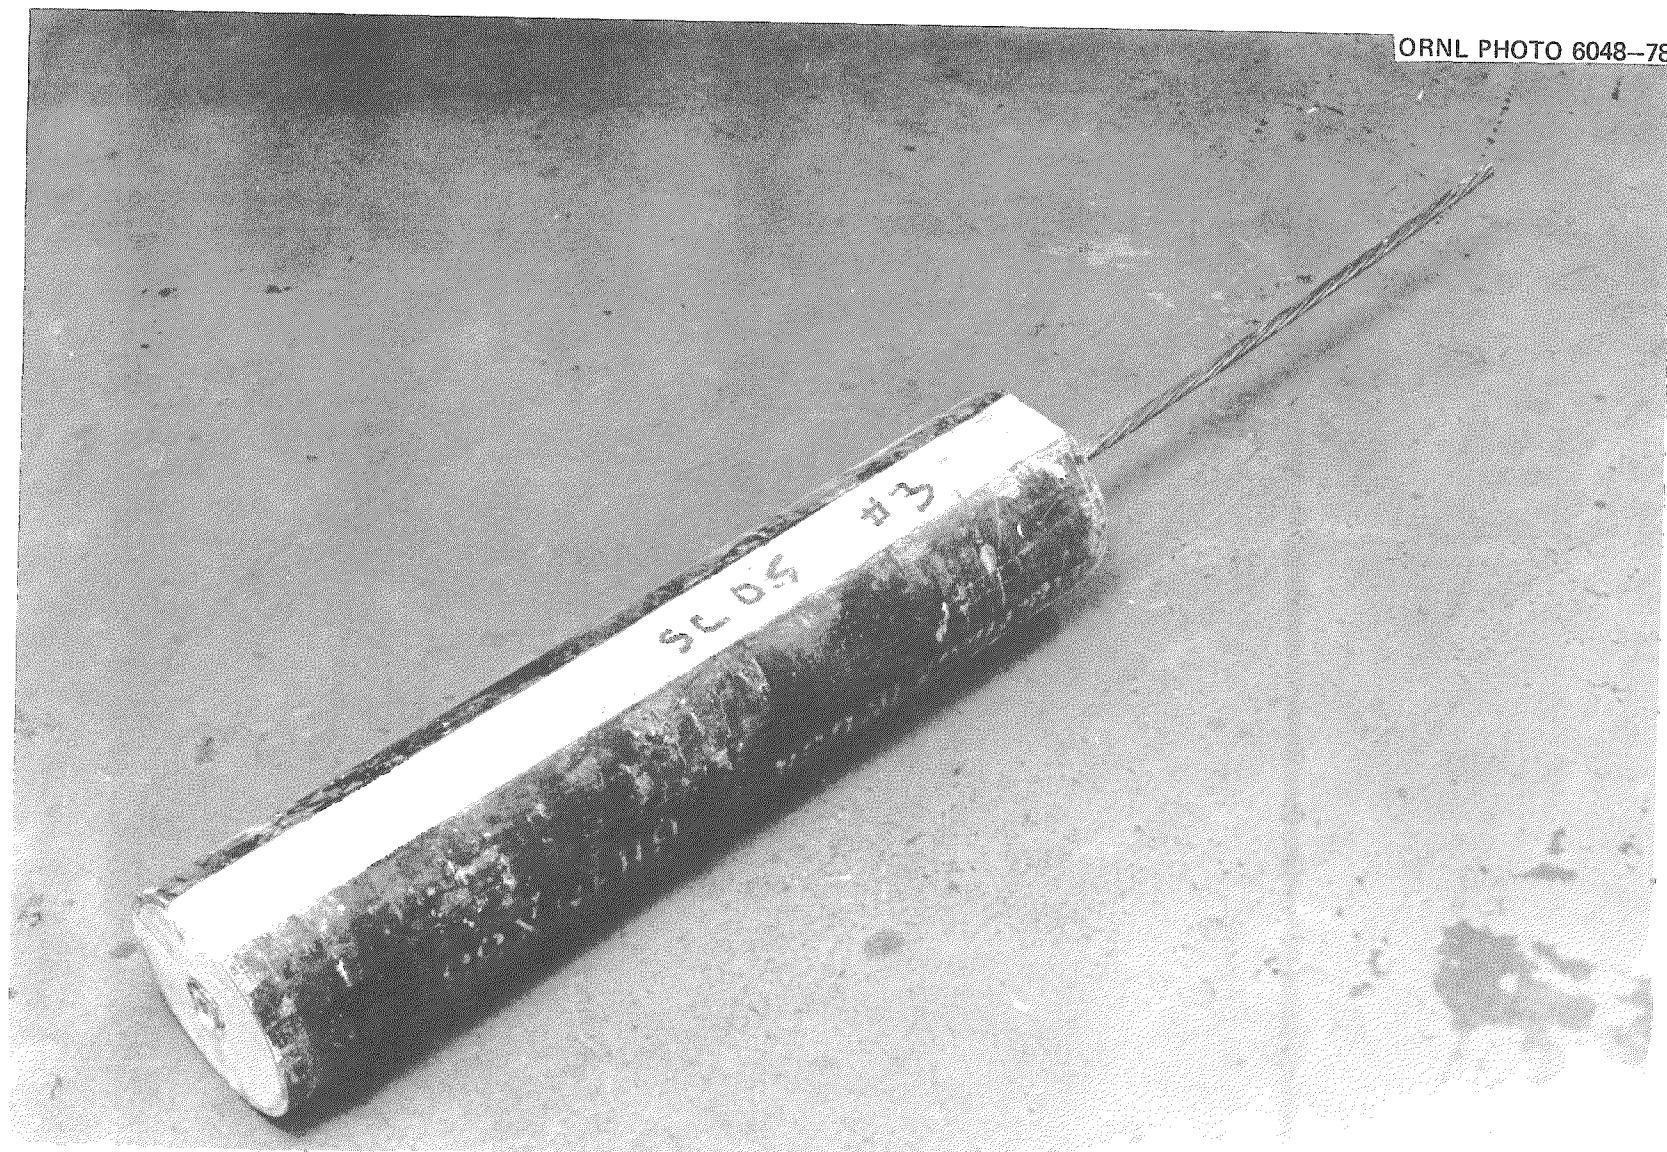
Fig. 59. Bond pull-out test specimen.

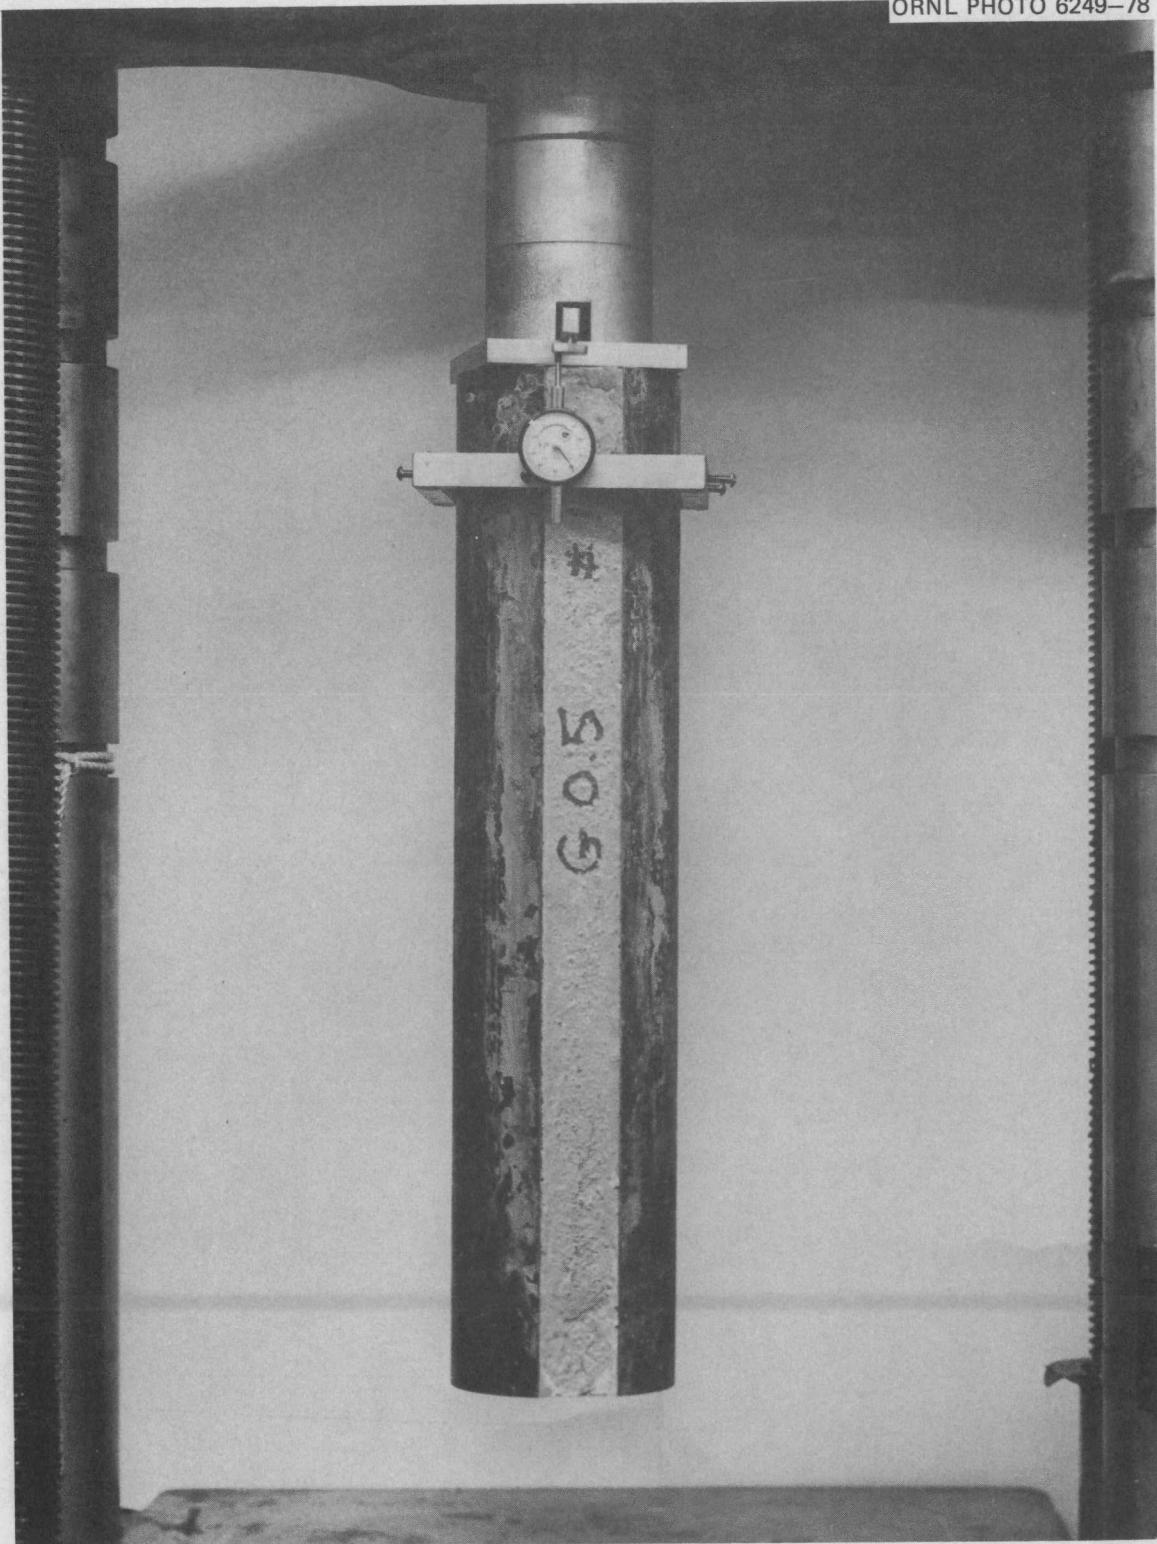
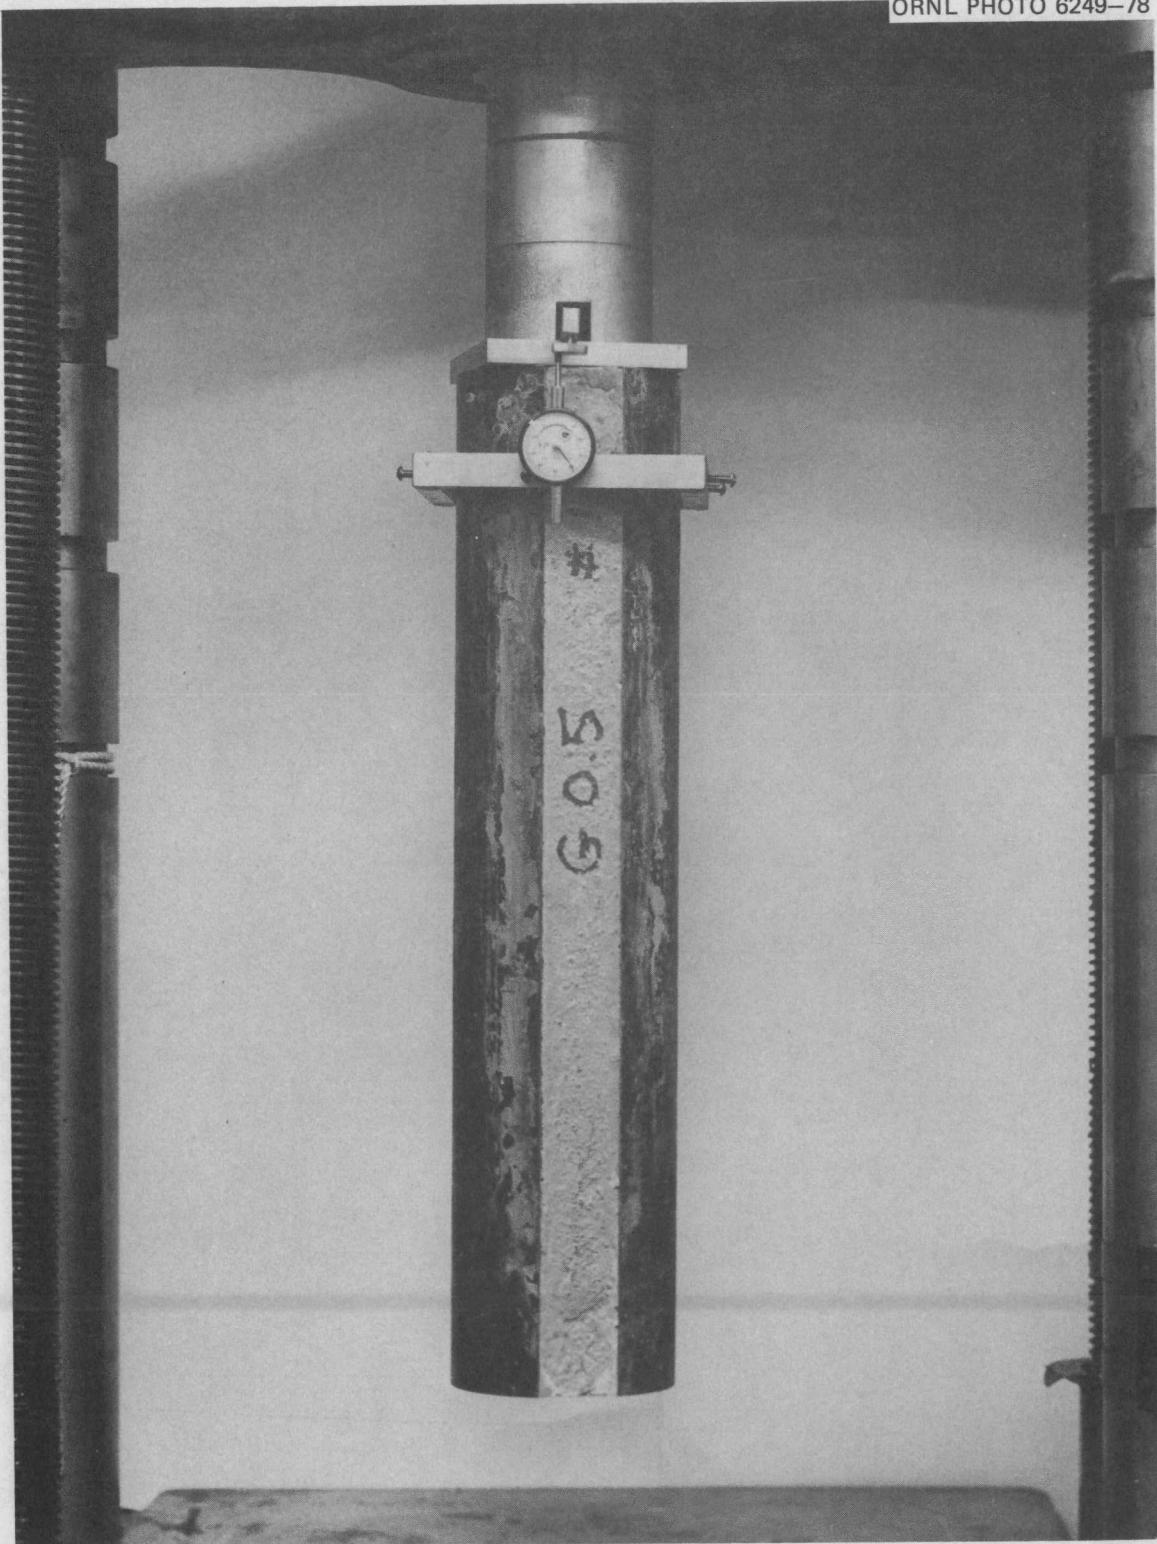
Fig. 60. Bond pull-out test setup.

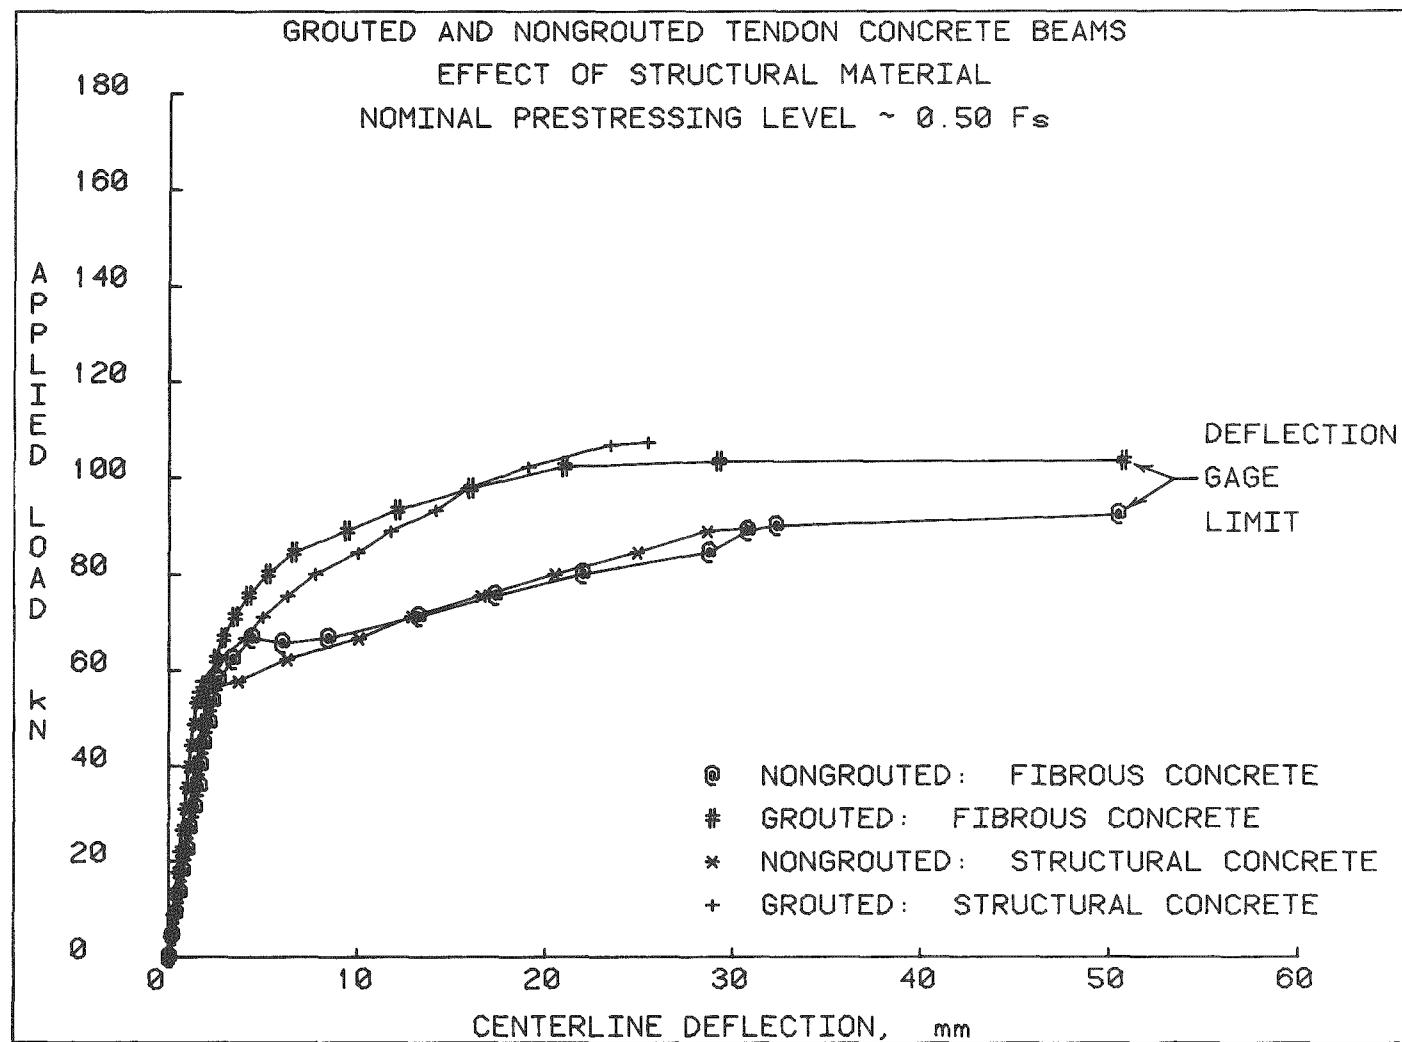
Fig. 78. Effect of structural material on beam performance —  
 $F_s = 0.50$ .

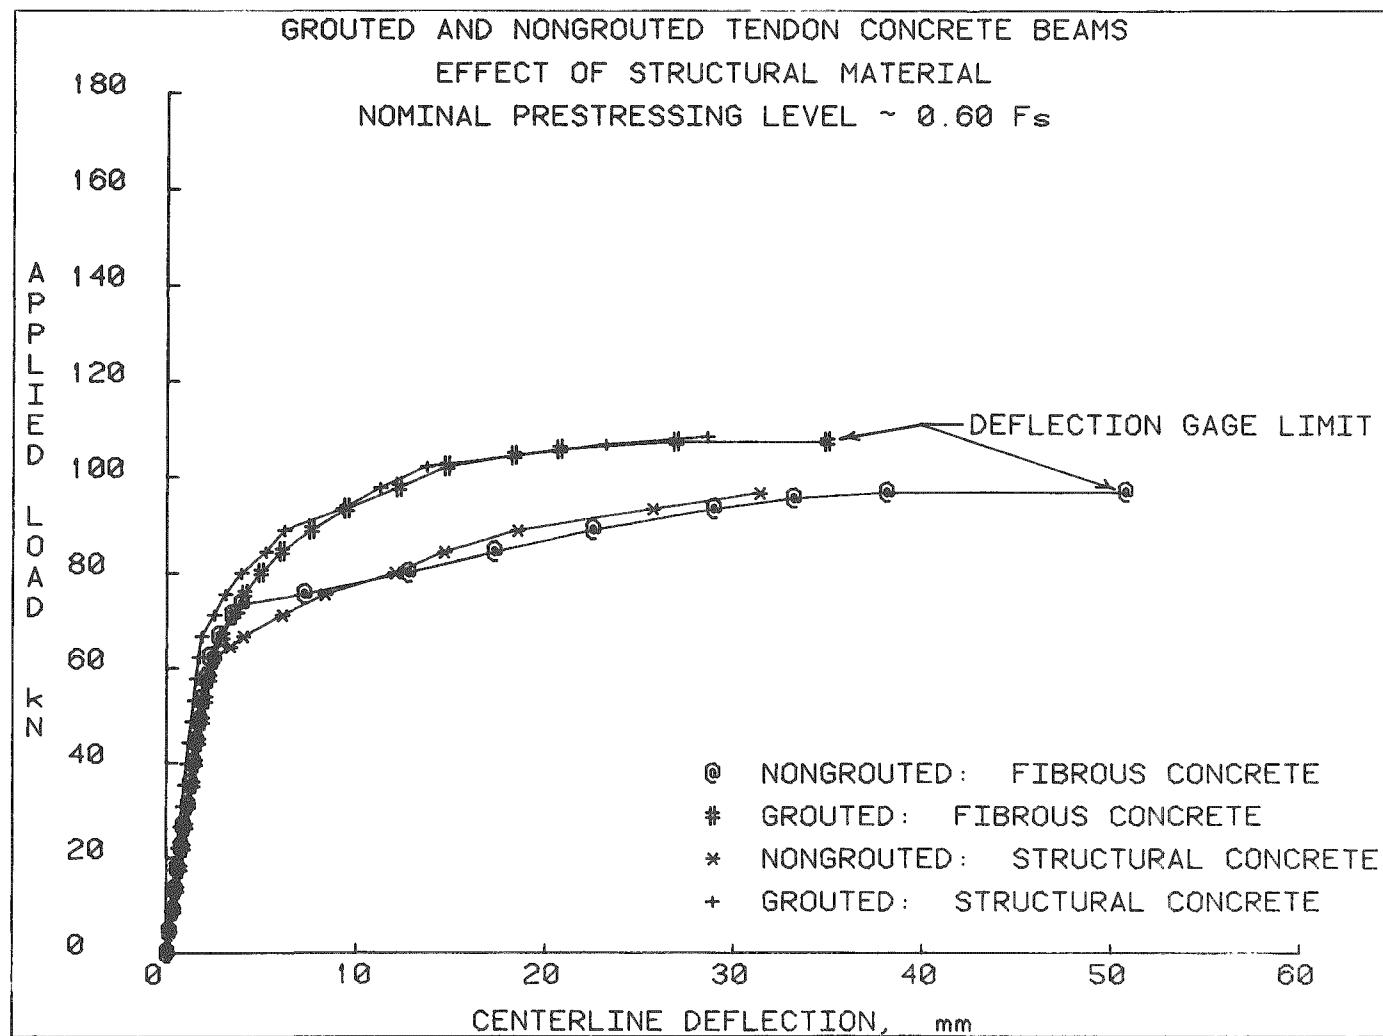
Fig. 79. Effect of structural material on beam performance —  
 $F_s = 0.60$ .

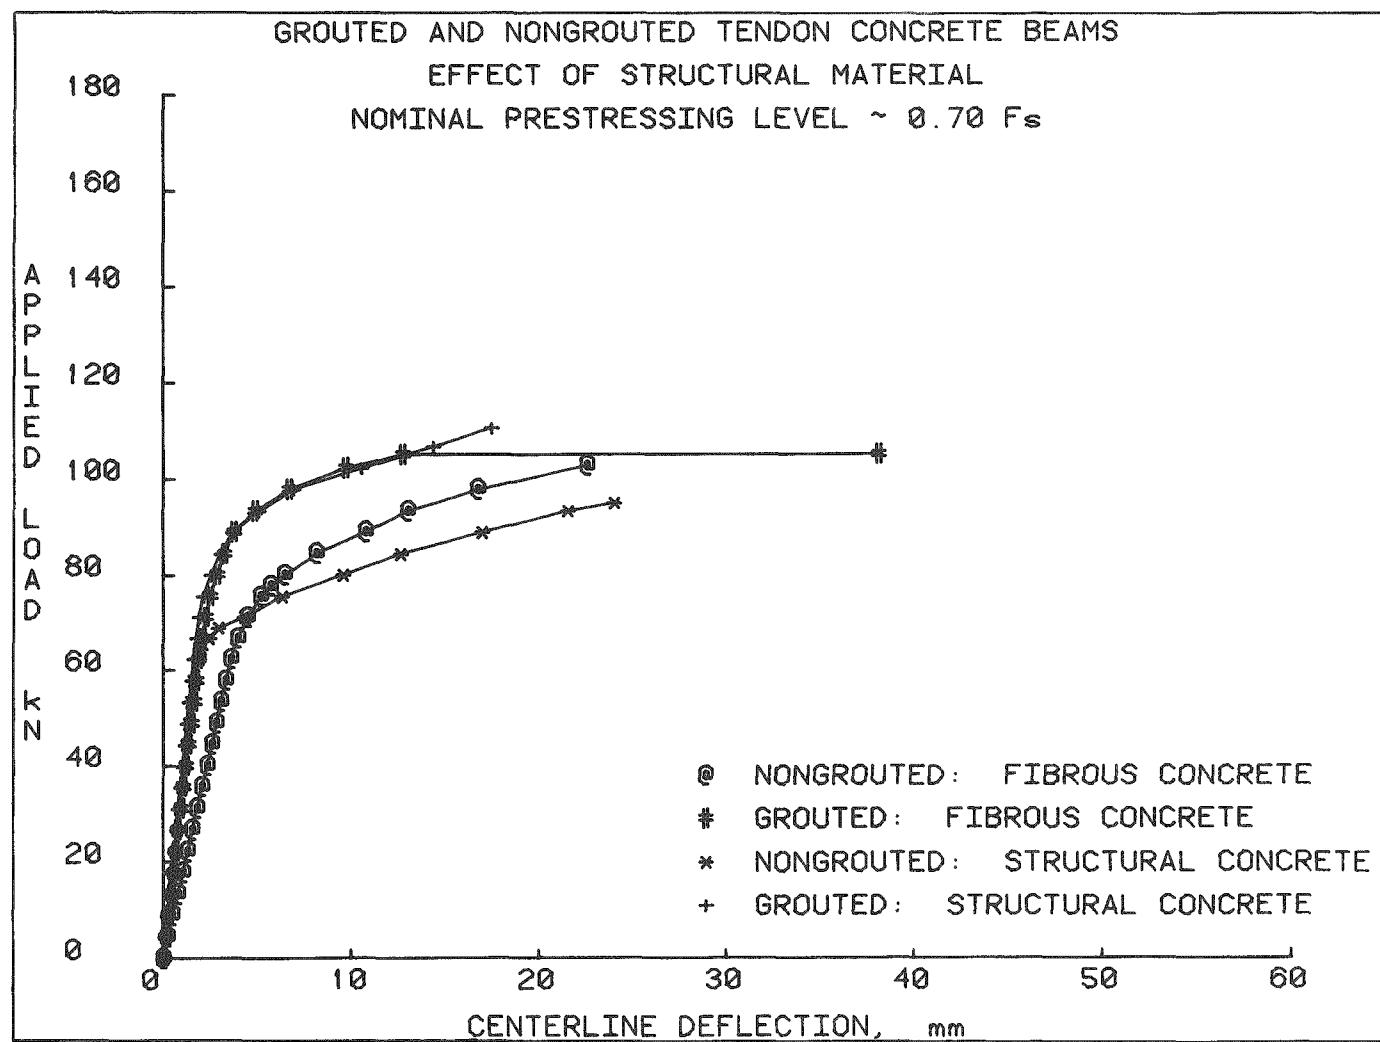
Fig. 80. Effect of structural material on beam performance —  
 $F_s = 0.70$ .

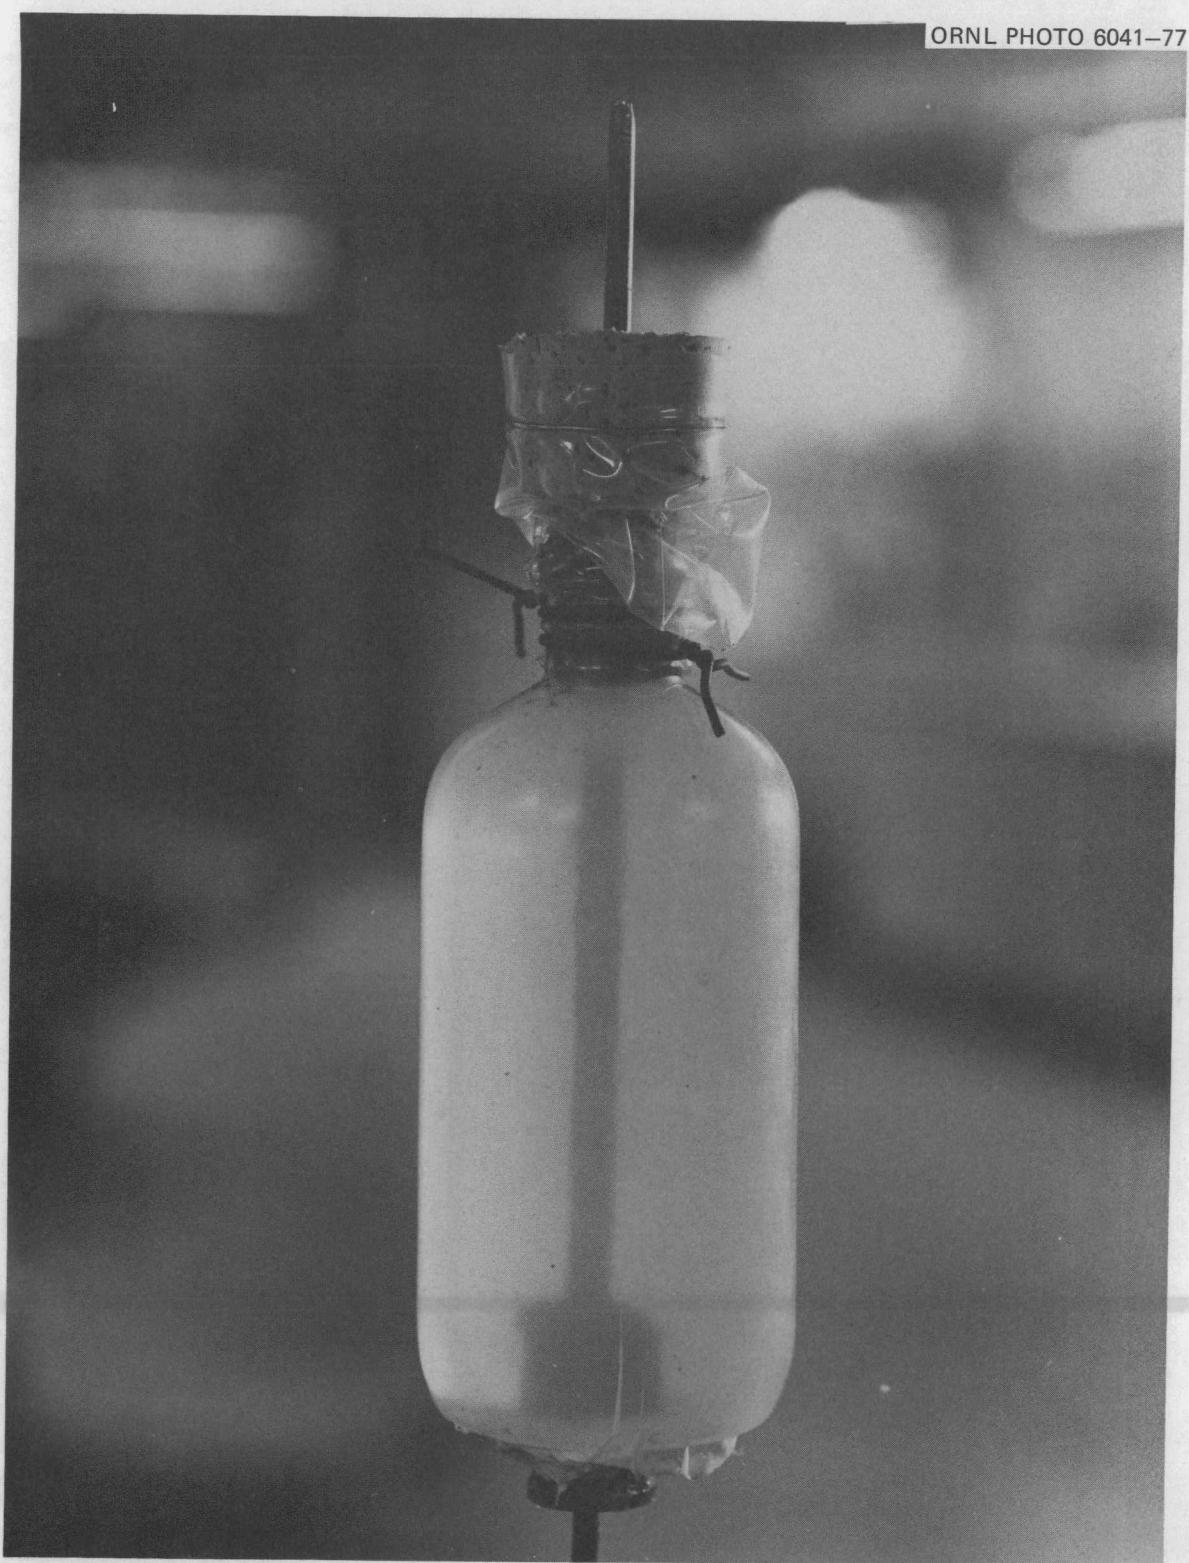
Fig. 91. Stressed tendon corrosion test specimen.

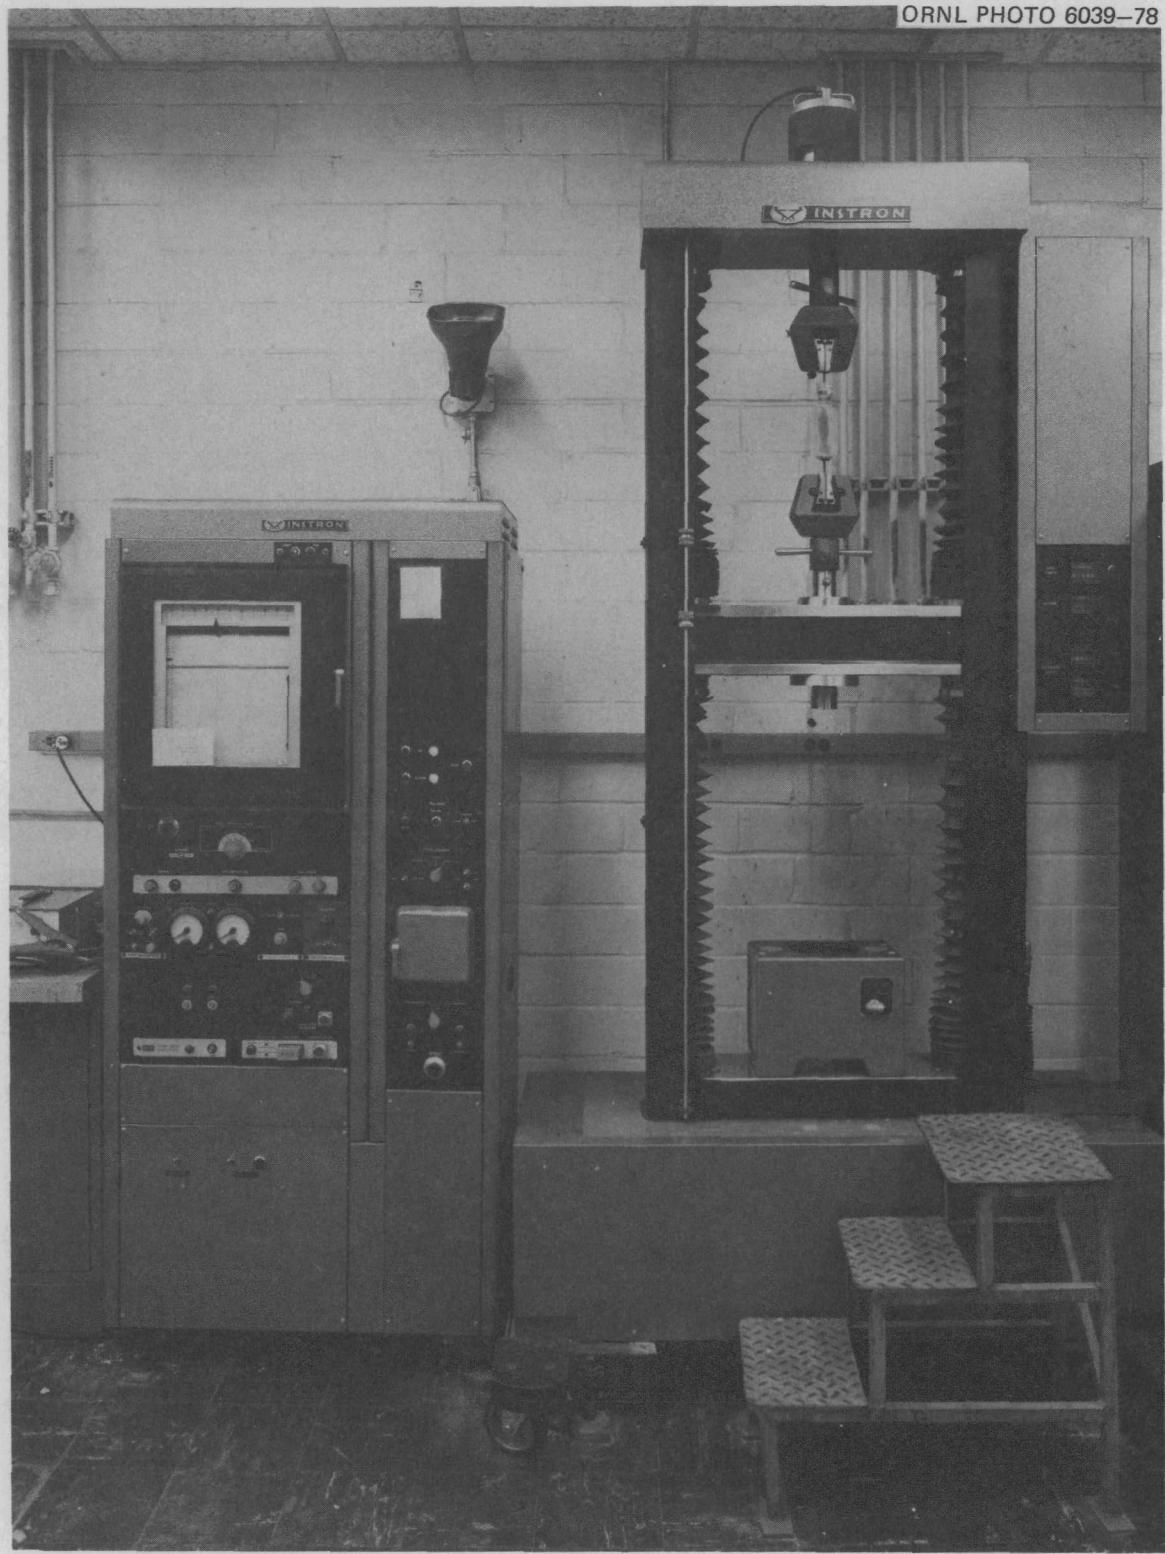
Fig. 92. Stressed tendon corrosion test setup.

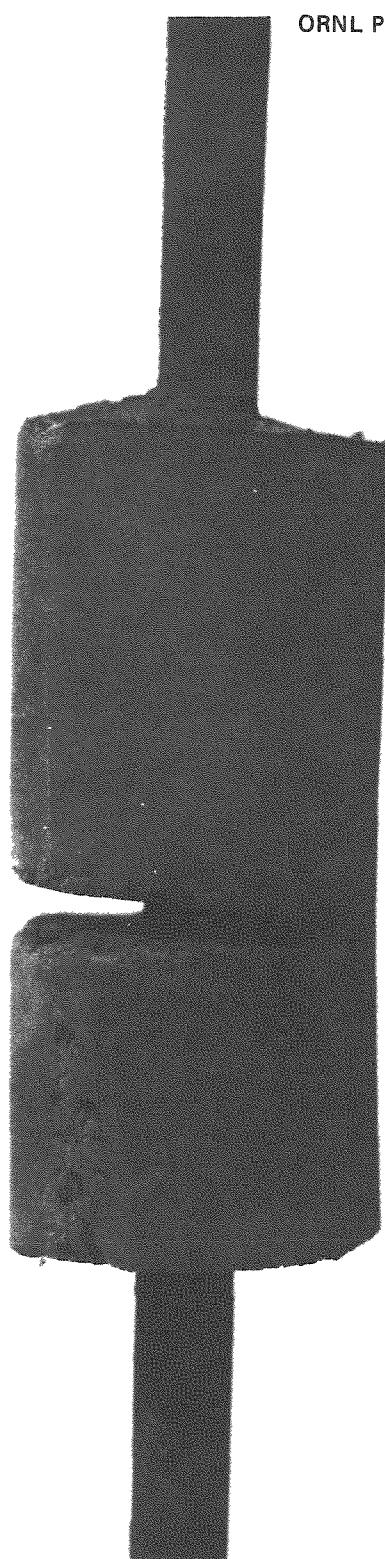
Fig. 93. Flawed grout corrosion test specimen.

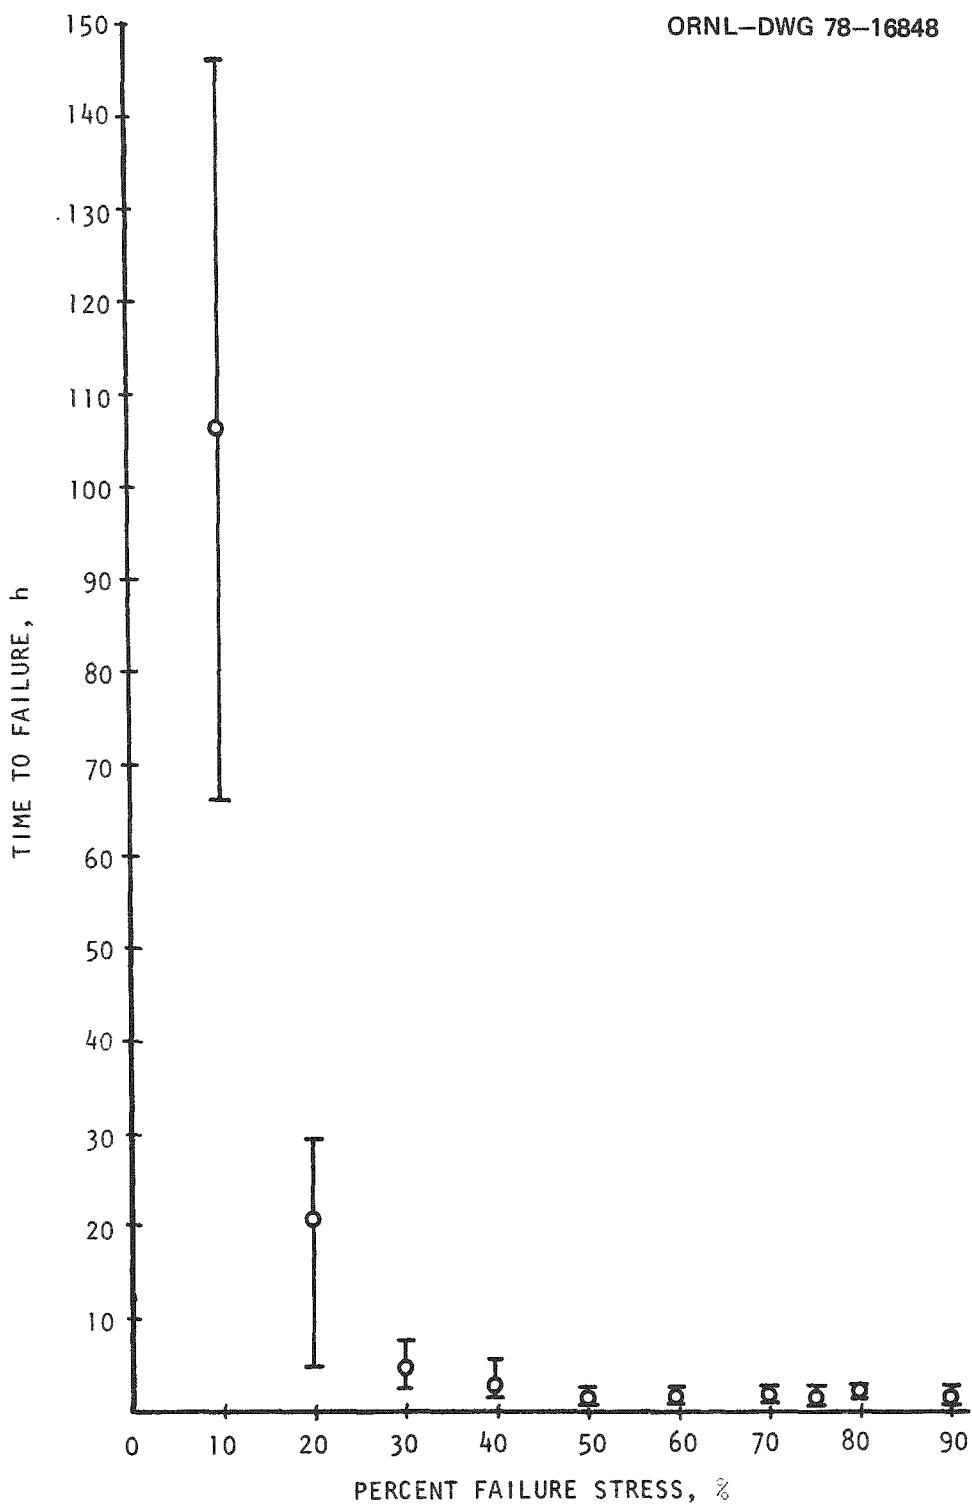
Fig. 94. Effect of percent failure load on failure time:  $\text{H}_2\text{S} + \text{H}_2\text{O}$  environment.

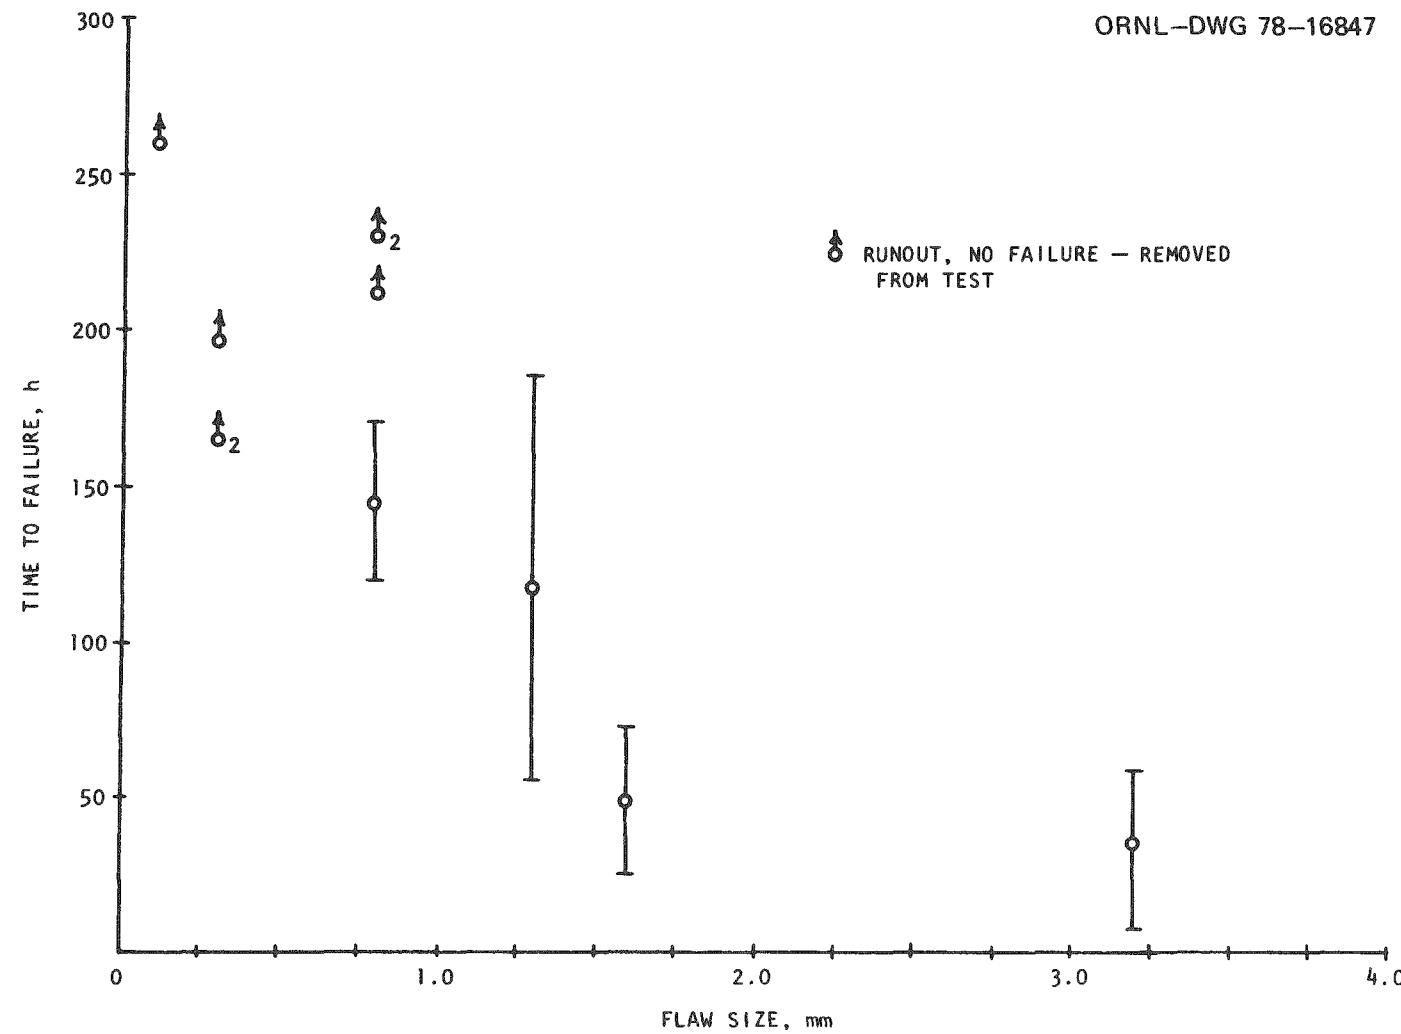
Fig. 95. Effect of flaw size on time to failure: tendons stressed to 60% failure in an  $\text{H}_2\text{S}$  environment.

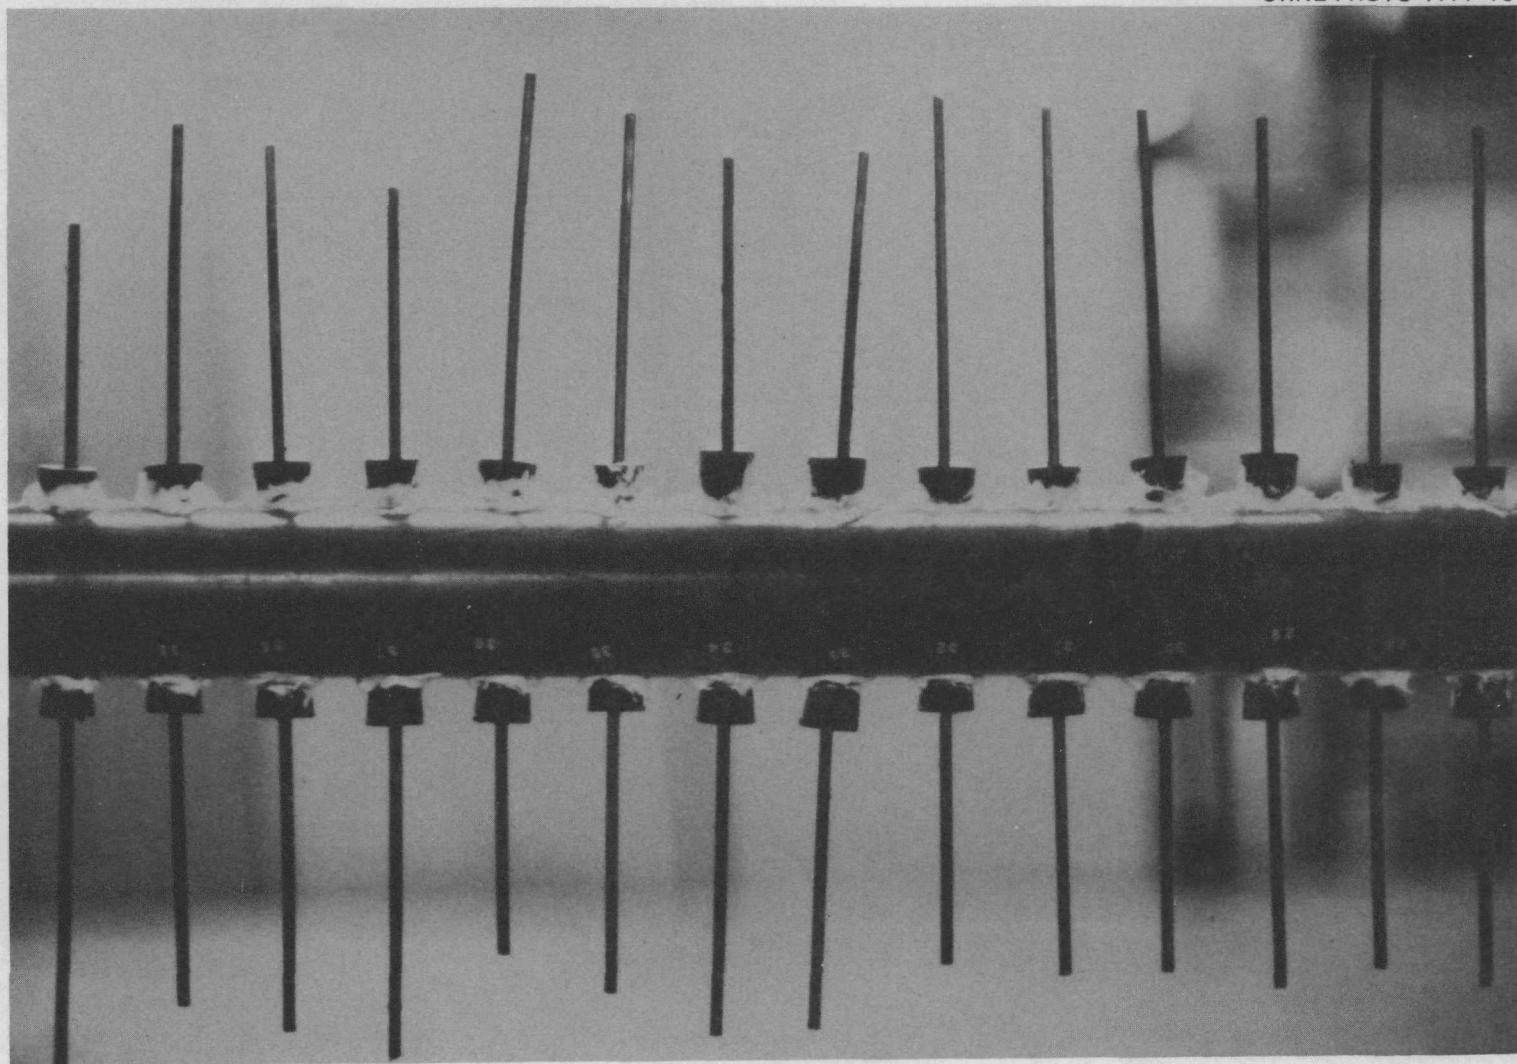
Fig. 96. Nonstressed tendon hydrogen sulfide exposure test setup.
