ORNL/TM-6478

**Structural Model Testing for Prestressed  
Concrete Pressure Vessels:  
A Study of Grouted vs Nongrouted  
Posttensioned Prestressing  
Tendon Systems**

HTGR BASE TECHNOLOGY PROGRAM  
Prestressed Concrete Nuclear Pressure  
Vessel Development (189a 01331)

Concrete Structures Testing — Milestone 7b

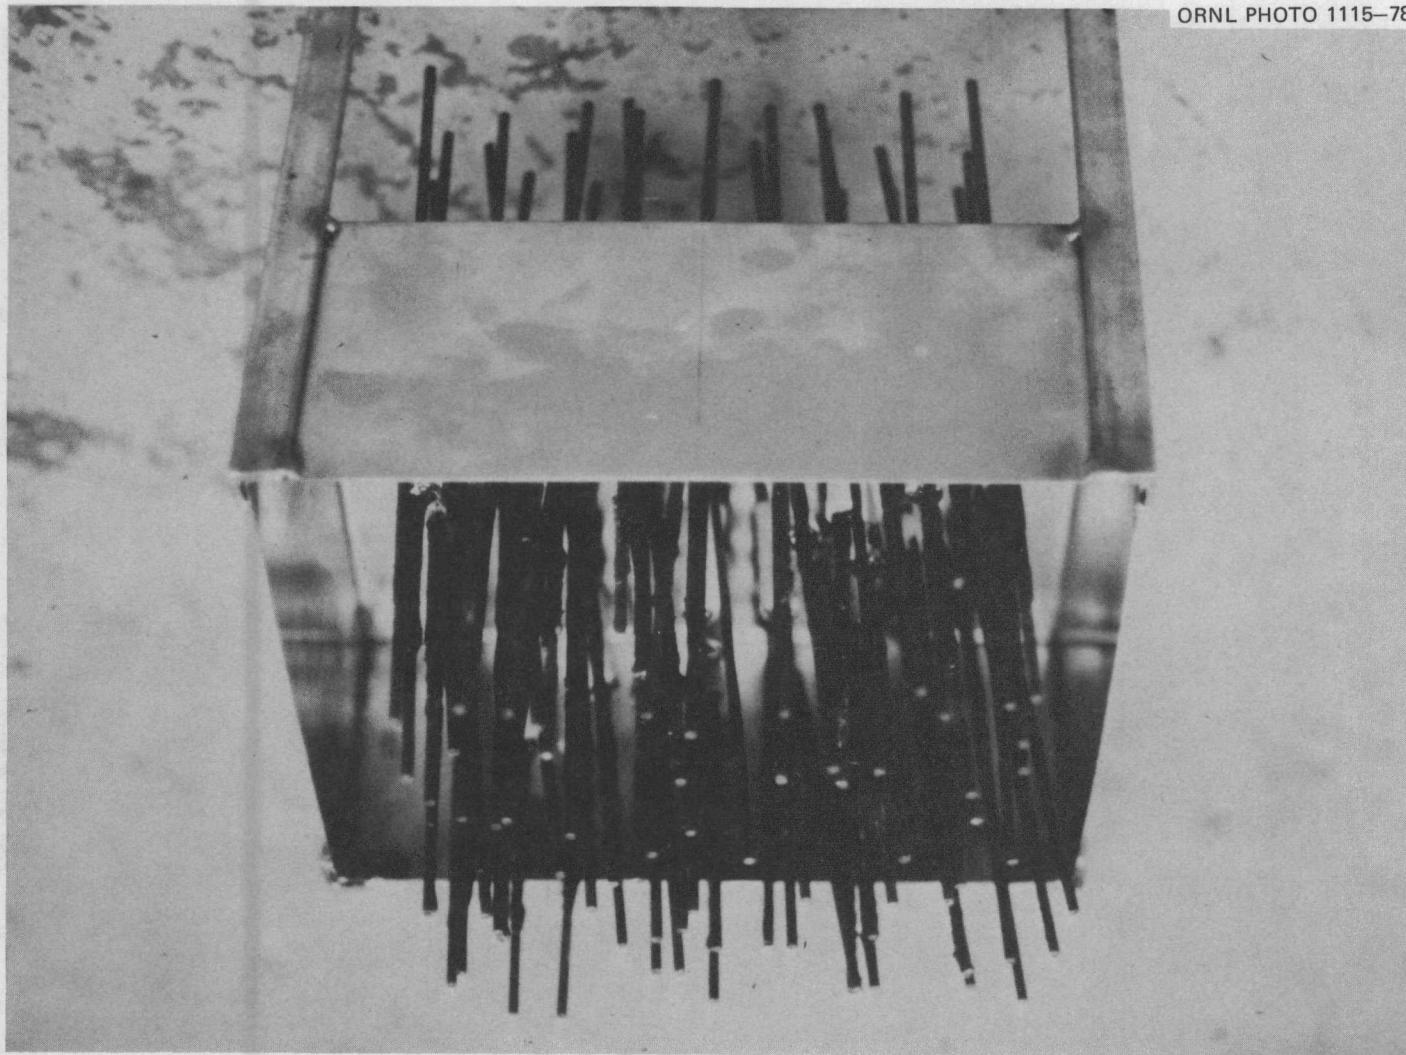
Fig. 97. Nonstressed tendon  $\text{NH}_4\text{NO}_3$  and  $\text{NaCl}$  exposure test setup.

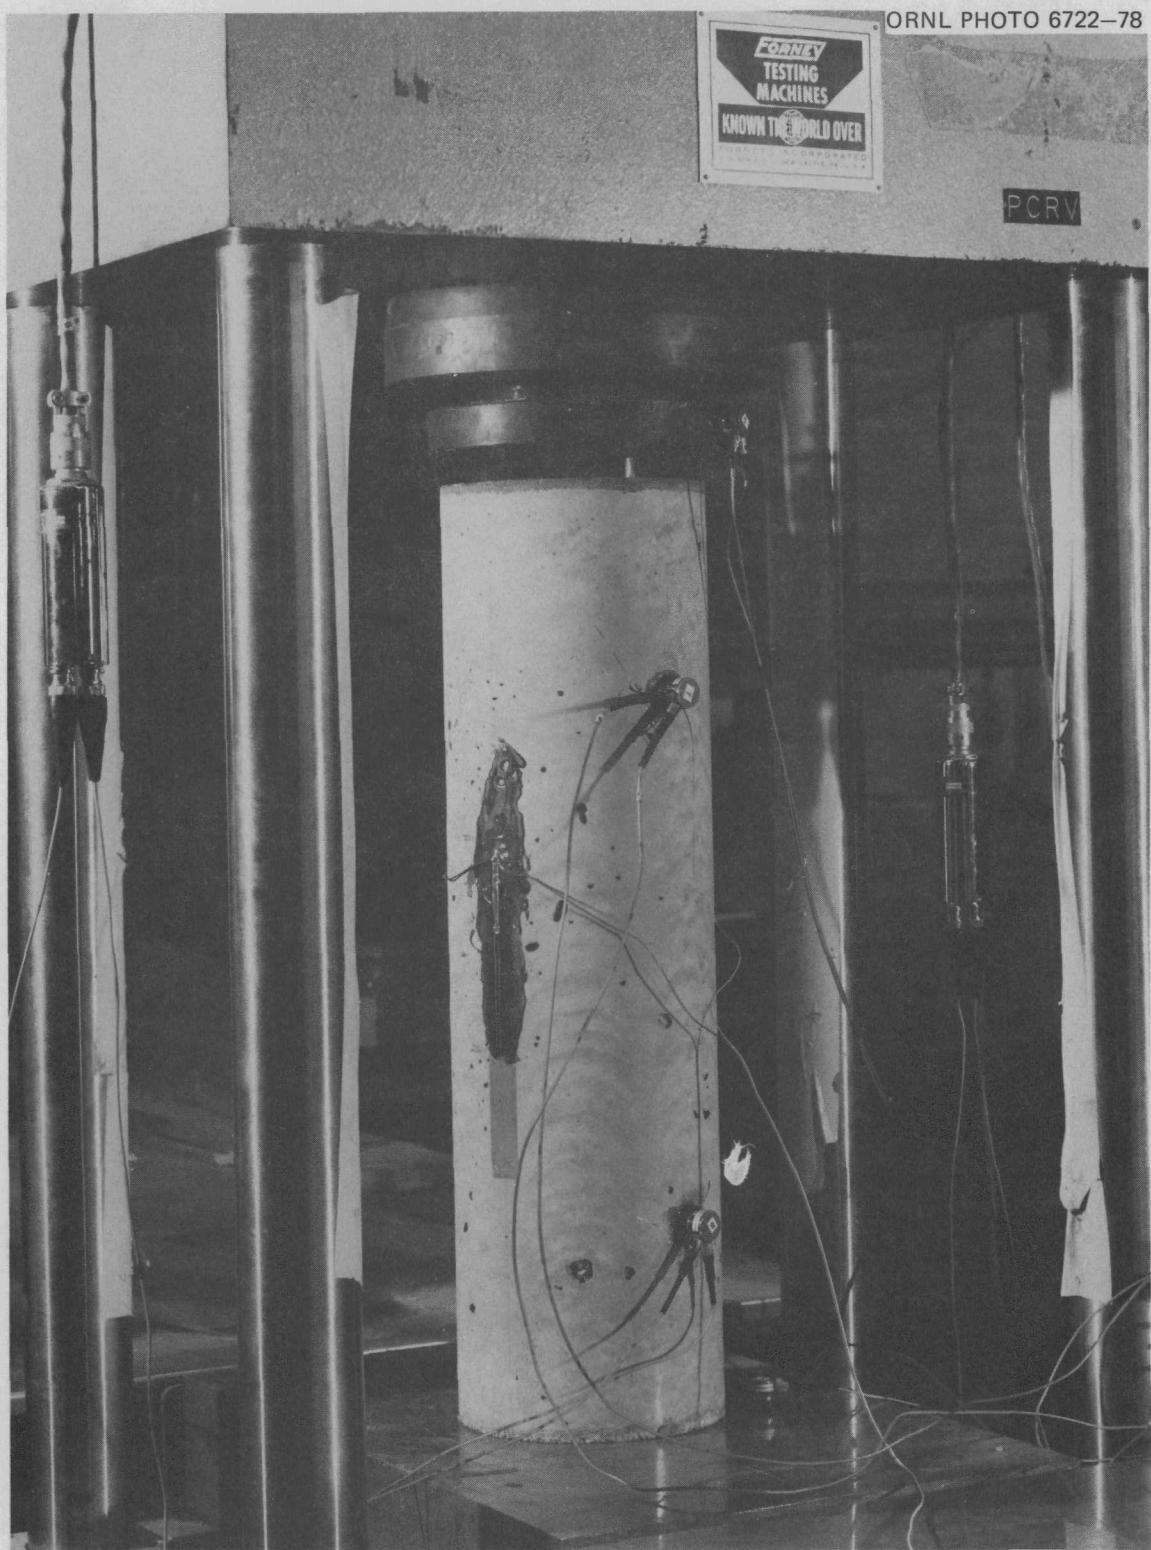
Fig. 98. Test setup for acoustic emission monitoring of plain concrete cylinders.

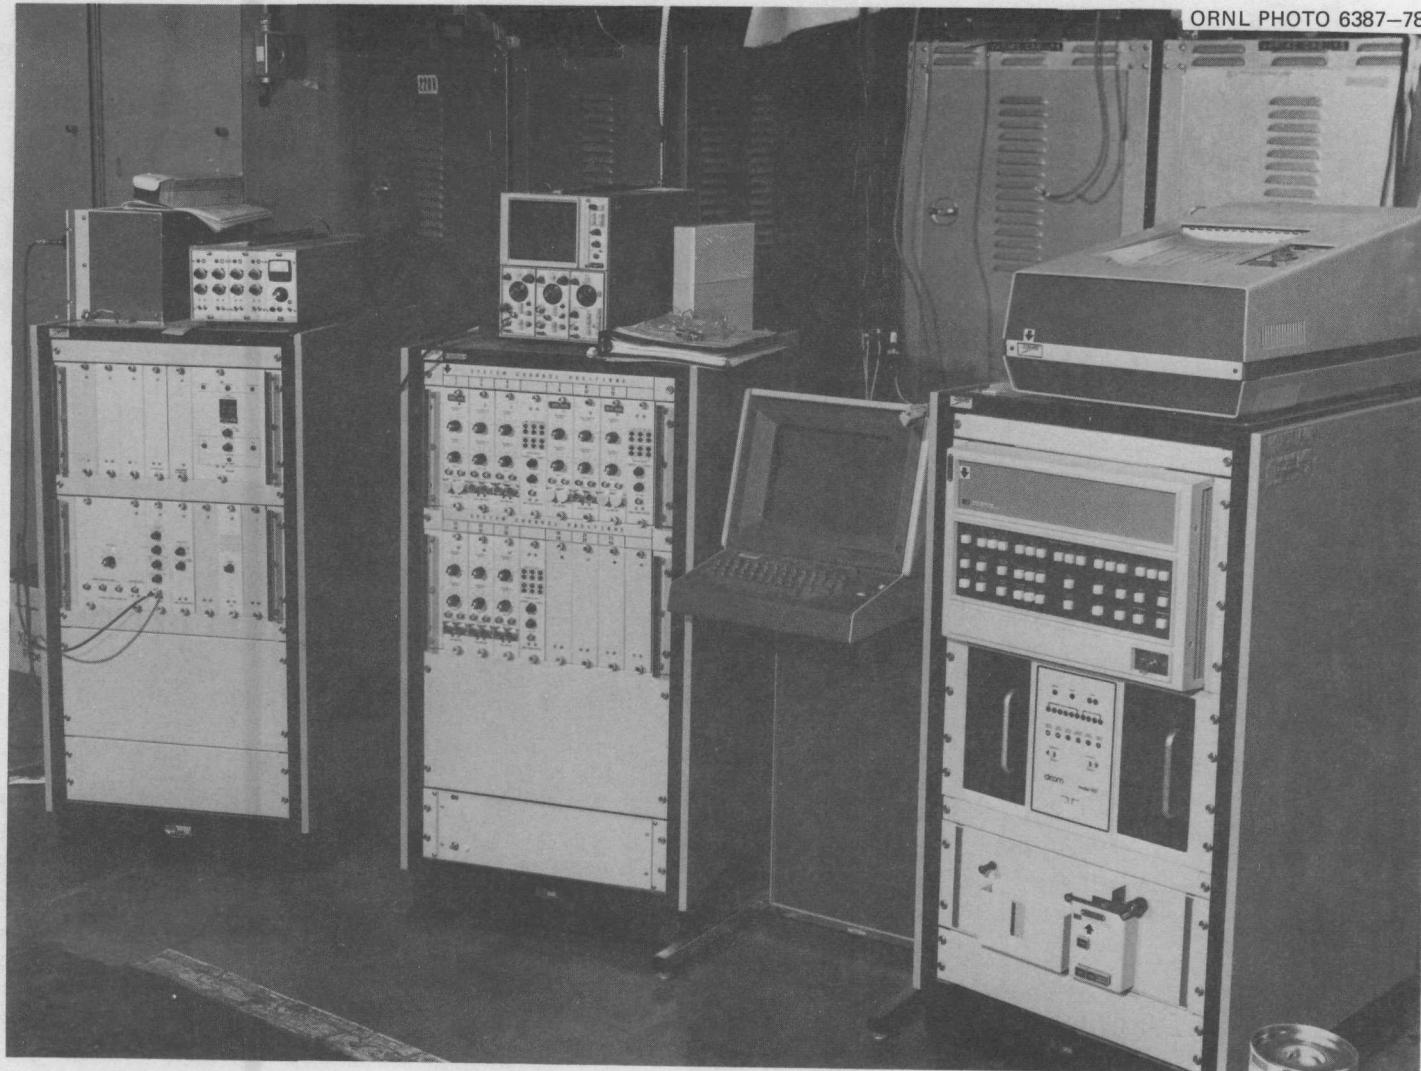
Fig. 99. Multichannel source location acoustic emission system.

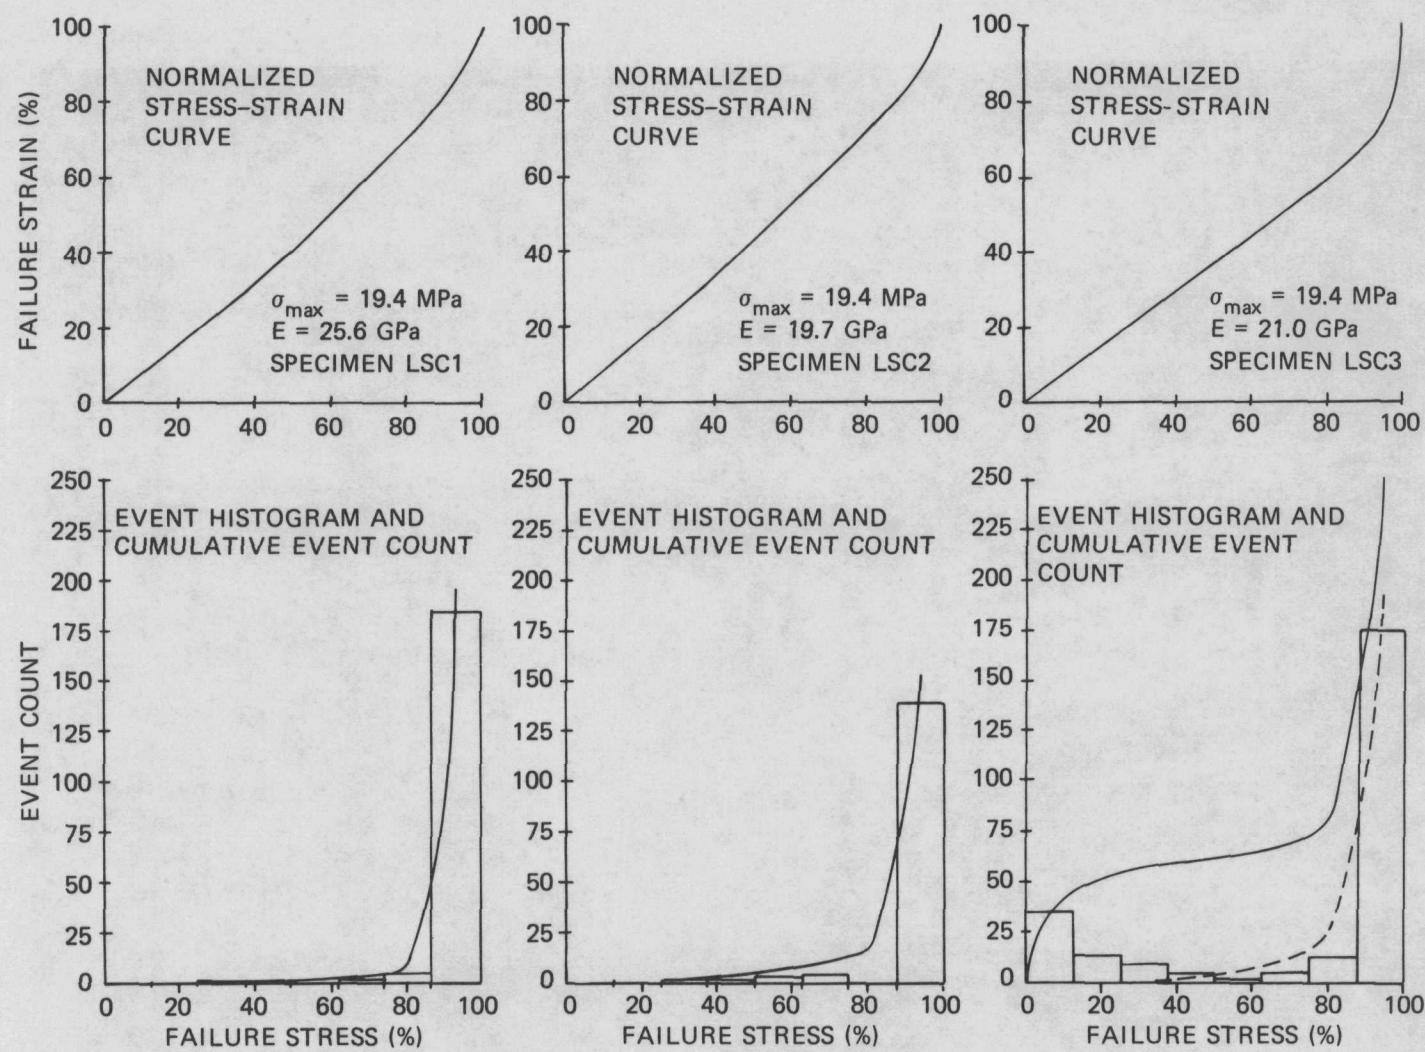
Fig. 100. Acoustic emission test results: low-strength concrete cylinders.

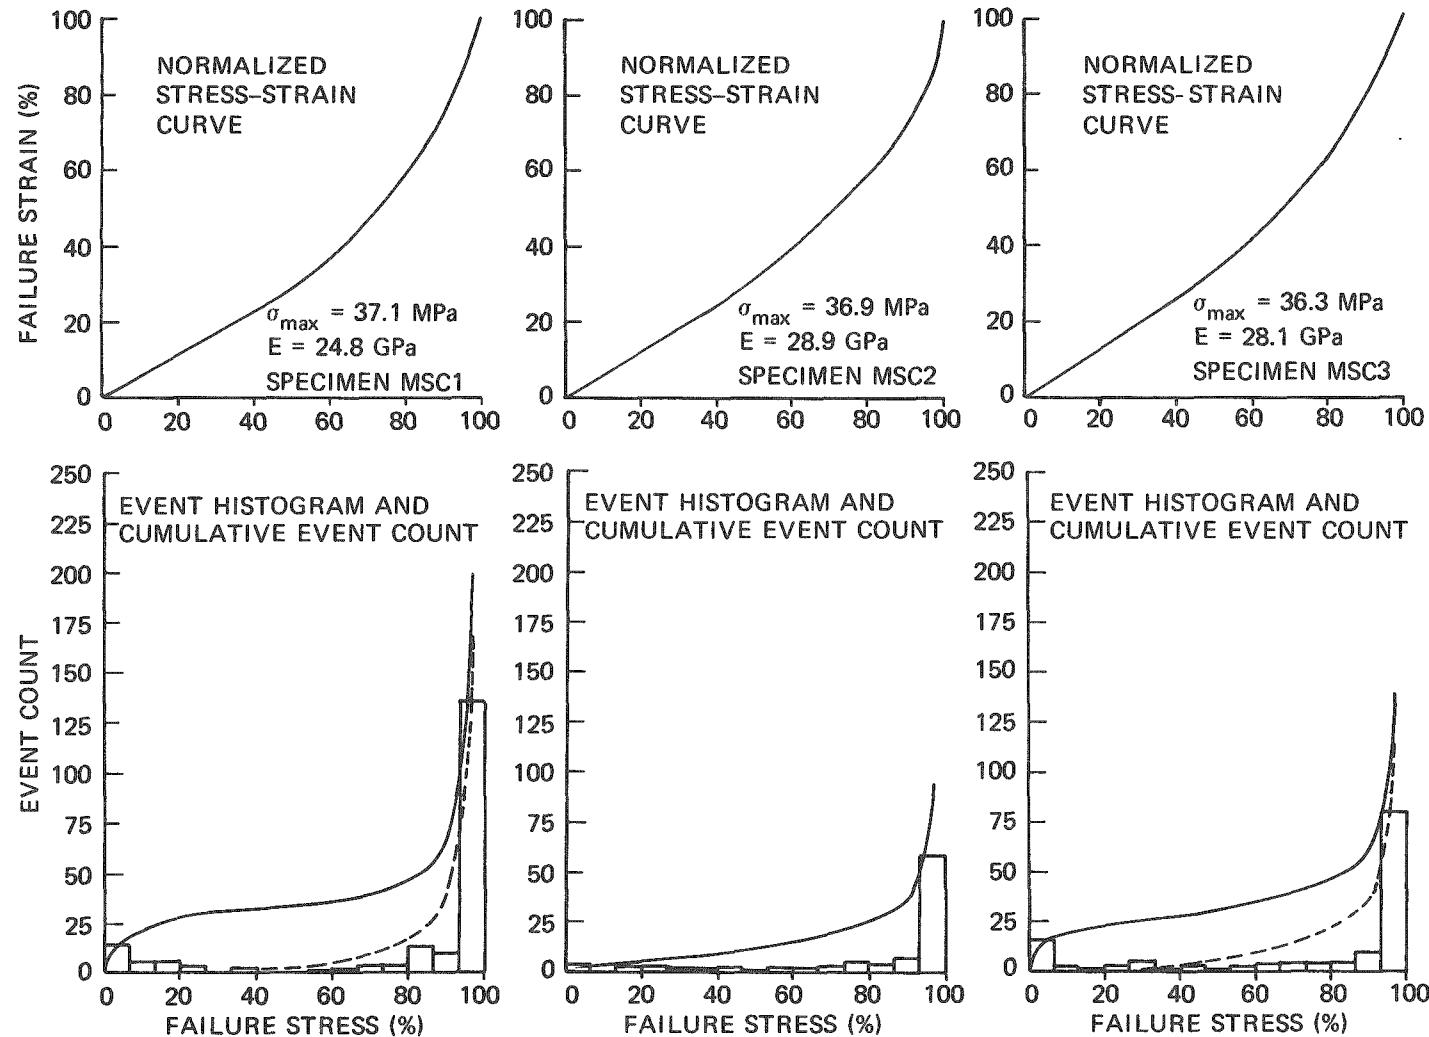
Fig. 101. Acoustic emission test results: medium-strength concrete cylinders.

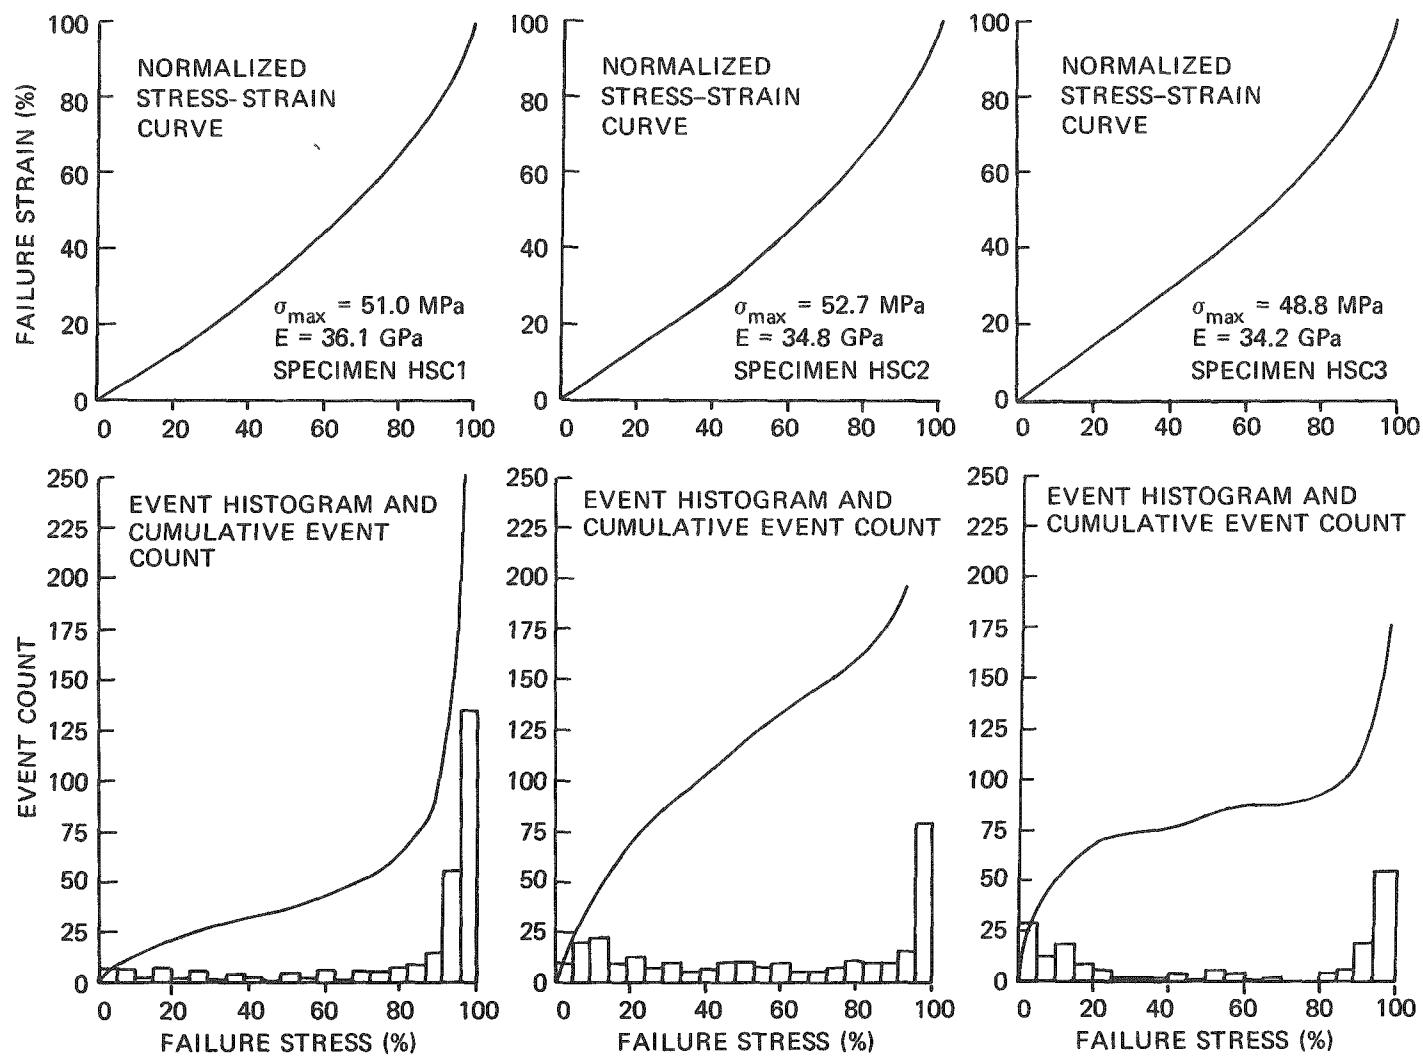
Fig. 102. Acoustic emission test results: high-strength concrete cylinders.

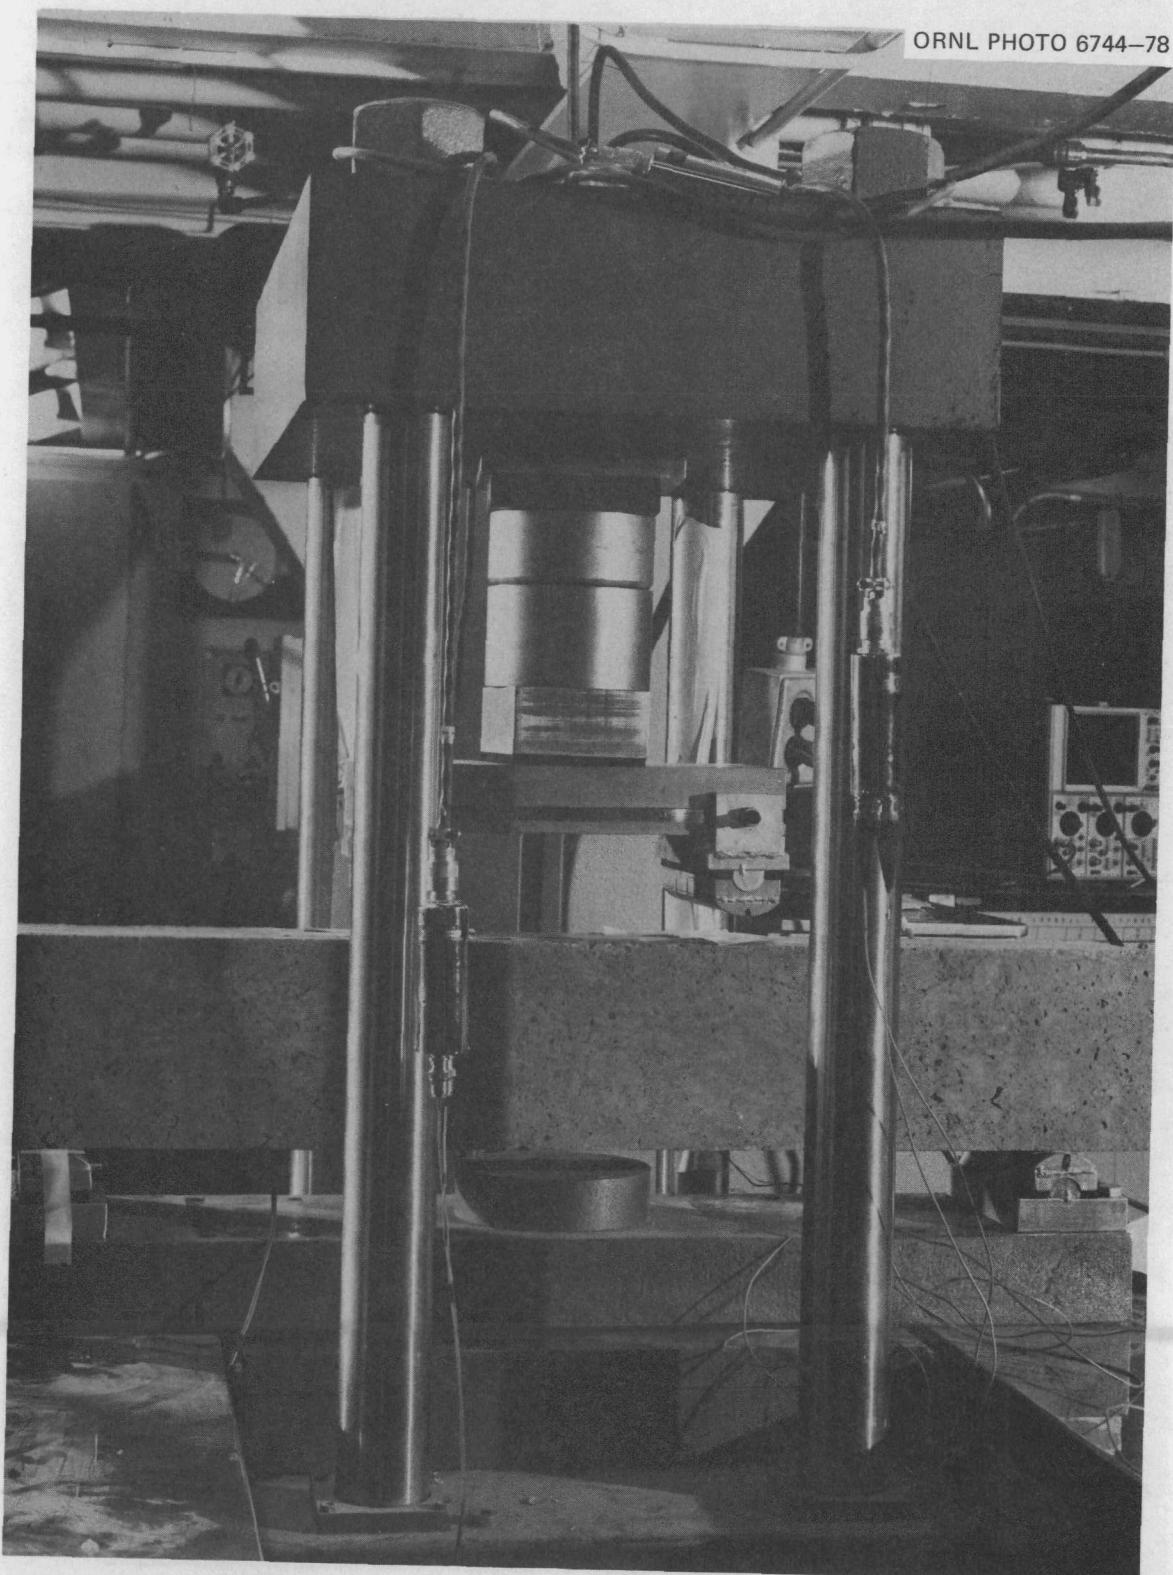
Fig. 103. Test setup for acoustic emission monitoring of plain concrete flexure specimens.

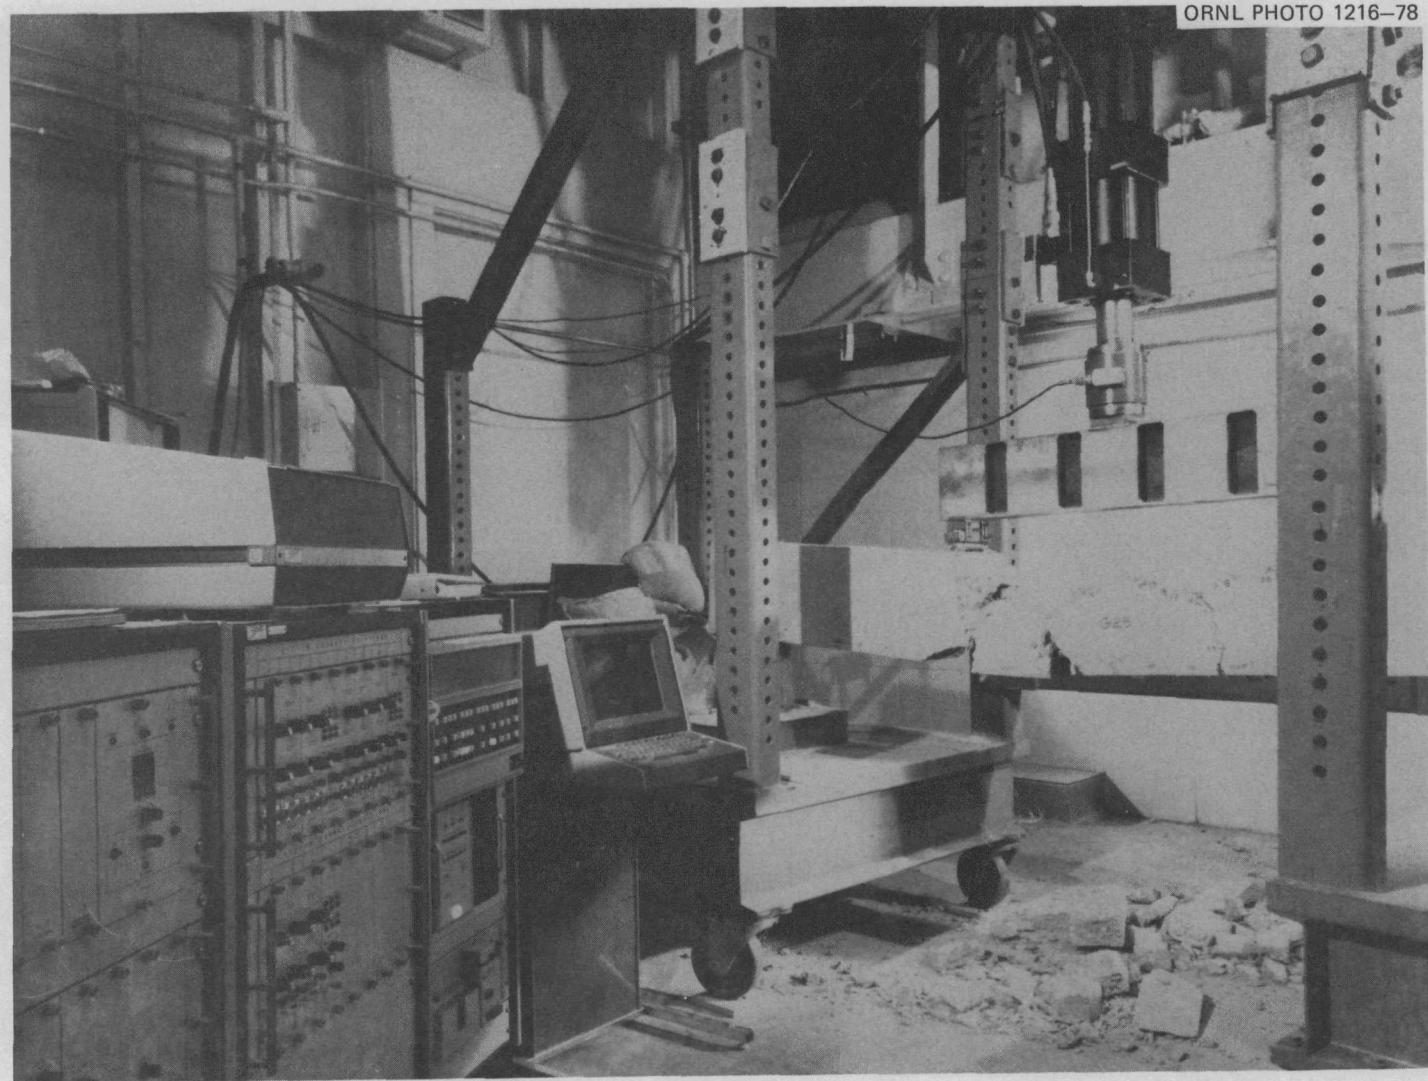
Fig. 104. Test setup for acoustic emission monitoring of posttensioned concrete beams.

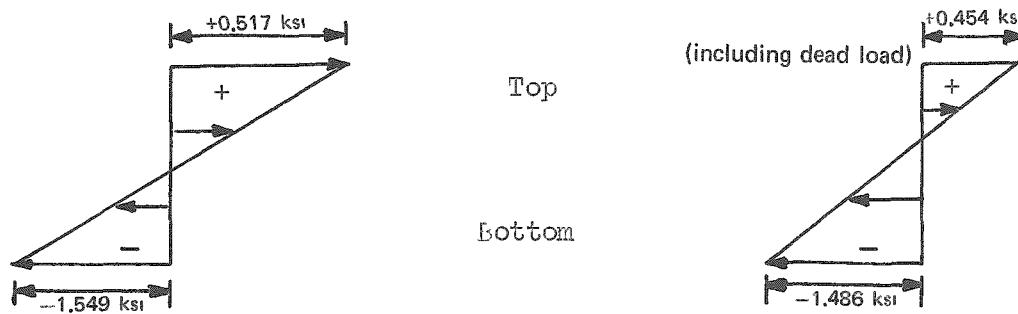
Initial Stress Distribution

$$\frac{w \ell^2}{8} \frac{(h/2)}{I_c} = \frac{0.15(9)^2(12)(6)}{8(1728)} = \pm 0.063 \text{ ksi} \rightarrow \text{Dead load stress}$$

$$M_{cr} = \frac{I}{c} \left[ f_r + \frac{F_{se}}{A_c} + \frac{F_{se} e (h/c)}{I_c} \right] = \frac{1728}{6} (0.605 + 1.549) \\ = 620 \text{ in.-k}$$

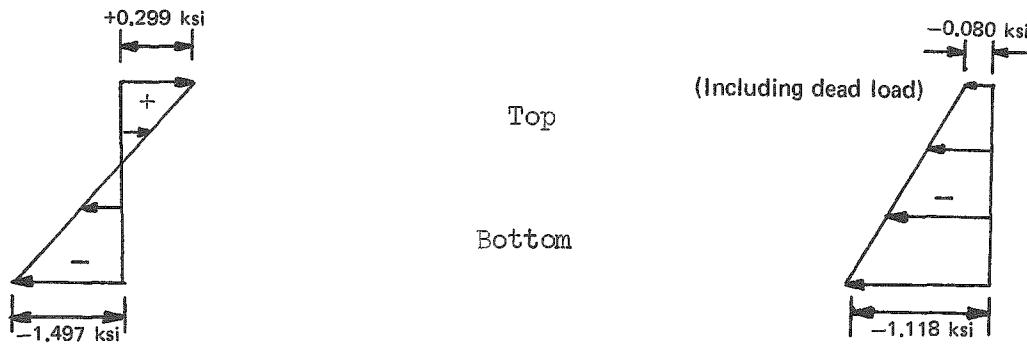
Initial Stress Distribution

$$\frac{w \ell^2}{8} \frac{c}{I} = \frac{0.466(36)^2(12)(16)}{8(38229)} = \pm 0.379 \text{ ksi} \rightarrow \text{Dead load stress}$$

$$M_{cr} = \frac{I}{c} \left[ f_r + \frac{F_{se}}{A_c} + \frac{F_{se} e (h/2)}{I_c} \right] = \frac{38229}{16} (2.102) = 5022 \text{ in.-k}$$
