Results of the Metallographic Examination of the Ta Crucible used in the M.S.E. Runs

UCRL-ID--105713

INTRODUCTION

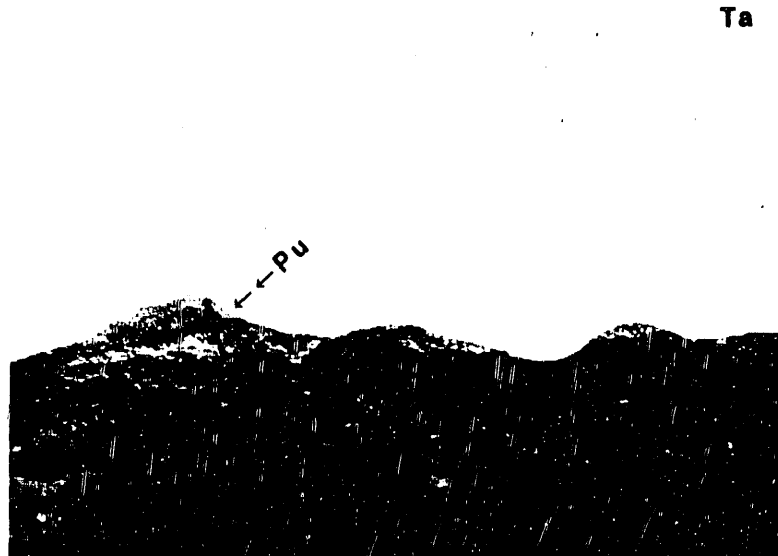
The metallographic examination of this sample in the as polished condition revealed some wicking of the Pu up the wall of the crucible, Figure 2 shows Pu on the inside wall of the Ta shell. Note the wavy surface of the wall at this point, the wavy surface indicates some dissolution of the Pu. The wall thickness of the Ta crucible above the meniscus measured 1.4mm. Figure 3 shows the cross section of the crucible.

Figure 2. 200X Pu on the inside surface of the Ta.

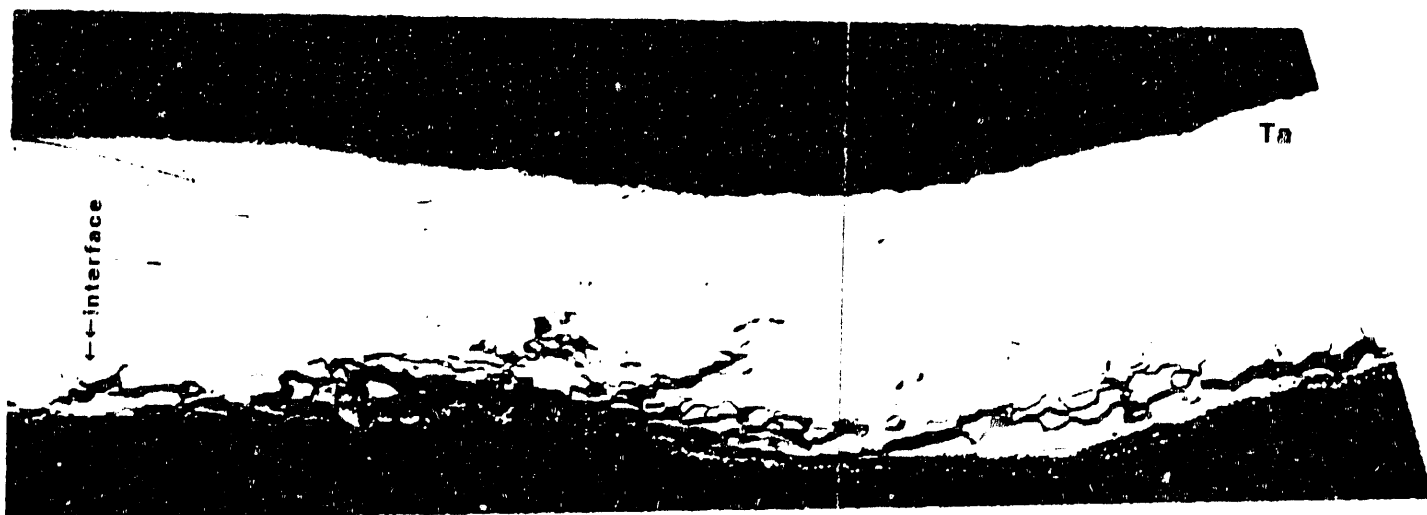
Metallographic examination of this sample revealed a heavy intergranular attack (IGA) of the crucible wall by the molten Pu Figure 4 is a montage taken at the location of the heaviest attack.

Figure 4. 50X Montage of sample ME2946 heaviest attack.

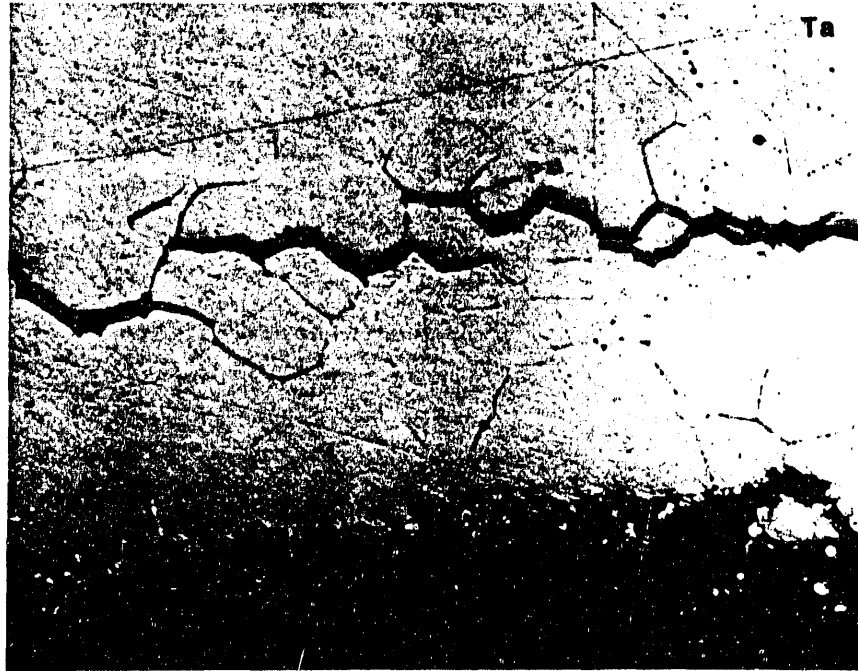
Figures 5, 6 and 7 show the major mode of attack. These photomicrographs show Pu in the grain boundaries of the Ta. The Pu penetrates along the grain boundaries until the grain becomes detached. When this happens the grain migrates into the melt. In Figure 5 the Pu molten path produces cracks several grains deep, when these cracks join a large section of the wall separates from the crucible resulting in reducing the wall thickness at a rapid rate.

Figure 5. 200X IGA of the Ta by Pu.

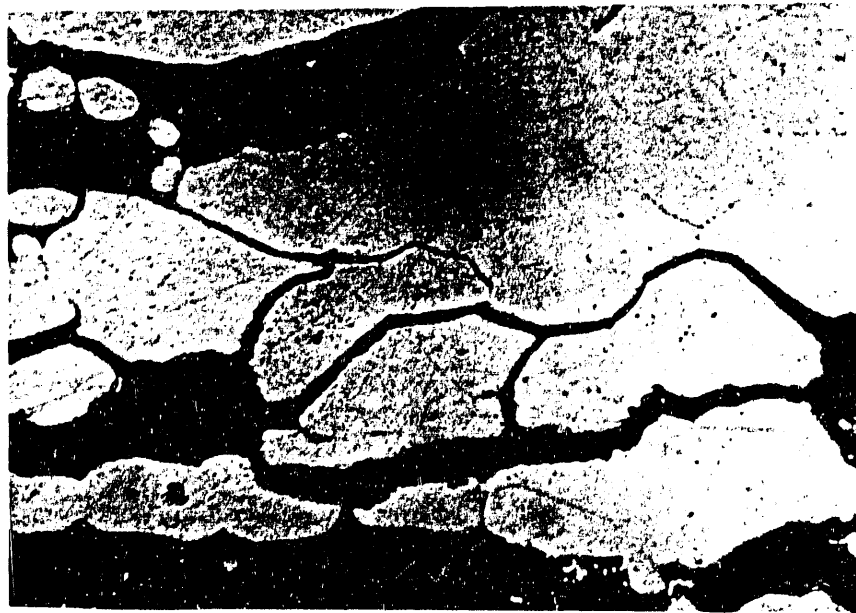
Figure 6. 500X Ta grains that have been completely wetted and detached by the molten Pu .

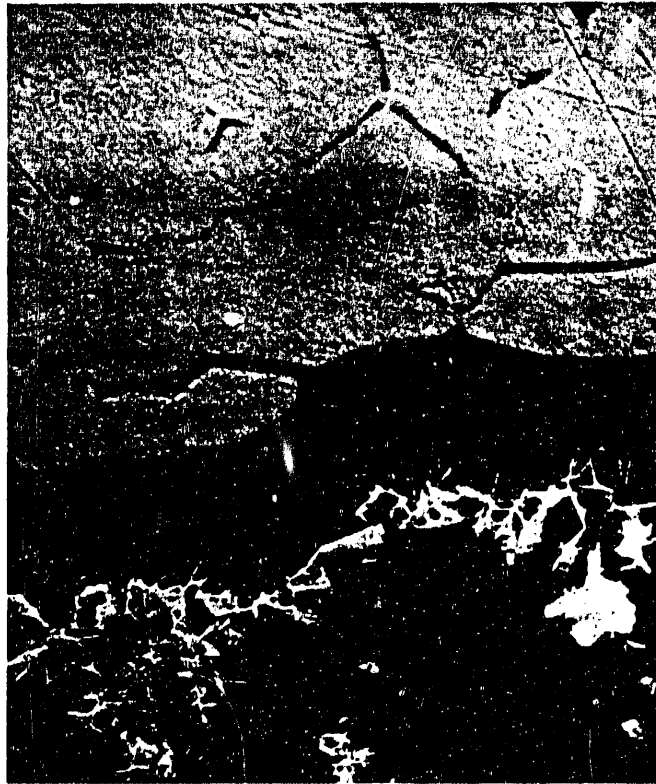
Figure 7. 500X IGA of the Ta by molten Pu. The acicular phase is TaC when the free Ta reacts with the carbon in the Pu.

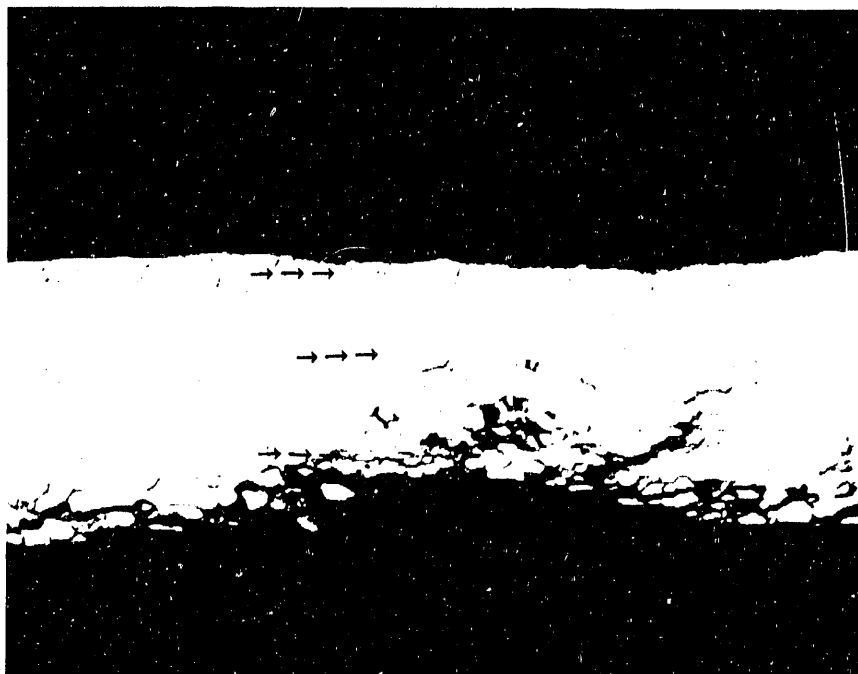
Microprobe analysis was done on sample ME2946 for the presence of Pu within the grain boundaries of the Ta crucible and on the outside wall. Figure 12 shows the location, as indicated by the arrows, where the microprobe analysis was done. This area is the area of maximum attack.

Figure 12. 50x Location of the microprobe analysis

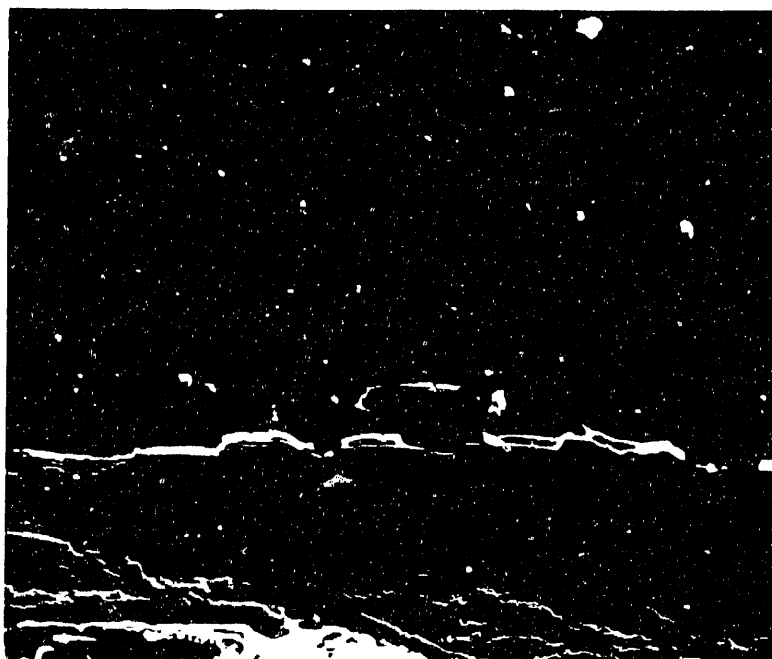
The microprobe analysis of the Ta Pu interface was made in this area because of the IGA at the interface, the large internal crack, and the spheroidized Ta at the interface. Figure 13 is a secondary electron image (SEI) view at the Ta Pu interface including the crack.

Figure 13. 200x SEI at the interface

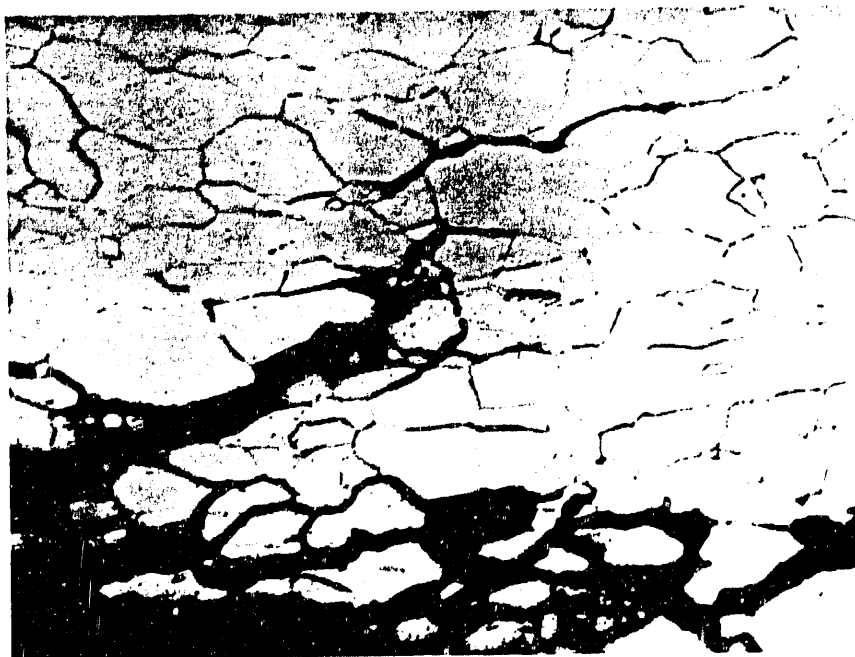
Figure 26. 200x Etched structure, inside surface with some free floating grains and a major crack.

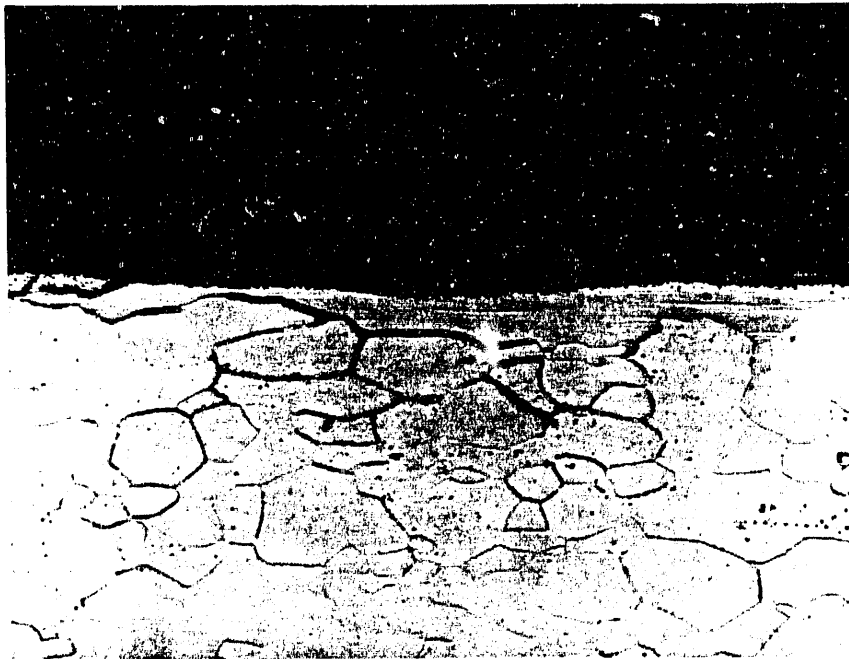
Figure 28. 200x etched outside edge. Pu can be seen on the surface and in the grain boundaries. The Pu in the boundaries has been removed by the etchant.

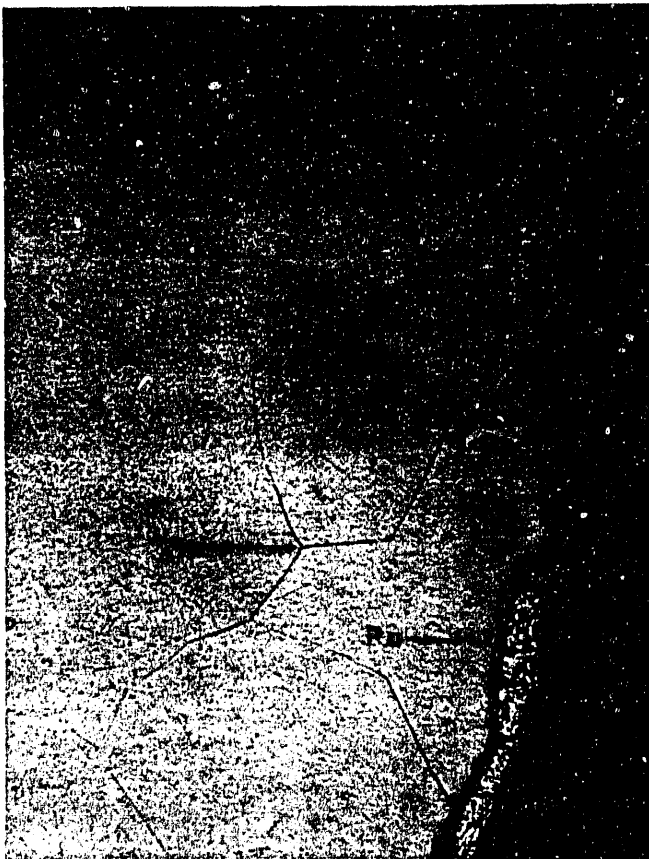
The IGA of Ta by liquid Pu is well documented. An example of this can be seen in photomicrographs and microprobe data taken from a Ta crucible used in a Trident run. Figure 31 is a cross section of this crucible. Figure 29 shows Pu on the inside wall and in the grain boundaries. Figure 30 shows Pu in the triple points of the Ta grain boundaries.

Figure 29. 50x As polished

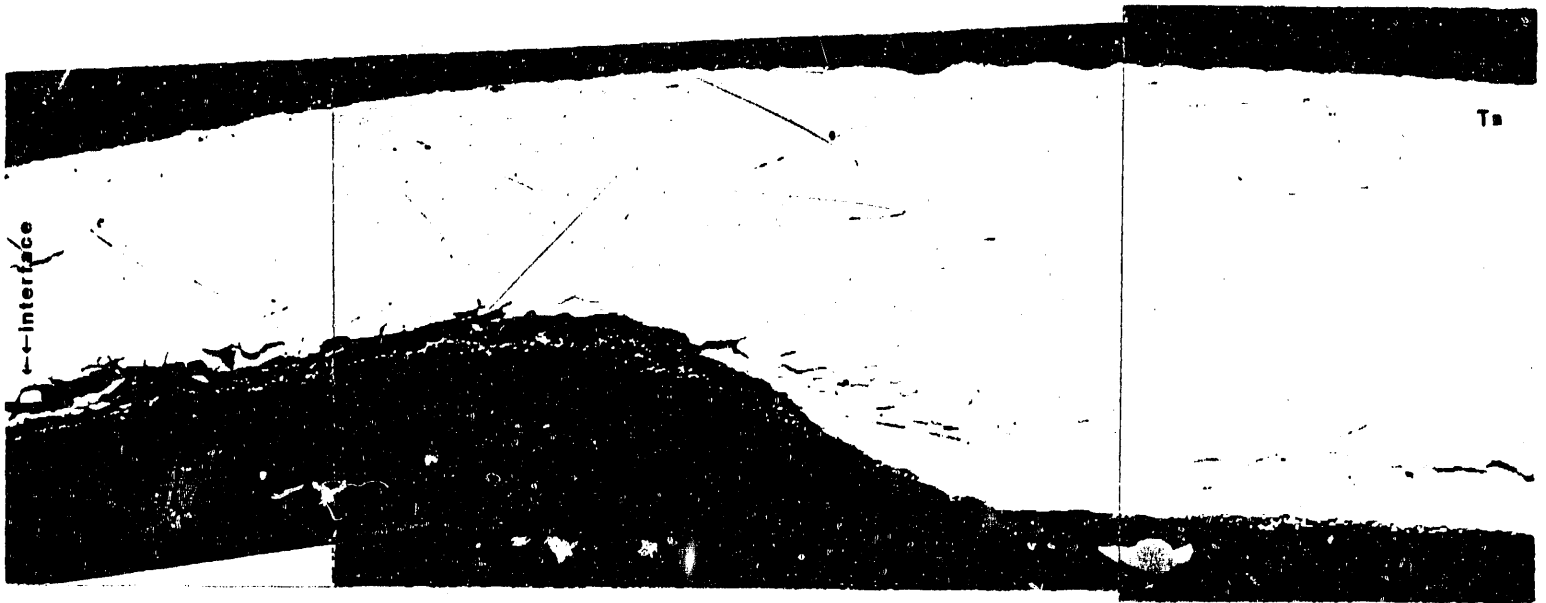
Figure 31. 50x As polished
