# 10 MWe Solar Thermal Central Receiver Pilot Plant: 1983 Operational Test Report

SAND86-8203  
Unlimited Release  
Printed January, 1986

10 MWe SOLAR THERMAL CENTRAL  
RECEIVER PILOT PLANT:  
1983 OPERATIONAL TEST REPORT

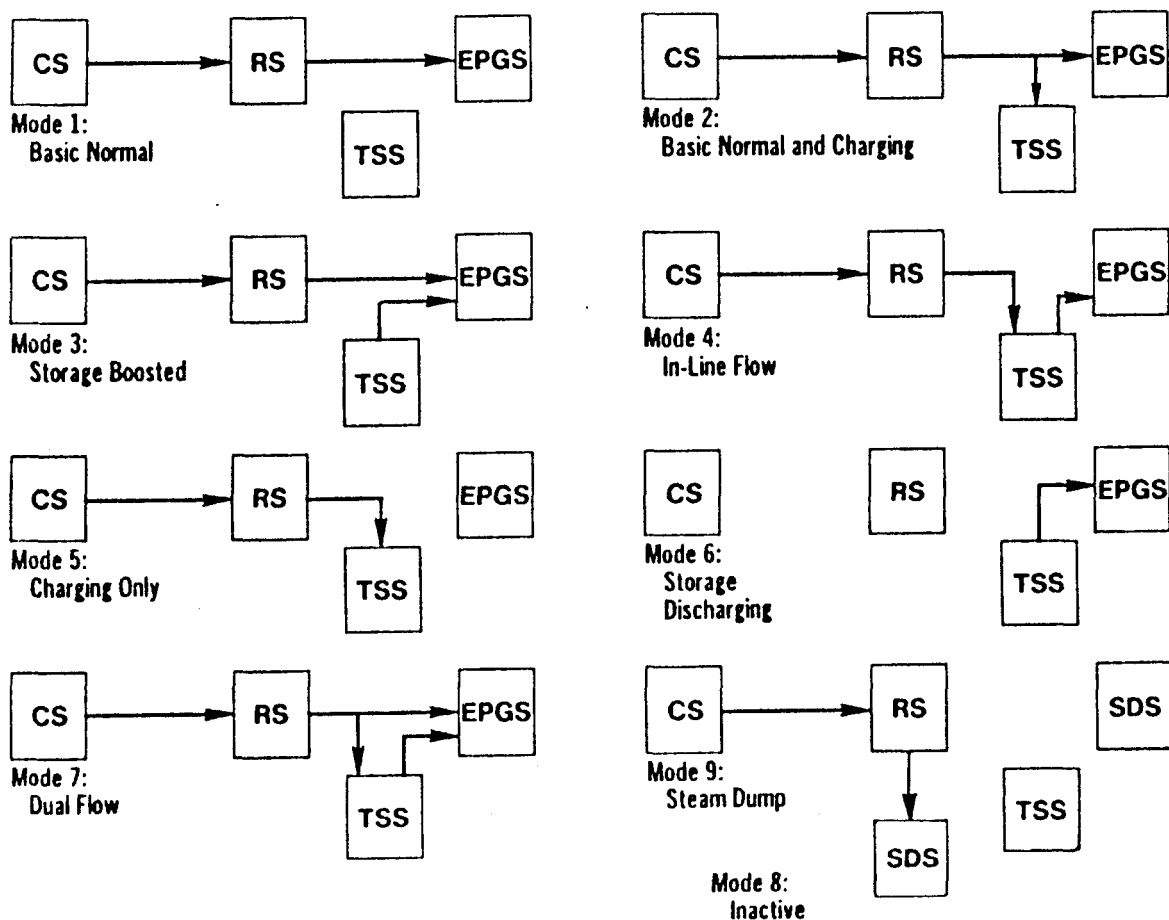
Figure 3. Major Plant Operating Modes

Plant operation is being evaluated in all operating modes under manual, semi-automatic, and automatic plant control options. The seven active operating modes (see Figure 3) will be tested using one or more of the following control combinations: manual, and clear- or cloudy-day automatic control. Collector modulation can be incorporated and operated to support any of the control modes. To maximize the energy produced, plant operation, other than testing, will be performed in a sun following strategy, that is, using as much sunlight energy as possible.

Figure 4 displays the 1983 Test Schedule. The mode testing refers to intersystem testing in the major operating modes (See Figure 3 for a schematic of the operating modes). All mode tests were initially scheduled for completion by June 1982. However, construction delays and resource depletion precluded this from occurring. The mode performance tests were deferred into the Test and Evaluation phase.

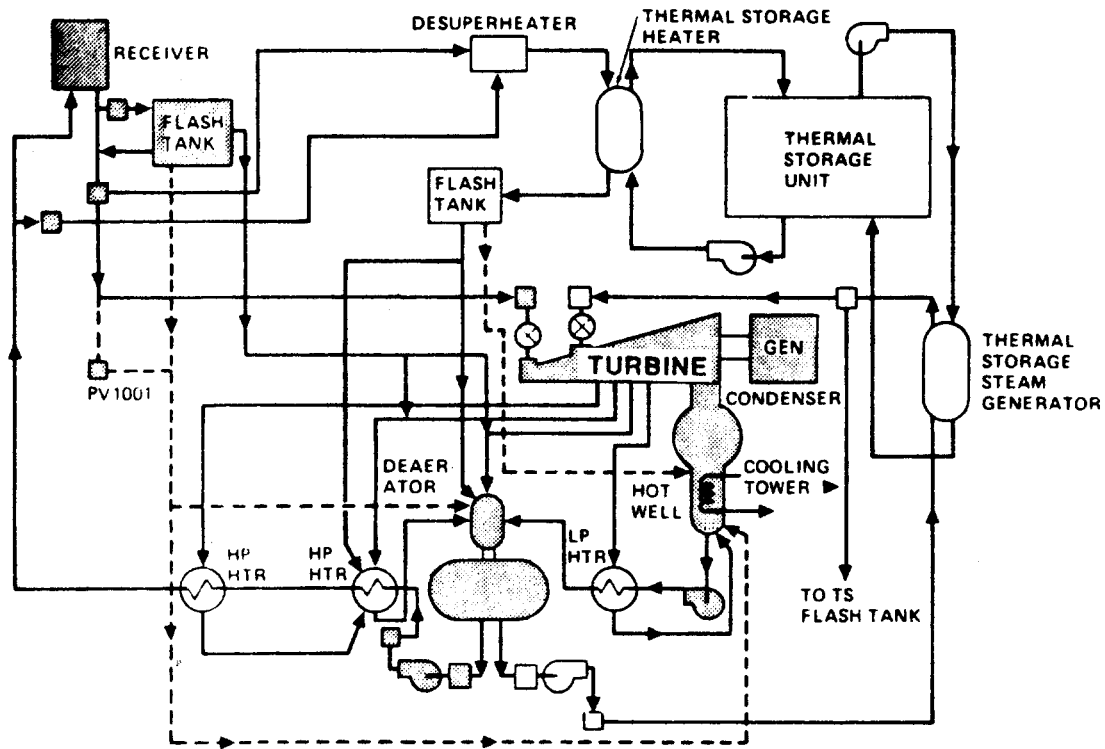
Figure 5. System Schematic of Major Thermal Flow Paths

Figure 5 is a schematic depicting the principal thermal circulation paths of the pilot plant.

Shaded areas of this figure show those components which were completely operational at the beginning of 1983. Those components which were evaluated during 1983 are primarily associated with the thermal storage system. Figure 5 is simplified deleting details such as the two separate 50 percent capacity storage-charging oil heaters and two 50 percent capacity steam generation trains. The dashed lines are simplified flow paths which are used during start up and shut down of the steam systems.

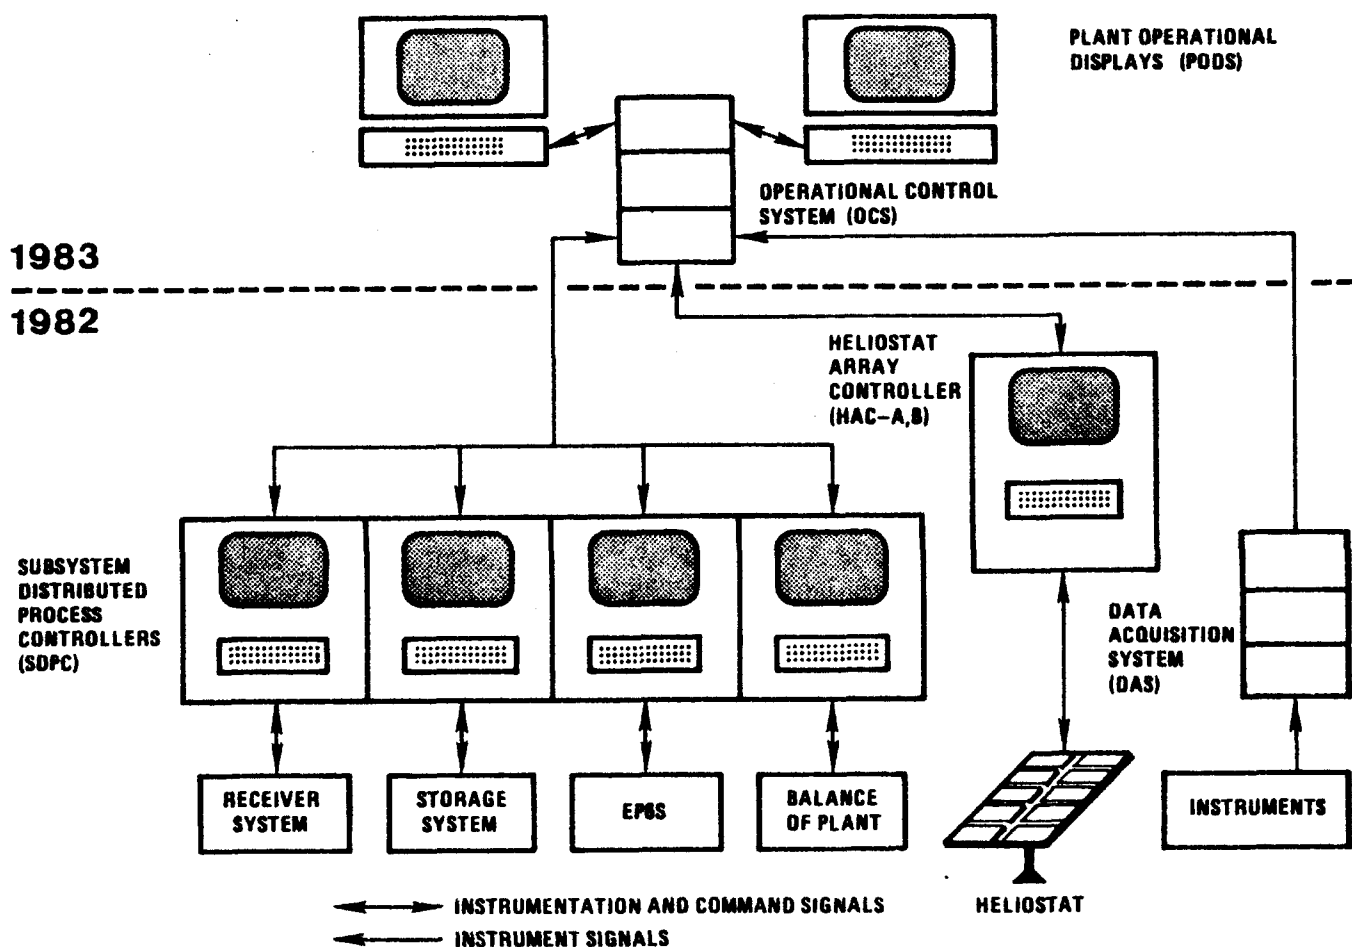
Figure 15. Overview of the Master Control Architecture

Solar One is unique in the electric utility industry because it is automatically controlled by a Master Control System consisting of an Operational Control System computer which supervises two Heliostat Array Control computers four subsystem process controllers (SDPC) and two thousand microprocessors. Information is supplied to operators on color-graphic video monitors. Figure 15 displays an overview of the control system architecture.

Initial emphasis was placed upon automation within the SDPC, signals from these and the heliostat controllers, were integrated into the Operating Control System computer and plant level data could then be displayed by the plant operational displays.

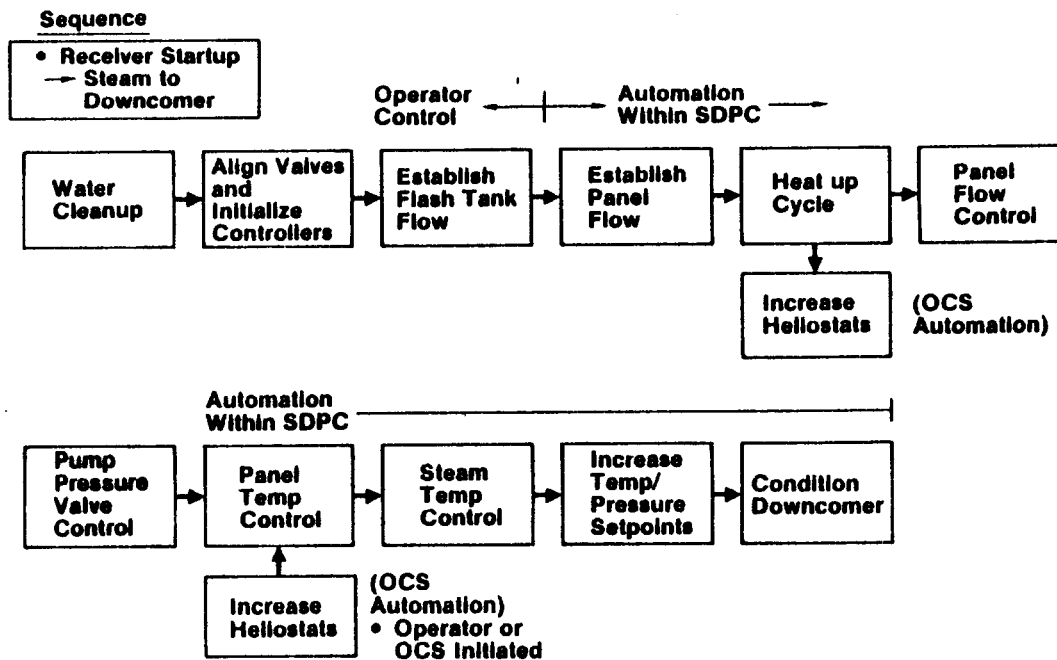
Figure 16. Receiver Start-up Sequence

Schematically, the automation sequence of a receiver start-up to attainment of Mode 9 is shown in Figure 16.

Mode 9 is not a productive operating mode, but it is important because the receiver system is started every day.

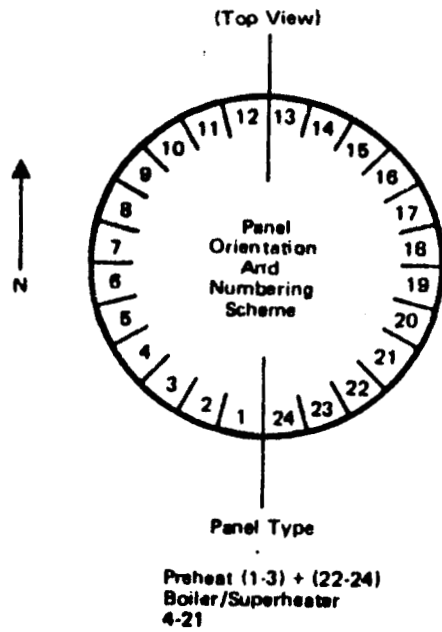
Figure 20 - Receiver panel numbering scheme
