LA-10557-PR

## Space Nuclear Safety Program

## SPACE NUCLEAR SAFETY PROGRAM

## I. GENERAL-PURPOSE HEAT SOURCE (GPHS)/SAFETY VERIFICATION TEST (SVT) SERIES

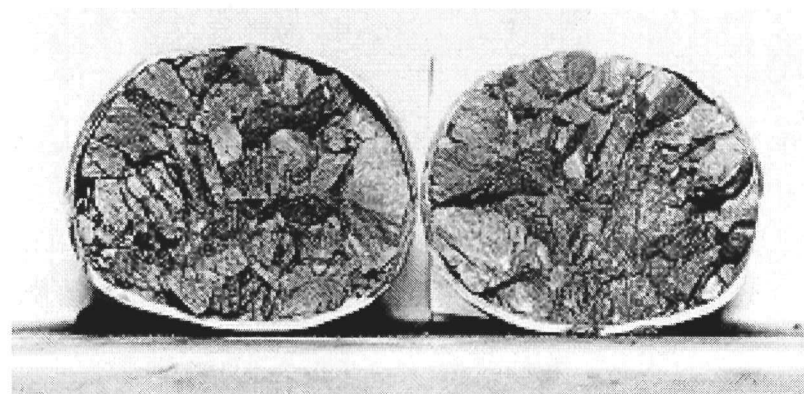
Fig. 14. The impacted plutonia pellets of SVT-7. (a) HF-364, (b) HF-368, (c) HF-165, (d) HF-112. All  $\sim 1.5X$ .

Fracture patterns of the plutonia pellets are shown in Fig. 14. The fracture pattern of pellet HF-368 consisted of small, radially oriented columnar fragments. In con-

trast, the fracture patterns of pellets HF-364, HF-165, and HF-112 showed relatively large, randomly oriented fragments.

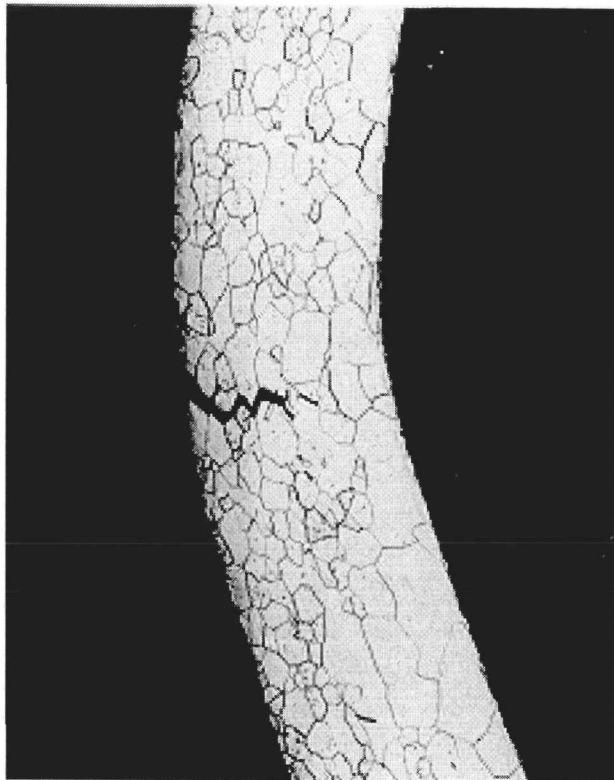
**Fig. 15.** Photomicrograph of the fracture in the FC-368 vent cup radius, 50X.

A fracture on the FC-368 vent cup radius is shown in Fig. 15. Visual examination of the interior surface did not indicate any penetration of the capsule wall, although metallographic examination indicated that the fracture had penetrated 50% of the wall thickness. Though the fracture mode was intergranular, a small reduction of thickness at the side of the fracture, about 2%, indicated limited ductility.

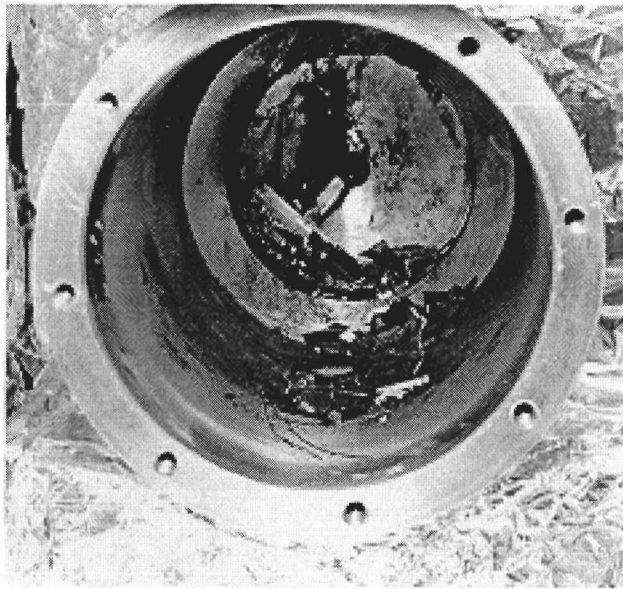
Fig. 20. A large amount of debris remained in the catch tube after extraction of the SVT-8 test assembly.

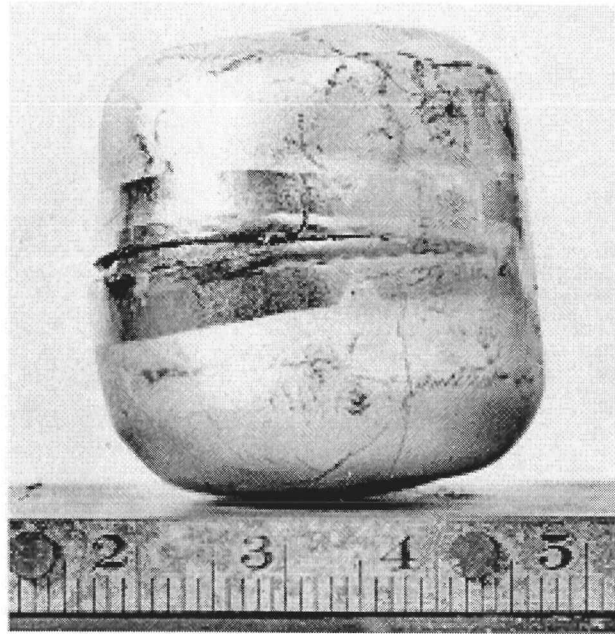
Fig. 26. The width of the main crack generated secondary cracks in the vent and weld-shield cups. (a) Impact face and (b) trailing face; both at 2X.

generated secondary cracks in the vent and weld-shield cups (Fig. 26). Capsule FC-441 experienced moderate deformation and contained no visible defects.
