PLANT OPERATIONS FINAL REPORT

✓ CO₂ ACCEPTOR PROCESS GASIFICATION PILOT PLANT:

FINAL REPORT
VOLUME 12, BOOK 1 OF 4
PERIOD: JANUARY 1972 - OCTOBER 1977

CONOCO COAL DEVELOPMENT COMPANY
RESEARCH DIVISION
LIBRARY, PENNSYLVANIA 15129
AND
STEARNS-ROGER INCORPORATED
P.O. BOX 5888
DENVER, COLORADO 80217

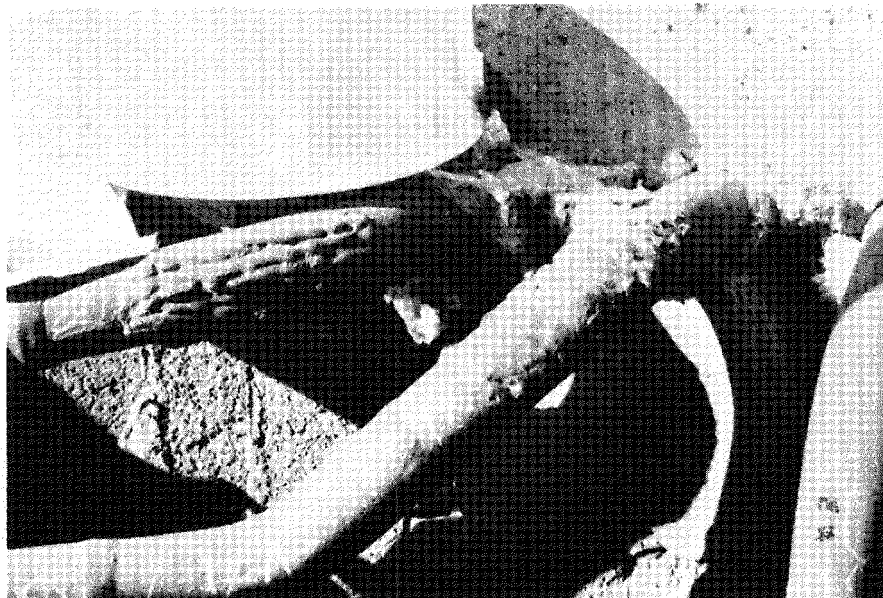
Figure 4-25. SULFUR CORROSION IN GASIFIER SIDE FLOW HEATER COIL

B-201-1B, GASIFIER SIDE FLOW HEATER-1, OCTOBER 20, 1973, SHOWING MORE WELD OVERLAYS ON OUTLET ELBOWS.

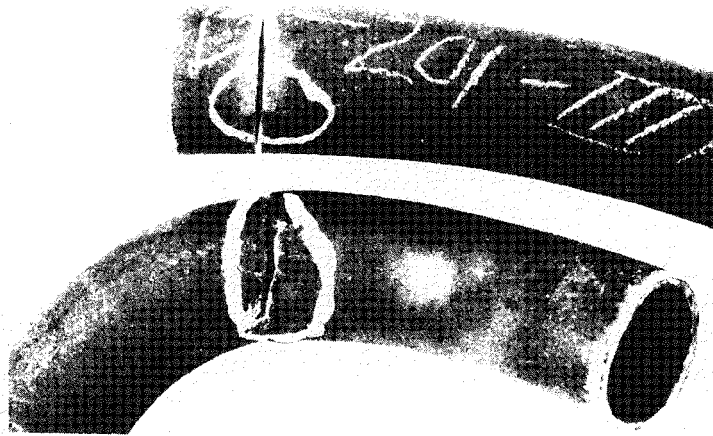
Figure 4-29. HEATER COILS FROM B-201-IIIA
DAMAGED BY CARBURIZATION

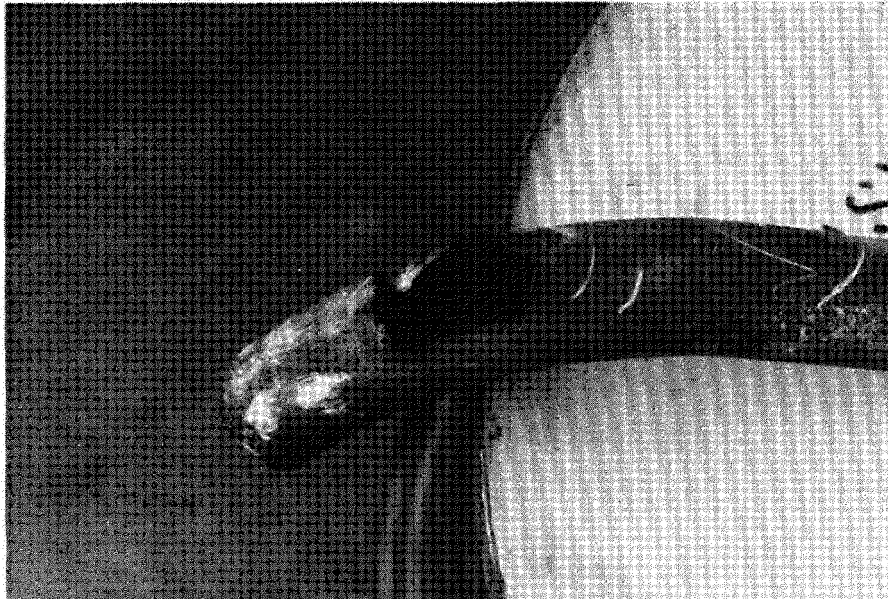
Figure 4-32. FAILURE OF ORIGINAL ALPHA COIL IN B-205,
ACCEPTOR LIFT HEATER, APRIL 30, 1974

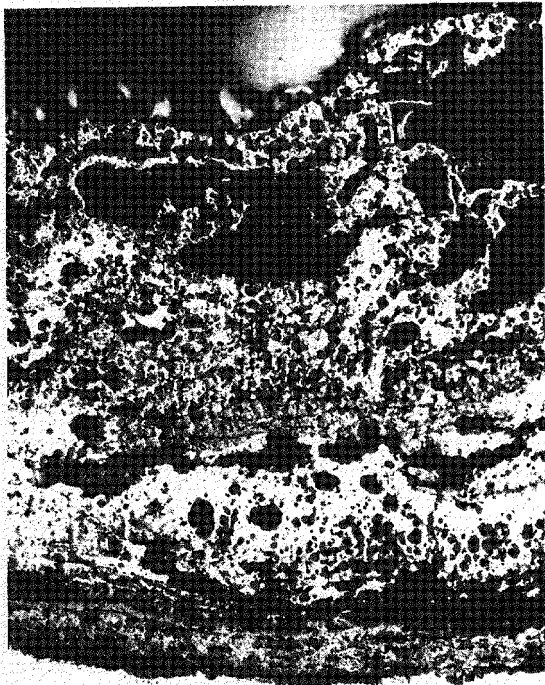
Figure 4-36. PHOTOGRAPH OF SCALE IN TUBE FROM B-205 HEATER BETA COIL (MAGNIFICATION 14.2X)

Figures 4-35 and 4-36 are photographs of restricted tubes removed from the Beta coil used in the B-205 heater. This coil was removed because of three tubes being restricted, causing an extremely high pressure drop across the heater. The scale on the tube inside diameter is a mixture of iron oxides, chromium oxides, nickel sulfide, and chromium sulfide. The scale is similar in composition to that on the tubes from the Alpha coil in May, 1974. The metal below the scale was carburized, with 50- to 80-percent of the original wall thickness left. The method of attack on this coil was sulfidation followed by oxidation.

GAS-SCALE INTERFACE

IRON OXIDE
(BRIGHT SPOTS ARE NICKEL SULFIDE)
(BLACK SPOTS ARE HOLES)

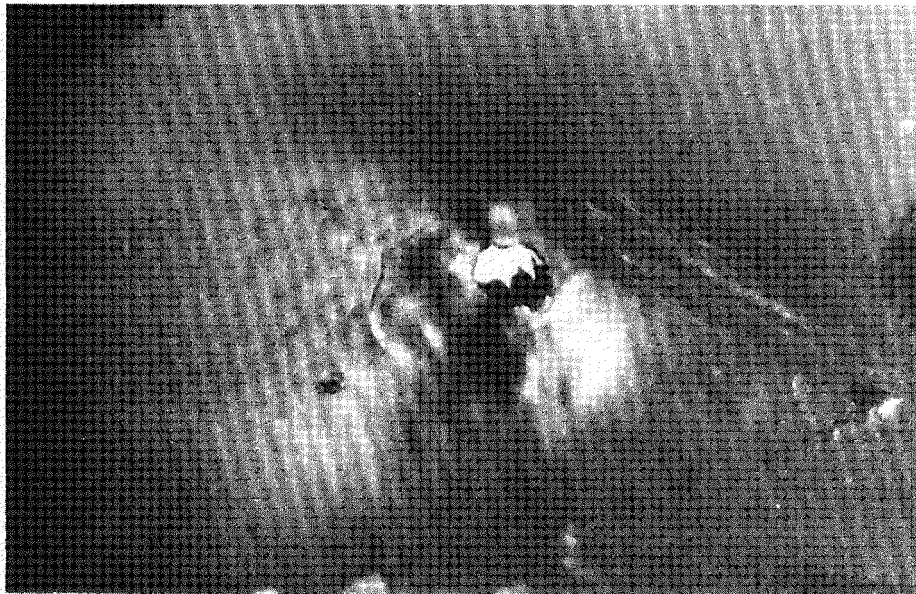
Figure 4-48. THINNED 310 STAINLESS STEEL METAL AROUND HOLE ERODED
IN SIDE OF GASIFIER EXTERNAL CYCLONE
