**TITLE: FIRESIDE CORROSION TESTING OF
CANDIDATE SUPERHEATER TUBE ALLOYS,
COATINGS, AND CLADDINGS—
Phase II Field Testing**

Topical Report, August 1996

**Report Prepared by:
FOSTER WHEELER DEVELOPMENT CORPORATION
12 Peach Tree Hill Road
Livingston, New Jersey 07039**

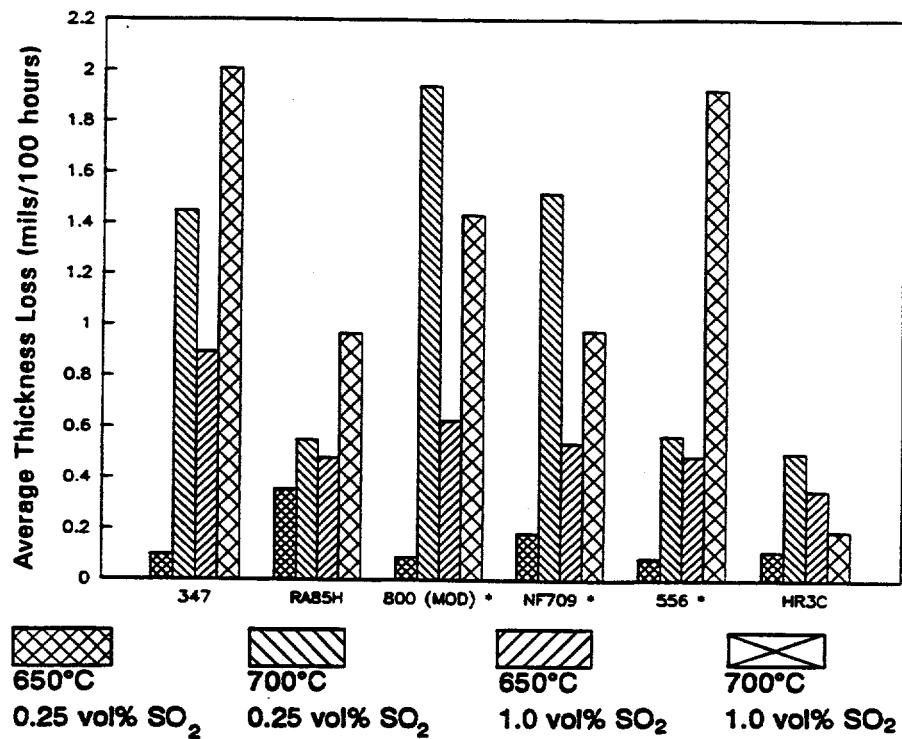
Fig. 1. Average thickness loss rate of alloys containing 14- to 30-percent chromium. (Alloys marked with an asterisk contain between 1- and 4-percent molybdenum.)

In Phase I of this ORNL program, "Fireside Corrosion Testing of Candidate Superheater Tube Alloys, Coatings, and Claddings," 20 commercial and developmental alloys listed in Table 1 were evaluated¹⁰. The coupons of the metals were exposed to multiple types of synthetic coal ash and synthetic flue gases at 650 and 700°C (1202 and 1292°F) for up to 800 hours. The average thickness loss rate for 14- to 48-percent chromium-containing alloys and the intermetallic aluminides are shown in Figures 1 through 3.

Chromium content was found to be the largest factor in determining the resistance of an alloy to liquid coal-ash corrosion. For stainless steels and nickel alloys, additions of chromium up to 25 percent provide increased resistance to coal-ash attack; however, above the 25-percent chromium level, there appears to be minimal benefit from more chromium, possibly because of the higher nickel content of those alloys.

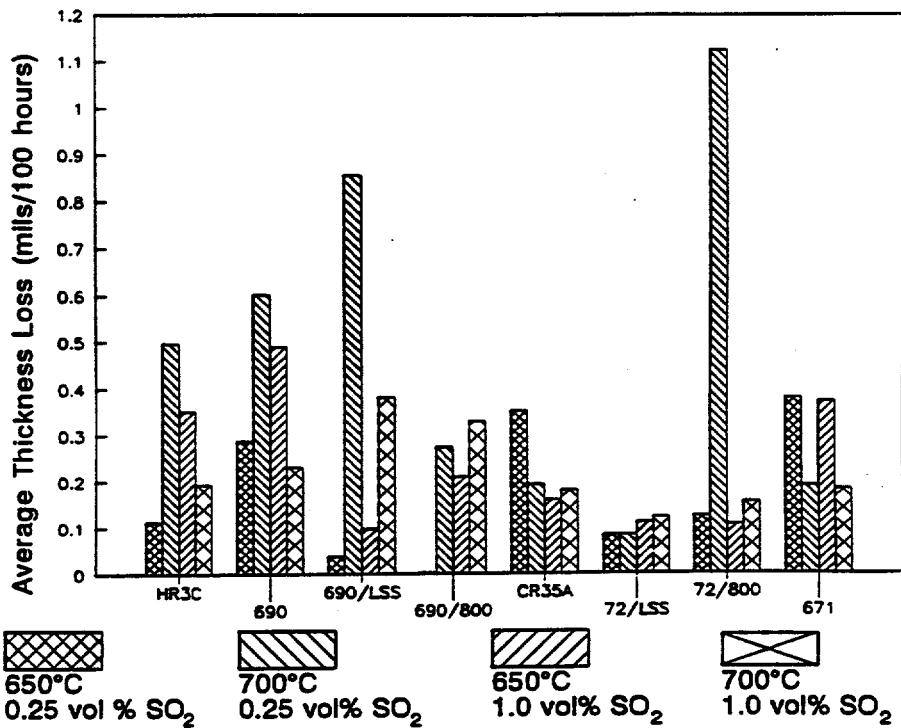
Fig. 2. Average thickness loss rates of various monolithic alloys and claddings coated with ash containing 10 wt% alkali sulfates and exposed for 800 hours

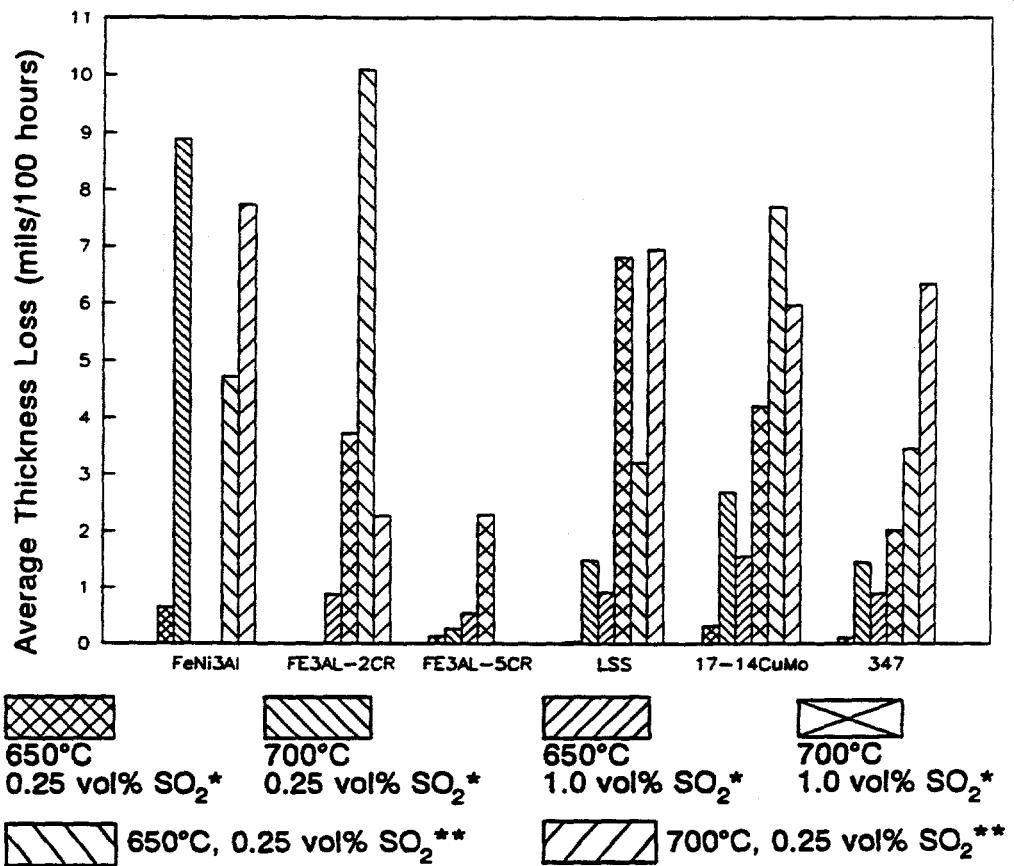
Fig. 3. Average thickness loss rates of three intermetallic aluminides and two stainless steels exposed to a variety of environments. (* = low sulfate ash, ** = high sulfate ash)

Molybdenum, on the other hand, may be detrimental to corrosion resistance. Silicon and aluminum were also beneficial, but to a lesser extent. The iron aluminide intermetallics also show a chromium dependence. Aluminides containing 5-percent chromium performed markedly better overall than those containing 2-percent chromium. The more resistant alloys show lower corrosion rates at longer exposure times, indicating the formation of a passive layer; the less-resistant alloys exhibit increasing corrosion rates at longer exposures. Lower-chromium alloys generally suffered greater wastage rates at the higher testing temperature [700°C (1292°F)], while higher-chromium alloys suffered the same amount of wastage at 650 (1202) as at 700°C (1292°F).

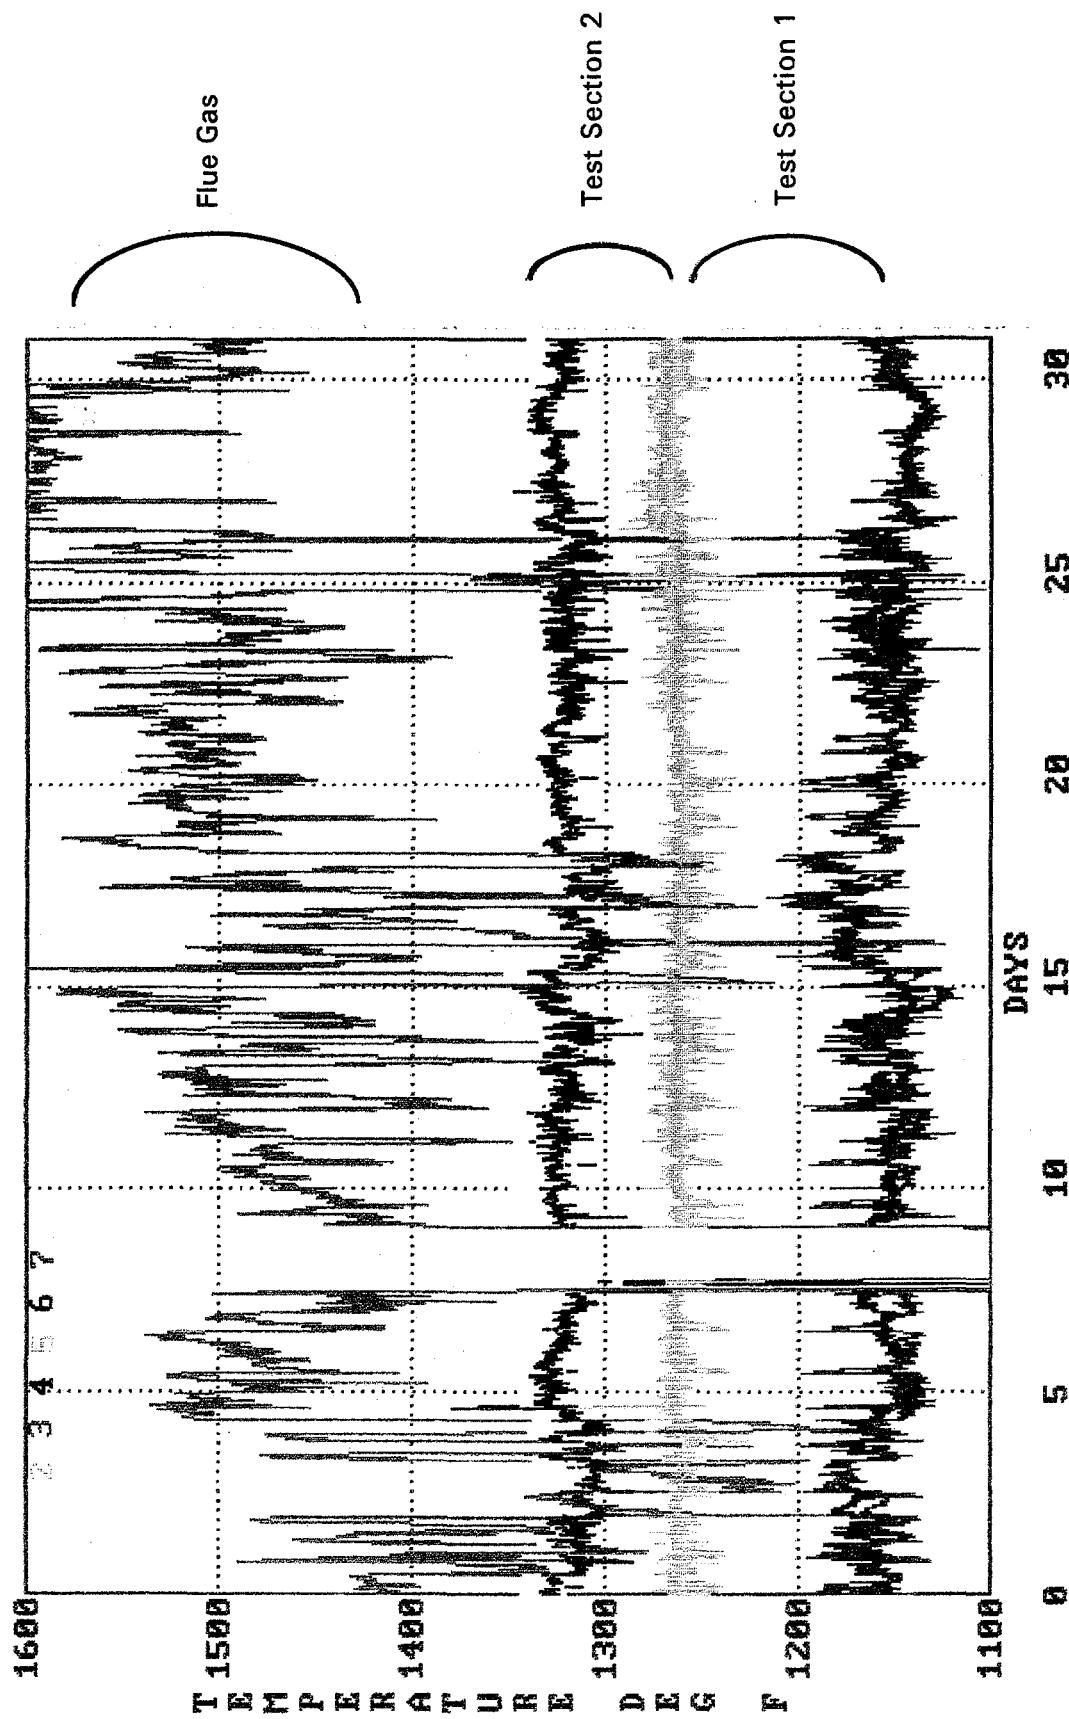
12/01/95 1 Upper T/C 1; 2 Upper T/C 4; 3 Upper T/C 5; 4 Lower T/C 1
00:10:06 5 Lower T/C 3; 6 Lower T/C 5; 7 Furnace T/C

Fig. 4. Temperature Plot

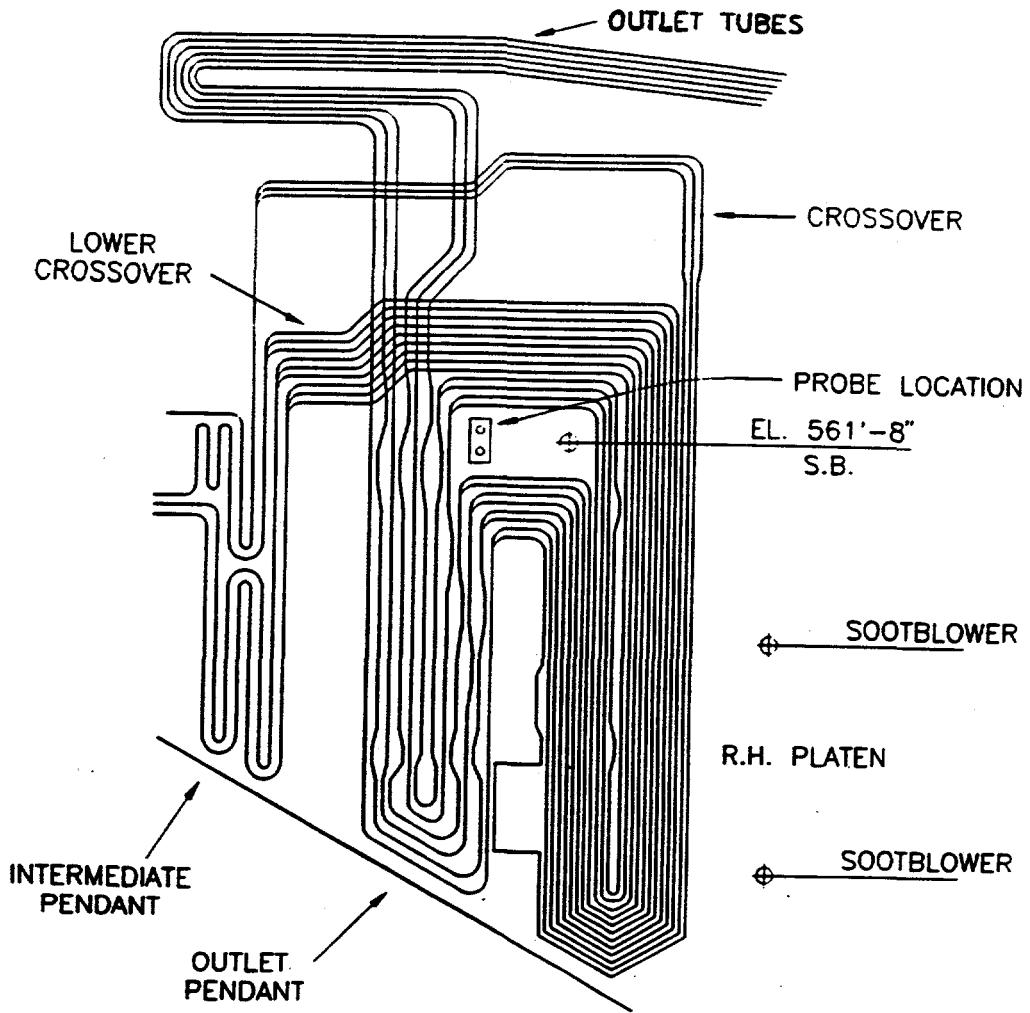
Fig. 5. Side elevation of reheat system at TVA Gallatin unit 2

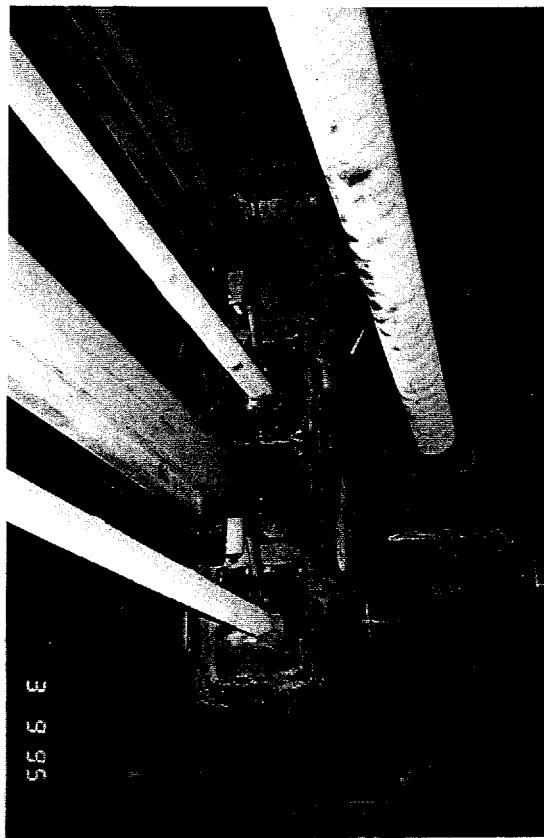
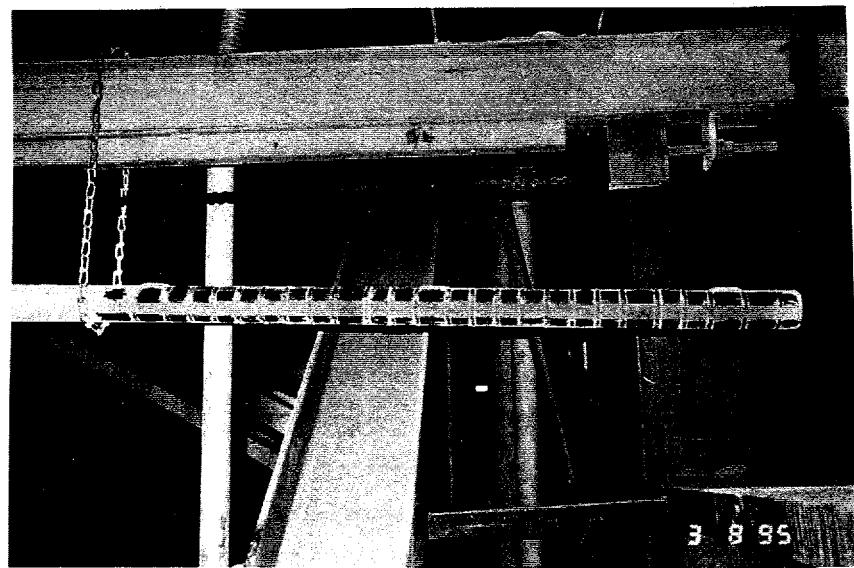
Fig. 6. The two retracted probes on the left and the soot blower on the right are shown in the top photograph. The bottom photograph shows the cleaned probe for ultrasonic thickness measurements.

During the quarterly inspections, FWDC personnel at the site manually retract the probes, selectively remove deposits, and make ultrasonic wall thickness measurements on the 4000- and 12,000-hour probe samples of the probe set. The 16,000-hour probe is left untouched at this time. The quarterly inspections provide preliminary nondestructive corrosion

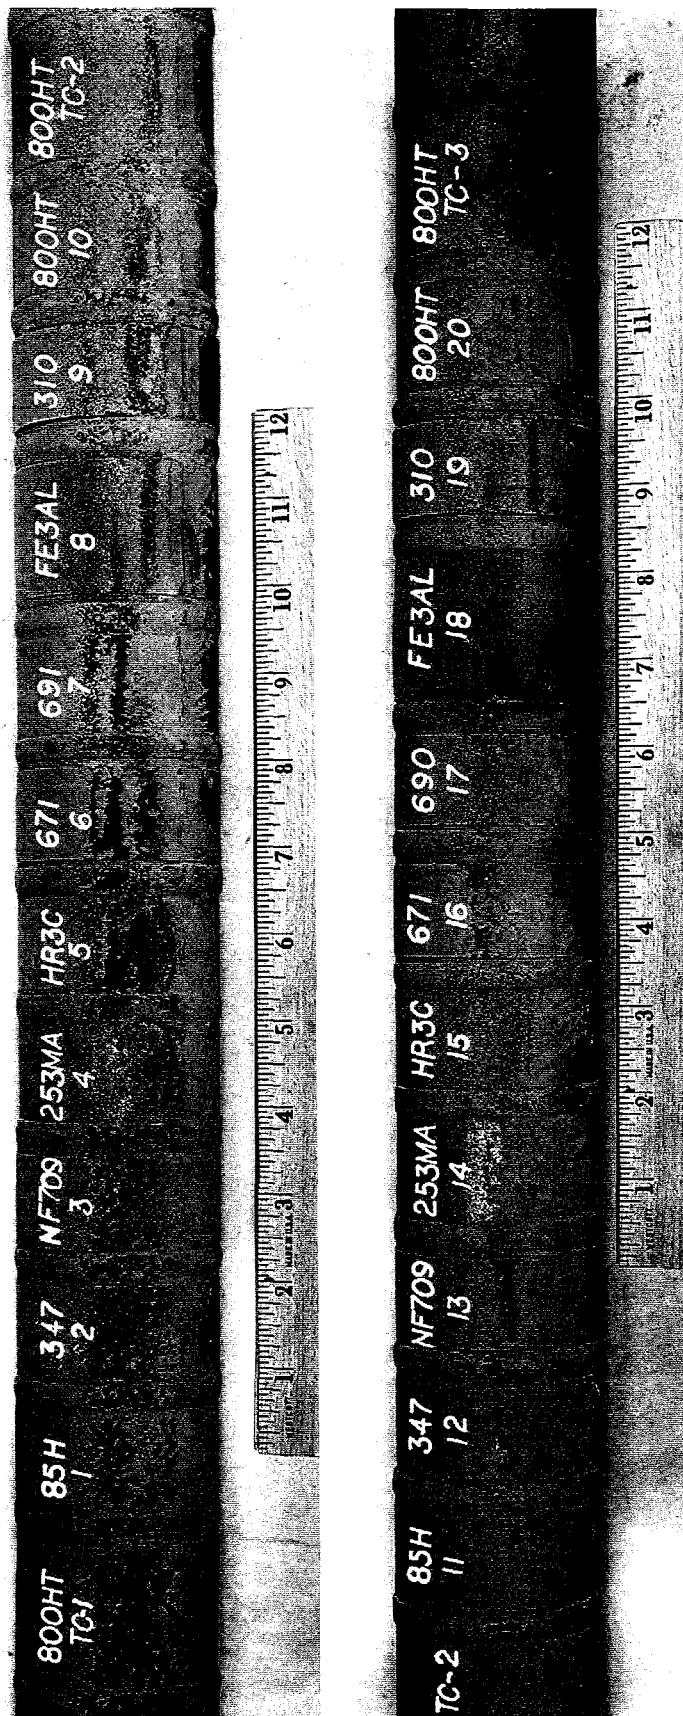
Fig. 7. Shown are the probe samples after removal from the probe support pipe. The fireside half of the samples and the rings with the thermocouples are shown.

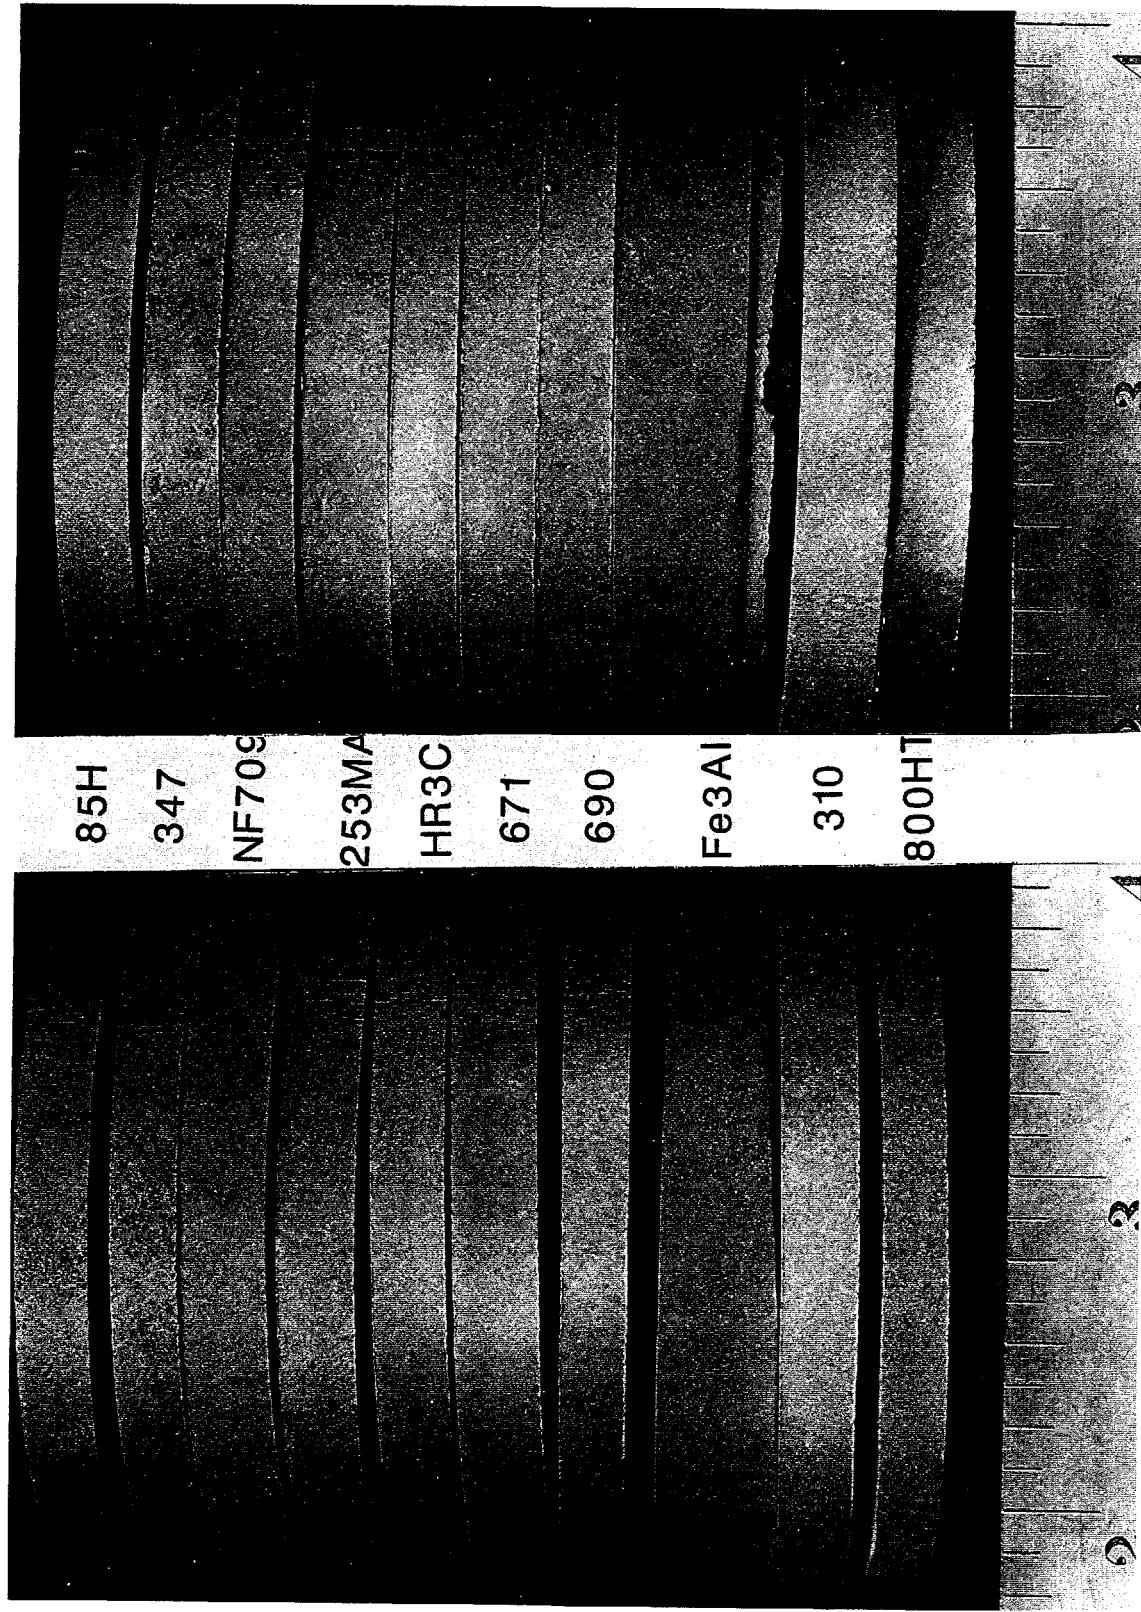
Fig. 8. The grit-blasted rights are oriented with the 135-deg location at the top. The cooler set of samples is on the left.

The appearance of the transverse cross sections used for the wall thickness measurements is shown in Figure 8. As illustrated, the middle of the sections is approximately the 135-deg location. [Note: Axially oriented grooves, evident at the 180-deg location, are artifacts believed to have been caused by a roller in the guide assembly.] Shallow pitting or surface irregularity is apparent in samples 1 (85H), 2 (347), and 4 (253MA) in the lower temperature group, and samples 12 (347) and 14 (253MA) in the high-temperature group. Post-exposure wall thickness readings were made at the 45-, 135-, and 270-deg locations, and the calculated wall loss at the three locations is presented in Table 8. [Note: Subsequent microscopic examination revealed most of the wall loss in samples 6, 7, 16, and 17 (671 and 690 clad on LSS) resulted from oxidation of the inside surface and not corrosion of the outside surface. Oxidation of the inside surface also contributed to the wall loss in samples 12 and 14.] Discounting the high values in samples 6, 7, 16, and 17 because of oxidation of the ID surface, the wall loss values of the specimens in each group were relatively minor. In correlation with their surface appearance in Figure 8, samples 2 (347) and 4 (253MA) in the lower-temperature group and samples 12 (347) and 14 (253MA) in the higher-temperature group exhibited higher values than most of the other alloys. Contrarily, the shallow pitting in sample 1 (85H) was not indicated by a wall thickness loss, nor was the 1.6-mil wall loss at

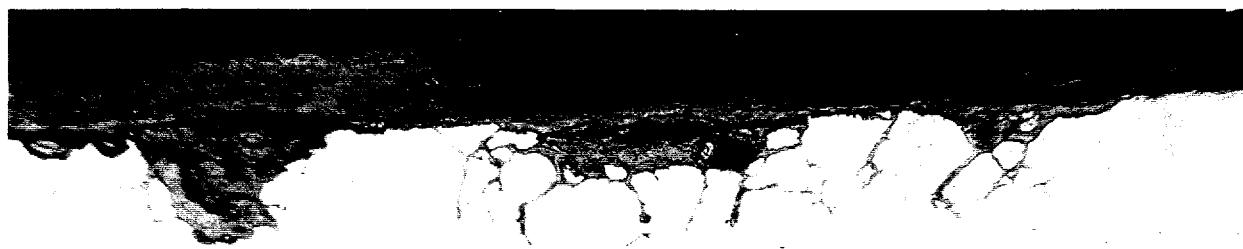
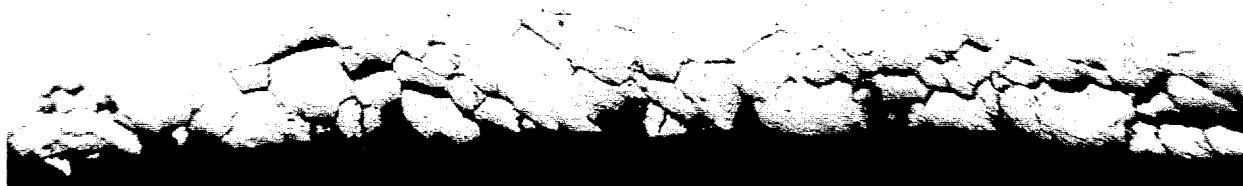
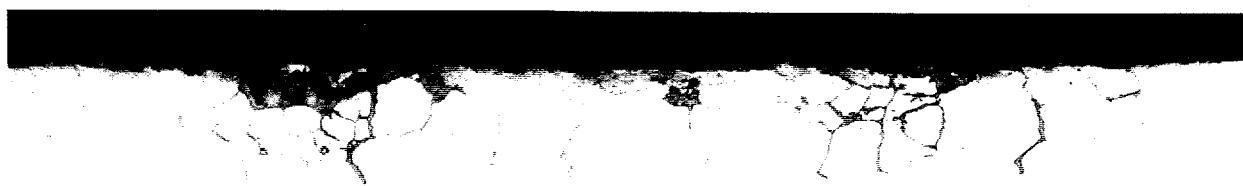
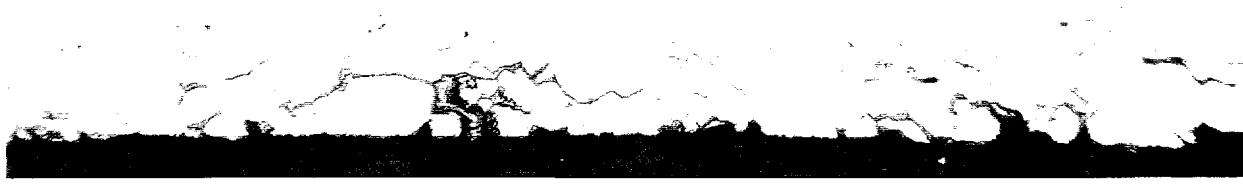
Fig. 9. The intergranular attack on the OD top and ID bottom of each pair of photomicrographs is shown for samples 85H-1 and 85H-11.

Short sections from the 45-, 135-, and 270-deg locations of the samples were prepared for microscopic examination. Photomicrographs depicting various surface conditions (both OD and ID) in the samples are presented in Figures 9 through 13. A summary of the examination follows.

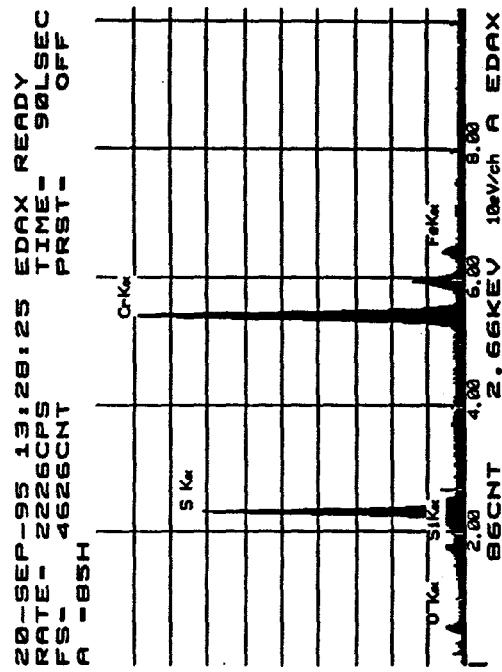
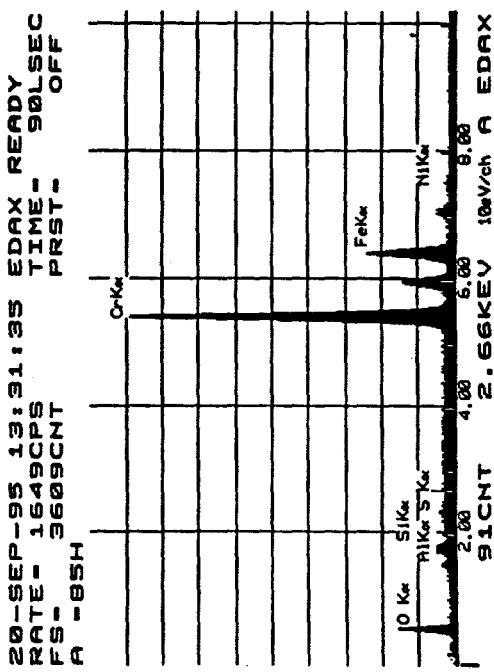
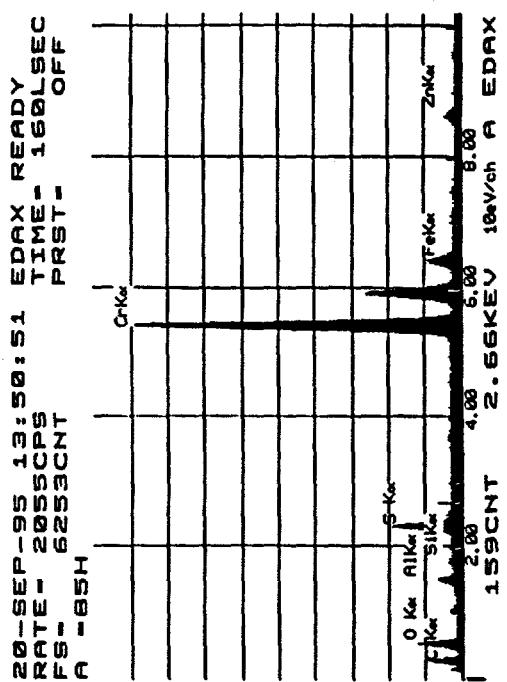
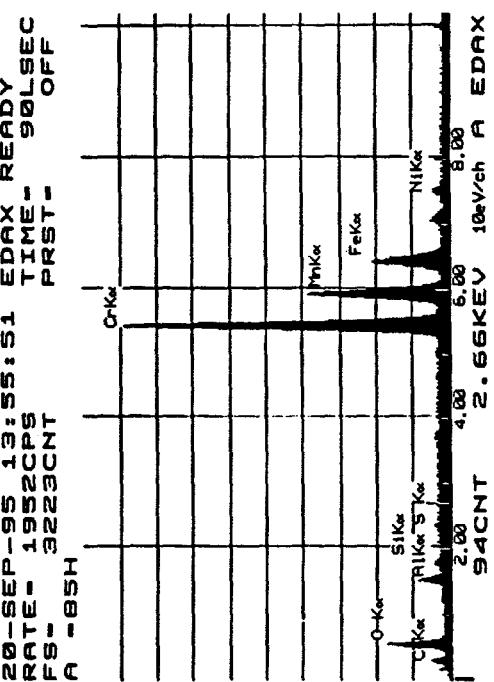
Fig. 10. Shown are EDX spectra of subsurface chromium sulfides (top) and oxides (bottom) in sample 85H-1 of Figure 9.

Fig. 11. A few grain boundaries in sample 85H-11 of Figure 9 show the top spectrum but most exhibit the bottom spectrum.

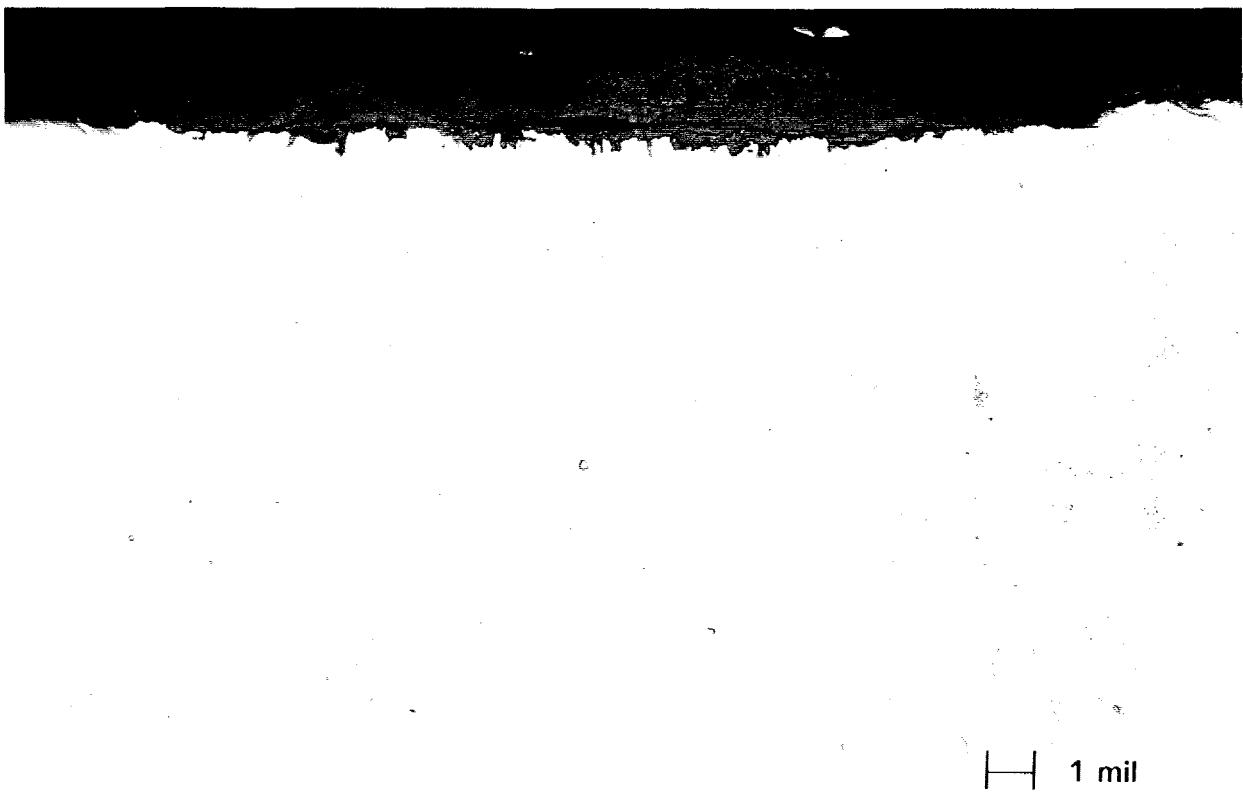
Fig. 12. The slight intergranular penetration at low and high magnification is shown for the 347-2 sample.

347 (Figures 12 and 13) — Both 347 samples contained a scale/deposit in the corroded areas. Sulfide penetration to a depth of approximately 0.5 mil below the scale/deposit was also evident in each sample. The outer layer of the scale/deposit (Figure 14) was predominantly iron oxide with embedded fly-ash particles; the inner layer was a chromium-rich oxide and contained a small amount of sulfur. The sulfides contained iron, manganese, and chromium.

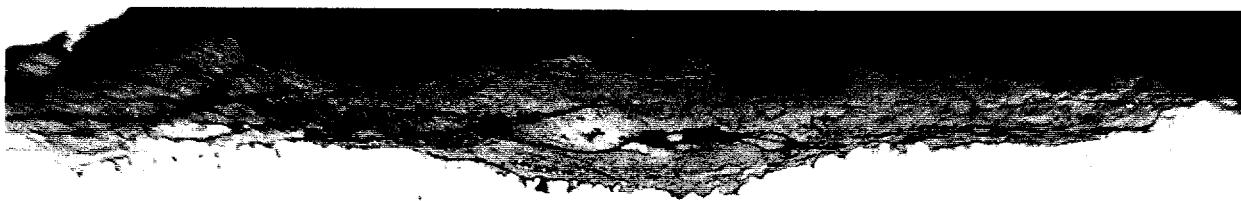
Fig. 13. The general corrosion on the OD and slight intergranular oxidation of the ID of the 347-12 sample is shown.

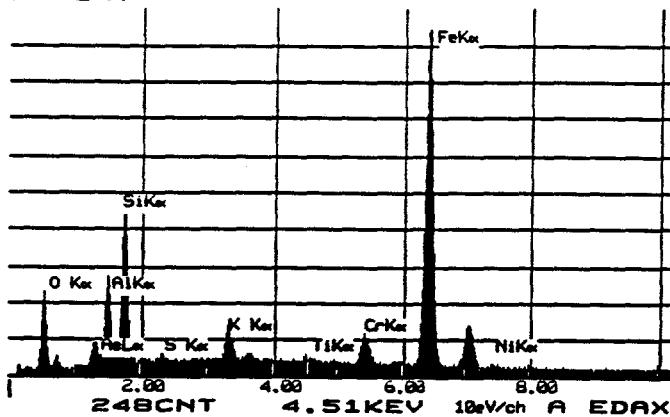
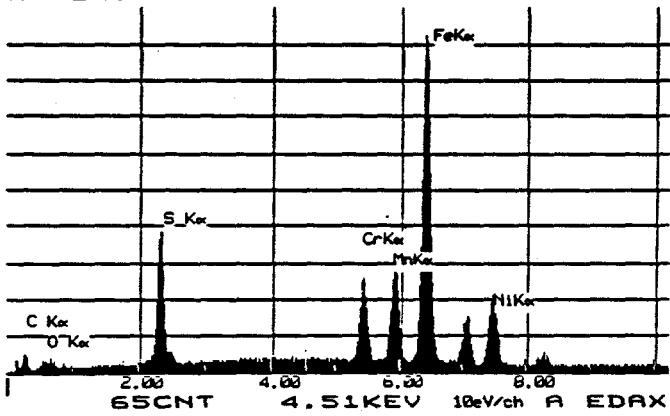
Fig. 14. The outer layer of scale/deposit in sample 347-12 in Figure 13 exhibited the top spectrum. The subsurface sulfides in that sample are shown in the bottom spectrum.

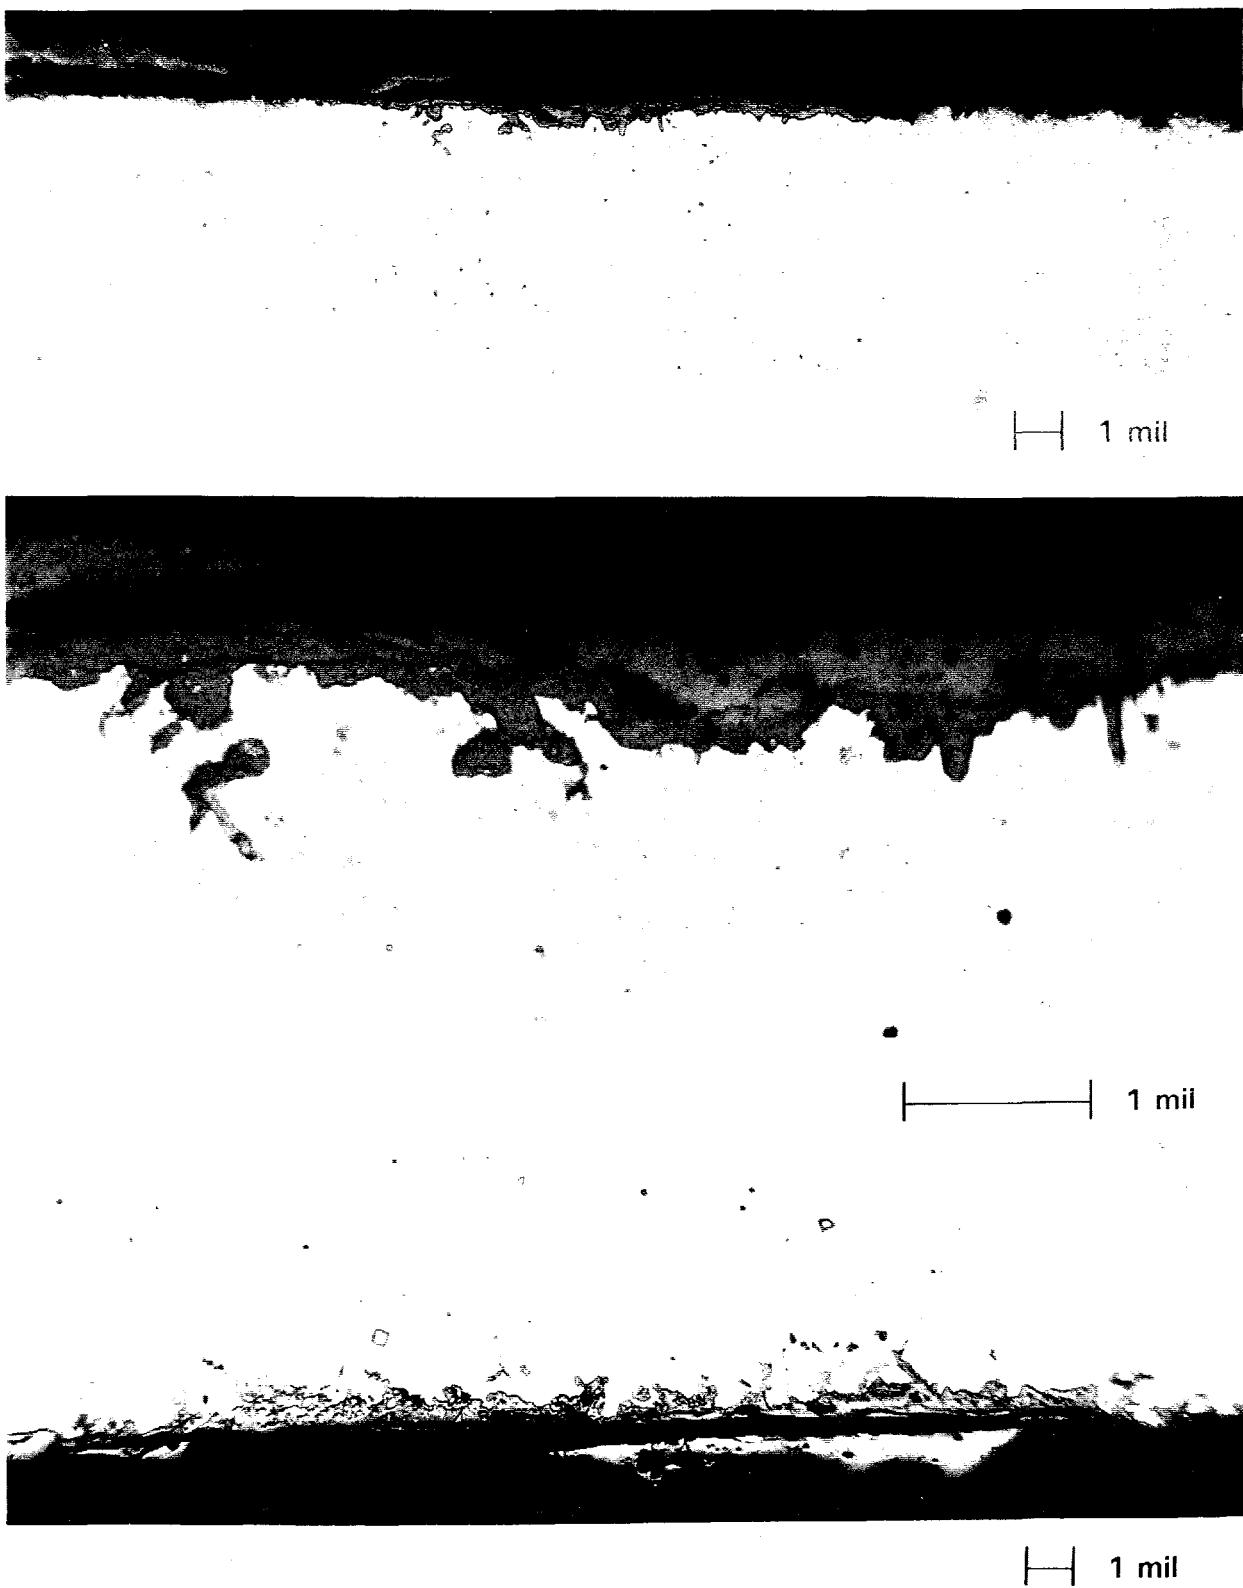
Fig. 15. Corrosion on the OD and intergranular oxidation on the ID of 253MA-14 are shown.

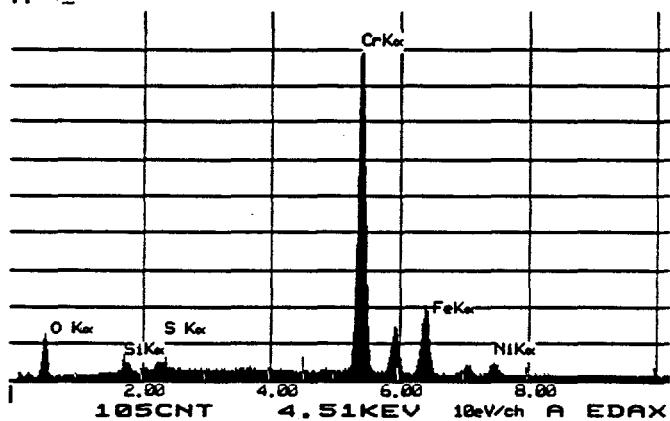
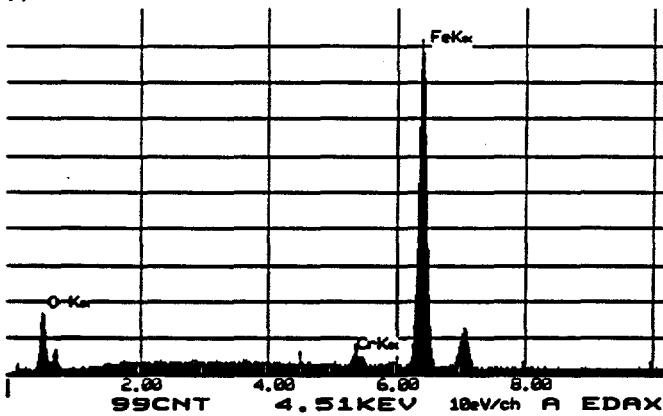
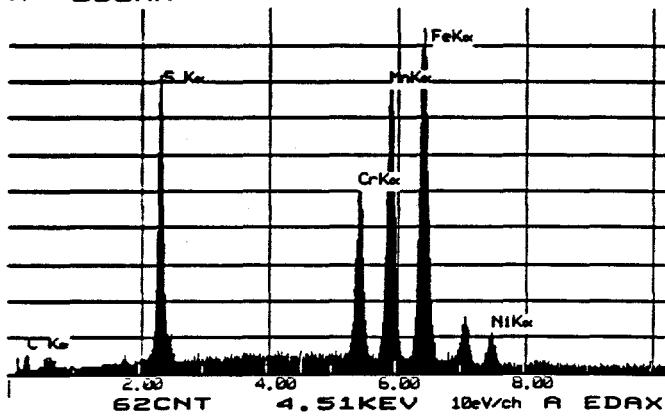
Fig. 16. The spectrums of the outer layer, inner layer, and subsurface sulfides are shown in the top, middle, and bottom spectrums respectively for 253MA-14 in Figure 15.

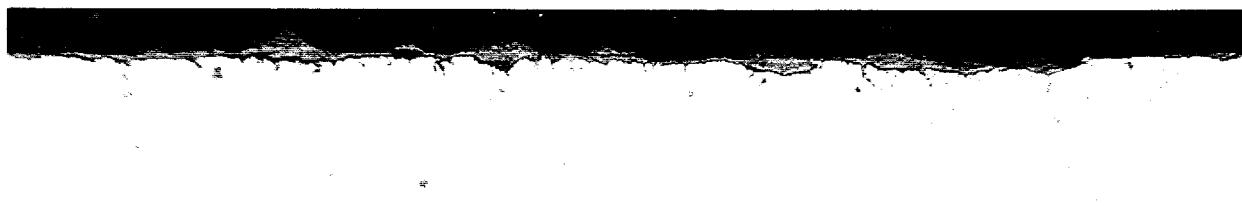
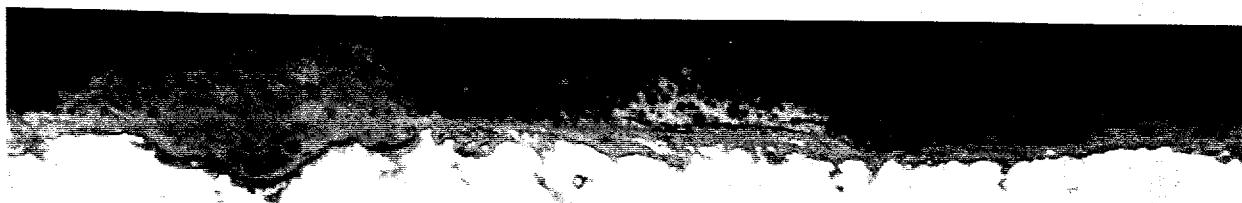
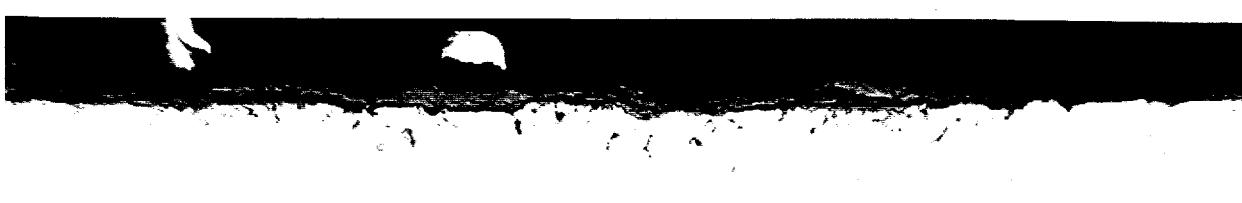
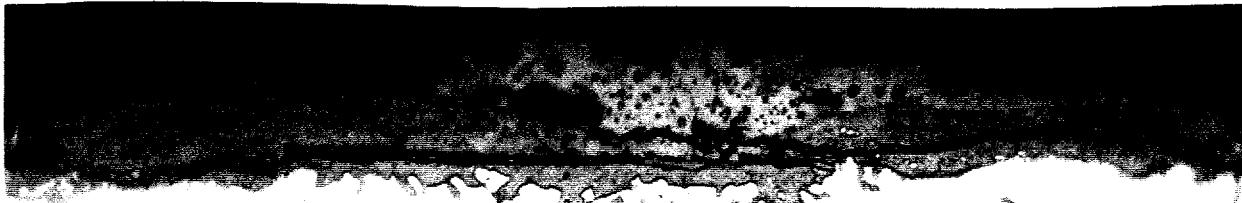
Fig. 17. Pitting and intergranular attack on the OD from the 800H-10 and 20 samples are shown.

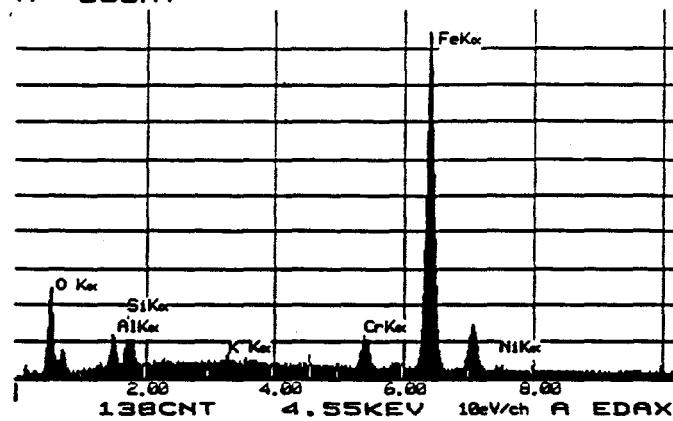
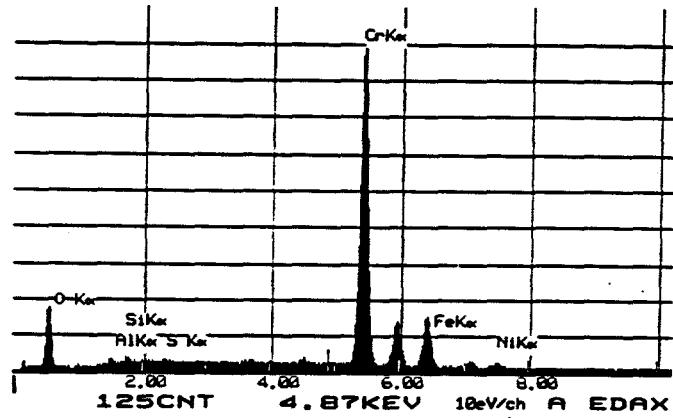
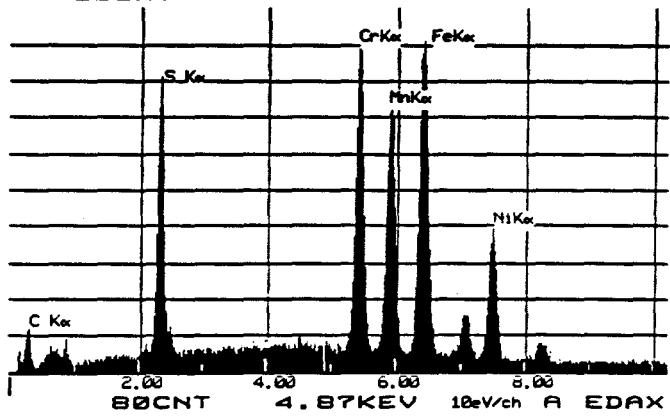
Fig. 18. The spectrums of the outer layer, inner layer, and subsurface sulfides are shown in the top, middle, and bottom spectrums respectively for 800HT in Figure 17.

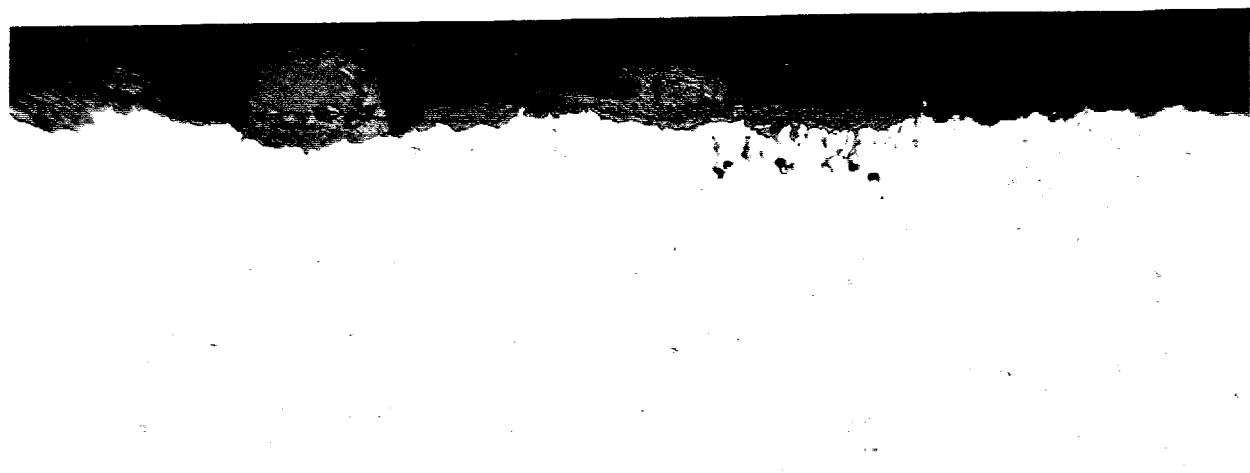
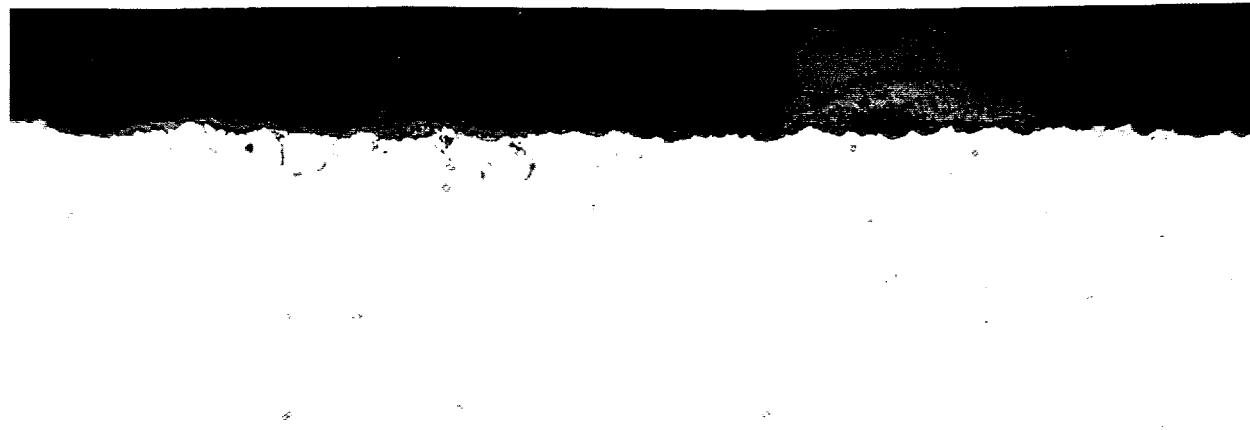
Fig. 19. Alloys 310 modified, HR3C, and NF 709 are compared. The 310 modified showed the least attack.

310 modified (Figure 19) — The 310 modified sample in both sections contained a thin, chromium-rich scale with embedded fly-ash particles. No internal oxidation or sulfidation was noted.

The silicon and aluminum addition in 85H and the silicon addition in 253MA do not appear in 4000 hours to provide any increased corrosion resistance. The tantalum addition in 310 modified, on the other hand, is very beneficial in reducing the corrosion.

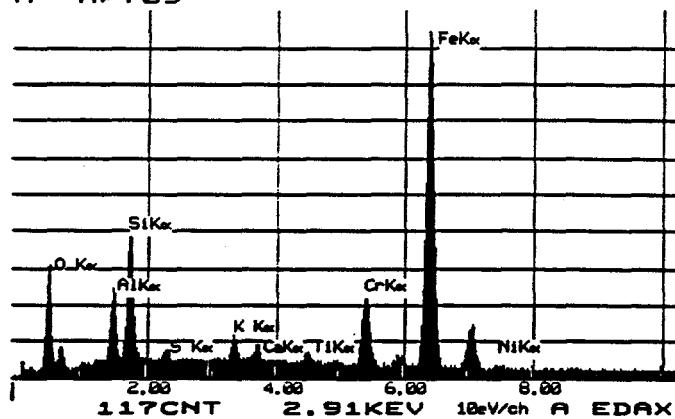
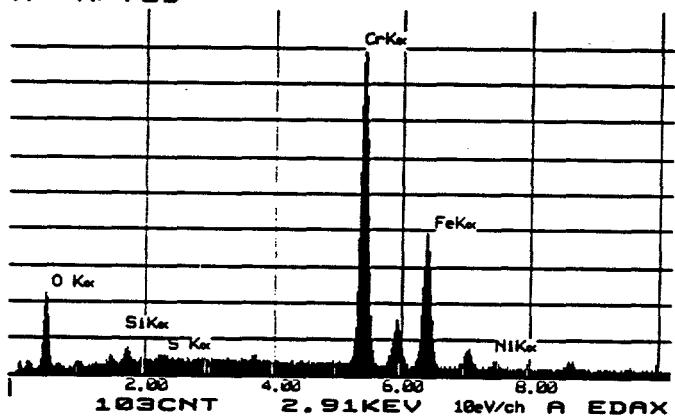
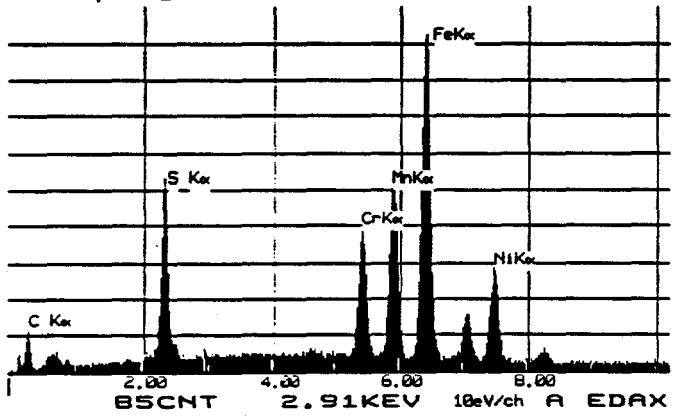
Fig. 20. The spectrums of the outer layer, inner layer, and subsurface sulfides are shown in the top, middle, and bottom spectrums respectively for NF 709 in Figure 19.
