**TITLE: FIRESIDE CORROSION TESTING OF
CANDIDATE SUPERHEATER TUBE ALLOYS,
COATINGS, AND CLADDINGS—
Phase II Field Testing**

Topical Report, August 1996

**Report Prepared by:
FOSTER WHEELER DEVELOPMENT CORPORATION
12 Peach Tree Hill Road
Livingston, New Jersey 07039**

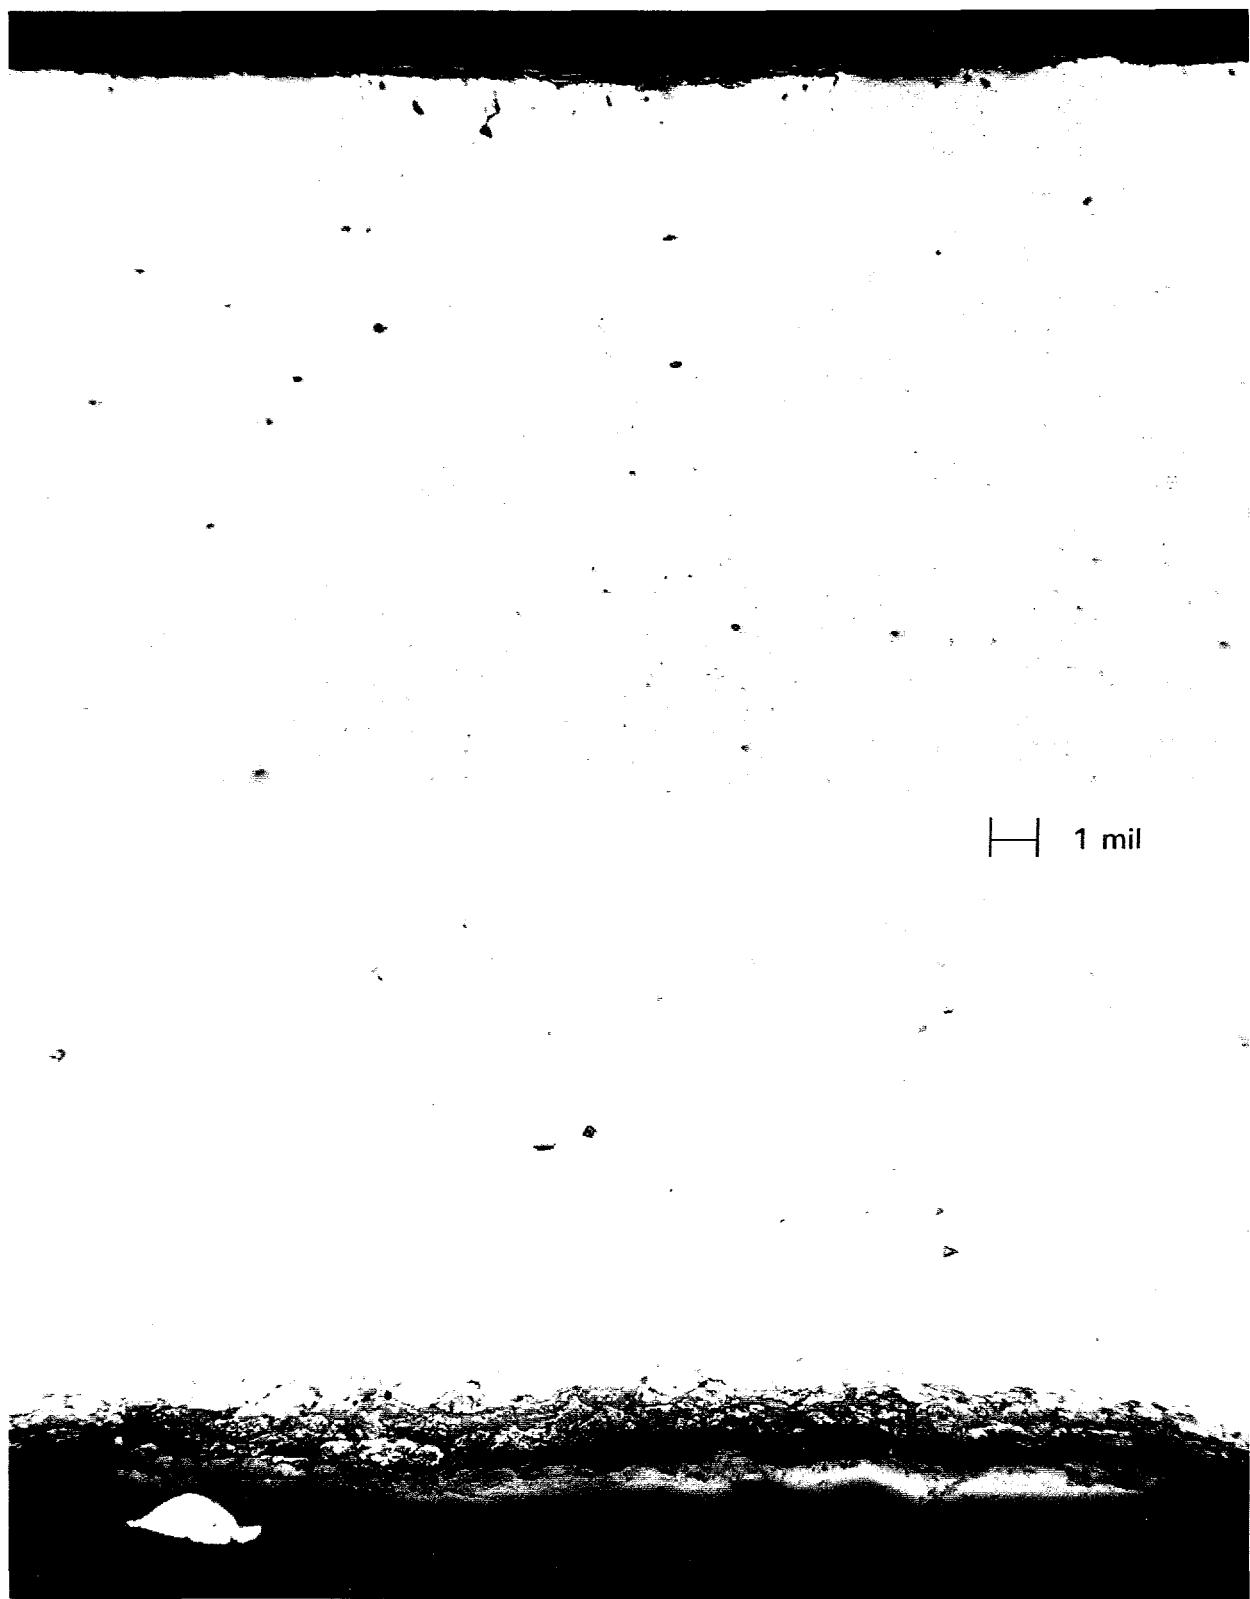
Fig. 22. One mil of internal oxidation was observed on the OD of 690-17 (top). The ID attack of the lean stainless steel can be seen in the bottom photomicrograph.

690 (Figure 22) — Similar to the 671 samples, both 690 samples displayed a thin, chromium-rich oxide on the outside surface. In a few areas in the hotter section (top photomicrograph), internal oxidation on the OD surface was noted to a depth of approximately 1 mil. No sulfidation was detected in either sample. The inside surface (which also consisted of LSS stainless steel material) contained a 2-mil-thick oxide scale (bottom photomicrograph) in the hotter section (sample 17) and a 1-mil-thick scale in the cooler section (sample 7). On the basis of the microscopic examination, the calculated wall loss from the wall thickness measurements for these samples also appears to be the result of the internal scaling. The wall loss from the outside surface is estimated to be less than 1 mil.

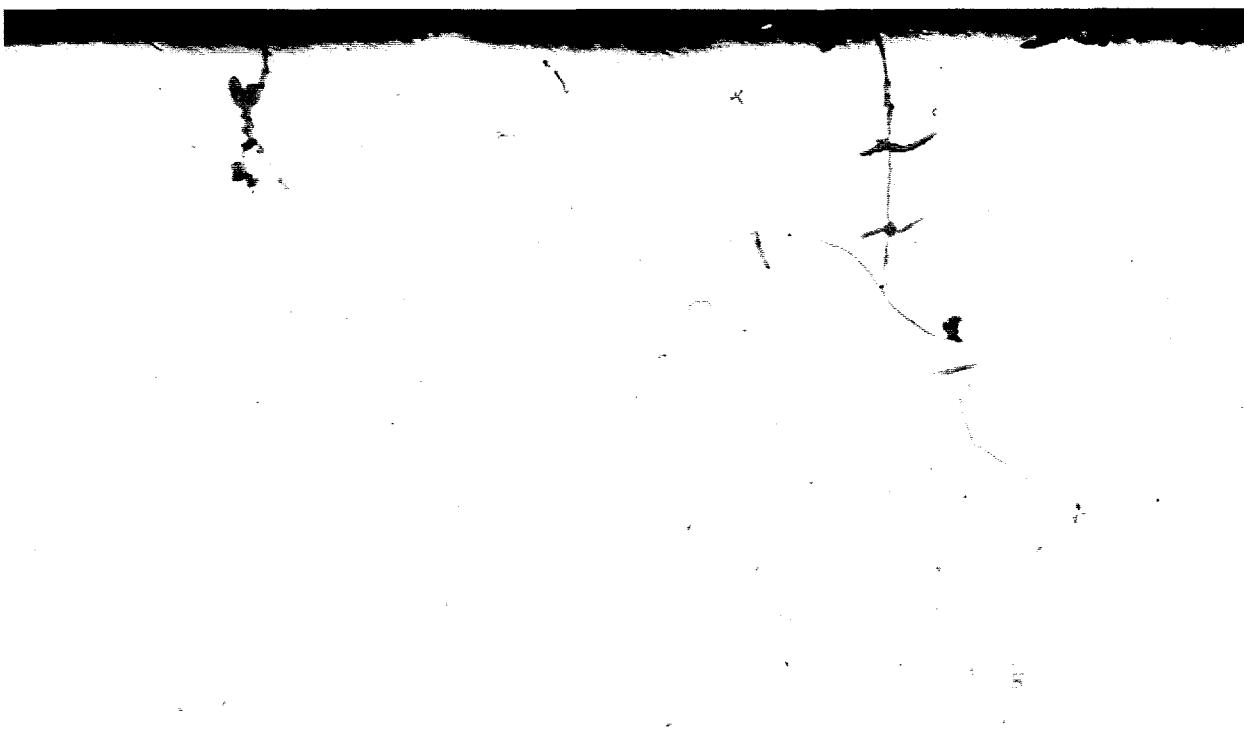
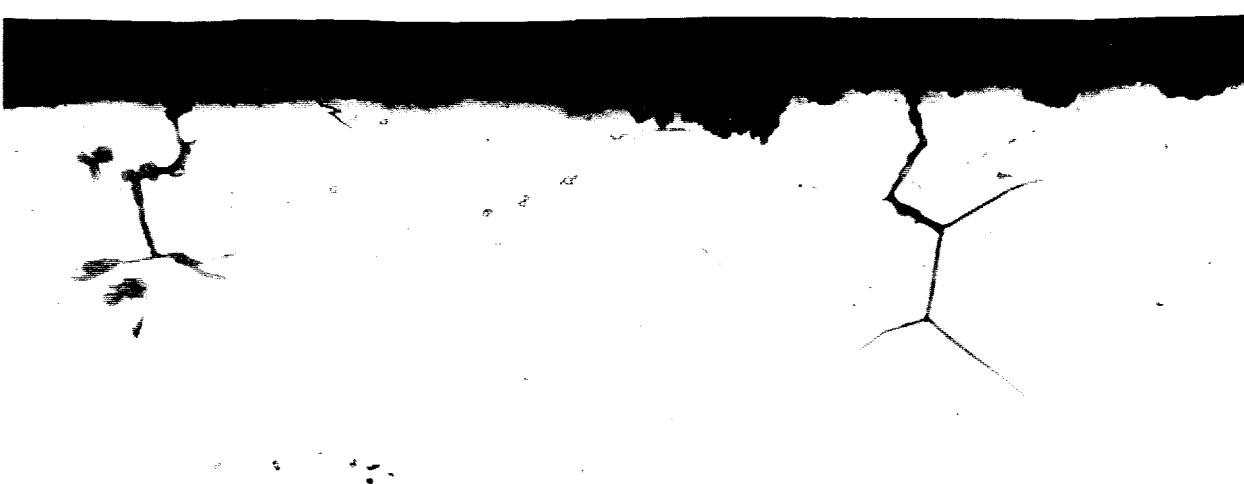
Fig. 23. Some slight surface attack can be seen on the Fe₃Al-18 sample. Also, cracks up to 5 mils deep can be seen in both samples.

Fe₃AL (Figure 23) — The outside surface of both Fe₃AL specimens was essentially free of any scale/deposit. Shallow pits (bottom photomicrograph) were noted in isolated areas in the hotter section (sample 18). The material in the pits was predominantly aluminum oxide. Numerous cracks that initiated from the outside surface were evident in both samples. The oxide in the cracks was rich in iron and contained some aluminum.

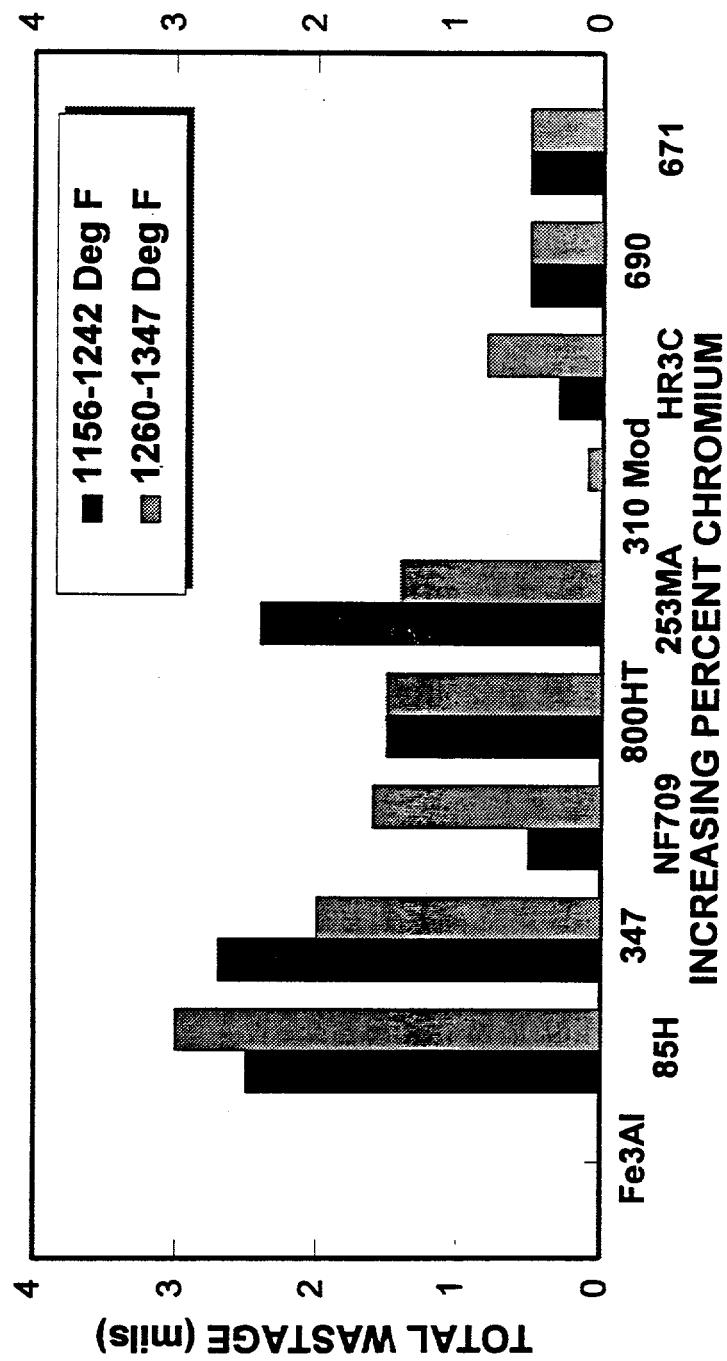
Fig. 24. Total wastage vs. the chromium level in the samples for the two different temperature bands is shown. (4000-hour probe)

measurements indicate the same benefit of chromium in providing corrosion resistance (i.e., the higher the chromium level, the lower the corrosion) as the previous Phase I laboratory testing. The exception to this is that the iron aluminide with only 5-percent chromium showed no evidence of measurable corrosion. Also, the 310 modified with tantalum performed better than the same 25-percent chromium HR3C with niobium. The data from the
