# Investigation of Properties and Performance of Ceramic Composite Components: Final Report on Phases III and IV

January 15, 1998

Report Prepared by  
W. A. Curtin, H. Halverson, R. H. Carter, N. Miraj, and K. L. Reifsnider  
Department of Engineering Science and Mechanics  
Department of Materials Science and Engineering  
Virginia Polytechnic Institute and State University  
Blacksburg, VA 24061

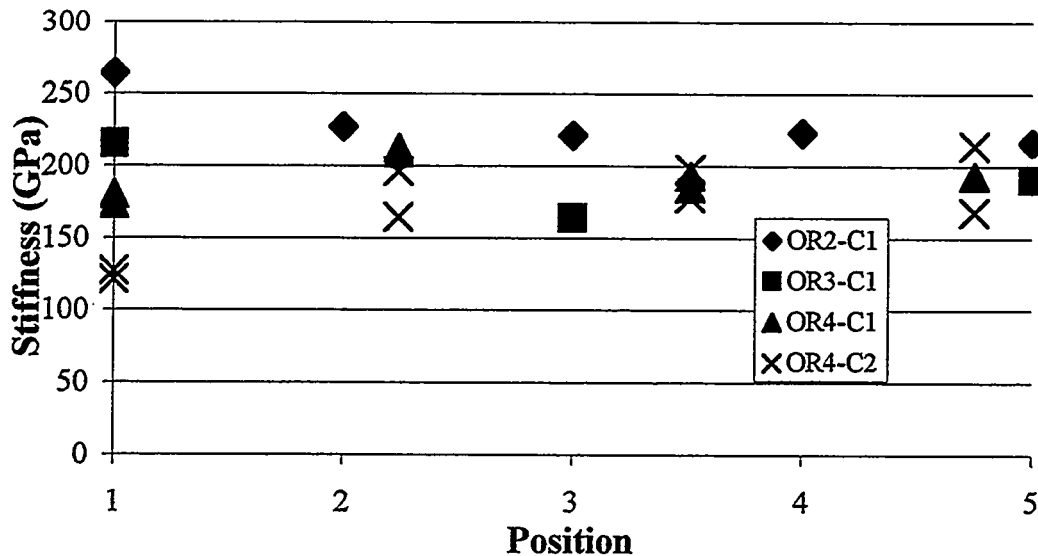
Figure 2.1.2 Axial Young's modulus versus tube position for four different tubes

The observed modulus variations are generally attributable to variations in the densification along the tube length, possibly caused by thermal gradients along the tube during processing. A correlation of modulus and density has been made by Becher et al. on similar

forced-CVI materials, shown in Figure 2.1.3.<sup>3</sup> The variations in modulus shown in Figure 2.1.2 correspond, using the results of Figure 2.1.3., to porosity variations of between 10% and 25% along the tube length.

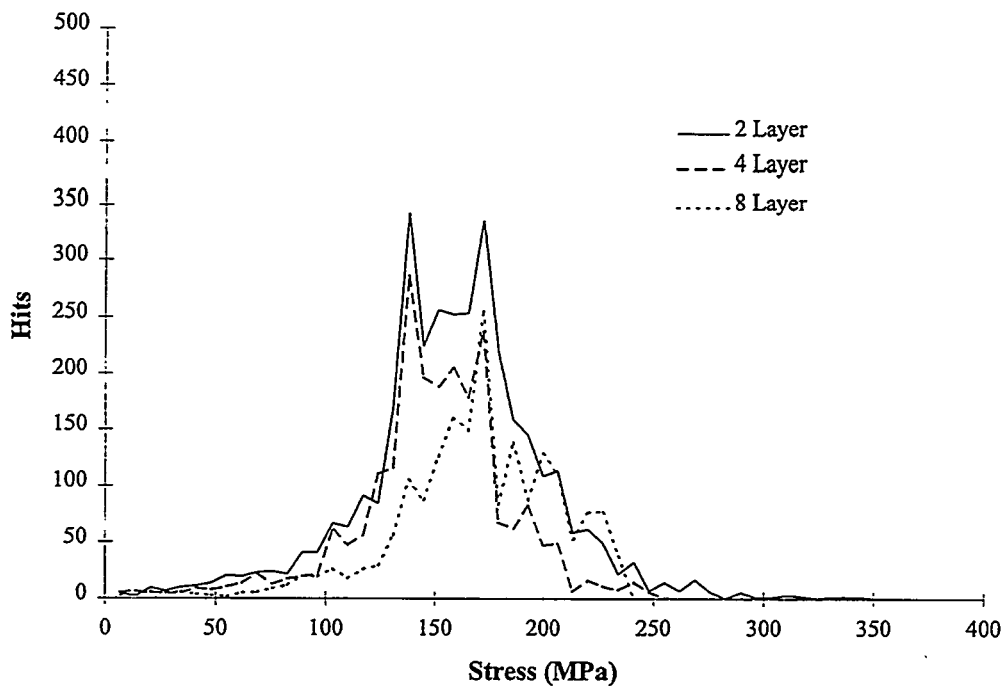
Figure 2.2.2: Acoustic Emission Hits vs. Stress for Medium Layer Specimens

We have also studied the acoustic emission from these materials during loading and unloading/reloading. There is essentially no acoustic emission during the fatigue cycles, indicating the absence of additional matrix damage during the fatigue. The level of acoustic emission activity during loading shows a clear peak in number of events versus stress around 140-175 MPa in all of the materials (see Figure 2.2.1), with some minor variations. The typical numbers of events are nearly independent of the number or thickness of the interface coatings, as evidenced by the data in Figure 2.2.2. The data suggests that there is slightly more activity for 2 layer specimens and thin layer specimens, with the thick layer specimens generally having the lowest numbers of hits. Consistent with the stress-strain behavior, the peak in acoustic emission events tends to coincide with the regime of strong non-linearity in the stress-strain curves between 140 and 175 MPa, as shown in Figure 2.2.1. Acoustic emission declines substantially above 210 MPa. We have examined the acoustic emission data for trends in amplitude, rise time, duration, and energy versus applied load but have found no strong correlations. Thus, we are not able to determine if any of the acoustic emission stems from fiber damage, or interface cracking. The cessation of acoustic activity above about 210 MPa indicates that the activity we are detecting is due solely to matrix cracking events.

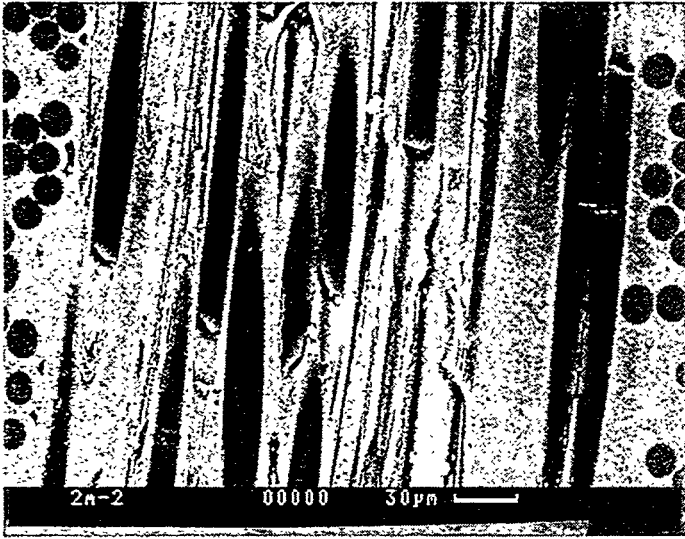
Figure 2.2.6 Zooming in on a crack approaching the multilayer coatings at a longitudinal fiber. The final image shows another crack which passes through the fibers tows including a "jog" in between two fibers and a very dark line at the fiber/coating interface suggestive of debonding at that interface.

The images in Figure 2.2.6 also show the efficacy of the multilayer fiber coatings. In the backscattered images, the thin Carbon interlayers appear as faint dark lines and are clearly visible along the surfaces of many fibers. *The cracks impinging on the fibers in the  $0^\circ$  tows almost always penetrate through the coatings and terminate at the fiber/inner coating interface.* We have not observed any cracks terminating at the outer layers. These observations are consistent with separate theoretical predictions which indicate that there should be no preferred layers for debonding, and that both roughness and thermal residual stress effects favor debonding at the fiber surface.

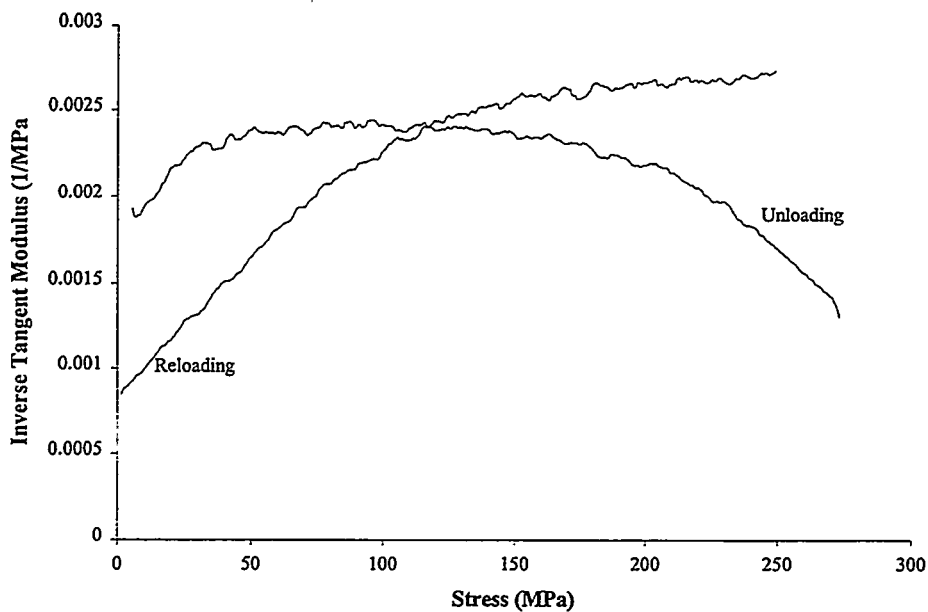
Figure 2.2.9 Inverse tangent modulus along the hysteresis loop

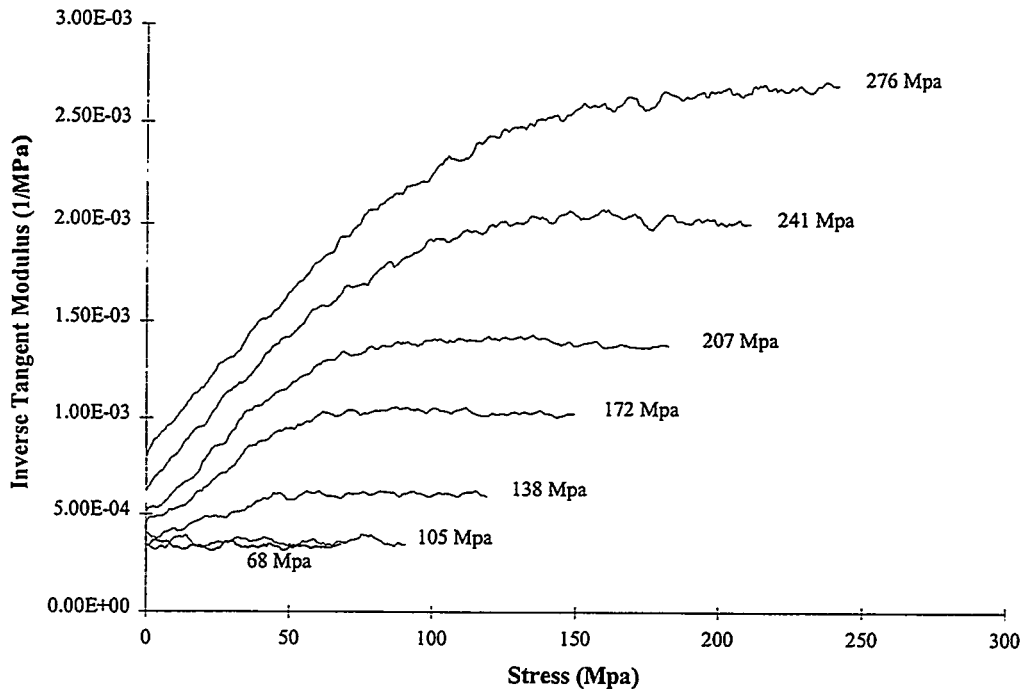
Figure 2.2.10 Reloading Inverse Tangent Modulus for specimen 2M-2 vs. peak stress

In order to evaluate the interface frictional stress, we examined the hysteresis loops in order to obtain  $L$ , and used microscopic examination of the failed specimens to determine  $d$ . As previously mentioned, we were unable to locate enough cracks in the 0° tows to determine a crack spacing. As a result, we were forced to examine the unloading modulus to calculate the crack spacing. This procedure is detailed below, and a set of ITM curves for a single sample is shown in Figure 2.2.10.

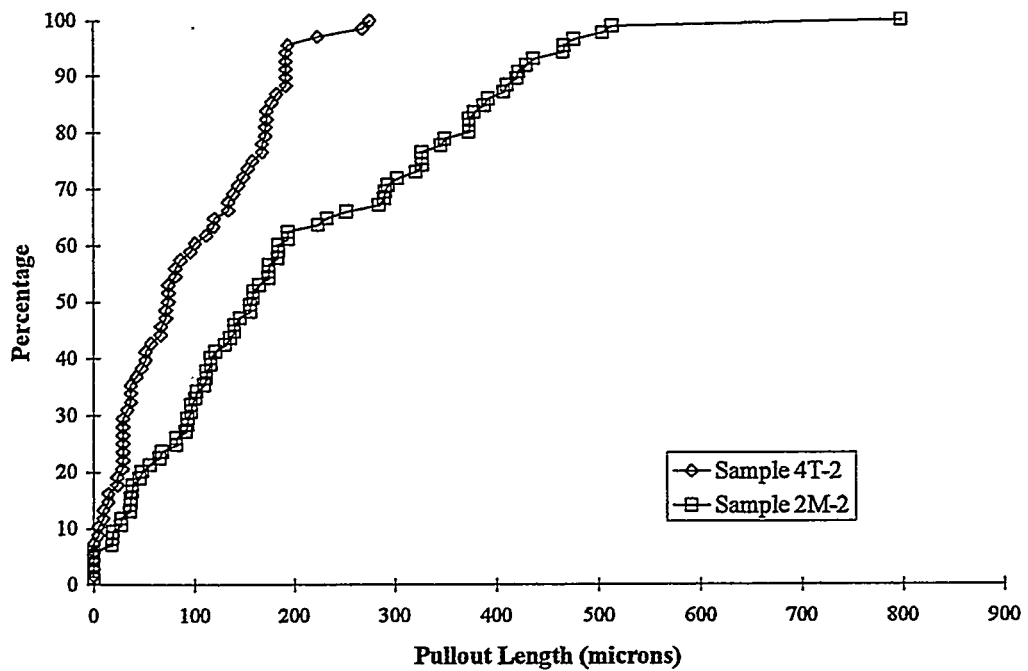
Figure 2.2.14 Cumulative pullout length distribution for the 4T-2 and 2M-2 materials; Only the 4T-2 data is from a gauge section failure.

To obtain useful information, the fracture surface must be from a gauge-section failure. Many of the straight-edged samples tested by us failed near the gripping or tab regions, and are not deemed reliable. A micrograph of the pullout from the 4T-1 specimen (gauge failure) is shown in Figure 2.2.13. The measured pullout length distribution for this material is shown in Figure 2.2.14 along with the (erroneous) distribution measured on sample 2M-2 which showed grip failure.

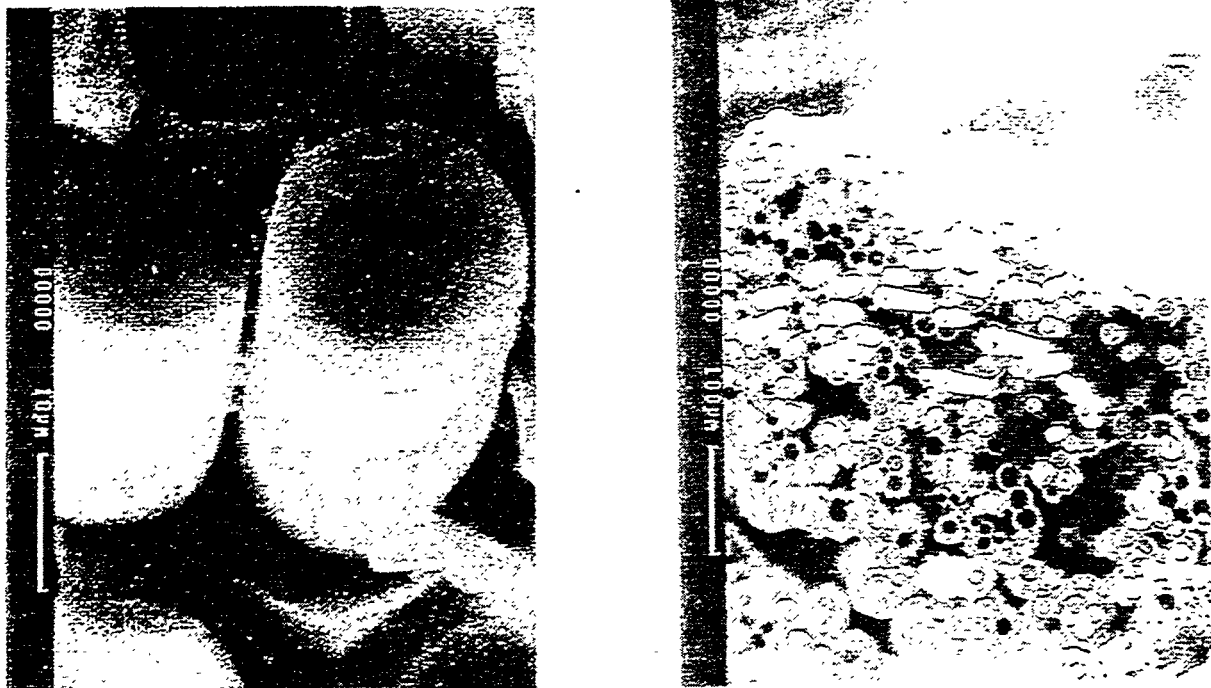
Figure 2.3.11 Fiber pullout from MOD coated tows.
