**Closure Report for CAU No. 430:
Buried Depleted Uranium Artillery
Round No. 1, Tonopah Test Range**

February 1997

Environmental Restoration
Division

U.S. Department of Energy
Nevada Operations Office

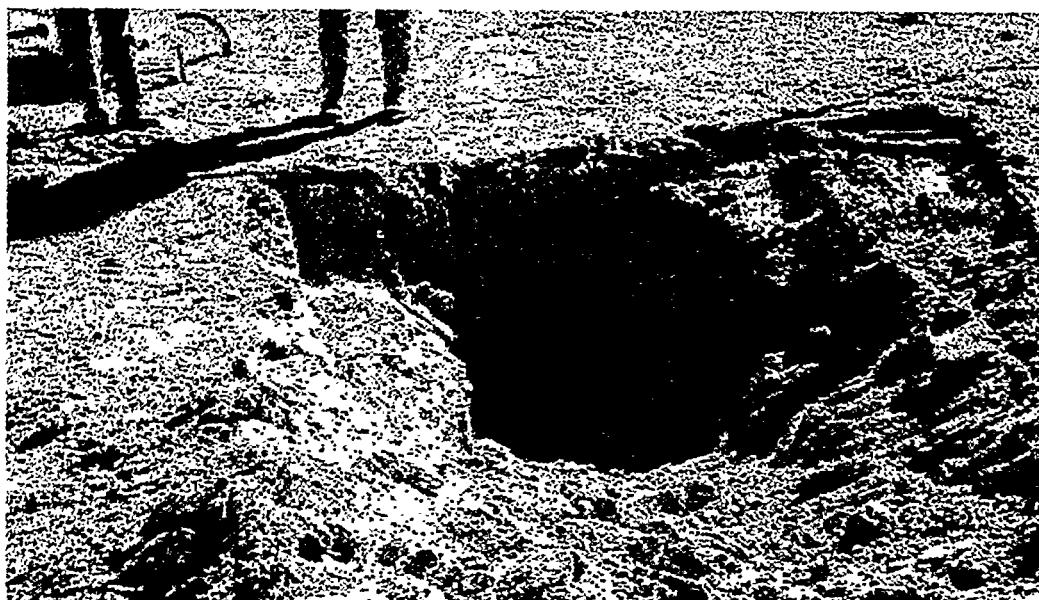
Figure 2-2
Buried DU Artillery Round No. 1, Site A-1,
Geophone sensor is on right side of excavation
(photo taken facing south)

Sites A, B, and C were excavated during field activities at the Buried DU Artillery Round No. 1 site. The metallic anomalous readings at Sites B and C are believed to have been caused by the magnetic characteristics of the soil and rocks in the area. Site A was the only site which contained subsurface metallic items. The metallic anomaly at Site A-1 was caused by a metallic geophone sensor. Site A-2 contained an inert artillery projectile.

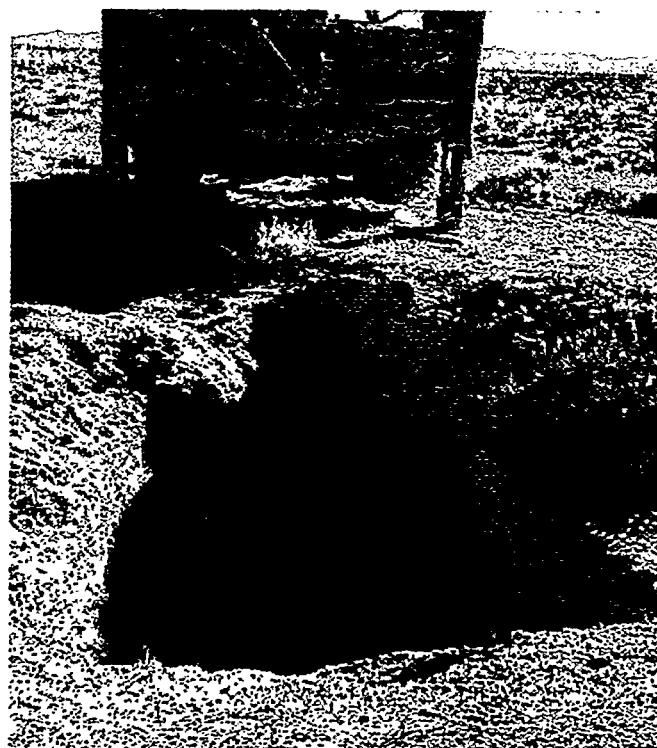
Figure 2-6
Buried DU Artillery Round No. 1, Site C
(photo taken facing west/southwest)

Site C is the northernmost area of concern and is located approximately 960 ft northwest of Site A-2. It consisted of a depression approximately 10 ft in diameter and 3 ft deep. The initial ordnance survey found weak anomalous readings in the depression. The surface radiological screening did not indicate elevated radiological readings; the pit was excavated to a total depth of 7 ft (Figure 2-6). Each 1-ft lift of soil excavated was screened for metallic anomalies and radiological readings. The soil within the excavation appeared to be native soil. Radiological screening readings were all at or below background levels, and no strong metallic readings were obtained (IT, 1996a). Magnetic readings at this site are also believed to be from magnetic geologic materials. Based on these facts, excavation activities were stopped at 7 ft, and the hole was backfilled using the spoils.
