MATERIALS TECHNOLOGY FOR COAL-CONVERSION PROCESSES

**Fourteenth Quarterly Report,
April—June 1978**

ARGONNE NATIONAL LABORATORY, ARGONNE, ILLINOIS

W. A. Ellingson
Project Leader

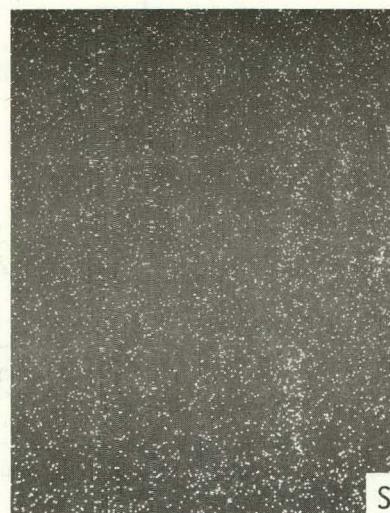
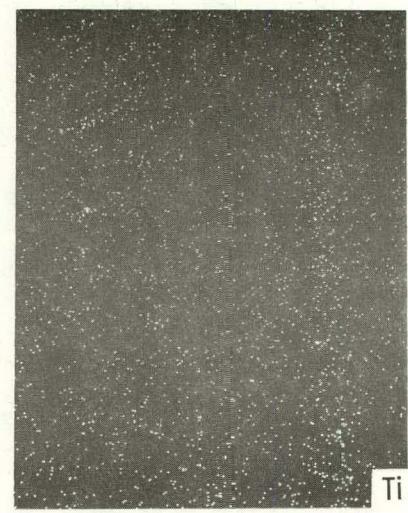
BO 3A 750 750 C 3.6 Ms

Fig. 18. X-ray Photograph and Cr, Fe, Ni, Si, Ti, and S Distribution in Incoloy 800 Specimen After a 3.6-Ms Exposure to a Complex Gas Mixture at 750°C (Run BO3A750). In the distribution pictures, light regions indicate high concentrations of the respective elements.
ANL Neg. No. 306-78-704

After the mechanical tests were completed, the cross sections and fracture surfaces of uniaxial tensile specimens were examined by SEM with an energy-dispersive x-ray analyzer. Figures 18-21 show SEM photographs of the cross sections of Incoloy 800, Type 310 stainless steel, Inconel 671, and U.S. Steel Alloy 18-18-2, respectively, after a 3.6-Ms exposure to a complex gas mixture (run B03A750). Also shown in these figures are the metallic-element (chromium, iron, nickel, and silicon) and sulfur distributions in the scale/alloy interface regions of the samples. The photographs show that the scales developed on Incoloy 800 and Type 310 stainless steel in run B03A750 are predominantly Cr-rich oxide; very little sulfur was detected. The thickness of the oxide scale in these specimens was $\sim 5 \mu\text{m}$ and the depth of internally affected zones was $\sim 25 \mu\text{m}$. Inconel 671 also developed

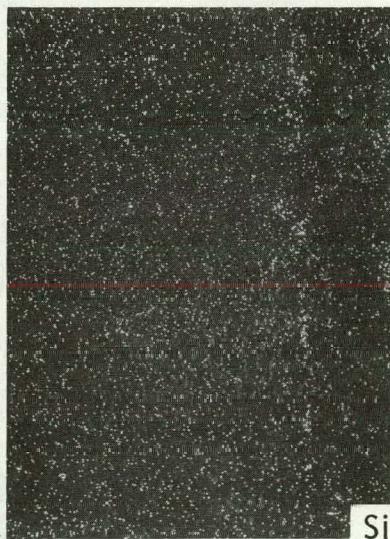
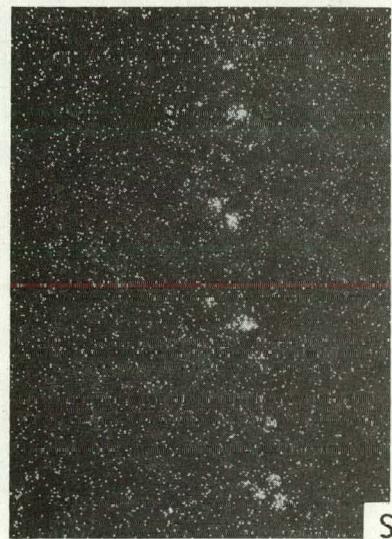
BO 3A 750 750 C 3.6 Ms

Fig. 19. X-ray Photograph and Cr, Fe, Ni, Si, and S Distribution in Type 310 Stainless Steel Specimen After a 3.6-Ms Exposure to a Complex Gas Mixture at 750°C (Run BO3A750). In the distribution pictures, light regions indicate high concentrations of the respective elements. ANL Neg. No. 306-78-703

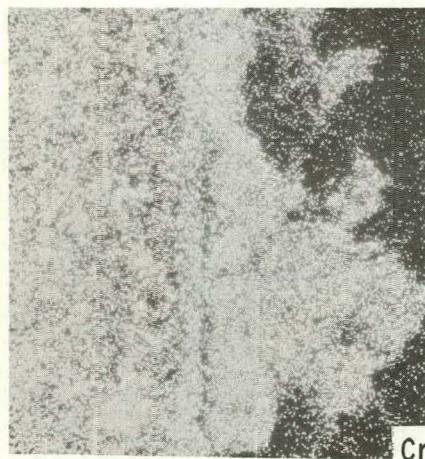
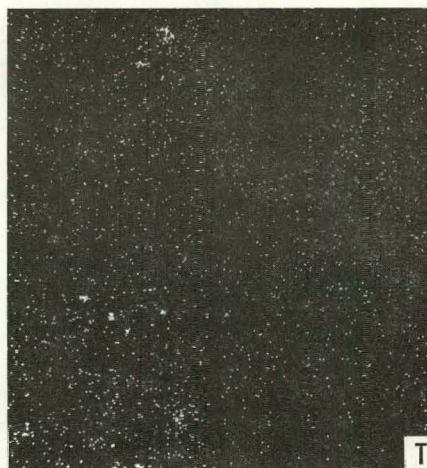
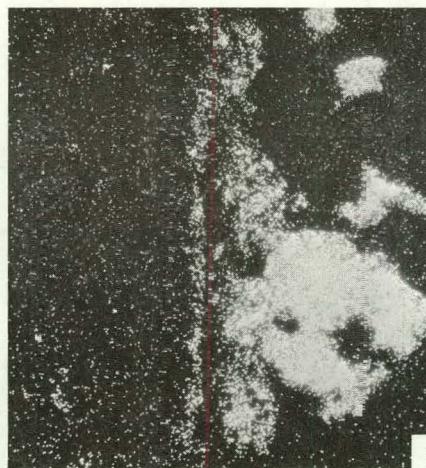
BO 3A 750 750 C 3.6 Ms

10 μm
Inconel 671
