ANL/LRP-TM-14

# STAUNTON 1 RECLAMATION DEMONSTRATION PROJECT

PROGRESS REPORT  
FOR 1977

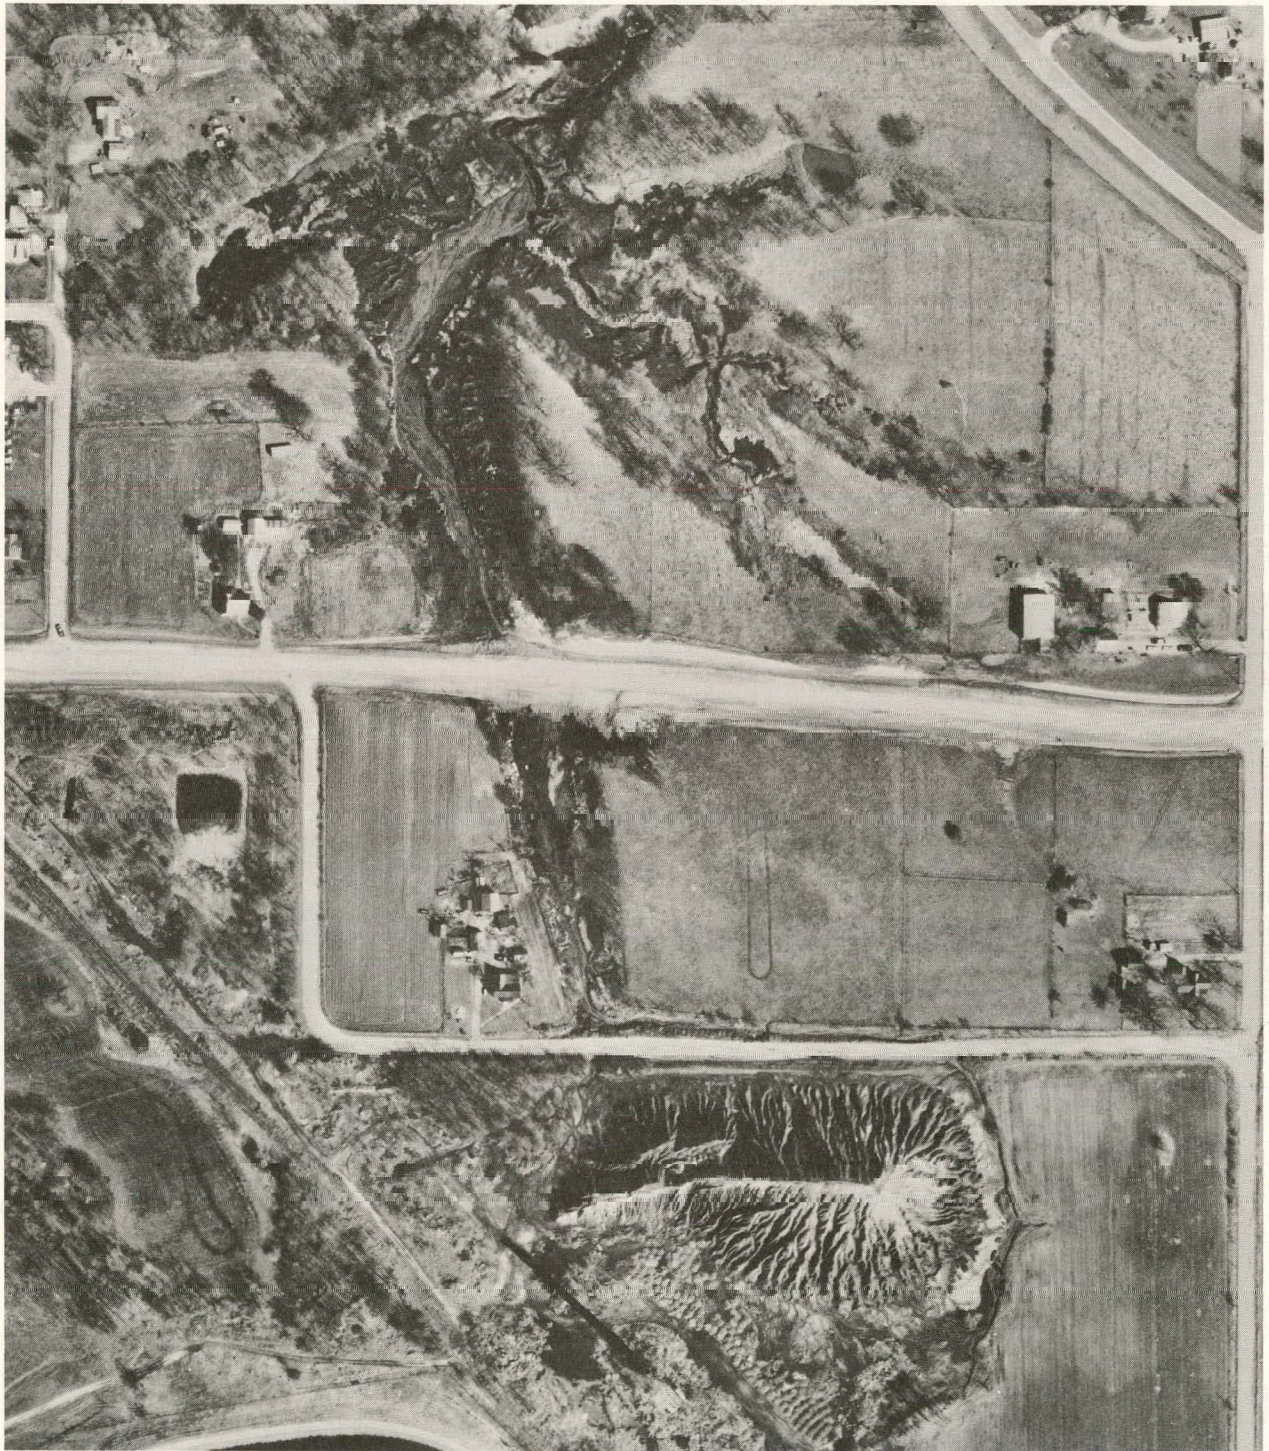
Fig. 2. The Staunton 1 site before reclamation. The gob pile is at the lower right, and drainage from the pile flows northward to the dark slurry area at the upper center.

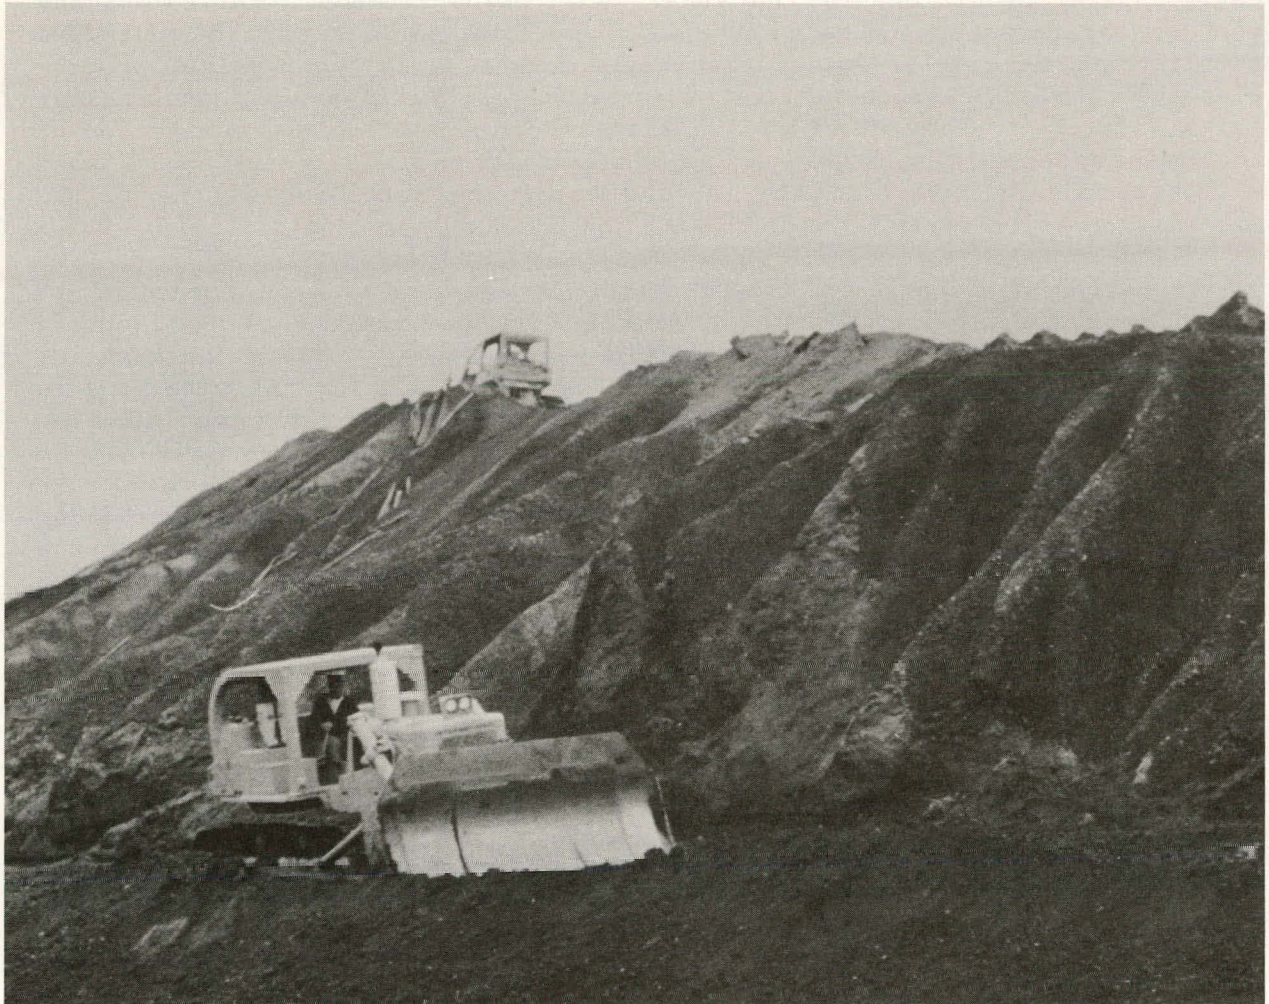
Fig. 3. Rough Grading the Gob Pile Early in the Site Development Phase

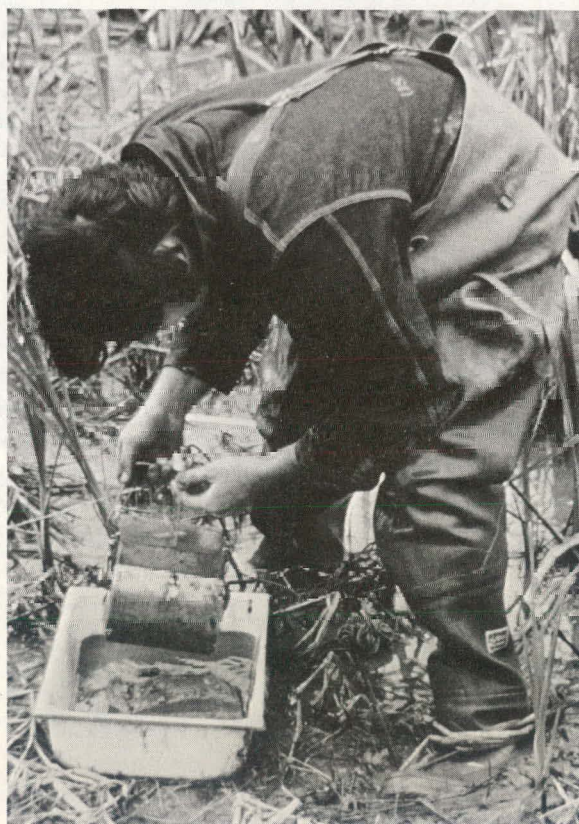
Fig. 7. Collecting Macroinvertebrate Samples in the New Pond

These objectives are being met by the seasonal sampling of macroinvertebrates in both ponds and at selected sites in Cahokia Creek (Figure 7). Samples are returned to the laboratory for sorting and identification. These data, used in

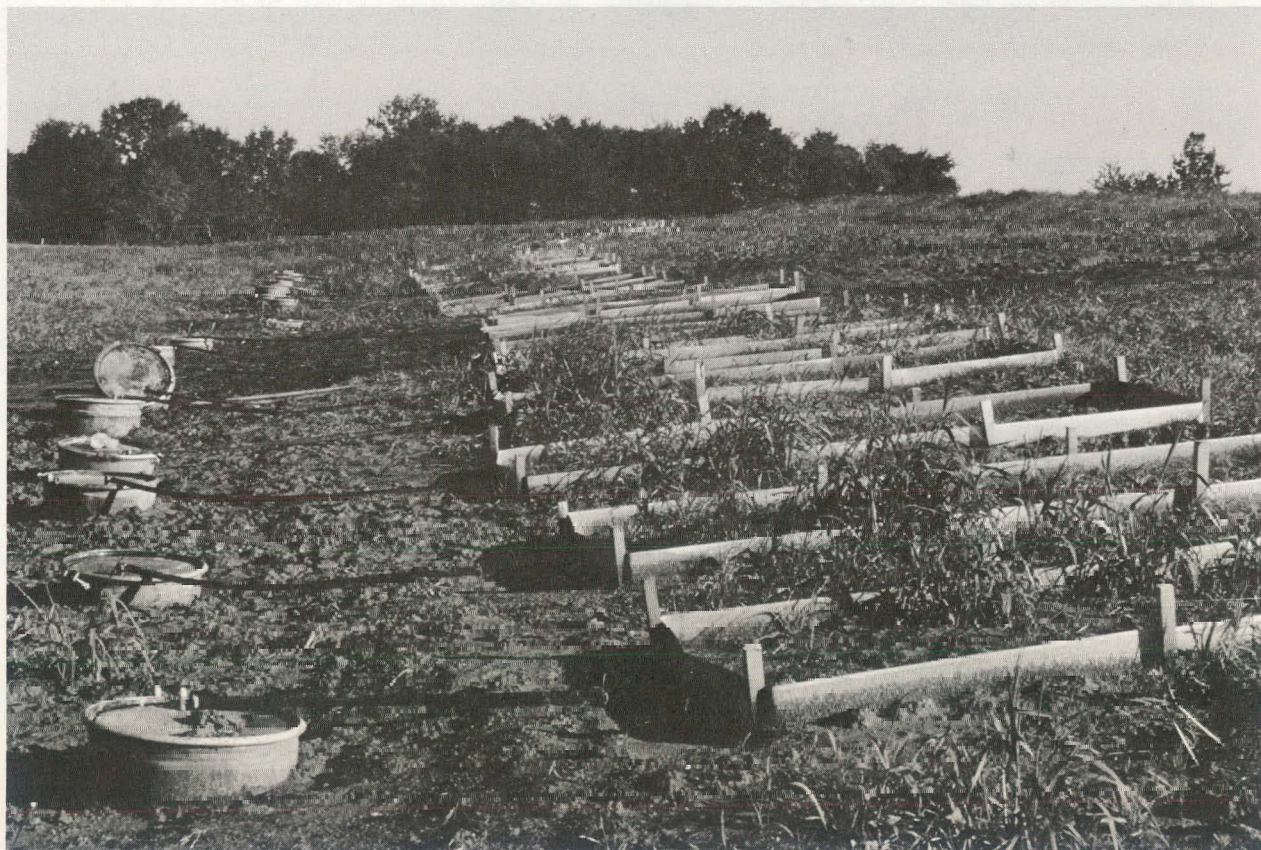
Fig. 12. Runoff/Sedimentation Research Plots at the Staunton 1 Site

TYPICAL PLAN VIEW FOR ONE SLOPE ANGLE

CROSS-SECTION OF SLOPES AND  
DETAILS OF COLLECTION DEVICE

During the site development phase, three research areas were located where nominal slopes of 3:1, 5:1, and 7:1 were cut into regraded refuse material. On each of these slopes, plots were established on bare refuse and on cover material that had been applied in thicknesses of 0.15 m and 0.30 m (0.5 ft and 1.0 ft) over the regraded refuse. Three replicated runoff collection devices were installed on each of these research plots (3 slopes times 3 cover thicknesses; see Figures 12 and 13). The sheet metal sides of each device enclose  $4.05 \text{ m}^2$  ( $43.56 \text{ ft}^2$ ). The runoff collects at a weir at the bottom of each device and runs through a plastic hose into
