SAND79-2291 • TTC-308 • Unlimited Release • UC-71

## A Study and Full-Scale Test of a High- Velocity Grade-Crossing Simulated Accident of a Locomotive and a Nuclear-Spent-Fuel Shipping Cask

Michael Huerta, H. Richard Yoshimura

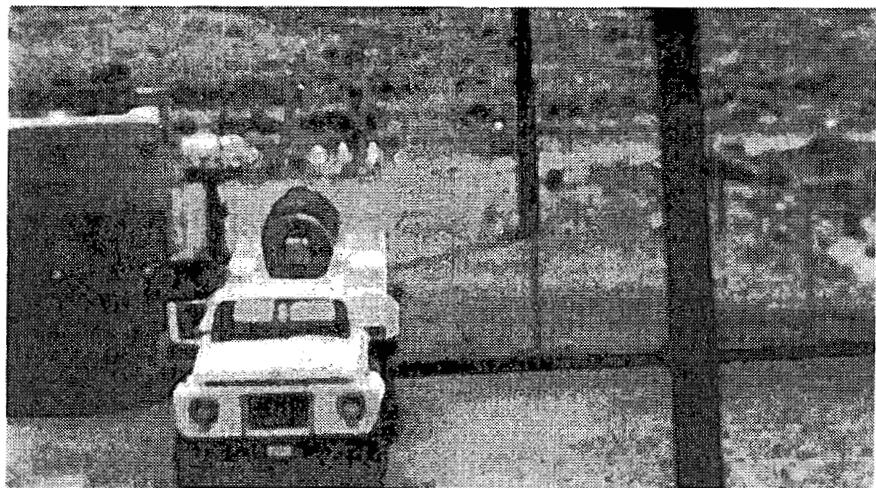
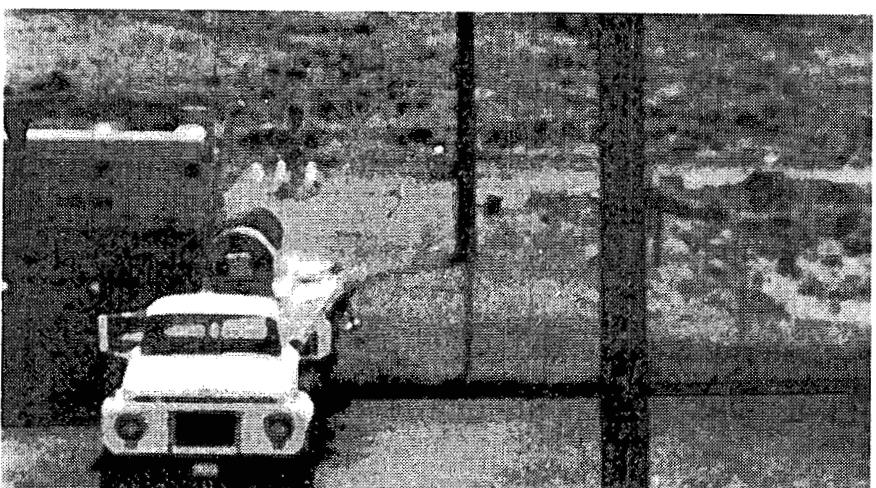
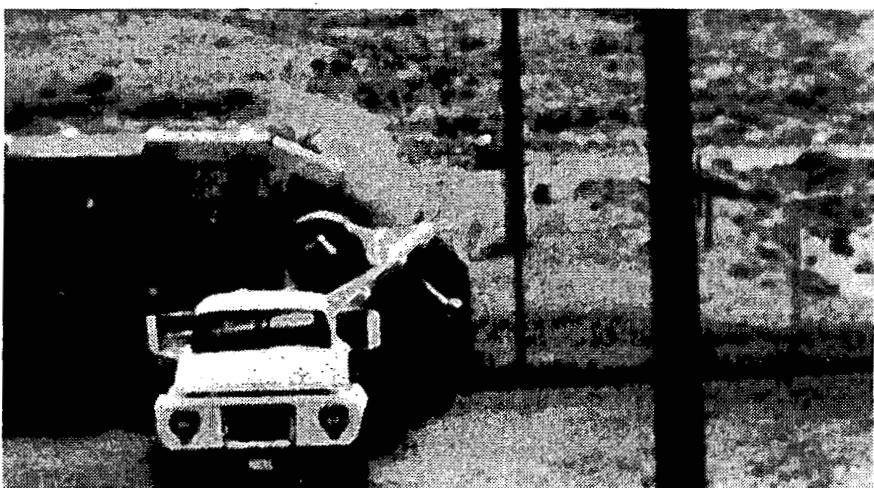
The impact can best be described by using series of photographs from the high-speed films. Views from both sides and from above are used. Figures 18 and 19 illustrate the view from the right from the instant of impact through 850 ms (at regular intervals through 180 ms and then skipping to a shot at 850 ms). The trailer-tractor connection was broken very early but the tractor remained almost undisturbed. At 180 ms the trailer almost completely wrapped itself around the locomotive, and the cask was hidden in the debris (Figure 19). Figures 20 and 21 show the view from the left. In this series, the cask remains visible longer and its motion into the superstructure can be better observed. The way in which the trailer wrapped itself around the locomotive can be clearly observed. Figure 22 shows two photographs taken from the overhead camera. This camera view revealed how the trailer structure was pushed out from under the cask while playing a relatively minor role in the impact of the cask with the underframe. Figure 23 shows two photographs also taken from above but slightly later: these indicate that at 250 ms the cask was well into the superstructure and had begun to rotate clockwise.

Figure 18. Right-Side View of the Full-Scale Test to 100 ms

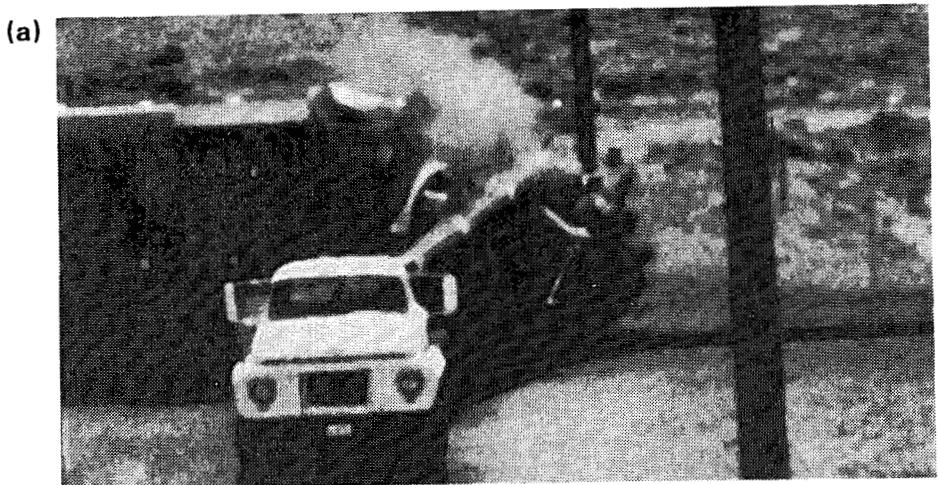
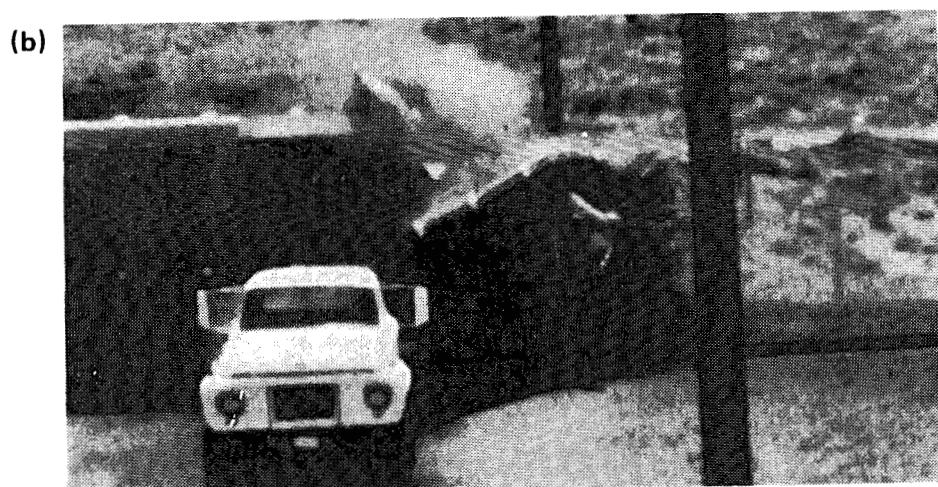
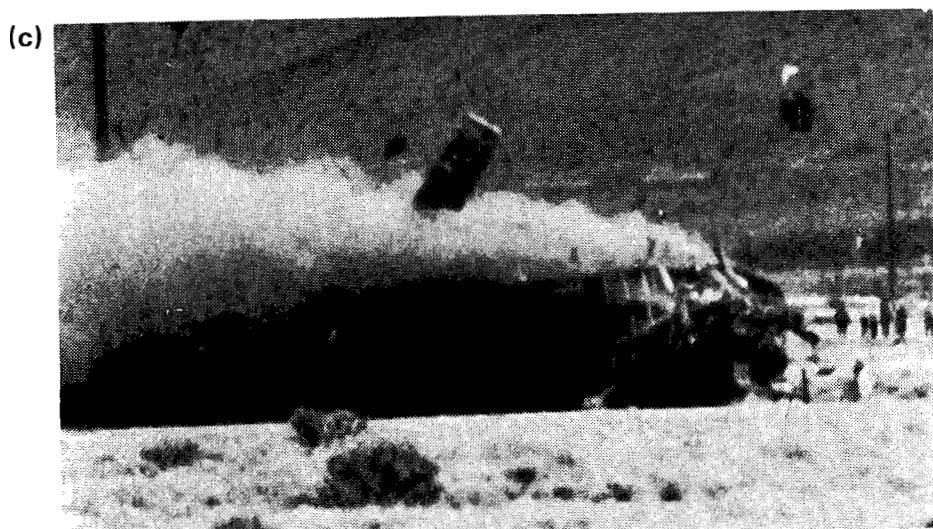
**Figure 19.** Right-Side View of the Full-Scale Test to 850 ms
