Lightning-Accommodation Systems for Wind-Turbine- Generator Safety

H. Bankaitis
National Aeronautics and Space Administration
Lewis Research Center

Prepared for
Fifth International System Safety Conference
Denver, Colorado, July 26-31, 1981

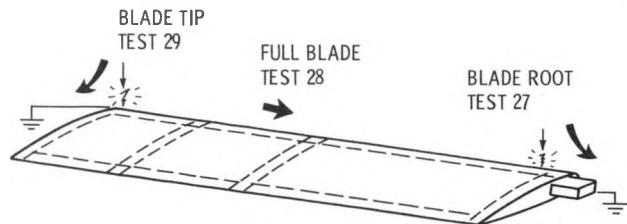
(a) Test arrangement for high-voltage, long-arc tests.

(b) Test arrangement for high-current tests of blade.

Figure 11. - Test sample and setup at Lightning and Transients Research Institute.

honeycomb-glass-skin tail panels are attached, as shown in figure 10. The lightning accommodation system intended for these types of blades consists of an aluminum metal tip cap electrically bonded to a plastic covered (encapsulated) 1.25-in.-wide and 0.25-in.-thick flat braided conductor cable located on the trailing edge of the rotor blade and electrically bonded to the metal root spool piece interfacing the machine. The area at the root end is completely covered with Thorstrand (Hexcel Corp.'s trade name for aluminum deposit-covered glass cloth). The extent of coverage exceeds the length of the metal adapter enclosed inside the blade (fig. 10). This is done to preclude any possibility of internal streamering between the root piece and the tip cap or the possible attachment of a lightning stroke at the root of the blade. The concept was tested by Lightning and Transients Research Institute at their Miami Beach, Florida, facility under the direction of J. D. Robb and J. Herring. The series of tests using an 18-foot sample (fig. 11) consisted of the procedures similar to those described in reference 4. The data indicate that regardless of the high-voltage stroke attachment location on the sample, the charge stayed on the surface without stitching (penetrating the structure) until it reached the aluminum down conductor, tip plate, or root and fitting.

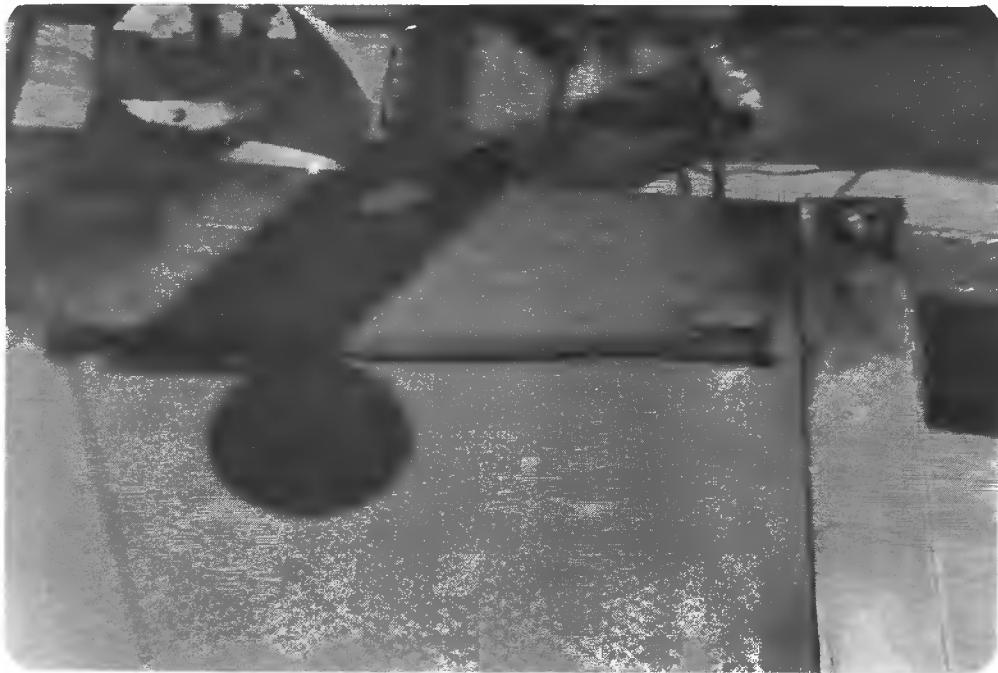
Figure 12. - Mechanical pinching effect on flat braided cable.

The data obtained during the high-current damage evaluation tests indicate severe pinching of the flat braided down conductor cable at 150 kA and destructive pinching at 210 to 230 kA (fig. 12). Pinching is the result of a magnetic field developed by the high peak current phase of the lightning flash flowing through sharp bends or corners of the test sample. The magnetic forces are proportional to the square of the magnetic field intensity and thus to the square of the lightning current. The resulting damage depends on the magnetic force generated and the response time of the system. Taking all the above into consideration, it is obvious that the interfaces between the tip cap and down conductor and the Thorstrand cover and the down conductor, as well as that between the Thorstrand cover and the metal spool piece, must be gradual-radius turns without sharp edges or abrupt changes of direction.
