## FRACTURE OF Fe-Cr-Mn AUSTENITIC STEEL

G. R. Caskey, Jr.

Savannah River Laboratory  
E. I. du Pont de Nemours and Company  
Aiken, South Carolina 29801

This paper is to be presented at the  
108th Annual AIME Meeting,  
New Orleans, Louisiana, February 18-22, 1979

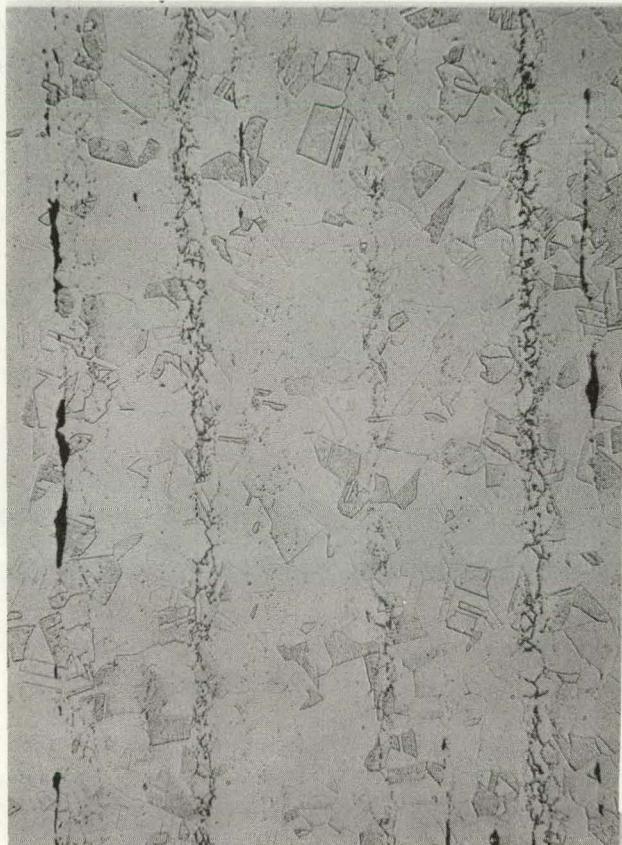
FIGURE 1. Grain Structure and Inclusion Stringers  
in Tenelon® Plate

The specimens had a uniform grain structure in the as-received condition, with an average grain size of 20 to 40  $\mu\text{m}$  (Figure 1). Annealing twins were a common feature in this alloy. Pronounced inclusion stringers were also present. These stringers consisted of fairly massive particles, predominantly manganese and sulfur, and smaller globular particles of undetermined composition. The larger inclusions formed characteristic depressions or mounds on the fracture surface (Figure 2).

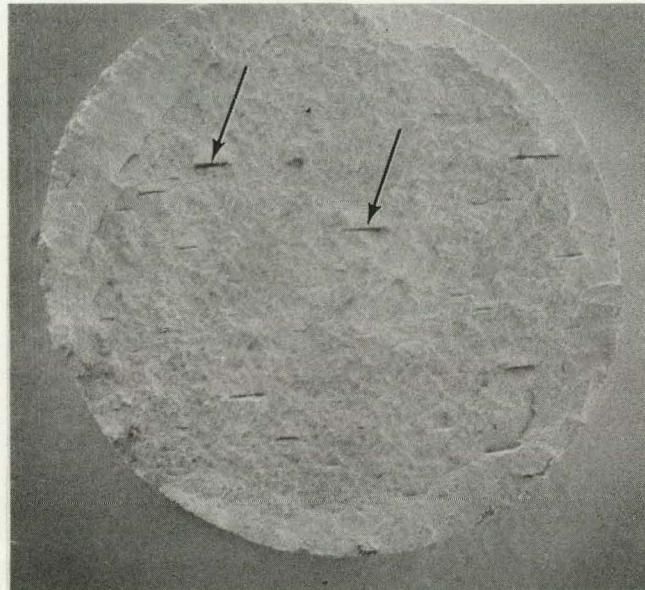
Arrows indicate  
large inclusion  
stringers

FIGURE 2. Fracture of Tenelon® Tensile Specimen at 273 K

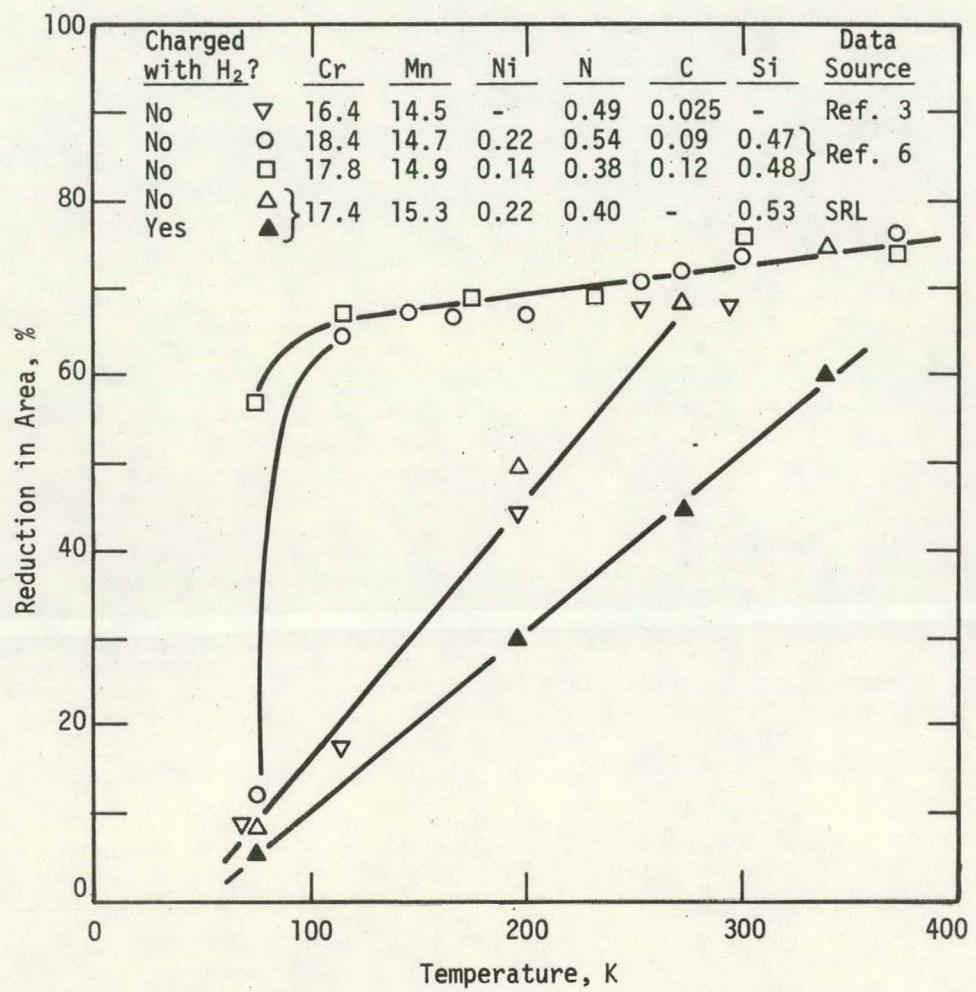
FIGURE 3. Temperature Dependence of Tensile Ductility of Fe-Cr-Mn Alloys

The temperature dependence of reduction-in-area, Figure 3, is comparable to that reported by Schaller and Zackay for an alloy of 16.4% Cr, 14.5% Mn, 0.025% C, and 0.49% N.<sup>3</sup> Steels of slightly differing composition retain relatively high ductility except at the lowest test temperature,<sup>3,6</sup> indicating that the ductile-to-brittle transition is extremely sensitive to composition.

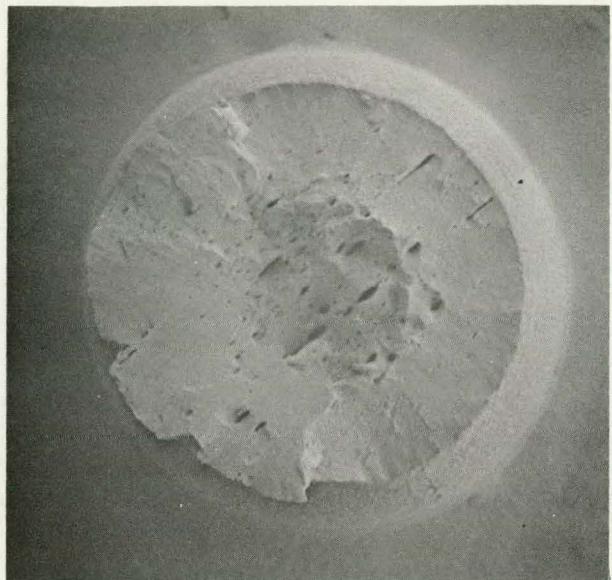
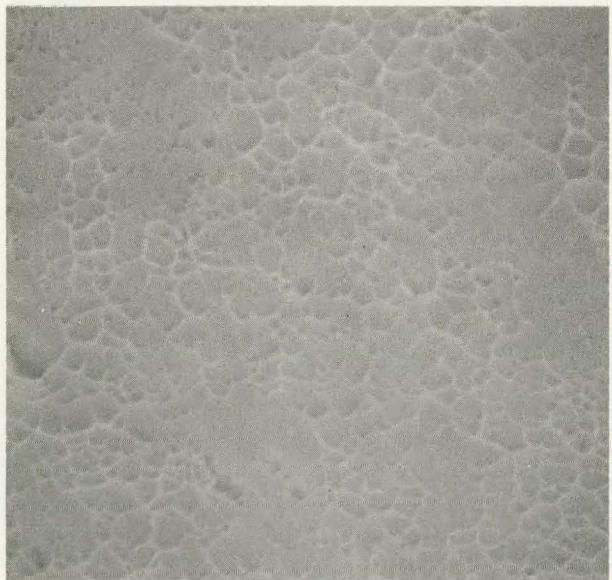
FIGURE 4. Ductile Rupture of Tenelon® at 350 K

Three fracture modes were observed, depending upon specimen treatment, hydrogen content, and test temperature: dimpled rupture, intergranular failure, and transgranular cleavage. Dimpled rupture was the only fracture mode observed in hydrogen-free specimens tested at 200 to 350 K (Figure 4). Intergranular failure was observed in hydrogen-free tensile specimens annealed at 1170 K and tested at 78 K (Figure 5). However, a mixed intergranular-transgranular cleavage fracture mode was observed in single-edge-notched specimens annealed at 1170 K and tested at 78 and 198 K (Figure 6). The stress state apparently had an influence on the fracture path. Tensile and single-edge-notched specimens of as-received Tenelon® tested at 78 K failed by mixed transgranular cleavage and dimpled rupture, regardless of their hydrogen content, as did hydrogen-charged specimens tested at 200 to 273 K.

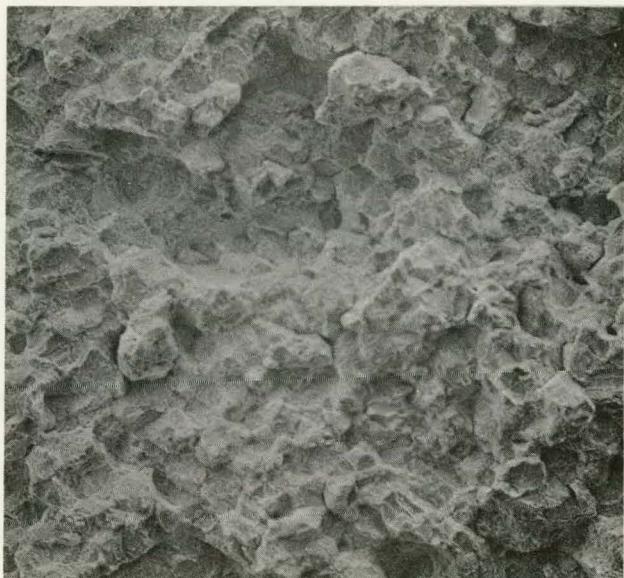
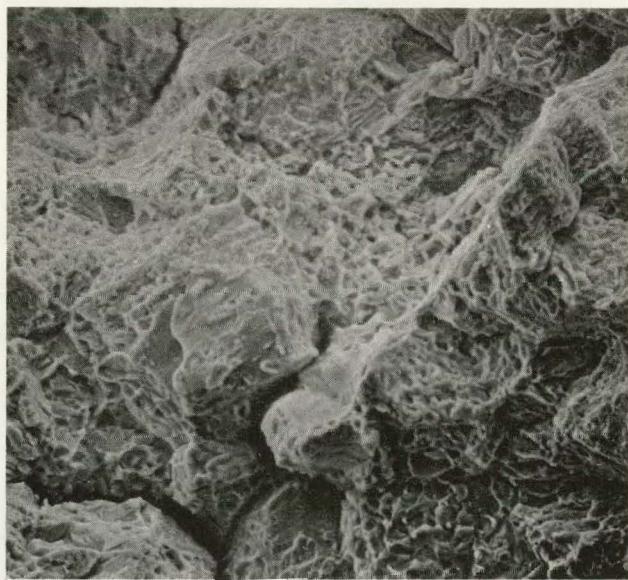
FIGURE 5. Intergranular Failure of Tenelon<sup>®</sup>  
at 78 K Following 1170 K Anneal

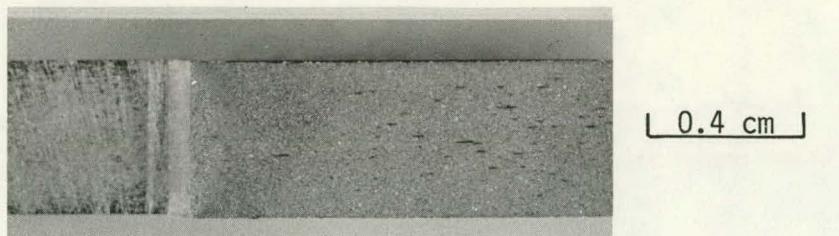
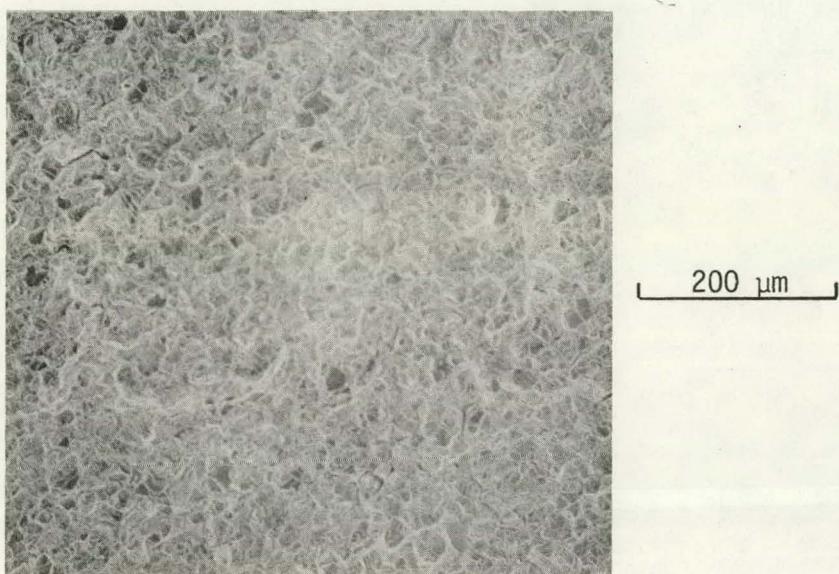
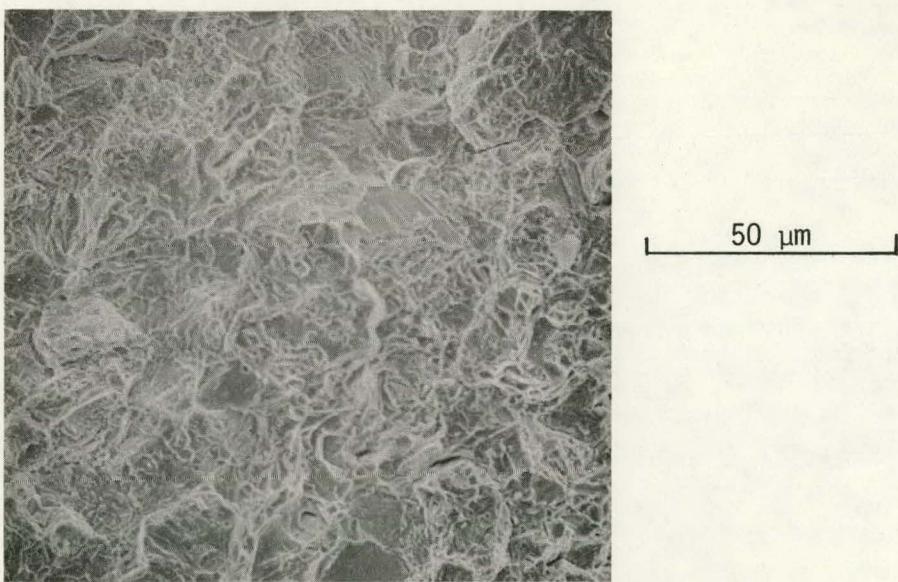
FIGURE 6. Mixed Fracture of Single-Edge-Notched Specimen Tested at 78 K

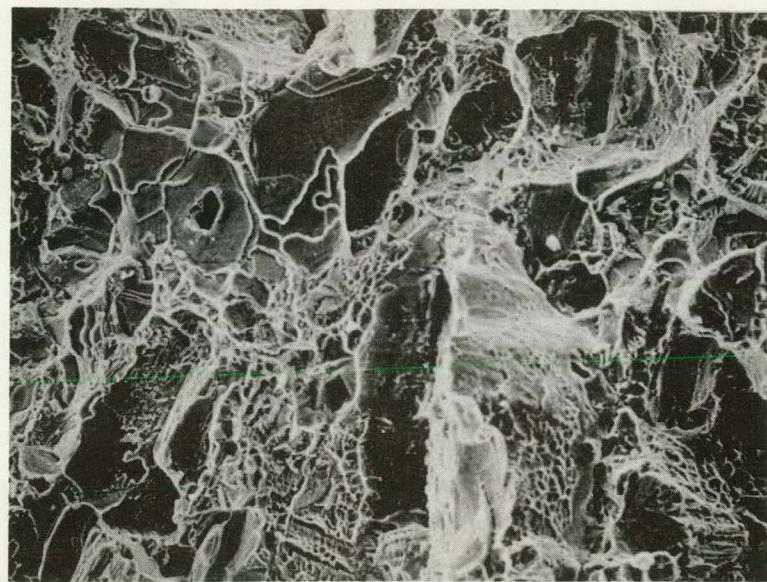
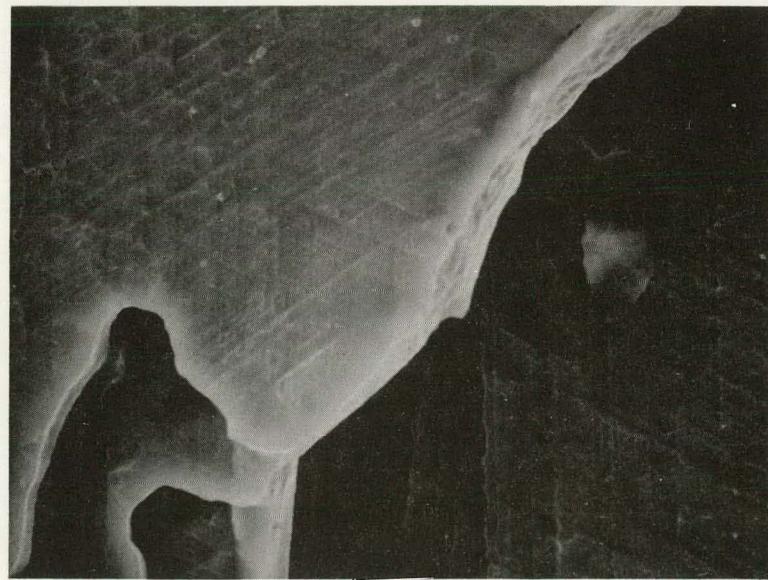
FIGURE 7A. Facets on Fracture Surfaces of Hydrogen-Saturated Specimen Tested at 78 K

Transgranular cleavage at 78 K was not significantly affected by hydrogen. The size, shape, and surface markings on the facets were identical whether or not the specimens were saturated with hydrogen before testing (Figure 7). Facets on Type 304L stainless steel have a similar appearance, although precise details differ slightly, which suggests a common mechanism of formation independent of chemical composition.<sup>10</sup>

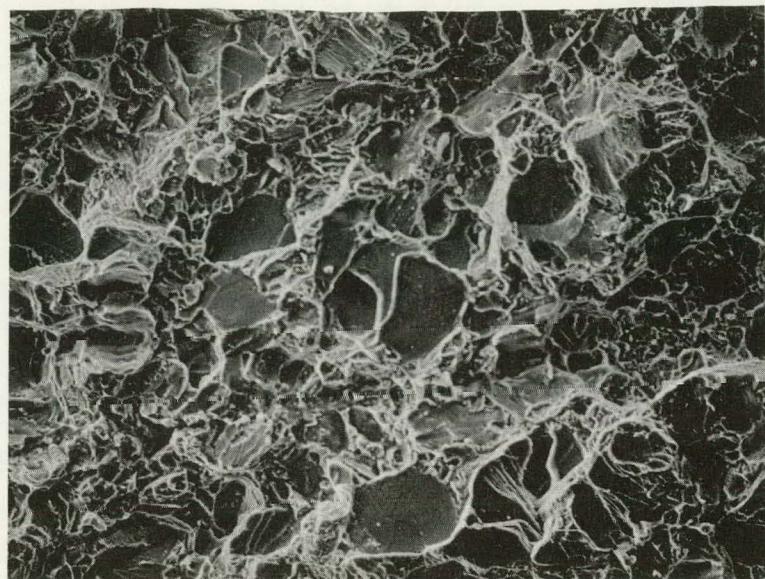
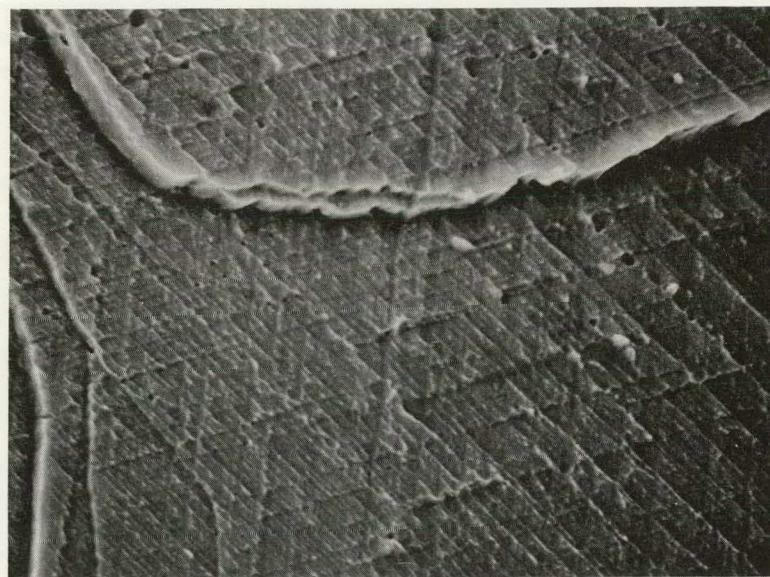
FIGURE 7B. Facets on Fracture Surfaces of Specimen  
Not Charged with Hydrogen Before Testing at 78 K

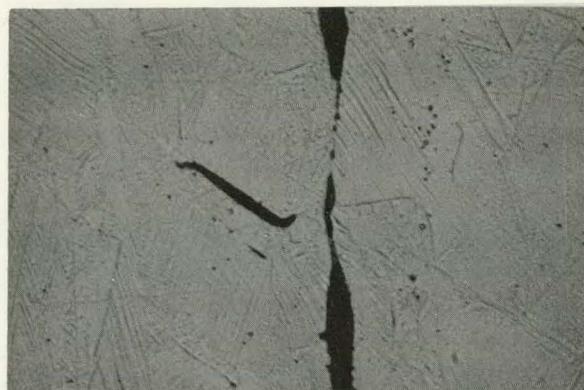
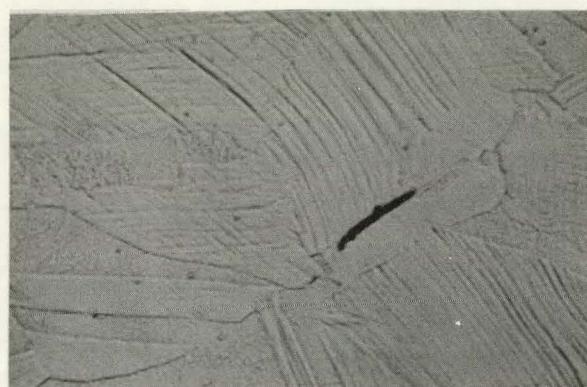
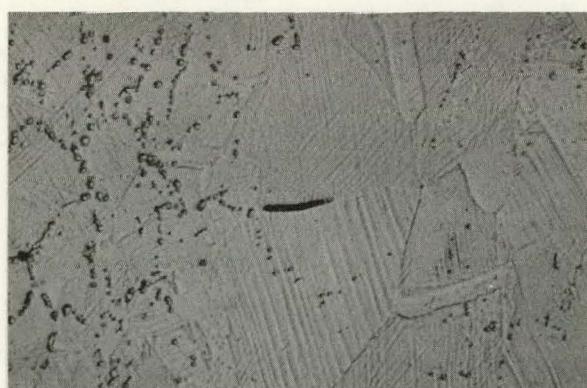
Twin Boundary

Grain Boundary

FIGURE 8. Microcracks Along Coherent Twin Boundaries and Grain Boundaries

Microcracks commonly formed along coherent twin boundaries and occasionally along grain boundaries (Figure 8). The faces of these microcracks were probably the facets observed on the fracture surface. Deformation bands intersecting the microcracks caused the markings on the facet. Both facets and microcracks extended across one grain only and never across grain boundaries. Consequently, the fracture surfaces had facets surrounded by areas of microvoid coalescence.

Deformation faulting is common in austenitic stainless steels and can be a precursor of deformation twinning or strain-induced transformation to the hexagonal close-packed configuration.<sup>11</sup> Low values of the stacking fault energy (a measure of the ease with which faults are formed) lead to widespread faulting. In Tenelon®, the stacking fault energy is low, about 20 mJ/m<sup>2</sup>, and faulting is extensive, developing readily observable bands in the microstructure (Figure 8). As the deformation temperature is lowered, the stacking fault energy decreases and faulting becomes
