Ultrasonic Evaluation of Flood Gate Tendons

This paper was prepared for submittal to the
International Symposium on Nondestructive Evaluation Techniques
for Aging Infrastructure & Manufacturing
San Antonio, Texas
March 30-April 2, 1998

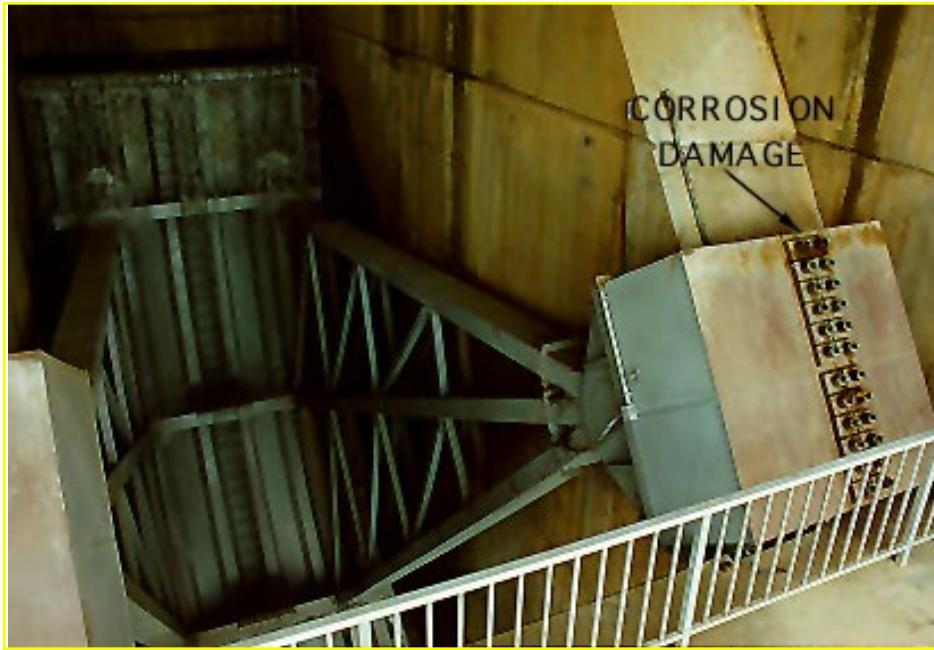
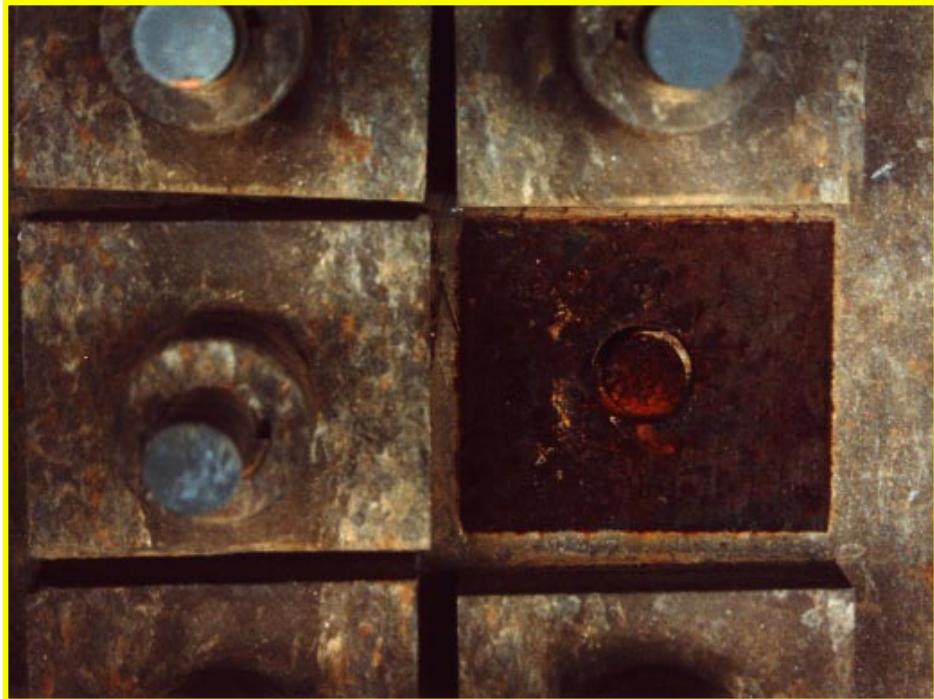
A) flood gate and tendons

B) damaged tendon.

Figure 1. Photographs of a flood gate showing the location of the tendons that attach the gate to the concrete structure.

The steel tendons that are embedded in the concrete and hold the flood gates to the dam are susceptible to corrosion. When they fail the nut on the end comes off and the tendon no longer supports the pivot plate, see Figure 1. Fortunately there are many redundant tendons for each support plate. An ultrasonic technique was developed and implemented to assess the condition of the tendon along its 40 foot length. The only access to the tendon is from the end above the nut, see Figure 2. The ultrasonic pulse-echo method insinuates the tendon from the end and senses signals returning from corrosion along the length of the tendon.
