Metals and Ceramics Division

IRIDIUM-ALLOY PROCESSING EXPERIENCE IN FY 1989

E. K. Ohriner

Date Published: November 1990

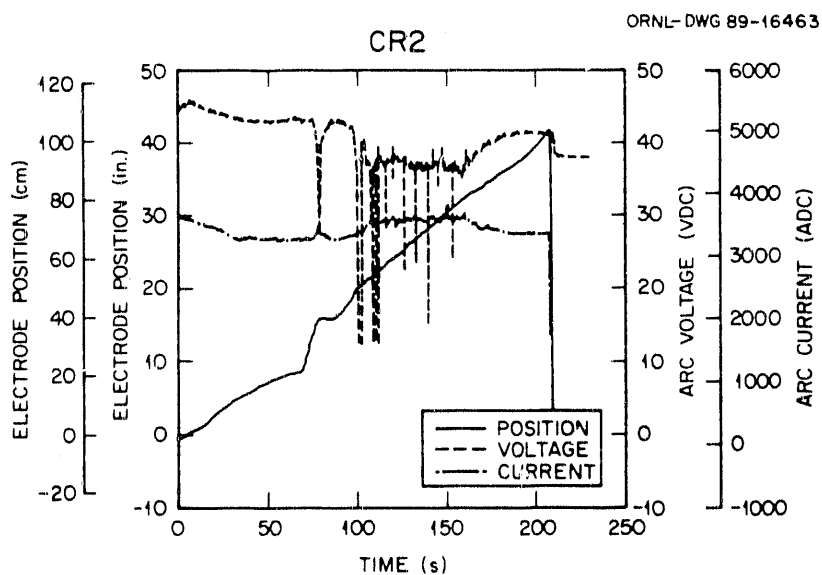
Fig. 1. Plot of arc-melting parameters obtained for the CR2 ingot showing lack of control of the arc gap.

The arc current, voltage, and position of the electrode in the mold are shown graphically in Fig. 1. The initial arc current of 3600 A was decreased to 3200 A over the first 30 s. At 70 s into the melt, the electrode was manually lowered 180 mm when it became evident that the arc length was excessive. The electrode was then returned to automatic advance under voltage control with a constant arc current of 3600 A. At approximately 160 s into the melt, the electrode feed rate was decreased when the arc length appeared unusually small. The total melt time was 210 s, and the weight of the melted alloy was 11.4 kg.

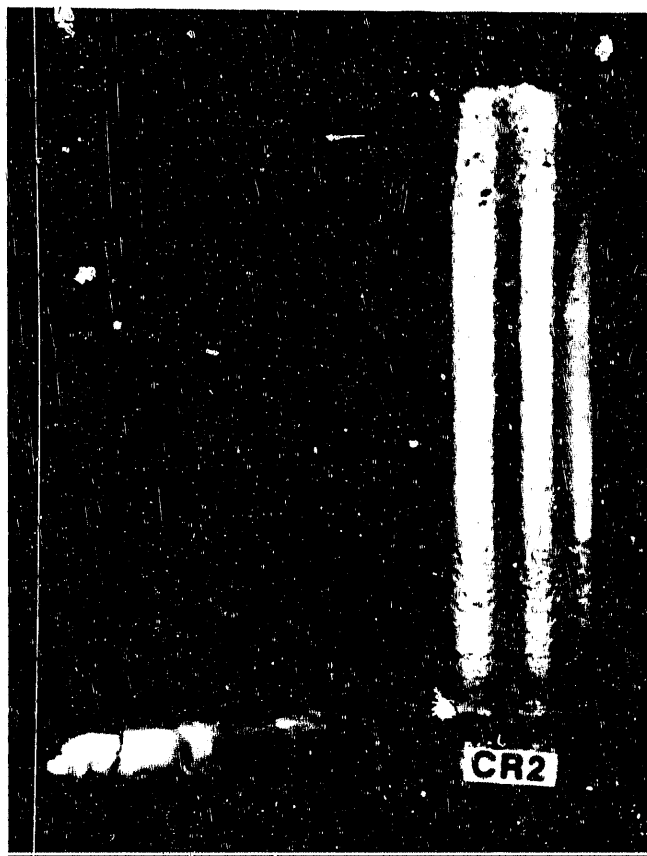
Fig. 2. The CR2 ingot showing evidence of unremelted splatter at the bottom associated with an overly long arc as well as a relatively large skull height.

The appearance of the melted ingot can be seen in Fig. 2. In comparison to ingots melted recently in the 50-mm-diam mold, the surface appearance is excellent. The rougher surface appearance seen at the bottom of the ingot is due to excessive arc length, but the

surface roughness is not expected to have any affect on subsequent processing. The thin skull extending about 50 mm above the solid surface of the ingot can also be associated with a long arc. There is only one region of adherent copper on the ingot. This is believed to be the result of an arc strike to the mold wall. The location of the expected minimum electrode-to-mold clearance, based on alignment measurements prior to melting, is in a similar rotational position but about 25 to 55 mm below the location of the strike. The copper mold exhibited an iridium-alloy coating over its entire surface except in the one region corresponding to the strike. The ingot diameter varied from 62.2 mm at the bottom to 63.0 mm at the top because of the mold taper. The ingot was cut to a 158-mm length and ground to a 61.5-mm diam.

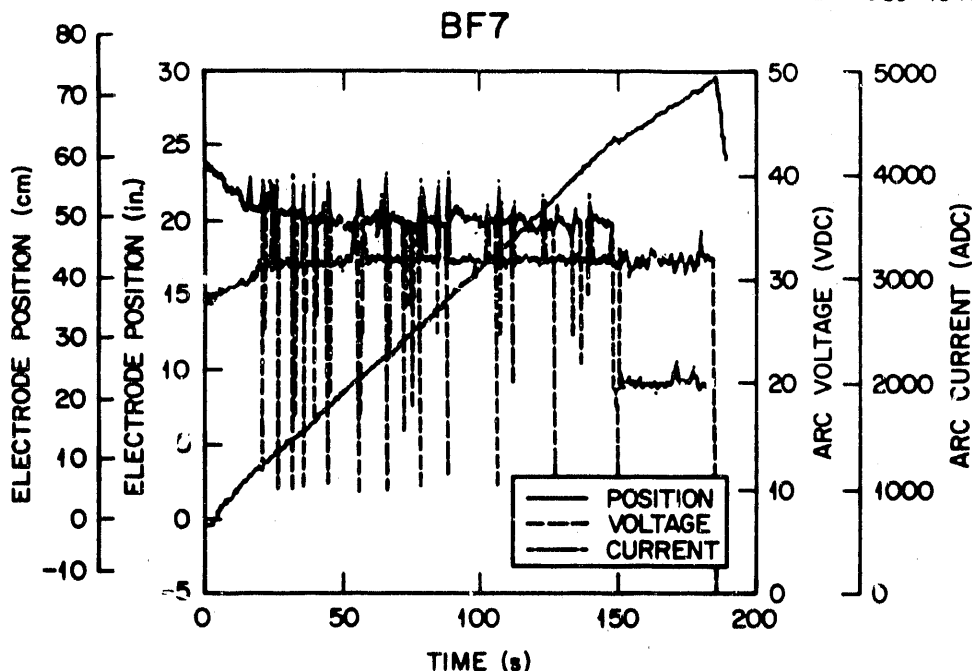
Fig. 3. Plot of arc-melting parameters obtained for the BF7 ingot showing uniform electrode feed and numerous short circuits indicative of a short arc length.

The electrode was melted at an average arc current of about 3200 A and an average arc voltage of about 36 V. The arc current, arc voltage, and position of the electrode with elapsed time are shown graphically in Fig. 3. The numerous voltage drops are an indication of short circuits caused by molten metal droplets closing a short arc gap. At approximately 90 s into the melt, the weldamatic controller was adjusted to give a slightly larger arc gap. The effect of this is seen in the reduced frequency of arc shorts, but there is no evidence of either an increase in baseline arc voltage or in the rate of the advance of the

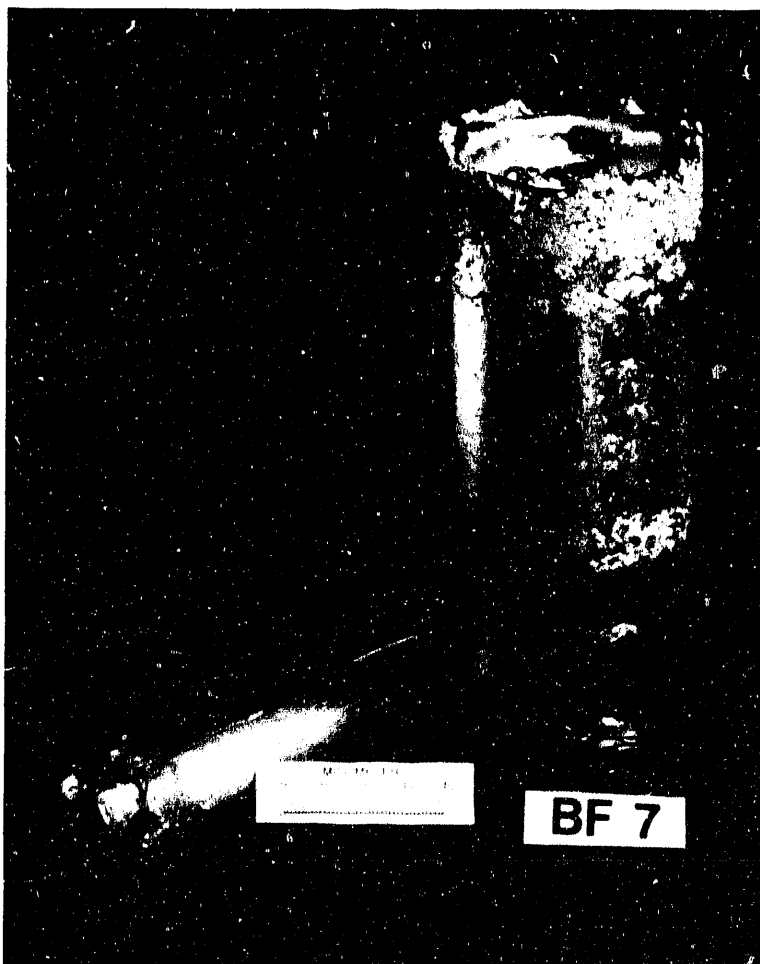
Fig. 4. The BF7 ingot showing uniformly smooth surface appearance and relative short skull height at the top of the ingot.

The BF7 ingot, shown in Fig. 4, has a smooth surface and exhibits no evidence of adherent copper from the mold. The region with the roughest surface corresponds to the small damaged region of the used copper mold. No additional mold damage was observed. The BF7 ingot was cylindrically ground to a 61-mm diam, which resulted in the removal of 0.9 to 1.4 mm from the diameter of casting.

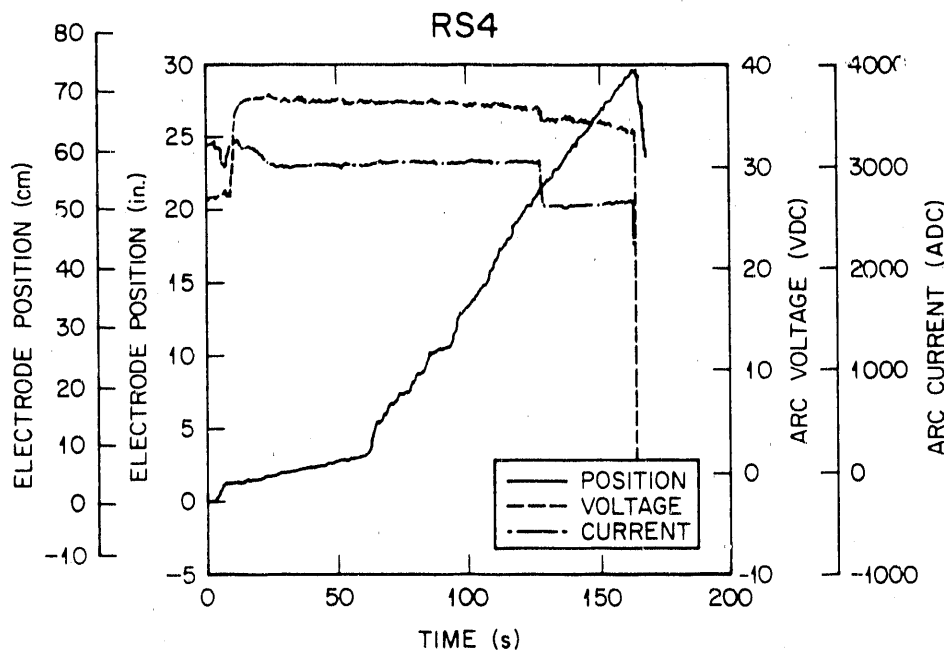
Fig. 5. The plot of arc-melting parameters for the RS4 ingot showing nonuniform electrode feed and a lack of arc-length control.

furnace's electrode electrical cables on the melting characteristics of the iridium alloy. The melt was made at a current of 3000 A, and a voltage of 36 V was used to control the arc gap. The plot of current, voltage, and position during the melt is shown in Fig. 5. The results indicated that a much longer arc was now associated with the current and voltage, which previously produced a controlled short arc for the BF7 ingot. It can be concluded that the old cables produced a significant voltage drop over their length, resulting in a lower actual arc voltage than was recorded. Use of the new cables requires a significant reduction in the voltage used to control the arc length.

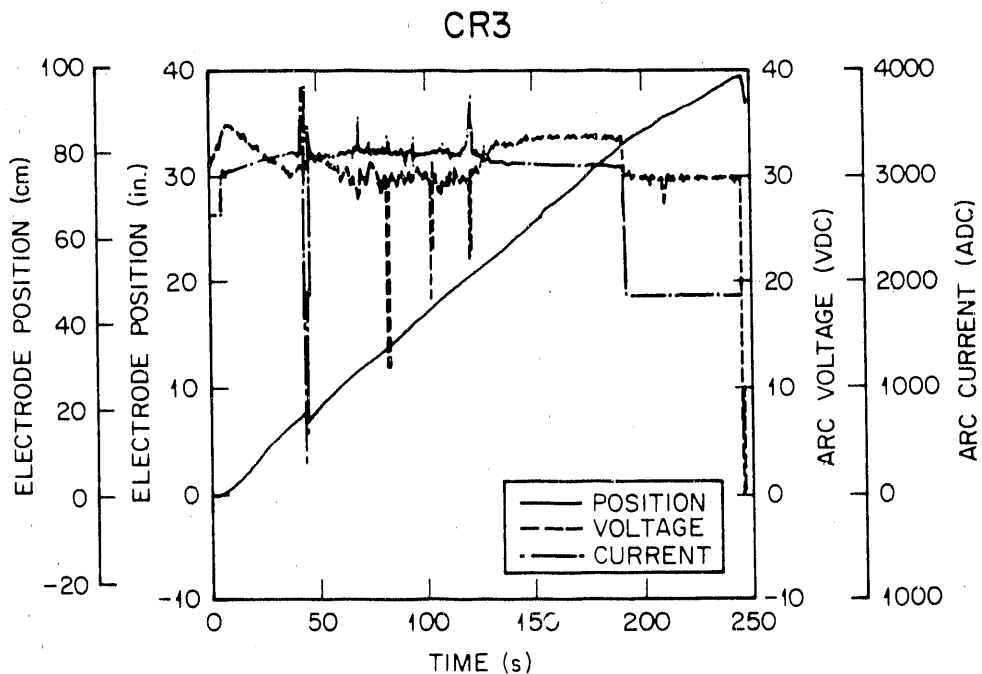
Fig. 6. Arc-melting parameters for the CR3 ingot showing uniform feed of the electrode and several short circuits indicative of a short arc length.

The CR3 electrode was melted in the iridium alloy-coated mold previously used to melt CR2 and BF7 ingots. The current of 3100 A and the voltage of 30 to 32 V were maintained to give a relatively short arc (estimated at 15 mm or less). The electrode-to-mold clearance was maintained at 19 ± 4 mm. The initial chamber pressure was 1.6 mPa; pressure increased to 9 mPa during melting. A graph of current, voltage, and position during the melt is shown in Fig. 6. Several short circuits were evident during the melt and associated with the short arc length. The current was reduced to about 1800 A for a 40-s hot-topping ending period to minimize the shrinkage cavity at the top of the ingot. The electrode feed rate was maintained at a relatively constant value of 4.5 mm/s.

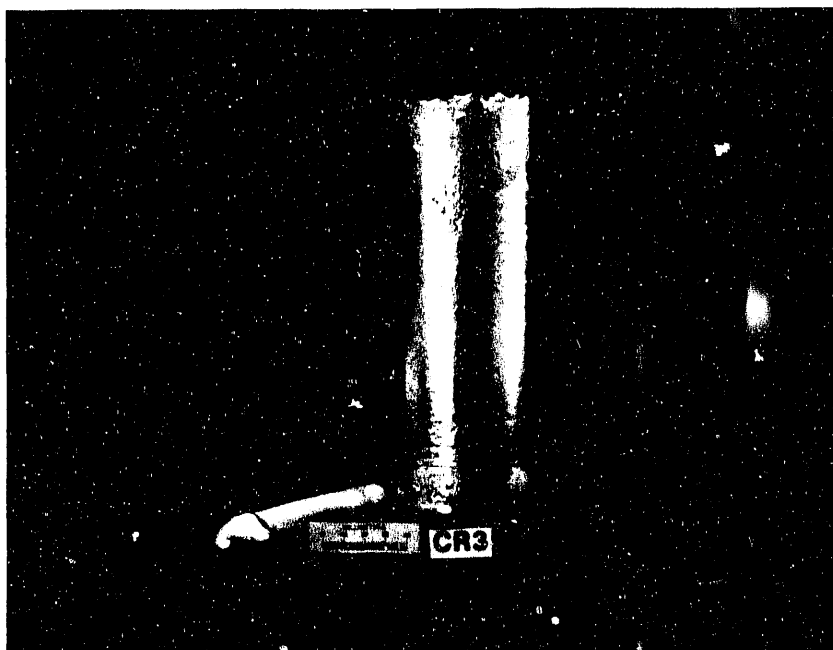
Fig. 7. The arc-melted CR3 ingot exhibiting a smooth surface with no evidence of arc strikes to the mold.

The arc-melted ingot showed a smooth surface with no evidence of arc strikes to the mold wall, as shown in Fig. 7. The ingot was ground to remove 1.3 to 1.9 mm from the

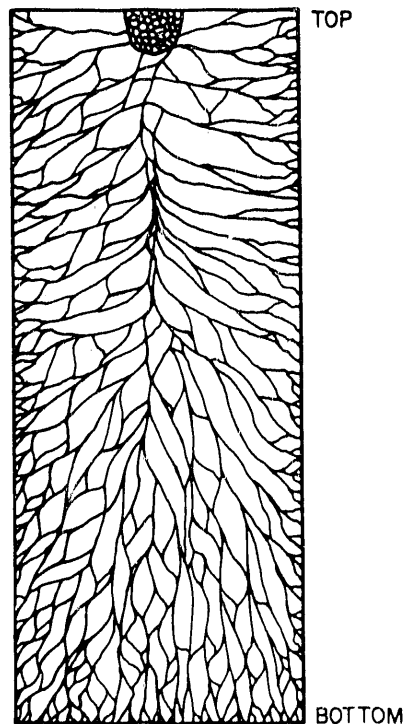
Fig. 10. A sketch of the grain structure in the CR2 ingot showing a columnar structure extending from the bottom surface to nearly half the height of the ingot.

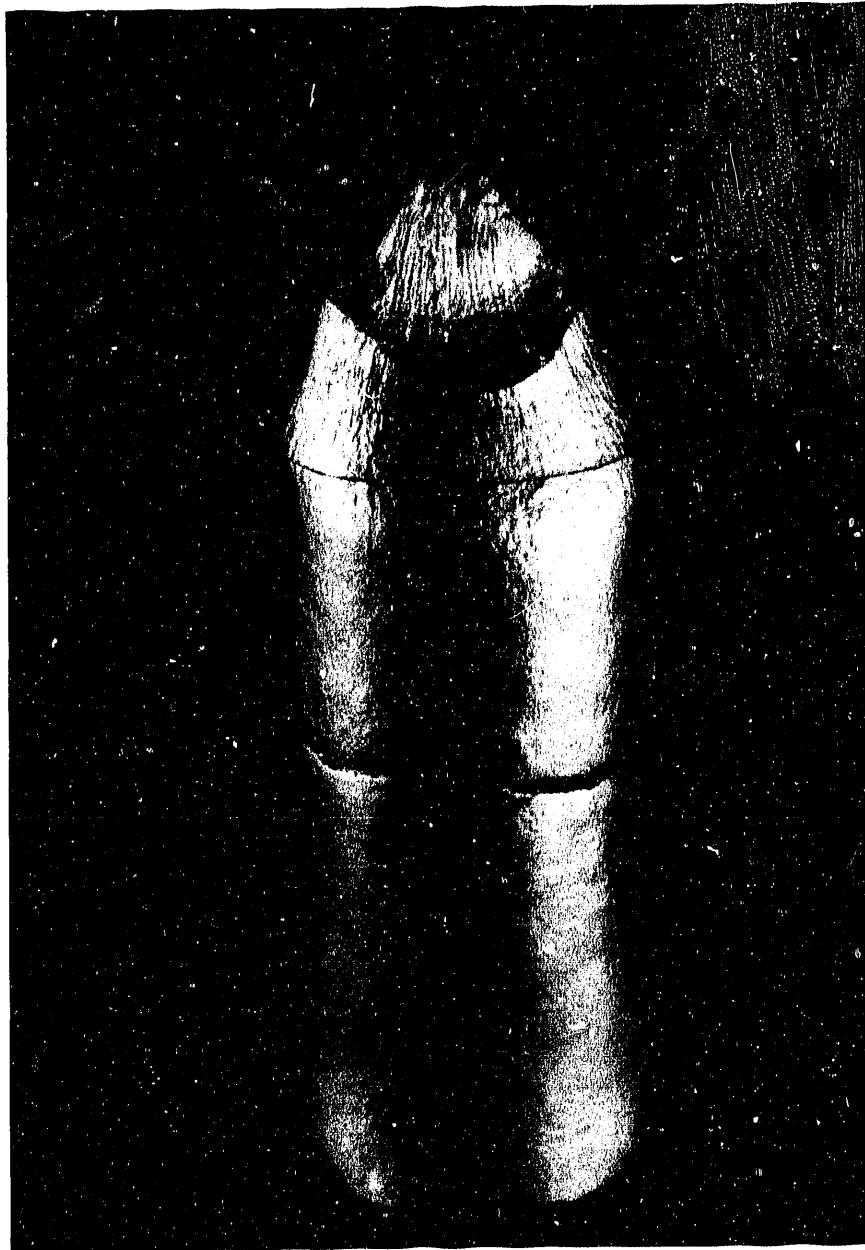
Fig. 11. Partial extrusion of CR2 ingot showing tensile-type fracture with measurable reduction of area.

The CR2 extrusion stopped prematurely as the press reached its capacity of 8 MN (900 tons). This was found to be the result of rotation of the die in the liner prior to the extrusion. Wear of the liner was a contributing cause of the rotation. The iridium-alloy ingot showed a large crack following removal of the molybdenum-can material, as seen in Fig. 11. The failure is tensile in nature with about 5% reduction of area at the fracture. It is postulated that differential thermal contraction produced tensile stresses sufficient to cause the fracture.

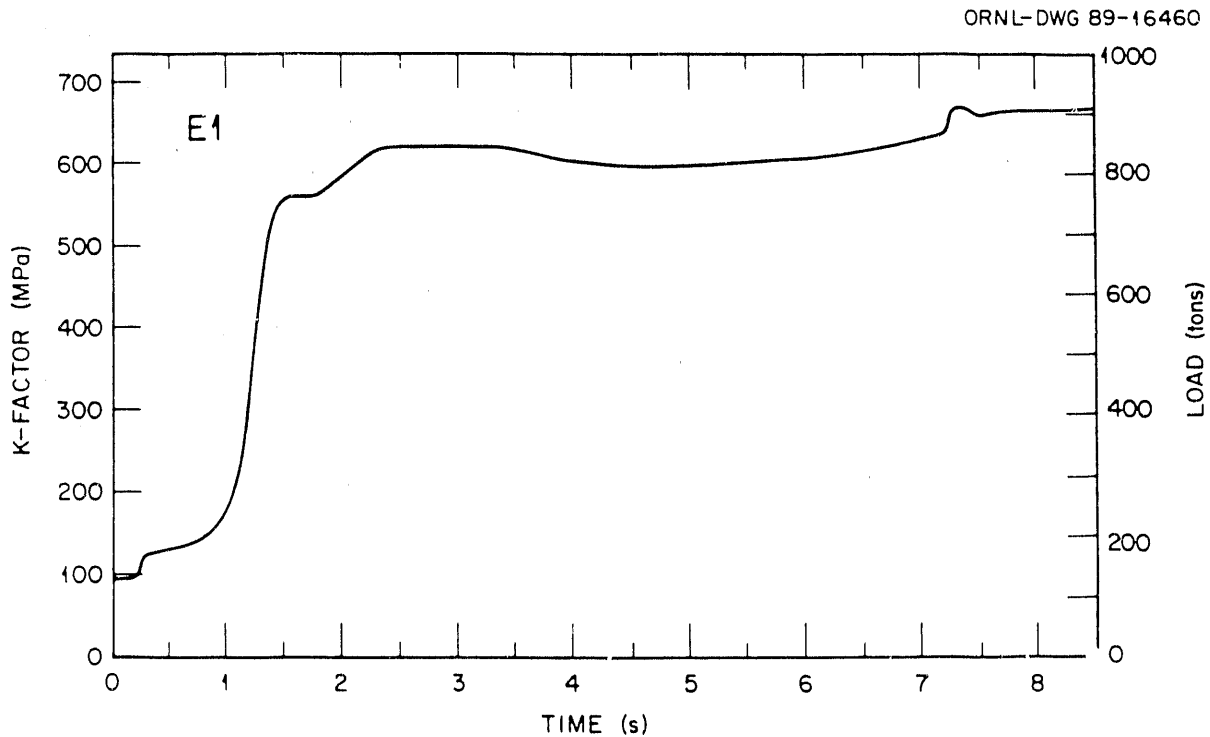
Fig. 12. Extrusion loads for E1 ingot exceeding the press capacity.

The E1 extrusion stopped at the point where the TZM alloy end cap entered the die, leaving about 1 kg of unextruded iridium alloy in the die. The incomplete extrusion was caused by an insufficiently heated graphite follower block which in turn caused excessive cooling of the end cap. The use of a TZM end cap, rather than molybdenum, was a contributing cause because of the greater flow strength of TZM, although it had been successfully used for previous extrusions. The location at which the end cap entered the die can be seen on the load curve in Fig. 12 at the 7-s position.

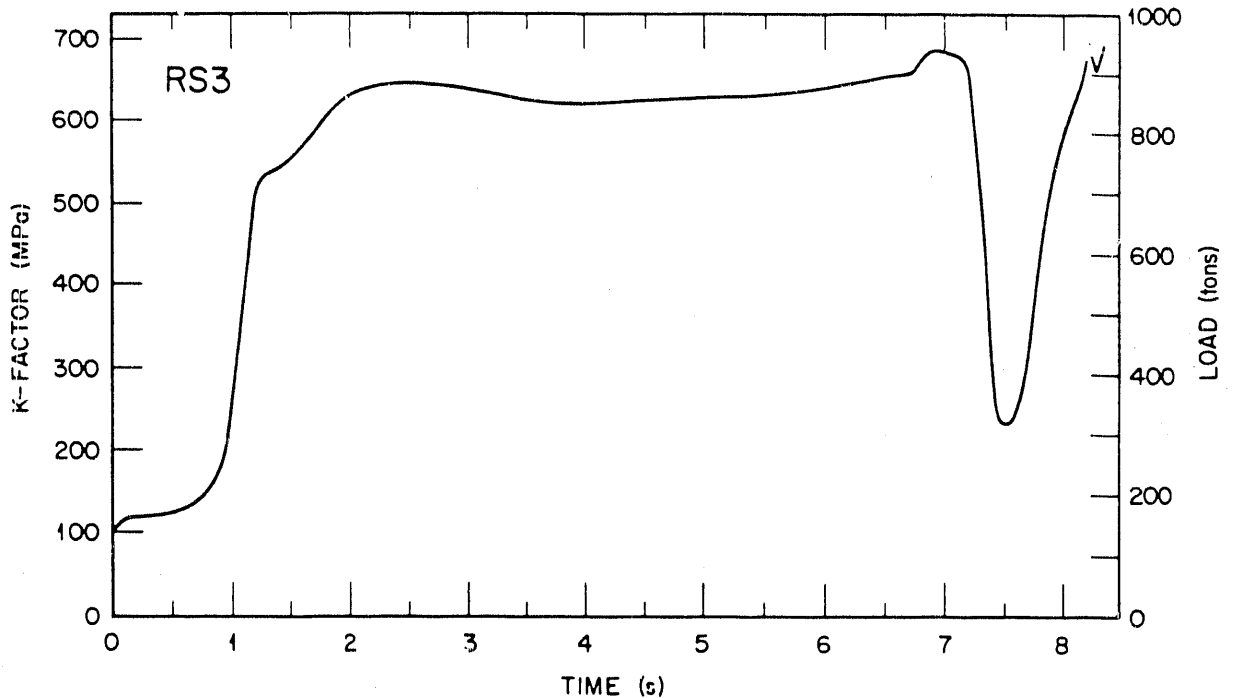
Fig. 13. Extrusion loads for RS3 ingot approaching press capacity as seen at the extreme right of the curve.

The load curve for the successfully extruded RS3 extrusion in Fig. 13 shows that even for this case, there is little margin between the extrusion load and the press capacity. This is clearly another contributing cause of the partial extrusion of E1.

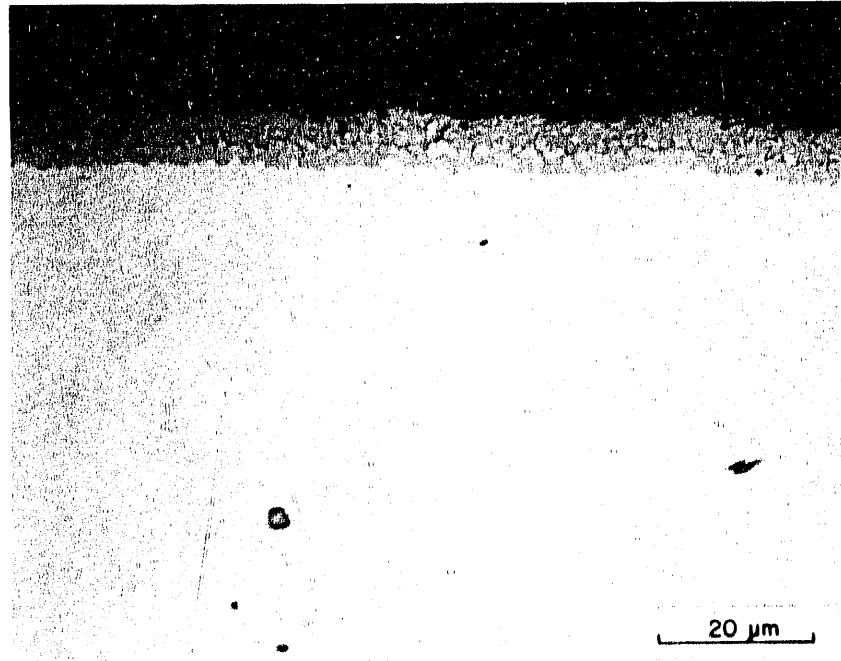
Fig. 14. Metallographic section of iridium-molybdenum diffusion couple with about 10 μm of intermetallic compounds formed at 1325°C in 4 h.

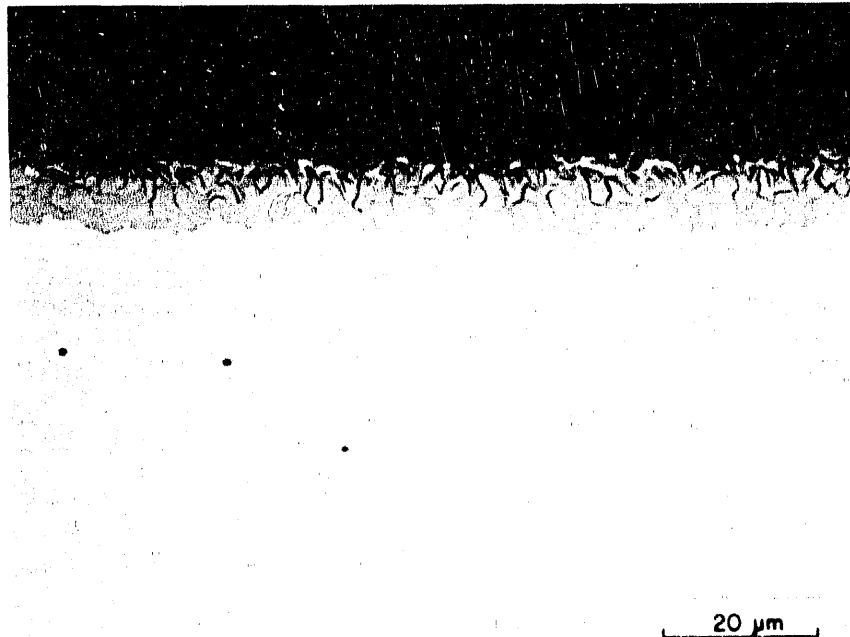
Fig. 15. Metallographic section of iridium-molybdenum diffusion couple with about 15 μm of intermetallic compounds formed at 1475°C in 4 h.

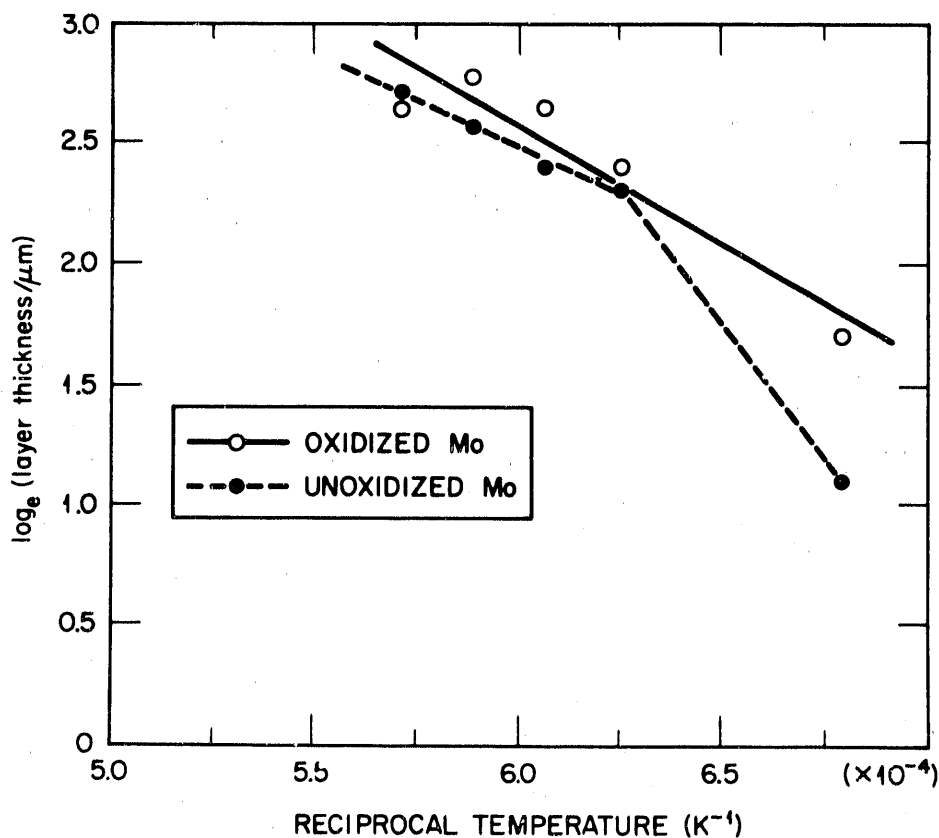
Fig. 16. The Arrhenius plot of natural log of intermetallic layer thickness formed in iridium-molybdenum diffusion couples heated for 4 h increases with reciprocal temperature showing no appreciable effect of preoxidation of the molybdenum at temperatures in the range 1325 to 1475°C.

The samples examined by optical metallography were generally etched electrolytically with alternating current (ac) at 10 V in a solution of 1 part HCl to 4 parts H₂O with a small addition of NaCl for improved contrast. Measurements of layer thicknesses were made using as-polished samples. Microprobe analysis was performed on as-polished samples heated at 1475 and 1325°C. Auger analysis was performed on the sample heated at 1475°C, which was fractured in the vacuum chamber of the Auger microscope. Optical micrographs of the intermetallic layers formed at 1325 and 1475°C are shown in Figs. 14 and 15, respectively. The results of optical metallographic examination of the total intermetallic layer thickness are shown in Fig. 16 as an Arrhenius plot of natural logarithm

of total layer thickness vs reciprocal absolute temperature for the temperature range of 1200 to 1475°C. The average total layer thickness is found to be similar for both the preoxidized and unoxidized molybdenum. The layers are uniform in thickness to within 1 or 2 μm on each sample. The average layer thickness is 3 to 5 μm at 1200°C, about 10 μm at 1325°C, and about 15 μm at 1475°C. The sample heated in vacuum at 1450°C for 4 h exhibits a layer thickness of about 13 μm , although a number of areas of contact between molybdenum and iridium show no intermetallic layer.

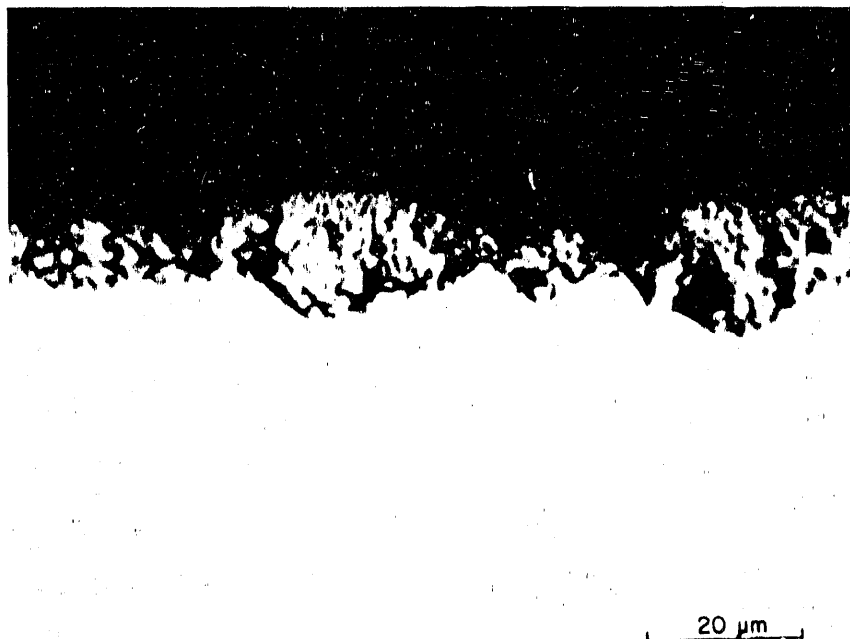
Fig. 19. Metallographic section of D1 extrusion showing intermetallic compounds of molybdenum with iridium on the surface.

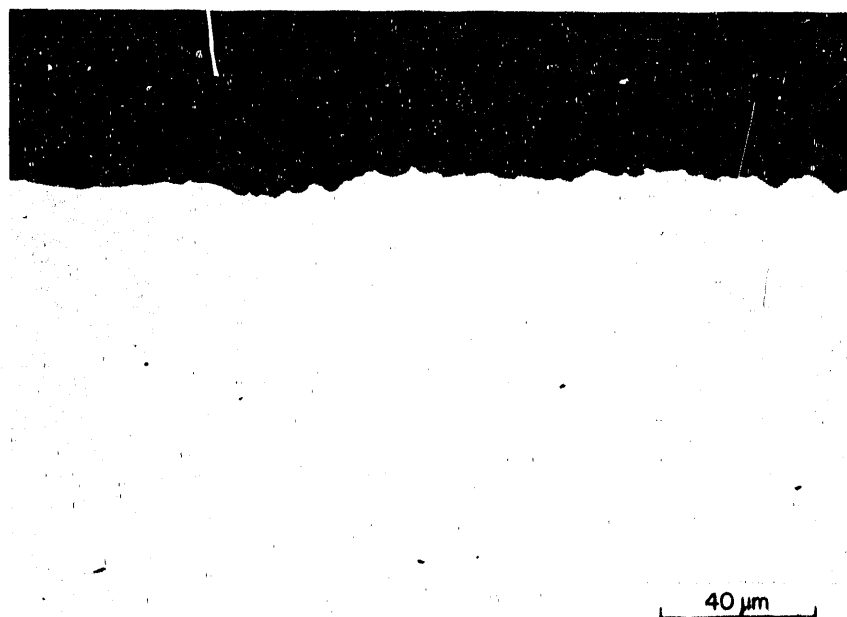
Fig. 20. Metallographic section of D1 extrusion following electrolytic cleaning in KCN showing removal of intermetallic layers on the surface.

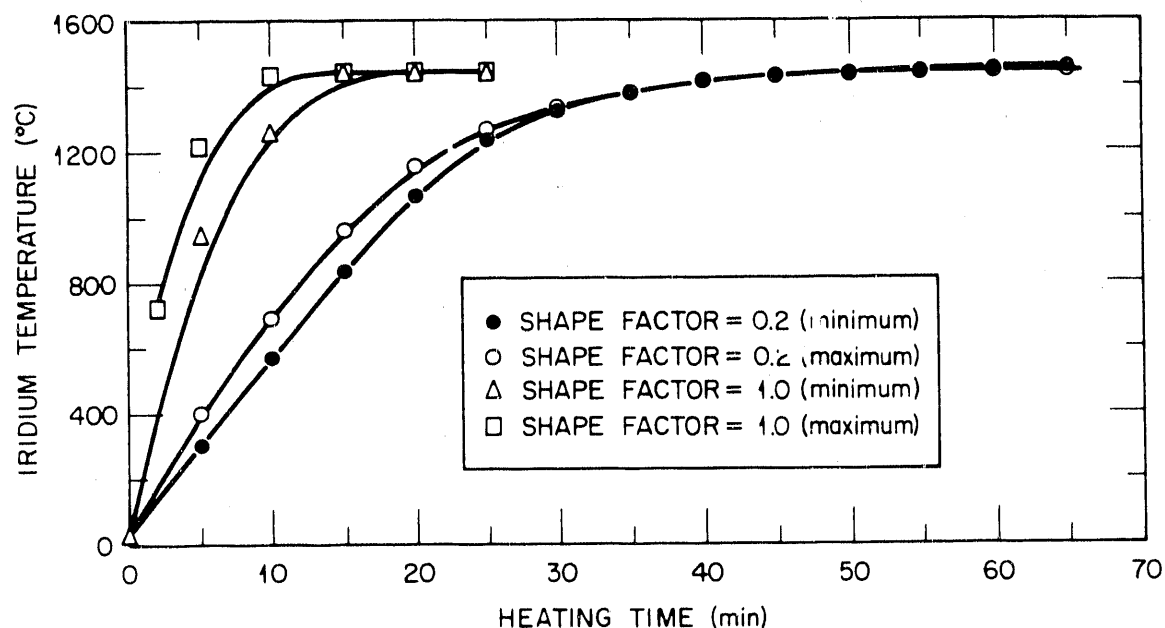
Fig. 21. The calculated heating of a molybdenum-canned iridium ingot showing the center of the ingot to be at temperature within 1 h.

Numerical analysis of billet heating and cooling was performed using the model of an iridium cylinder in a molybdenum can with a 0.4-mm air-gap space between the two. Because emissivity data for the iridium and molybdenum components were not available, extreme shape factor values of 1 and 0.2 were both analyzed. The calculated maximum and minimum temperatures in the iridium cylinder are shown in Fig. 21 for heating at 1450°C. The results show that even under the most conservative estimates, the iridium is heated to temperature within 1 h. On this basis the minimum preheat time for iridium-alloy billets was decreased from 4 to 3 h. The minimum reheat time in the event of an aborted extrusion attempt was set at 1 h. A similar analysis of the cooling of the canned billet is shown in Fig. 22. On this basis, a minimum temperature of 1300°C is reached in 0.4 min under the least favorable assumptions, providing some justification for the 25-s maximum transfer time permitted for iridium-alloy extrusions.

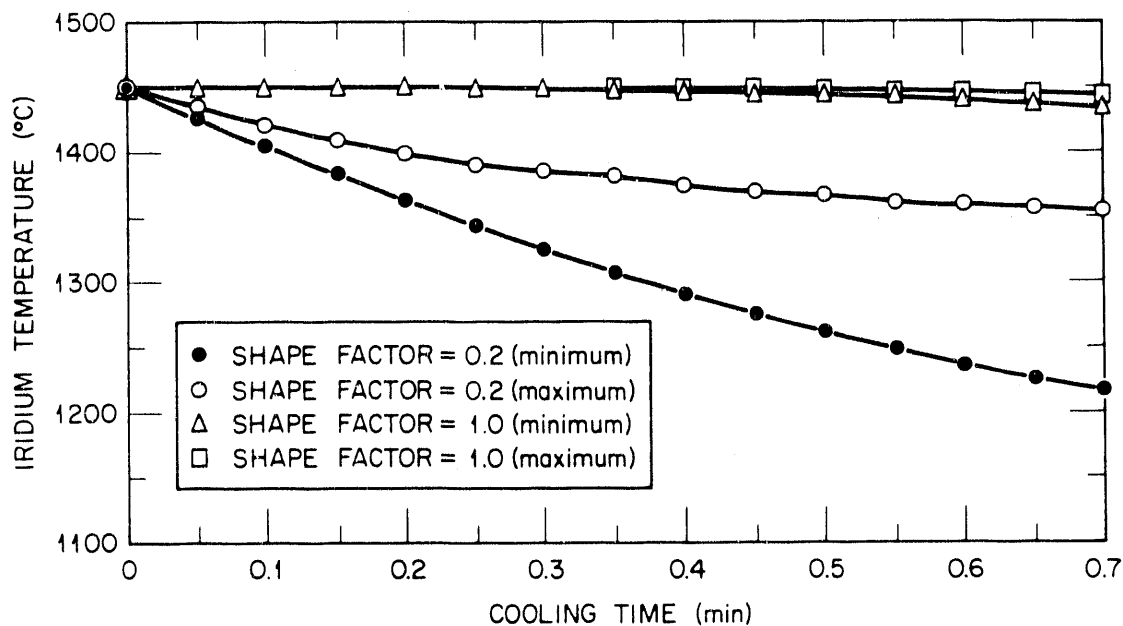
Fig. 22. The calculated cooling of a molybdenum-canned iridium ingot showing that temperatures below 1300°C may be at times greater than 30 s.

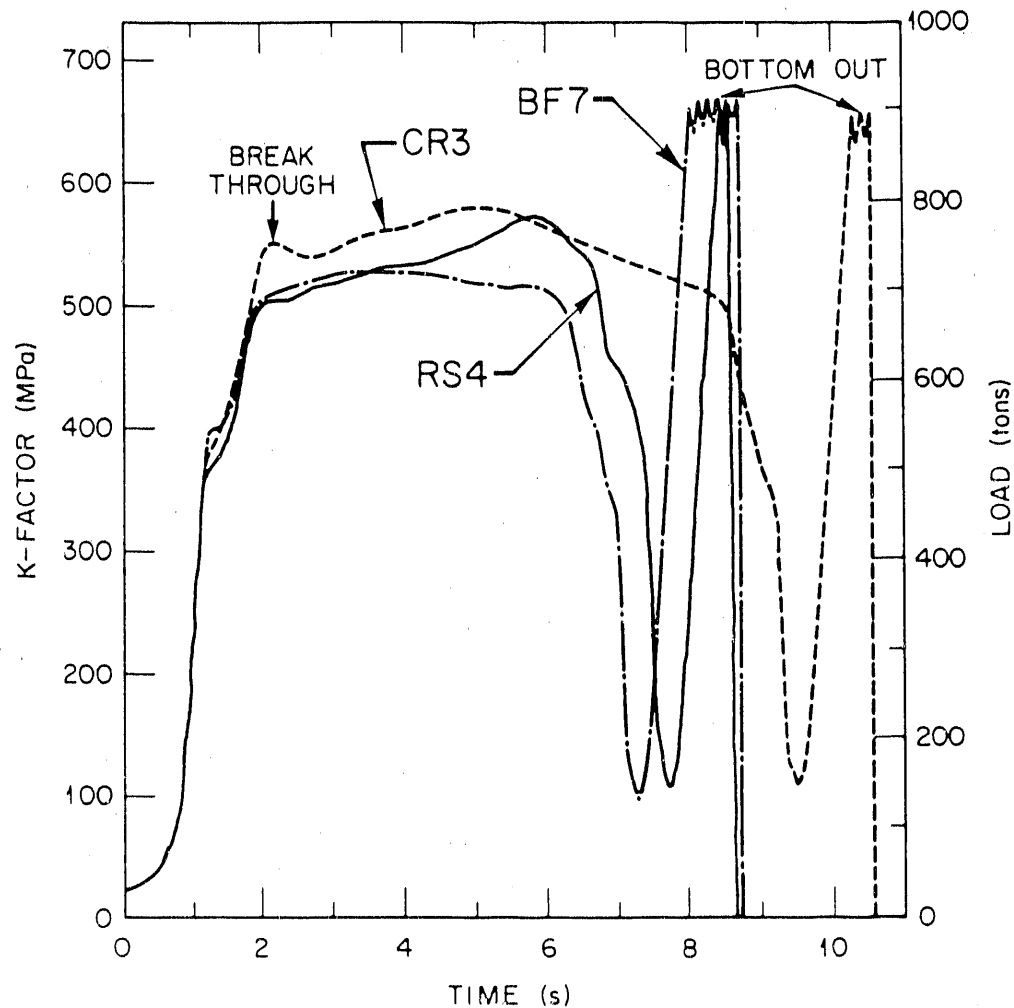
Fig. 23. The load curves for RS4, CR3, and BF7 ingots, extruded using the improved process, showing maximum load significantly below the press capacity.

The three extrusions were successfully made. The load curves are shown in Fig. 23. In each case, the load increases rapidly in the first 2 s. The CR3 extrusion shows a small indication of a breakthrough load, characterized by a load drop following the transient deformation flow at the nose. The lack of breakthrough load is associated with the lower flow stress of the molybdenum nose as compared to the iridium alloy. The K -factor increases continuously from 500 to 570 MPa for RS4 over the course of the extrusion of the iridium alloy but the K -factor is a nearly constant 510 MPa for BF7. The CR3 extrusion, which took longer because of the greater billet length, shows an initial increase from 530 to 580 MPa for about the first half of the extrusion, followed by a gradual decrease to 500 MPa. The load or K -factor during an extrusion depends on both frictional effects and the flow characteristics of the material, which are affected by cooling of the billet from conduction and radiation and by the heat input from both the deformation and friction. Although the slight differences in behavior of the three extrusions cannot be easily explained, the most important result is that the maximum load is significantly lower than the press capacity as indicated on the curves by the bottom-out condition when the stem contacts the container. The maximum load experienced was about 88% of press capacity.

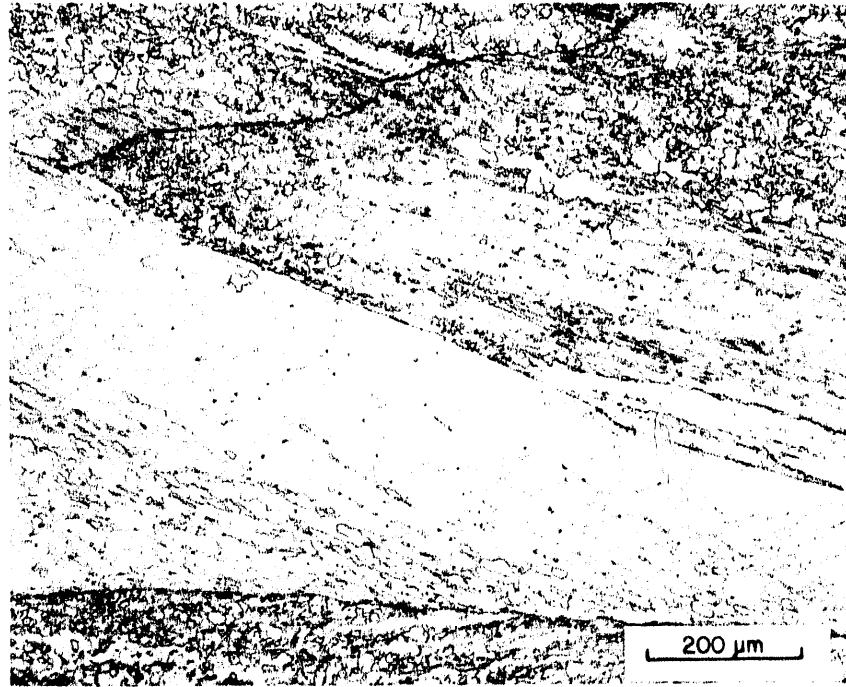
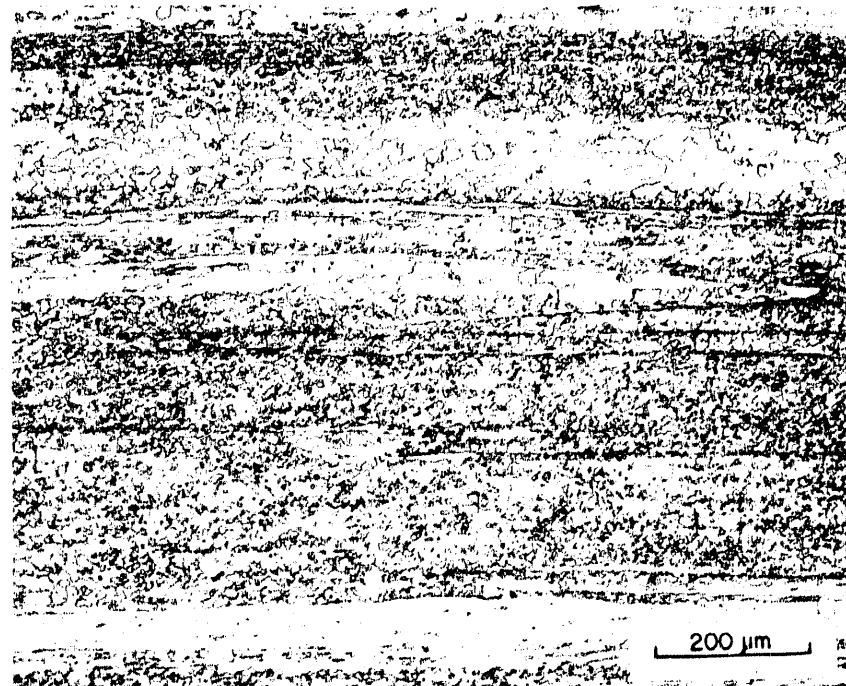
Fig. 24. Microstructure of the E1 extrusion showing partial recrystallization of both the (a) nose region and (b) tail region.

The microstructures of the three extrusions performed at 1425°C have been examined in order to determine the effect of increased preheat temperature. In the early stages of development of the extrusion process for iridium alloys, it was believed that a worked structure was necessary to avoid edge cracking during subsequent rolling of the extruded material. The first two extrusions, B1 and B2, were performed using preheat temperatures of 1200 and 1250°C. The microstructure of the B2 extrusion showed about 50% recrystallization. The later D1 extrusion was performed with a 1325°C preheat temperature and showed no recrystallization. The microstructure of the E1 extrusion, also performed with 1325°C preheat shows substantial recrystallization both in the nose and tail regions as seen in Fig. 24.

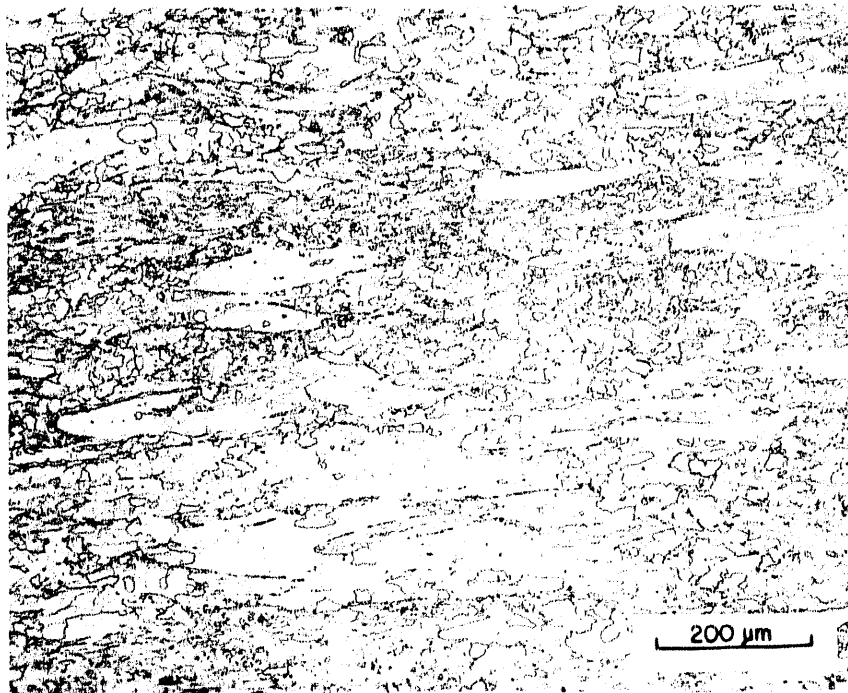
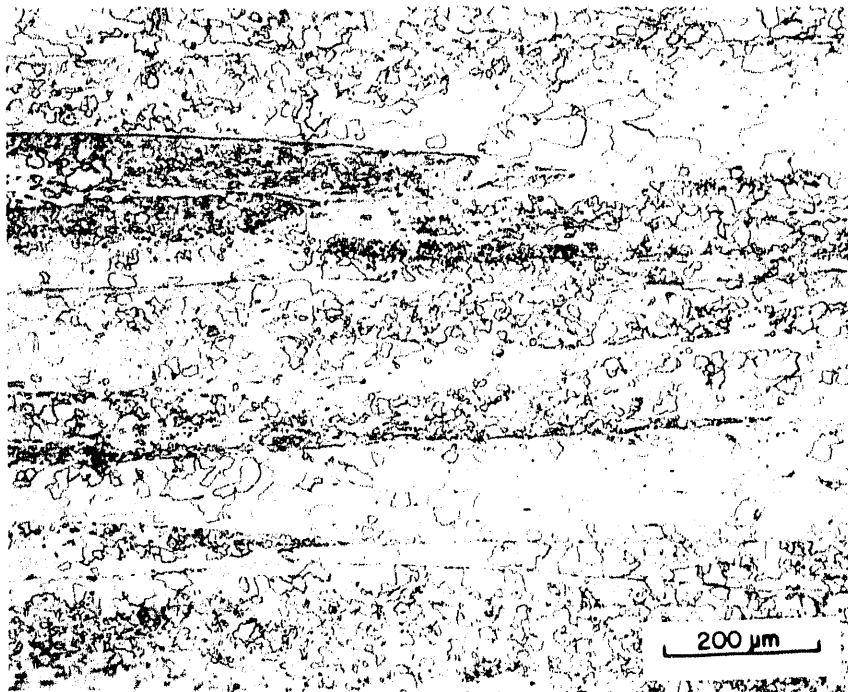
Fig. 25. Microstructure of the RS4 extrusion showing (a) about 10% recrystallization in the nose region and (b) about 90% recrystallization in the tail region.

The RS4 extrusion, preheated at 1425°C, has a partially recrystallized structure. The sample from the nose of the extrusion [Fig. 25(a)] shows deformation of the coarse cast grains with about 10% recrystallization. The tail sample, shown in Fig. 25(b), exhibits evidence of the original cast grain boundaries with about 90% recrystallization of very fine grains of 10 to 50 μm in diameter. The CR3 ingot, extruded under the same conditions, shows a similar microstructure in the nose portion [Fig. 26(a)] but no evidence of recrystallization within the tail sample [Fig. 26(b)]. The BF7 ingot, with the DOP-4 composition, is expected to have a somewhat lower recrystallization temperature. In contrast to the other two extrusions in this group, it shows complete recrystallization in the nose section [Fig. 27(a)]. The tail section [Fig. 27(b)] is approximately 50% recrystallized.

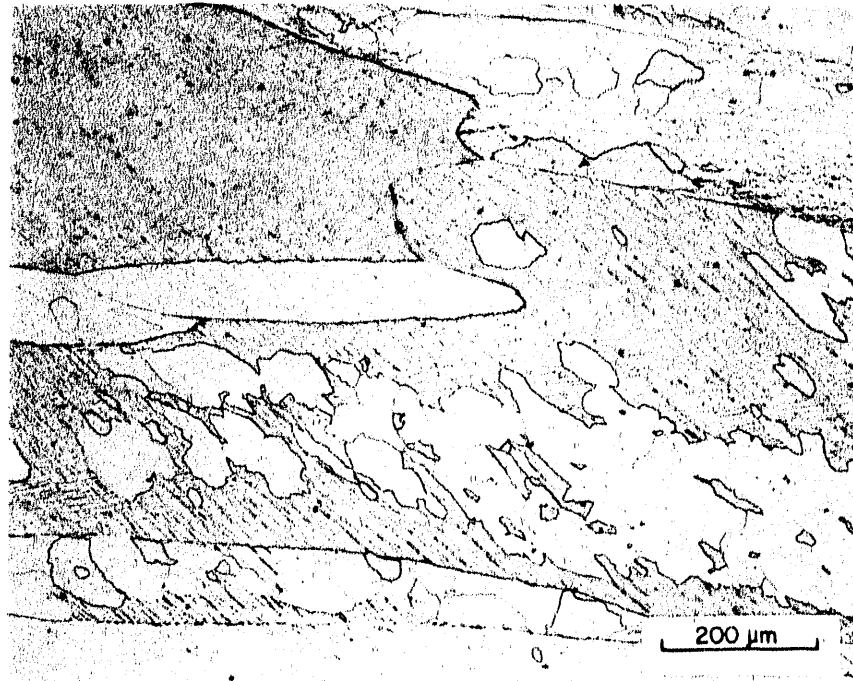
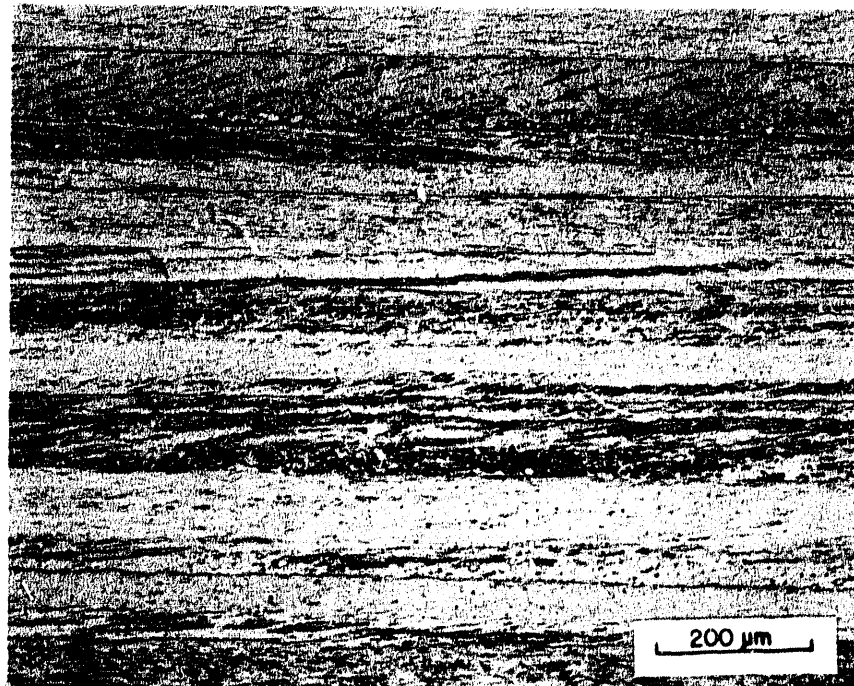
Fig. 26. Microstructure of the CR3 extrusion showing (a) the nose region with approximately 50% recrystallization and (b) the tail region with essentially no recrystallization.

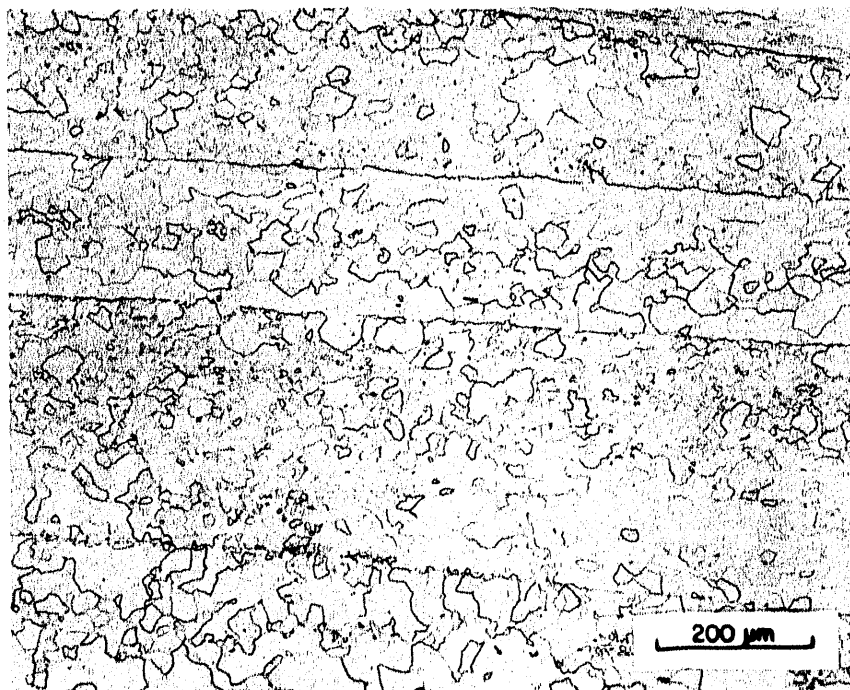
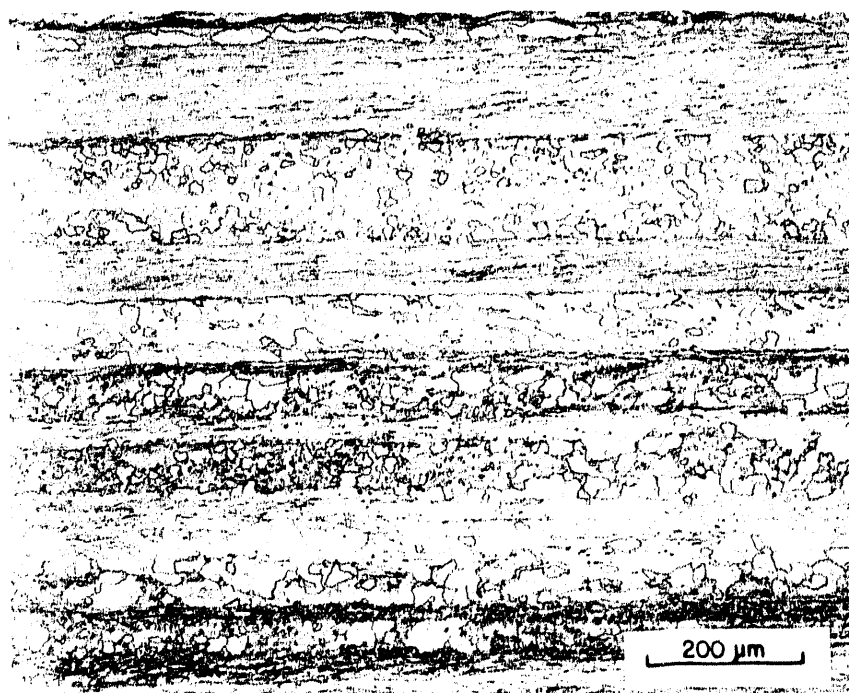
Fig. 27. Microstructure of the BF7 extrusion showing (a) complete recrystallization in the nose region and (b) 50% recrystallization in the tail region.

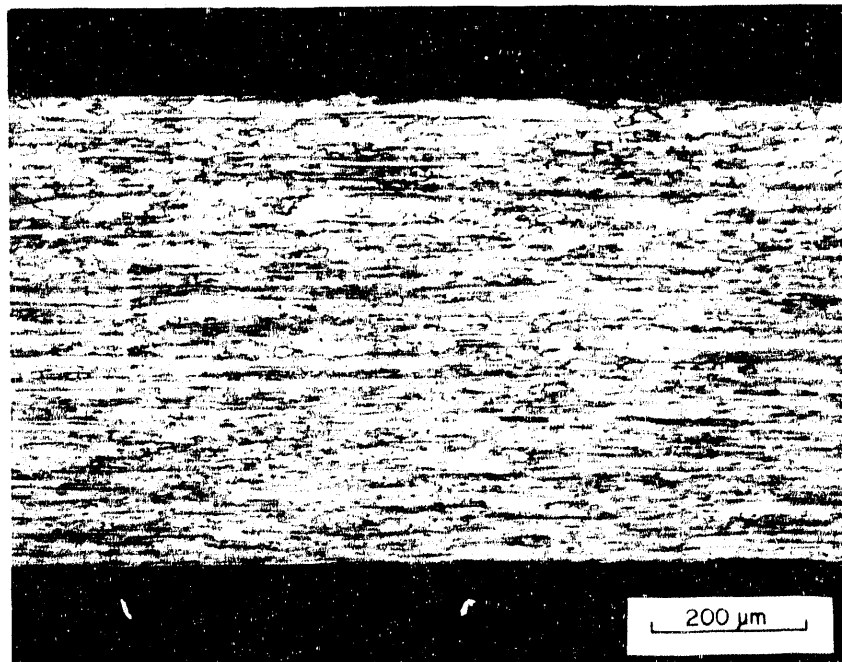
Fig. 30. Microstructure of sheet E1-6 showing recrystallization in excess of 5%.

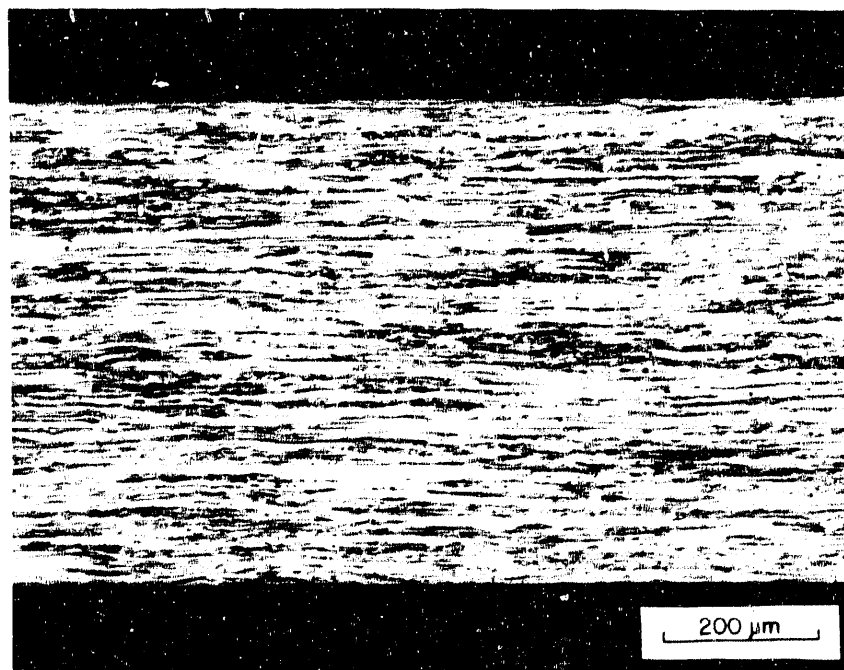
Fig. 31. Microstructure of sheet E1-7 showing no evidence of recrystallization.
