Metals and Ceramics Division

IRIDIUM-ALLOY PROCESSING EXPERIENCE IN FY 1989

E. K. Ohriner

Date Published: November 1990

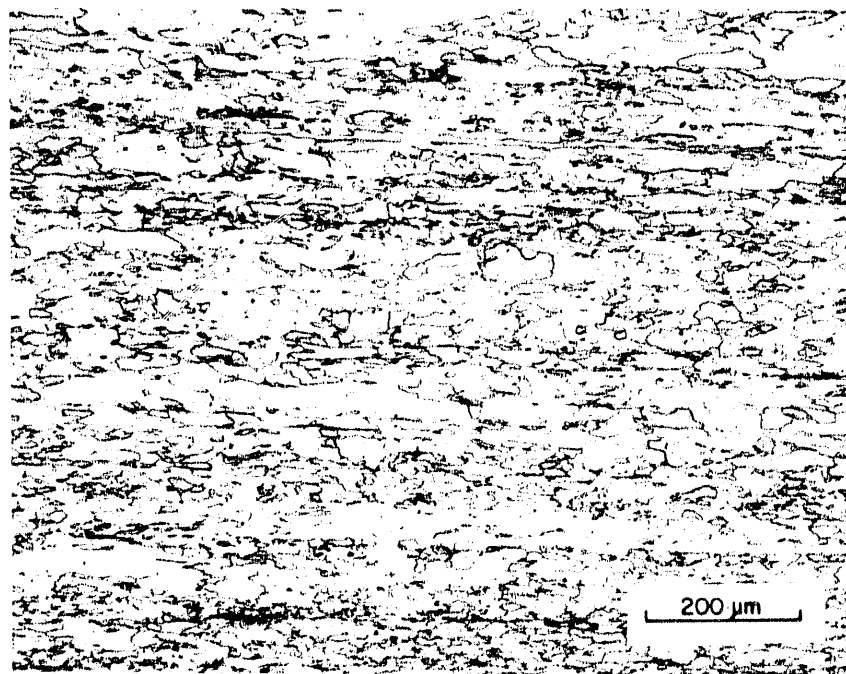
Fig. 32. Microstructure of CR3 sheet following breakdown rolling with 1200°C preheat temperature showing substantial recrystallization structure.

A total of 14 sheets were rolled from the CR3 extrusion in according to procedure MET-MatP-SOP-101, Rev. 1. The microstructure following breakdown rolling with 1200°C preheat shows substantial recrystallization, as seen in Fig. 32. The microstructure following recrystallization shown in Fig. 33 does show evidence of the grain boundaries in the original casting in the form of several lengths of horizontally aligned boundaries. Metallographic evaluation of the first six sheets following bare rolling and stress-relieving showed recrystallization to be well within acceptable limits. A total of 31 blanks were produced from these sheets. This was less than the expected seven blanks per sheet because of rolling to greater than optimal width that decreased length and contributed to some splitting during bare roll. The remaining eight sheets have been rolled and laid out to produce 52 blanks. A few potential blanks were lost because of greater than normal edge cracking. This is the result of an average gage thickness of 1.1 mm following covered rolling rather than 1.0 mm, the aim thickness. A greater reduction during bare rolling to the finish thickness created more opportunity for edge cracking. The specification of about 1.0 mm may need to be made more specific. However, there are practical difficulties in recovering sheets at this point in the rolling schedule which need additional evaluation.

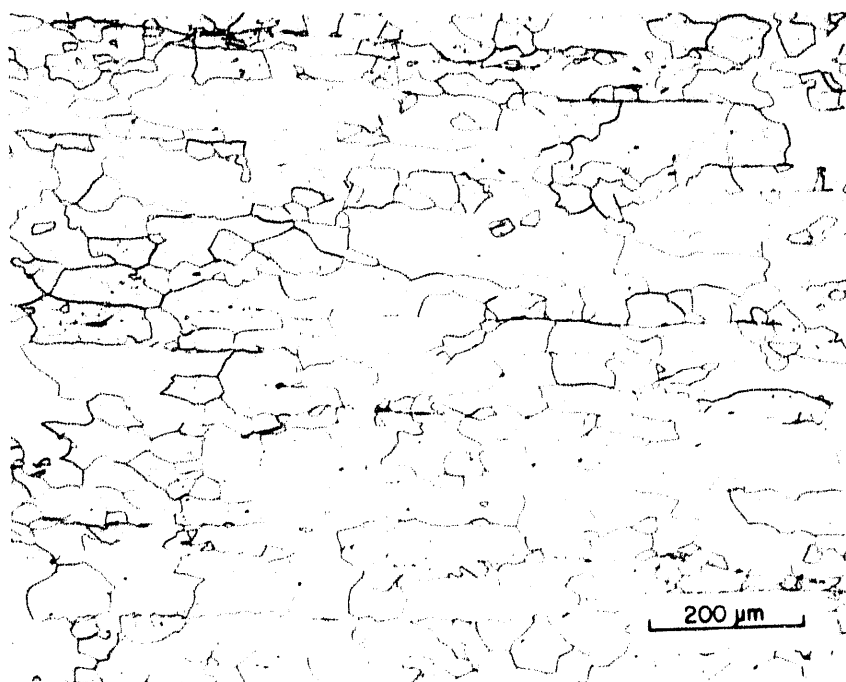
Fig. 33. Microstructure of CR3 sheet following recrystallization at 1300°C showing evidence of original grain boundaries in the arc-melted ingot.
