ACOUSTIC EMISSION MONITORING OF INTERMEDIATE PRESSURE
VESSELS TESTED UNDER THE ORNL HEAVY-SECTION
STEEL TECHNOLOGY PROGRAM*

D. J. Naus
Oak Ridge National Laboratory
Oak Ridge, Tennessee 37830

ABSTRACT: An overview is presented of ten tests of 15.2-cm-thick steel pressure vessels containing surface cracks. Flaws in the vessels ranged from 31 to 135 mm in depth, and test temperatures ranged from 0 to 91°C. A detailed description of the acoustic emission (AE) monitoring of the most recently completed vessel test, V-7B, and the fatigue crack sharpening of the flaw for test vessel V-8 is also presented. Results obtained during these tests indicate that AE is capable of locating flaws, detecting the onset of flaw growth, and providing an indication of the rate of crack extension (immediacy of fracture).

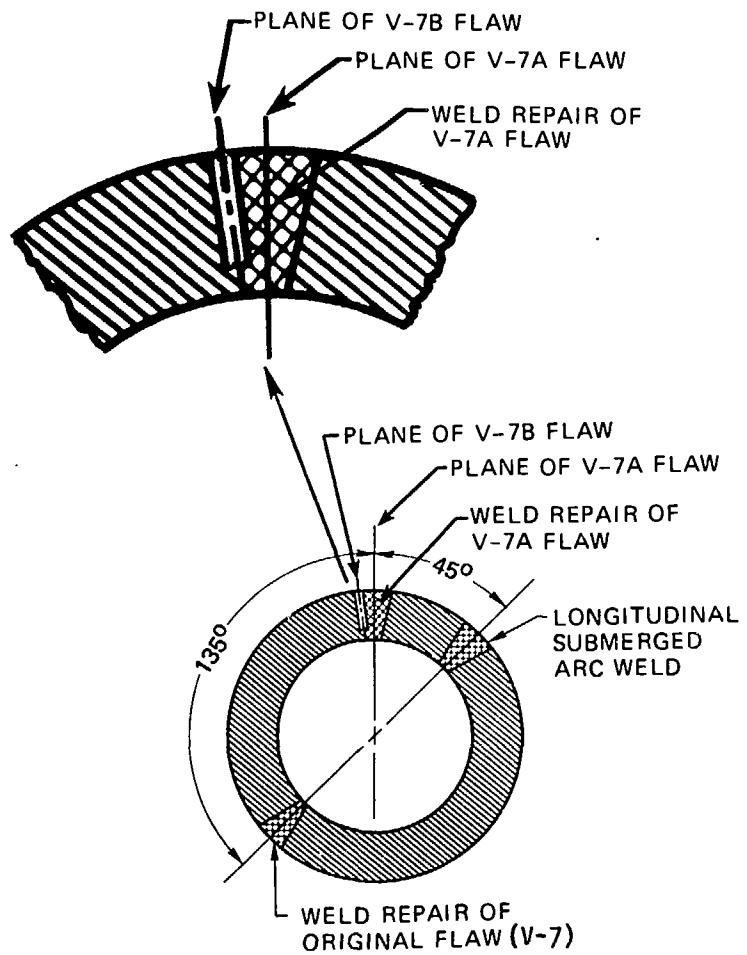
- Fig. 1. Intermediate test vessel V-7B.
- Fig. 2. Flaw design for V-7, V-7A, and V-7B.
- Fig. 3. Acoustic emission instrumentation.
- Fig. 4. Transducer locations relative to the flaw.

HSST vessel V-7B was fabricated from ASTM A533, Grade B, Class 1 steel plate. The test vessel had an outside diameter of 991 mm (39 in.) and an inside diameter of 686 mm (27 in.). The region of interest was a flaw formed by hydrogen charging of an electron-beam weld in the heat-affected zone of a previous weld repair. Details of the test vessel and flaw are presented in Figs. 1 and 2, respectively.

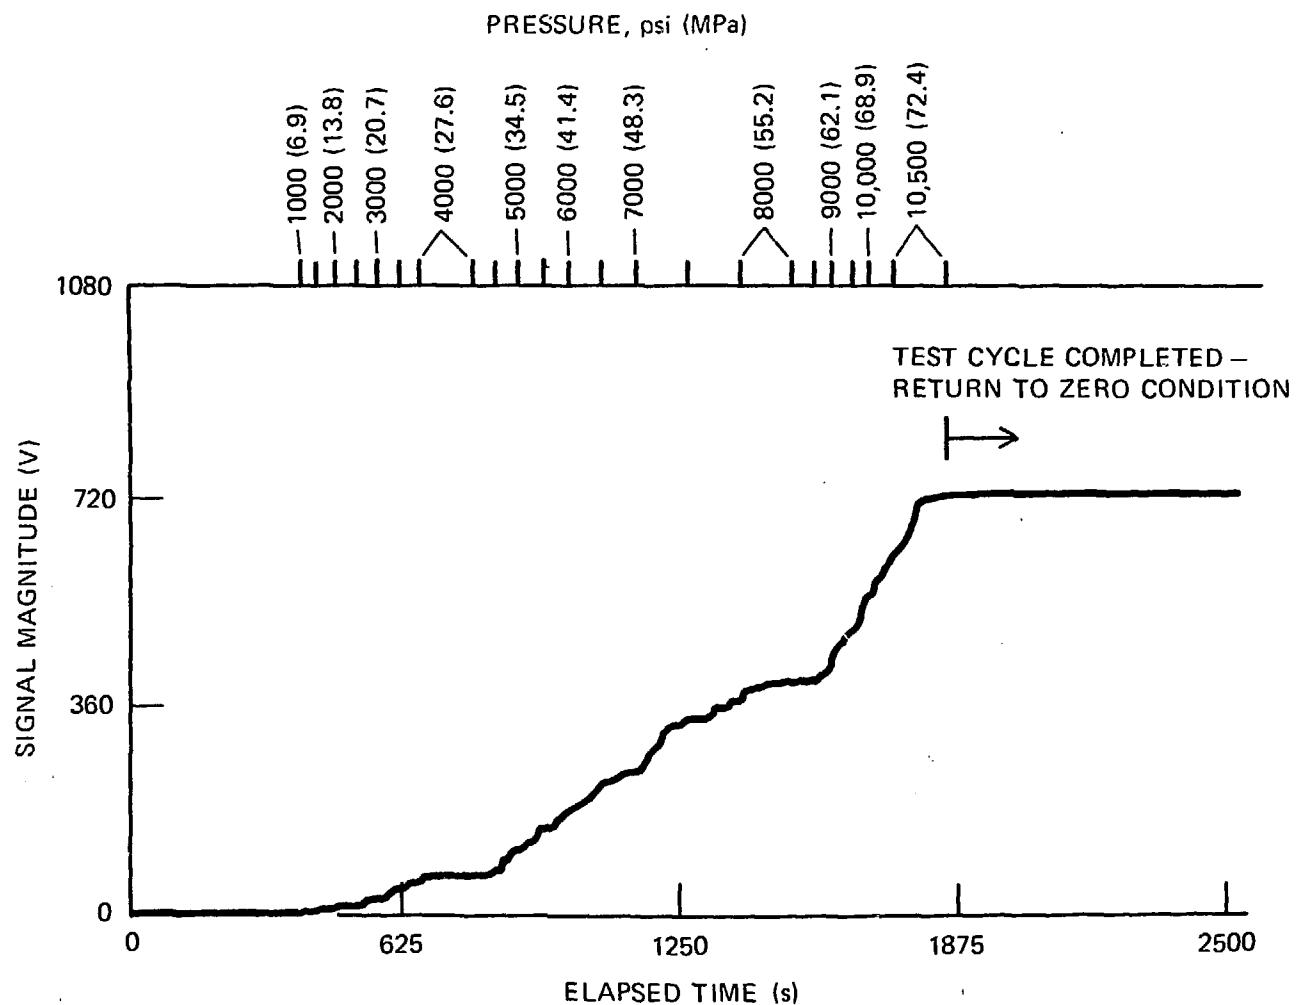
- Fig. 9. Magnitude vs elapsed time and pressure: cycle 1.
- Fig. 10. Grid display of initial pressurization cycle: 448 events.
- Fig. 11. Event occurrence histogram: cycle 2.

Acoustic emission data were obtained throughout the cycle. A total of 448 valid events were detected during this cycle. Figure 7 presents a histogram of event occurrence for each 3.4 MPa loading interval. A summation of event occurrence and COD gage output as a function of pressure is presented in Fig. 8. Figure 9 presents a summation of event magnitude voltages as a function of elapsed time and pressure. A two-dimensional grid displaying sensor and flaw locations, and events and event magnitudes at the conclusion of the initial pressurization cycle is presented in Fig. 10. In the figure, the 20.3-cm base of the flawed region is noted as a solid line, and the flawed region extending from the base to the vessel outer surface is noted by the dashed line. Each square of the grid where events have been noted contains two numbers: the upper number corresponds to the total number of accepted events and the lower number the summation of the magnitudes of the voltages for the events. The letter after each number is the scaling factor with A representing the number times one and B the number times ten. Regions with the most intense activity have been highlighted in the figure. It can be noted that these regions, with one exception, were adjacent to the flaw, and there appeared to be more activity for the upper part of the flaw than the lower. The one region not adjacent to the flaw showing intense activity corresponds to the position where a 406 by 610 by 1.59 mm (16 by 24 by 1/16 in.) sheet of 304L stainless steel was fillet welded to the inner surface of the vessel to act as a leak-retarding membrane, and this activity may have been associated with a weld defect.

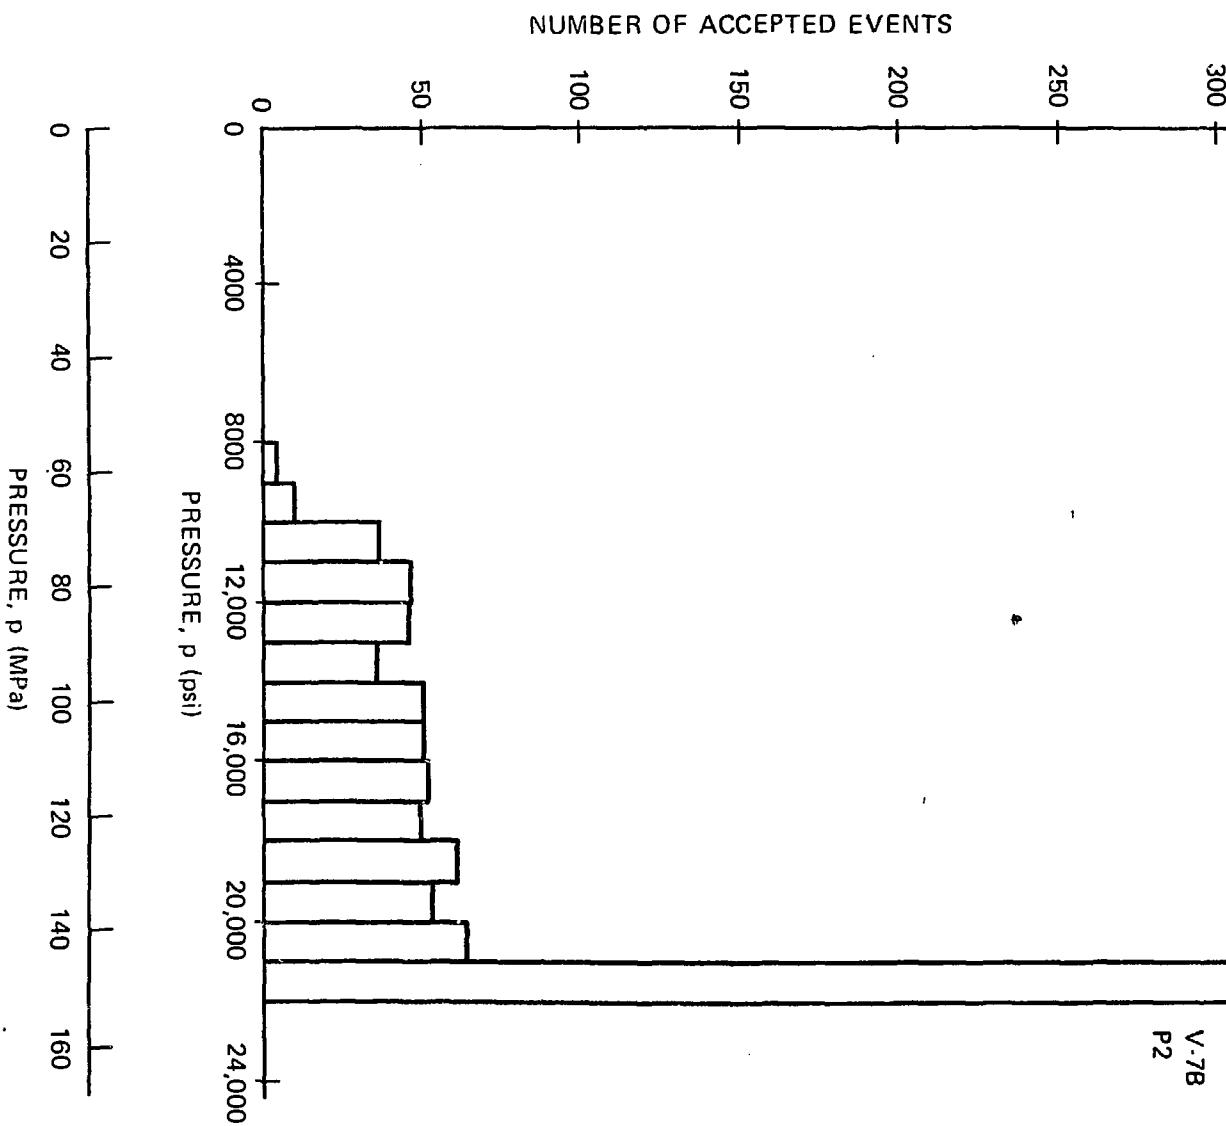
V-7B
P2

- Fig. 12. COD and summation of events vs pressure: cycle 2.
- Fig. 13. Magnitude vs elapsed time and pressure: cycle 2.
- Fig. 14. Grid display of pressure cycle 2: test conclusion; 931 events.

During the second pressurization cycle the vessel was loaded as shown in Fig. 6 until a leak developed through the vessel wall at the base of the flaw. During the test, pressure was intermittently held constant for short intervals while instrument scans were taken. As for the first cycle, AE data were obtained throughout the loading cycle. A total of 931 valid events were detected during this cycle. Figure 11 presents a histogram of event occurrence for each 3.4 MPa of load. Crack opening displacements and summation of accepted events as a function of pressure are presented in Fig. 12. It can be noted that the curves are of the same general shape in that both the displacements and number of events increase rapidly as failure is approached. Figure 13 presents a summation of event magnitude voltages as a function of elapsed time and pressure. A two-dimensional grid display of events and voltage magnitudes as a function of location at conclusion of the second pressurization cycle is shown in Fig. 14. Significant event occurrence by location as a function of pressure interval is presented in Fig. 15 where significant event occurrence is defined to be a grid square in the figure where at least four events or an event with a magnitude greater than 3.0 V has occurred during the pressure interval defined. As noted in the figures, regions of primary activity were adjacent to the flaw.
