Experimental Investigation of Creep Behavior of Reactor Vessel Lower Head

T.Y. Chu*, M. Pilch*, J.H. Bentz* and A. Behbahani**

*Sandia National Laboratories, **USNRC

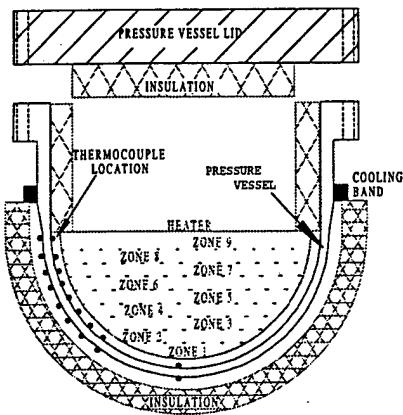
Figure 1. Schematic of LHF test apparatus.

The apparatus is basically a scaled version of the lower part of a TMI-like reactor pressure vessel (RPV) without the vessel skirt, consisting of a SA533B1 steel hemispherical head, and a 30-cm vertical section replicating the lower part of the RPV cylindrical wall, see Figures 1. The inner-diameter of the lower head is 0.91 m corresponding to a geometrical scale factor of 4.85. The wall thickness is typically 30 mm. Due to the hot-spinning forming operation, the wall is slightly thicker at the equator.

A hemispherical heater with nine independently controlled segments is used to simulate the energy transfer from the core debris to the reactor vessel, see Figures 1 and 2. The inner surface of the lower head is coated with Pyromark[®] black paint for efficient radiation absorption. The outer surface of the lower head and the inner surfaces of the cylindrical section and the top flange are insulated. A cooling band near the bottom of the cylindrical section provides the proper far field temperature condition (due to the presence of water in the RPV). The pressure load is provided by a manifold of bottled argon, and controlled by automatic fill and bleed valves.

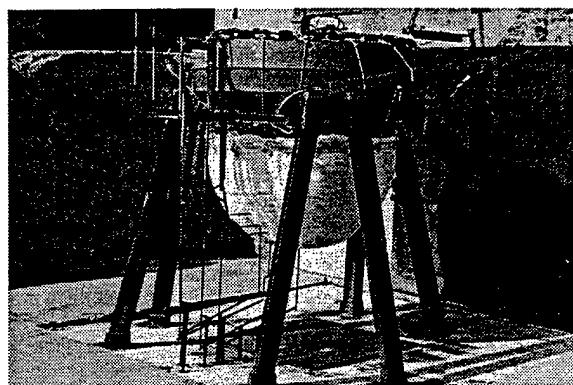
Figure 2. An overall view of the LHF test vessel and support.

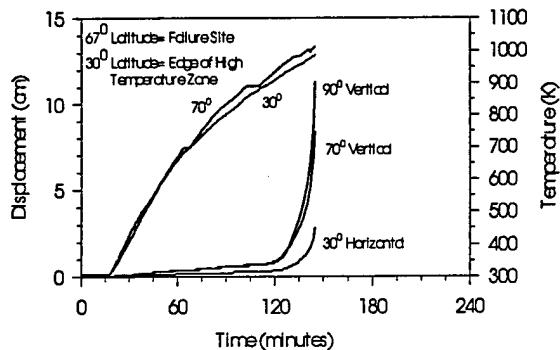
Figure 3. LHF-1 temperature and displacement history.

The lower 60° (latitude 30° to 90°) of the vessel wall was heated uniformly in LHF-1. Representative temperature and displacement histories of the vessel wall are shown in Figure 3. Significant increase of the creep rate was observed at about 120 minutes into the test at a vessel temperature of approximately 930 K. As the wall temperature increased, the creep rate continued to accelerate. The vessel failed catastrophically at 145 minutes into the test; at a vessel temperature of 1011 K. The recorded displacement at vessel bottom center at the time of failure was 0.12 m.

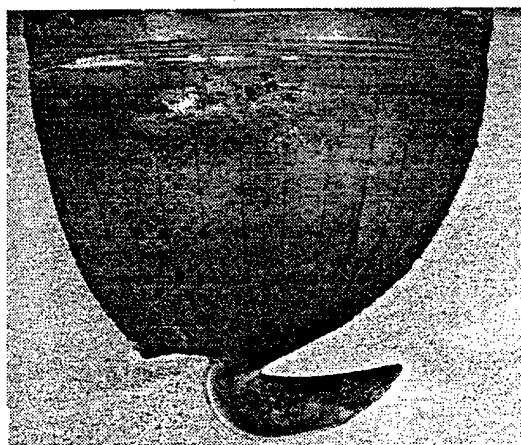
Figure 4. LHF-1 vessel profile 270° view - 180°/0° plane.

As shown in Figure 4, the vessel failed non-symmetrically with respect to the 90°/270° plane. The 180° longitude (left side) profile shows more deformation than the 0° profile. The deformation is relatively symmetrical with respect to the 0°/180° plane. The shape of the failure is approximately oval, measuring 0.49 m by 0.25 m. The hole opening corresponds to the material bounded approximately by latitude 66° and 80°, and longitude 110° and 240°. Post-test inspection indicates that the initial failure occurs at approximately 150° longitude/66° latitude. Examination of the pre-test and post test thickness maps of the vessel, Figures 5 and 6, suggests that the failure region corresponds to a region of slightly reduced wall thickness in the pre-test vessel, and the thin section "attracts" deformation during vessel creep.

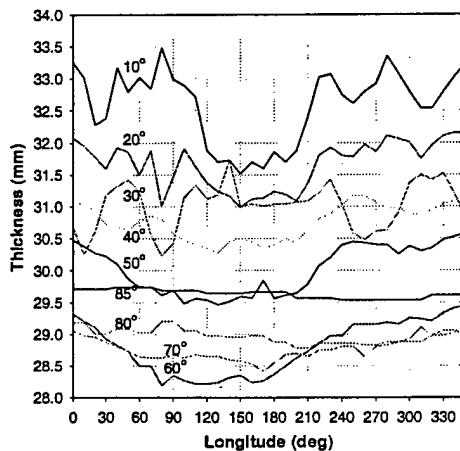
Figure 5. LHF-1 Pre-test thickness map (by latitudinal angle).

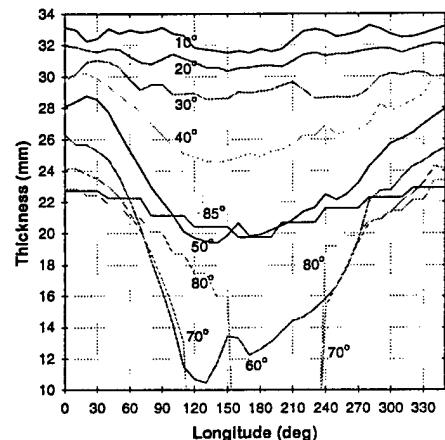
Figure 6. LHF-1 Post-test thickness map (by latitudinal angle).

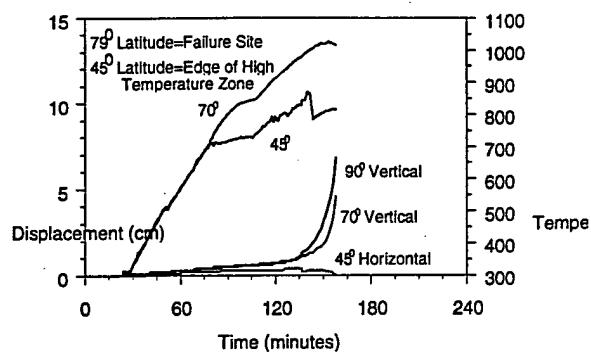
Figure 7. LHF-2 temperature and displacement history.

Representative temperature and displacement histories of the vessel wall during the second run are shown in Figure 7; the displacements shown are values beyond that of the first run (7 cm at 90° and 5 cm at 70°). Figure 8 illustrates the center-peaked vessel temperature profile and the corresponding vessel yield strength distribution. The yield strength is based on a best fit of existing property values as a function of temperature (Pilch et al., 1998). Significant creep occurred at approximately 135 minutes and failure occurred at approximately 160 minutes into the second run. The corresponding wall temperature at creep initiation was in the range of 930-950 K. The vessel temperature at failure was in the range of 1000-1025 K.

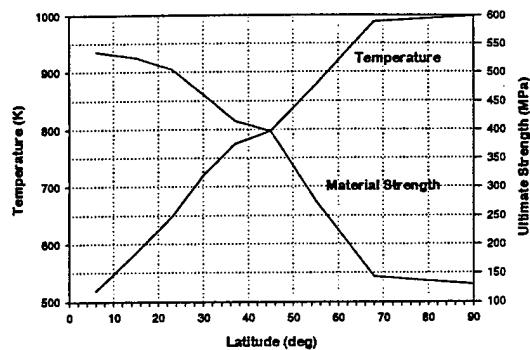
Figure 8. LHF-2 vessel temperature and strength profile.

The overall profile of the posttest vessel, as shown in Figures 9 and 10, was shaped like an inverted top half of a pear. The total vessel deformation was 16.7 cm. There is an inflection point in the 60°-70° region corresponding to the knee in the vessel yield strength profile, Figure 8. The failure is an oval approximately 4 cm by 7 cm, substantially smaller than the 25 cm by 49 cm of the LHF-1 failure. The minimum wall thickness at failure was approximately 3 mm, similar to LHF-1. The failure appeared to have initiated near 77° latitude and 205° longitude, and is bounded between 77° to 79° latitude and 200° to 210° longitude.

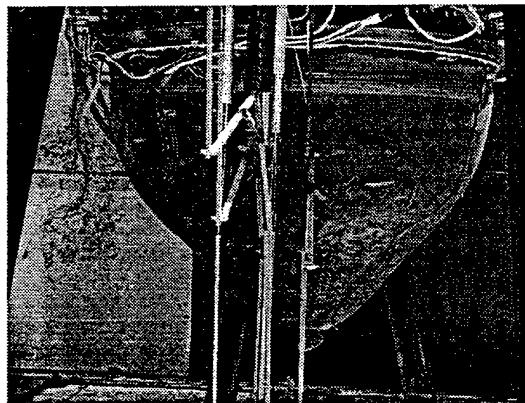
Figure 9. LHF-2 Vessel profile, 180° view - 90°/270° plane.

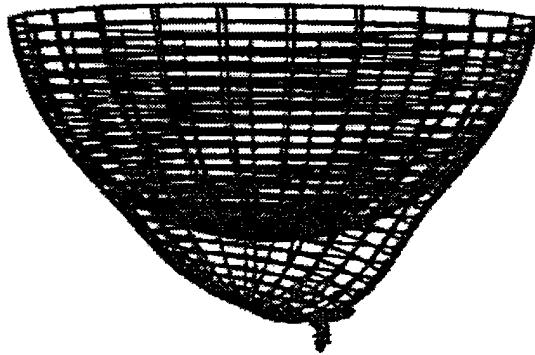
Figure 10. LHF-2 vessel deformation maps.

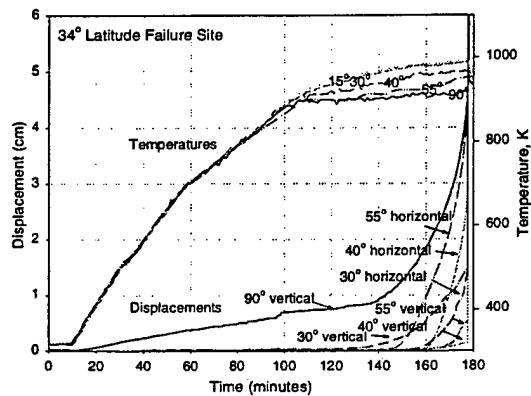
Figure 11. LHF-3 Temperature and displacement history (by longitudinal angle).

are shown in Figure 11. Figure 12 illustrates the edge-peaked vessel temperature profile and the corresponding vessel yield strength distribution. Significant creep occurred at approximately 140 minutes at a peak vessel temperature of 960K and failure occurred at approximately 160 minutes at a peak wall temperature of approximately 1000K. The measured deformation at failure, at the bottom center, was about 5 cm. The failure of LHF-3 is a nearly perfect latitudinal rip at 33.5°, coinciding with the location of the temperature peak, see Figure 13. The rip spans approximately 70° between 310° and 20° longitude. From the deformation of the grid pattern it is also quite obvious that the region of large strain is confined to materials surrounding the rip. An examination of the pre-test vessel thickness mapping indicated a region of reduced thickness between 250° and 360° longitude for the 30° to 40° latitude region of the vessel. There is a 50° overlap between the thin-wall region (250°-360°) and the failure region (310°-20°). It is interesting to note that the circumferential distribution of the peak temperature is uniform within 10K, but the low temperature/high strength region is near the 270° longitude. It is plausible that pre-test vessel wall thickness variation is still the precursor of vessel failure but the final failure configuration is modified by the 10K circumferential temperature variation.

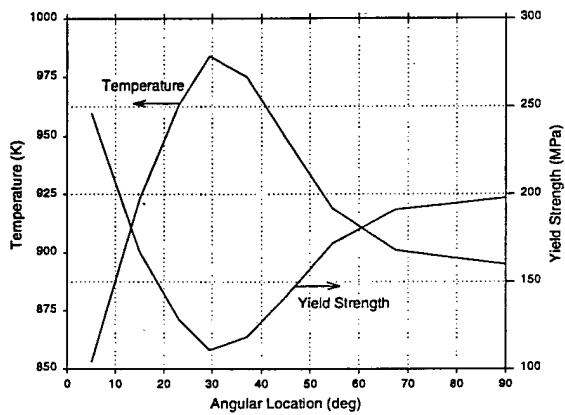
Figure 12. LHF-3 Yield strength Profile at 150 minutes.

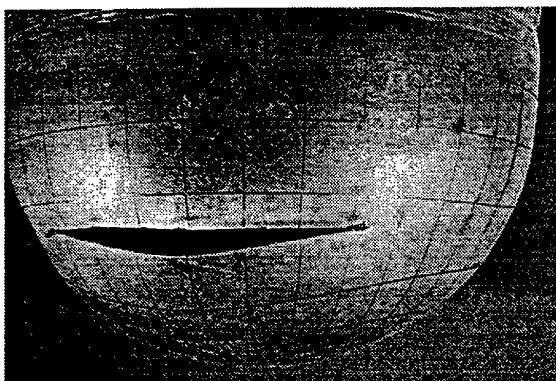
Figure 13. Close-up view of LHF-3 failure.

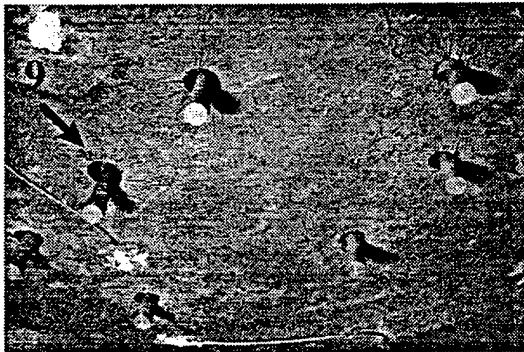
Figure 17. LHF-4 penetration through-hole enlargement.

Post-test examination indicated the failure occurred at penetration #9, located at 73° latitude, see Figure 17. The through-hole for the penetration was greatly enlarged, from 8.2 mm to a 1.3 mm by 1.6 mm oval. The neighboring penetrations at 68° latitude and 78° latitude also show similar through-hole deformation. It is interesting to note that these angles overlap the LHF-1 failure zone (66° to 80°). A comparison of the pre-test and post-test appearance of the weld indicates that failure occurred at the weld-fillet/vessel interface, see Figure 18. Apparently, the large global deformation of the vessel simply pulled apart the weld. Since Inconel has higher strength at elevated temperature, it is reasonable

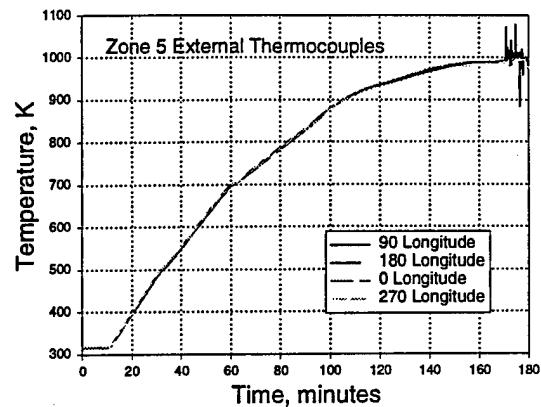
Figure 14. LHF-3 wall temperature history at four circumferential locations near the peak temperature region.

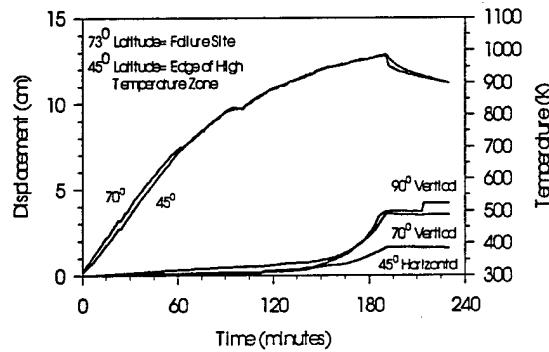
Figure 16. LHF-4 temperature and displacement history.

The temperature and displacement histories of LHF-4 are shown in Figure 16. The heating history of the vessel was designed to be comparable to LHF-1. Due to a failure of heater zone 3, the actual heating rate was slightly slower than that of LHF-1. Creep initiation was observed 140 min into the experiment at a vessel temperature of approximately 930K. This temperature is consistent with the creep initiation temperature observed in LHF-1. The vessel developed a leak at 190 min into the experiment, at a vessel temperature between 970K (at 68° latitude) and 980K (at 90° latitude). The total deformation at the time of vessel failure was approximately 4 cm or about 8% strain. This is substantially smaller than the 12 cm, 25% strain observed in LHF-1.

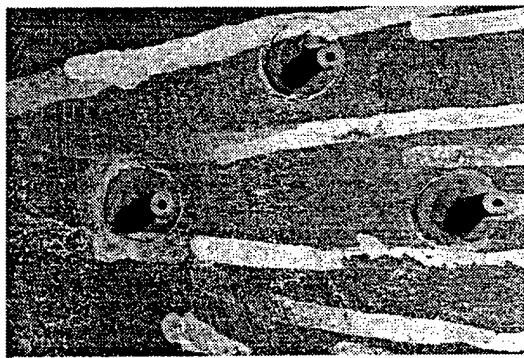
Figure 18. LHF-4 penetration weld (post-test).

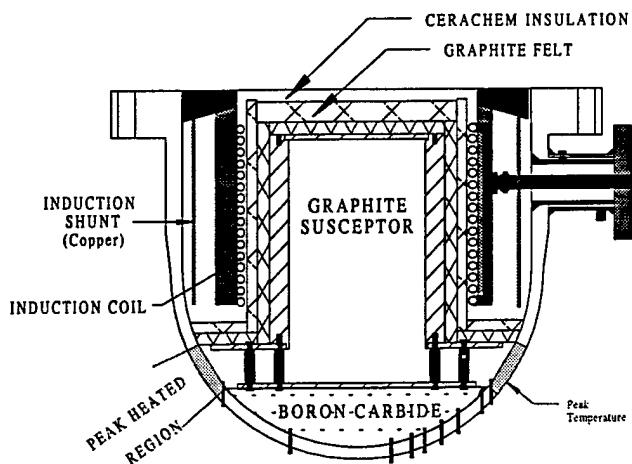
Figure 19. LHF-5 experimental design.

LHF-5 made use of an induction heated graphite radiating cavity located within the test vessel, see Figure 19. The cavity consists of a "top hat" supported on a 12.7 mm graphite base plate using 16, 8.9 cm high, 25-mm-diameter graphite spacers. The cylindrical section of the top hat is heated by induction. Thermal radiation escaped through the 8.9 cm gap between the rim of the top hat and the base plate is used achieve the edge-peak heat flux profile on the lower head.

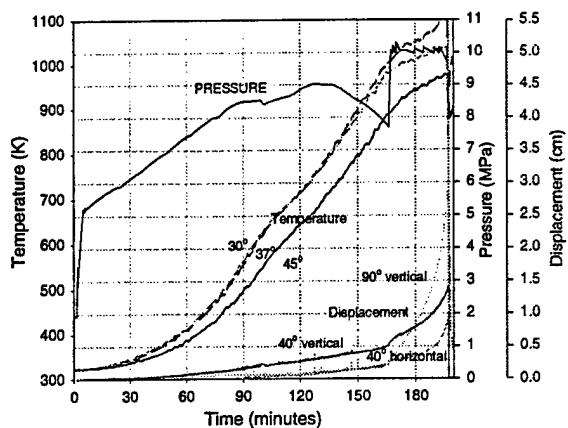
Figure 20. LHF-5 vessel Temperature (180° azimuth; 30°, 37°, and 45° latitude), internal pressure, and displacement history.

The temperature, displacement, and pressure histories of LHF-5 are shown in Figure 20. The peak temperature is at 37° latitude. The peak to surrounding temperature contrast for LHF-5 is in the range of 200K; therefore, the normalized (with respect to yield stress at temperature peak) yield stress profile has a sharper minimum as compared to LHF-3, Figure 21. It appears that the test apparatus developed a slight leak at approximately 120 minutes into the experiment resulting in a gradual decrease in internal pressure from 9 MPa to 7.7 MPa at about 165 minutes. The pressure was brought up to the desired pressure of 10 MPa within 1.1 minutes. This increase in pressure resulted in a slight but noticeable (≈ 1 mm) response in the displacement transducer. Judging from the displacement measurement at 90°, vessel creep initiated at or slightly after the vessel pressure was increased to 10 MPa; the corresponding vessel temperature was 940K at 0° longitude and 1000K at 180° longitude. After creep initiation, the vessel continued to deform at an accelerated rate as the peak vessel temperature increased. The vessel ruptured at approximately 200 minutes into the experiment. The vessel temperature at failure was in the range of 1030K-1120K, with the maximum vessel temperature at 180° longitude. The overall vertical deformation at the time of failure was approximately 4 cm, comparable to the 5 cm observed in LHF-3.

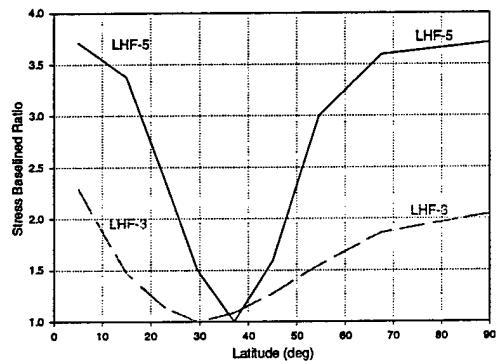
Figure 21. Comparison of latitudinal yield stress profile for LHF-3 and LHF-5.

LHF-3 and LHF-5 both had side-peaked heat flux distribution. LHF-3 vessel failed with a partial rip and LHF-5 vessel was almost completely severed. The key difference is the relative magnitudes of hoop stress and the vessel yield stress at the time of creep initiation. The nominal hoop stress in the vessel wall for 10 MPa internal pressure is 75 MPa. At creep initiation LHF-3 was in the range of 960-970K; the corresponding yield stress is 120-127 MPa. In LHF-5, because of the delay in full pressurization, at creep initiation, the vessel temperature was in the range of 980-1025K, the corresponding yield stress was in the range of 70-110 MPa.

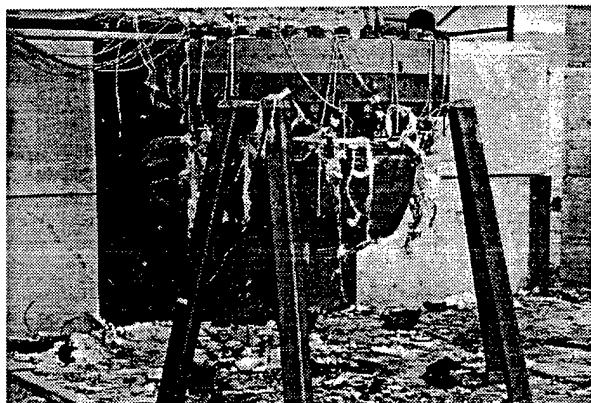
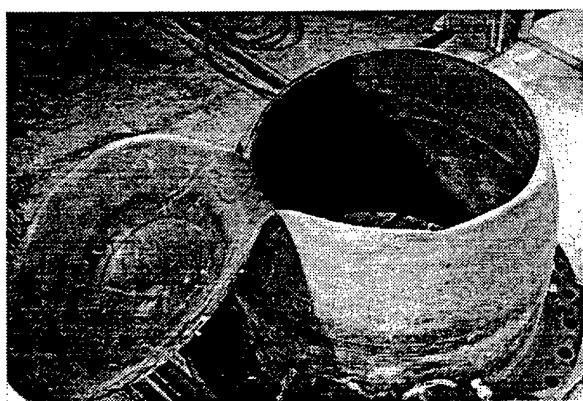
Figure 22. LHF-5 Post-test view.

Figure 23. LHF-5 Post-test view.

As shown in Figures 22 and 23, the vessel failed with a horizontal rip at 37° latitude. The location of the rip appears to be coincidental with the circular locus of the peak temperature at 37° latitude. Post-test inspection indicated that vessel failure initiated at approximately 200° longitude quite near the region of maximum vessel temperature. The failure propagated in both directions for approximately 160° to 165°. Only the 5° to 40° section remained attached. The vessel thickness at the region of initial failure was between 3 mm and 4 mm, and increased monotonically along the tear, reaching approximately 11 mm near the termination of the tear. Both penetrations at 41° latitude (closest penetrations to the peak temperature location) suffered weld failure, see Figure 24. However, the penetrations were sufficiently far from the failure site, they were unlikely to have contributed to the failure.
