HIGH EFFICIENCY FILTER BURNING
HUMIDITY TESTS
FOR PROJECT CGI - 791
IPD CONFINEMENT PROGRAM

J. H. PALMER, Supervisor

POWER AND GENERAL MAINTENANCE
CHEMICAL PROCESSING DEPARTMENT

HIGH EFFICIENCY FILTER BURNING, HUMIDITY, AND DOP TESTING

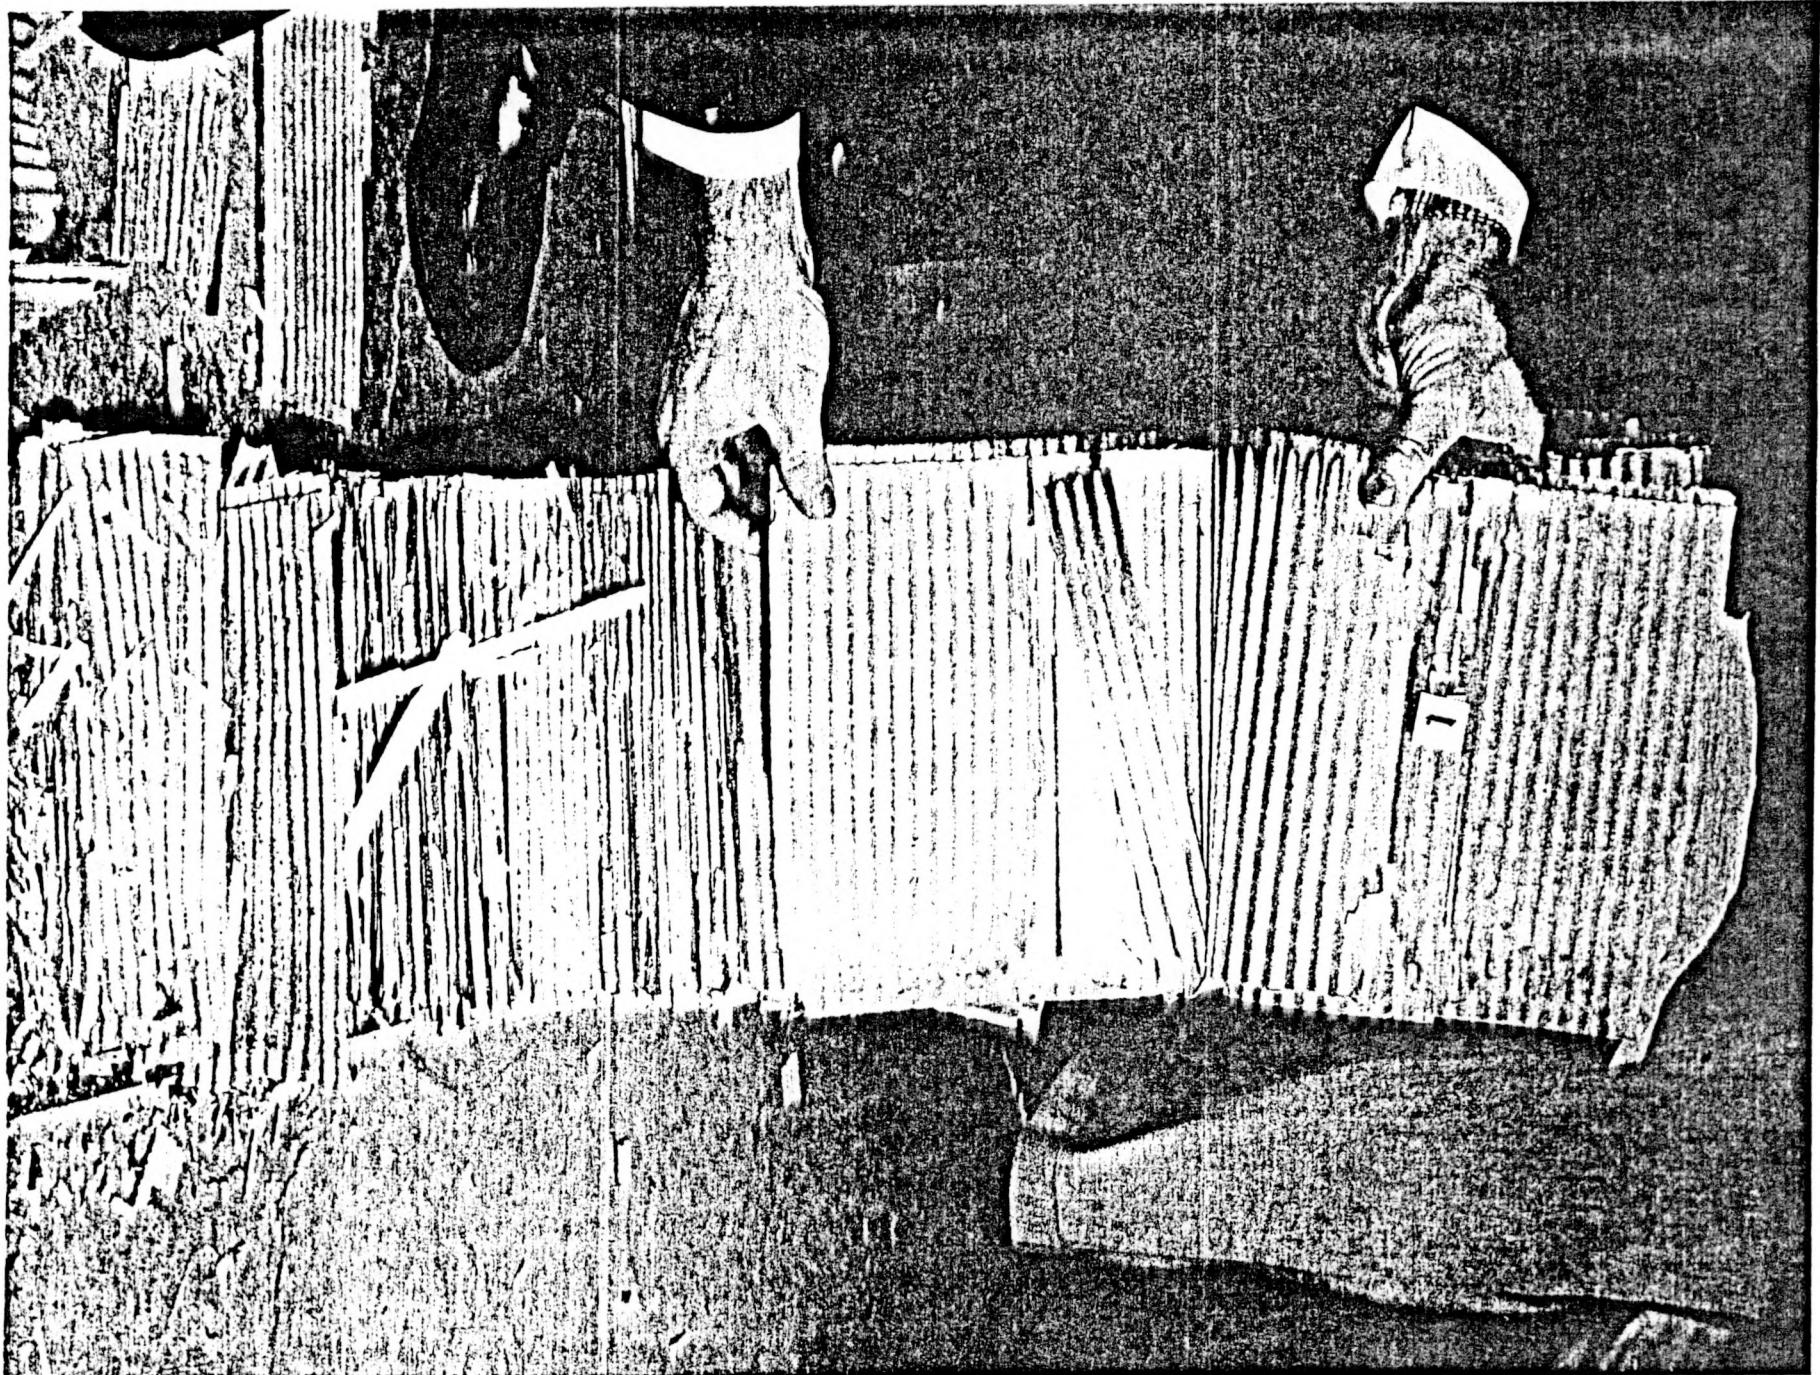
PICTURE NO. 5

(same filter)

Filter has been opened up. Note globules of glass
adhering to the separators.

It is again emphasized that once exposed to fire, this type filter has lost efficiency and should be replaced immediately.
