# Tests of Isothermal Soaking Procedures for Limiting Tube Denting in Nuclear Steam Generators

NP-1761  
Research Project 623-2

Interim Report, April 1981

COMBUSTION ENGINEERING, INC.  
Nuclear Power Systems  
1000 Prospect Hill Road  
Windsor, Connecticut 06095

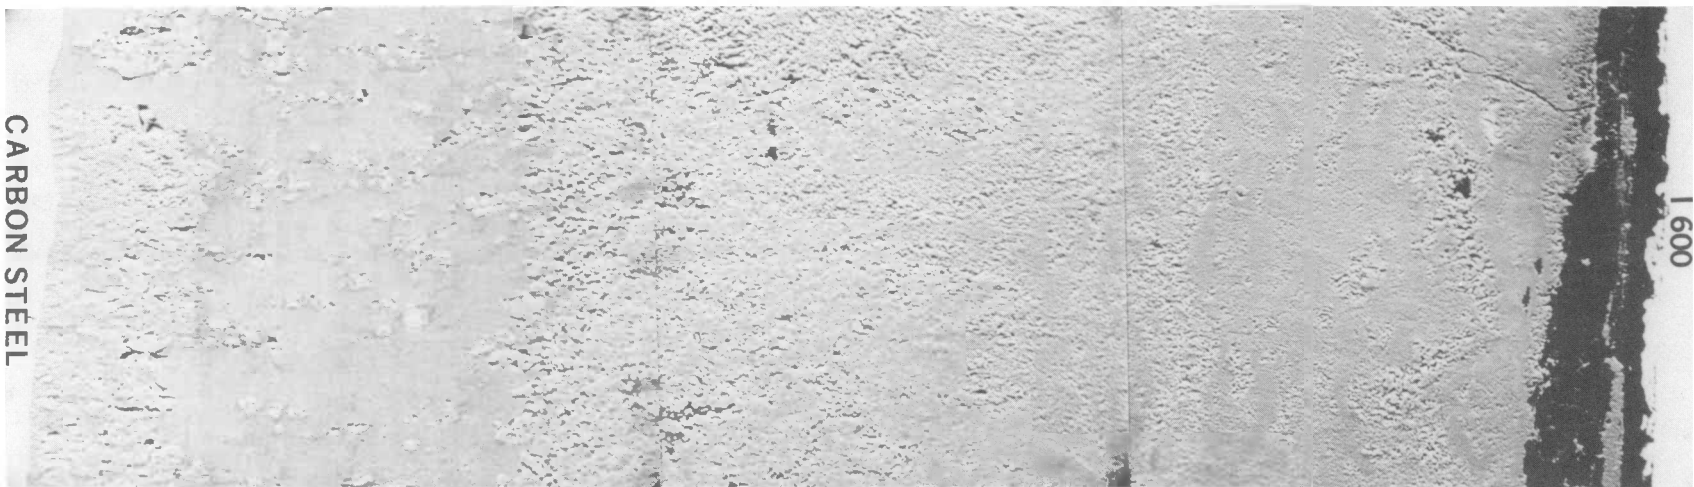
Figure E-58. SEM and Cl X-Ray Map from the Top of Support Plate Specimen H-7E-4-K (150X)\*
