# NBS TECHNICAL NOTE **1134**

## **Guidelines for the Installation of Solar Components on Low-Sloped Roofs**

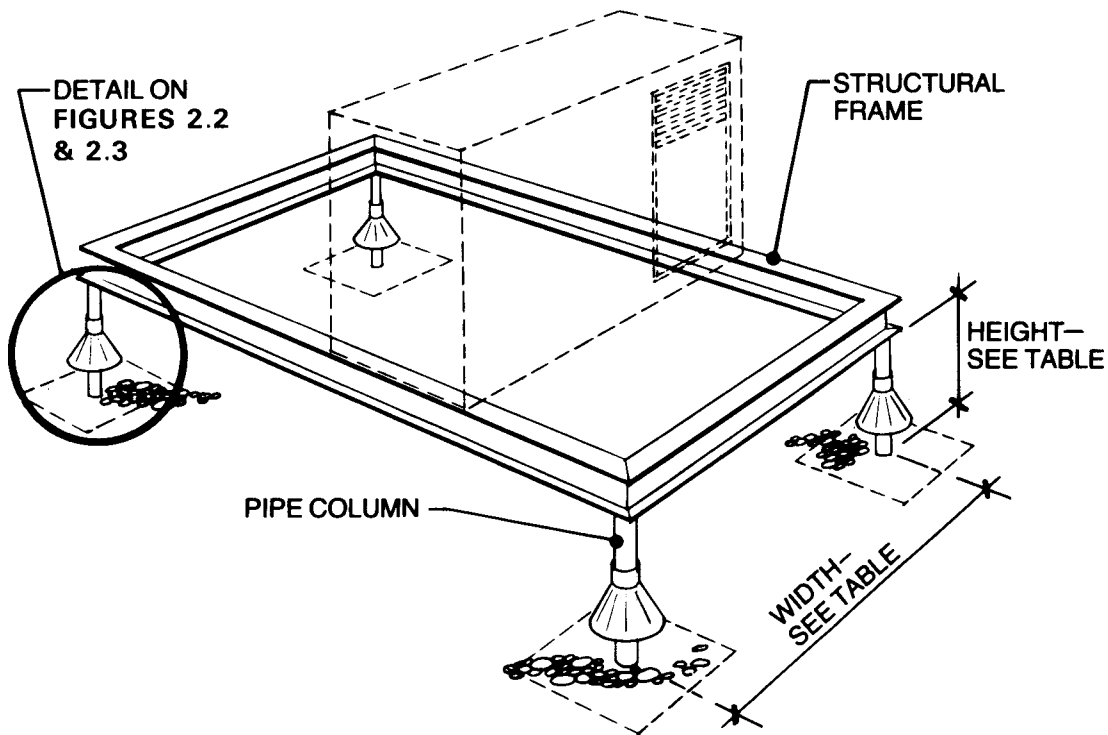
Figure 2.1 Installation for Mechanical Equipment Stand or Collector Support Frame

WIDTH OF EQUIPMENT	HEIGHT OF LEGS
UP TO 24"	14"
25" TO 36"	18"
37" TO 48"	24"
49" TO 60"	30"
61" AND WIDER	48"

The National Roofing Contractor Association (NRCA) has recommended minimum clearances between equipment frames (stands) and roof surfaces to allow for proper roofing. The NRCA recommended clearances vary according to the width of the equipment frame, as shown in Table 2.1 and Figure 2.1. The provision for minimum clearance given in these guidelines is based on the NRCA recommended clearances. In general, the widths of frames supporting solar collectors range from about 3 to 5 feet (0.9 to 1.5 m). If collector frames having other widths are installed, the clearance under the frames may vary according to the NRCA recommendations. The minimum recommended distances for adequate clearance may be less than the 24 to 30 inches (600-750 mm) if provisions are provided for easy removal of the collectors (Section 2.1.1).

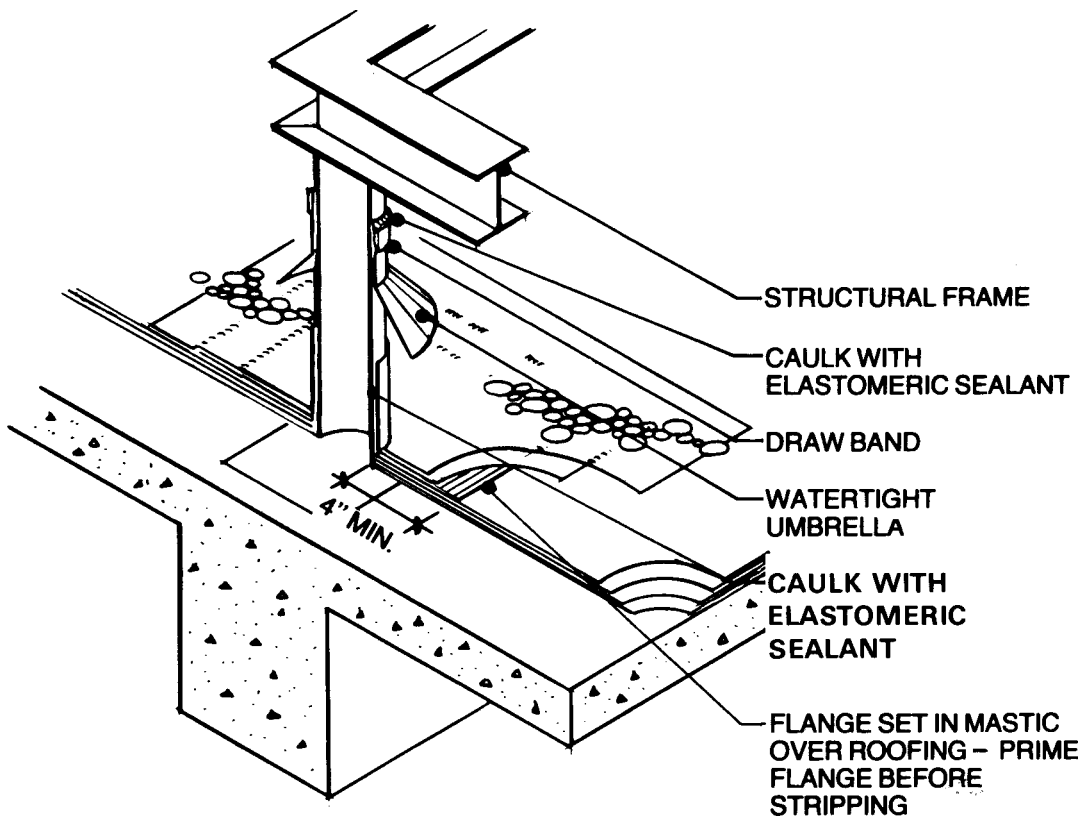
Figure 2.3 Detail of Column Support for Collector  
 Frame on Concrete Structural Deck

**NBS NOTE:**  
 Present roofing practice normally includes insulation  
 in the roofing system.

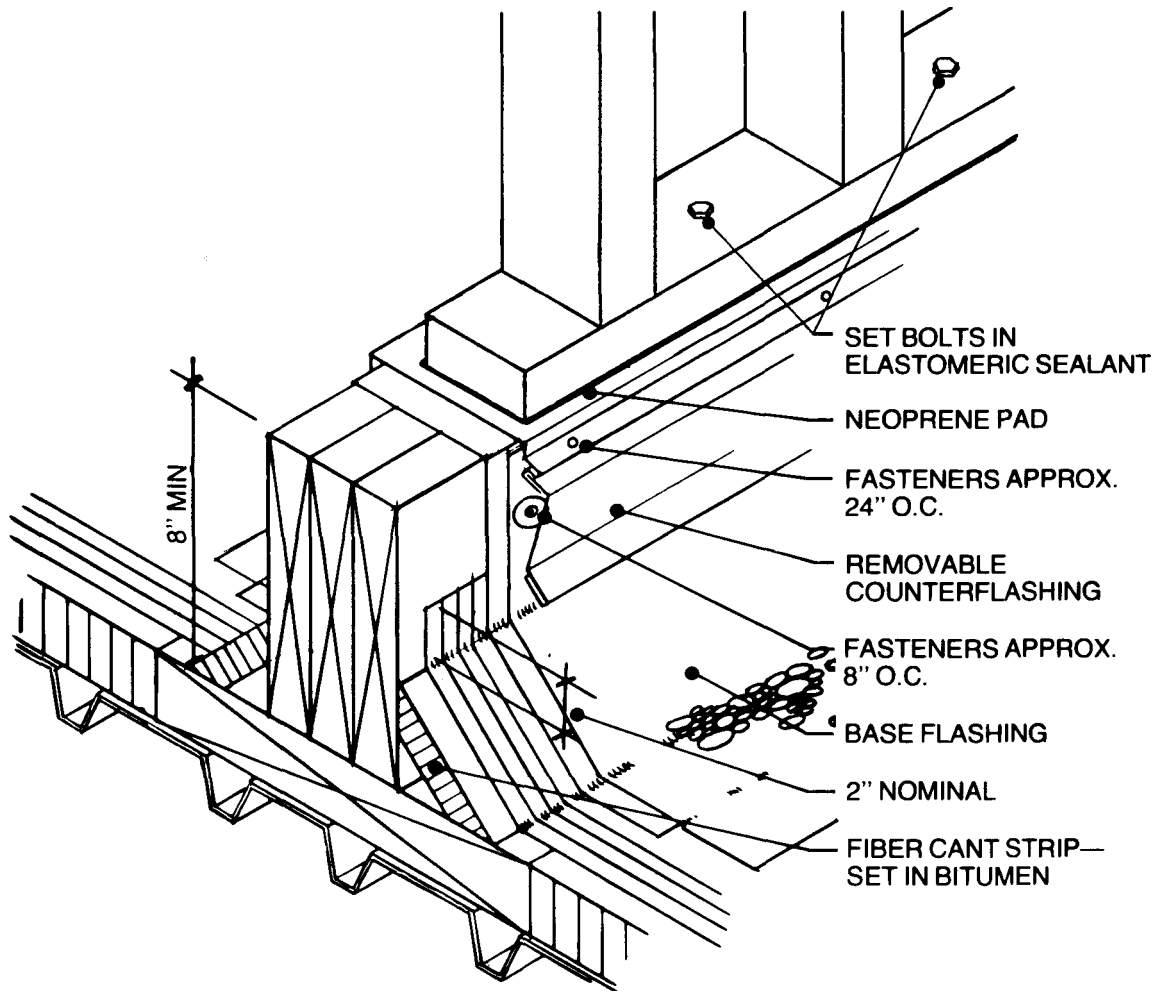
Figure 2.4 Installation of Wooden Supports for Collector Frame on a Solid Curb

This detail allows for roof maintenance around the equipment or sign. The continuous support is preferred in light weight roof systems since the equipment weight can be spread over more supporting members. Where heavy structural systems are used or where the load can be concentrated over a column detail "N" (Figures 2.1, 2.2 & 2.3) is preferred. Clearance must be provided for removal and replacement of roofing and flashing between parallel supports.

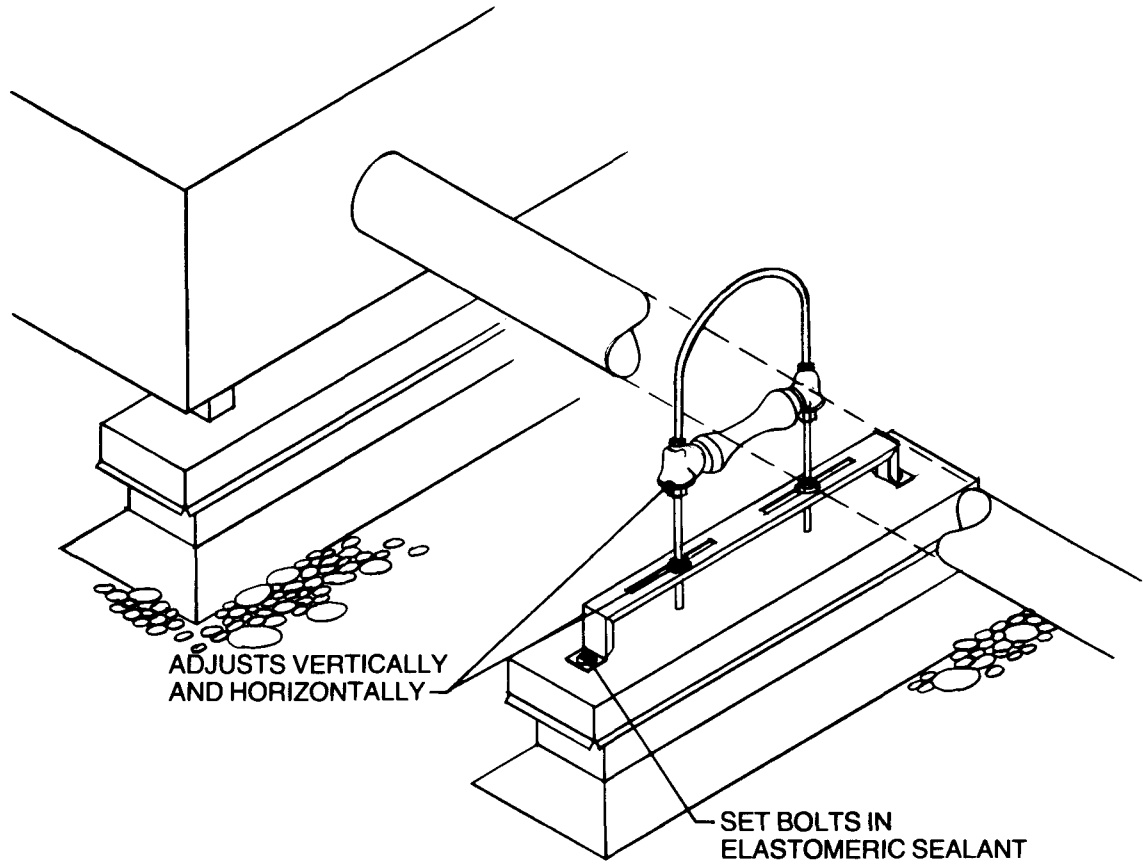
**This detail allows for expansion and contraction of pipes without roof damage. NRCA reaffirms its opposition to pipes and conduits being placed on roofs. However, where they are necessary, this type of pipe roller support is recommended.**

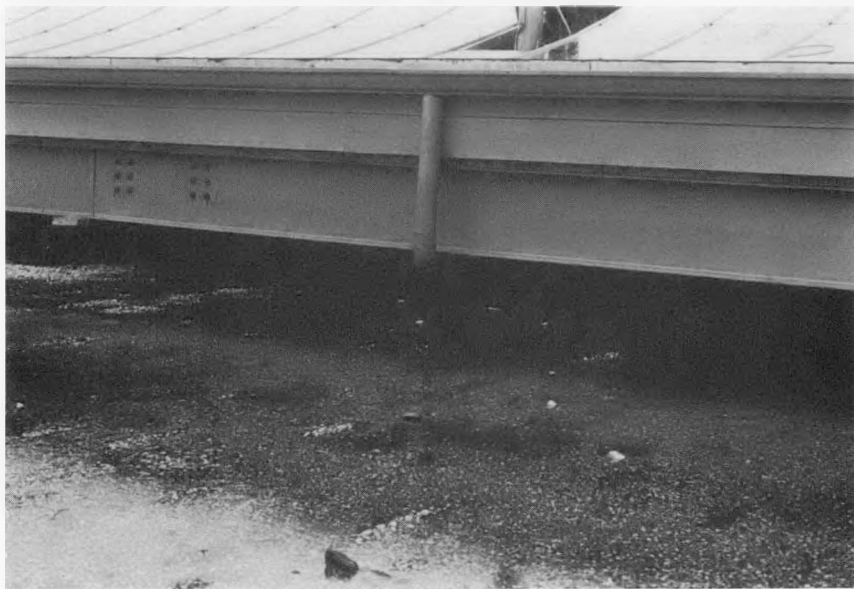
Figure C.3 Ponded Water on Roof Surface Extending Under Large Wooden Platform Supporting Solar Reflectors

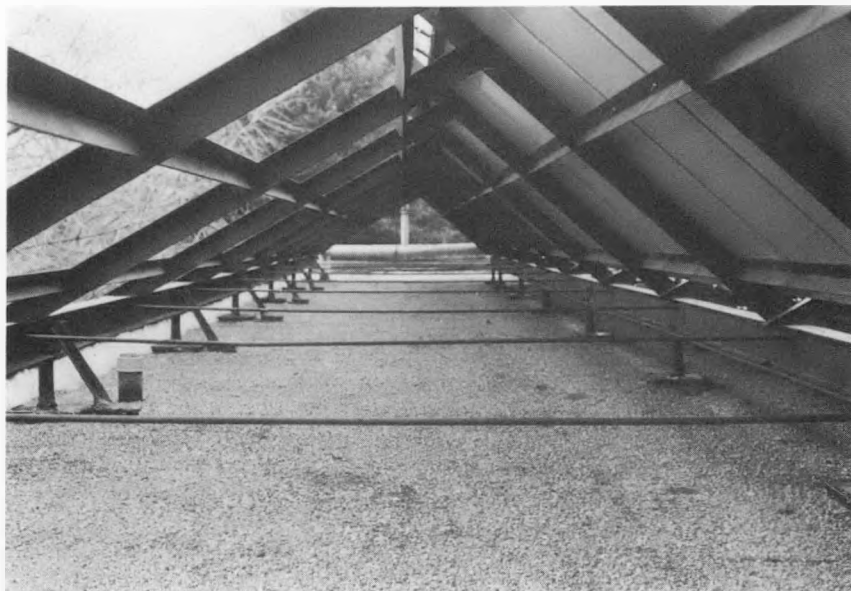
Figure C.4 Steel Columns Extending Through Roofing Support Collector Frames

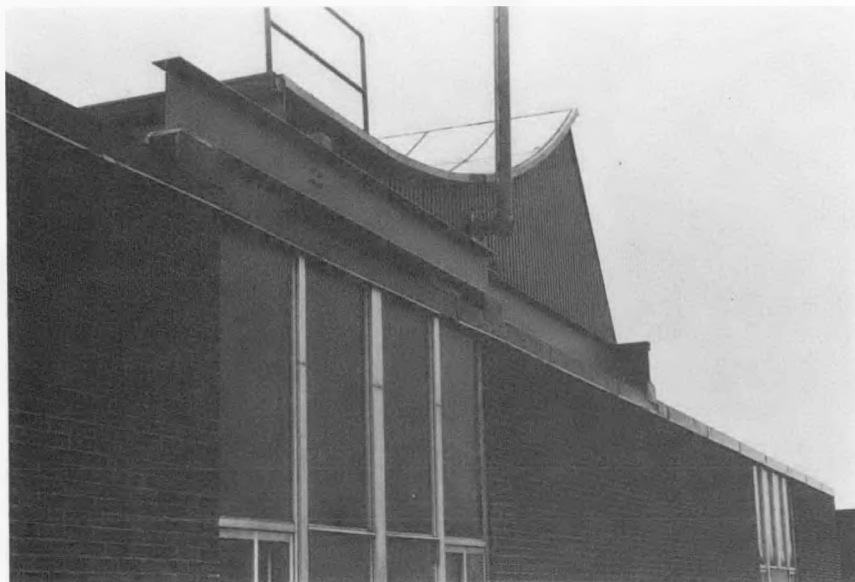
Figure C.6 Large Wooden Reflector Frame Supported by Exterior Walls and Columns of the Building

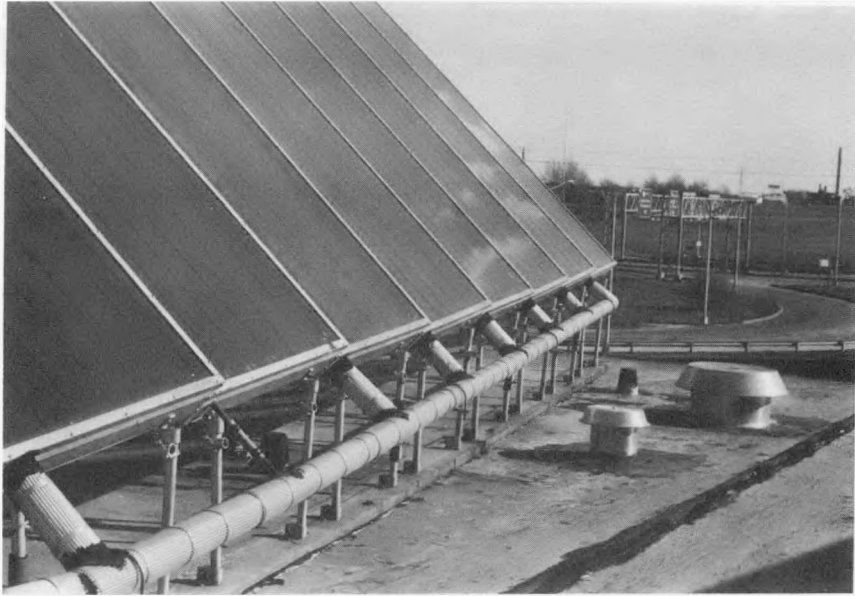
Figure C.7 Collector Frame Supported by Wooden Sleeper Mechanically Fastened to the Roof

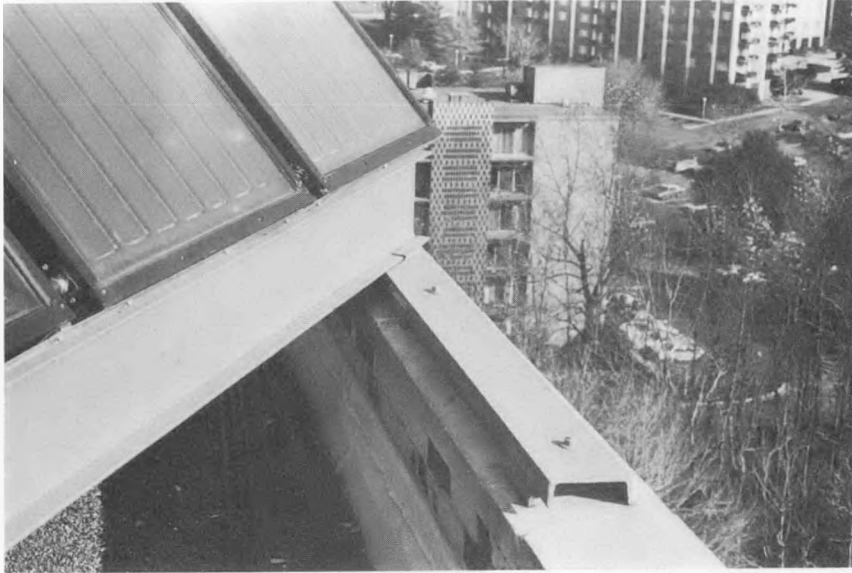
Figure C.9 Attachment of Collector Support Beam Using a Steel Clip Welded to a Channel which is Bolted to a Parapet Wall

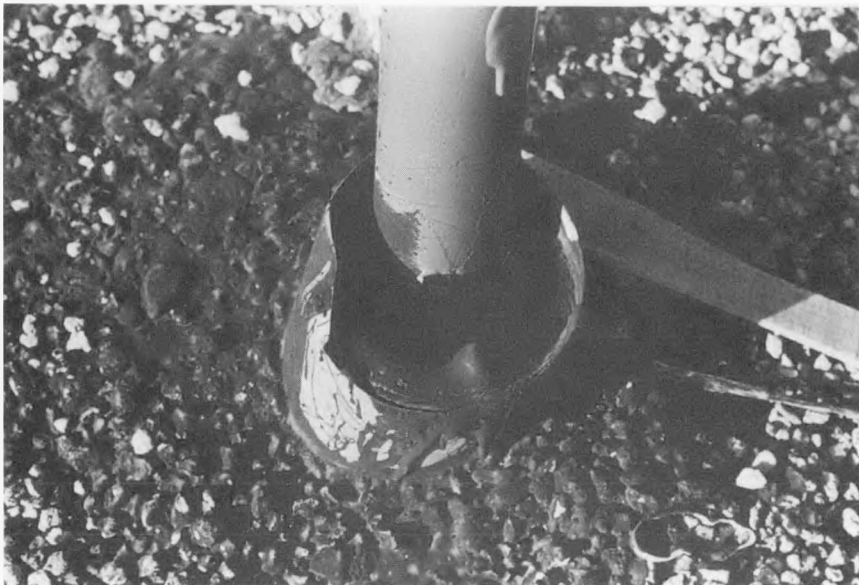
Figure C.10 Collector Support Column in a Tilted Pitch Pocket

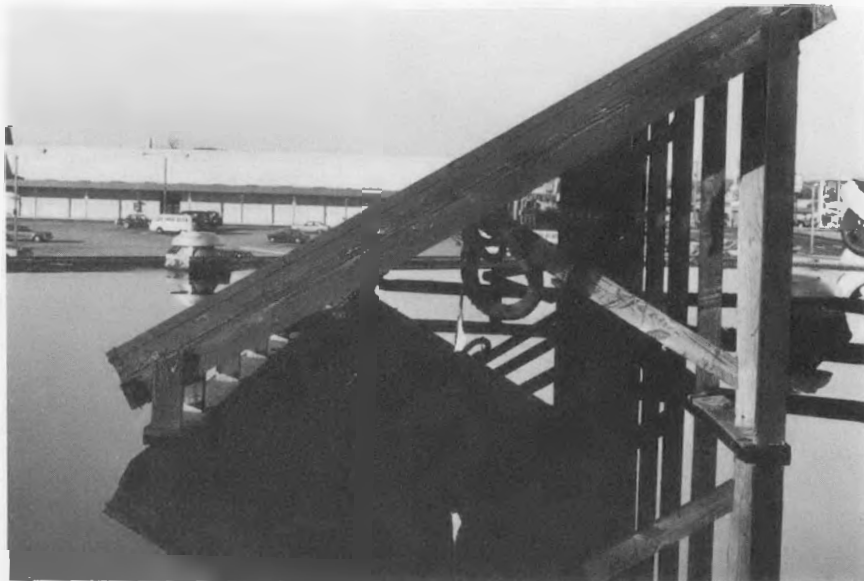
Figure C.12 Ponded Water Above the Bottom Surface of the Wooden Sleepers

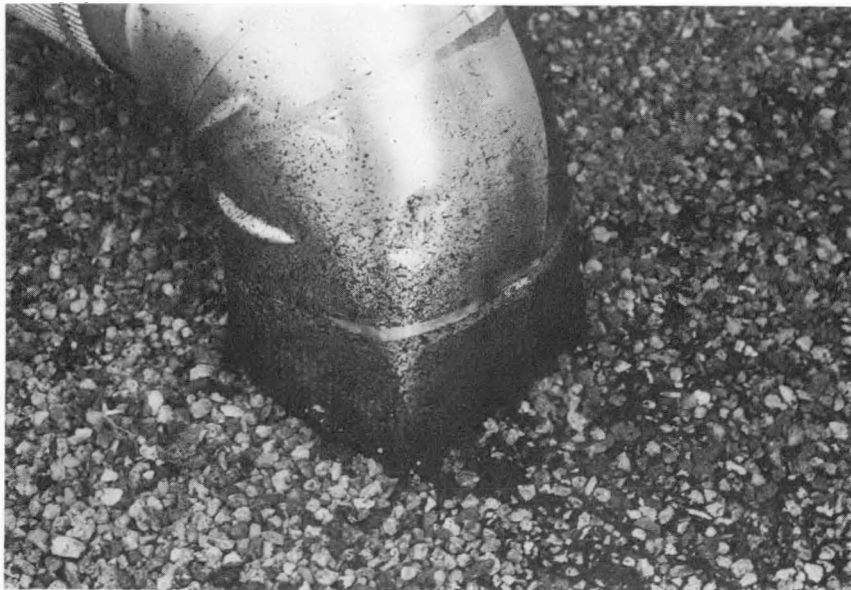
Figure C.14 Pipe Penetration for Which The Type of Flashing was Not Determined

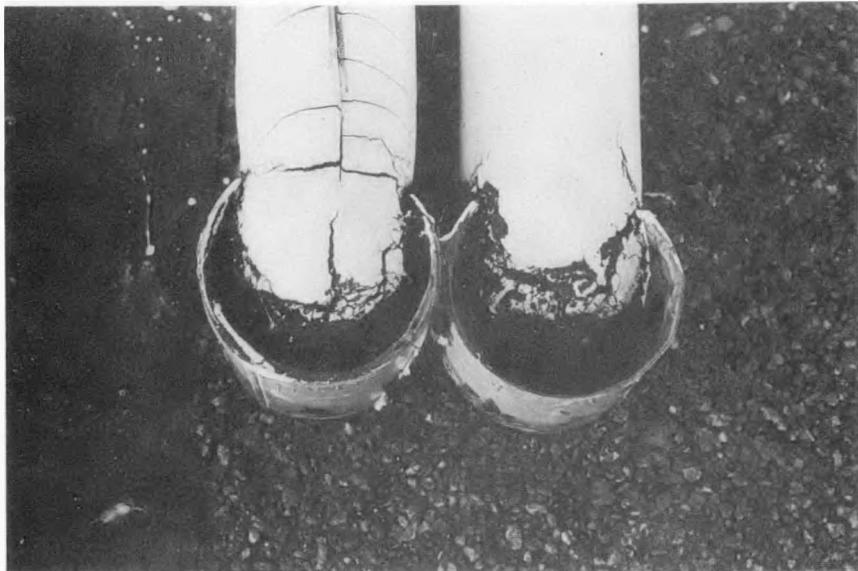
Figure C.16 Pitch Pockets for Pipe Penetrations

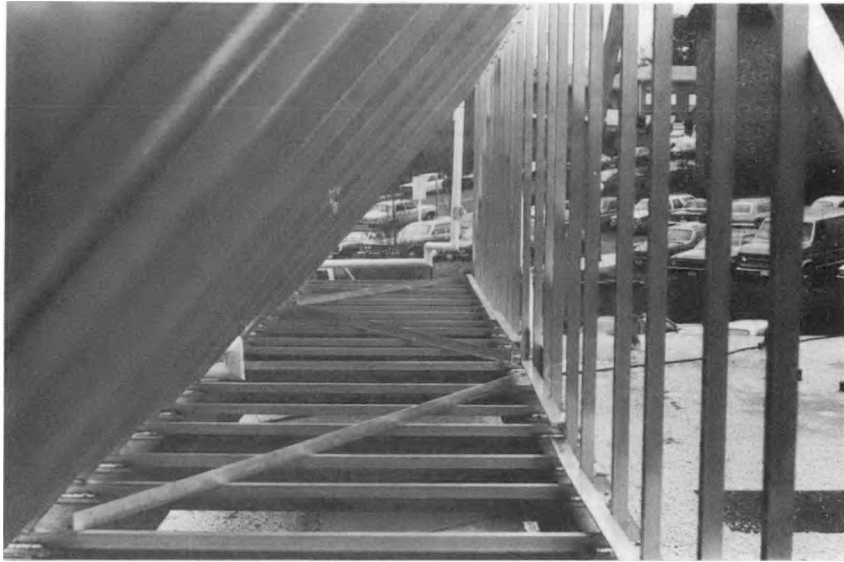
Figure C.17 Inadequate Clearance Between Steel Collector Frames and Roofing

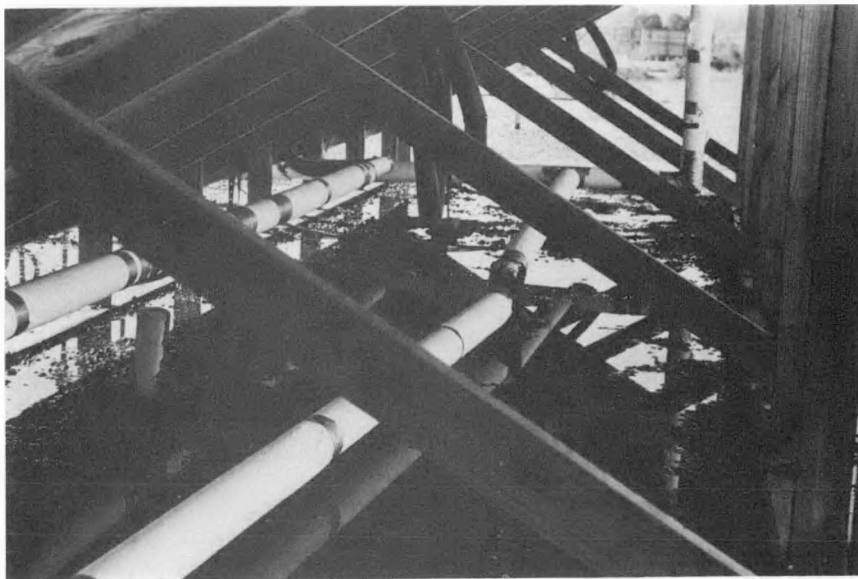
Figure C.18 Inadequate Clearance Between Wooden Collector Frames and Roofing

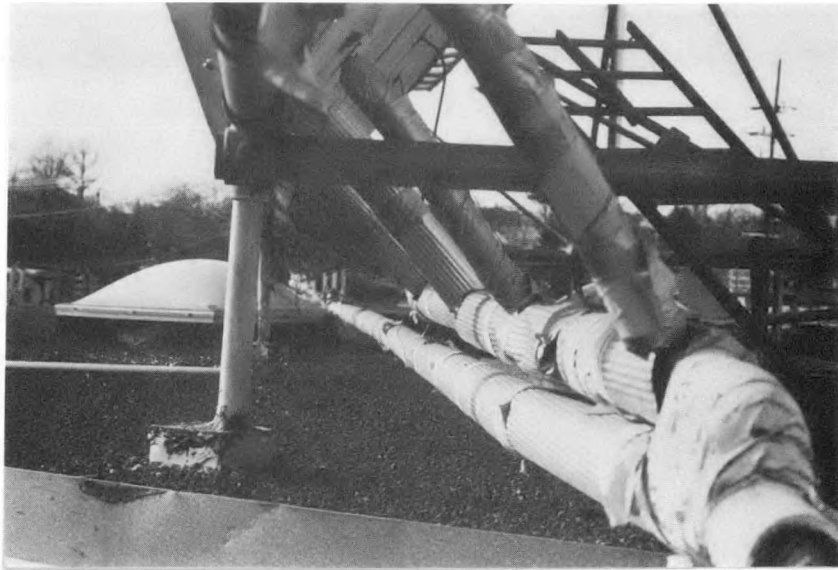
Figure C.19 Piping Located Close to Roof Surface

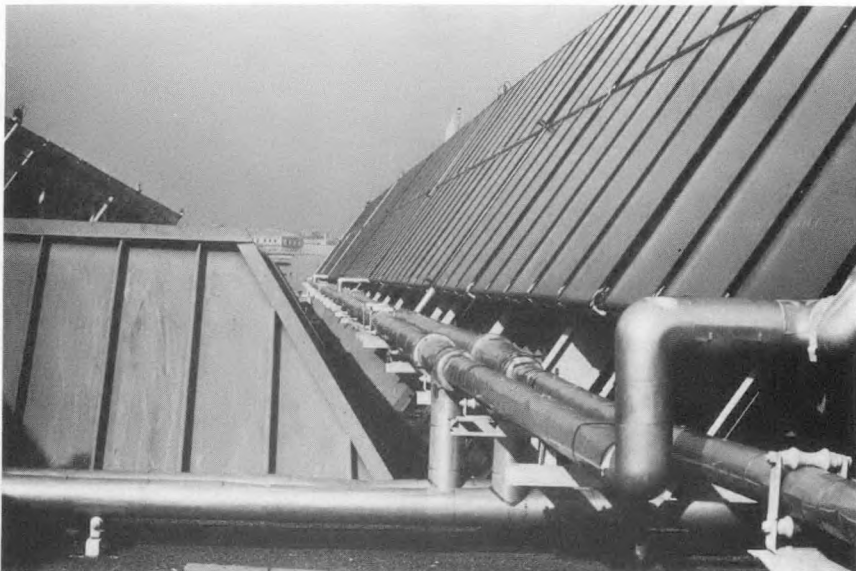
Figure C.20 Inadequate Clearance Between Front of Collector Array and a Mansard Style Roof Projection

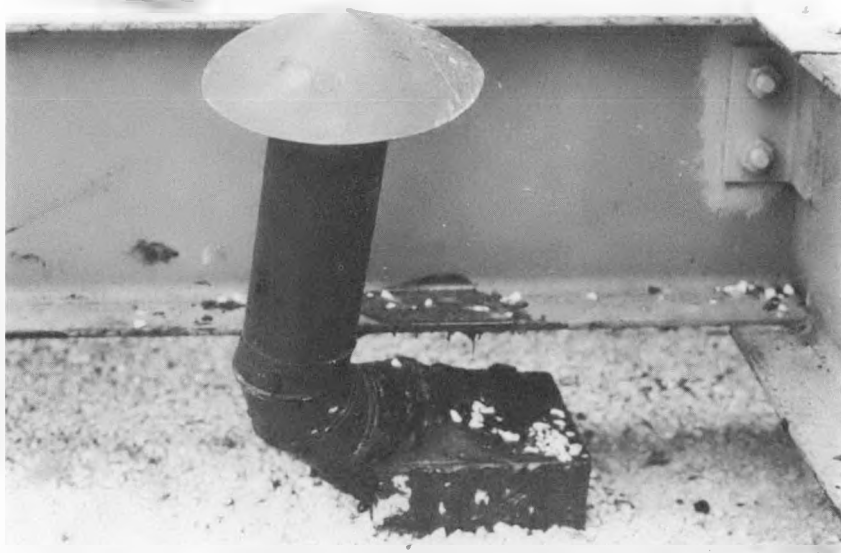
Figure C.21 Vent Pipe Modified to Allow for Solar Collector Installation

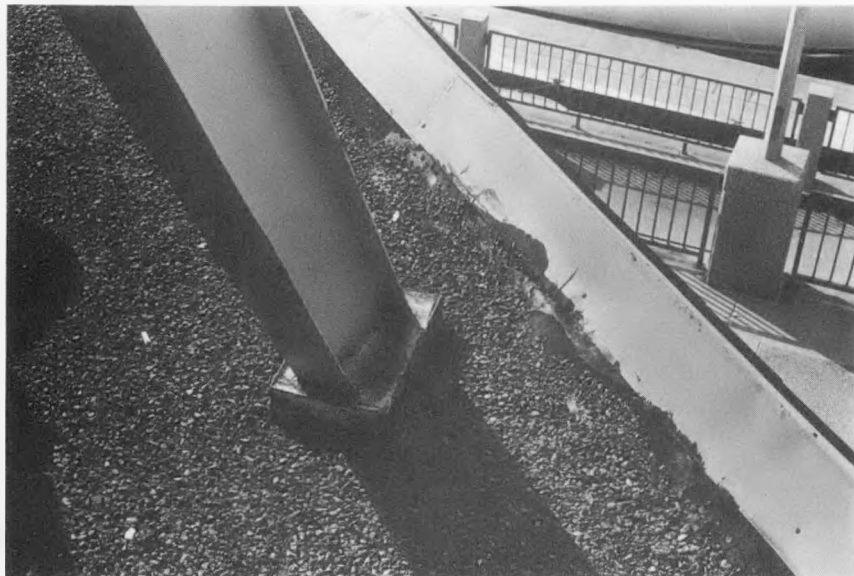
Figure C.24 Solar Penetration Adjacent to the Edge  
of the Roof

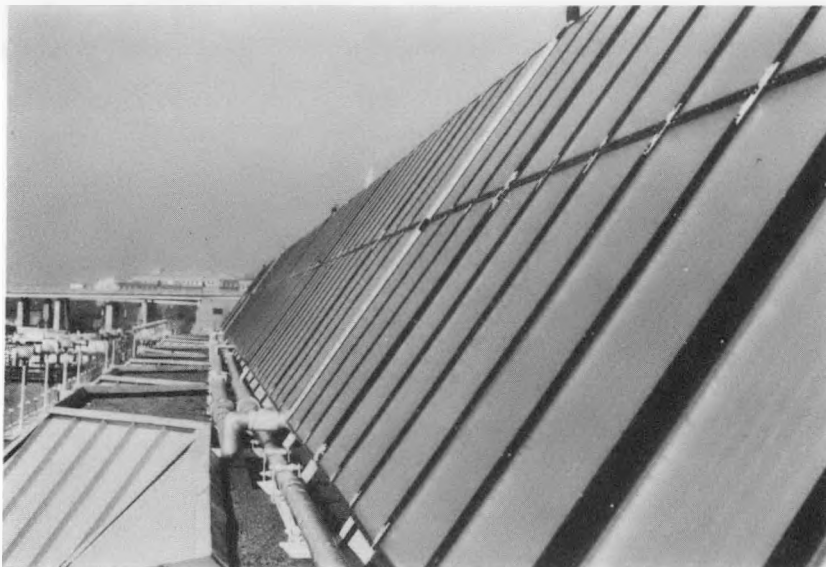
Figure C.27 Collector Array Installed Near Roof Edge

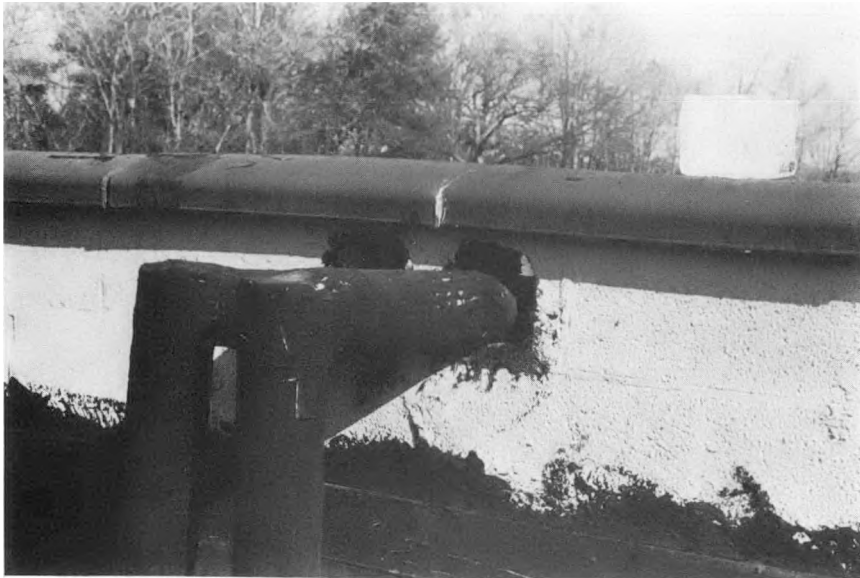
Figure C.29 Fire Wall Penetrated by Solar Piping

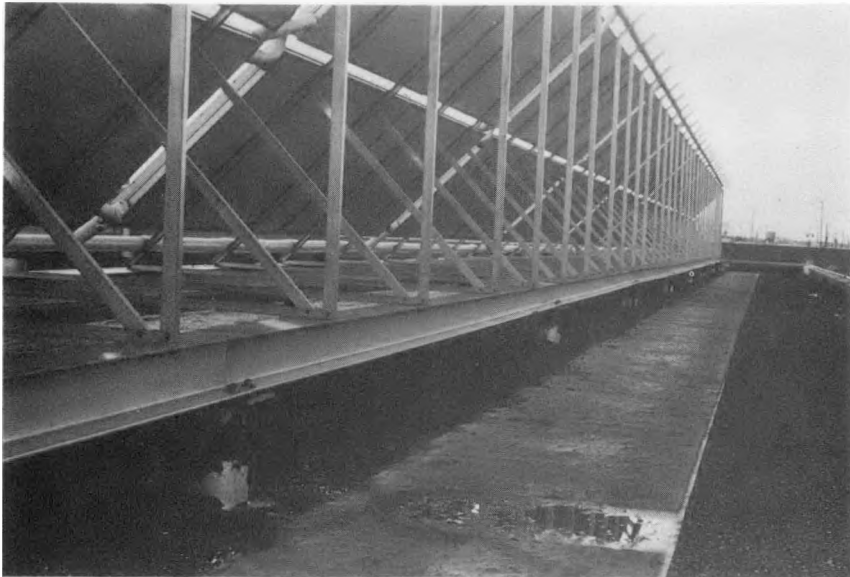
Figure C.31 Coated Felt Walkway on Roofing

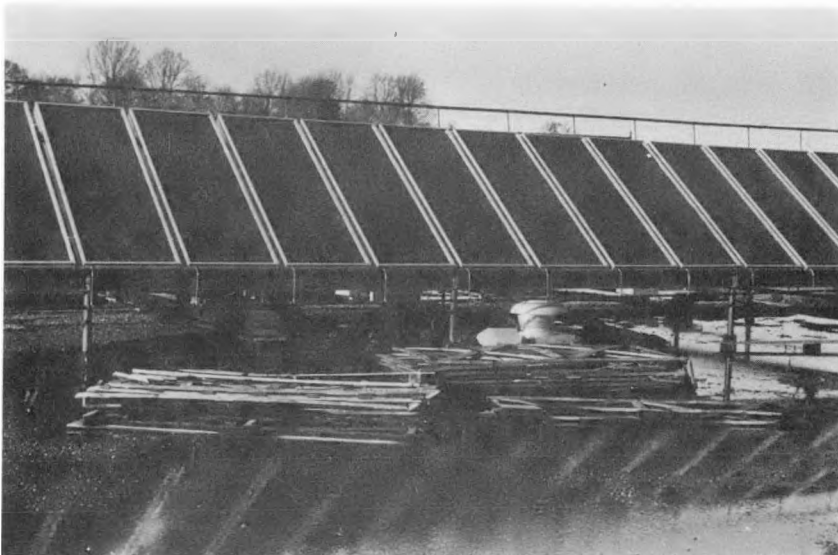
Figure C.34 Debris On Roof from Solar Installation
