Test Report for Core Drilling Ignitability Testing

Key Words: Ignitability, Sampling, Stoichiometric, Hydrogen, USBM, Rotary

TEST REPORT
FOR
CORE DRILLING
IGNITABILITY TESTING

WHC-SD-WM-TRP-257
REV. 0

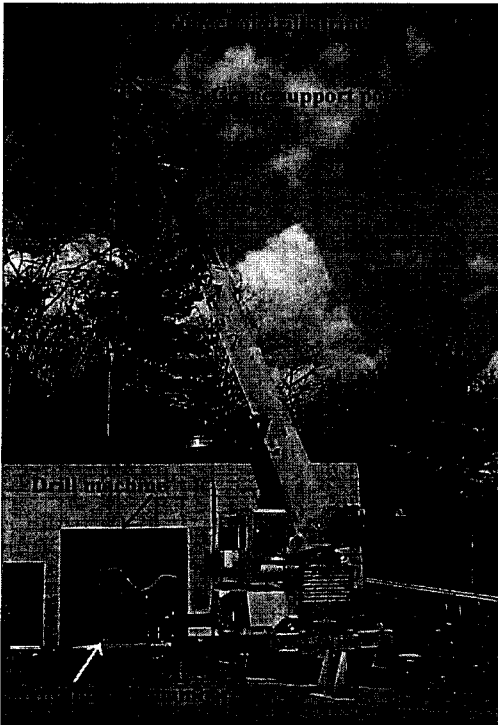
PHOTO 1 - 60 Foot Drop Test Arrangement

The drilling machine used was a Longyear Model 34¹. This testing drill, in its basic form, is the same type of drill installed on the core sampling trucks for field operations. The drill provided both rotational and downward motion for bit testing as well as a support fixture for the 60 foot length of drill string used in the drop tests. Photo 1 shows the 60 foot test arrangement. Notice that the pipe is supported near the bottom using the drill rig and near the top using a mobile crane.
