RELIABILITY OF TERRESTRIAL PHOTOVOLTAIC MODULES AT  
VARIOUS DOE/MIT LINCOLN LABORATORY TEST SITES\*\* \*

S. E. Forman  
M. P. Themelis

Massachusetts Institute of Technology  
Lincoln Laboratory  
Lexington, Massachusetts 02173

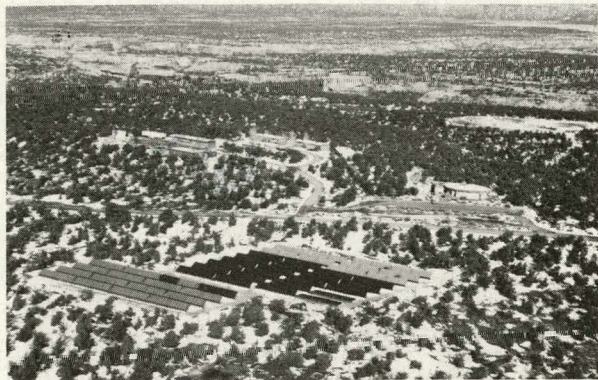
CP267-5524

An aerial view of the array field is shown in Fig. 1. There are 1,740 Model E modules in the front of the array field, 2,064 Model F modules in the center, and 720 Model A modules at the rear. The Models E and F modules were purchased as part of Block III and the Model A modules are from Block II. All three types are glass covered. [Modules were purchased by JPL for DOE in three "Block" buys: I (1975-76); II (1977-78); and III (1979-80).]

Fig. 1. Aerial view of NBNM.

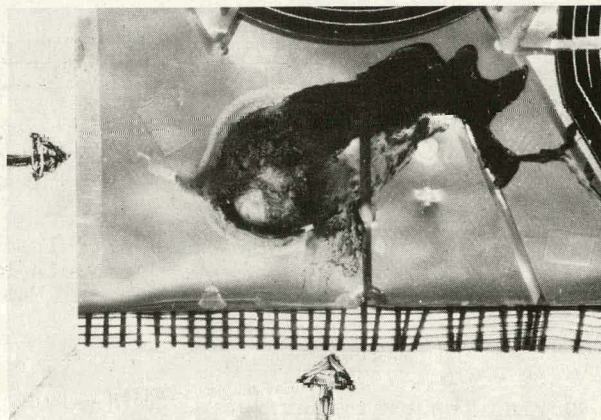
Fig. 2. Shorted Model F module, front side.

Photographs of the damage caused by shorting, to a module in the area of its terminals, are shown in Figs. 2 and 3. In Fig. 2, a large scorch mark is shown under the glass. In Fig. 3, similar scorching is shown about the module terminals on its rear side. Closer examination near the terminals indicates a blast hole through the stainless steel. A better example of the latter condition is shown in Figs. 4 and 5, where two large holes through the substrate can be seen. In two of the 31 failures, arcing and subsequent heat were sufficient to shatter the front glass on the modules.

Destructive analysis of several shorted modules of this type revealed that in each module examined the interconnect foil under the cells contained sharp edges of bare copper which shorted to the substrate during diurnal temperature cycling.

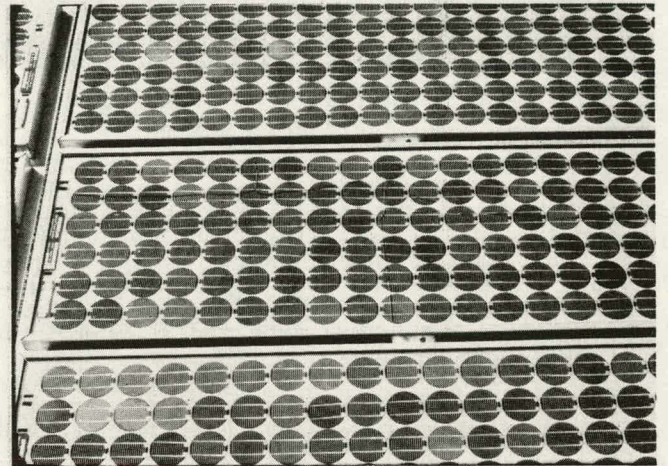
Fig. 6. Cracks in glass cover sheet, Model A.

Shortly after installation (January 1980), it was noted that the glass covers on 25 modules were cracked. During a later visit in March, 27 more modules were found with cracked cover sheets. The cracks always emanated from a long edge of a module. The center module in Fig. 6 illustrates two cracks starting from opposite long edges, running toward the center and then changing direction and running parallel to the long edges. The cracks caused no immediate electrical degradation in the module's output.

Close examination of three modules removed from the site indicated that each crack emanated from a flaw on one of the long edges of the untempered glass. It is believed that the cracks occurred during diurnal temperature cycling which caused excessive tensile stresses at the flaw sites. Subsequent observations in November, 1980, indicated no new cracking, however the PVB along the cracks was starting to yellow due to moisture penetration. The long-term effect of these cracks on module electrical performance is not known.

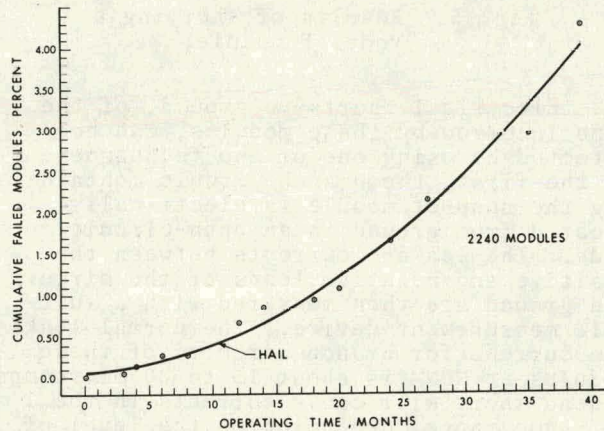
Fig. 8. In-service performance record for Mead PV modules.

The data of Table I are plotted in Fig. 8, where each data point represents the cumulative percentage of failed modules after a particular period of operation. In 39 months of operation, 96 of 2,240 modules (4.28%) have failed. Since the hailstorm of May, 1978, the slope of this curve has been steadily increasing. As indicated in Reference 3, there are still many cracked cells which have not yet caused modules to fail. In order to disrupt current flow, a crack must penetrate through the entire thickness of a cell. This phenomenon can happen in days or years after the initial cracking.

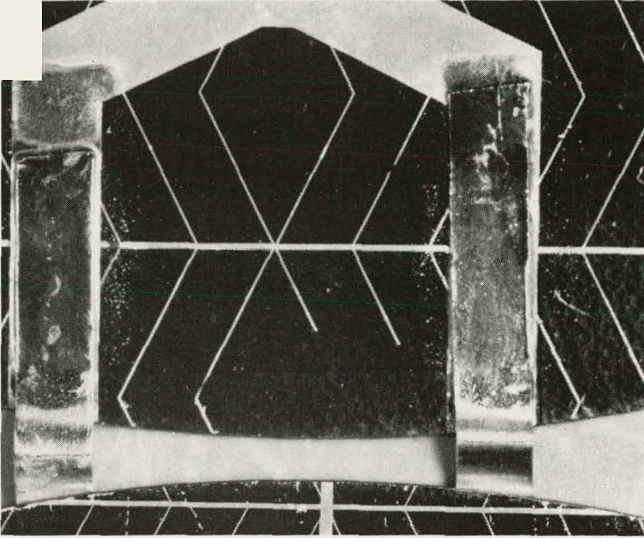
Fig. 9. Model D failure with pair of broken interconnects.

Four of the Model D failures found in 1980 contained a different type of failure mode--a pair of broken interconnects on one cell, as shown in Fig. 9. This type of failure mode has been observed at Bryan, Ohio, and Concord, Massachusetts, in the Block III version of this module. It is caused by differential thermal expansion of the polyester substrate, metal interconnects, and silicon cells which occurs during diurnal temperature cycling. The likelihood of failure is increased when inadequate strain-relief loops are placed on the interconnect.

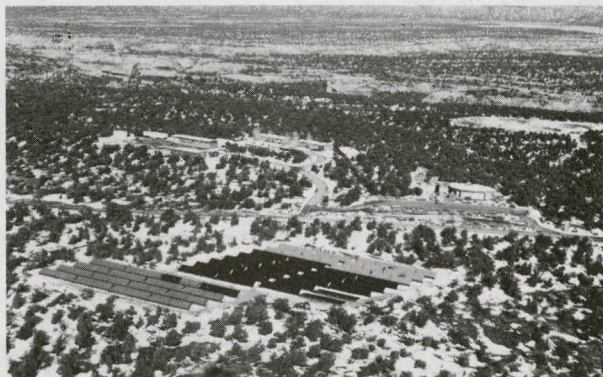
CP267-5524

An aerial view of the array field is shown in Fig. 1. There are 1,740 Model E modules in the front of the array field, 2,064 Model F modules in the center, and 720 Model A modules at the rear. The Models E and F modules were purchased as part of Block III and the Model A modules are from Block II. All three types are glass covered. [Modules were purchased by JPL for DOE in three "Block" buys: I (1975-76); II (1977-78); and III (1979-80).]

Fig. 1. Aerial view of NBNM.

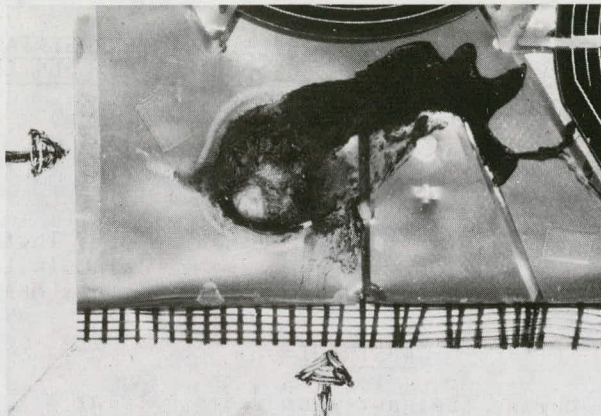
Fig. 2. Shorted Model F module, front side.

Photographs of the damage caused by shorting, to a module in the area of its terminals, are shown in Figs. 2 and 3. In Fig. 2, a large scorch mark is shown under the glass. In Fig. 3, similar scorching is shown about the module terminals on its rear side. Closer examination near the terminals indicates a blast hole through the stainless steel. A better example of the latter condition is shown in Figs. 4 and 5, where two large holes through the substrate can be seen. In two of the 31 failures, arcing and subsequent heat were sufficient to shatter the front glass on the modules.

Destructive analysis of several shorted modules of this type revealed that in each module examined the interconnect foil under the cells contained sharp edges of bare copper which shorted to the substrate during diurnal temperature cycling.
