# USING HISTORICAL AERIAL PHOTOGRAPHY AND SOFTCOPY PHOTOGRAMMETRY FOR WASTE UNIT MAPPING IN L LAKE

Aiken, South Carolina

L. M. Christel  
Project Scientist

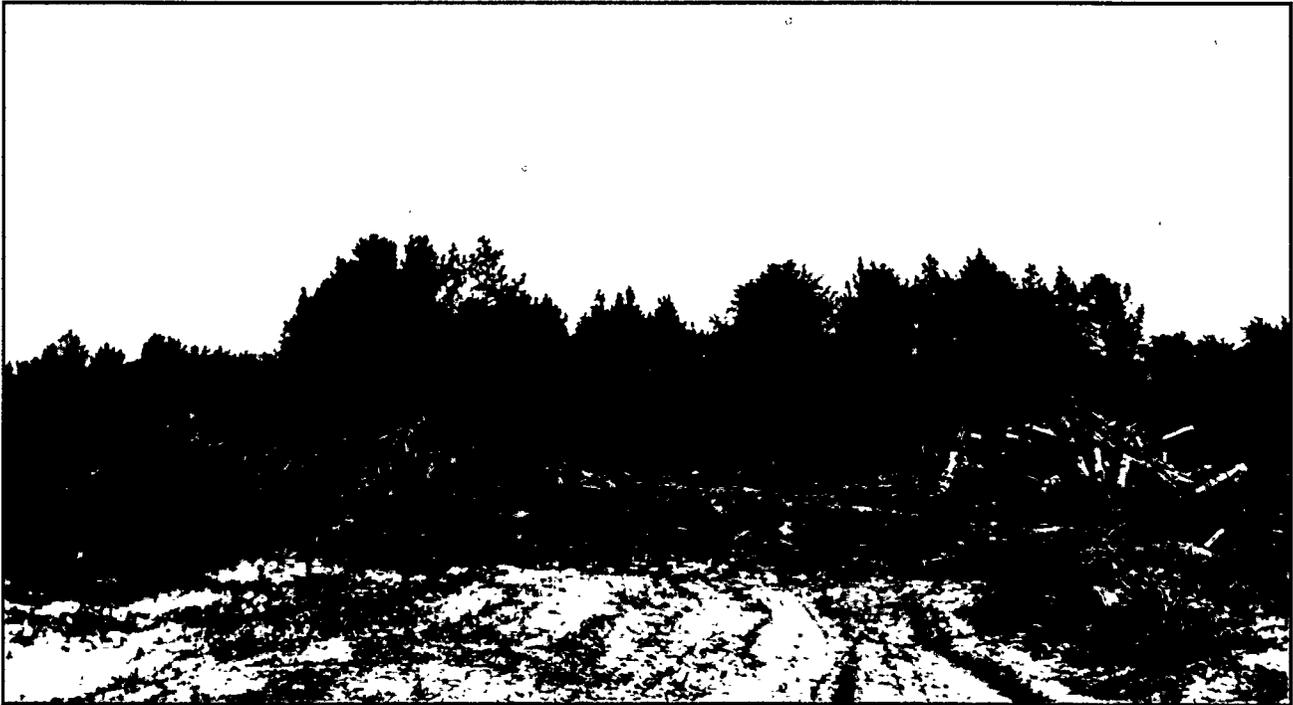
**FIGURE 5. VEGETATION DEBRIS (TOP), CONCRETE BLOCKS (LOWER RIGHT), AND ANCHORED TREE TRUNKS (LOWER LEFT) WERE USED TO FACILITATE HABITAT DEVELOPMENT IN L LAKE.**

*et al.*, 1989). Several of these structures, shown in Figure 5, are evident in the aerial photography used in this report. The filling of L Lake began on September 15, 1985, and the lake reached a normal operating level of 58 meters above MSL on November 4, 1985 (Gladden *et al.*, 1989).
