# Summary Report on Close-Coupled Subsurface Barrier Technology Initial Field Trials to Full-Scale Demonstration

John H. Heiser  
Environmental & Waste Technology Center  
Brookhaven National Laboratory

Brian Dwyer  
Mixed Waste Landfill Integrated Demonstration  
Sandia National Laboratory

**September 1997**

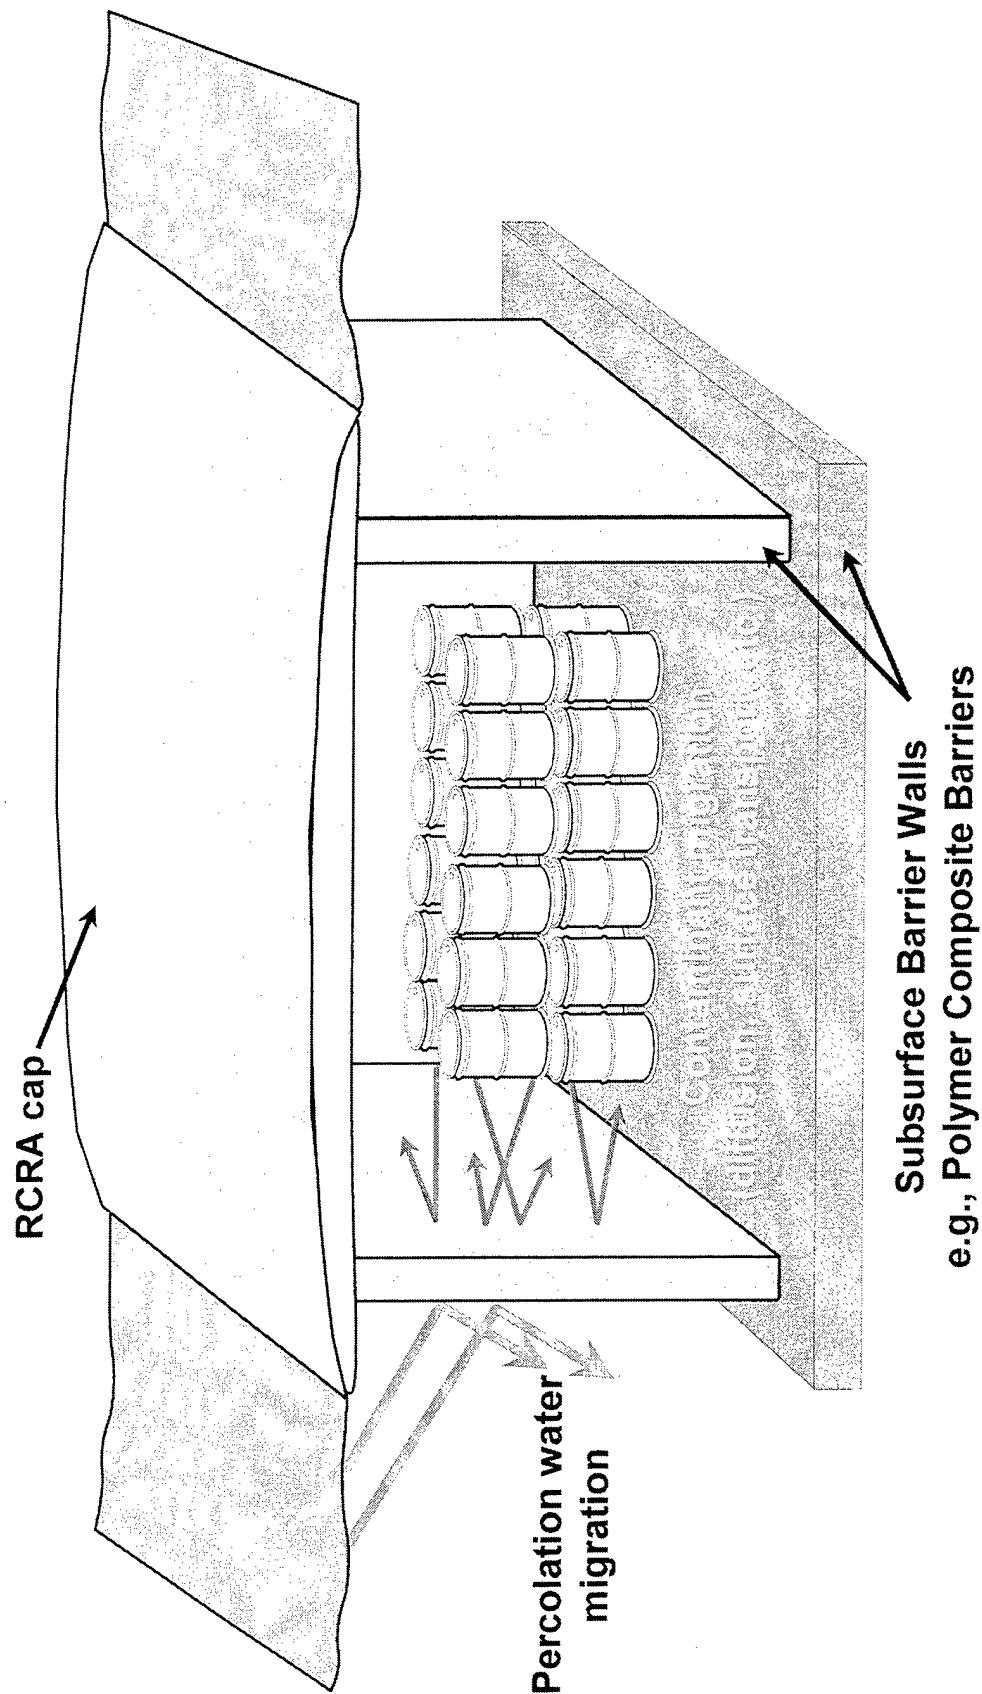
Figure 1.1 Subsurface barriers prevent contamination spread.

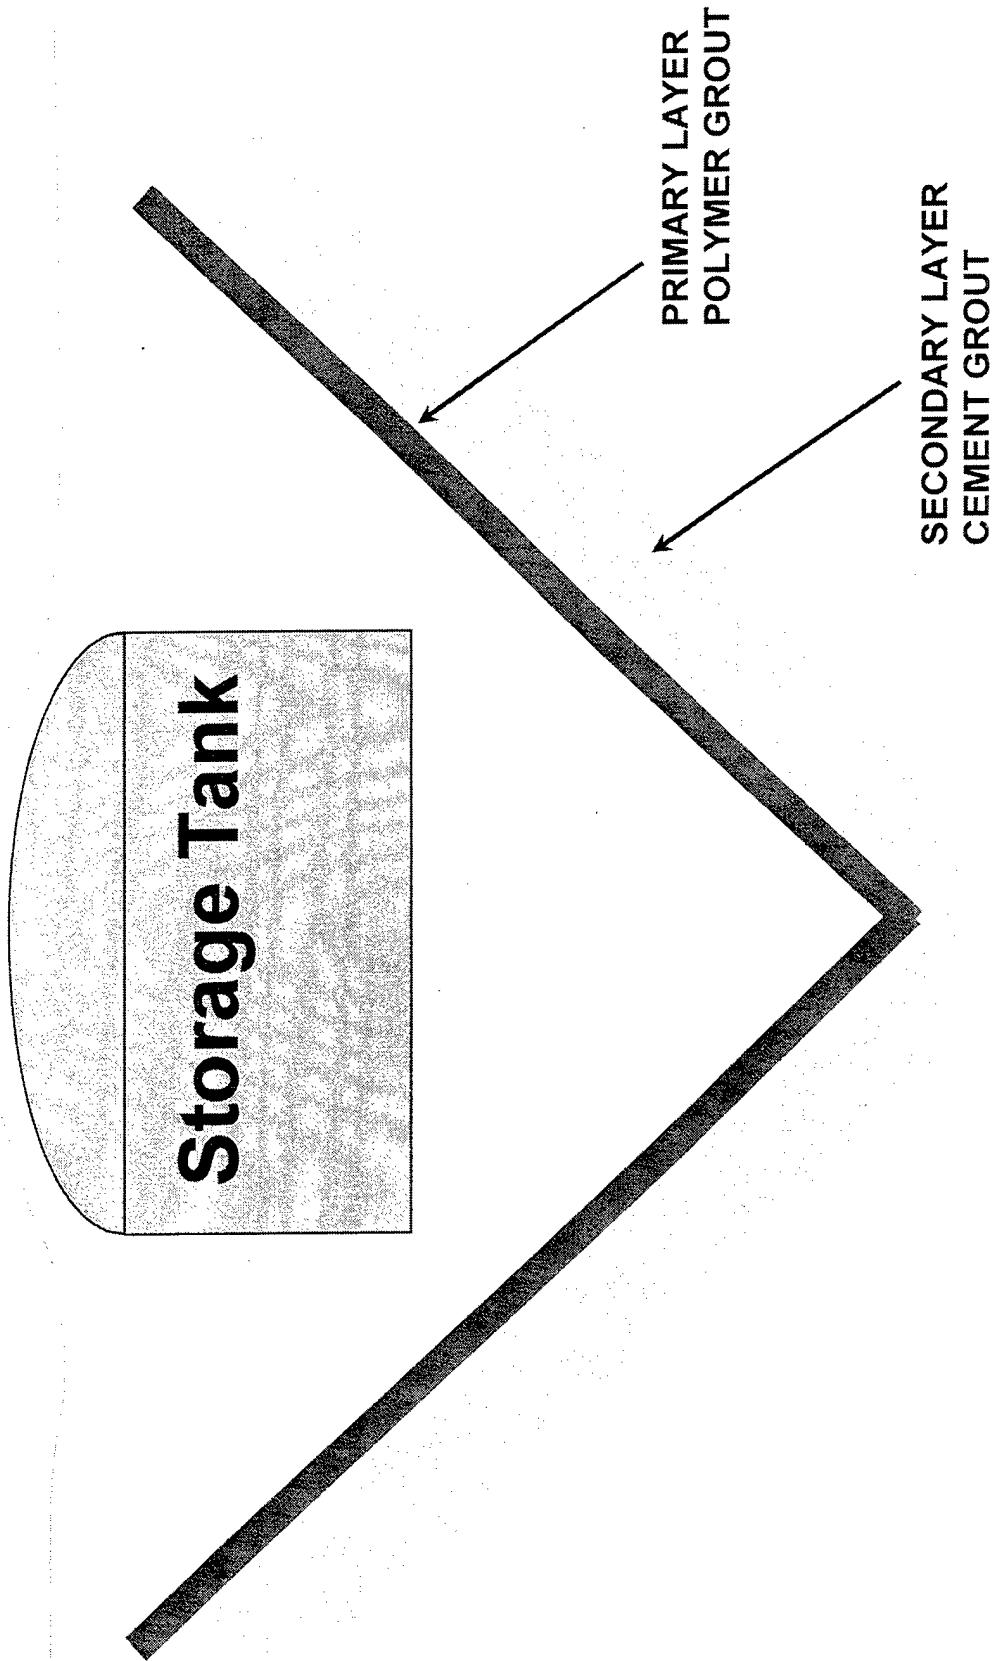
Figure 1.2 Schematic of Close-Coupled Barrier

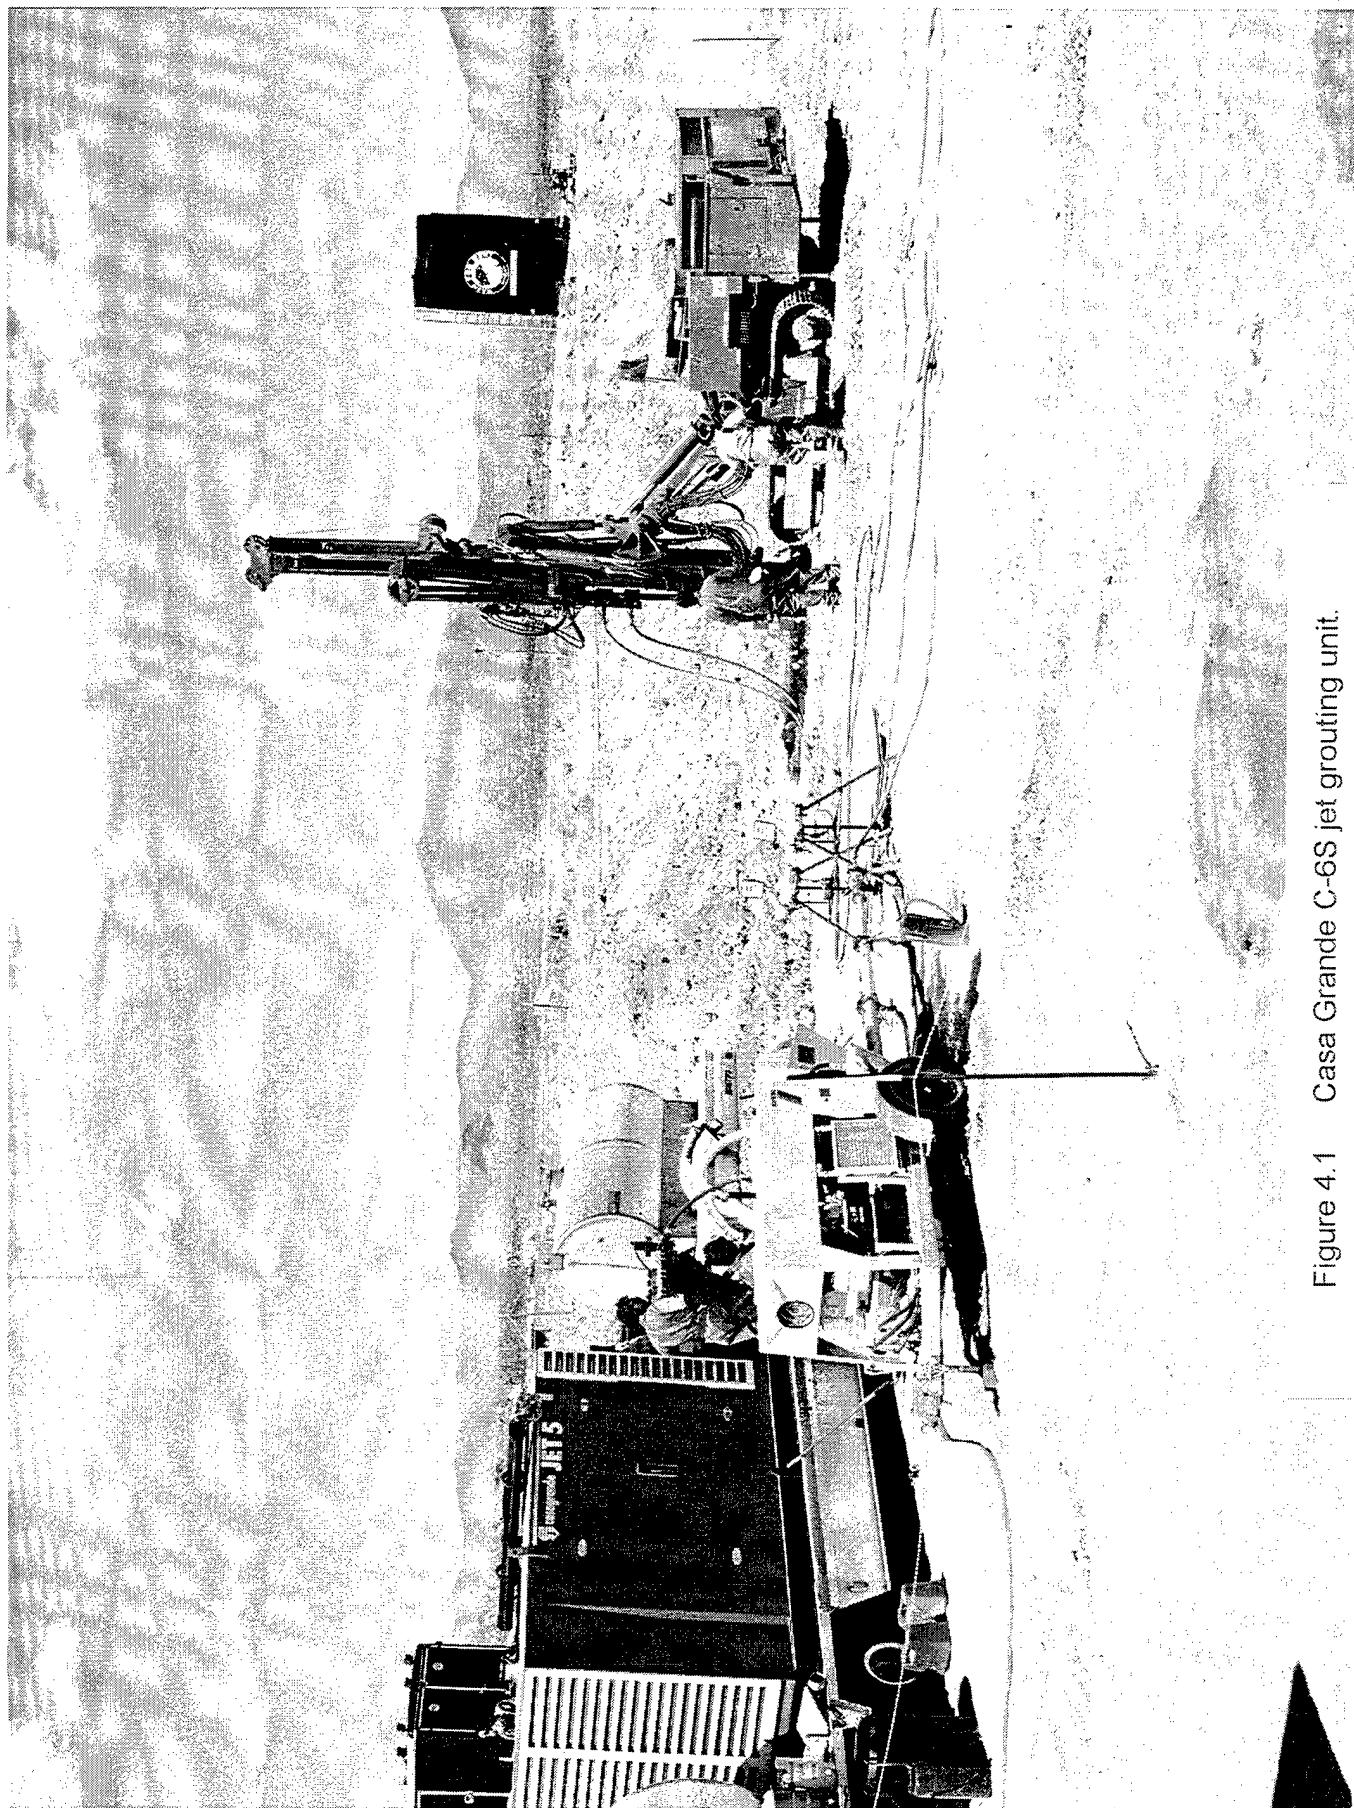
Figure 4.1 Casa Grande C-6S Jet grouting unit.

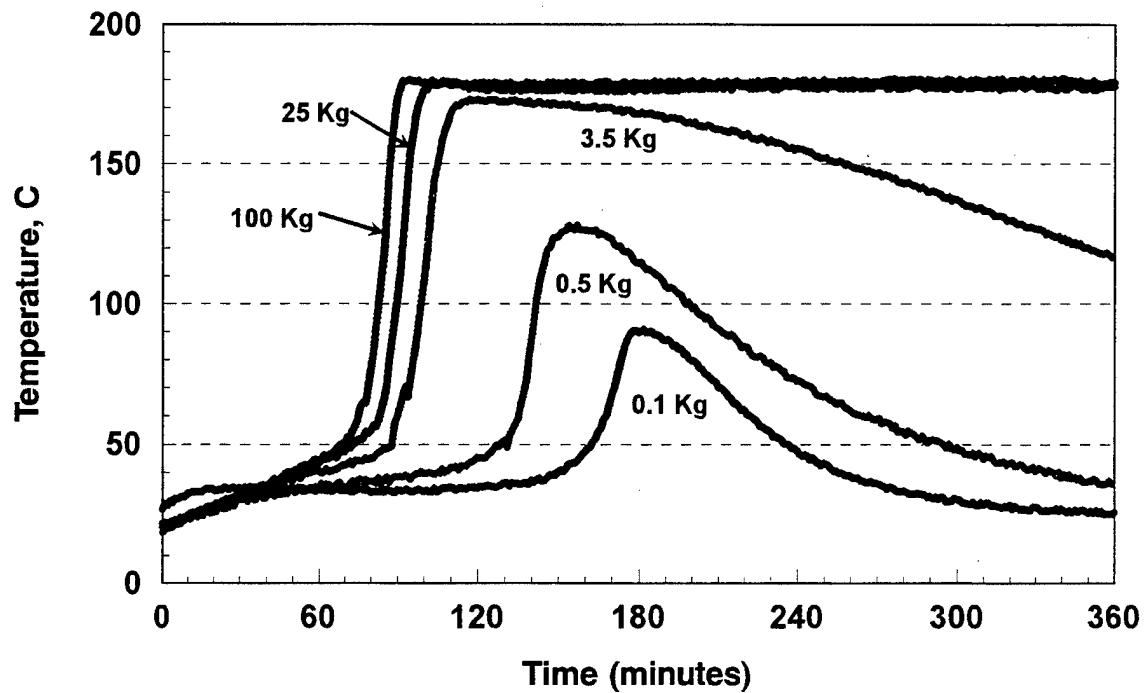
Figure 4.2 Temperature History of Acrylic Resins During Polymerization.

The remaining resins from the Sandia field test were shipped back to BNL to determine the cause of the rapid gelling. Adiabatic effects on peak exotherm and gel time were investigated. The absolute gel times had increased (for 0.5 Kg samples) from 30 minutes to approximately 2 hours. Some of the resins were shipped back to 3M where it was determined the likely cause of this change was due to some degradation of the co-polymers. This had little effect on the heat measurements other than requiring the results to be normalized to the Sandia gel times. Resin samples of 0.1, 0.5, 3.5, 25, and 100 Kg were transferred into cylindrical containers such that the ratio of width to height was  $\sim$ 1. The promoter was mixed into the resins followed by the initiator and a thermocouple was placed into the mix at the center. No mixing took place after the thermocouple was in place. Computer data acquisition software recorded the time and temperature every 0.5 minutes for at least 360 minutes. The results are given in Figure 4.2. The peak exotherms were 91, 128, 173, 180 and 183°C for the 0.1, 0.5, 3.5, 25, and 100 Kg lots respectively. The gel times were taken when the resins reached 50°C (viscosity  $\sim$ 200 cps) and were 163, 129, 89, 73 and 69 minutes for the 0.1, 0.5, 3.5, 25, and 100 Kg lots respectively. The gel time was of most interest and is depicted in Figure 4.3 normalized to the Sandia field test gel times. The test samples at Sandia were 0.5 Kg and the average gel time for three drums was 26 minutes, a factor of 5 times faster than the laboratory gel times for similar sized lots. Using the simple normalization of dividing the laboratory gel times by 5 to obtain the expected field gel times yields a useful life of 12 minutes in 210L (55gal) drum quantities at 24°C (75°F). The drum that "quick set" gelled in approximately 5-7 minutes. This is close to the normalized gel time for a 210L (55gal) drum. The slight discrepancy is most likely due to the 6 months "aging" of the resins or the temperature differences between the laboratory and the field.

The cause of the rapid gelling was a simple adiabatic heat process. It is well known that the volume of resin can greatly affect the gel time of thermosetting resins. The polymerization process is begun by reacting the initiator and promoter in the resin mix. The rate of reaction between the two is very dependent on temperature. The polymerization process is exothermic and the heat released can increase the rate of reaction of the initiator and promoter, the reaction is said to be autoaccelerating. Small quantities of resin can dissipate heat fast enough so that rapid curing does not occur. As the volume is increased, exothermic heat generated can not dissipate as rapidly due to the insulating properties of the resin itself and thus causes auto acceleration of the polymerization reaction. If the heat released from the polymerization is small or the heat can be

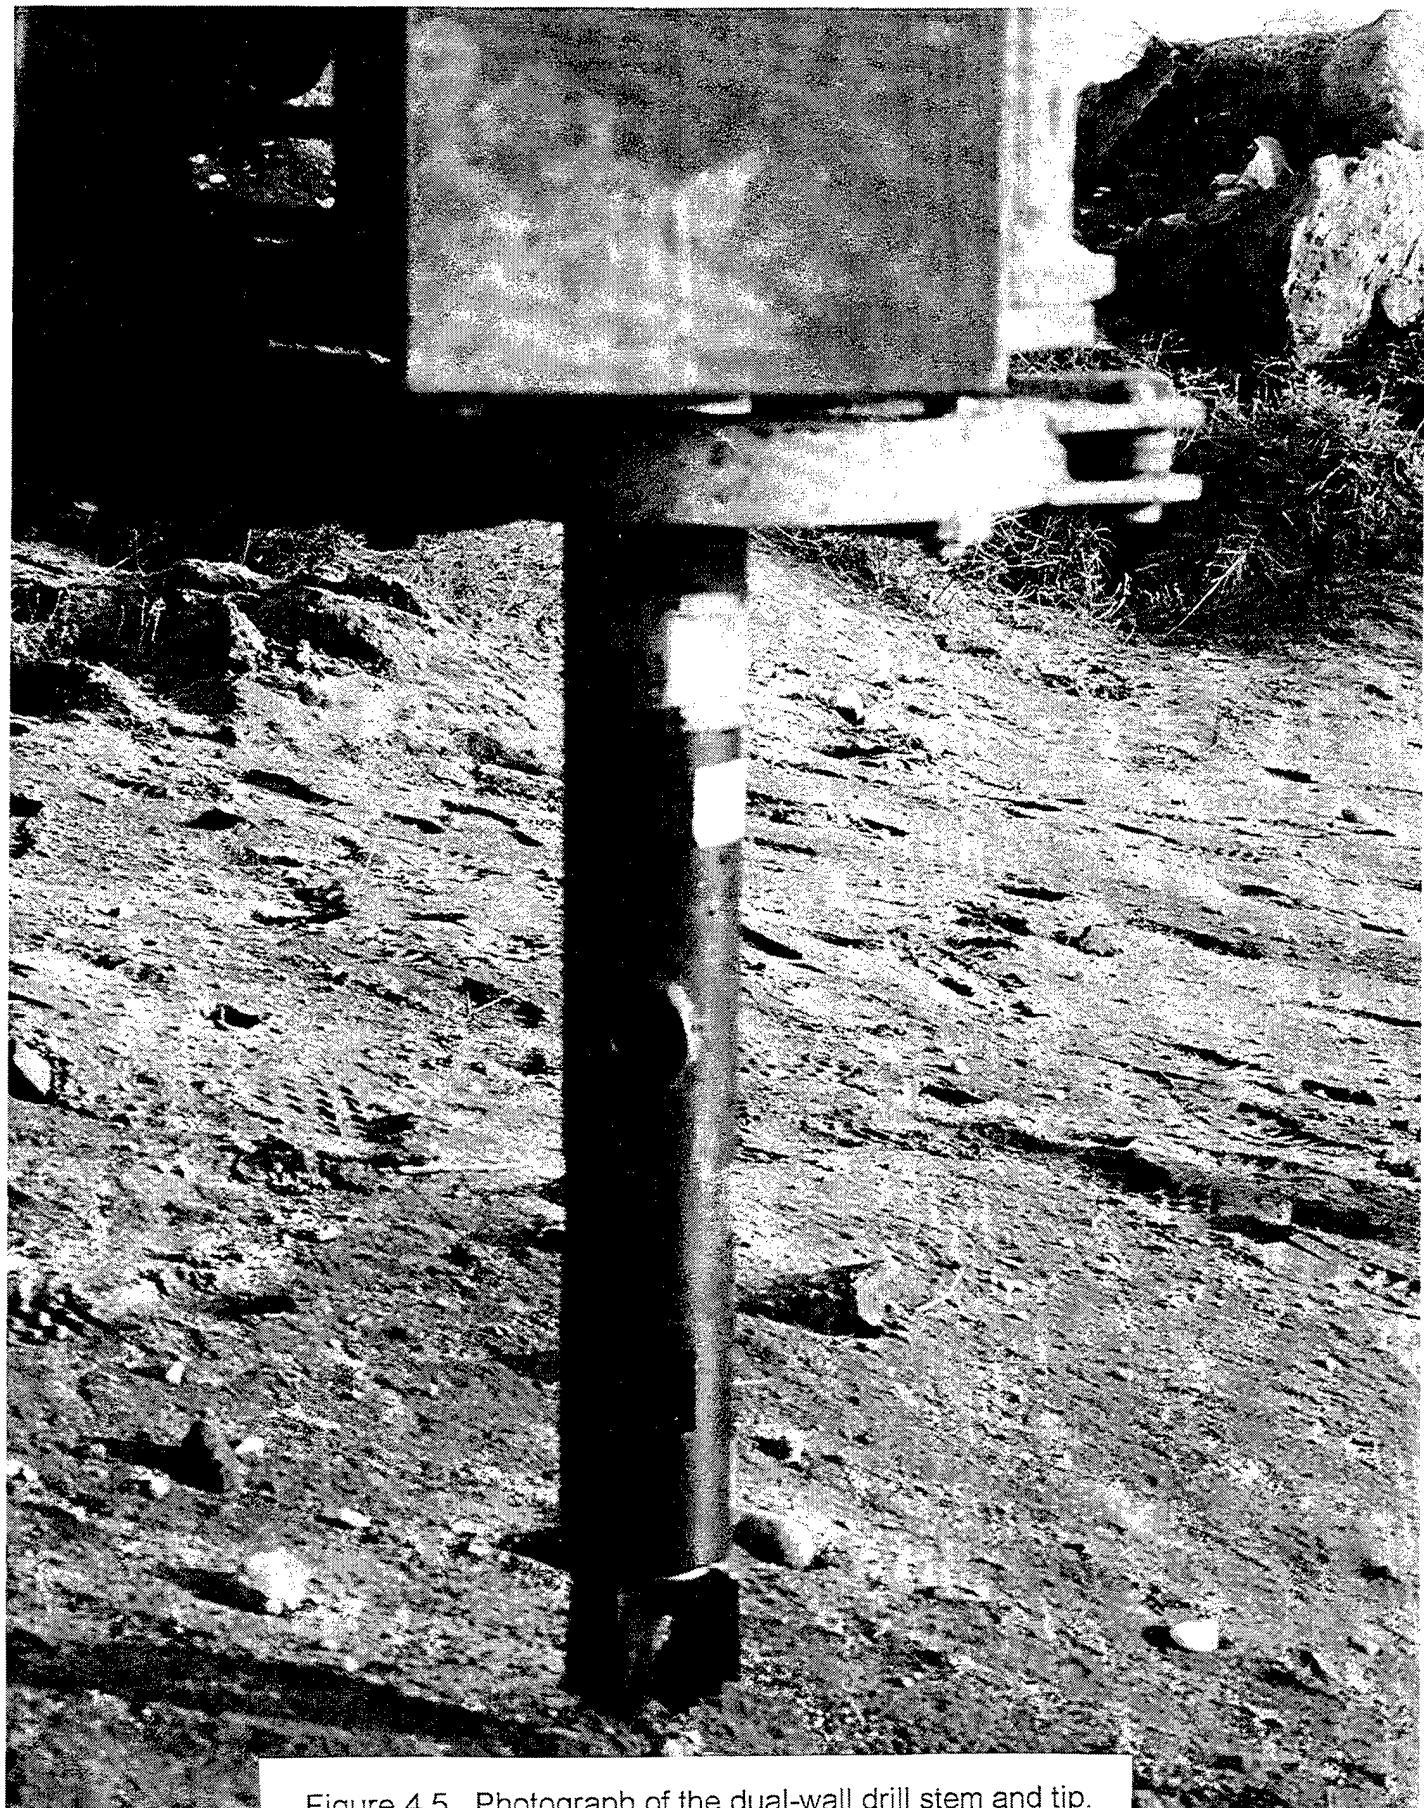
Figure 4.5 Photograph of the dual-wall drill stem and tip.

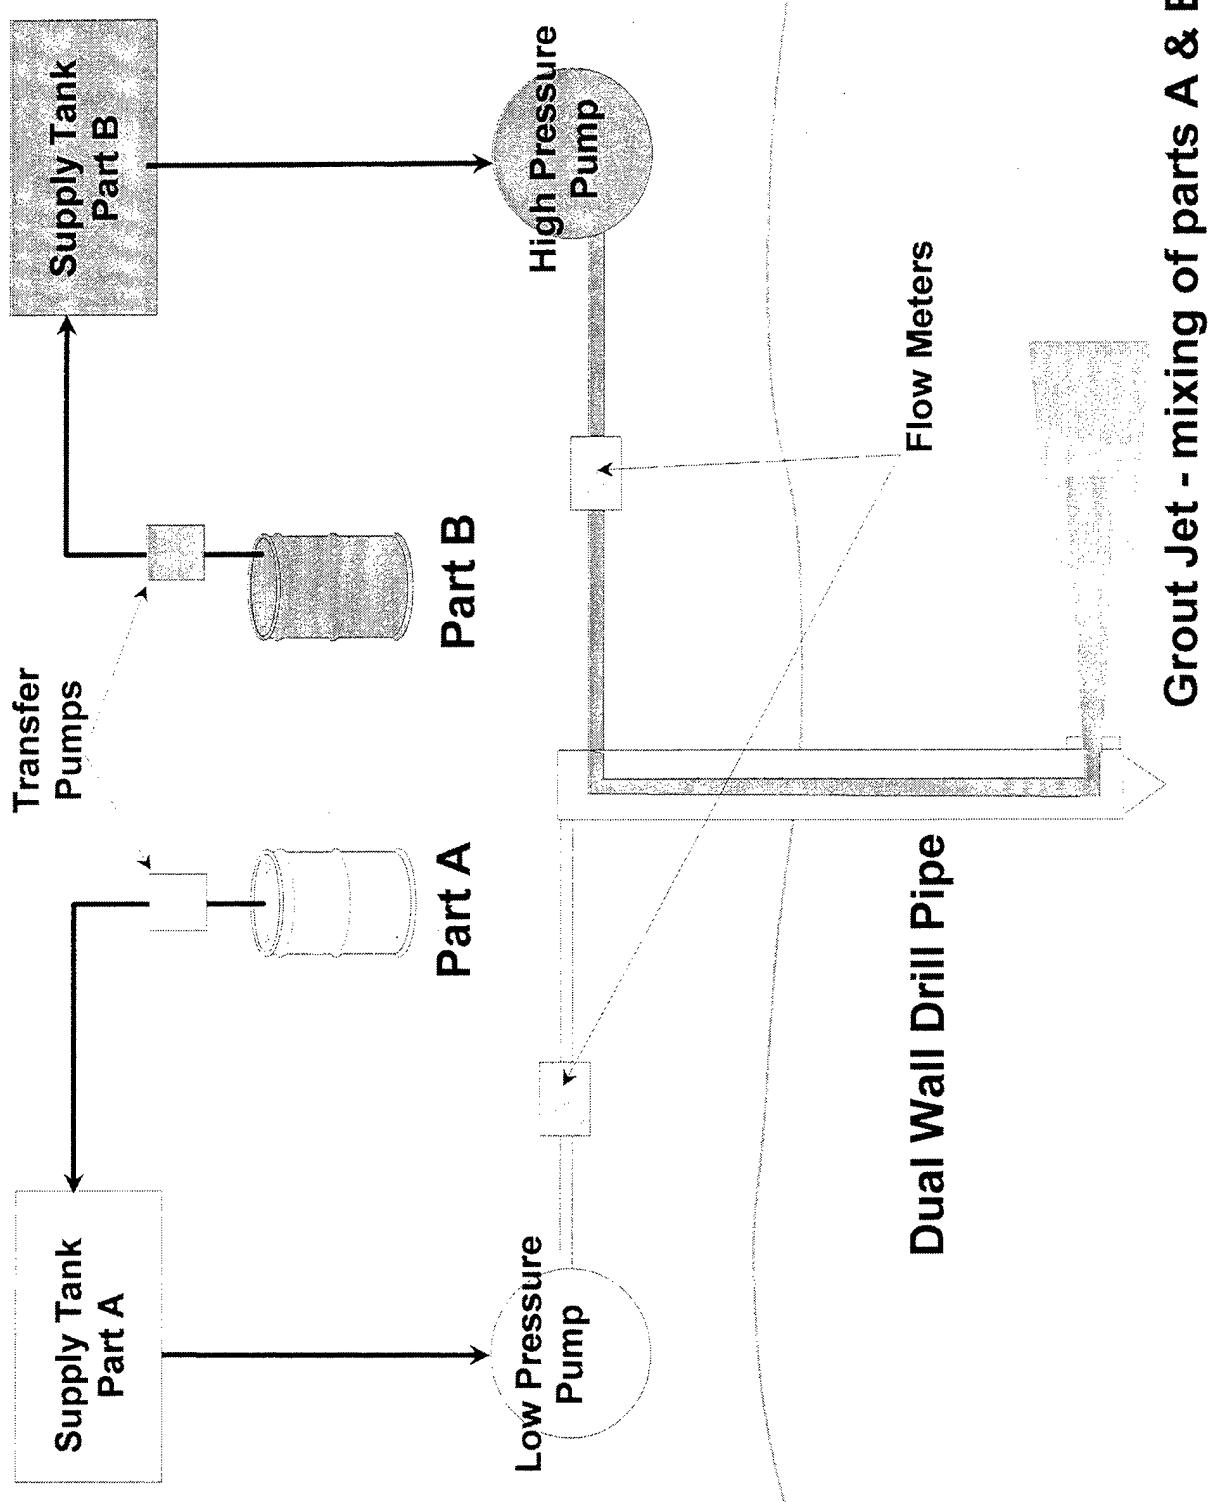
Figure 4.6 Schematic of two-part polymer grout delivery system.

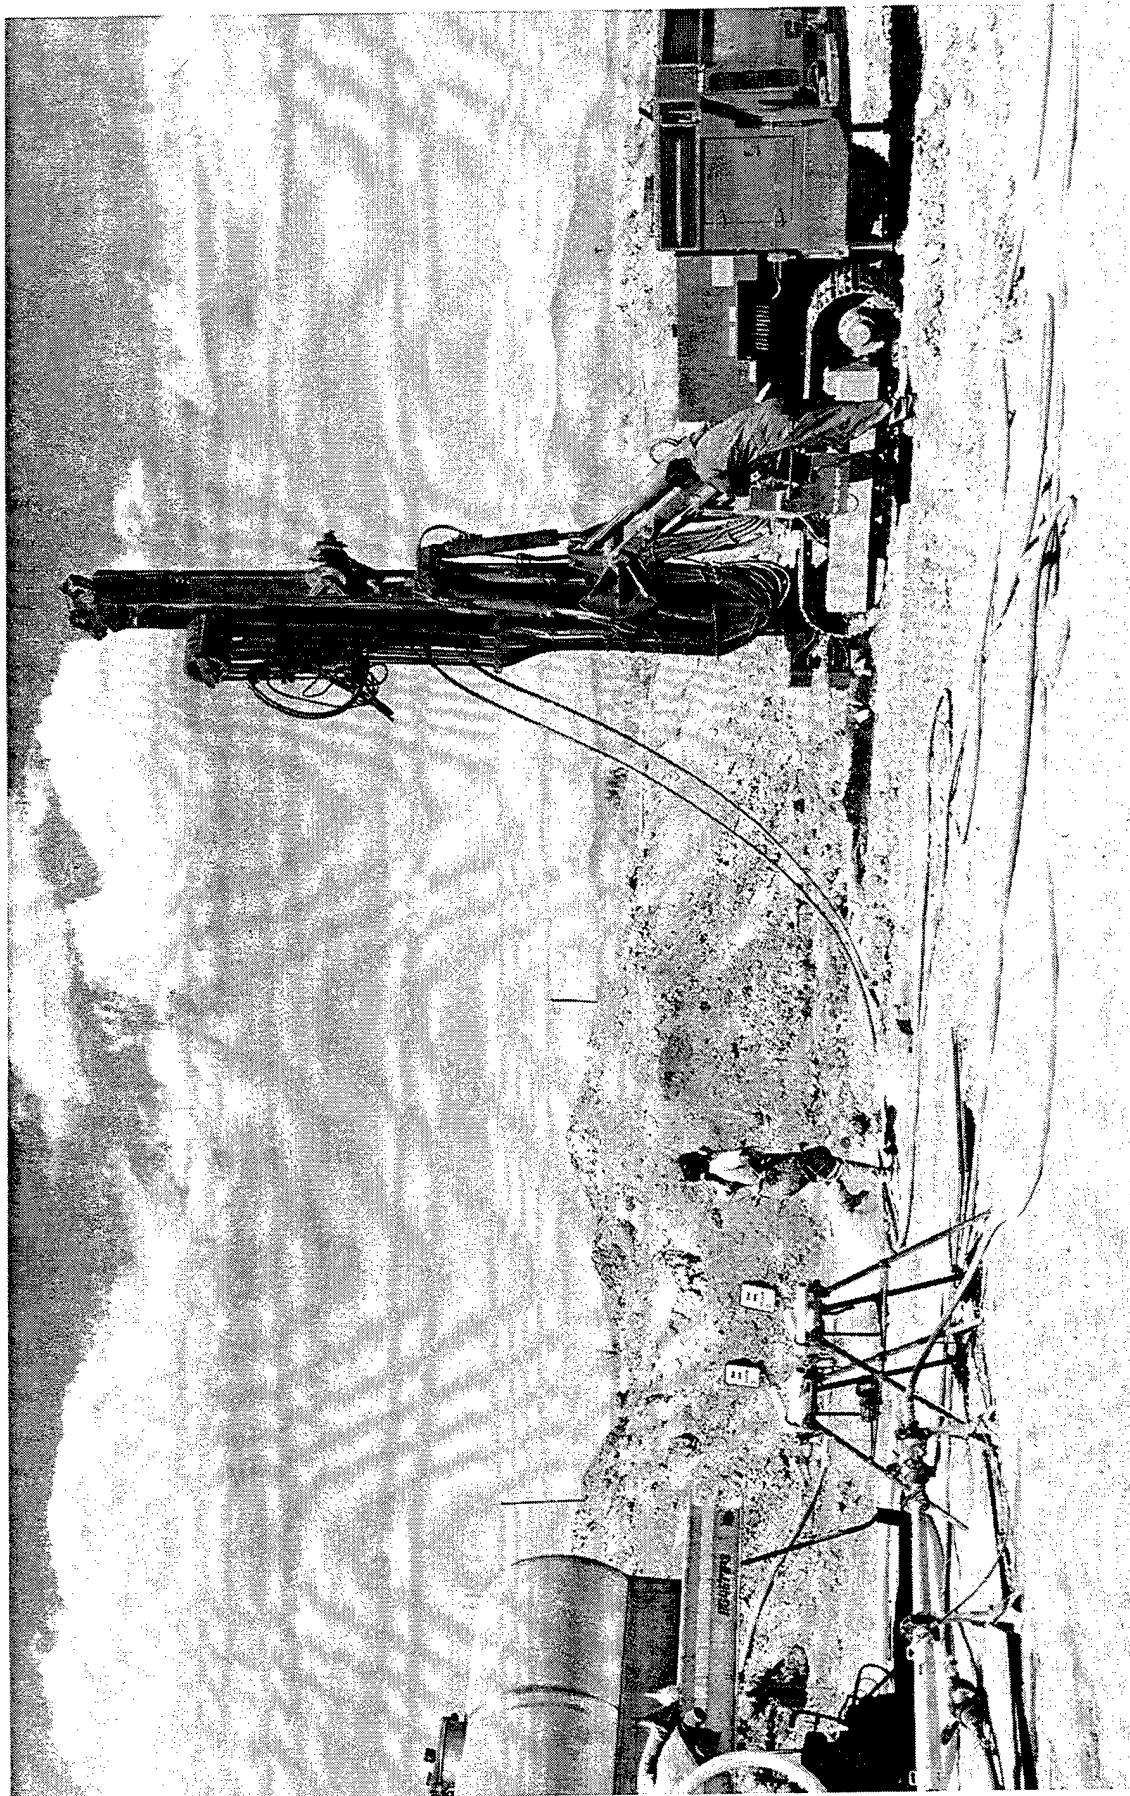
Figure 4.7a Photograph of the polymer grout delivery equipment (drill rig).

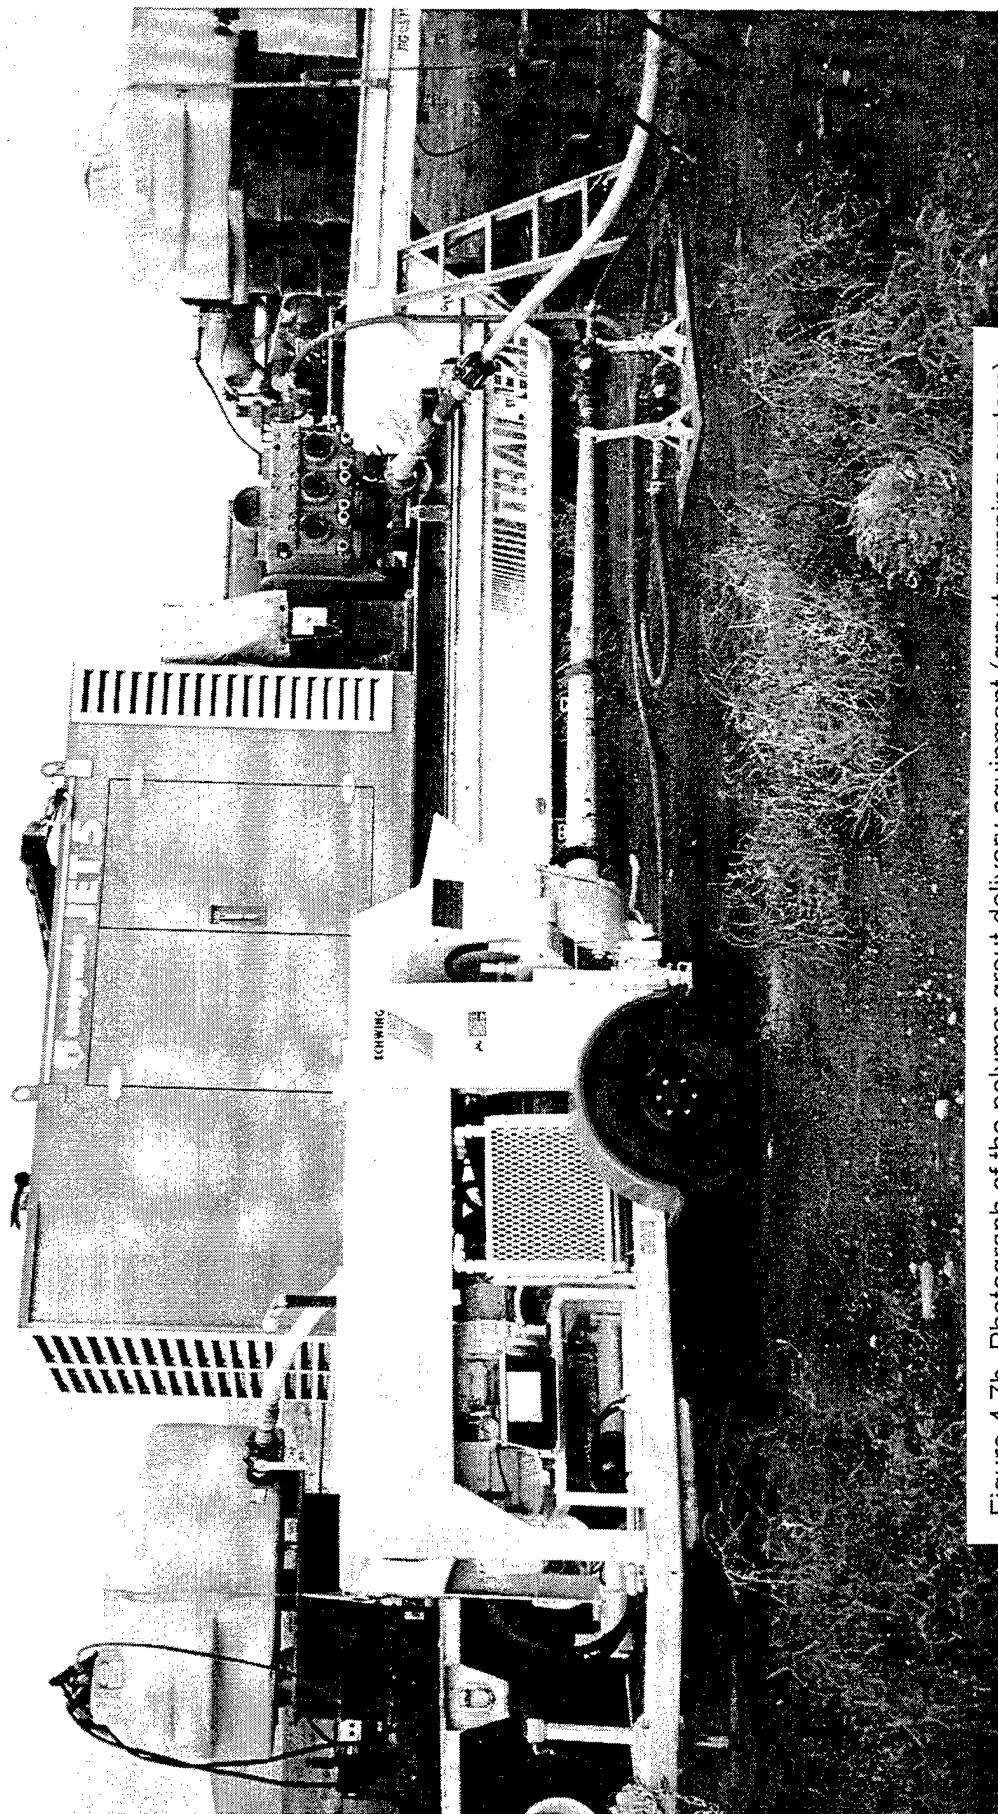
Figure 4.7b Photograph of the polymer grout delivery equipment (grout pumping system)

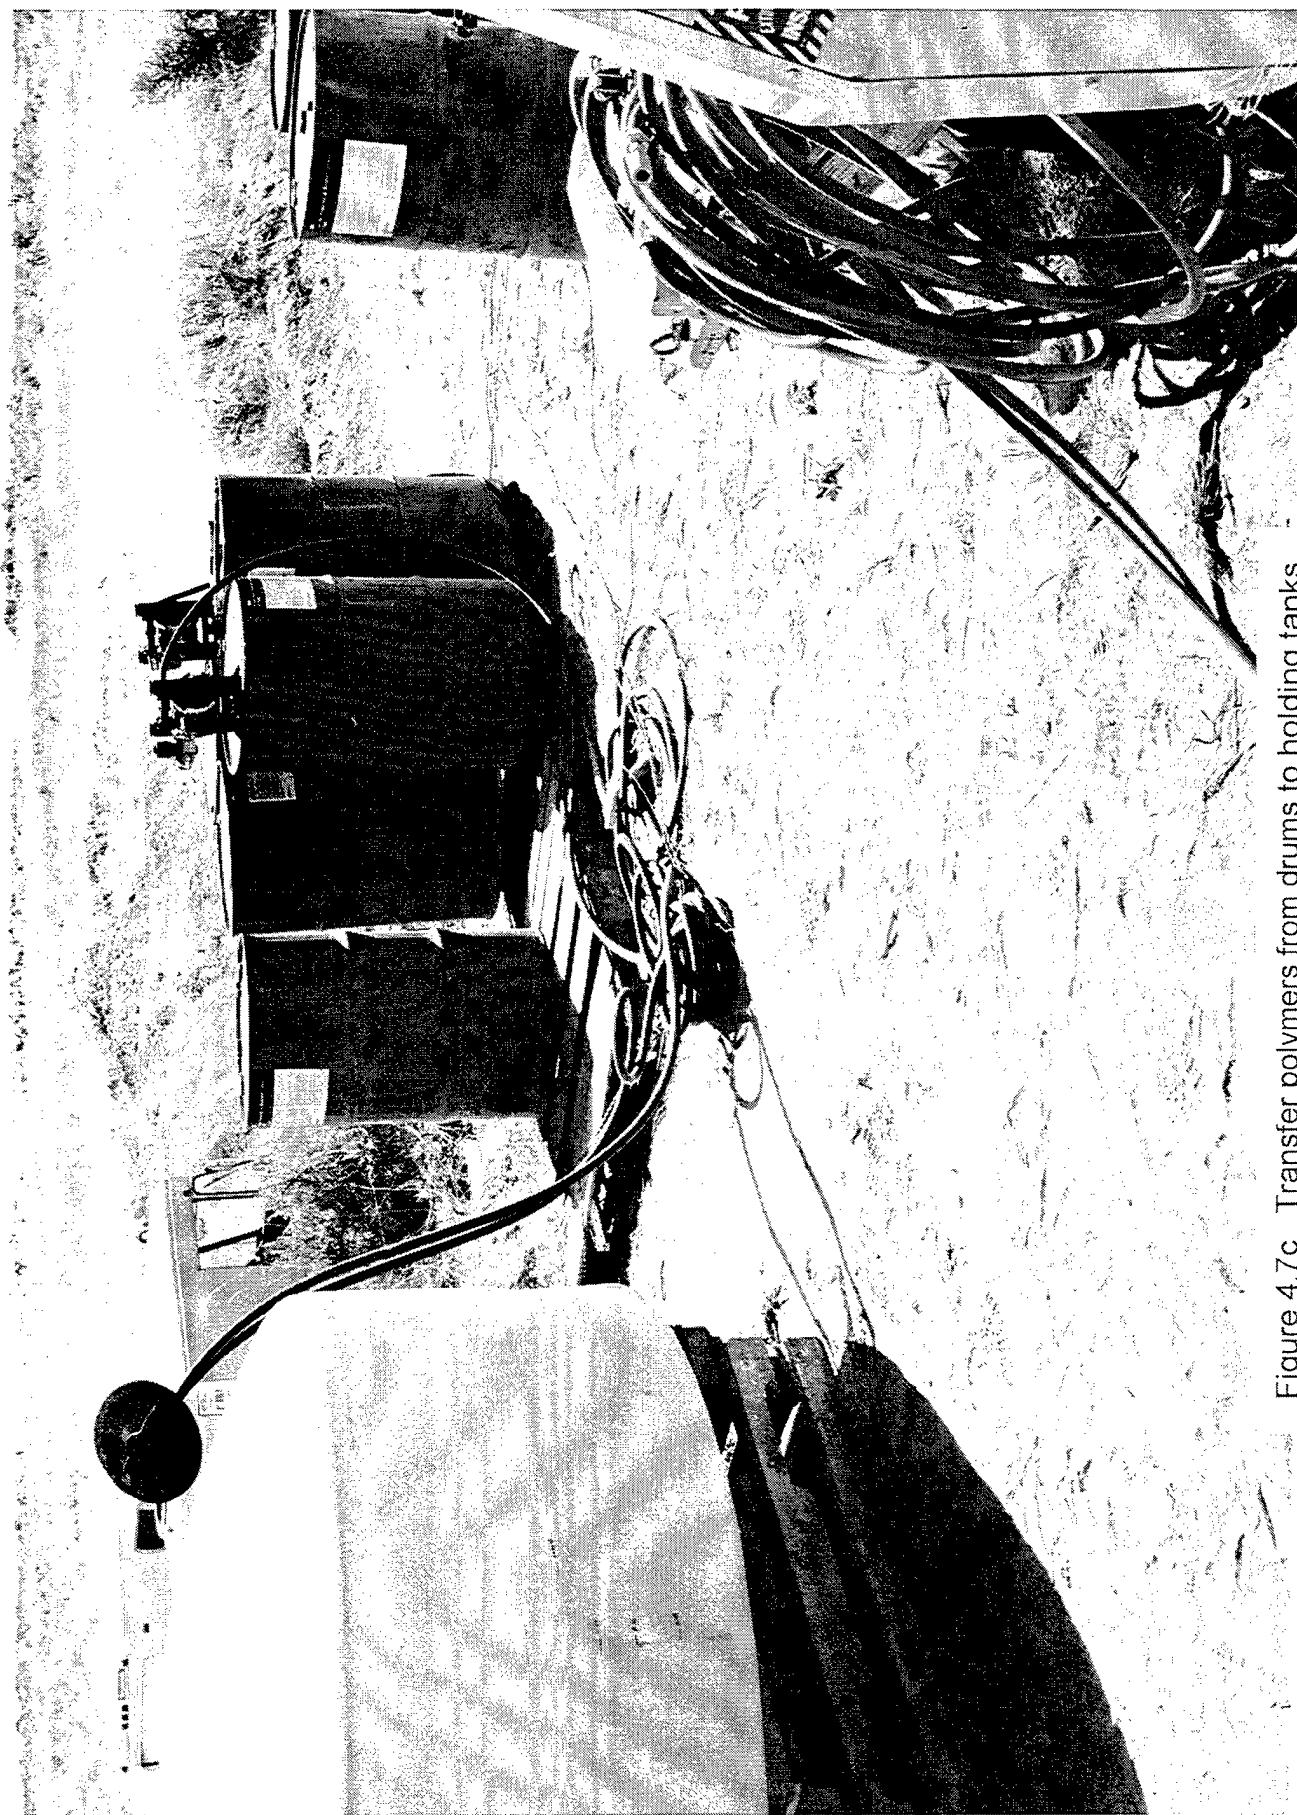
Figure 4.7c Transfer polymers from drums to holding tanks.

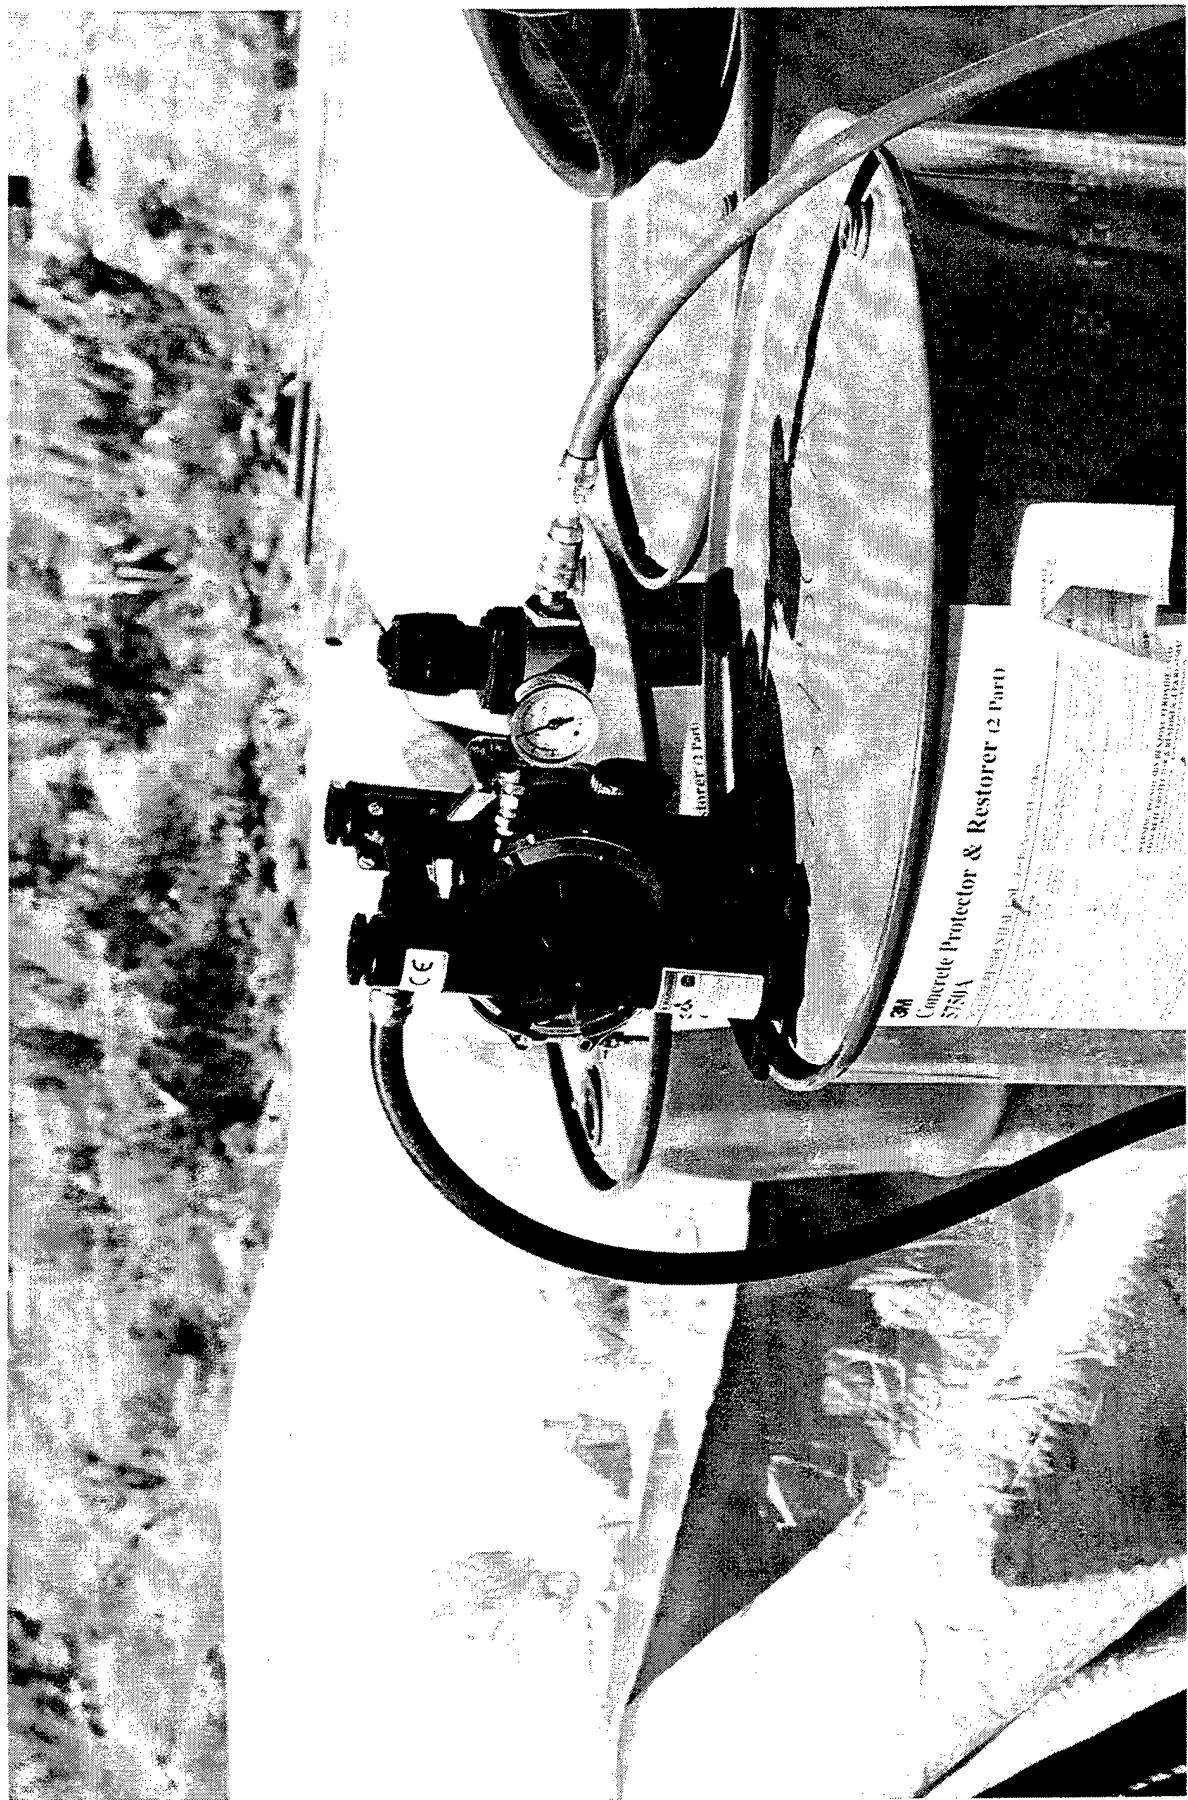
Figure 4.8 Photograph of the pneumatic transfer pump used to move grouts from drums to 1500 liter (400 gallon) supply tanks.

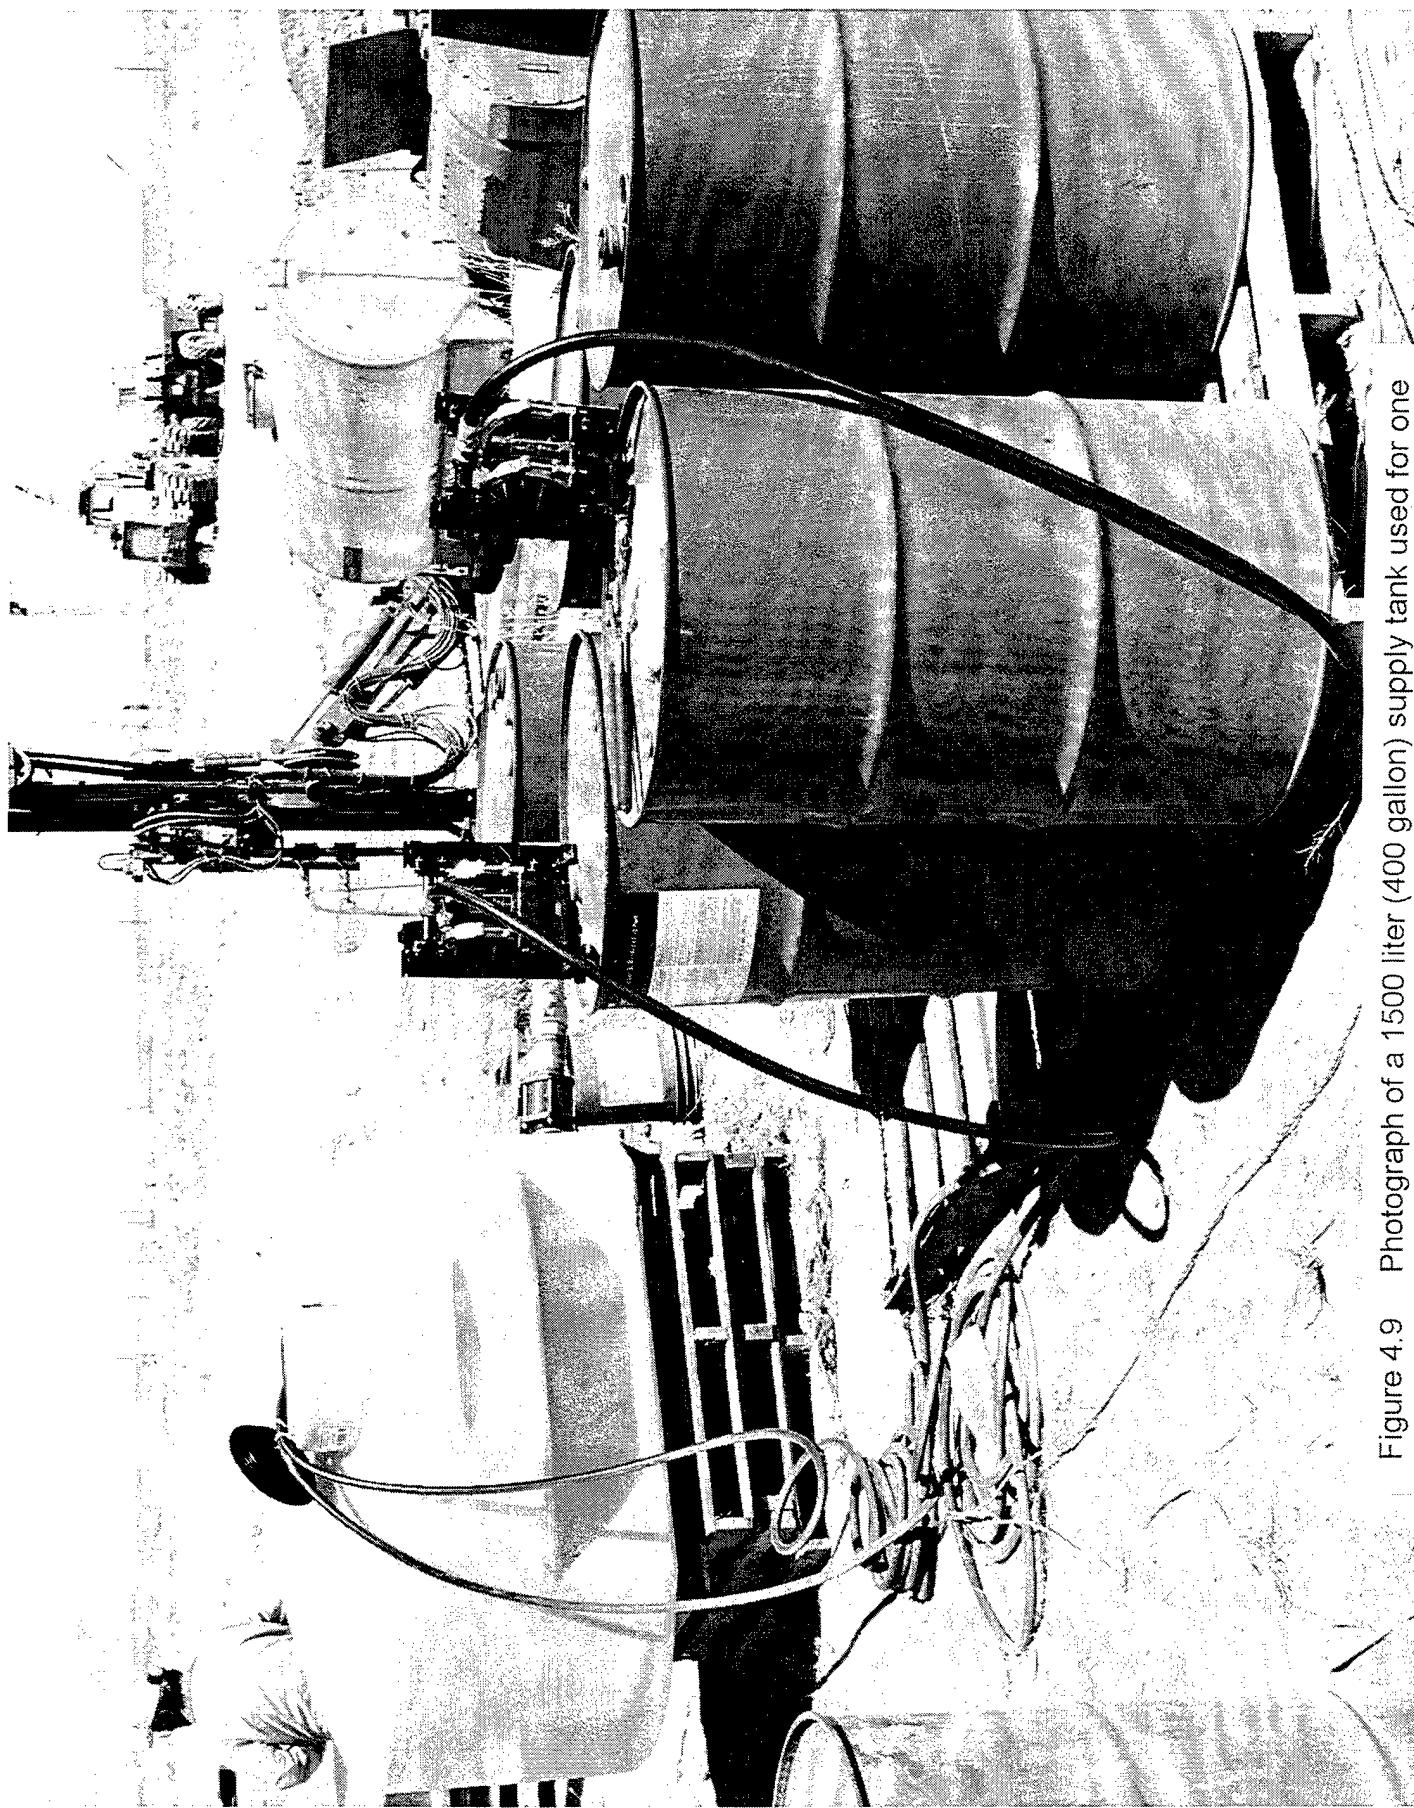
Figure 4.9 Photograph of a 1500 liter (400 gallon) supply tank used for one part of the polymer grout.
