# Summary Report on Close-Coupled Subsurface Barrier Technology Initial Field Trials to Full-Scale Demonstration

John H. Heiser  
Environmental & Waste Technology Center  
Brookhaven National Laboratory

Brian Dwyer  
Mixed Waste Landfill Integrated Demonstration  
Sandia National Laboratory

**September 1997**

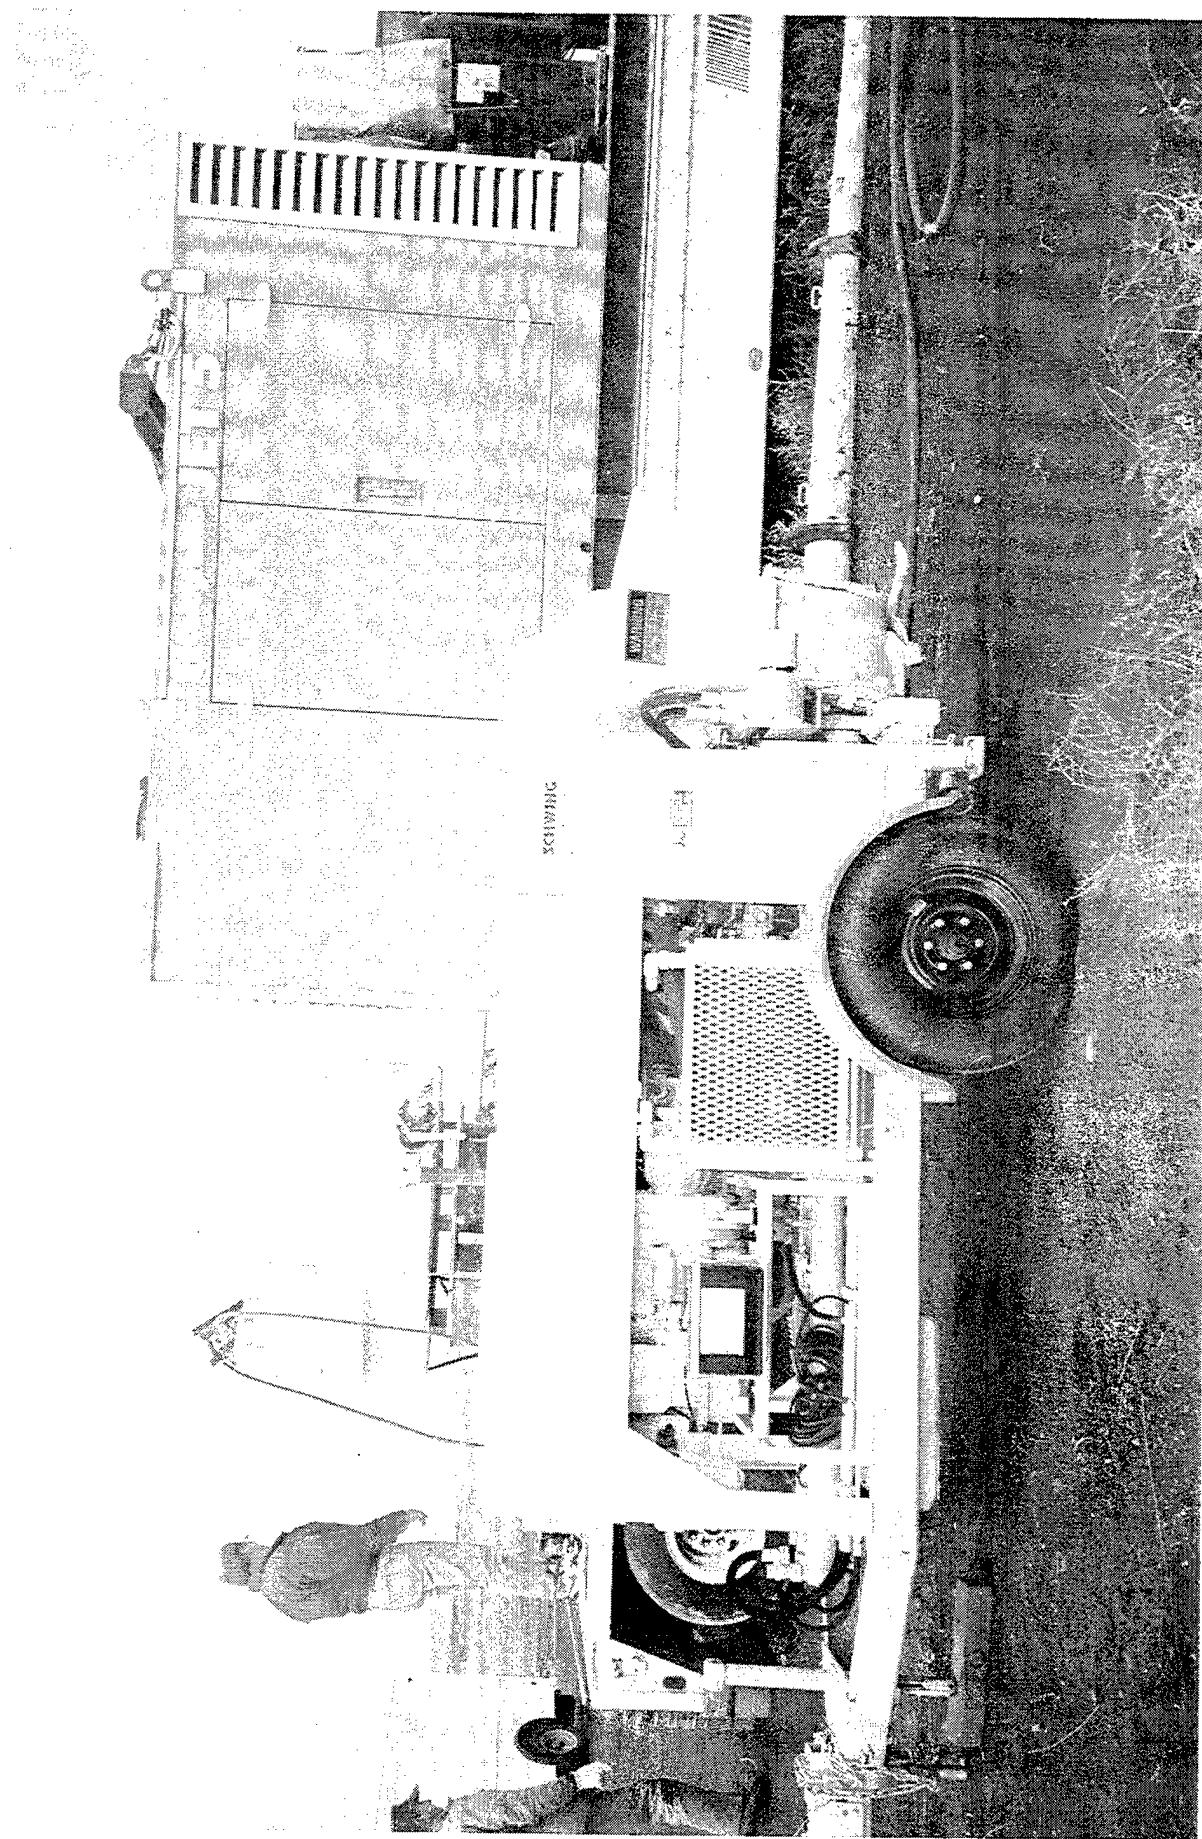
Figure 4.10 Photograph of the low-pressure Schwing pump used to deliver part B.

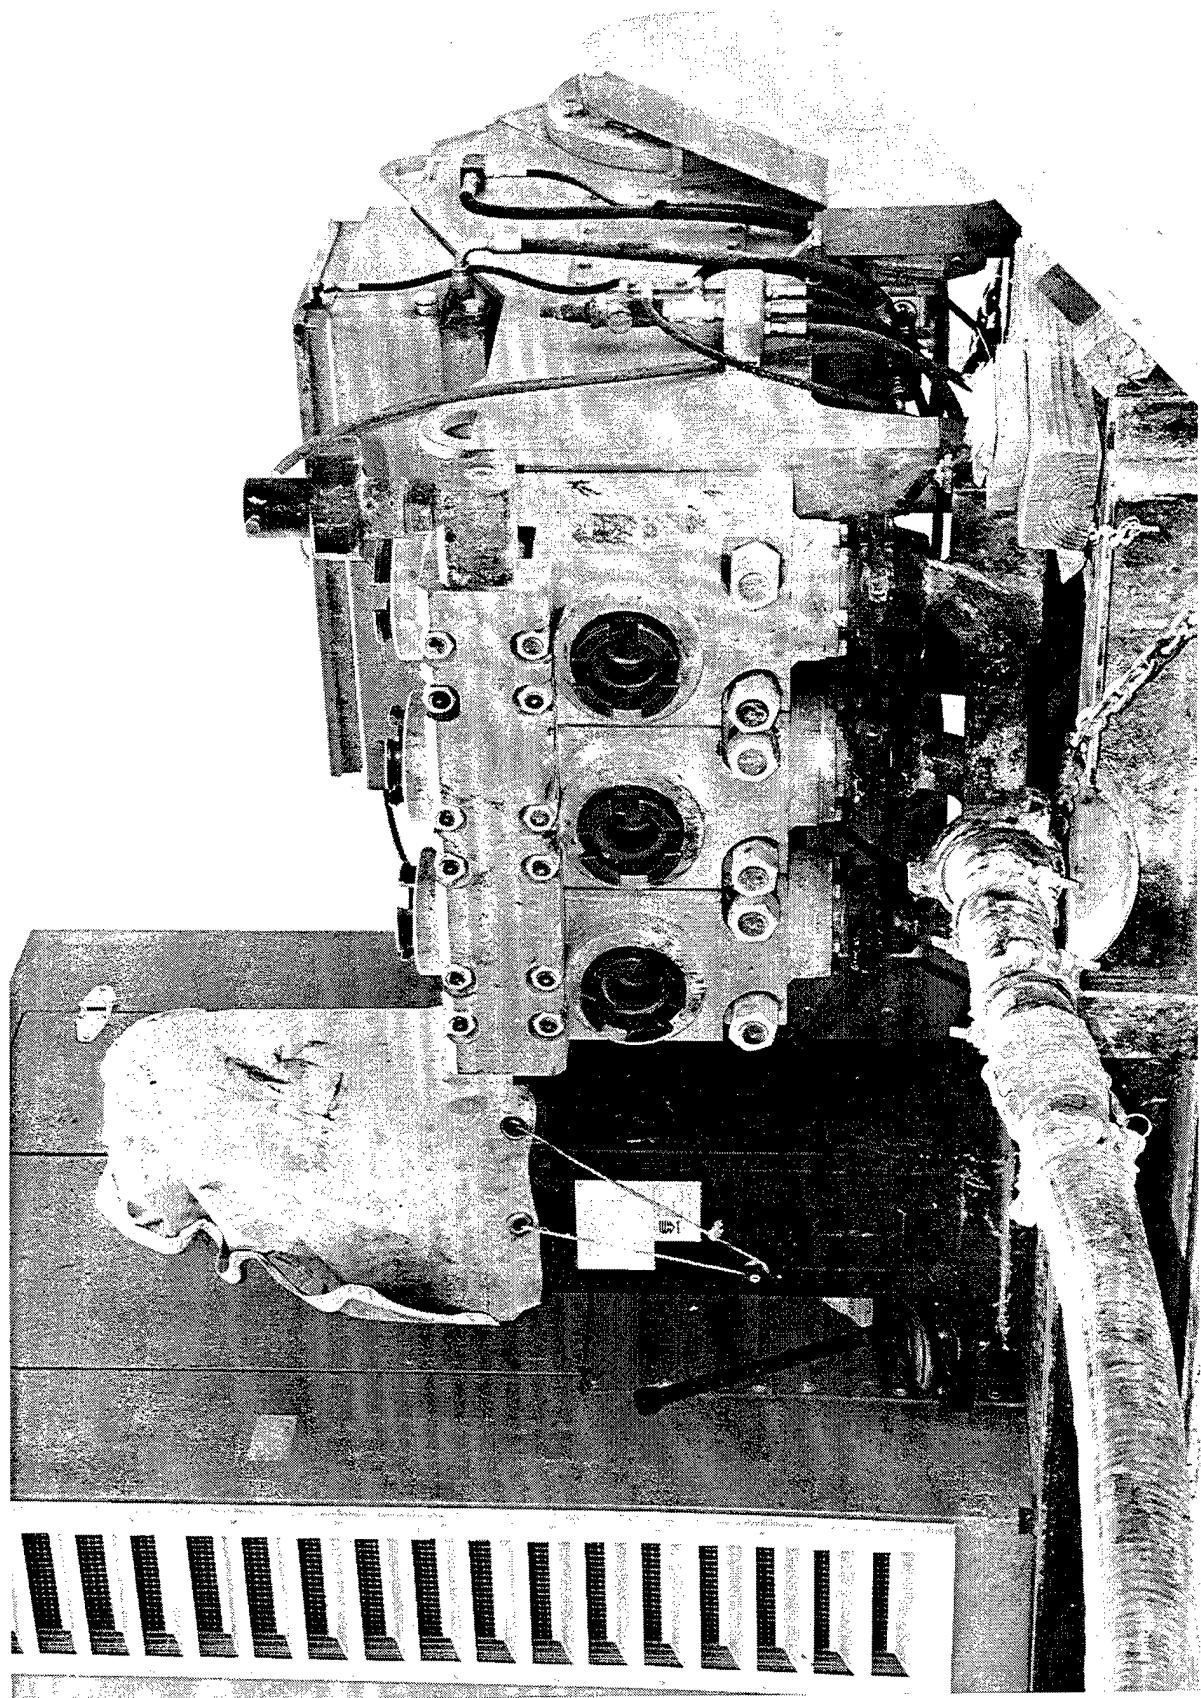
Figure 4.11 Photograph of the high pressure pump used to deliver part A.

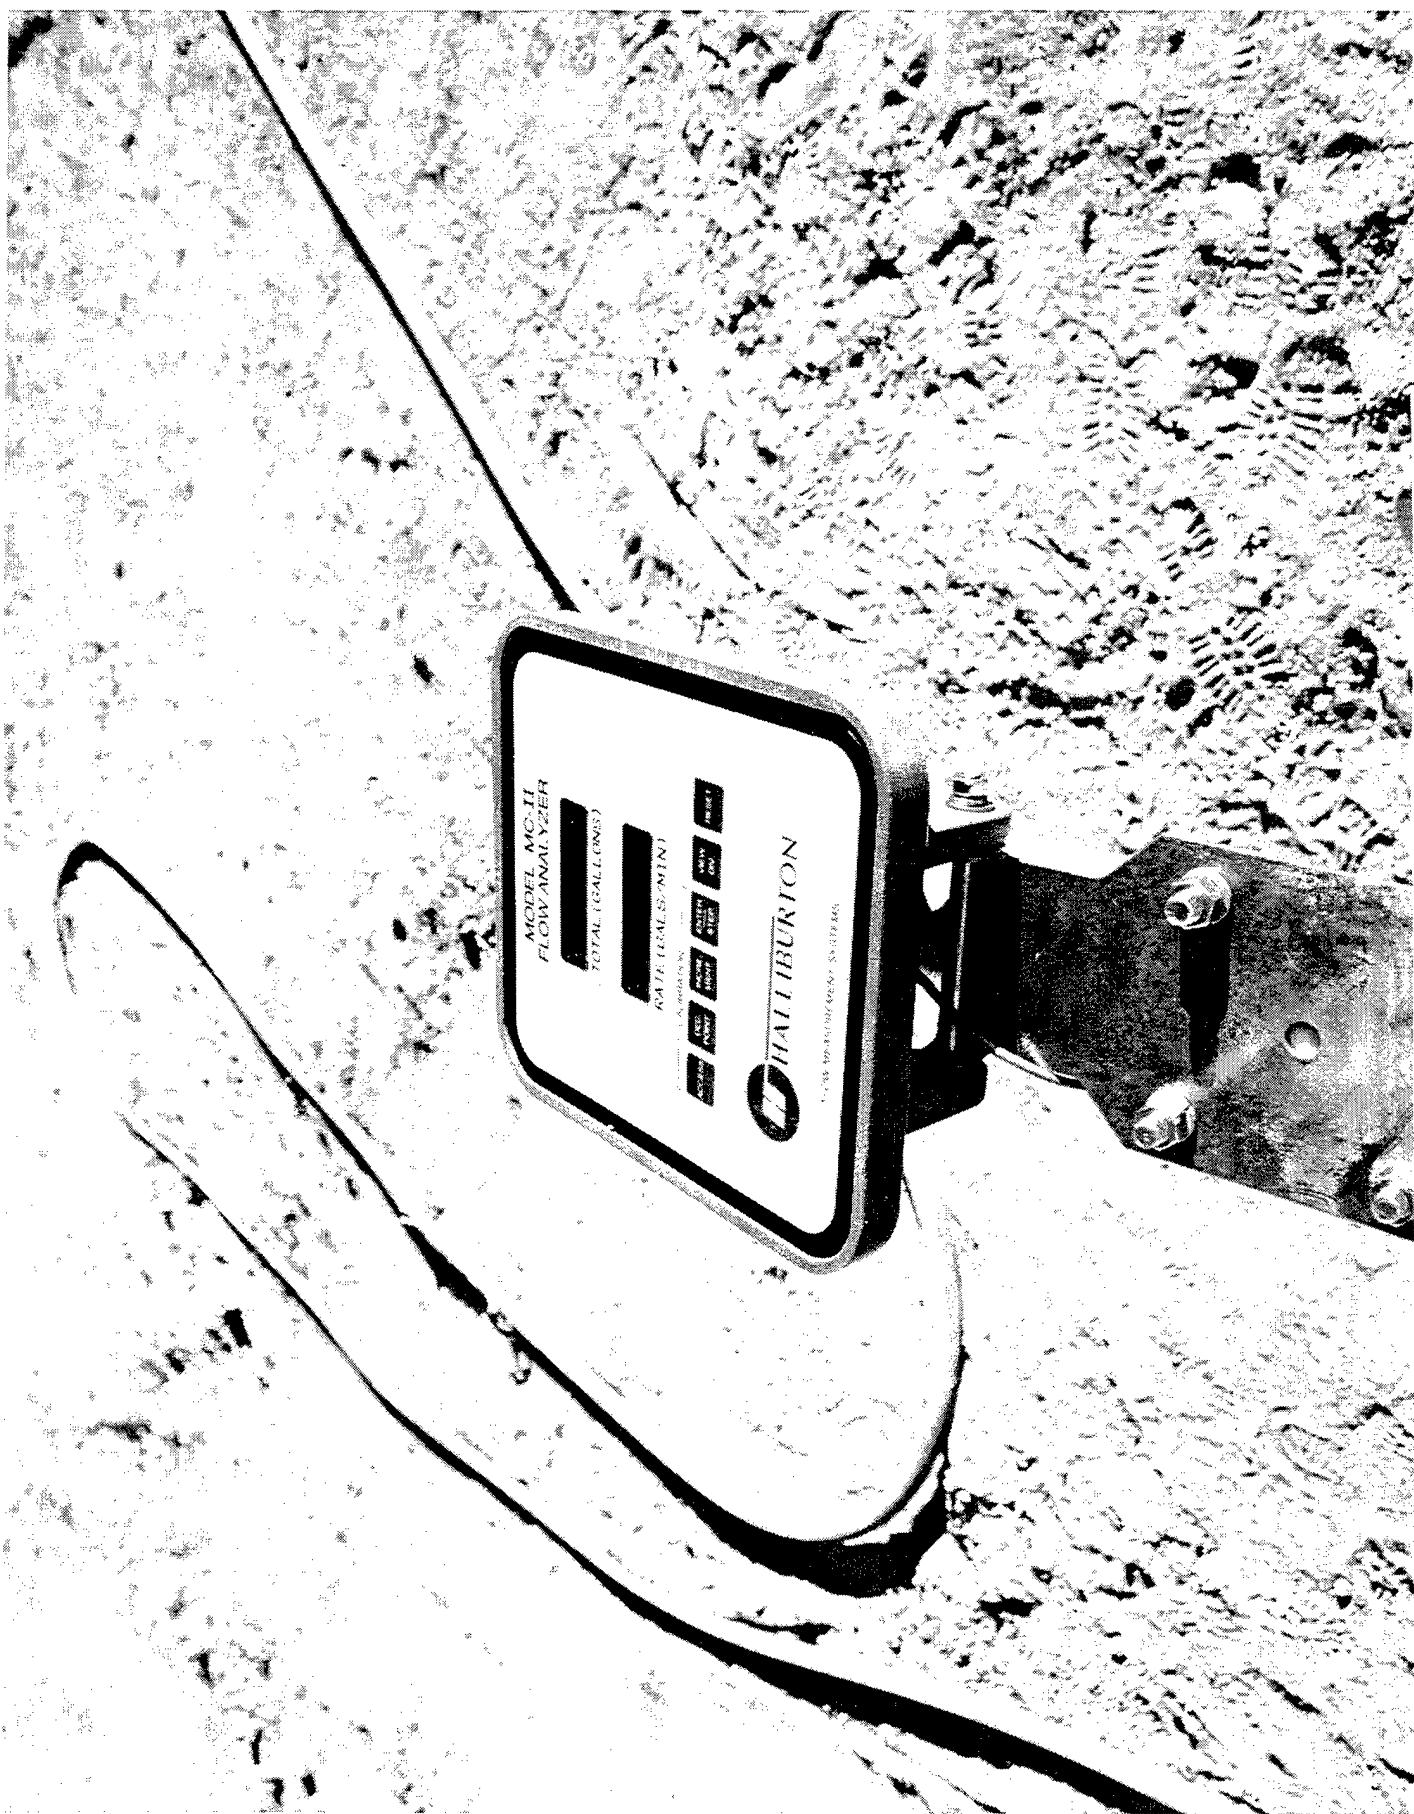
Figure 4.12 Photograph of the flow meter used to measure grout flow rates.

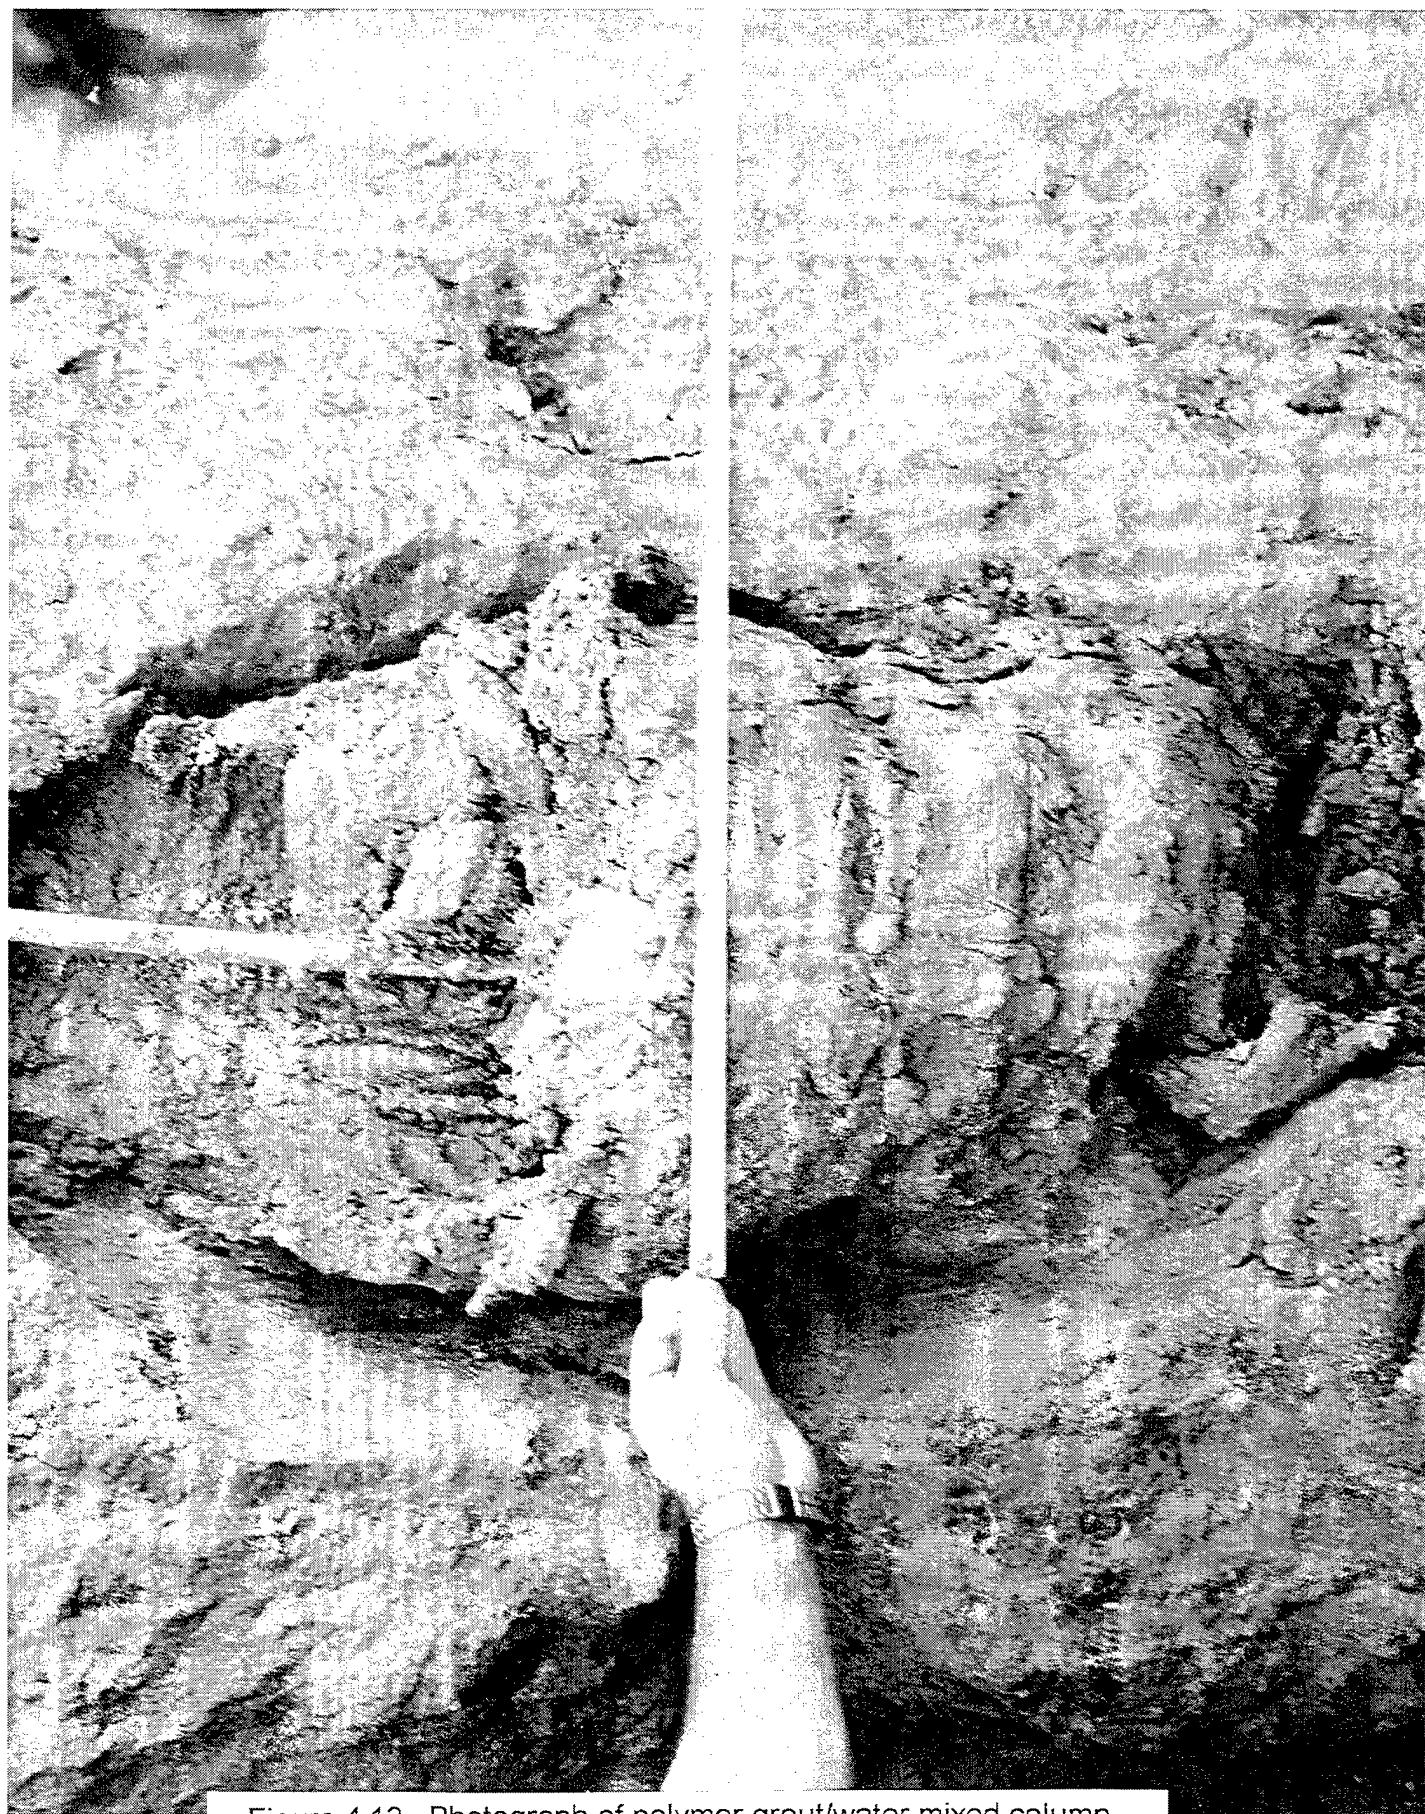
Figure 4.13 Photograph of polymer grout/water mixed column.

At this point excavation of the two columns was performed. Examination of the first grouted area failed to show development of a solid grouted column. In fact, the only evidence of a column was at the lower portion of the grouted region where there was a 50cm (20in) long right circular cylinder of hard polymer-soil was found. The region (see Figure 4.13) was a 46cm (18in) in diameter ring of polymer soil grout that was 5cm (2in) thick, filled with a highly viscous clay-water mixture (determined by the lack of the polymer odor for the interior material). The technical possibilities included the potential for the low-viscosity polymer material to have leaked out of the pit prior to grouting. However, this would not explain the large amount of water in the central region of the ring and given the hydraulic conductivity of the soil didn't seem reasonable. The grouting contractor, Westinghouse Hanford Company, personnel claimed that when setting the flow rates to achieve equal parts A and B the calibration of the flow meters was performed with water. About 75L (20gal) of water remained in the high-pressure injection lines, and injection hole number 1 became saturated with water during the initial jet-grouting process. This explained the high water content in the interior of the first grouted column. The high water content of the grouted zone also explained the low temperature readings measured downhole. The polymer zone occurred at the very outer circumference of the column due to centrifugal forces flinging the less dense material outward. The polymer zone may have reached 116°C (240°F) but this temperature would not be seen through the water zone. At best 100°C (212°F) [boiling of water] would have been reached. It is also possible that the thin layer of polymer with such good heat sinks surrounding it would not reach the peak exothermic temperature expected.

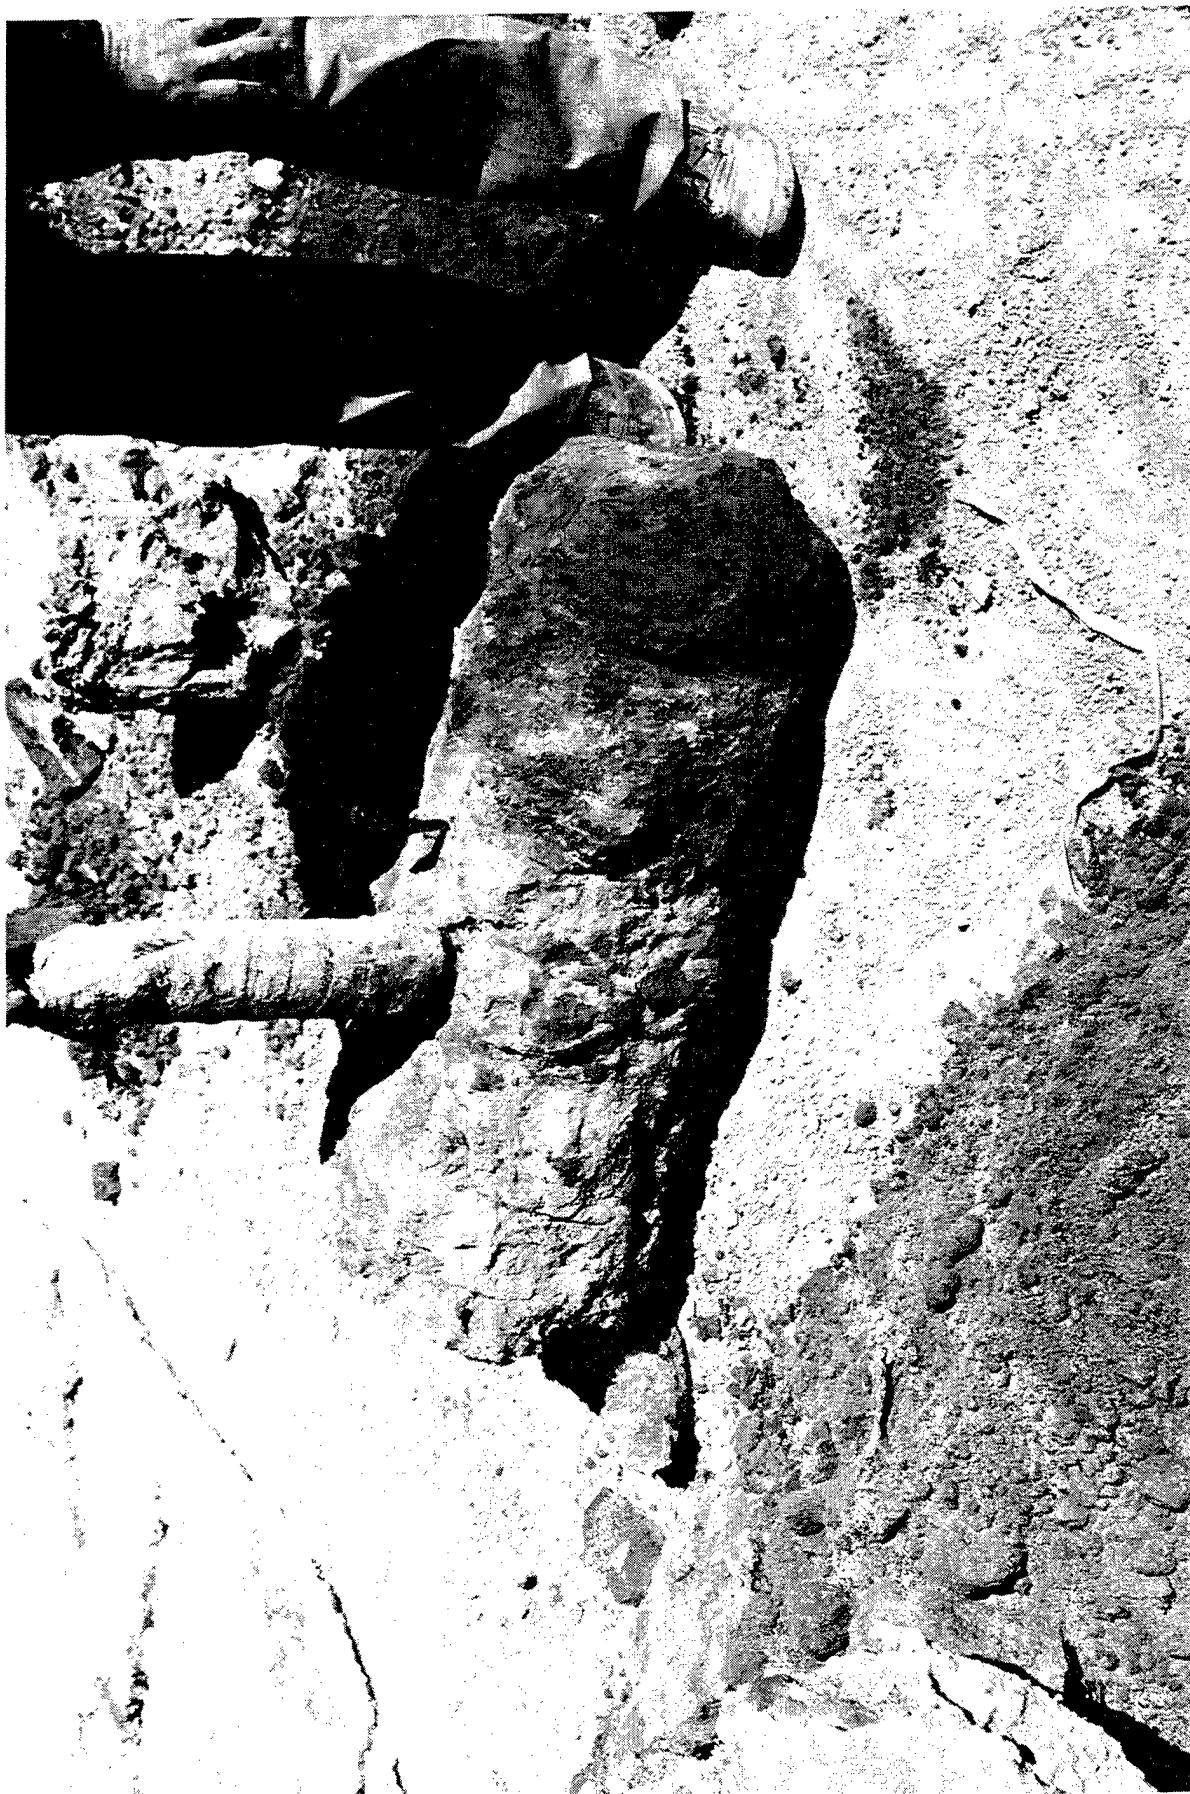
Figure 4.14 Photograph of polymer grout column.

Afterwards the second test column was cross-sectioned perpendicular to the drill axis. Several pieces were sliced and all were uniform, void-free pieces. We were able to meet all the objectives of this pilot-scale demonstration. The dual-wall drill system worked as planned and continued to work flawlessly for the duration of INEEL in situ stabilization of buried waste demonstration. Excavation of the test column showed the grouting to be ~46cm (18in) in diameter and very uniform in diameter. Two differences were noted for the dual-fluid polymer grout injection using dual injection nozzles versus single-fluid cement grout using a single nozzle injection. First was uniformity of the column. The polymer column didn't vary much while cement columns from a previous test varied considerably. It is believed that the single nozzle

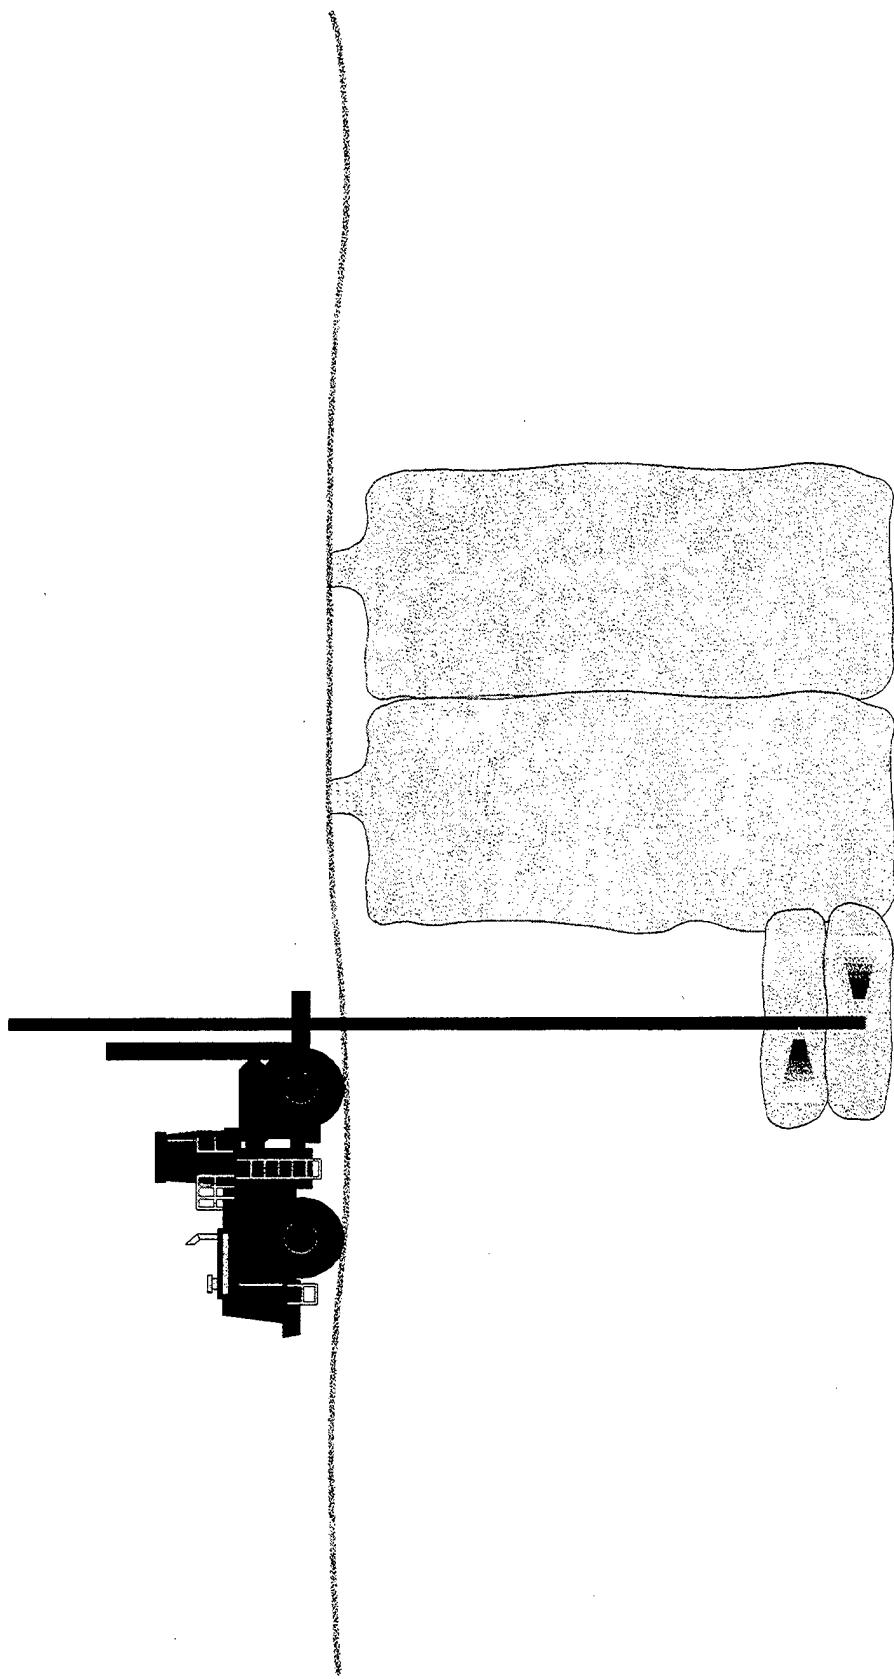
Figure 5.1 Subsurface barriers prevent contaminant spread.

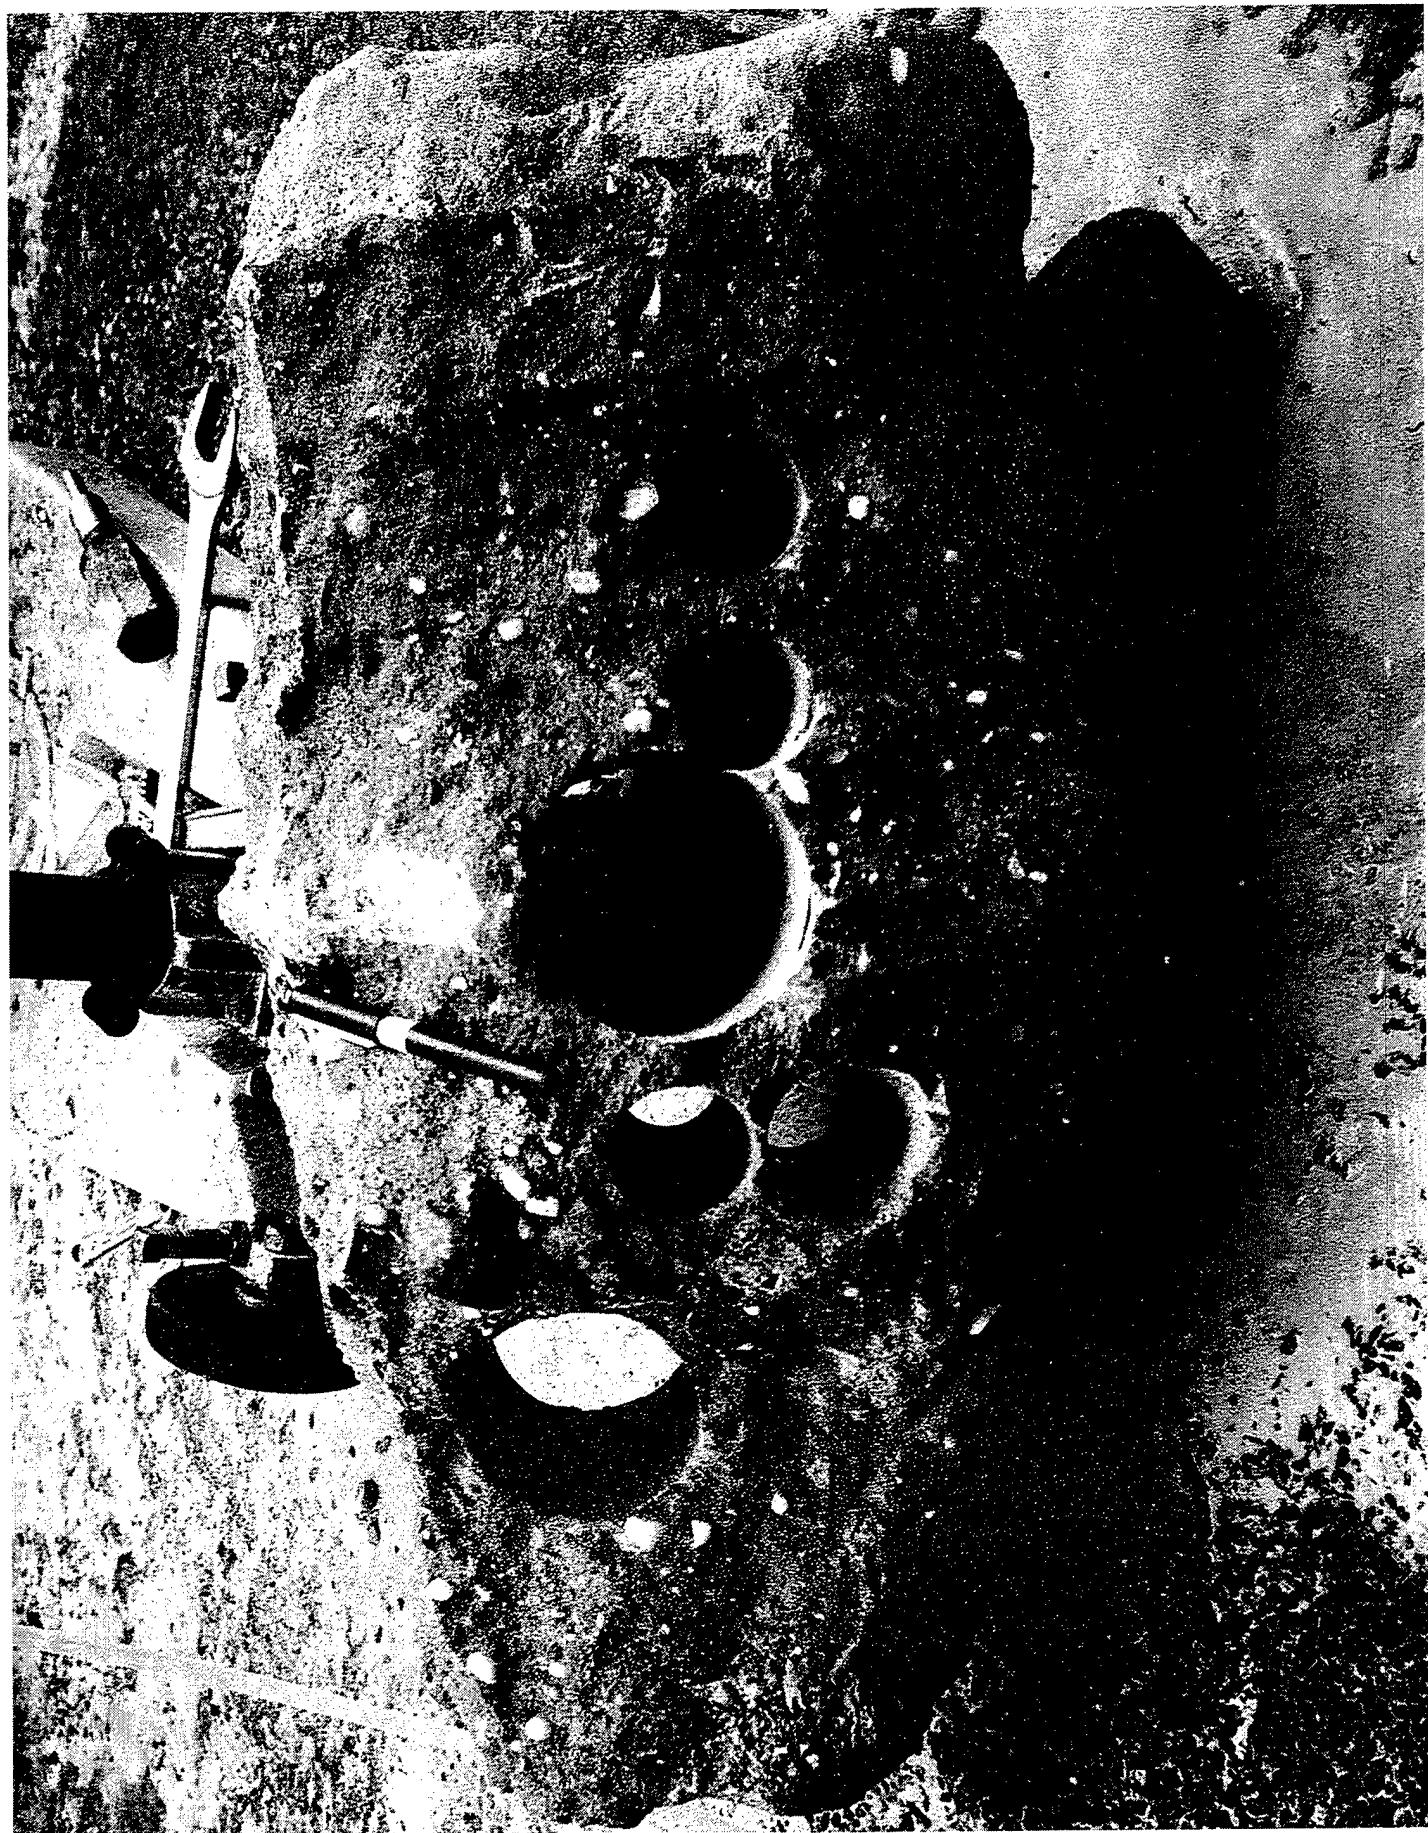
Figure 5.2 Photograph of excavated cement column formed by jet grouting.

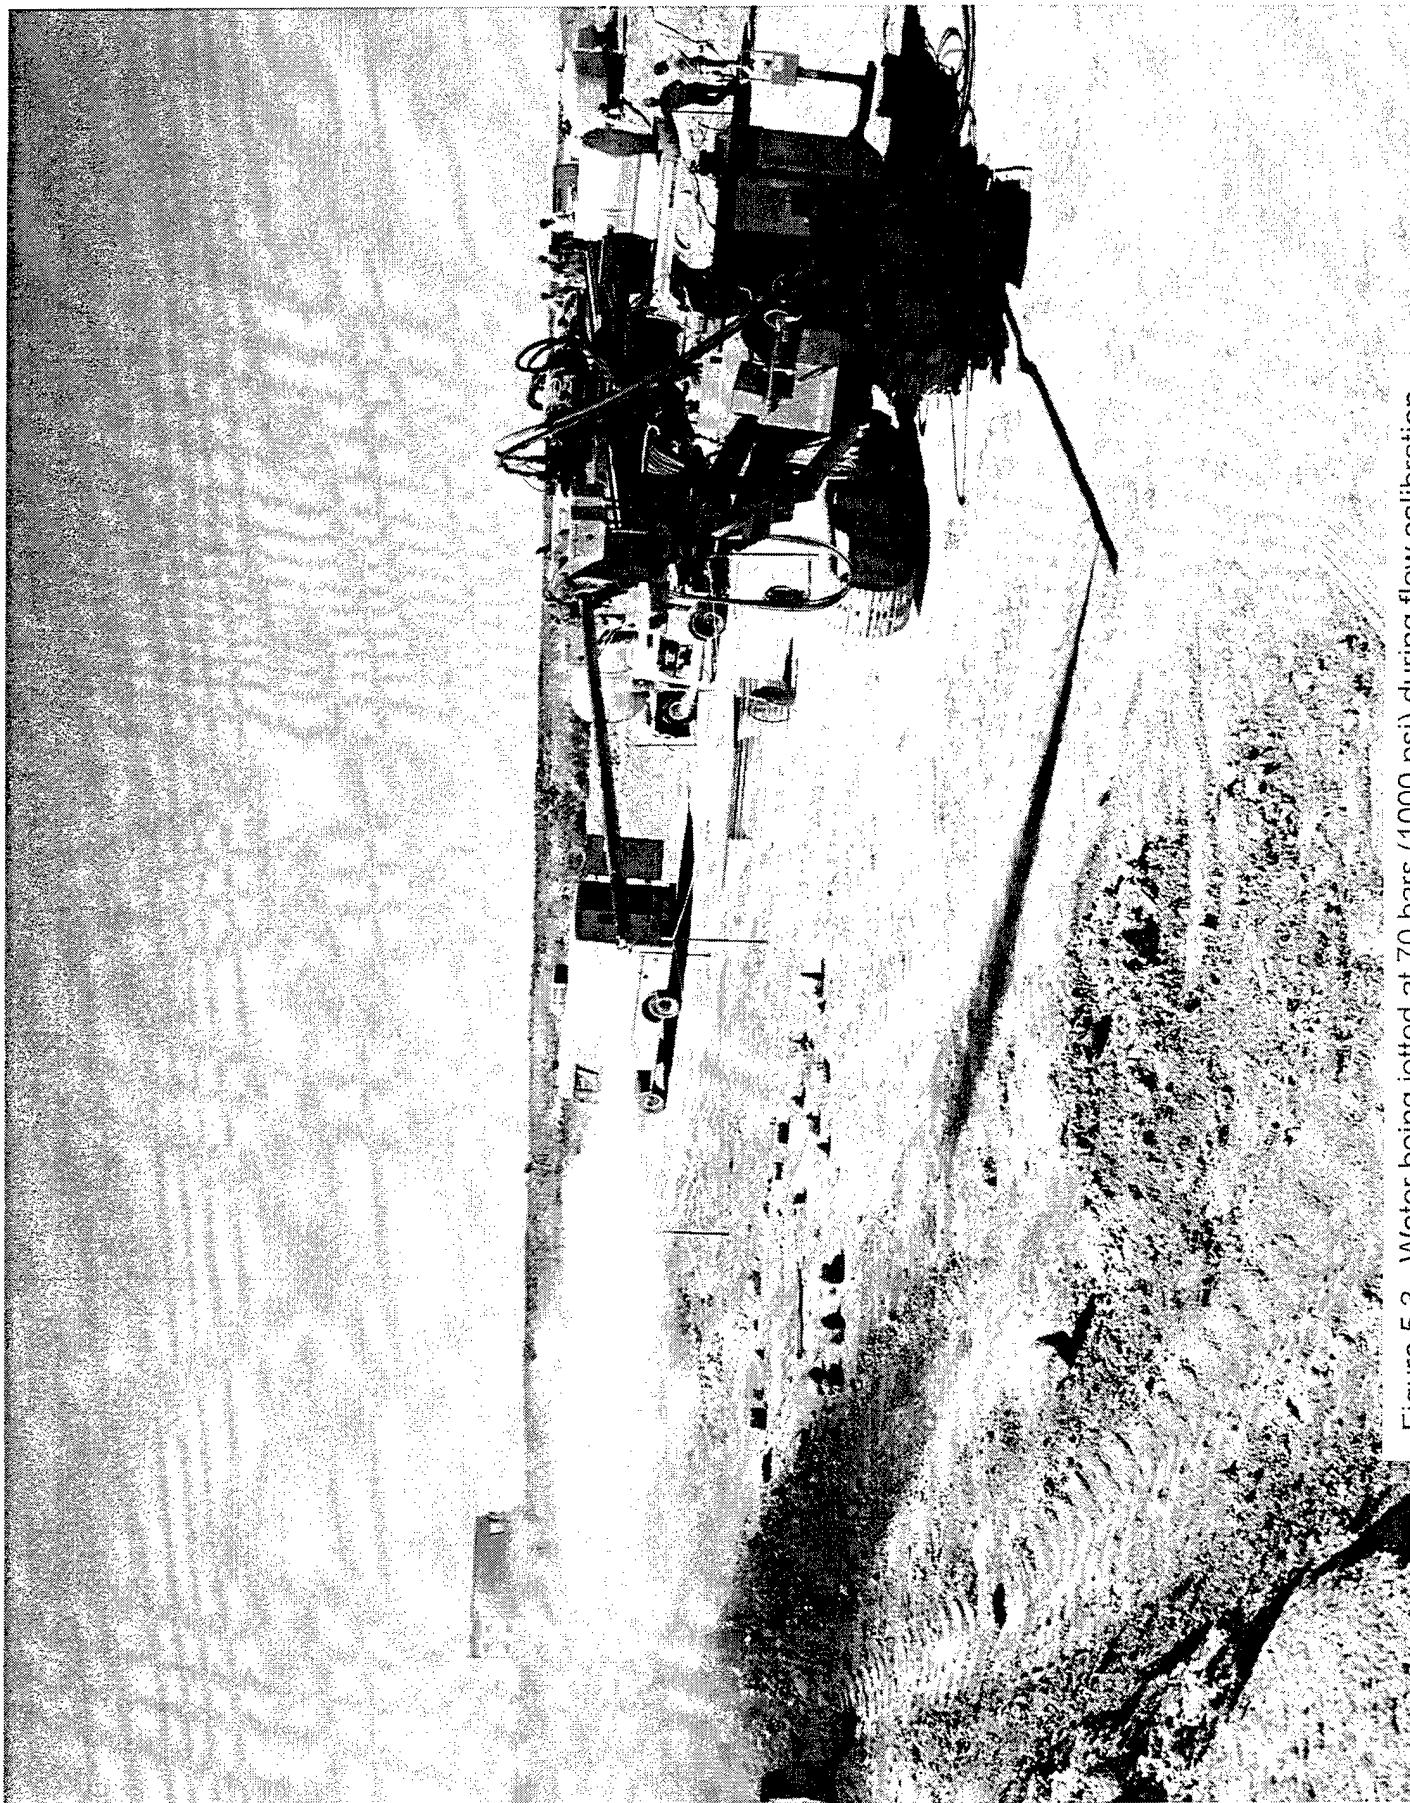
Figure 5.3 Water being jetted at 70 bars (1000 psi) during flow calibration.

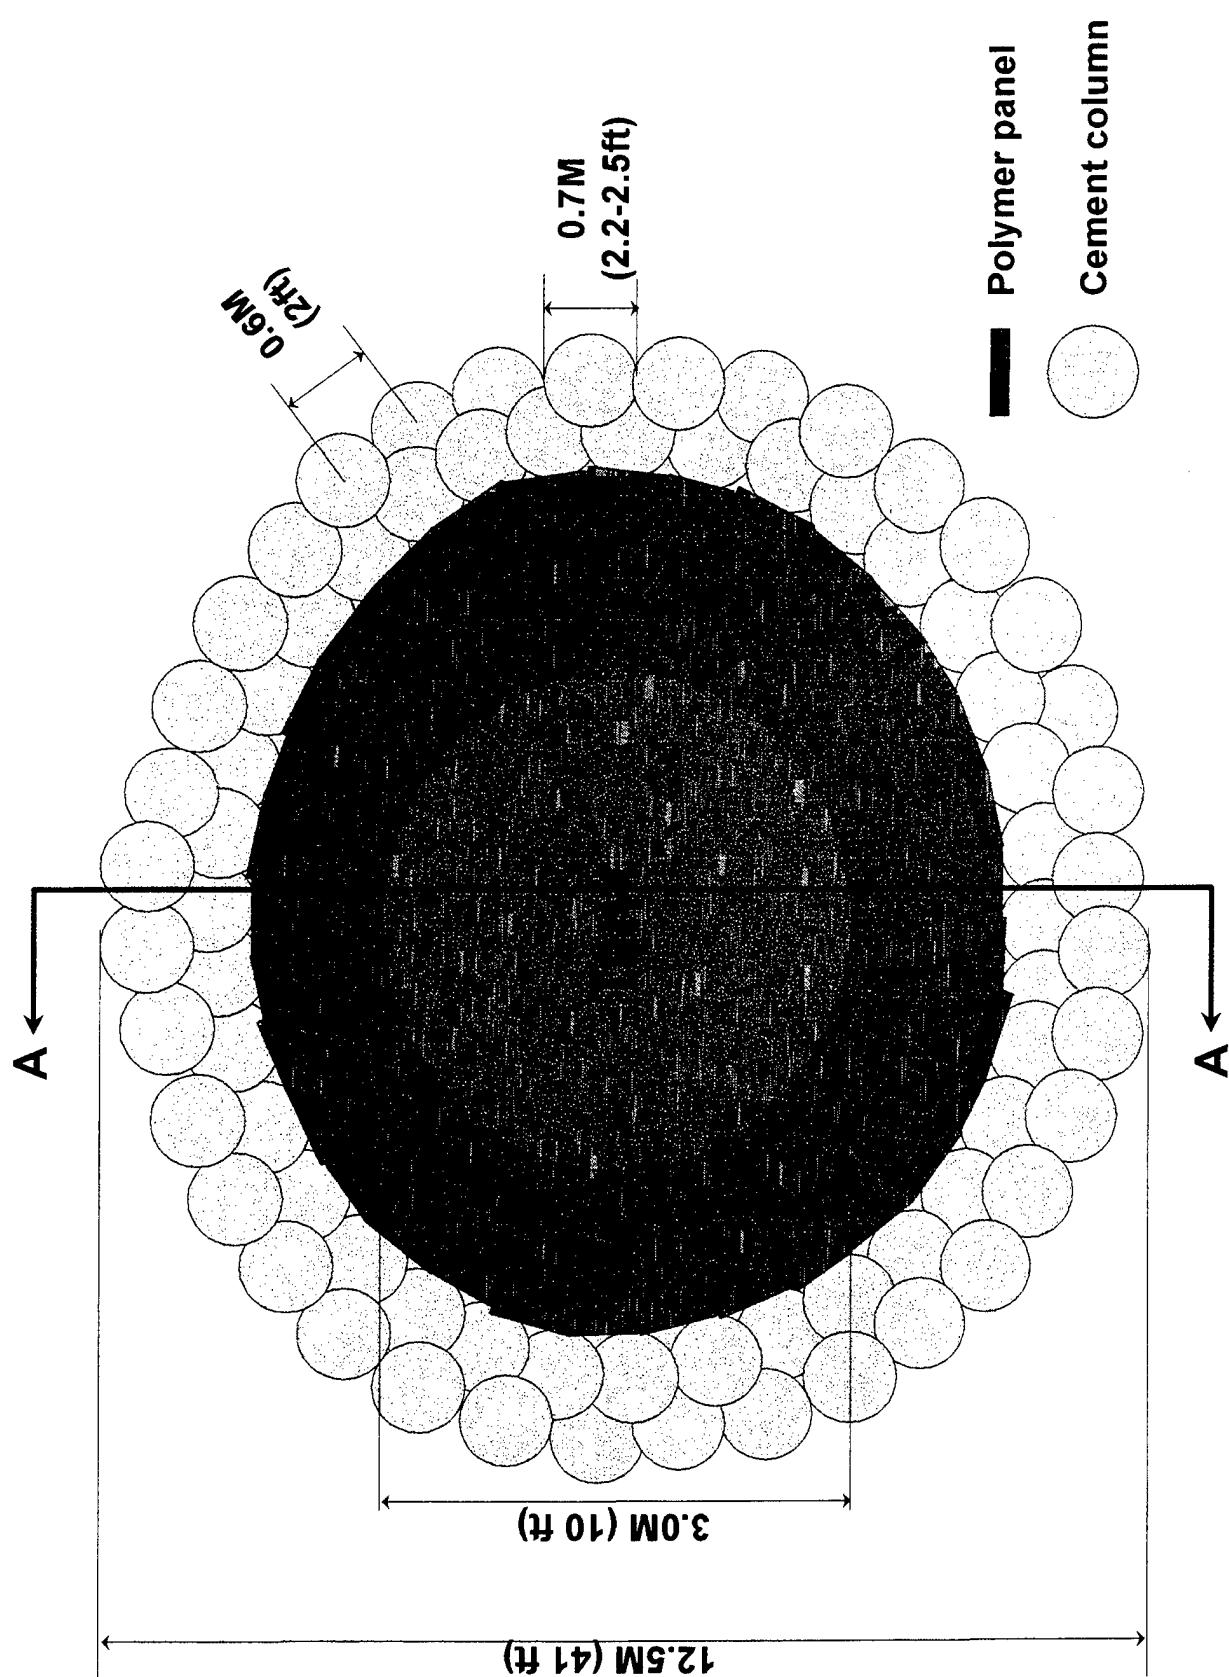
Figure 5.4 Plan view of the Close-Coupled Barrier at Hanford.
