# Summary Report on Close-Coupled Subsurface Barrier Technology Initial Field Trials to Full-Scale Demonstration

John H. Heiser  
Environmental & Waste Technology Center  
Brookhaven National Laboratory

Brian Dwyer  
Mixed Waste Landfill Integrated Demonstration  
Sandia National Laboratory

**September 1997**

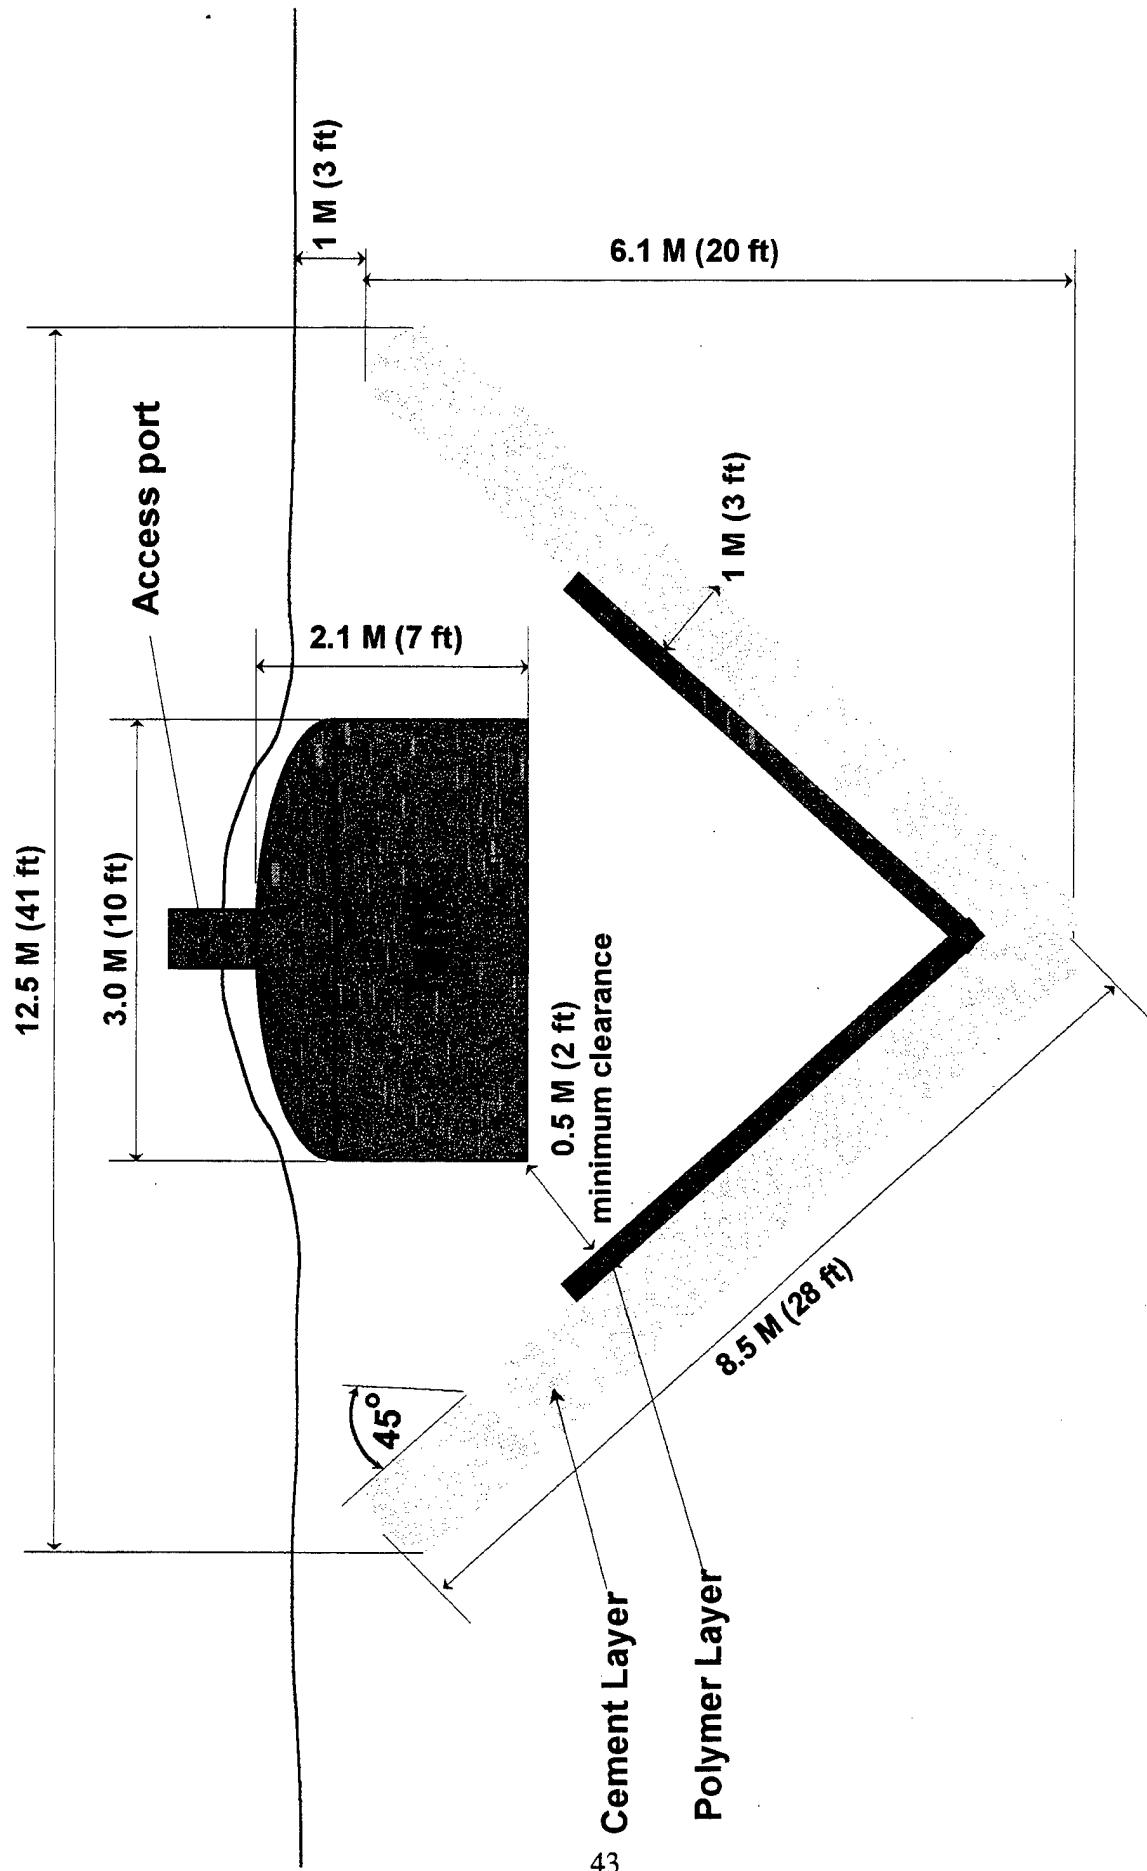
Figure 5.5 Cross-sectional view [A-A] of the Close-Coupled Barrier at Hanford.

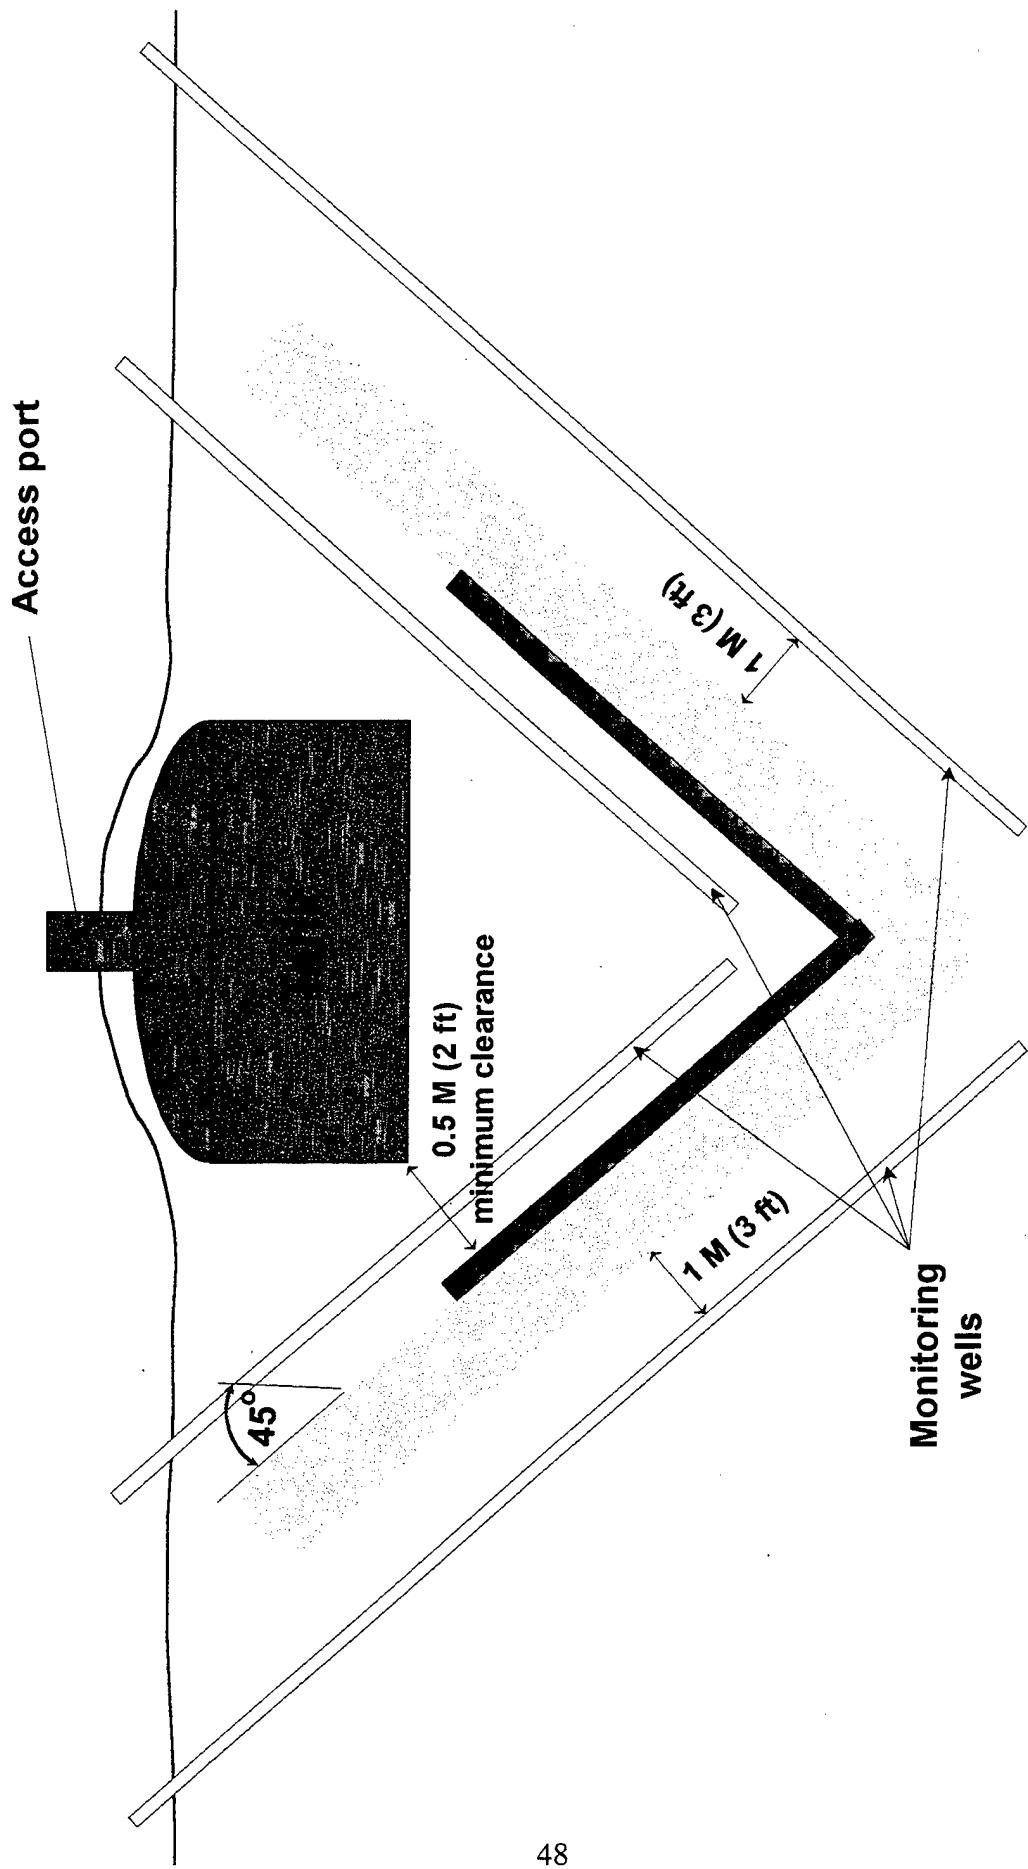
Figure 5.6 Tracer monitoring well locations in relation to the barrier.

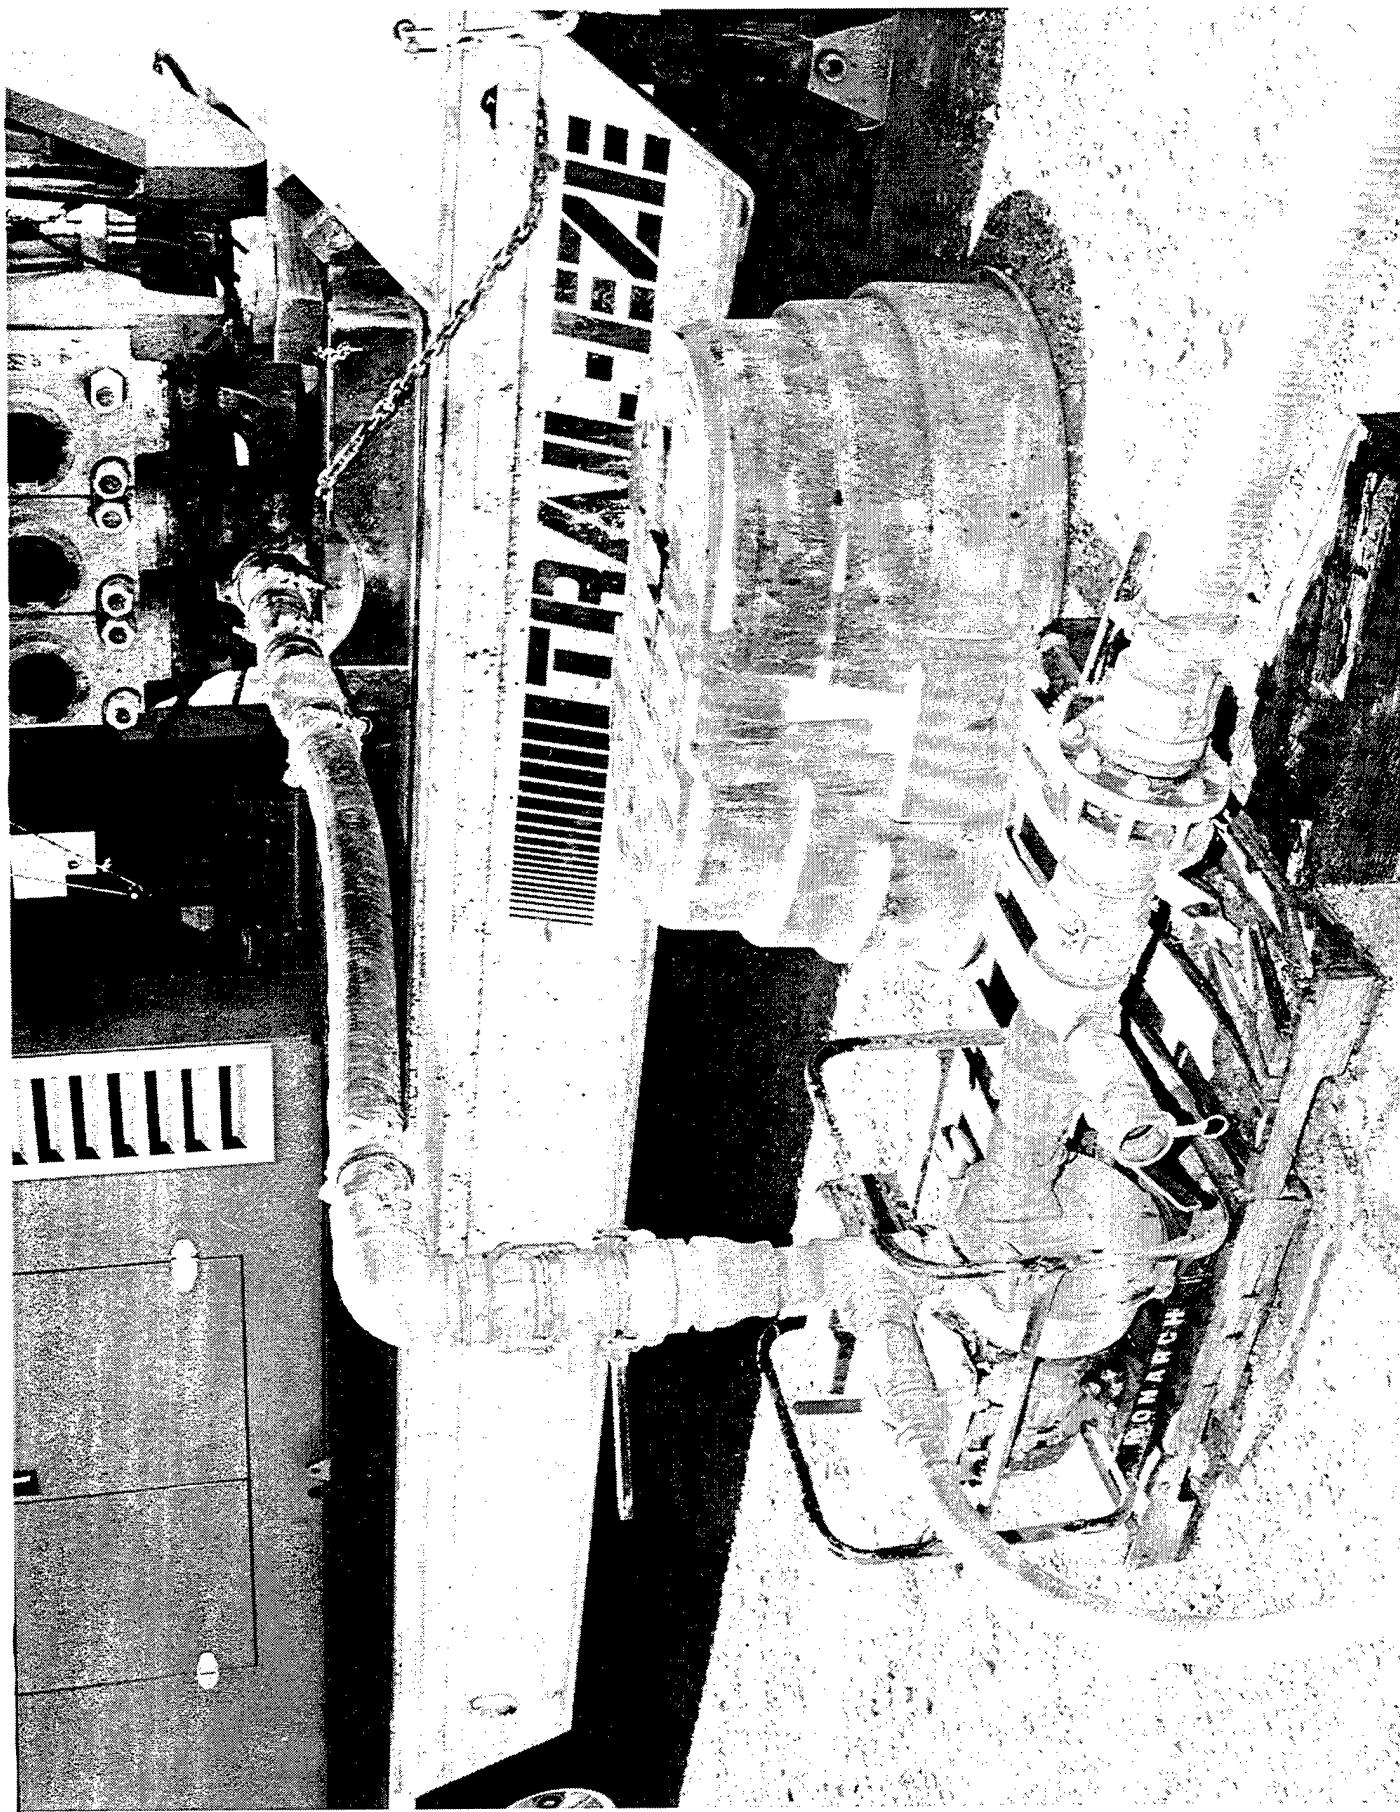
Figure 5.8 Slurry pump used to transfer cement grout to the high pressure pump.

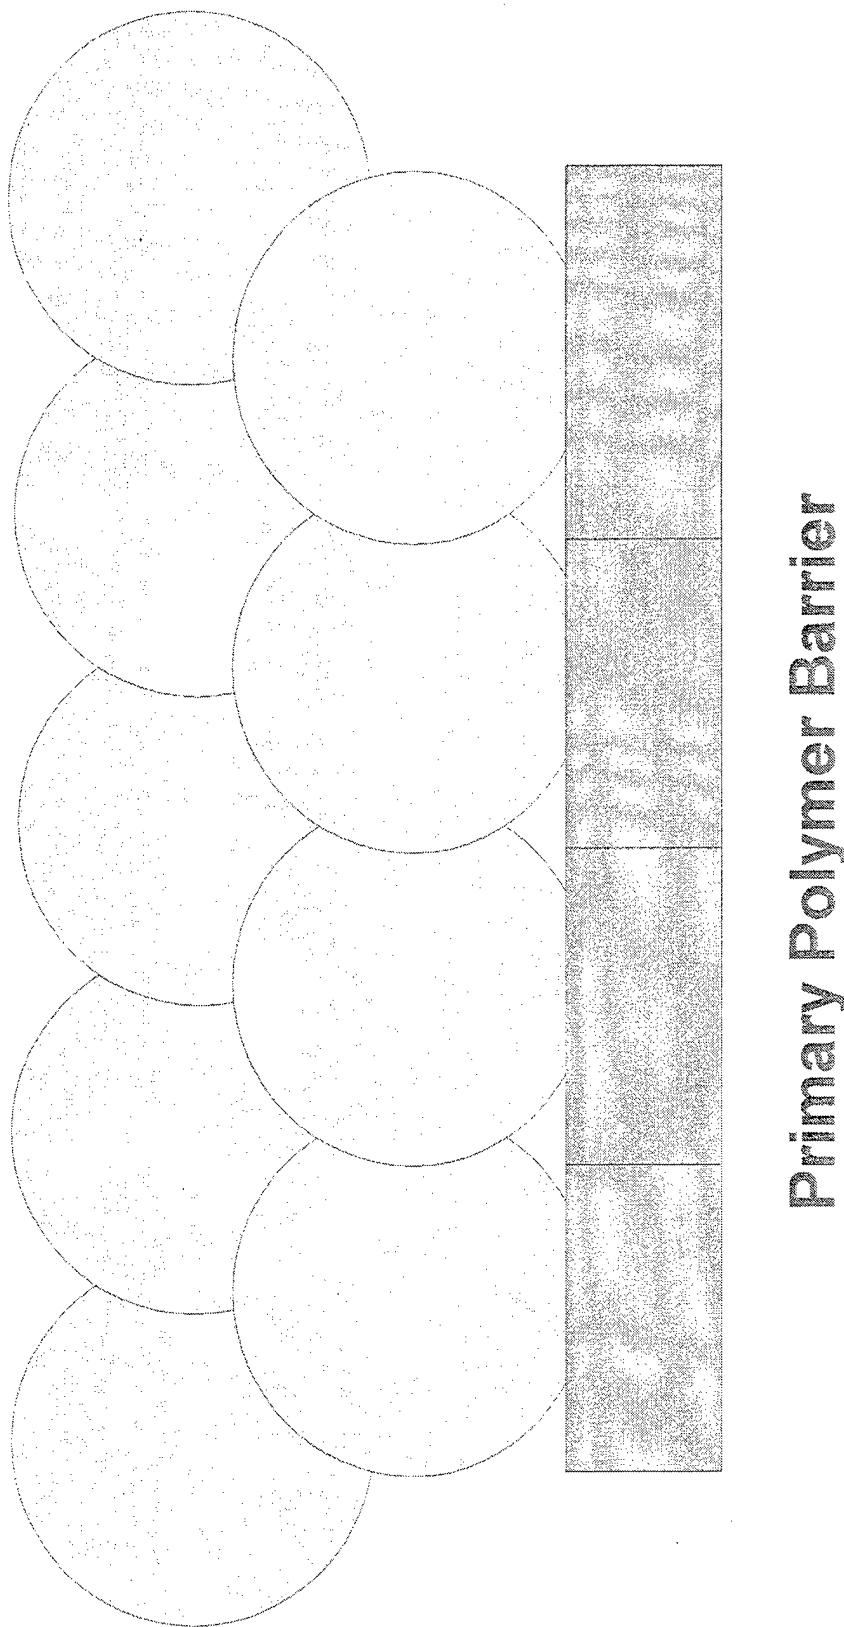
Figure 5.9 Schematic of triangular pitch column layout.

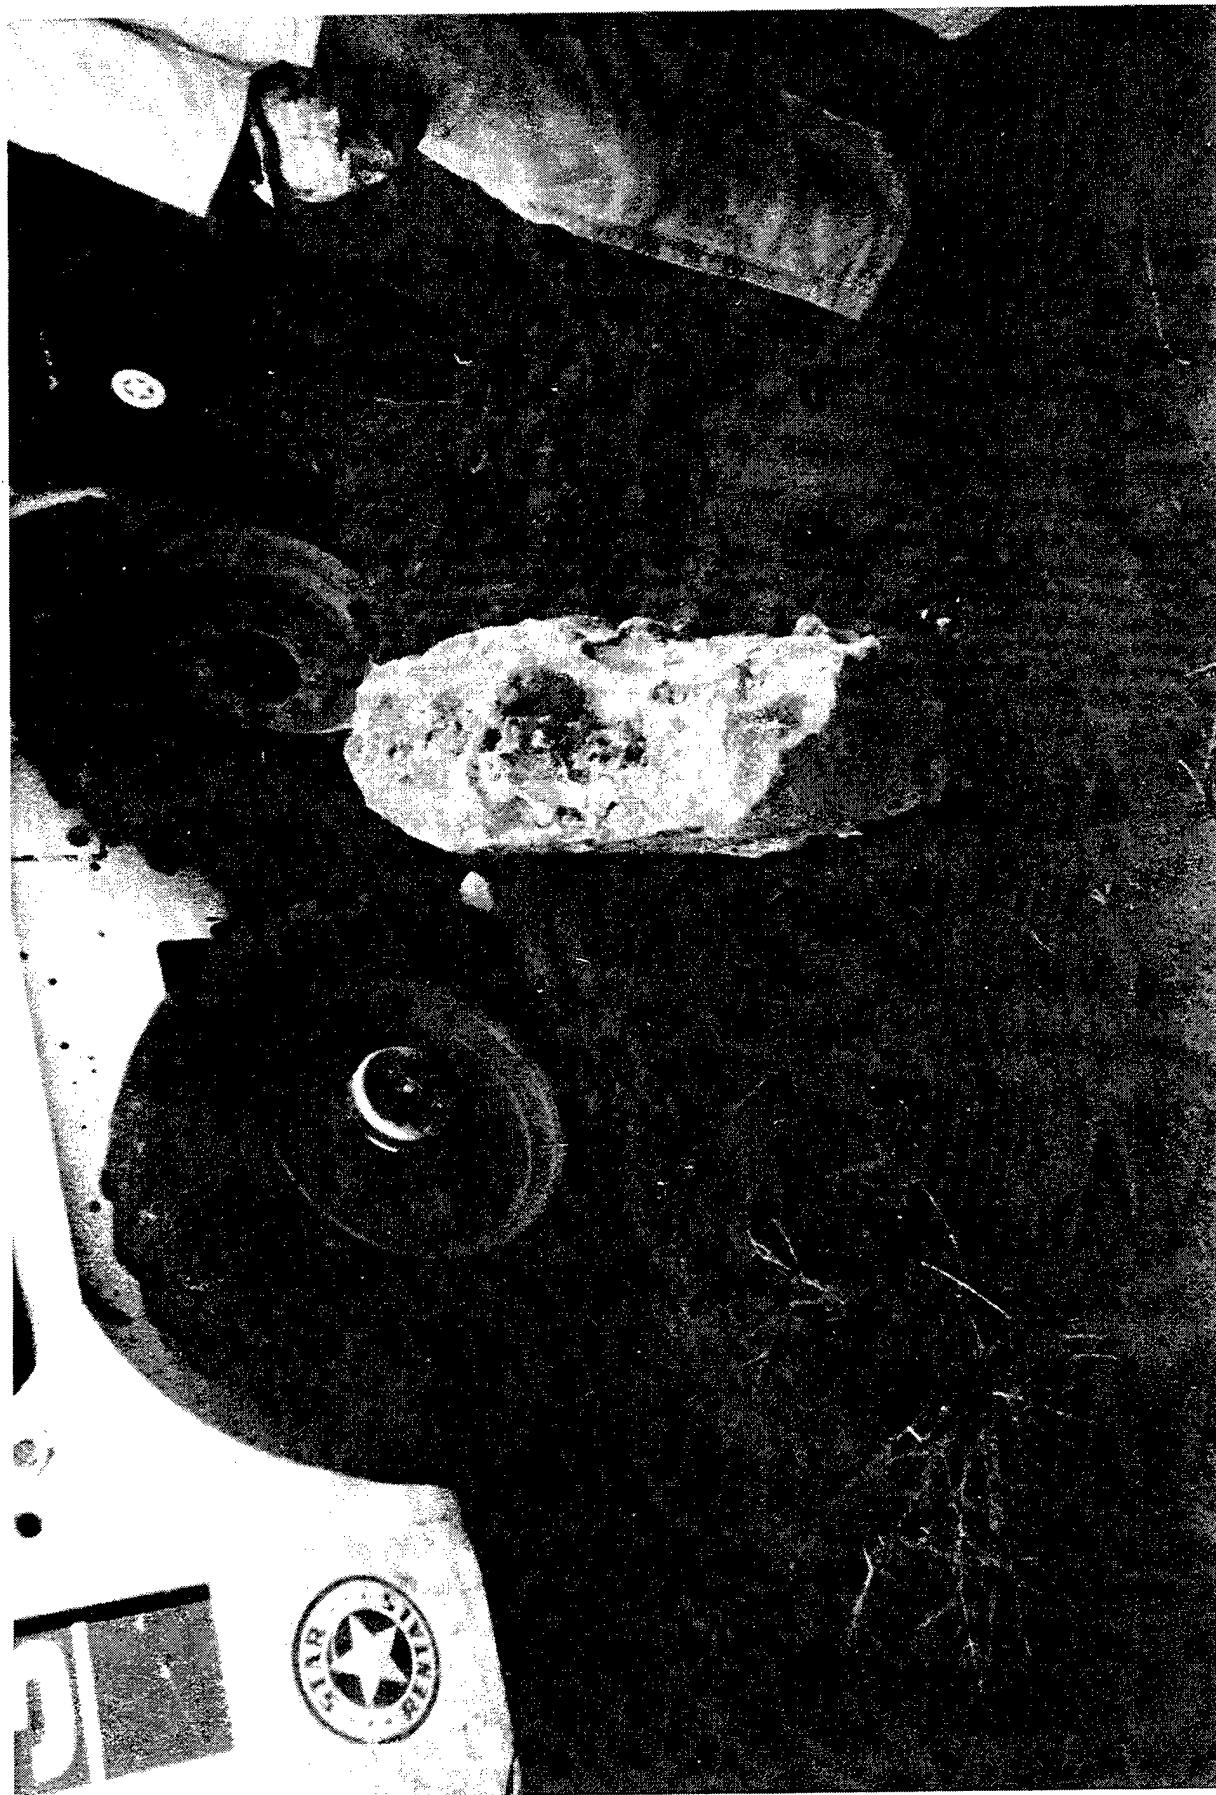
Figure 5.10 Photograph of excavated polymer test column installed using panel jet grouting.

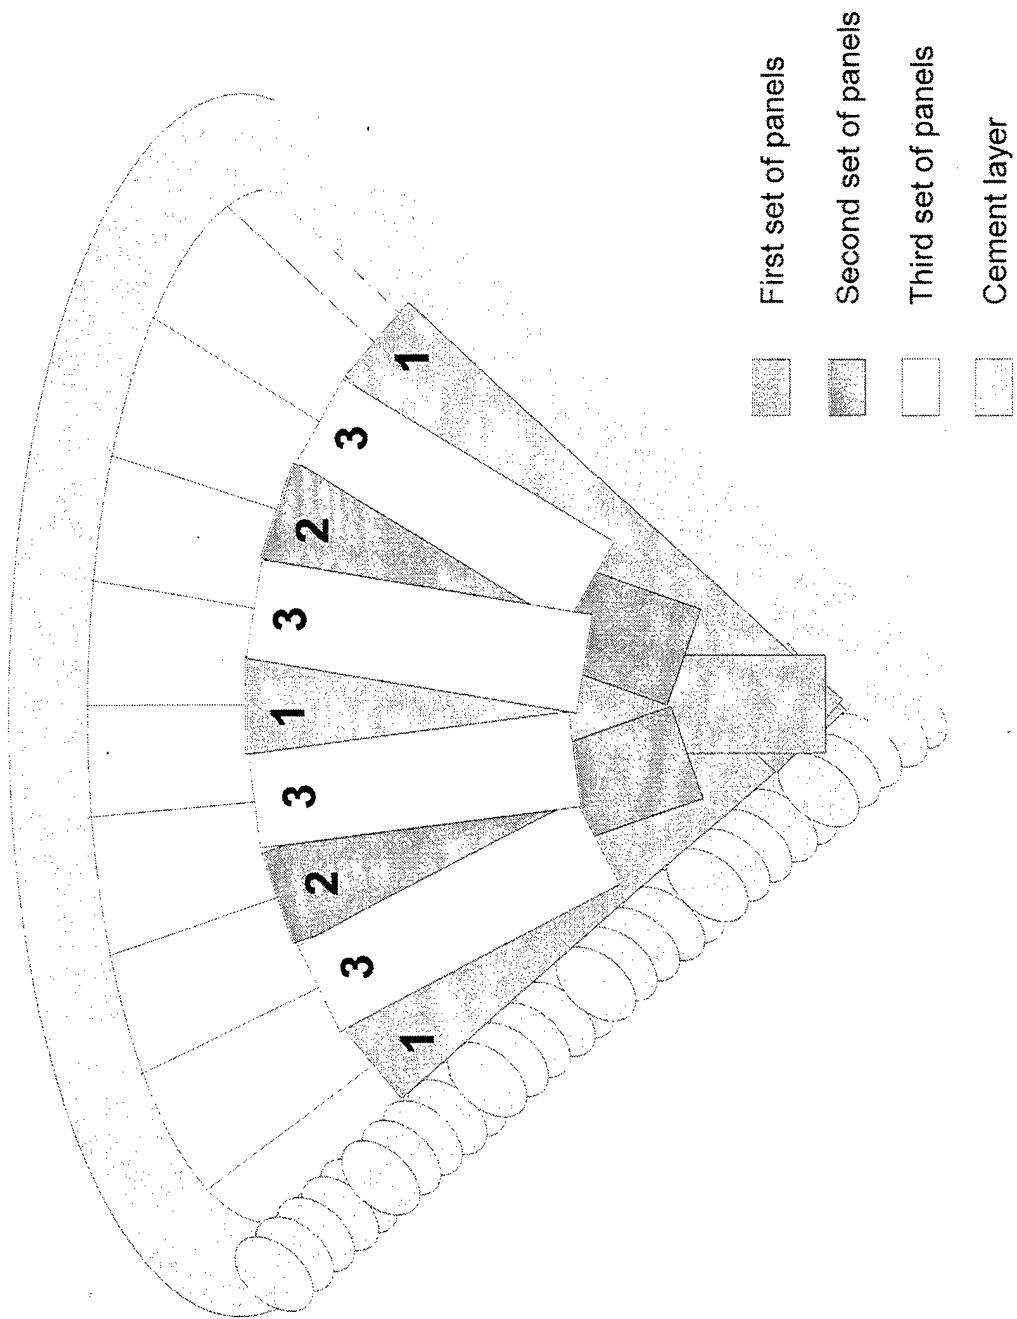
Figure 5.11 Layout of polymer panels for cone-shaped barrier.

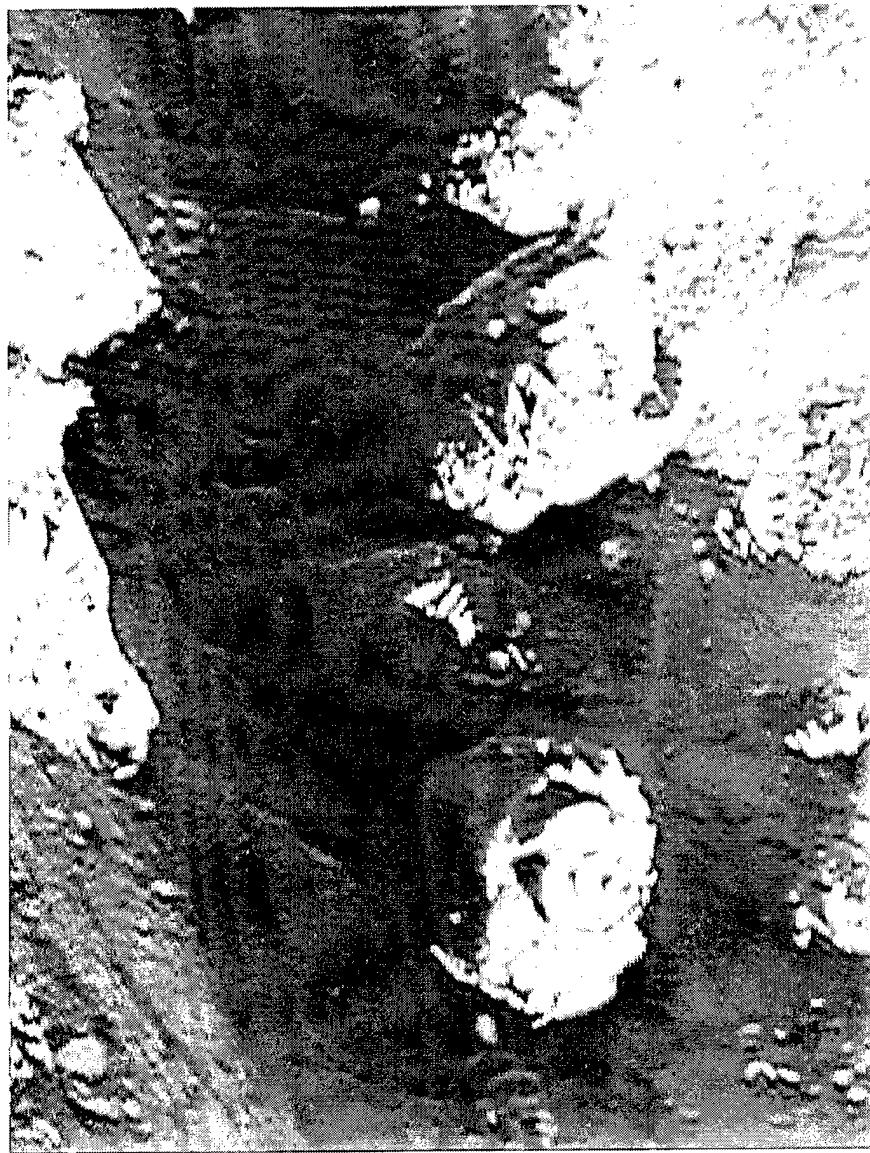
Figure 5.12 Photograph of excavation of the exterior portion of the cement layer of the Hanford barrier.

Visual inspection proved the barrier placement was completed as planned. The composite barrier provided integral containment for the storage tank and showed no signs of breached areas or leak pathways. Interior inspection showed the primary polymer layer to be continuous and breach free and the upper portion of the cement layer to be the same. Exterior inspection revealed several small gaps in one ring of columns but, still proved the upper portion cement layer to be continuous and breach free. The lower section of the cement cone could not be inspected since it was covered by the polymer on the interior and below the excavation point on the exterior. It is assumed that since the upper section is intact and the columns continue to converge approaching the apex, that the lower portion is intact and of greater grout density than the upper section.

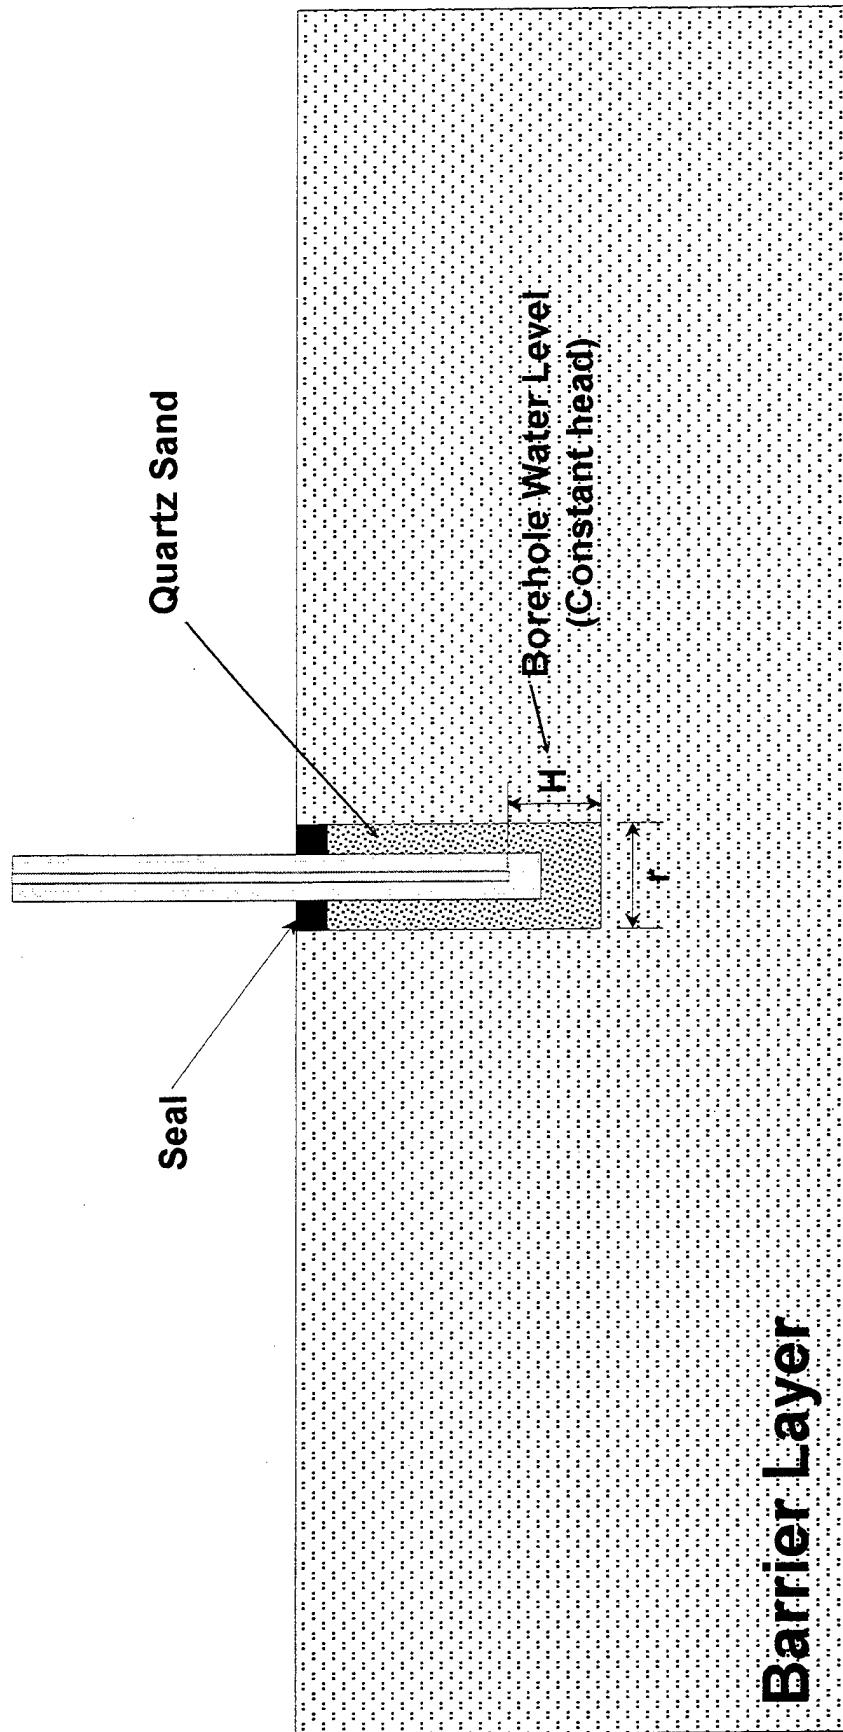
Figure 5.16 Schematic of a guelph permeameter.

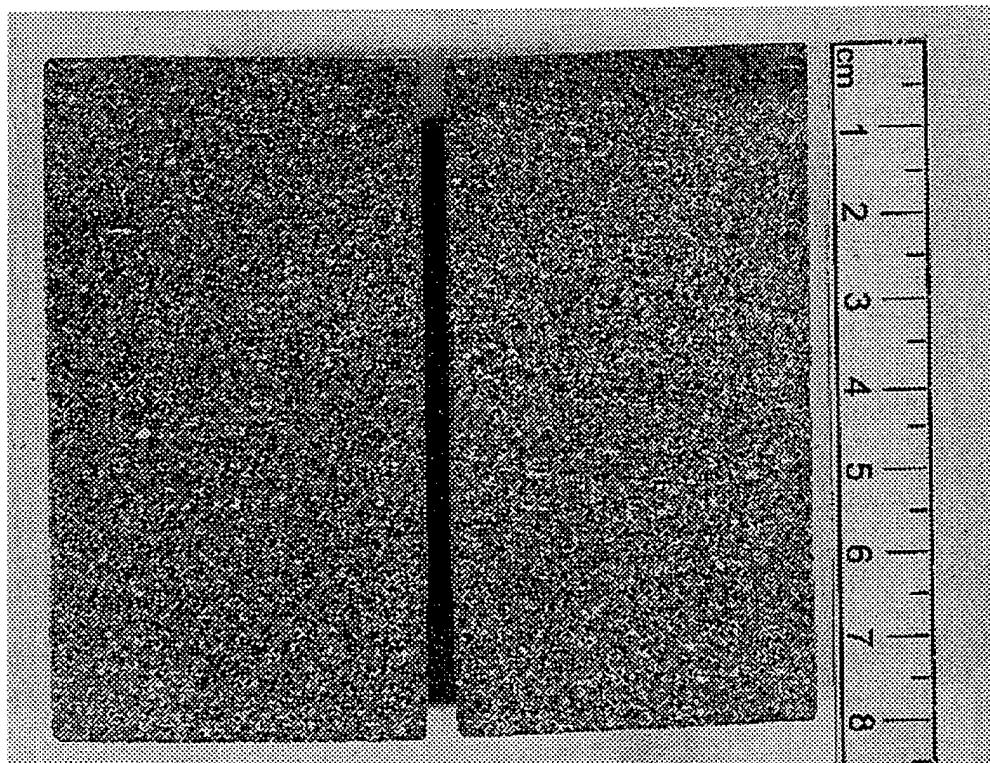
Figure 5.19 Cross-sections of polymer cores taken from the Hanford barrier.

Samples were also cross-sectioned to determine visually the homogeneity, in terms of voids or stratification. Figure 5.19 shows two core samples that were cut in half along the vertical axis. These samples show a well mixed grout with no small voids apparent.

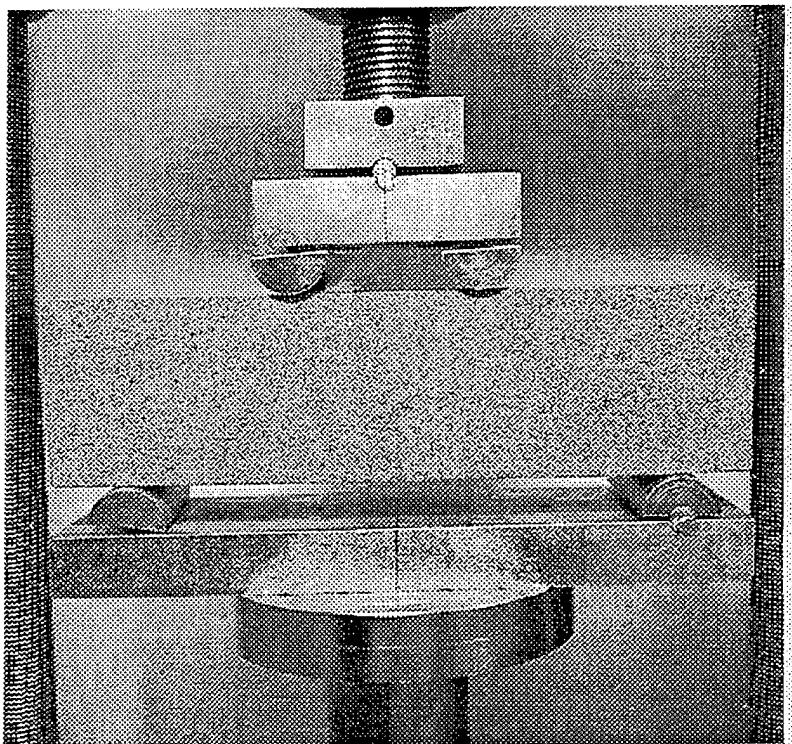
Figure 5.20 Apparatus for Flexural Strength Testing

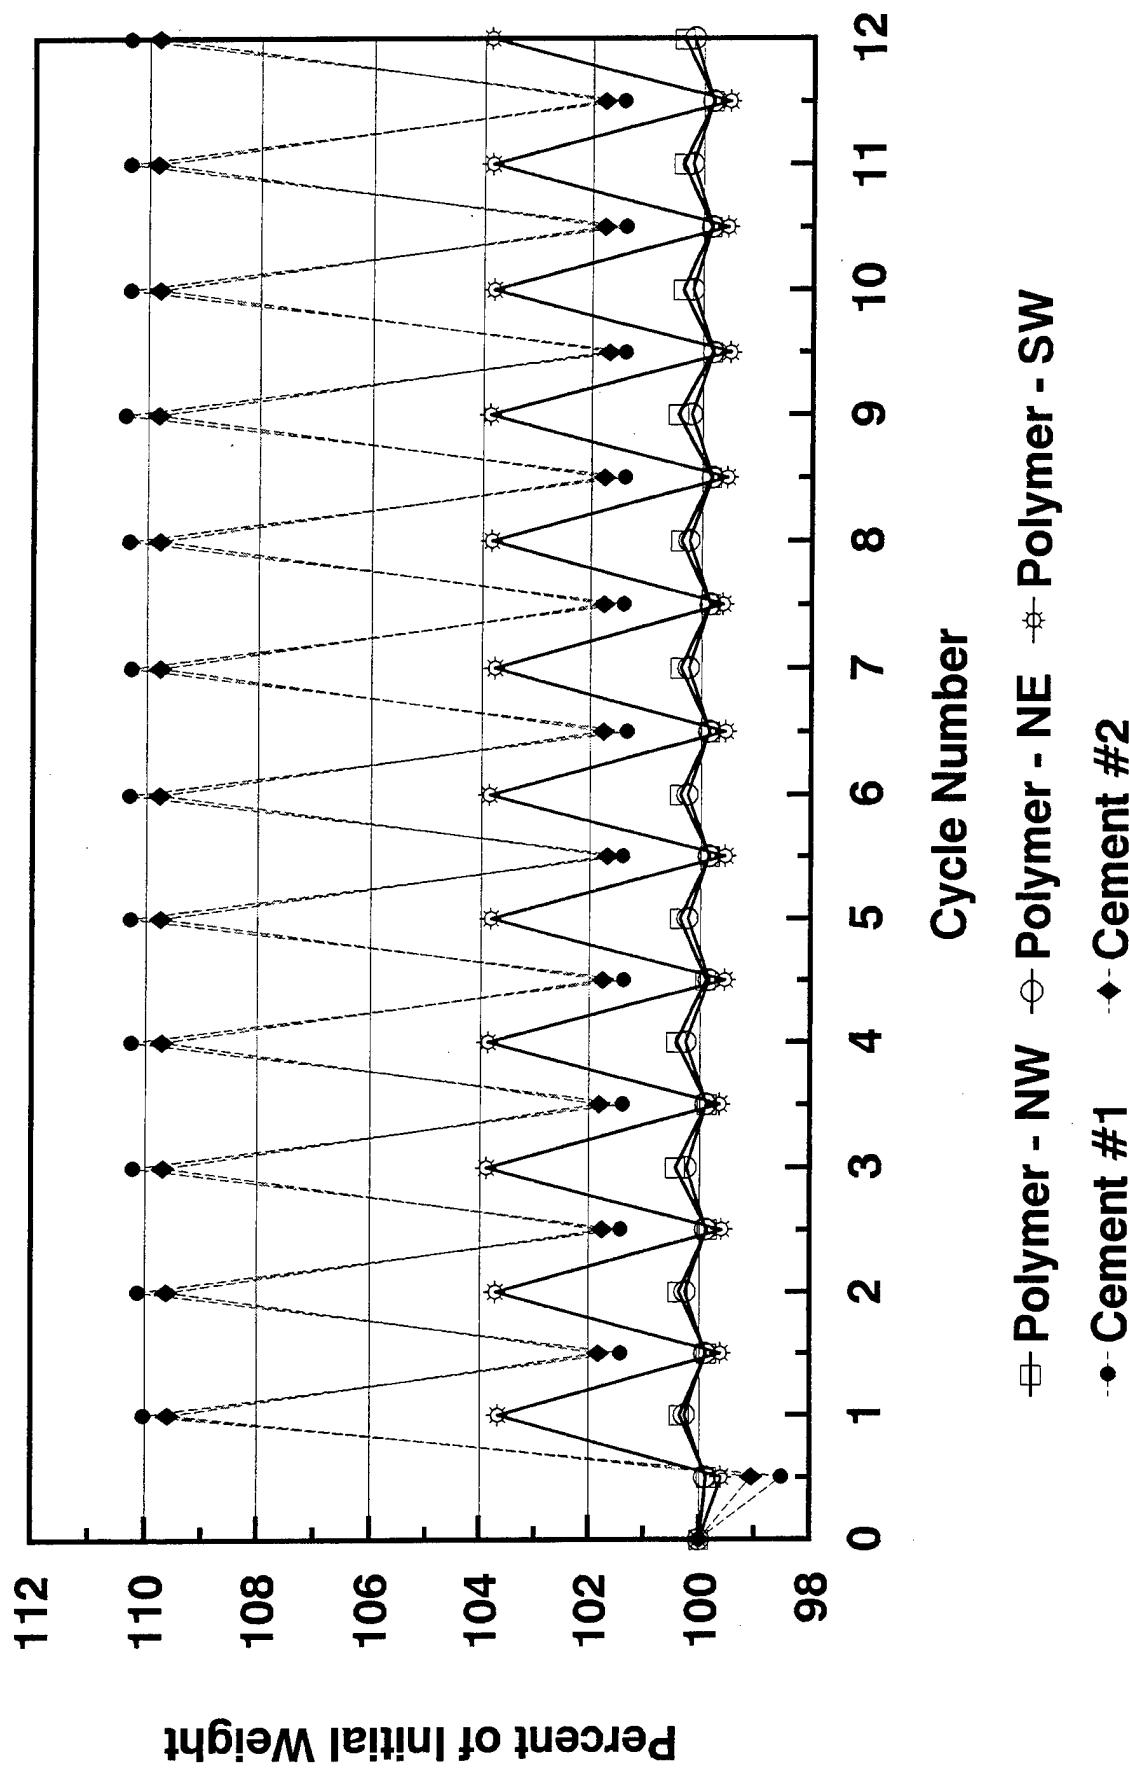
Figure 5.21 Weight history of Hanford barrier core samples during wet-dry cycling.

Neither the polymer nor cement core samples showed any visible degradation (i.e., cracking) after 12 cycles. Weight changes for the polymer soil mortars were minimal from beginning to end. Comparing the initial pretest weight to the final dry cycle weight, average weight change for the three field emplaced samples was 0.07%, which compares to 0.20% for laboratory prepared samples. Looking at the first dry cycle weight and comparing it to the final dry cycle weight shows a change of 0.29%, similar laboratory prepared samples had differences averaging 0.86%. The average weight histories of the core samples are given in Figure 5.21. Note that one polymer sample shows higher weight fluctuations than the other two (0.17% versus 0.49%). The difference may be due to a lower binder to soil ratio in the area this core was taken or the soil stratification may have been such that a coarser sand existed near the bottom of the barrier where this core was taken. Figure 5.22 depicts the weight of the specimens after each dry cycle. Looking at the trend of this plot we see that the weights remain constant throughout the

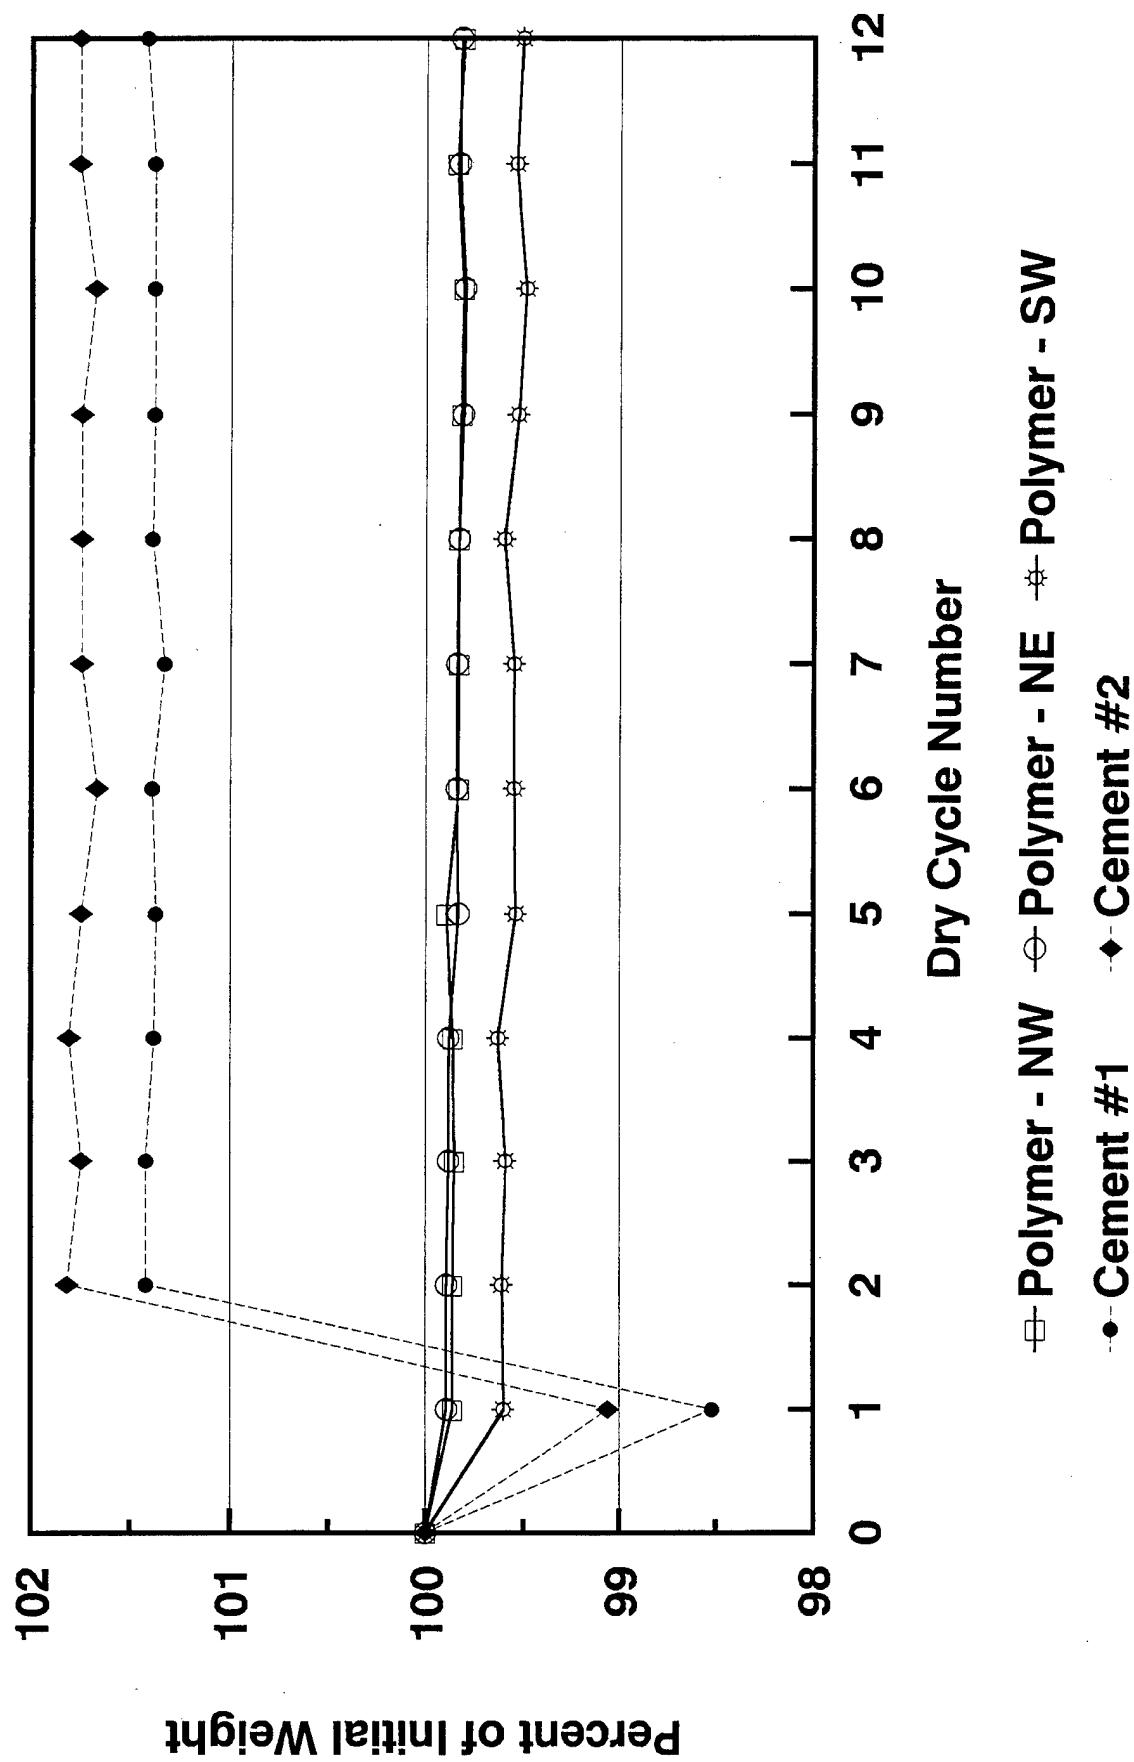
Figure 5.22 Weight history of Hanford barrier core samples during dry cycling.

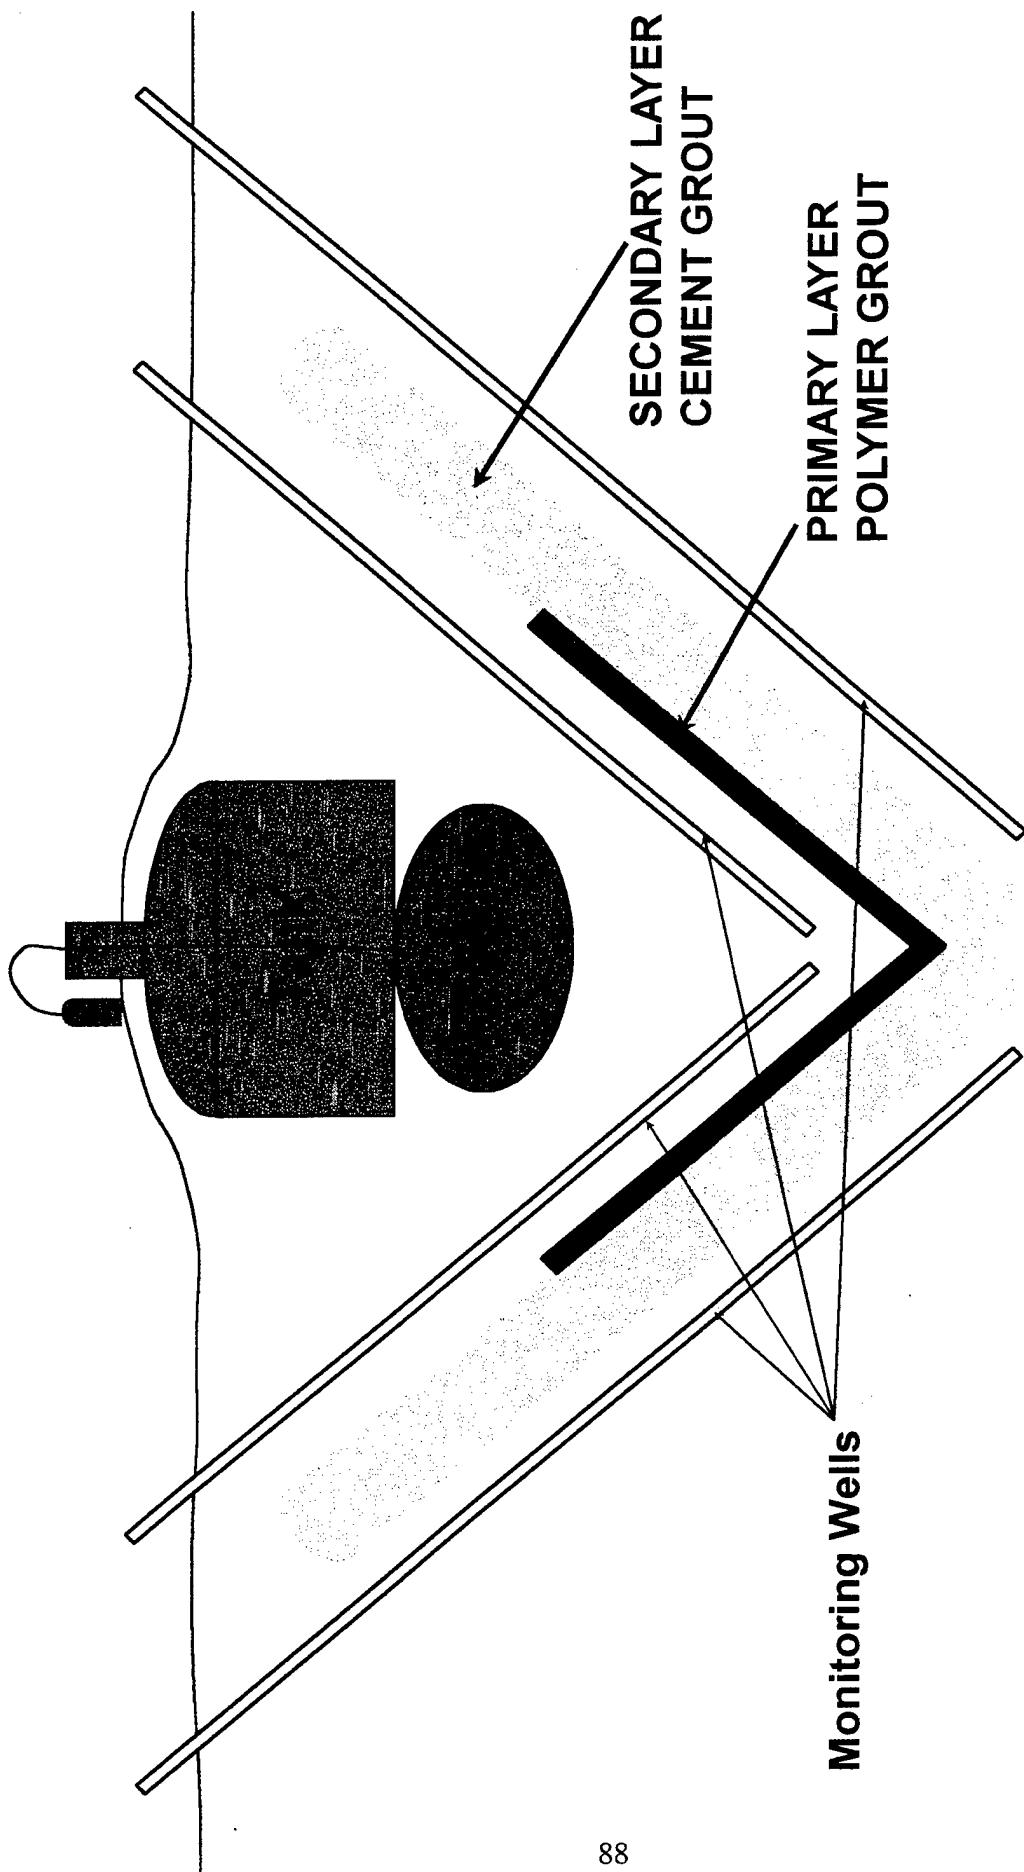
Figure 6.1 Layout of the barrier system used in modeling perfluorocarbon tracer transport.
