# Summary Report on Close-Coupled Subsurface Barrier Technology Initial Field Trials to Full-Scale Demonstration

John H. Heiser  
Environmental & Waste Technology Center  
Brookhaven National Laboratory

Brian Dwyer  
Mixed Waste Landfill Integrated Demonstration  
Sandia National Laboratory

**September 1997**

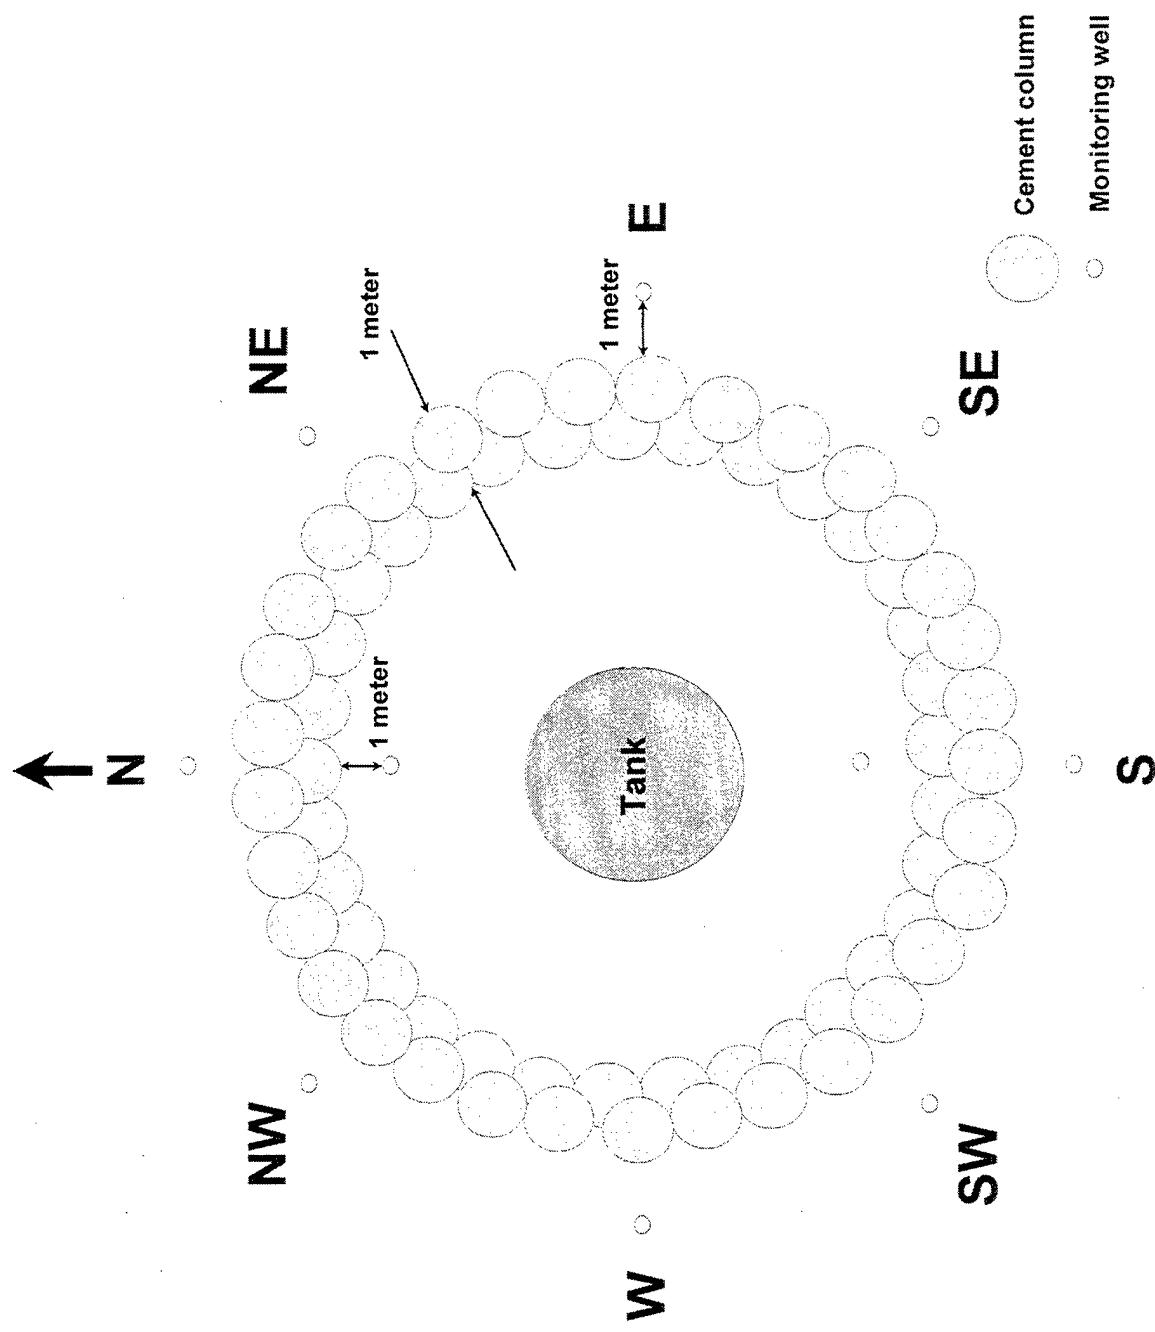
Figure 6.2 Schematic representation of barrier configuration for tracer modeling.

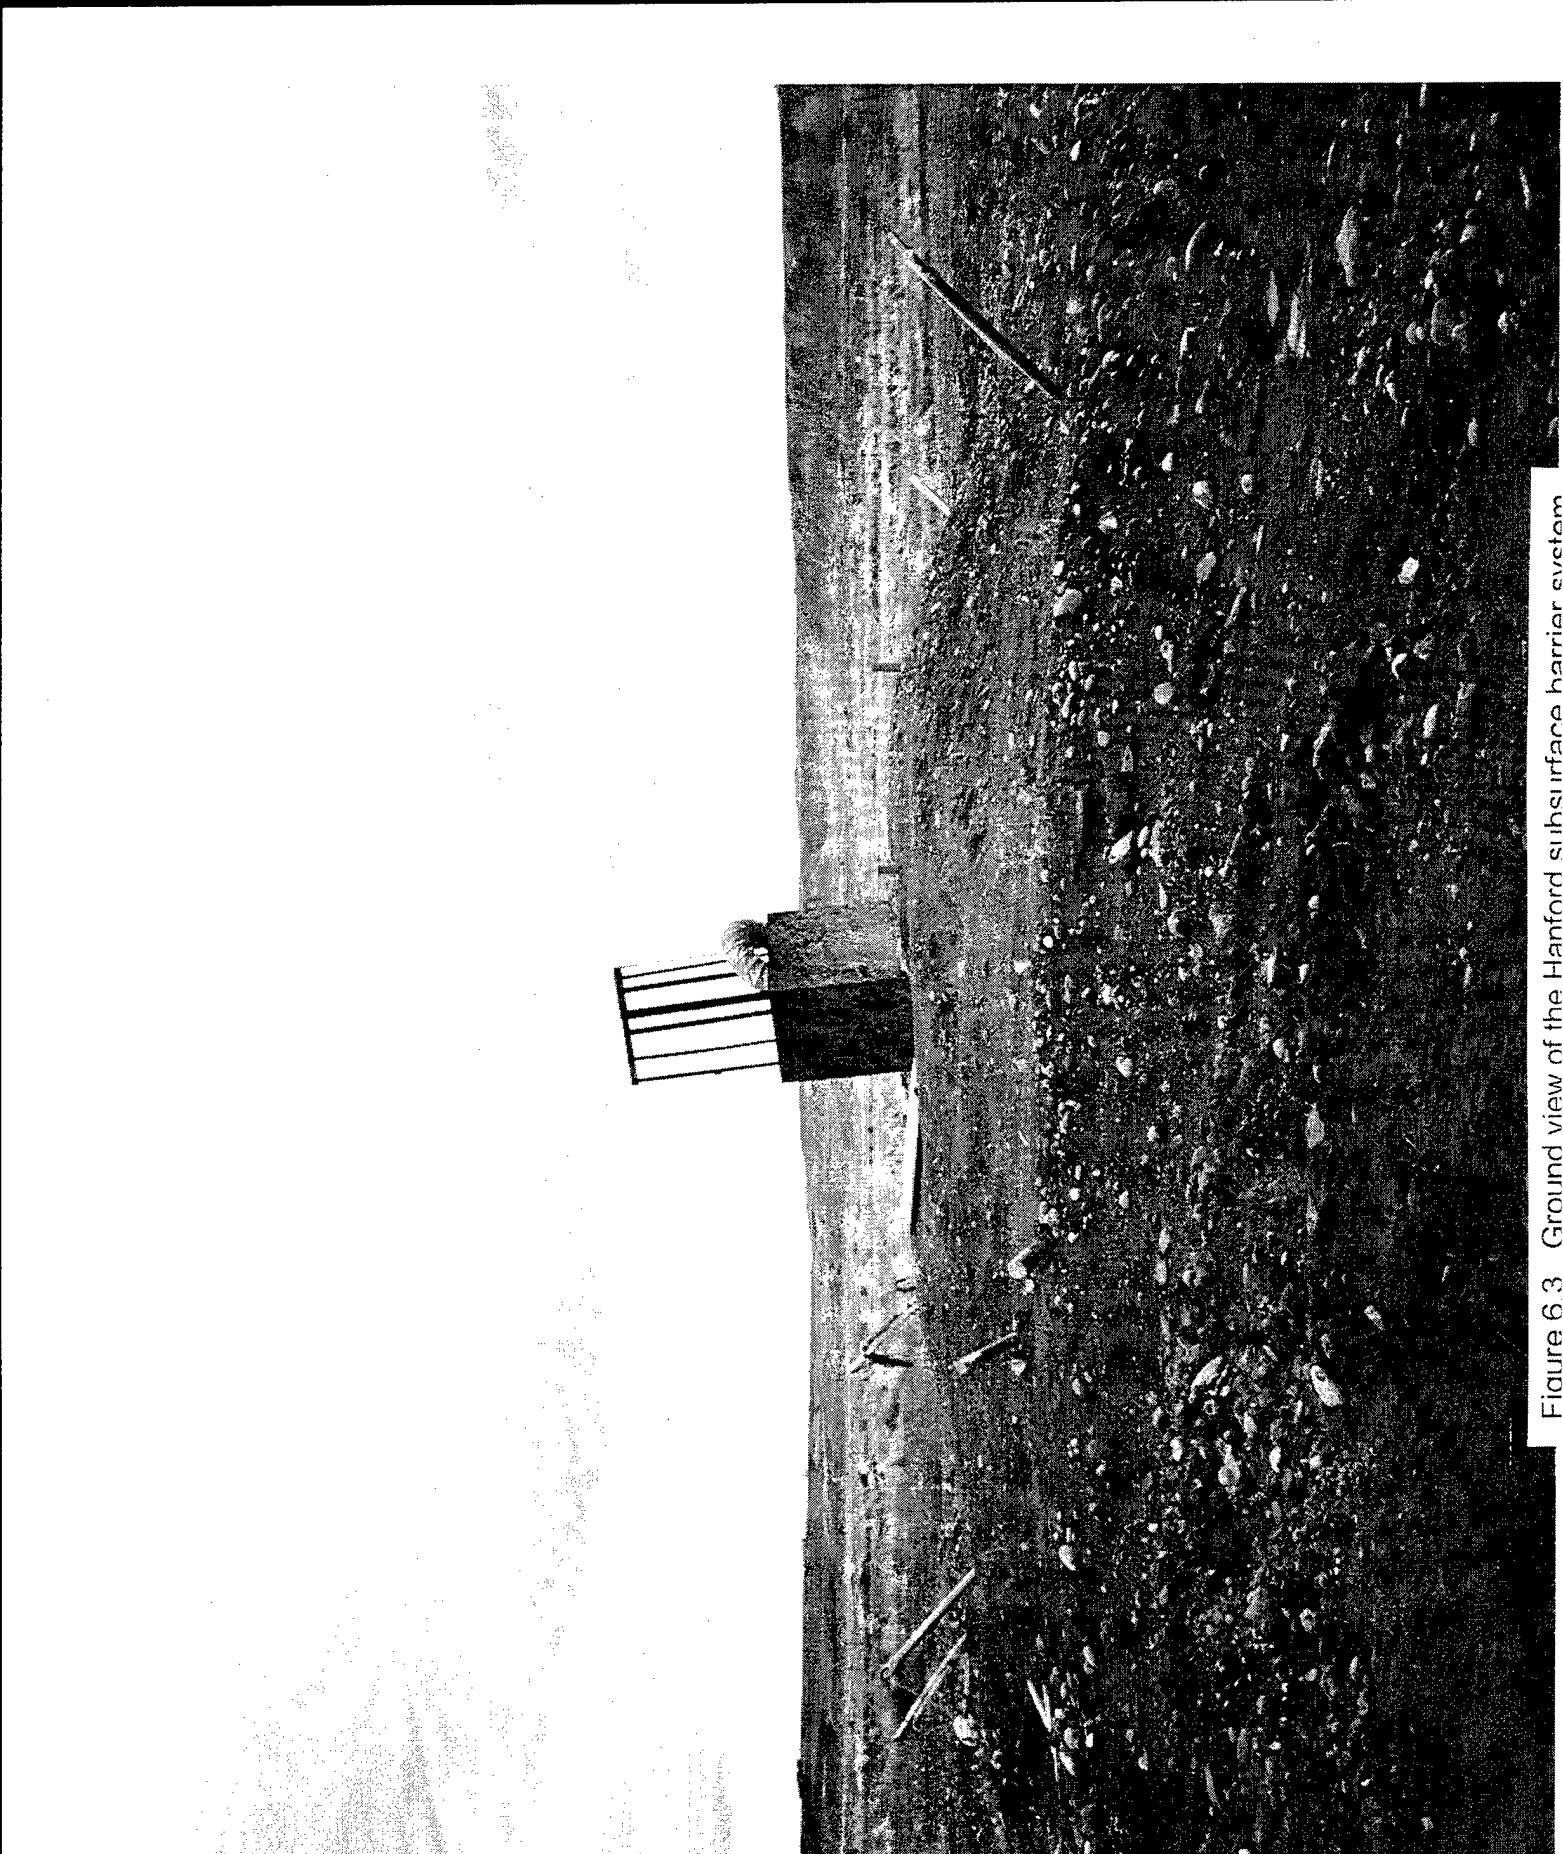
Figure 6.3 Ground view of the Hanford subsurface barrier system

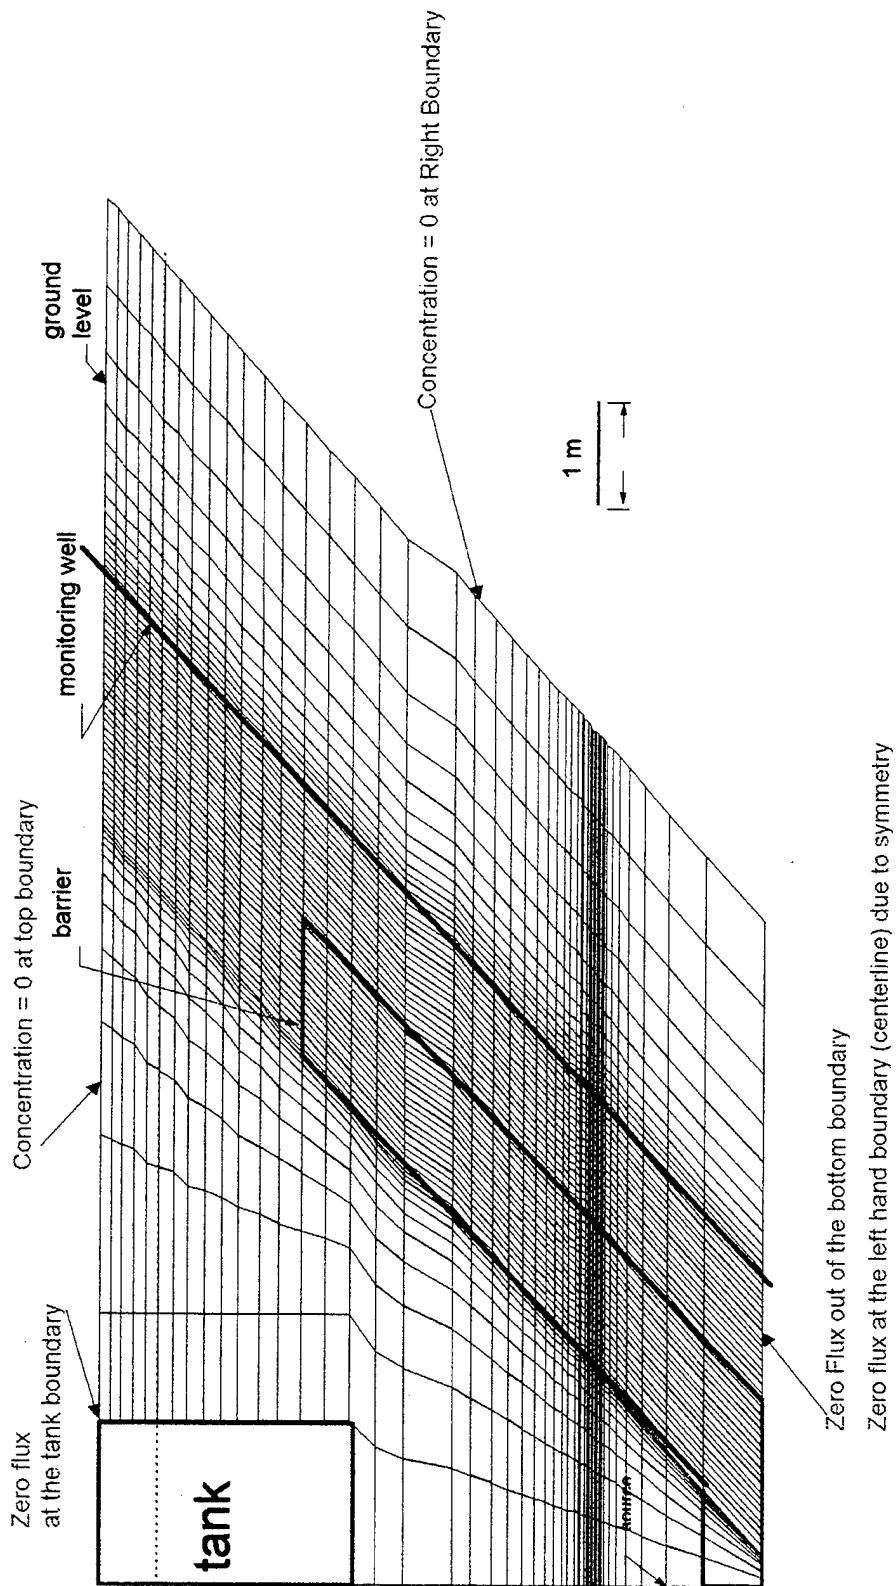
Figure 6.4 Finite element grid used to simulate transport through the subsurface barrier system.

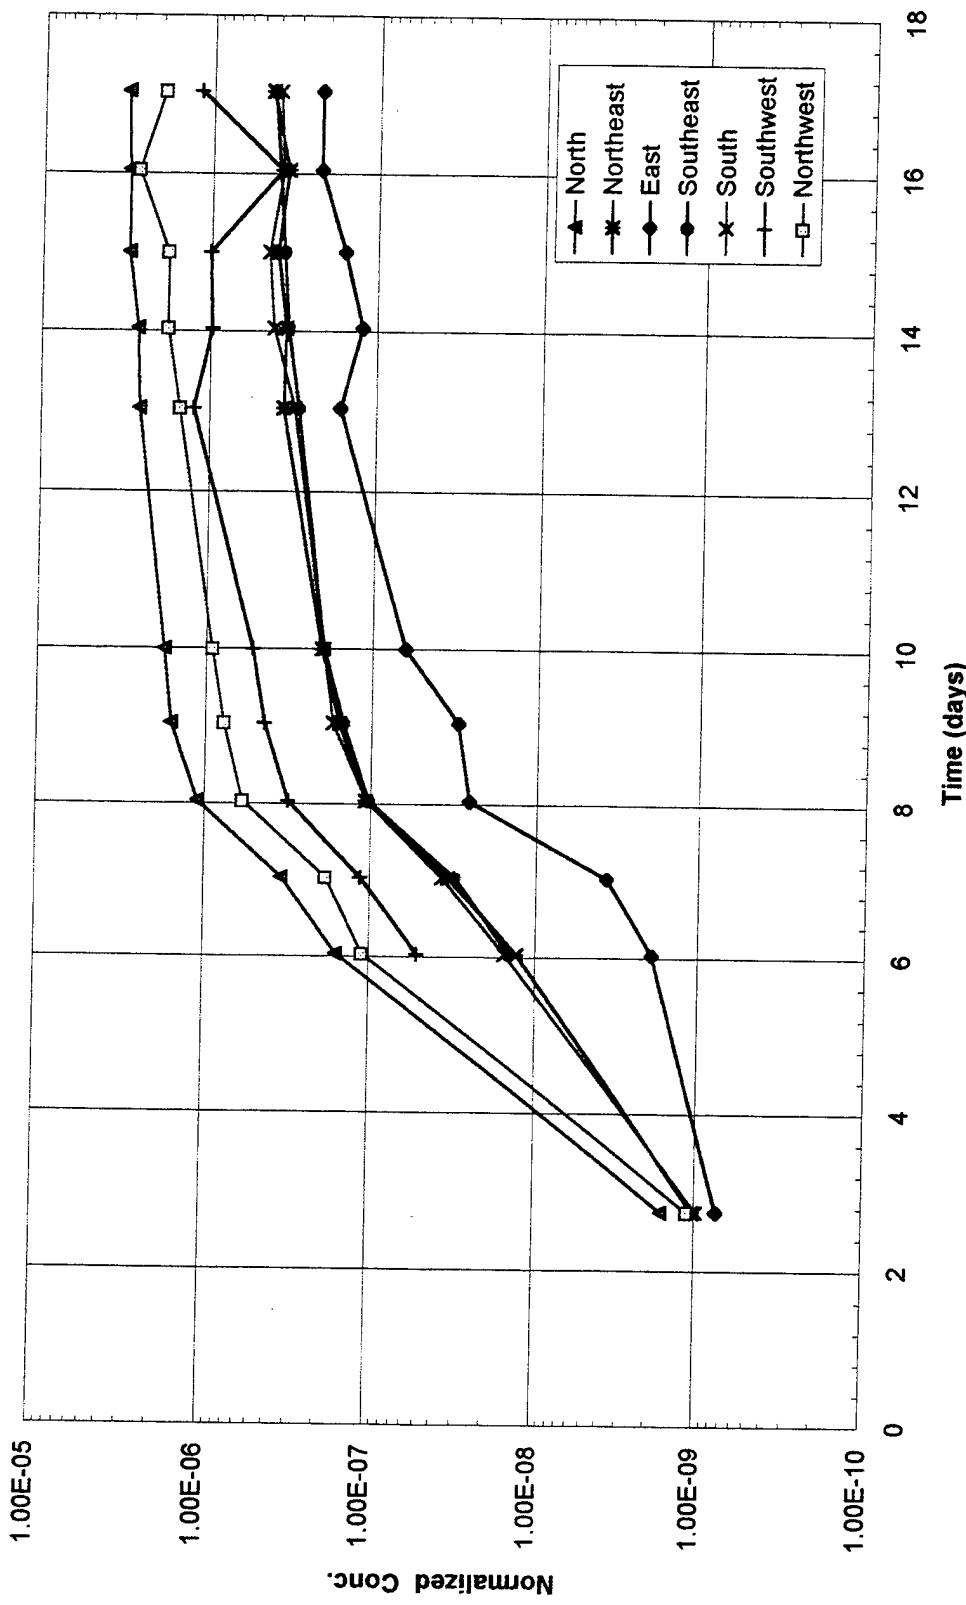
Figure 6.8 Time history of normalized PFT concentration in the seven exterior wells.

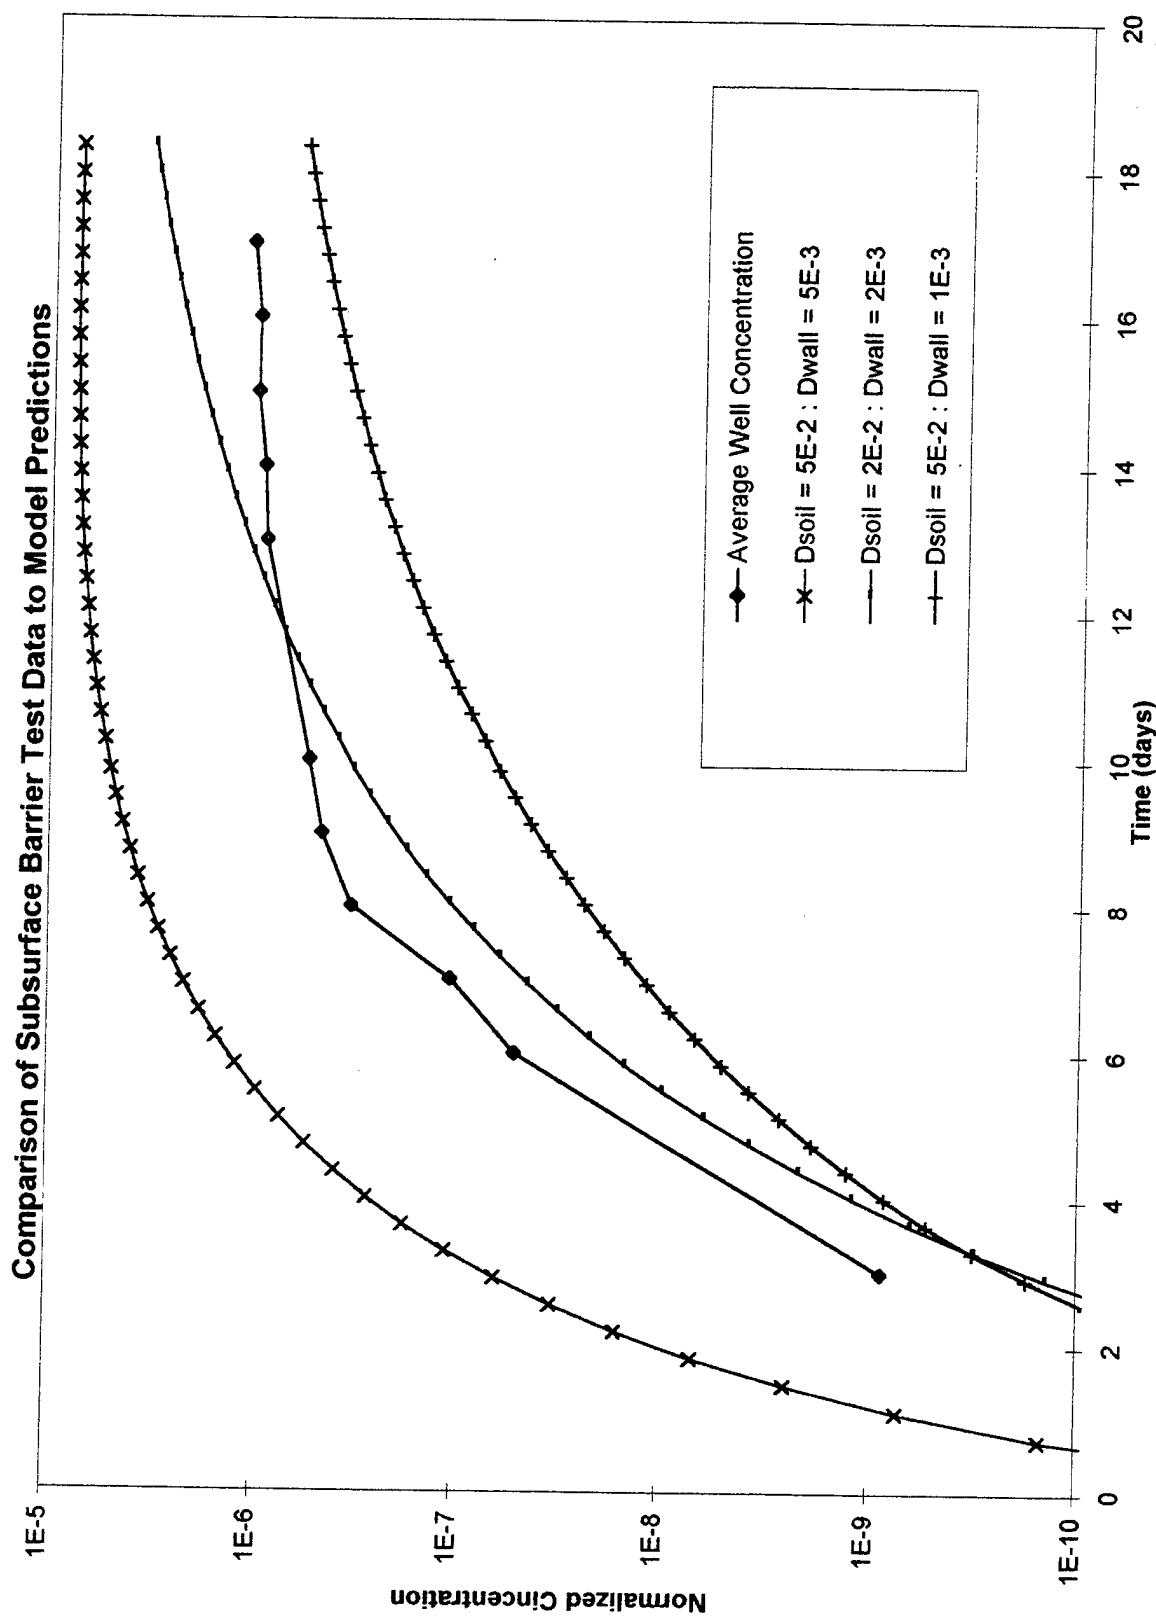
Figure 6.9 Comparison of the time history of the average monitoring well concentrations with model results.

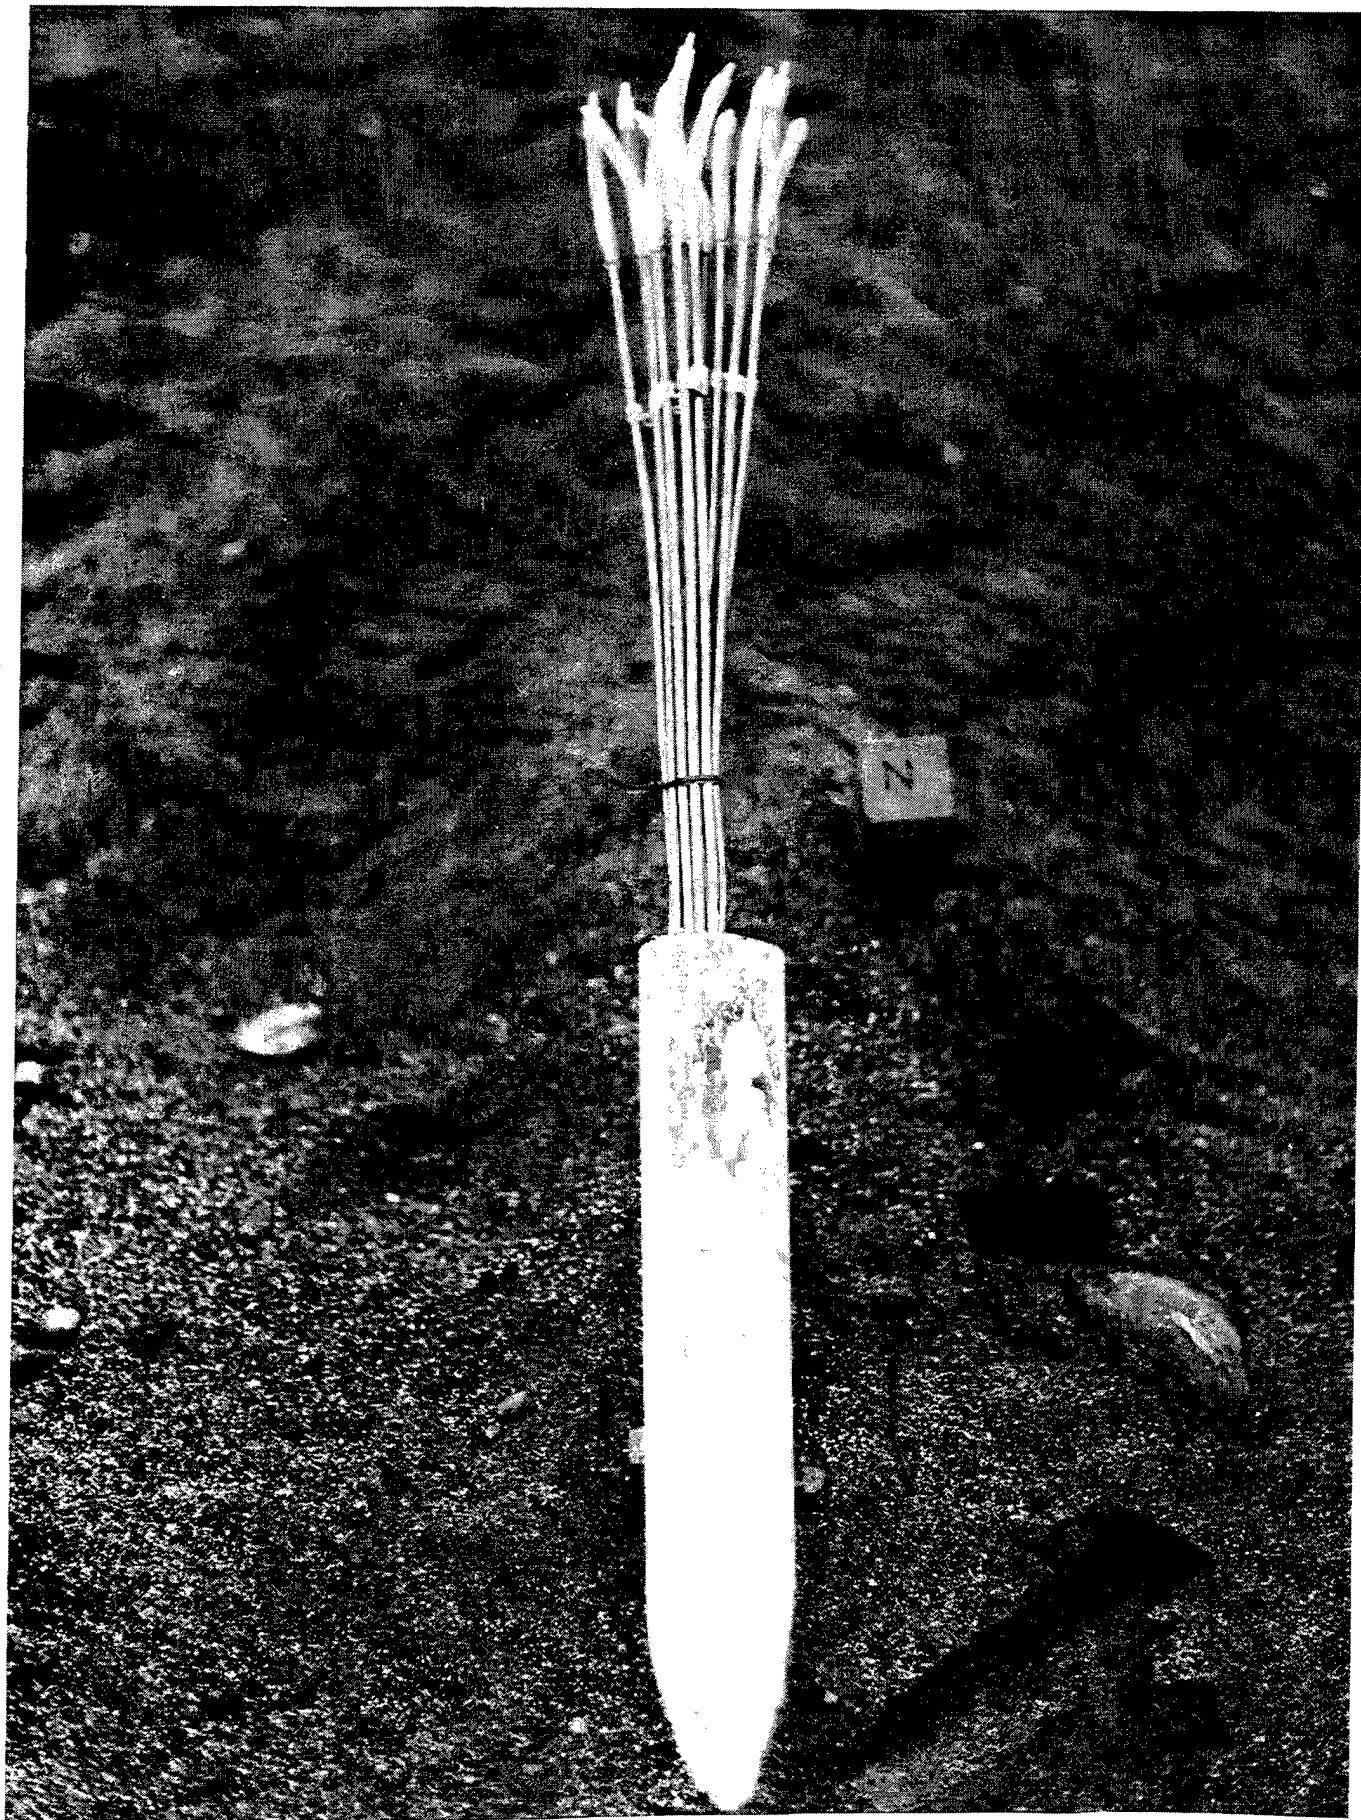
Figure 6.10 Sampling tubes in an exterior monitoring well. Each tube samples from a different depth.

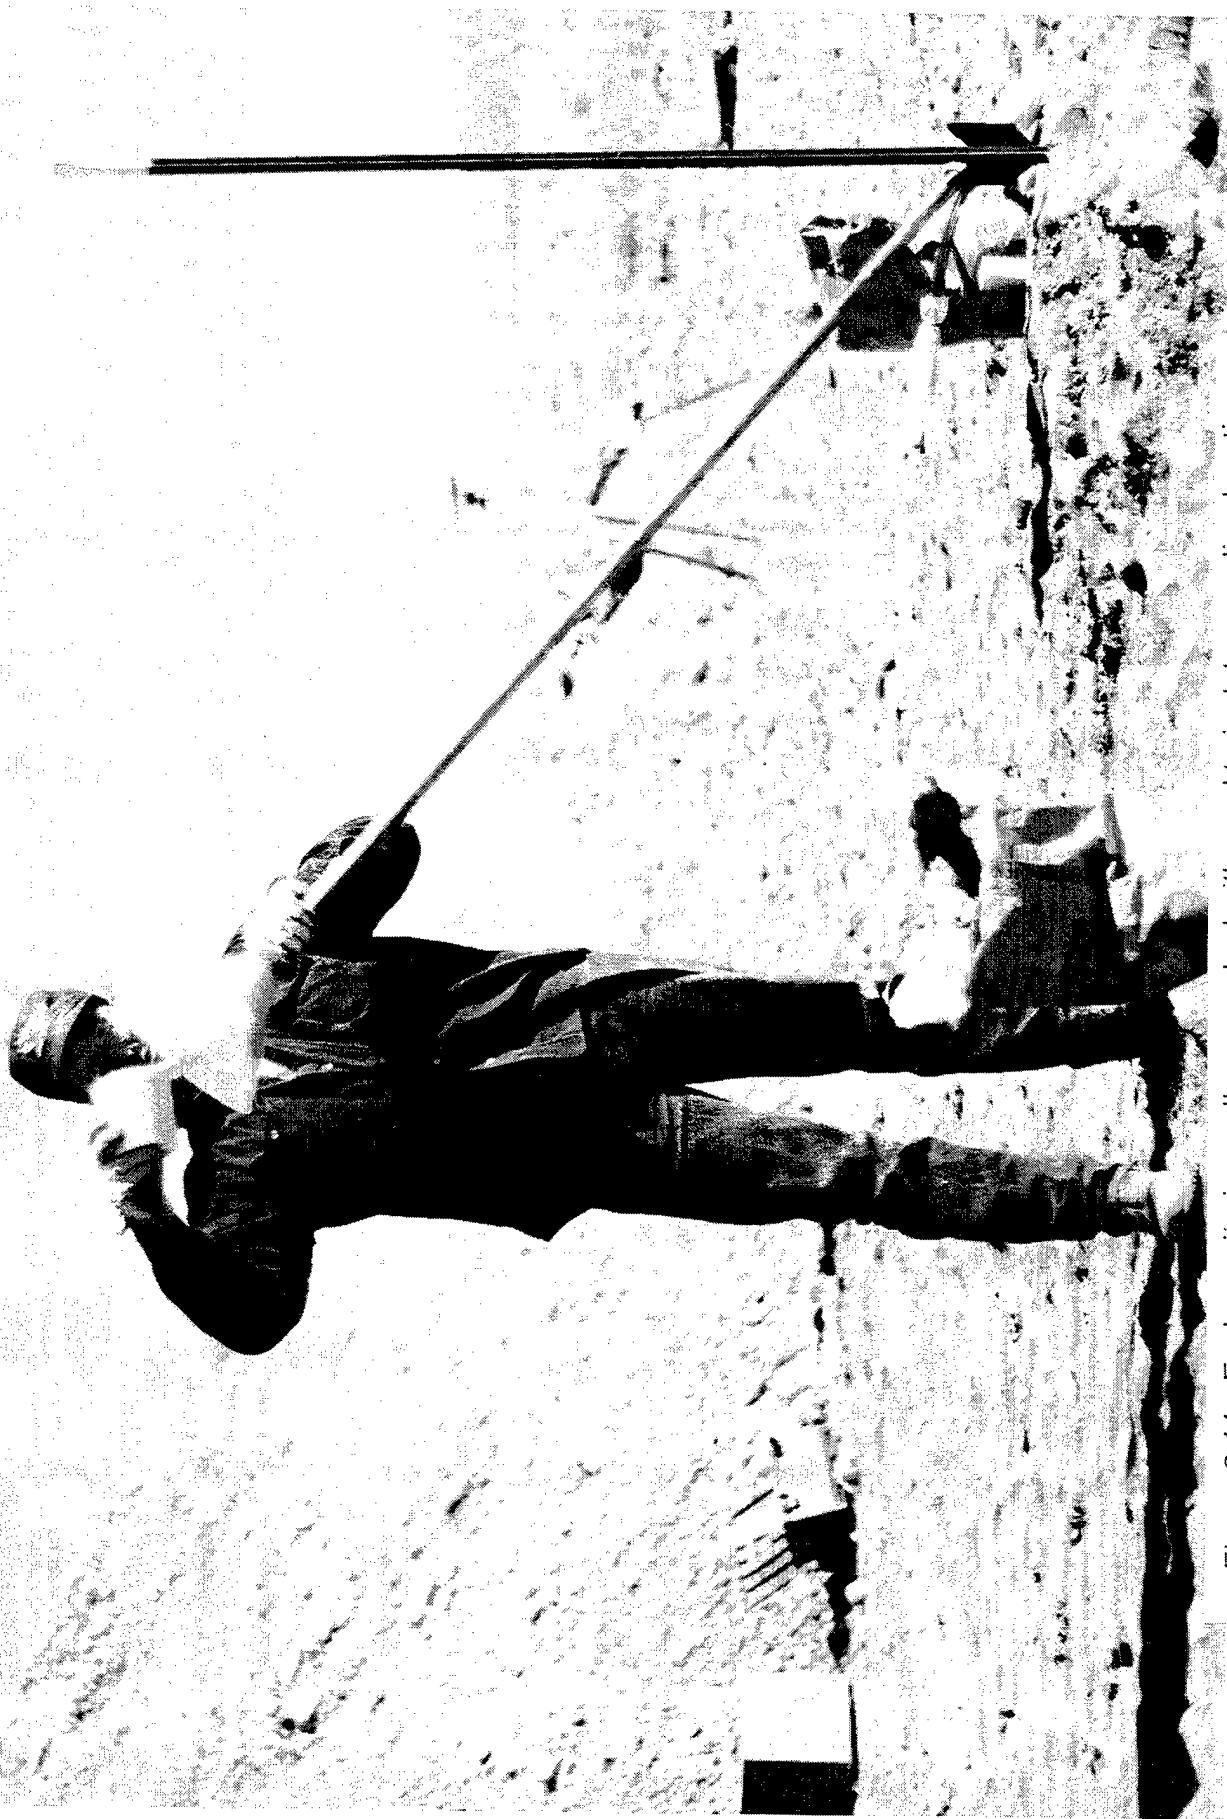
Figure 6.11 Each monitoring well was packed with sand to isolate sampling locations.

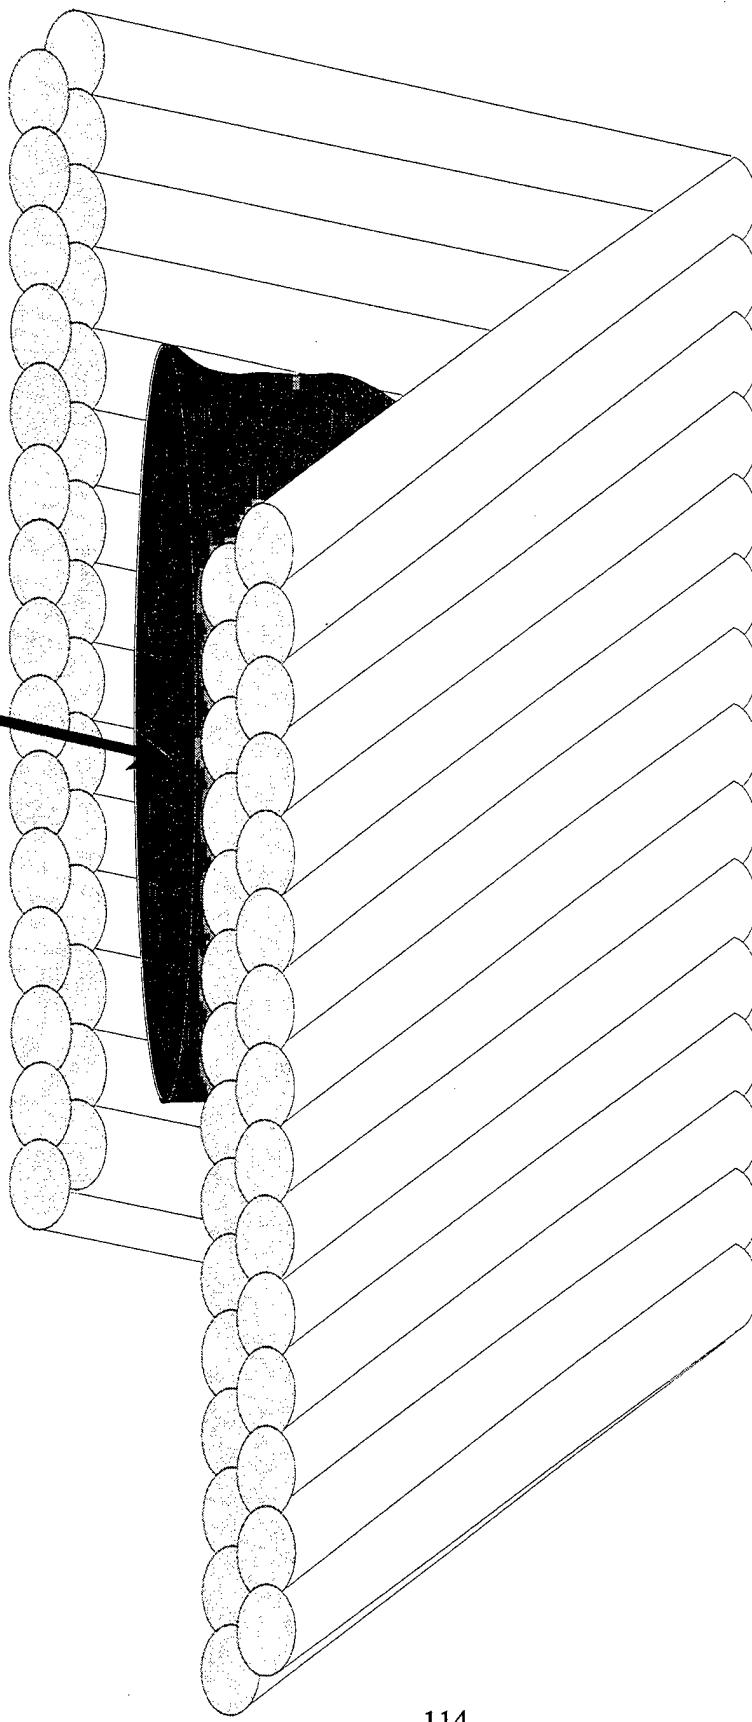
Figure 7.1 Schematic of V-trough close-coupled barrier.

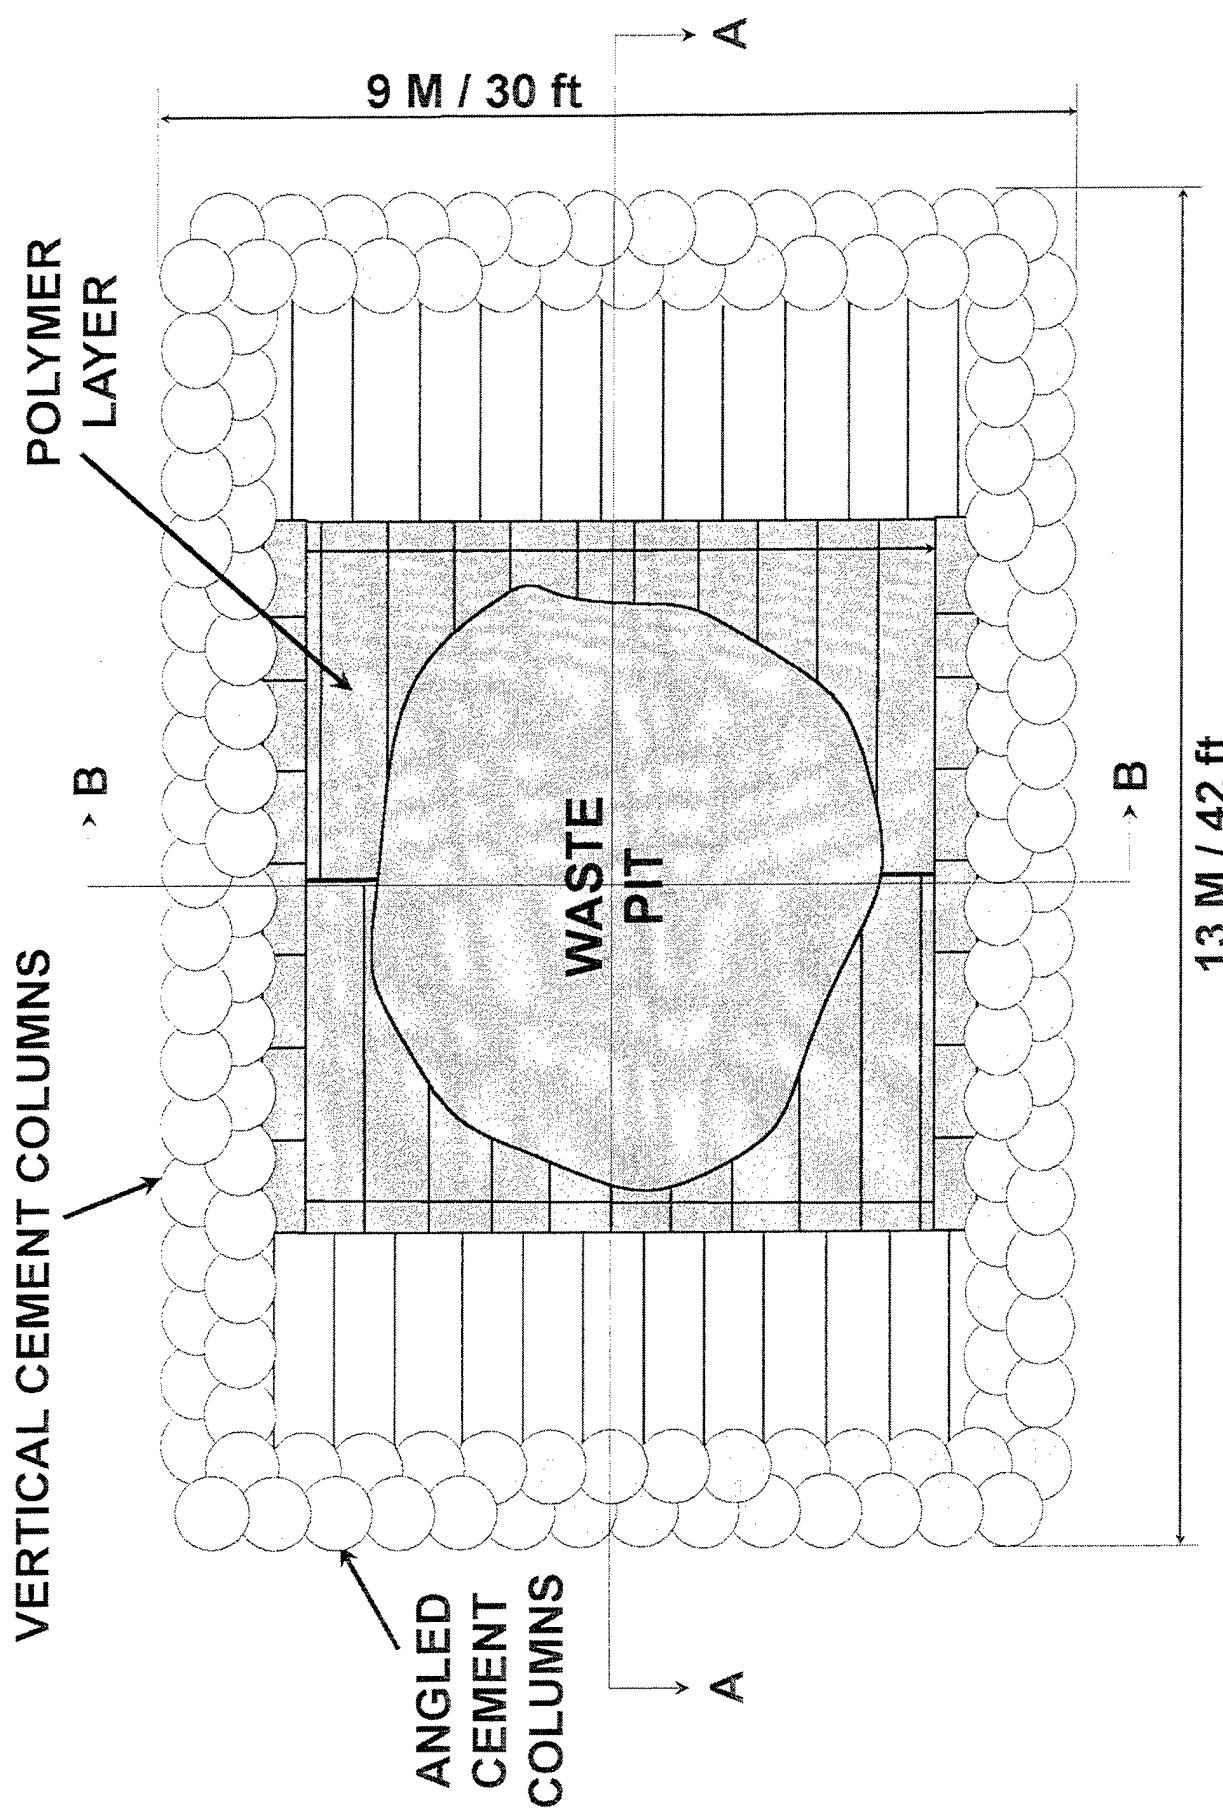
Figure 7.2 Plan view of the V-trough barrier installed at Brookhaven National Laboratory.

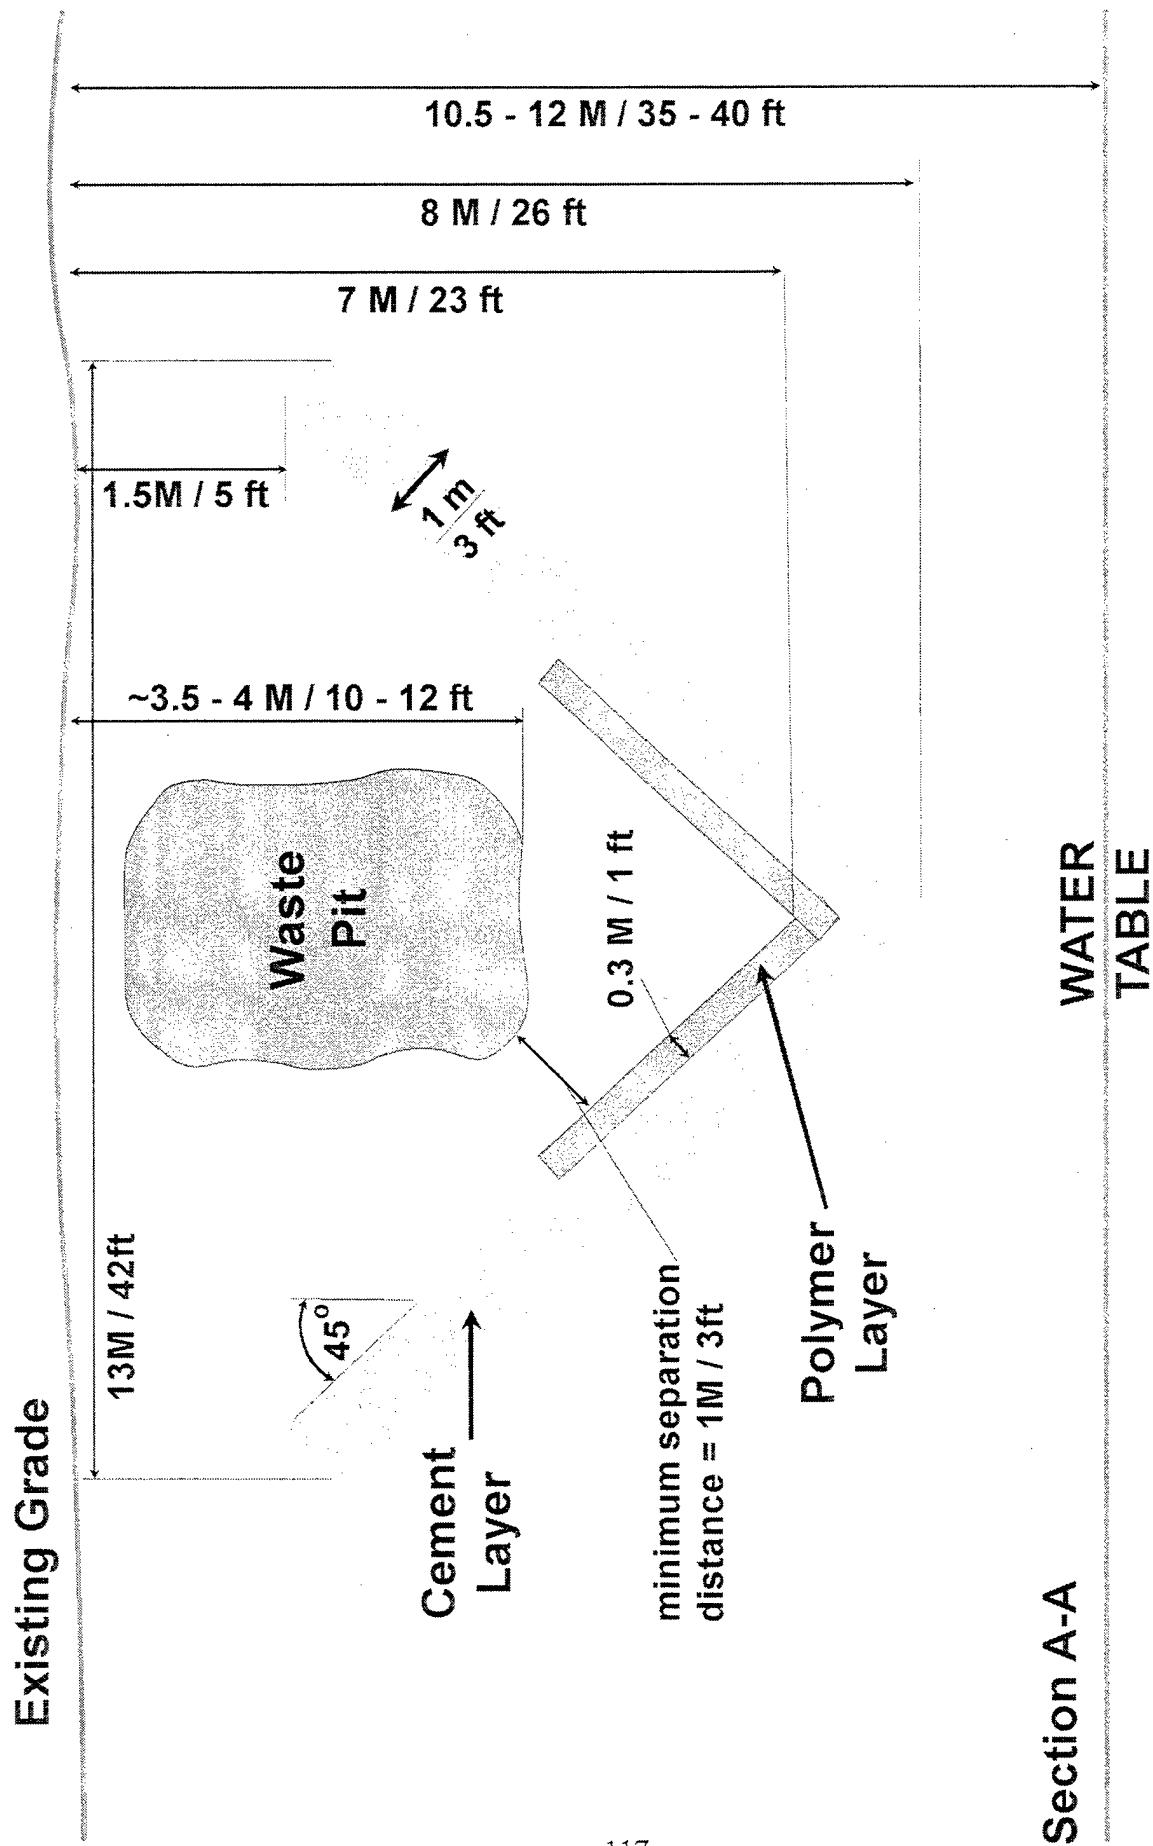
Figure 7.3 Side view [A-A] of the V-trough barrier installed at Brookhaven National Laboratory.

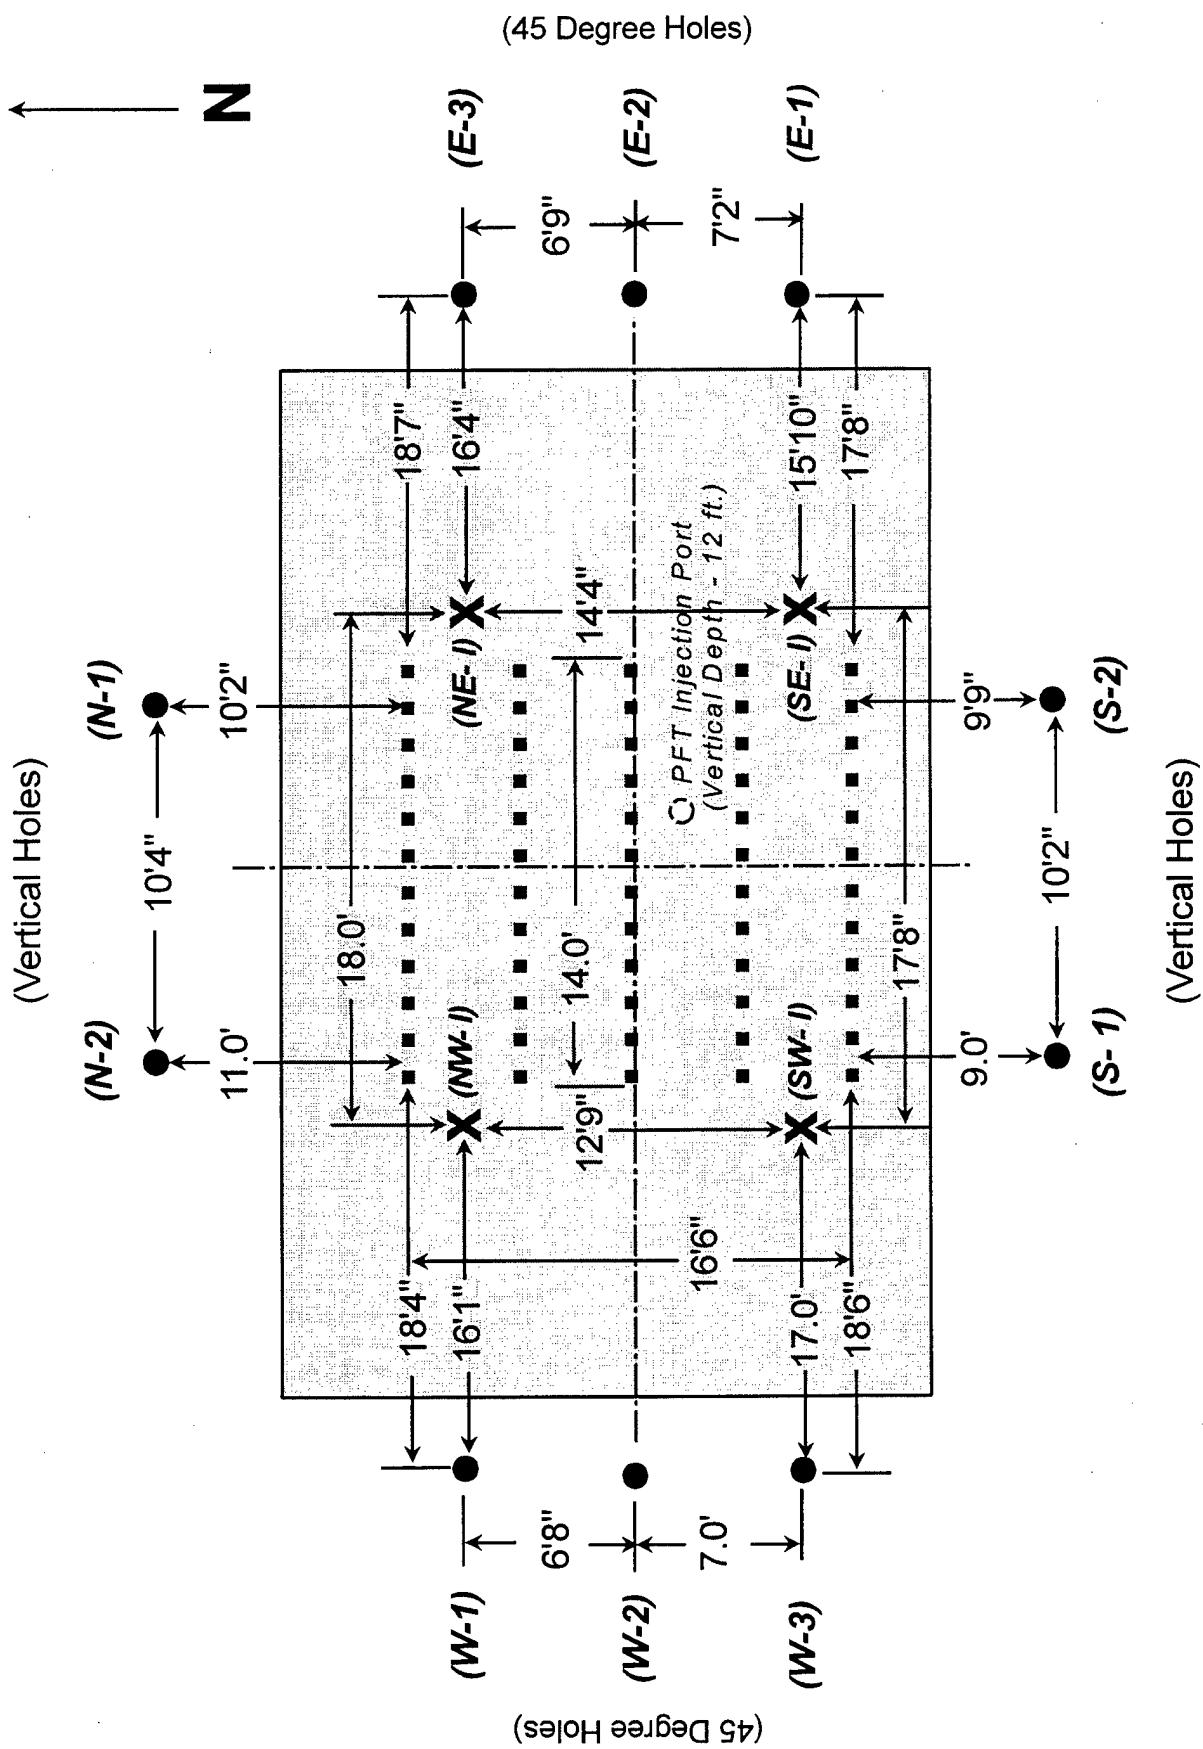
Figure 7.8 Layout of monitoring and injection wells at the G-11 waste pit barrier.
