# Summary Report on Close-Coupled Subsurface Barrier Technology Initial Field Trials to Full-Scale Demonstration

John H. Heiser  
Environmental & Waste Technology Center  
Brookhaven National Laboratory

Brian Dwyer  
Mixed Waste Landfill Integrated Demonstration  
Sandia National Laboratory

**September 1997**

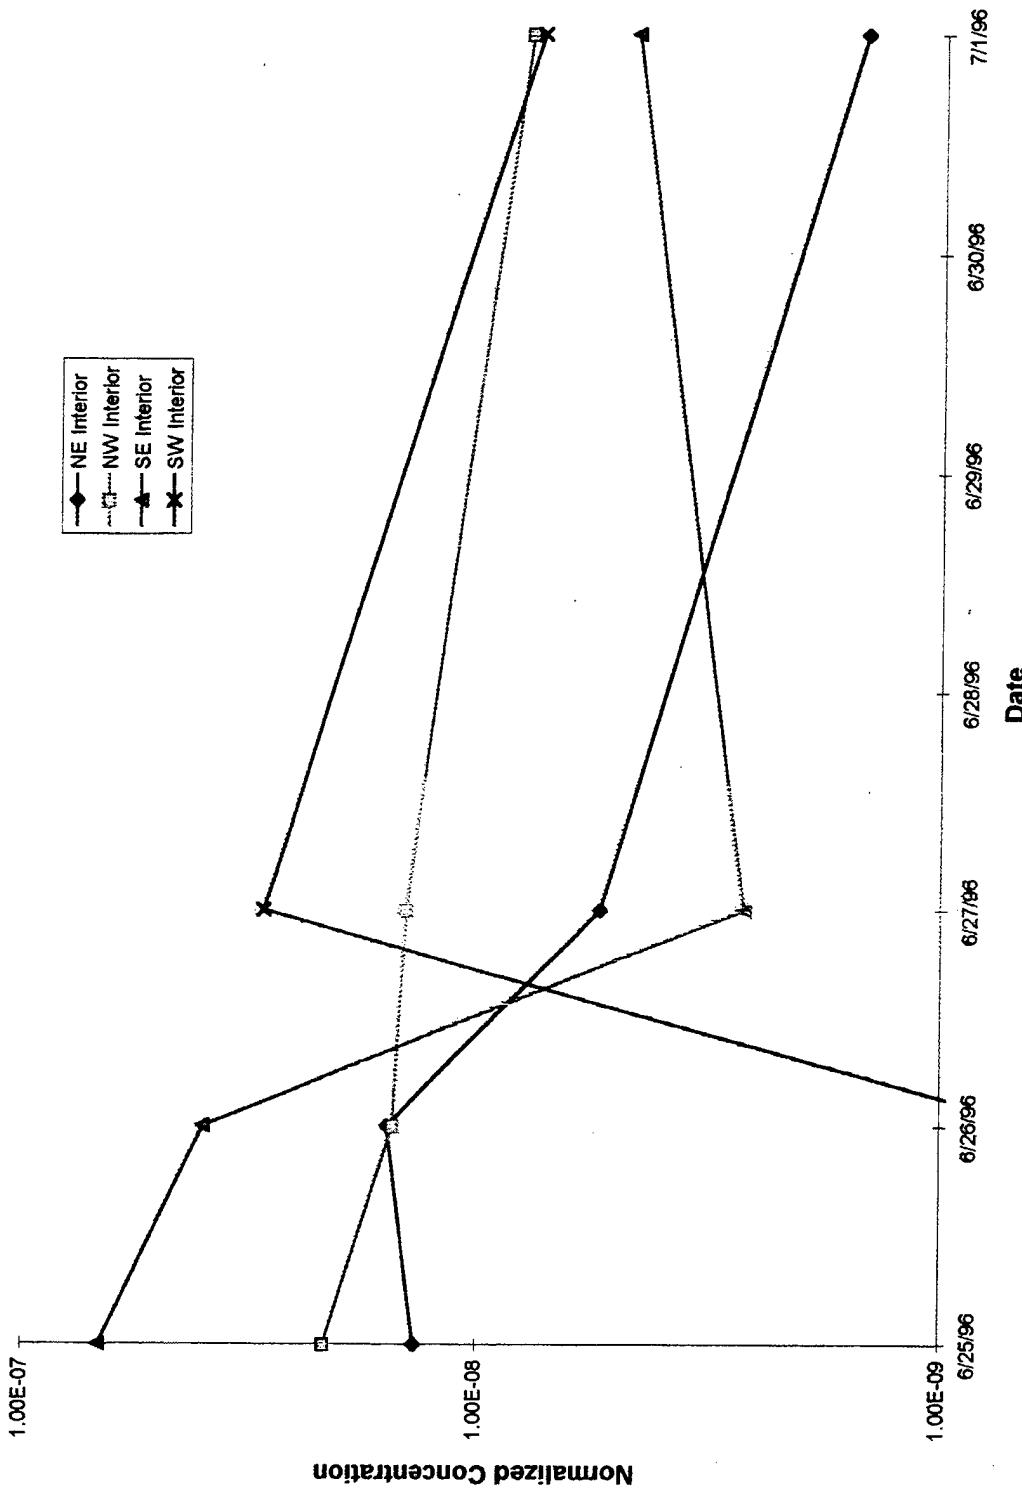
Figure 7.10 Normalized ocPDCH concentrations at the four interior wells.

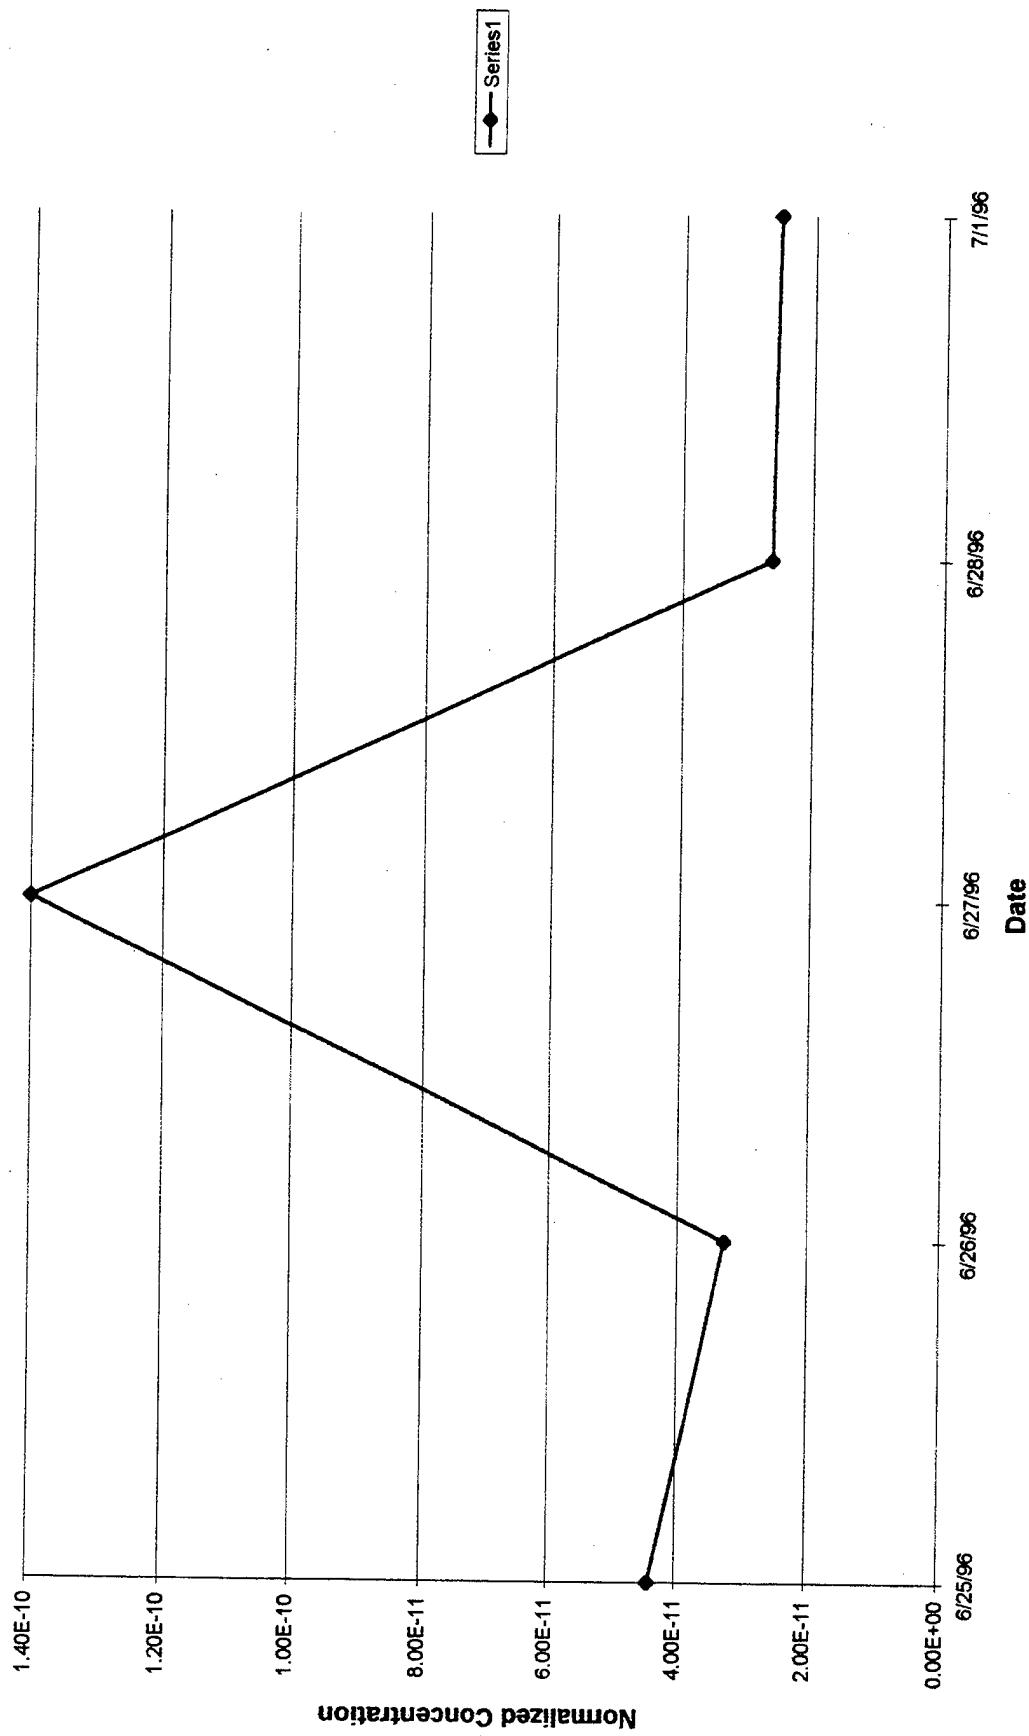
Figure 7.11 Normalized oCPDCH concentrations from the well designated as E-1 at the 6 meters (20 feet) location.

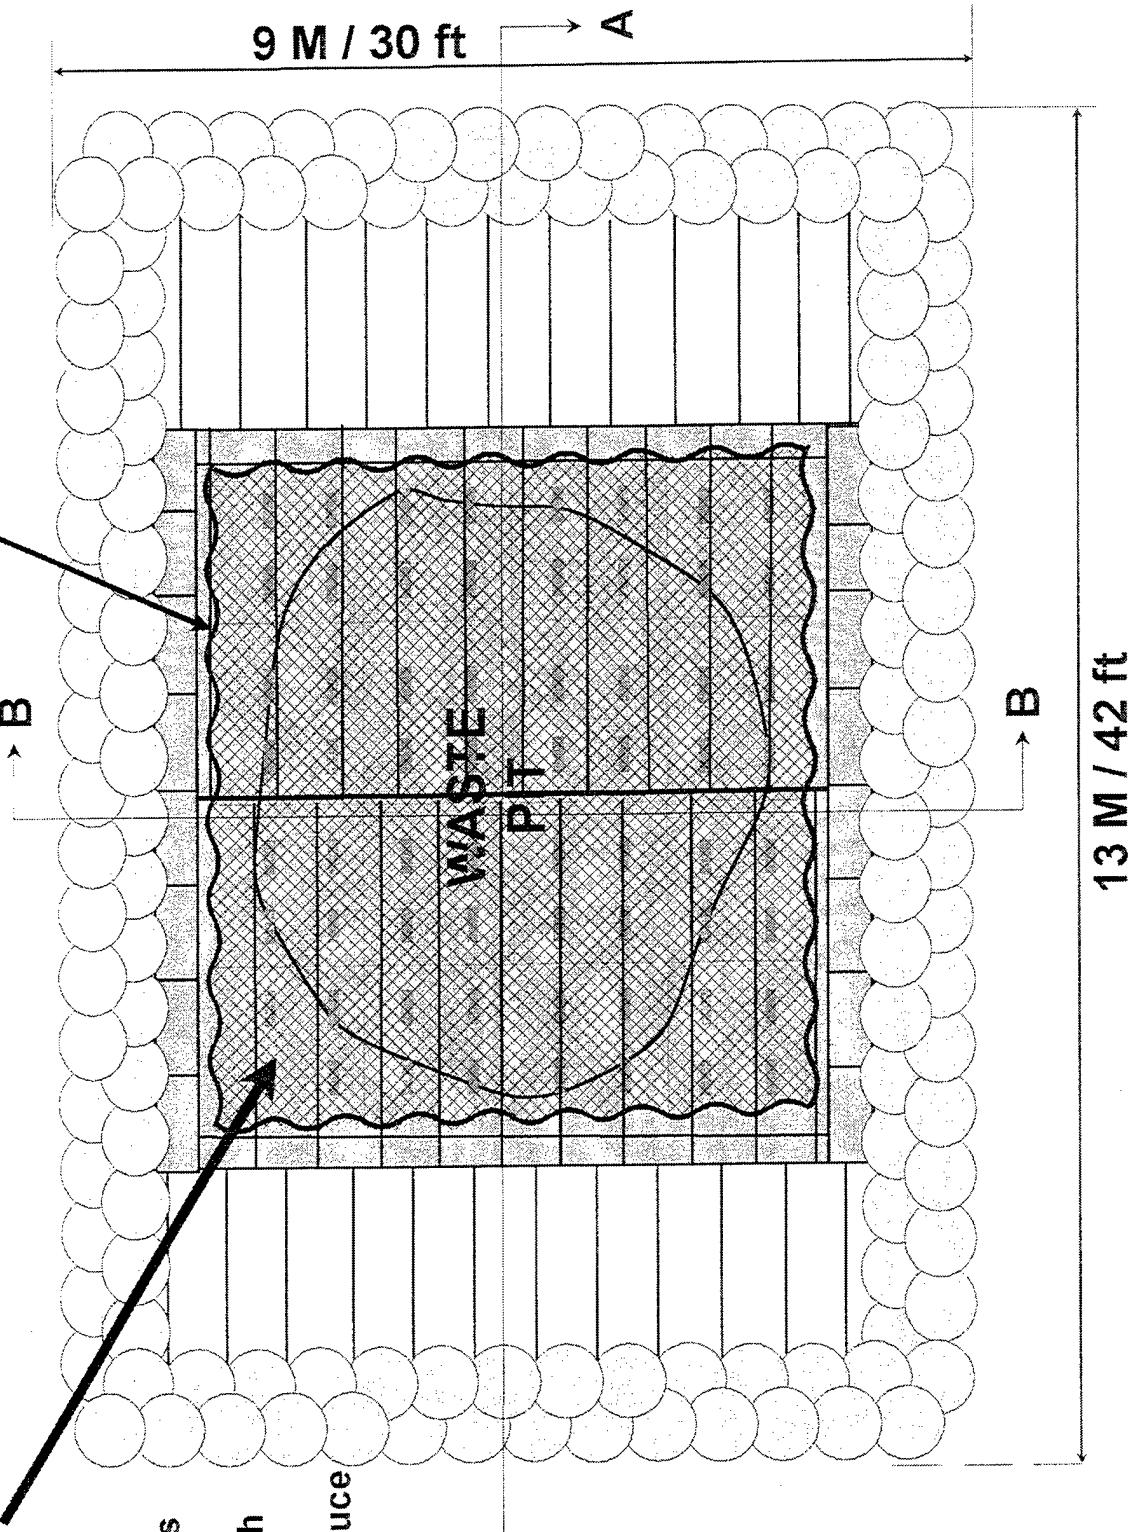
Figure 7.12 Plan view of in-situ stabilization of waste pit.

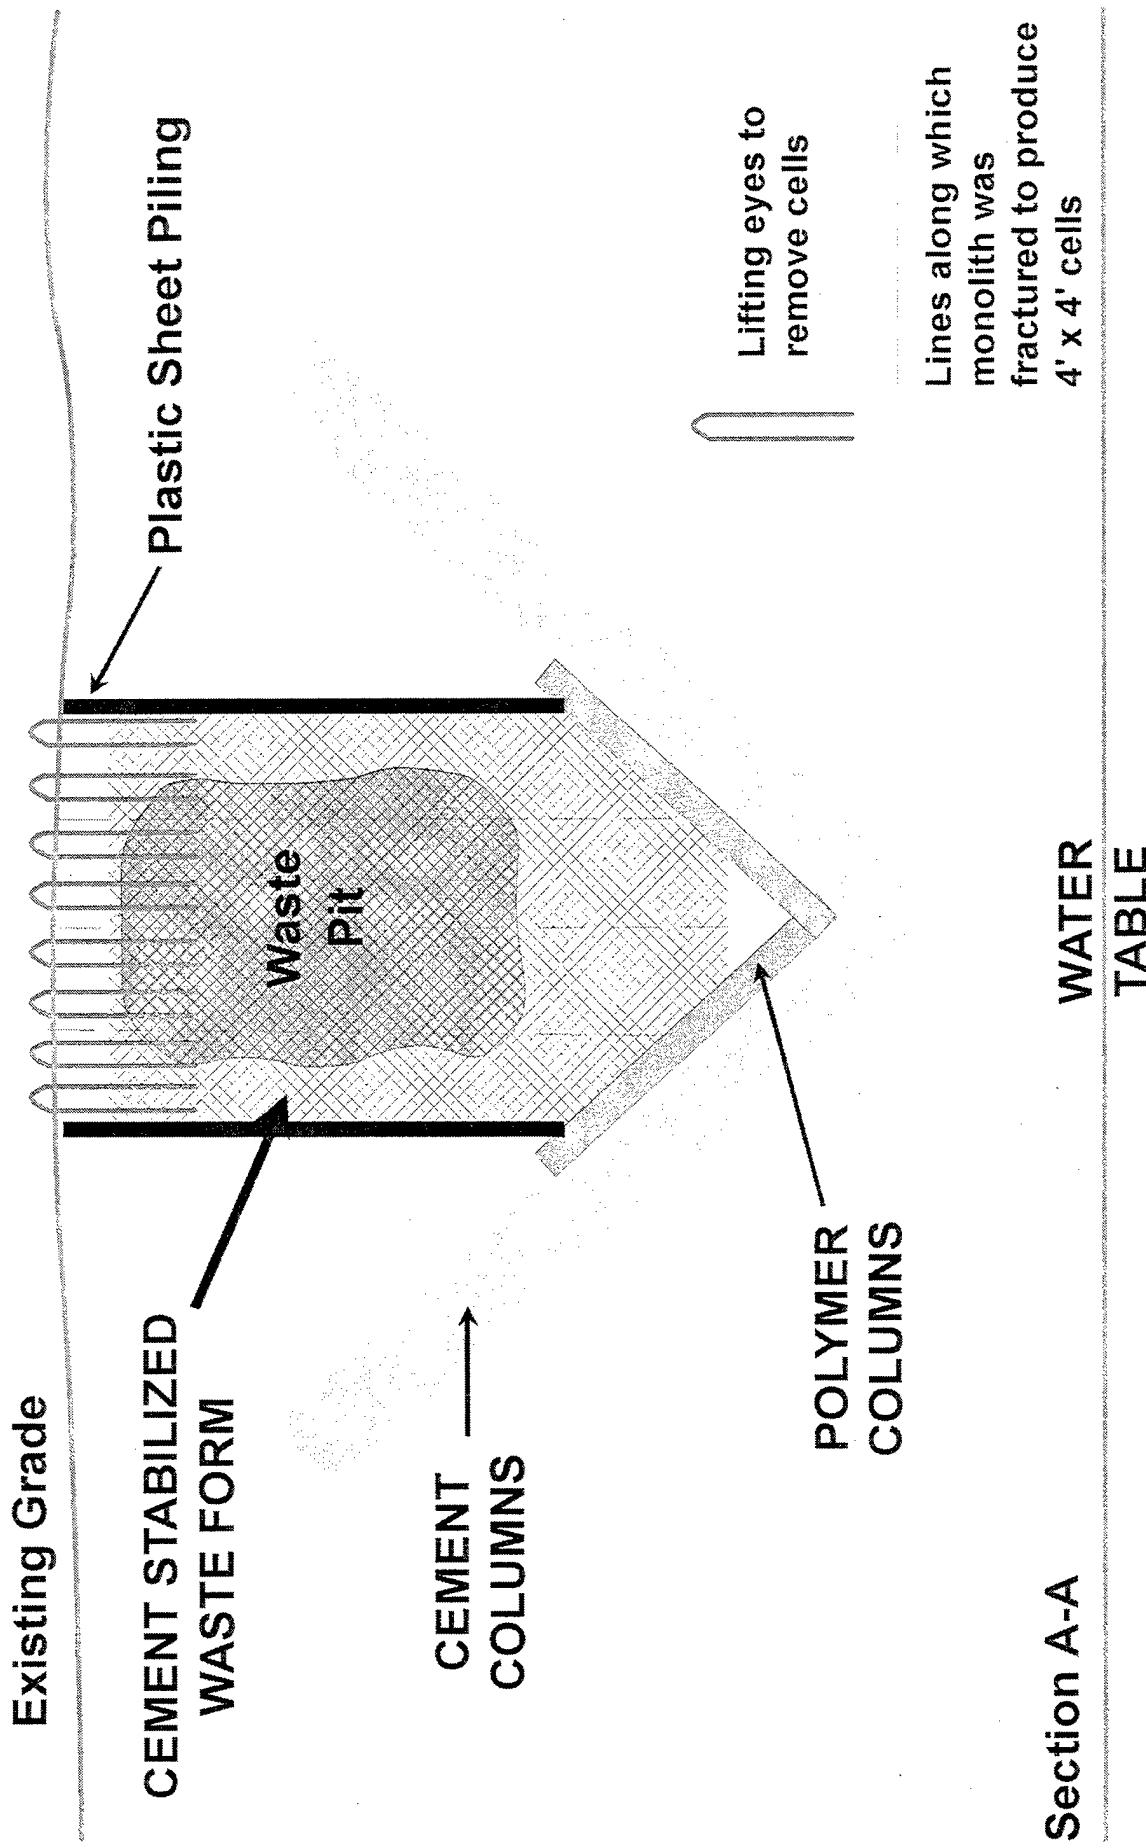
Figure 7.13 Cross-sectional [A-A] view of in-situ stabilization of waste pit.

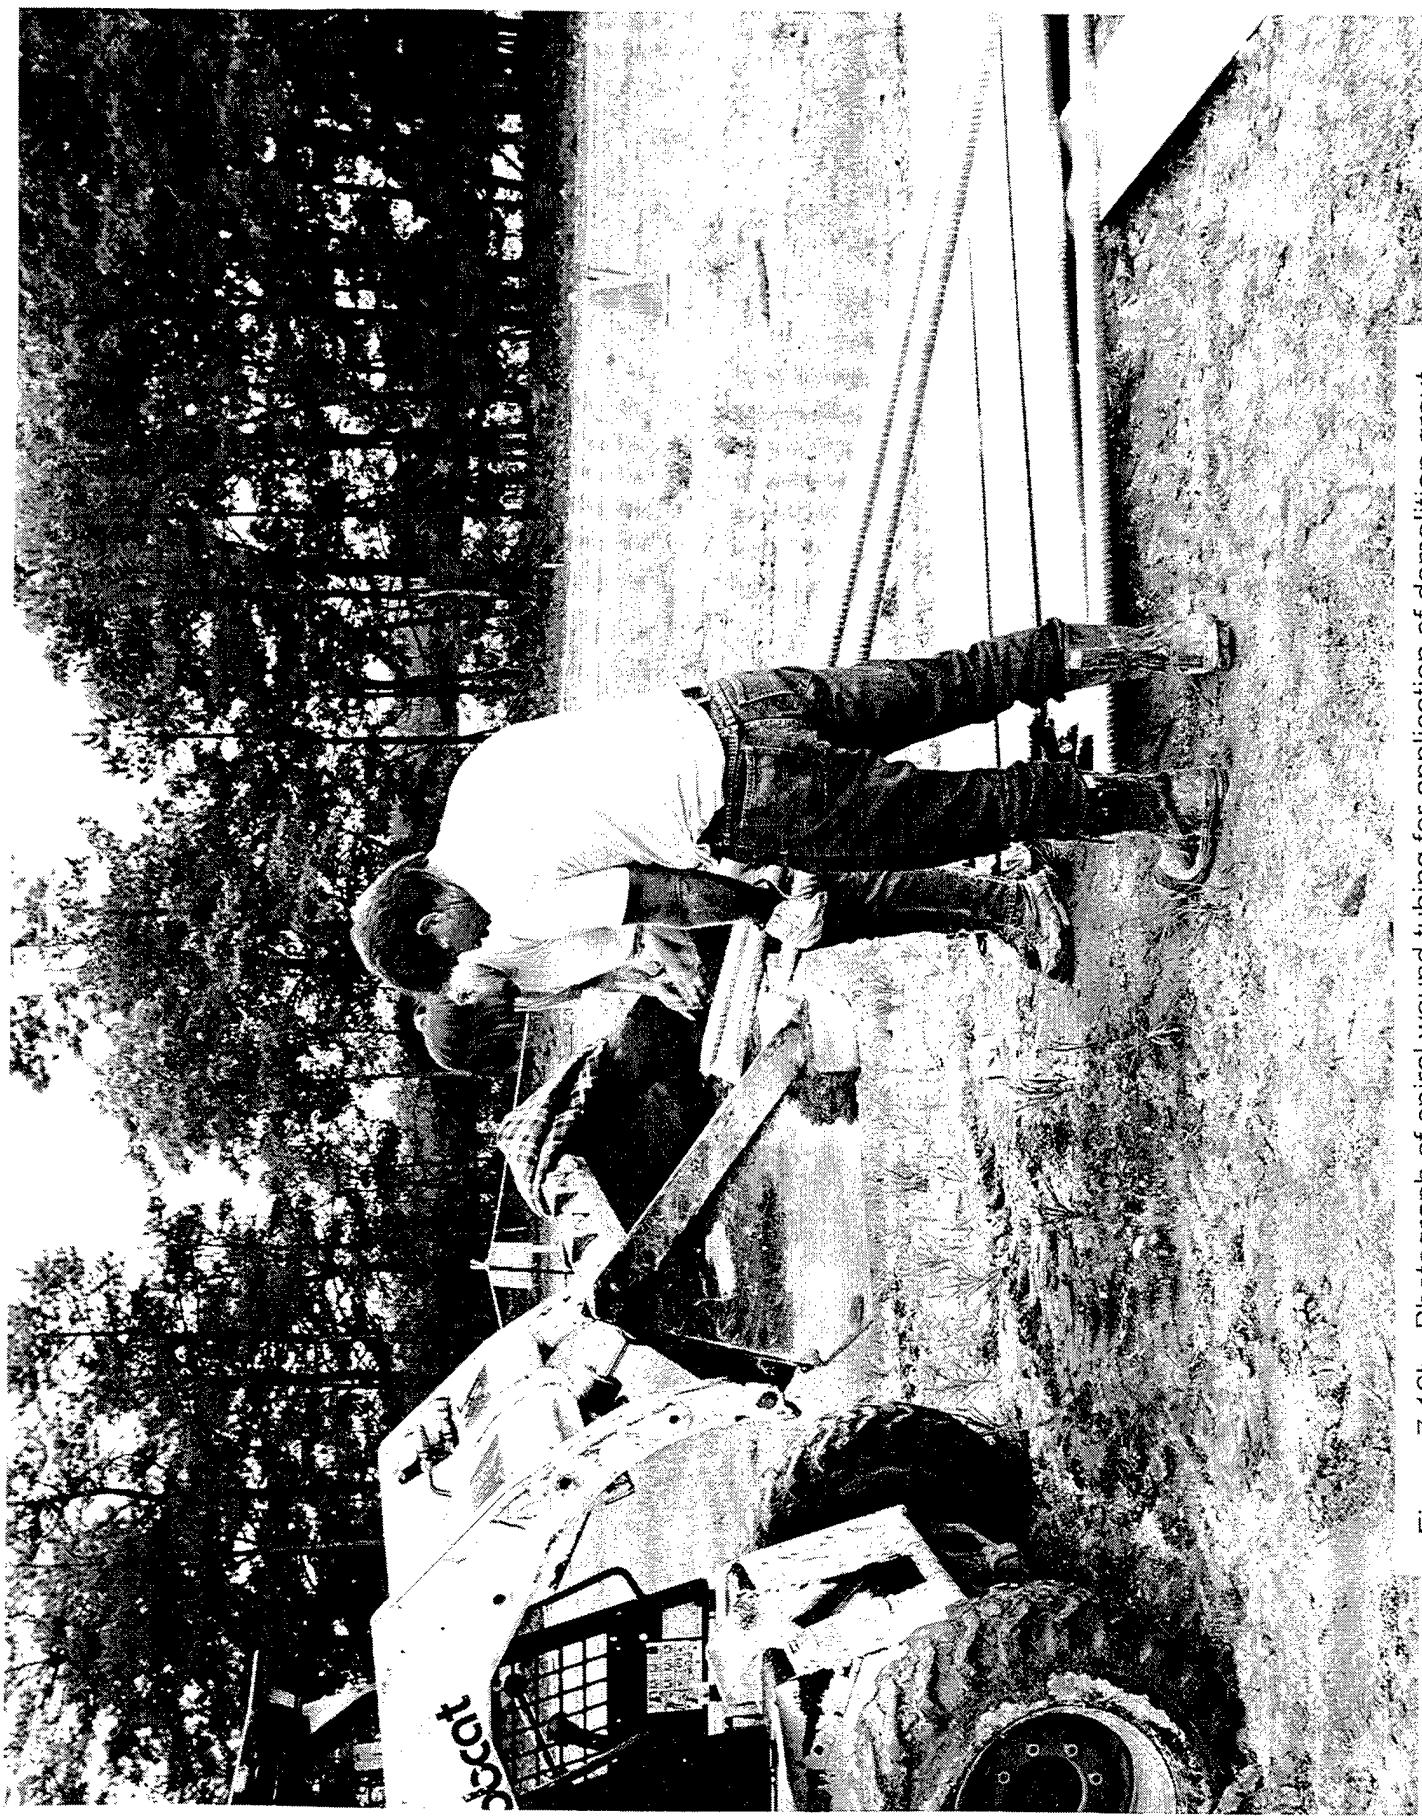
Figure 7.16b Photograph of spiral wound tubing for application of demolition grout.

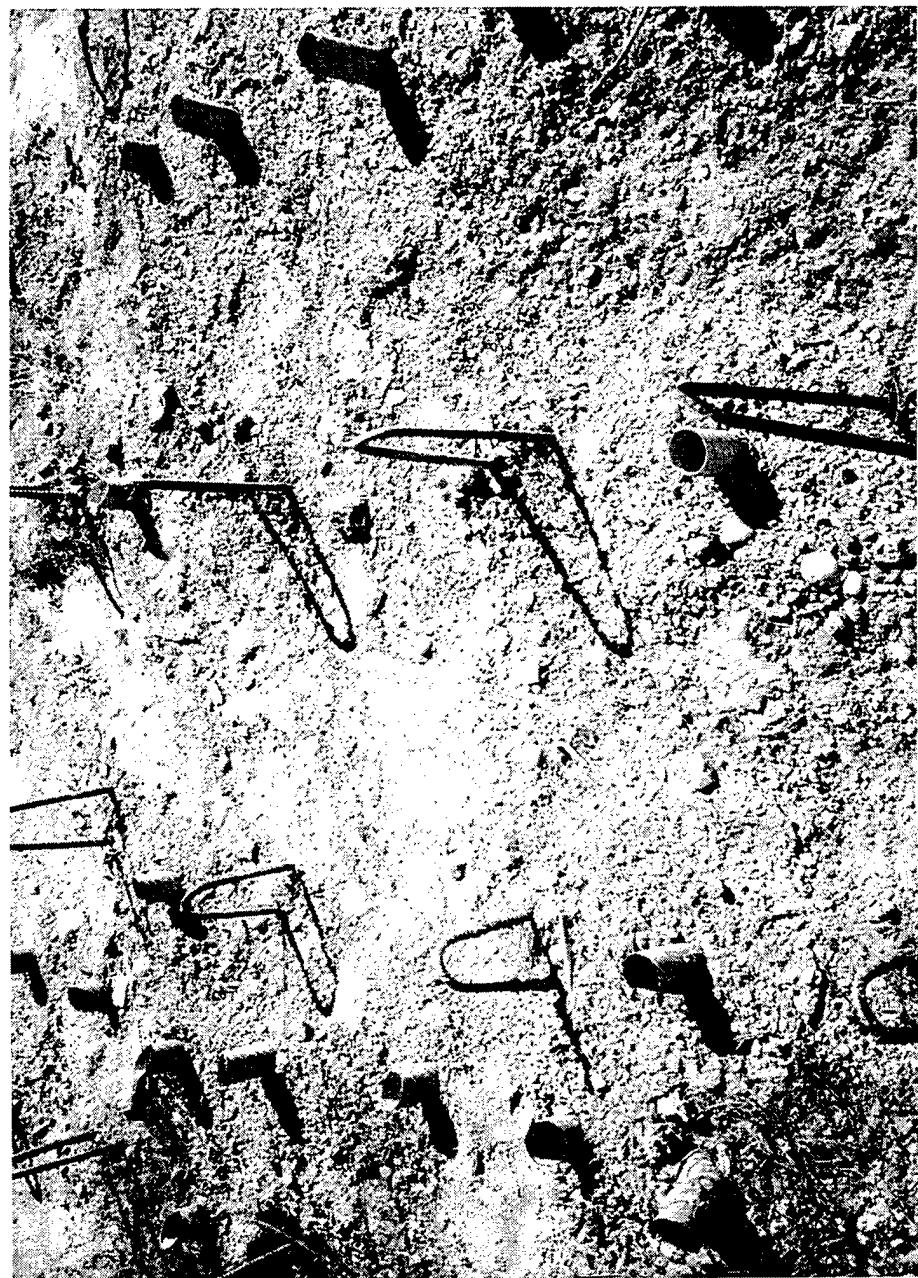
Figure 7.19 Monolithic cells were formed that are 1.3M by 1.3M (4ft by 4ft).

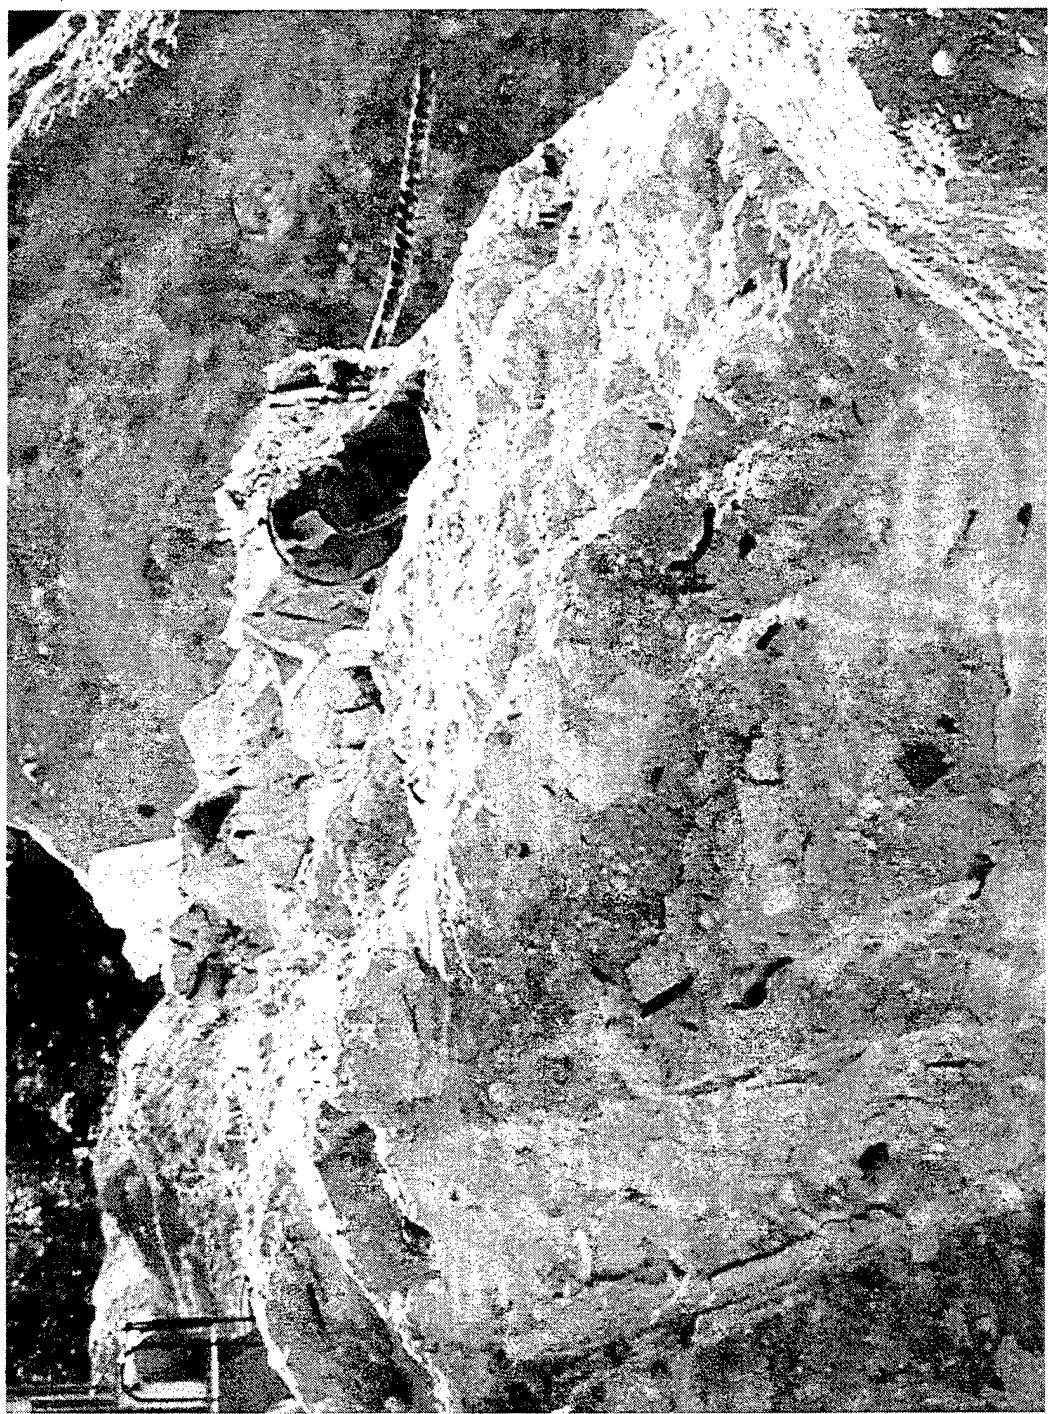
Figure 7.22 Section of in-situ stabilized waste form retrieved from pit G-11.

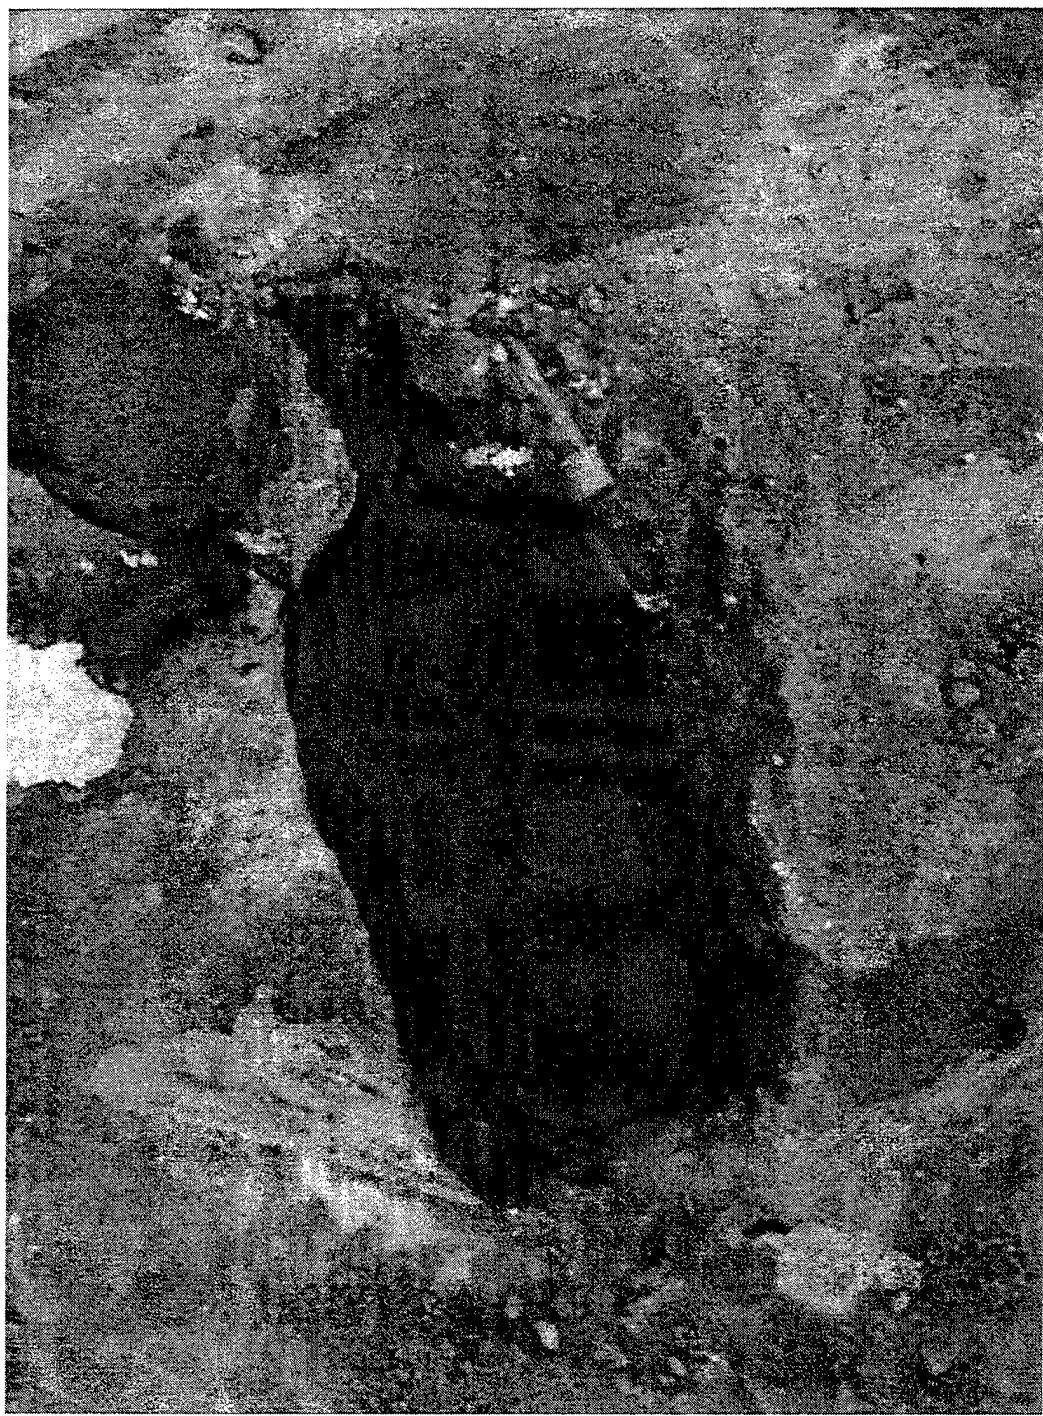
Figure 7.24 Cross-section of waste form showing chemical bottle encased in grout.

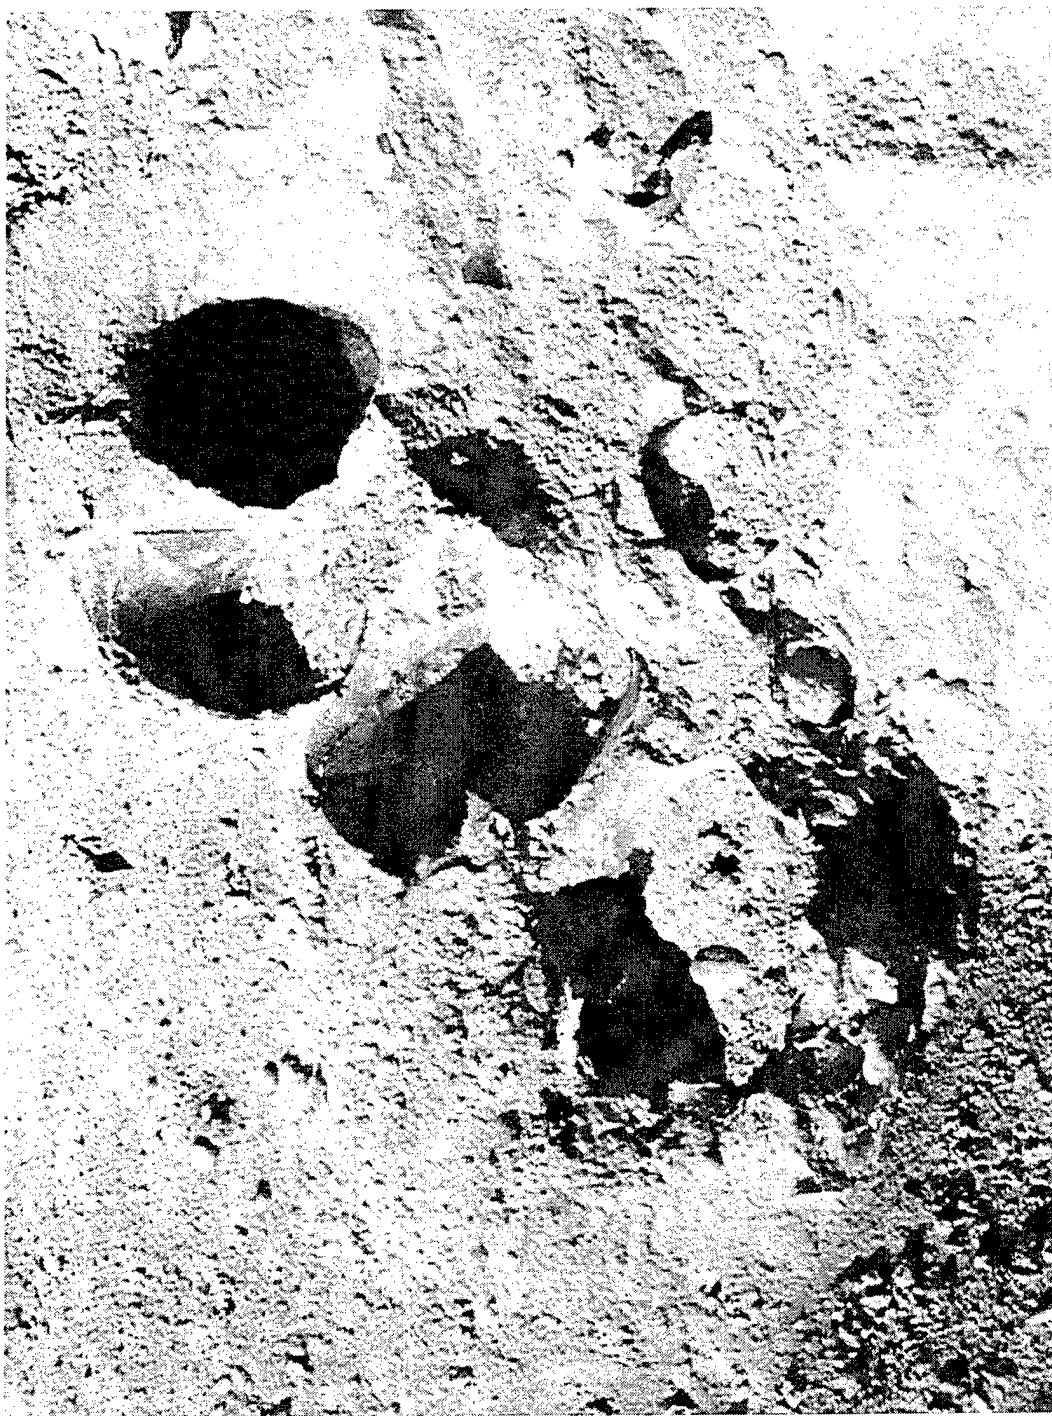
Figure 7.25 Section of waste form from pit G-11 showing encapsulated glass bottles.

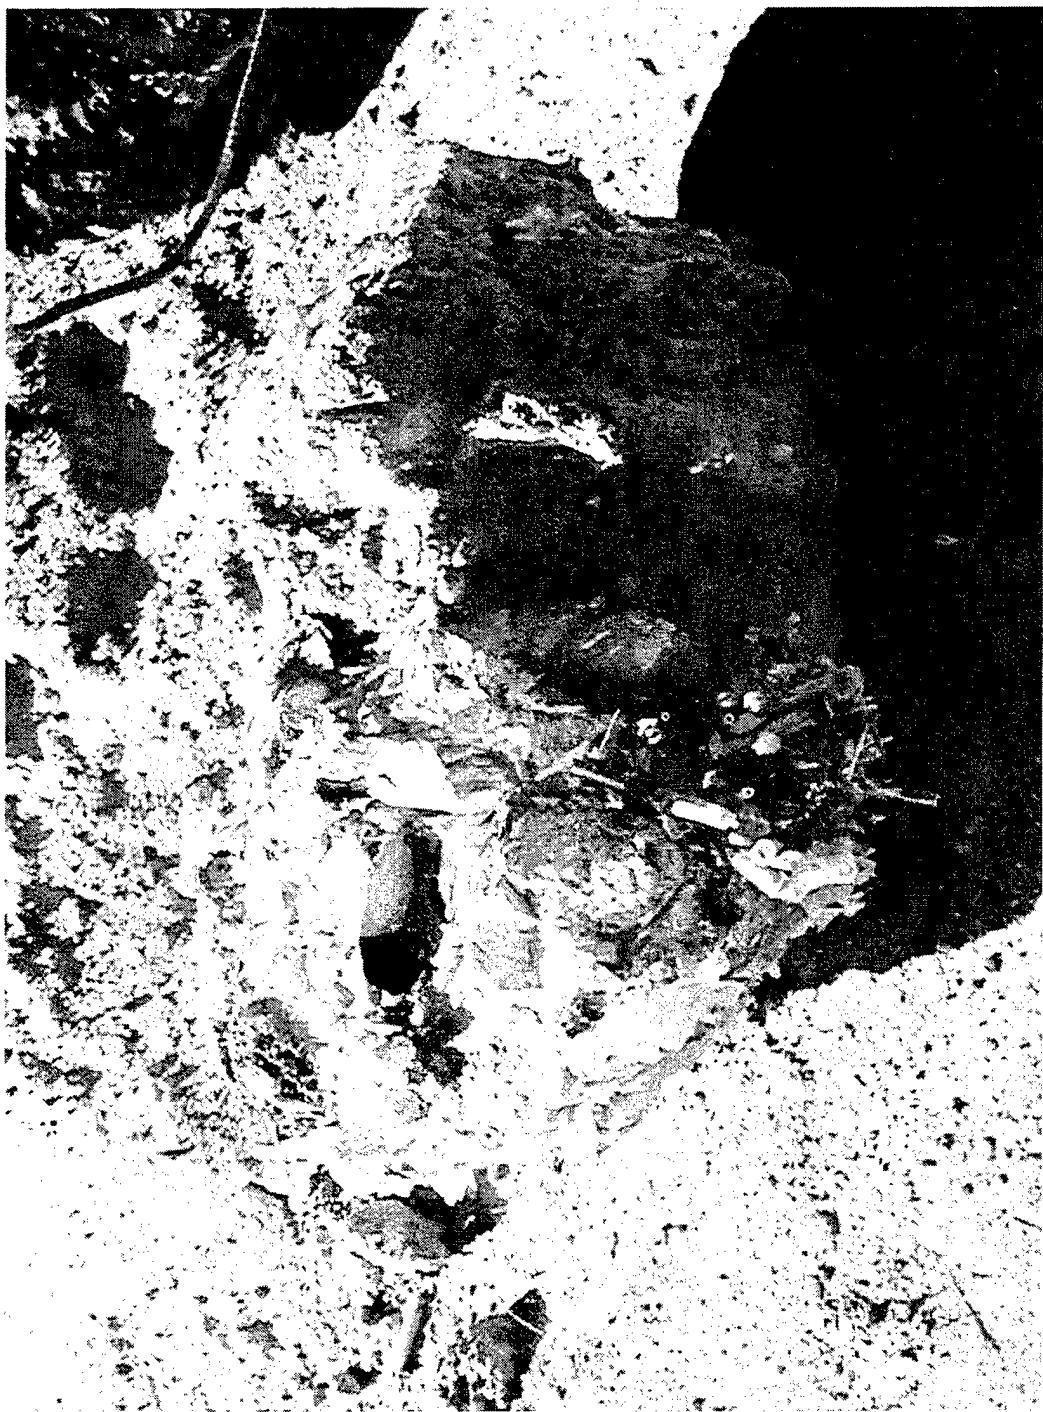
Figure 7.26 Section of pit G-11 waste form showing solidified waste.

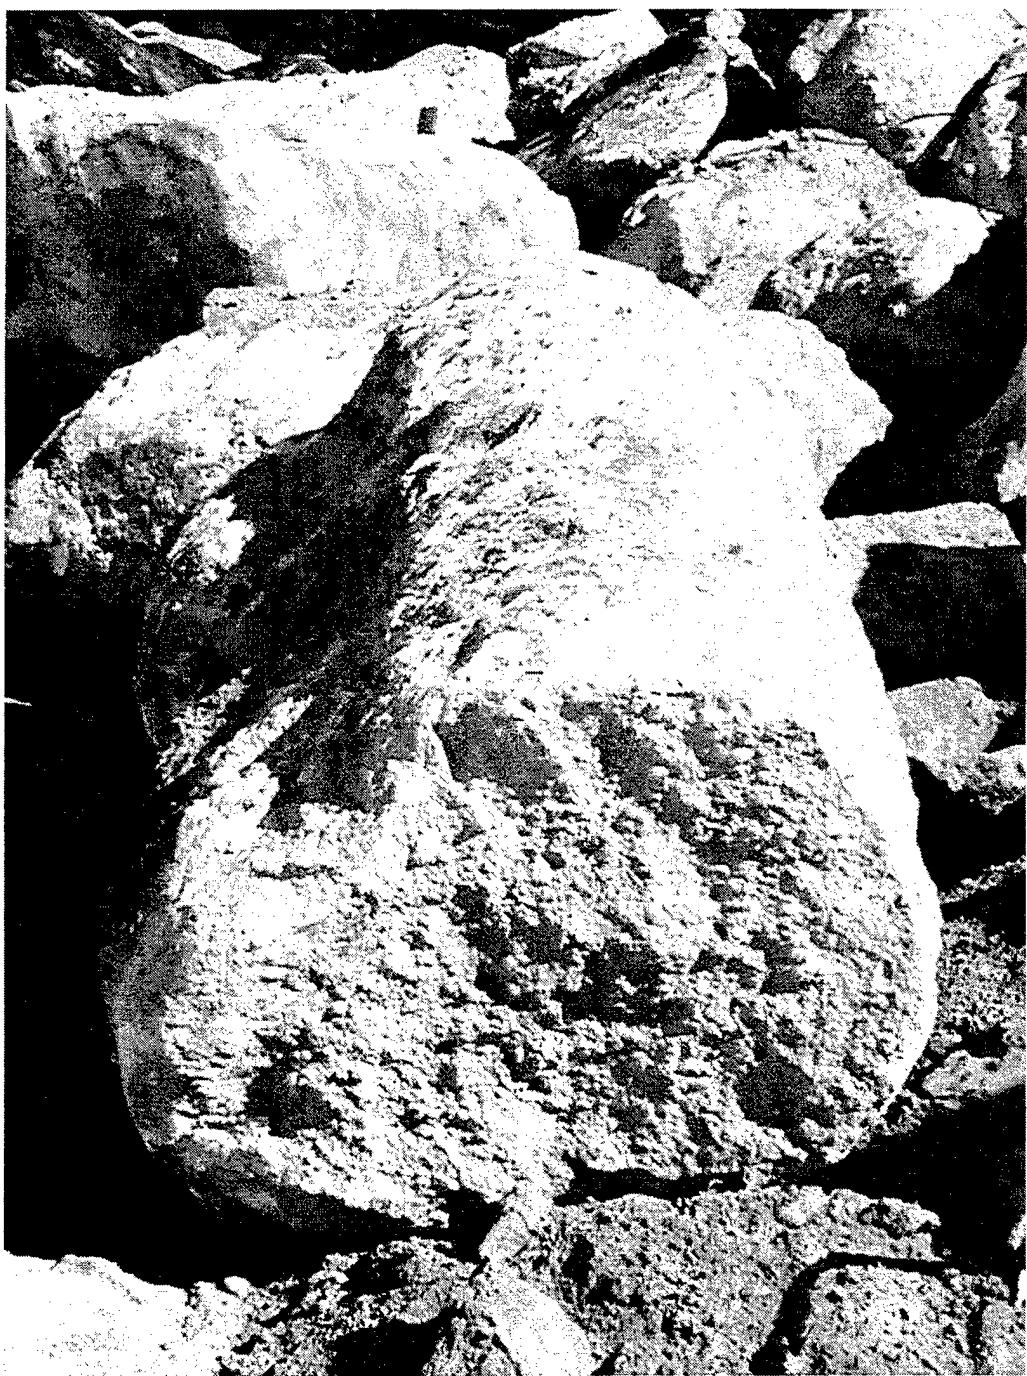
Figure 7.27 Section of the cement layer of the BNL close-coupled barrier showing adjacent columns.

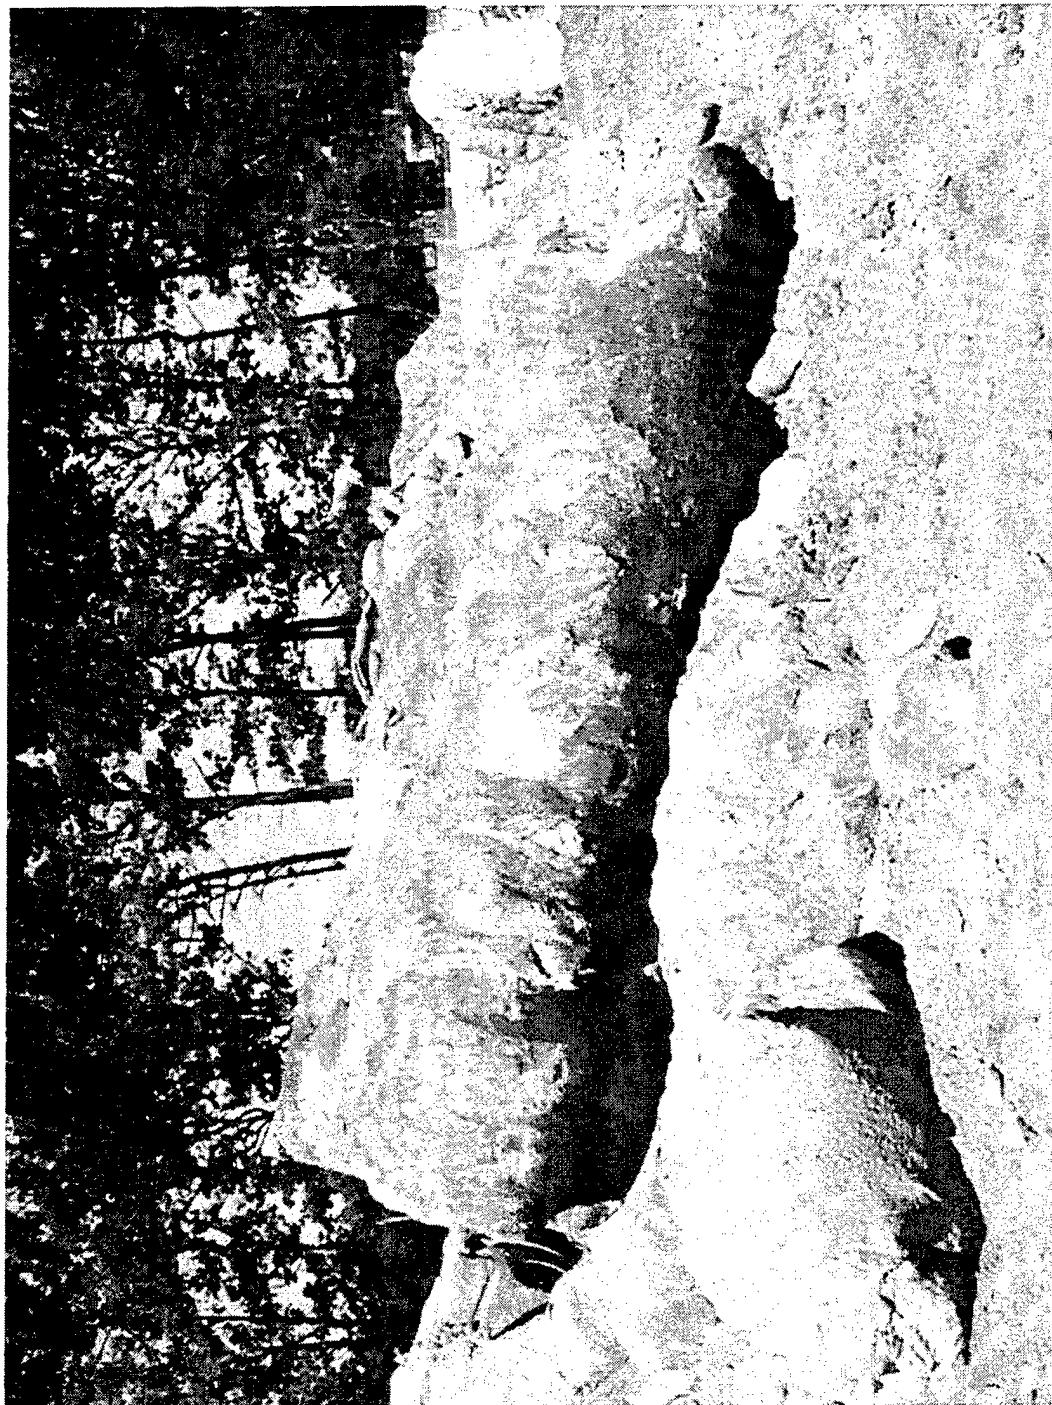
Figure 7.28 Side view of a jet-grouted column from the BNL close-coupled barrier.

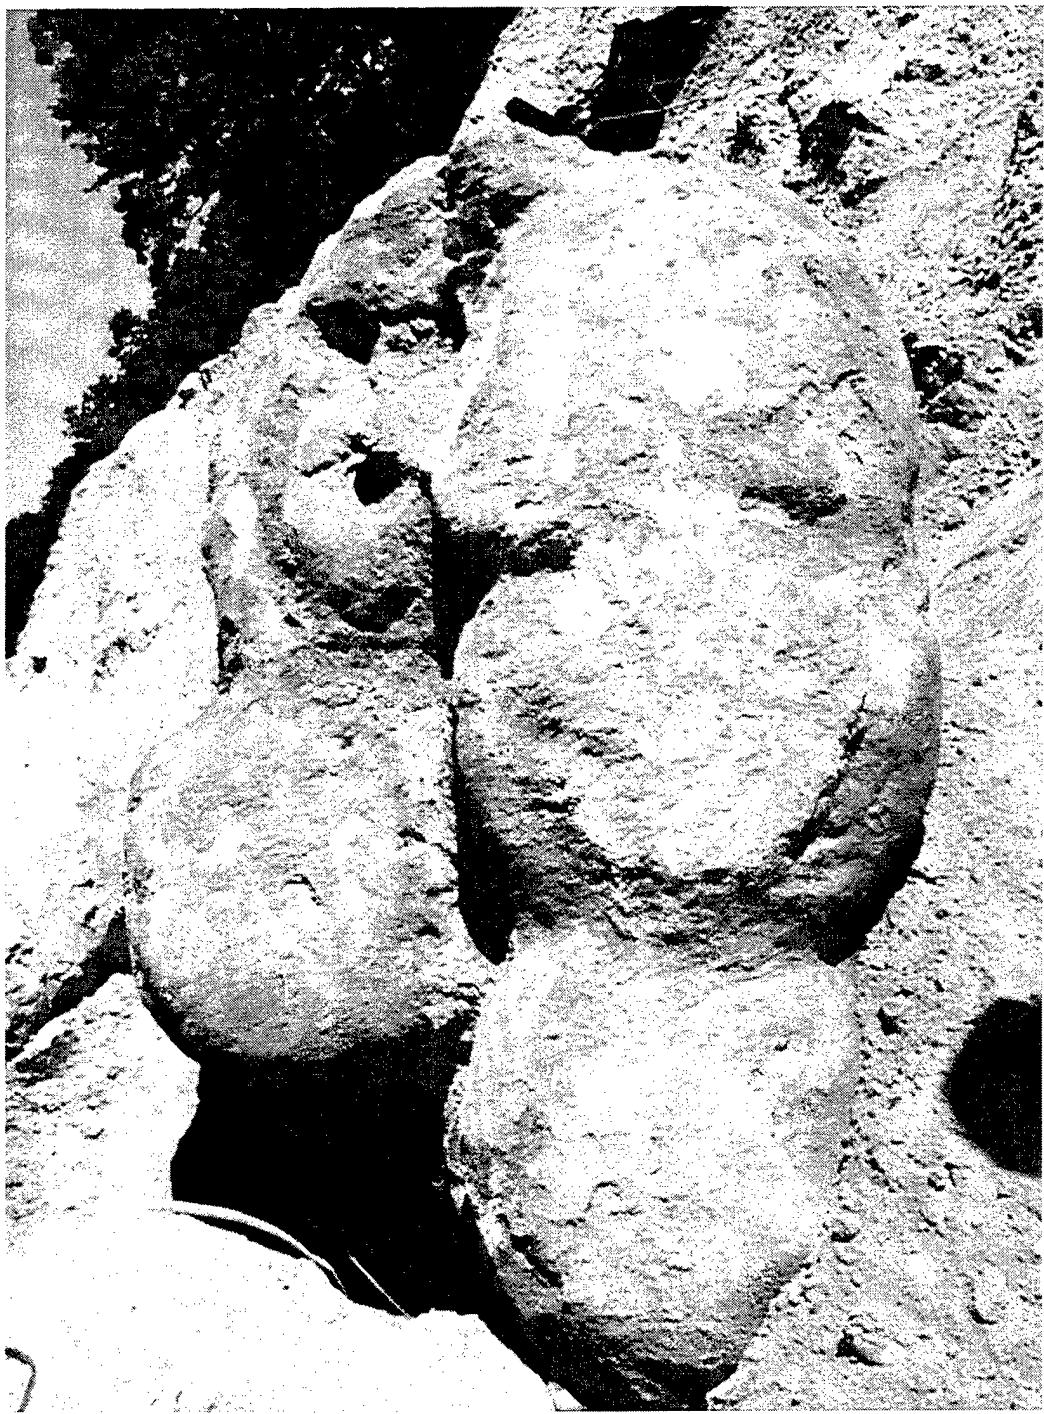
Figure 7.29 Top view of a section of a vertical wall from the BNL close-coupled barrier showing the overlap of columns.

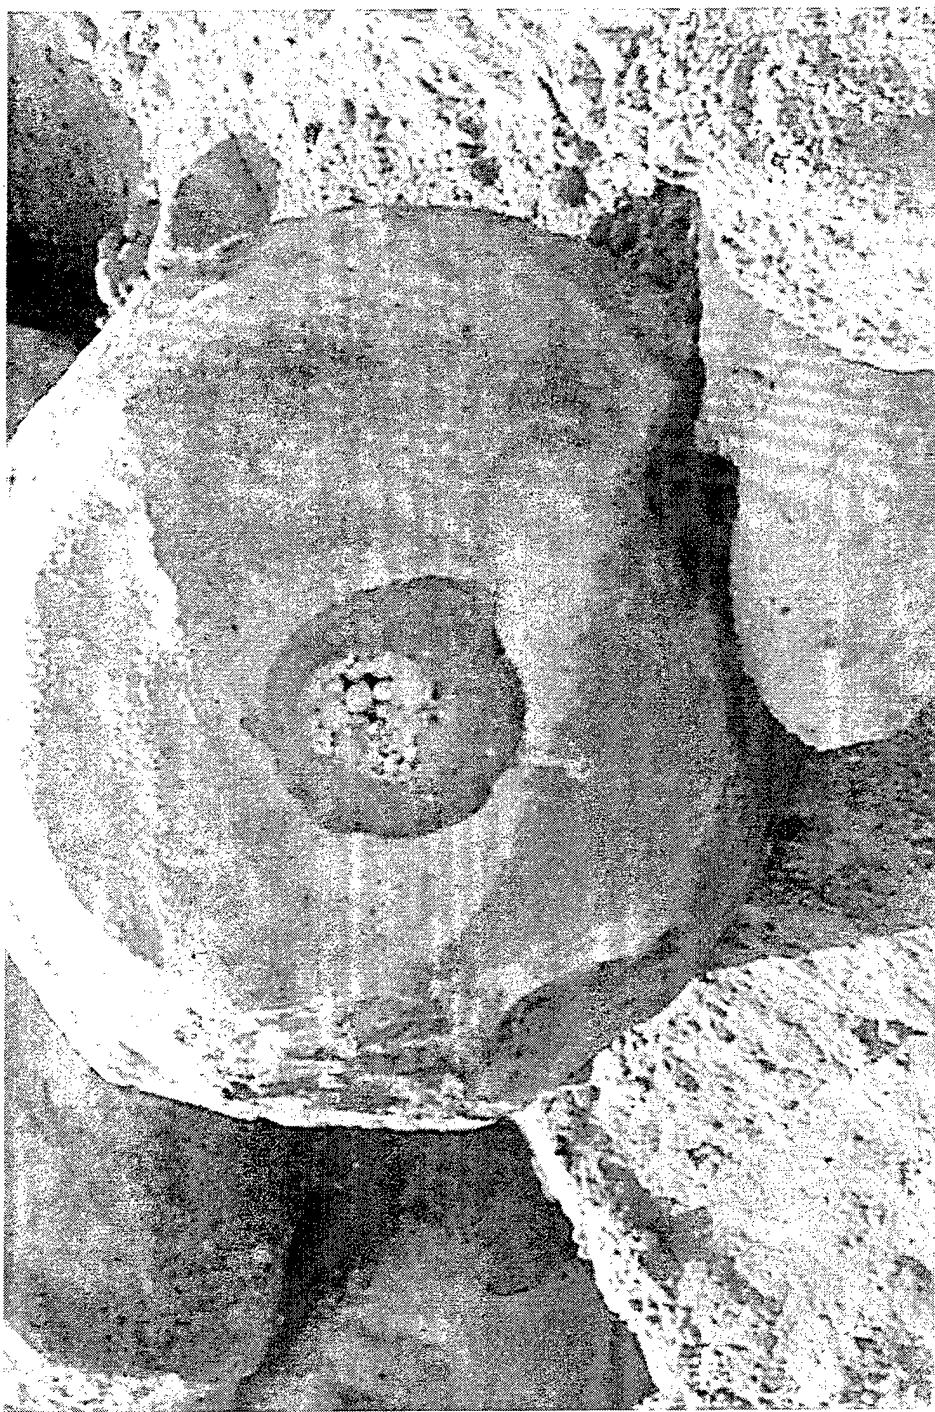
Figure 7.30 Cross-section of a jet-grouted column from the BNL close-coupled barrier.
