Subject: ✓ *Evaluation of On-Line Chelant Addition  
and Dilute Chemical Cleaning of PWR  
Steam Generators, DOE Final Report  
DOE/ET/34015-8*

STEAM GENERATOR CHEMICAL CLEANING PROJECT

ON-LINE CHELANT ADDITION  
DILUTE CHEMICAL CLEANING

FINAL REPORT

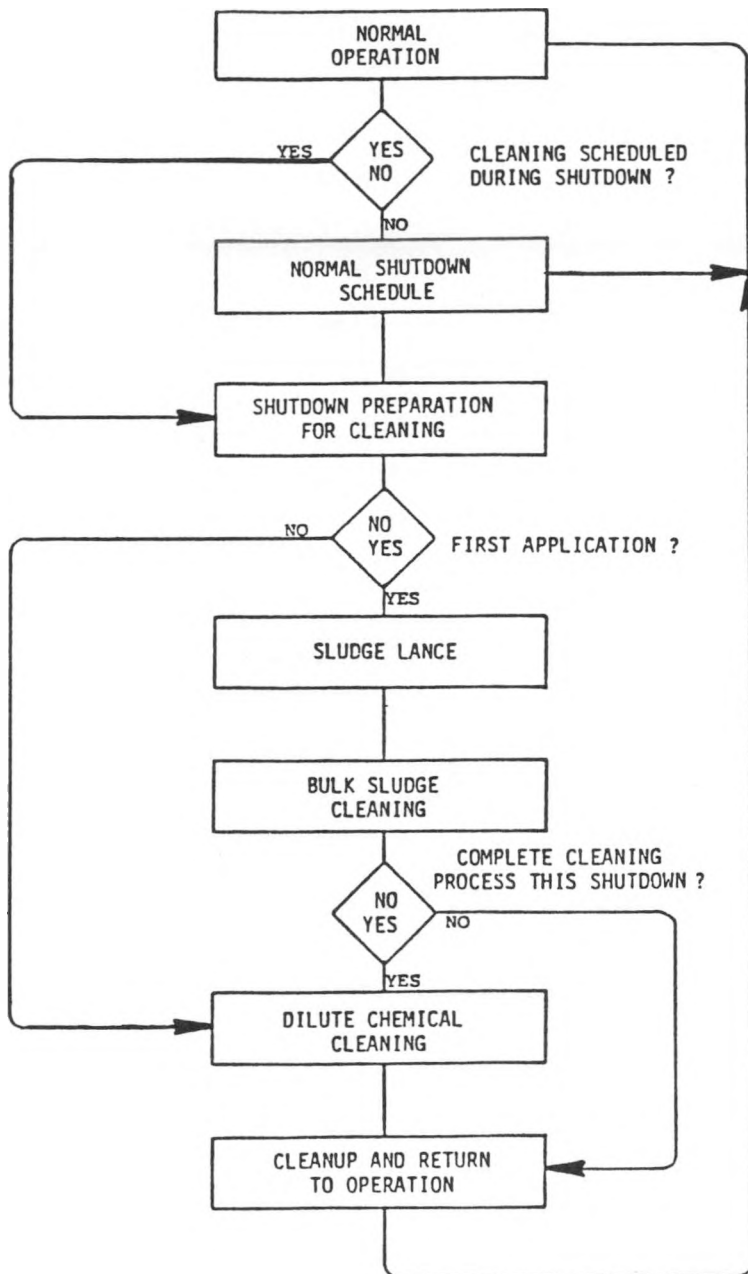
FIGURE 1-1. Logic Diagram for Dilute Steam Generator Chemical Cleaning Process.

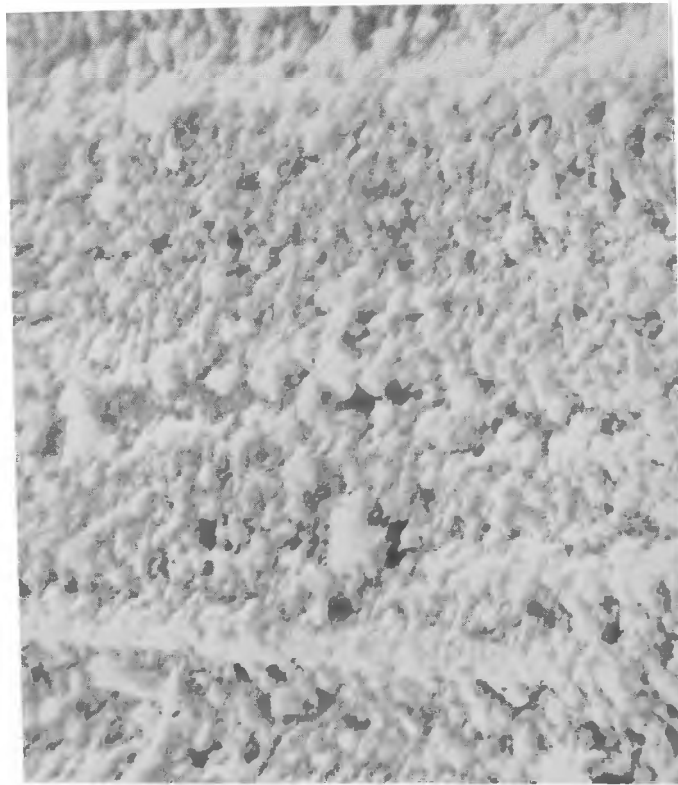
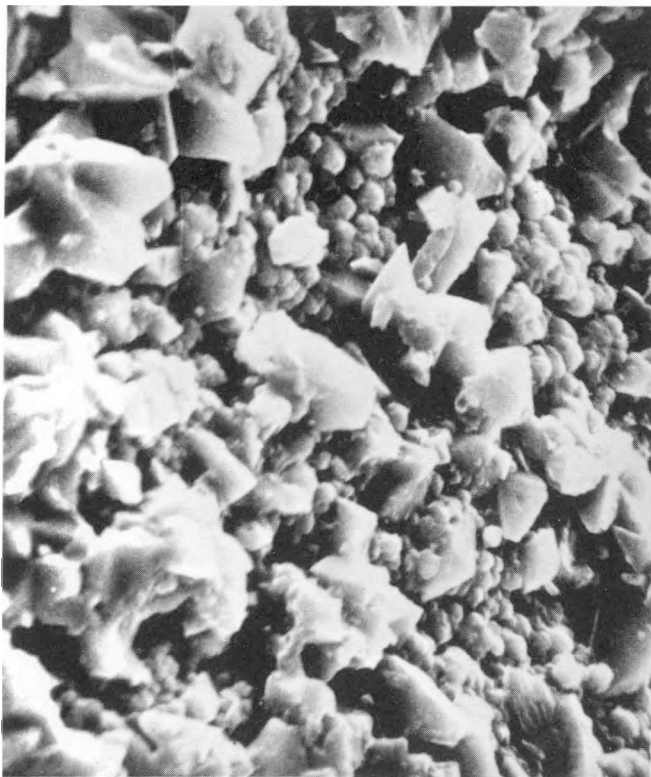
FIGURE 3-7

SCANNING ELECTRON  
MICROGRAPHS  
OF SA533

Exposed to  
AVT only  
2000X

Exposed to 0.1%  
EDTA + 5 ppm Fe +  
AVT 2000X

Exposed to 0.1%  
HEDTA + 5 ppm Fe +  
AVT 2000X

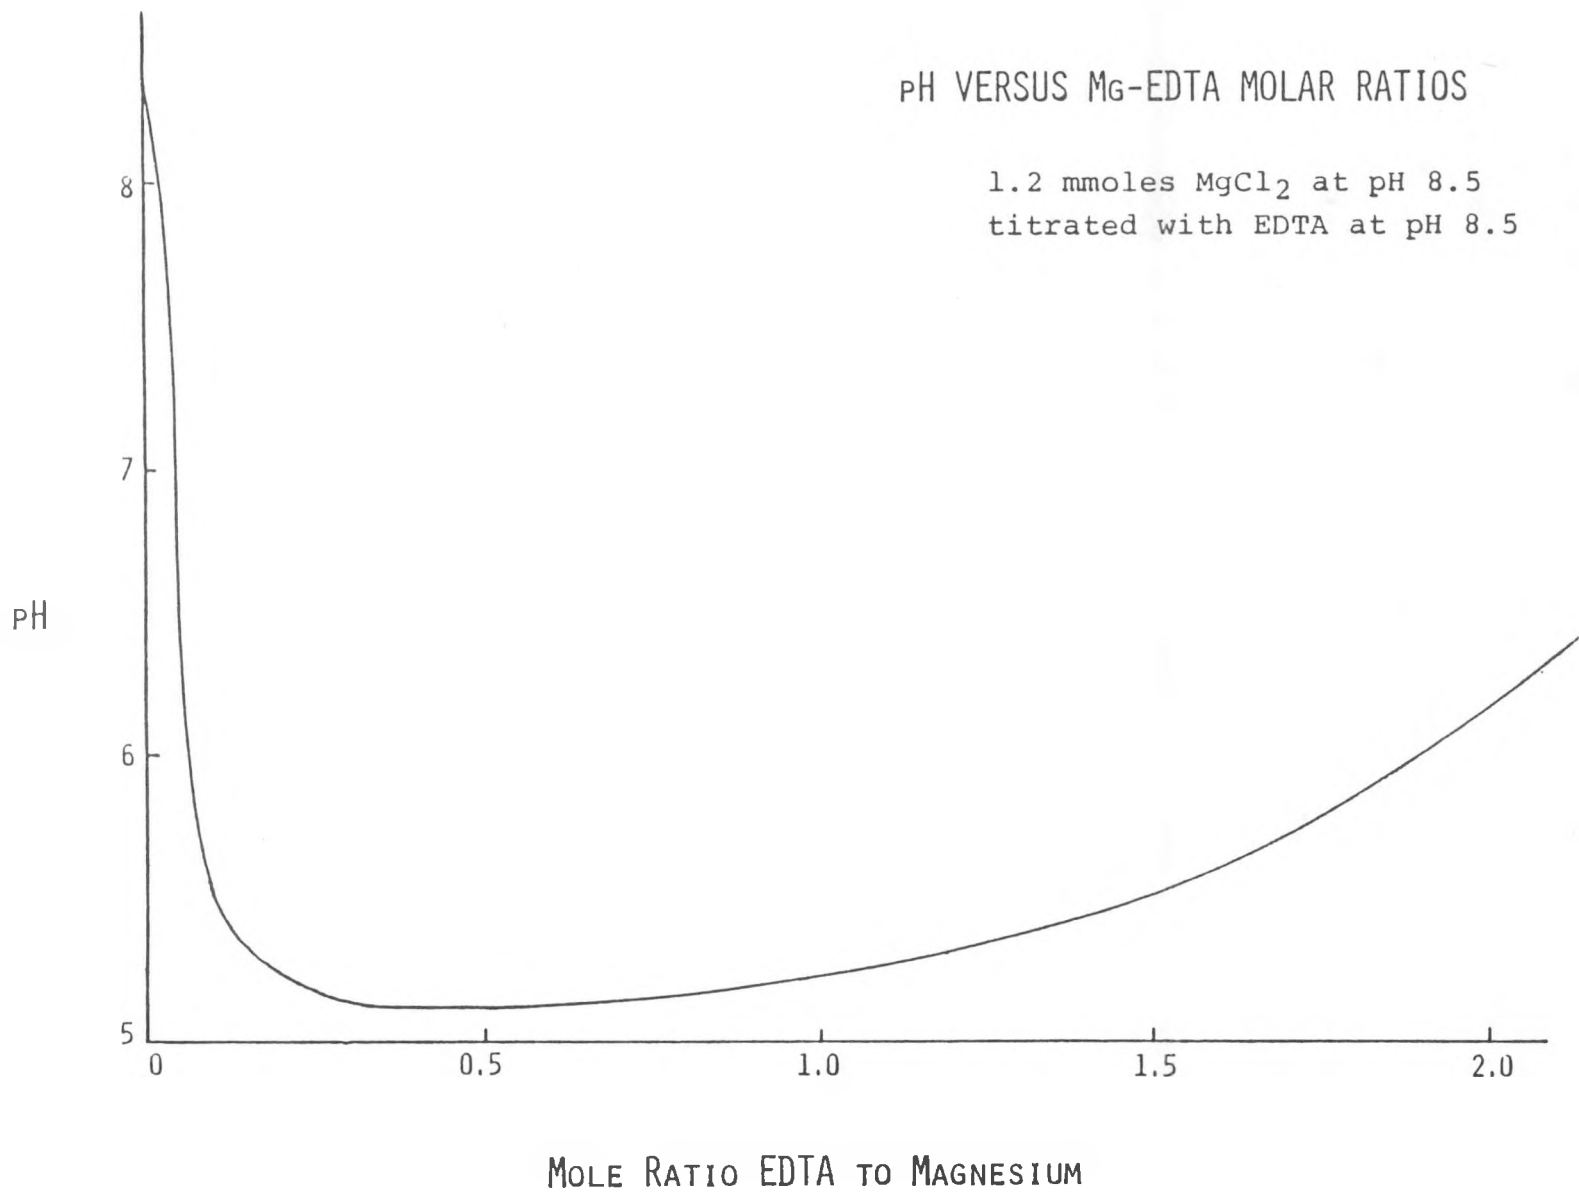
FIGURE 3-11

PH VERSUS MG-EDTA MOLAR RATIOS

1.2 mmoles  $MgCl_2$  at pH 8.5  
titrated with EDTA at pH 8.5

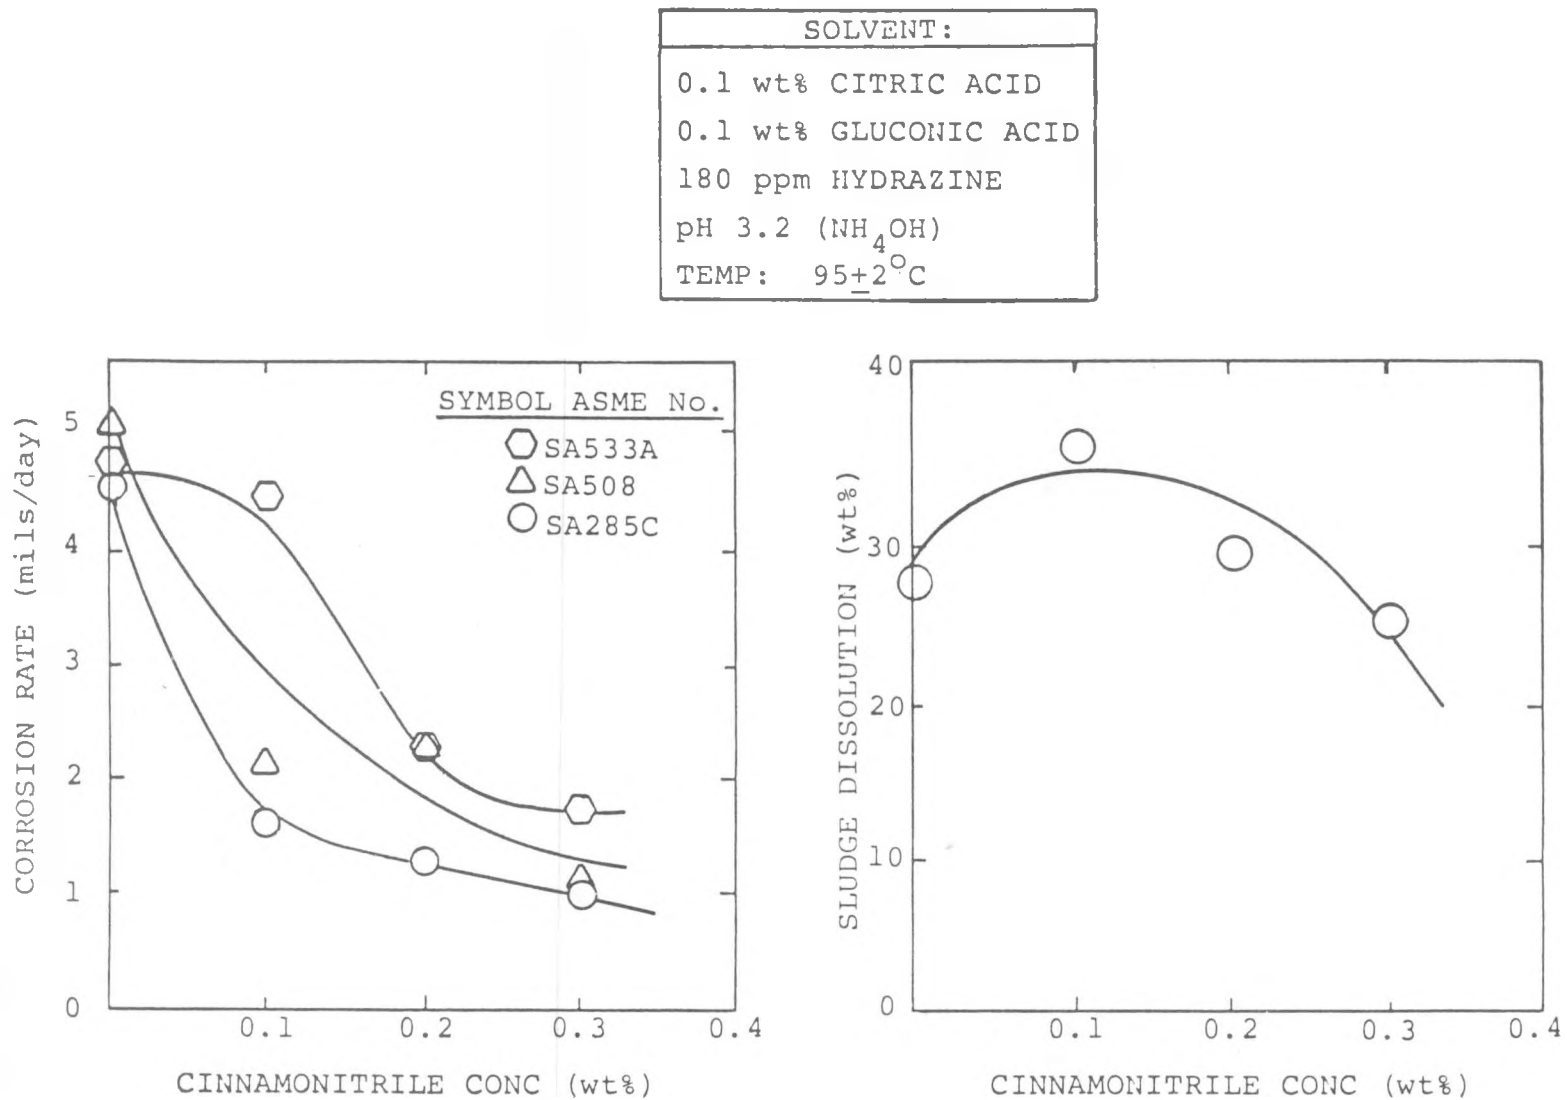
FIGURE 4-1 Effect of Inhibitor Concentration on Corrosion Rate and Sludge Dissolution.

Effect of Inhibitor Concentration on Corrosion Rate and Sludge Dissolution.

The data in Figure 4-1 indicate that the cinnamitrile concentration must be at least 0.3 wt% to keep the corrosion rate of the materials of construction near the 1 mil/day level. It also appears that in this solvent, which contains 0.1 wt% citric acid and 0.1 wt% gluconic acid, the presence of cinnamitrile at 0.3 wt% also reduced the amount of sludge dissolved during the 6-hour contact at 95°C.

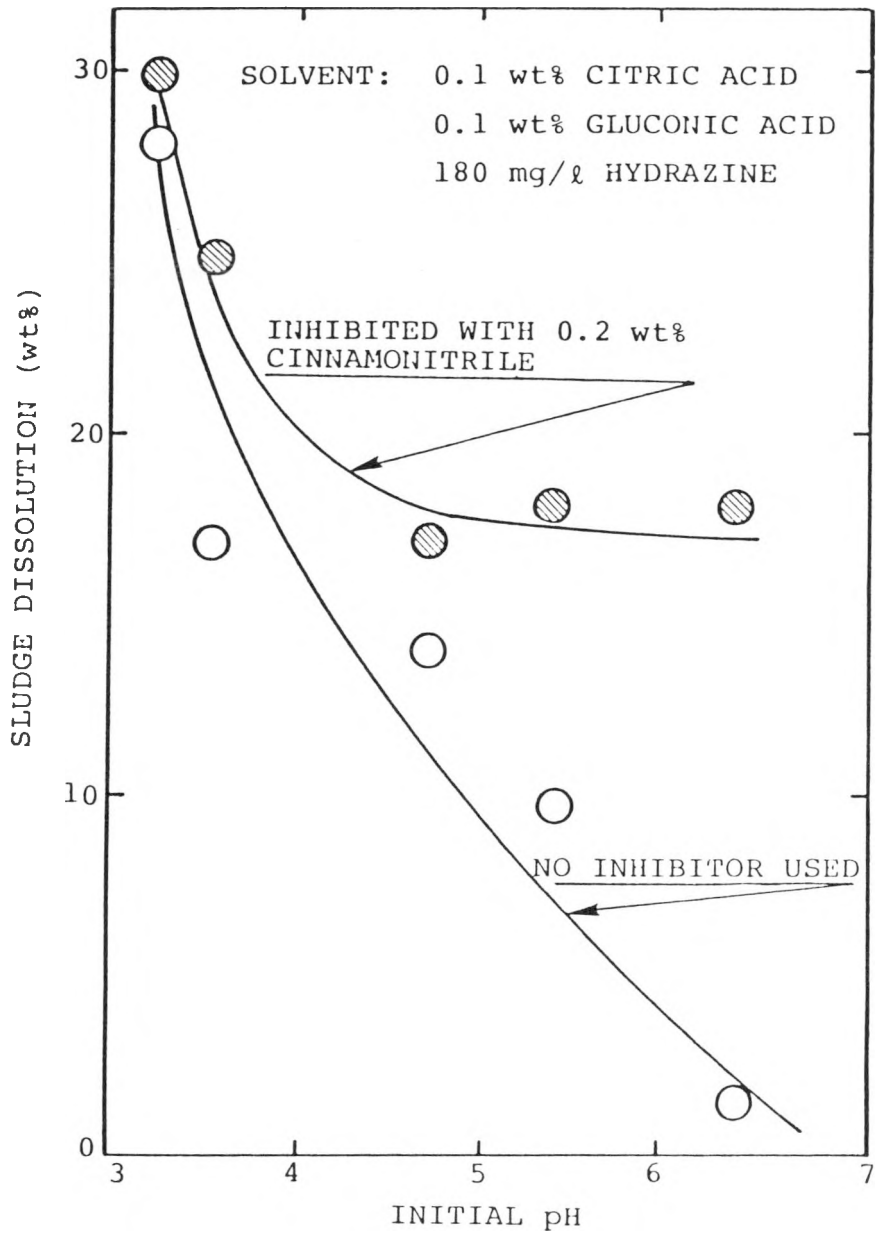
FIGURE 4-2 Effect of Initial pH on Sludge Dissolution

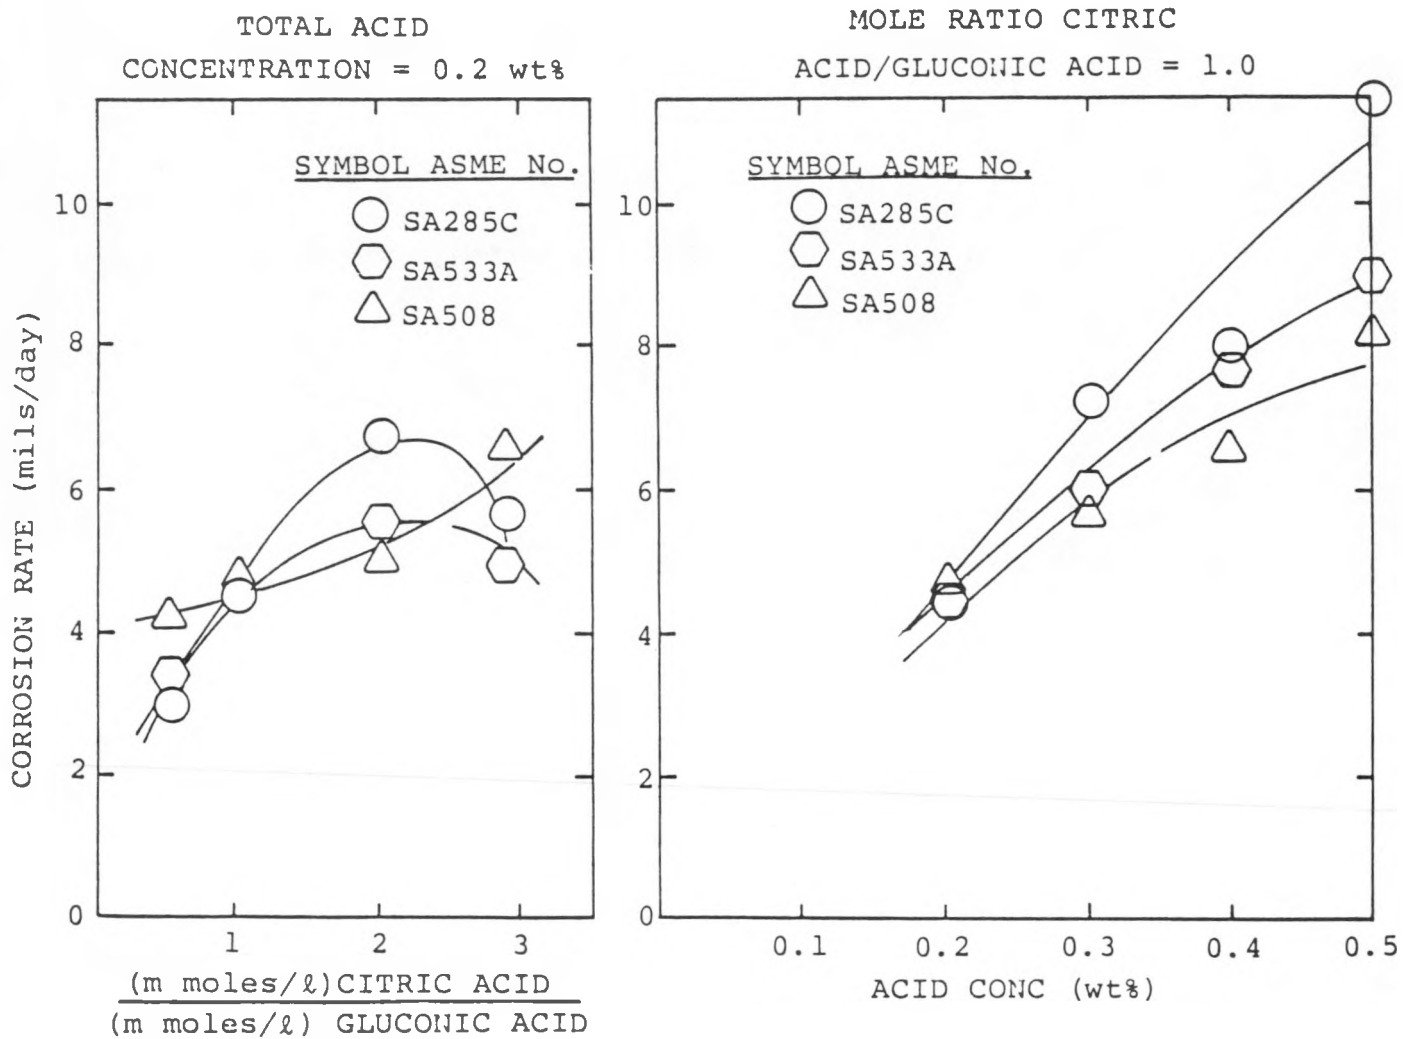
FIGURE 4-3 Effect of Mole Ratio and Acid Concentration on Corrosion Rate

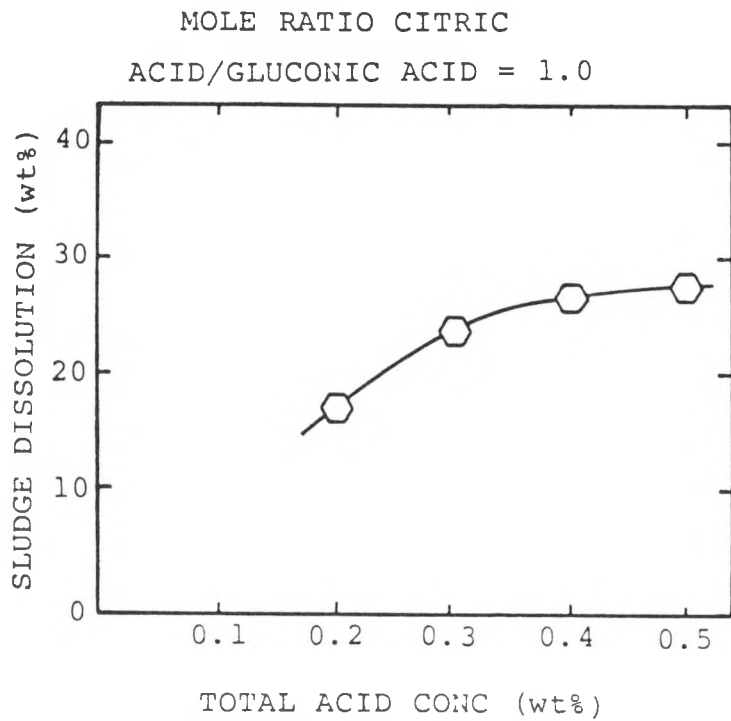
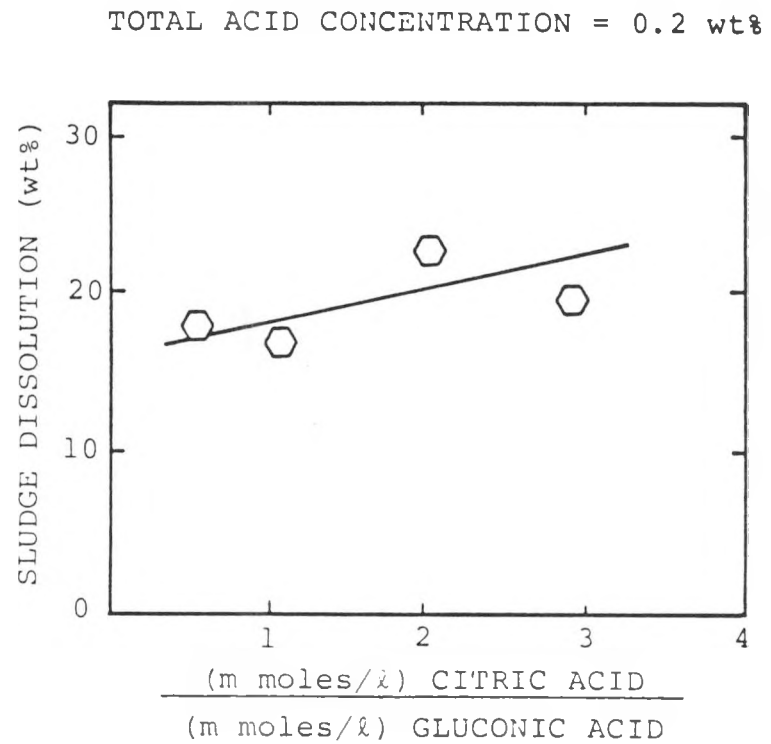
FIGURE 4-4 Effect of Acid Concentration and Mole Ratio on Sludge Dissolution.

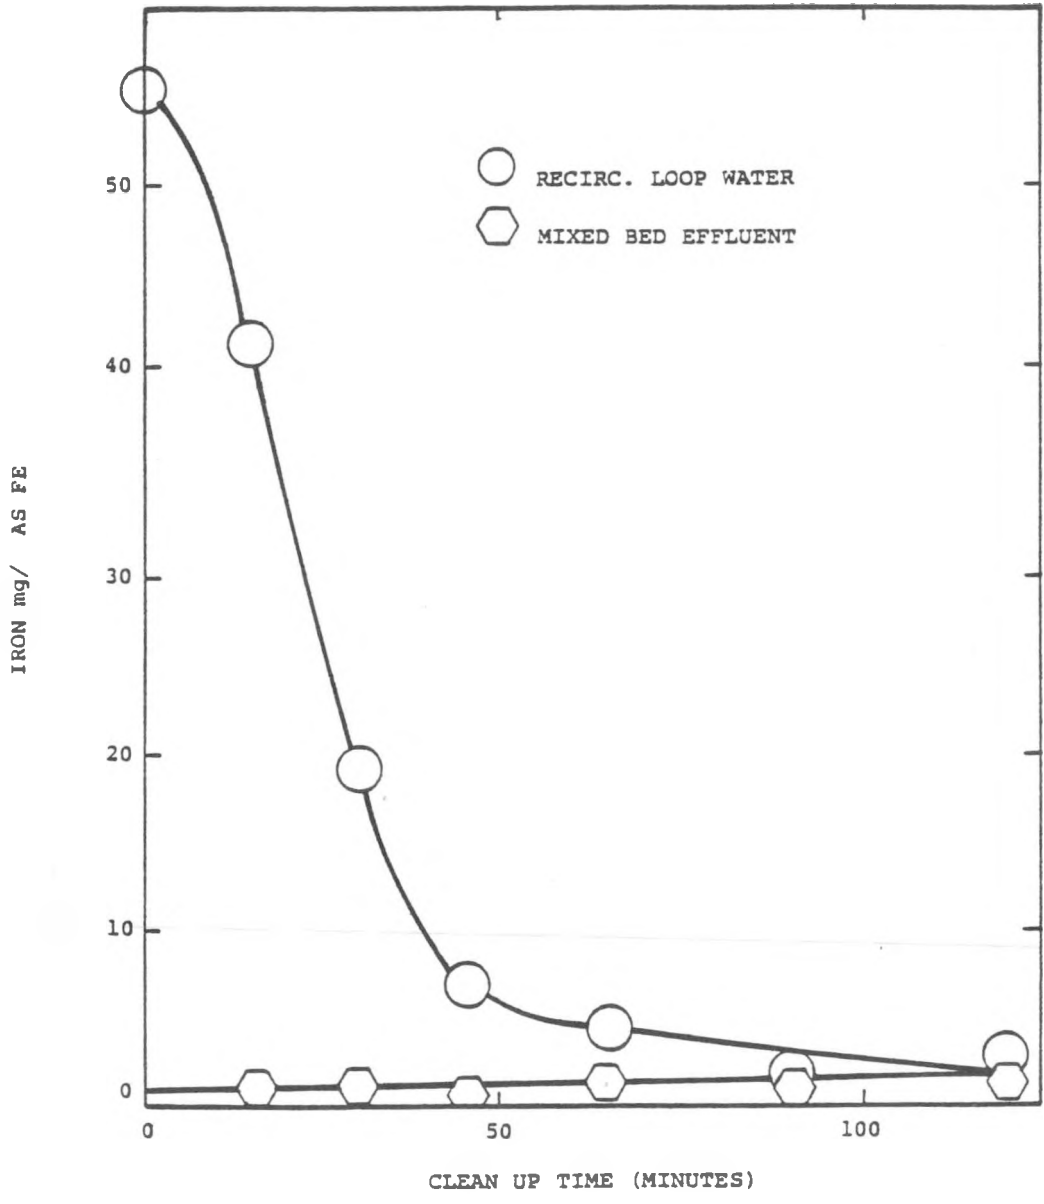
FIGURE 4-10. Typical Mixed-Bed Cleanup After Sludge Iron Step.

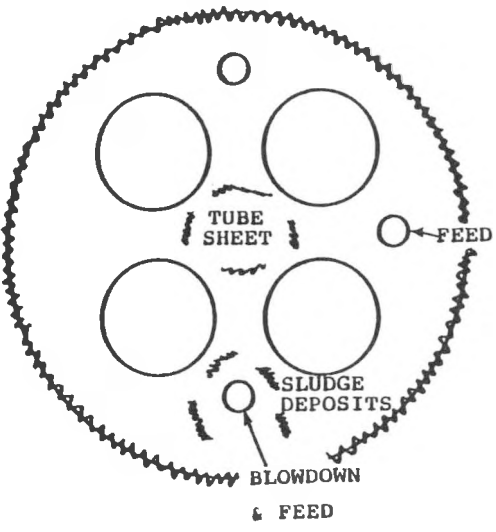
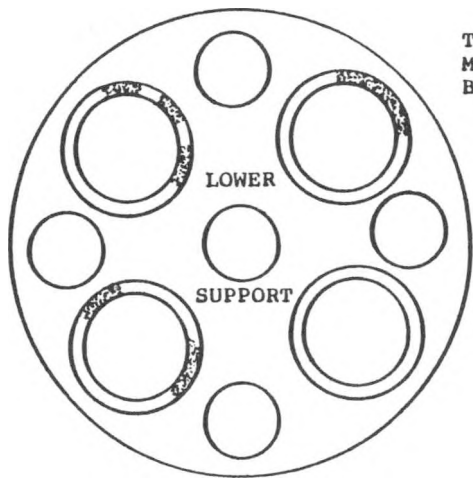
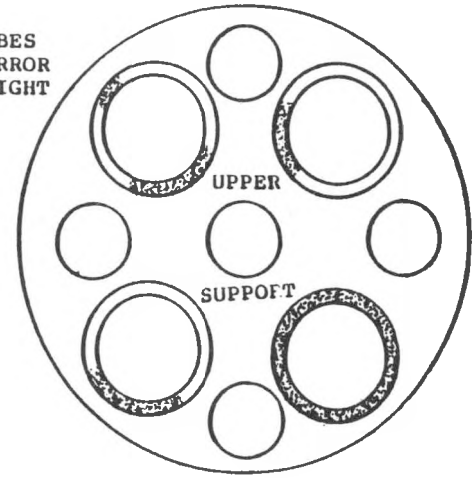
CONDITION BEFORE CLEANING 60-75 % BLOCKED

TUBES  
MIRROR  
BRIGHT

CONDITION AFTER CLEANING

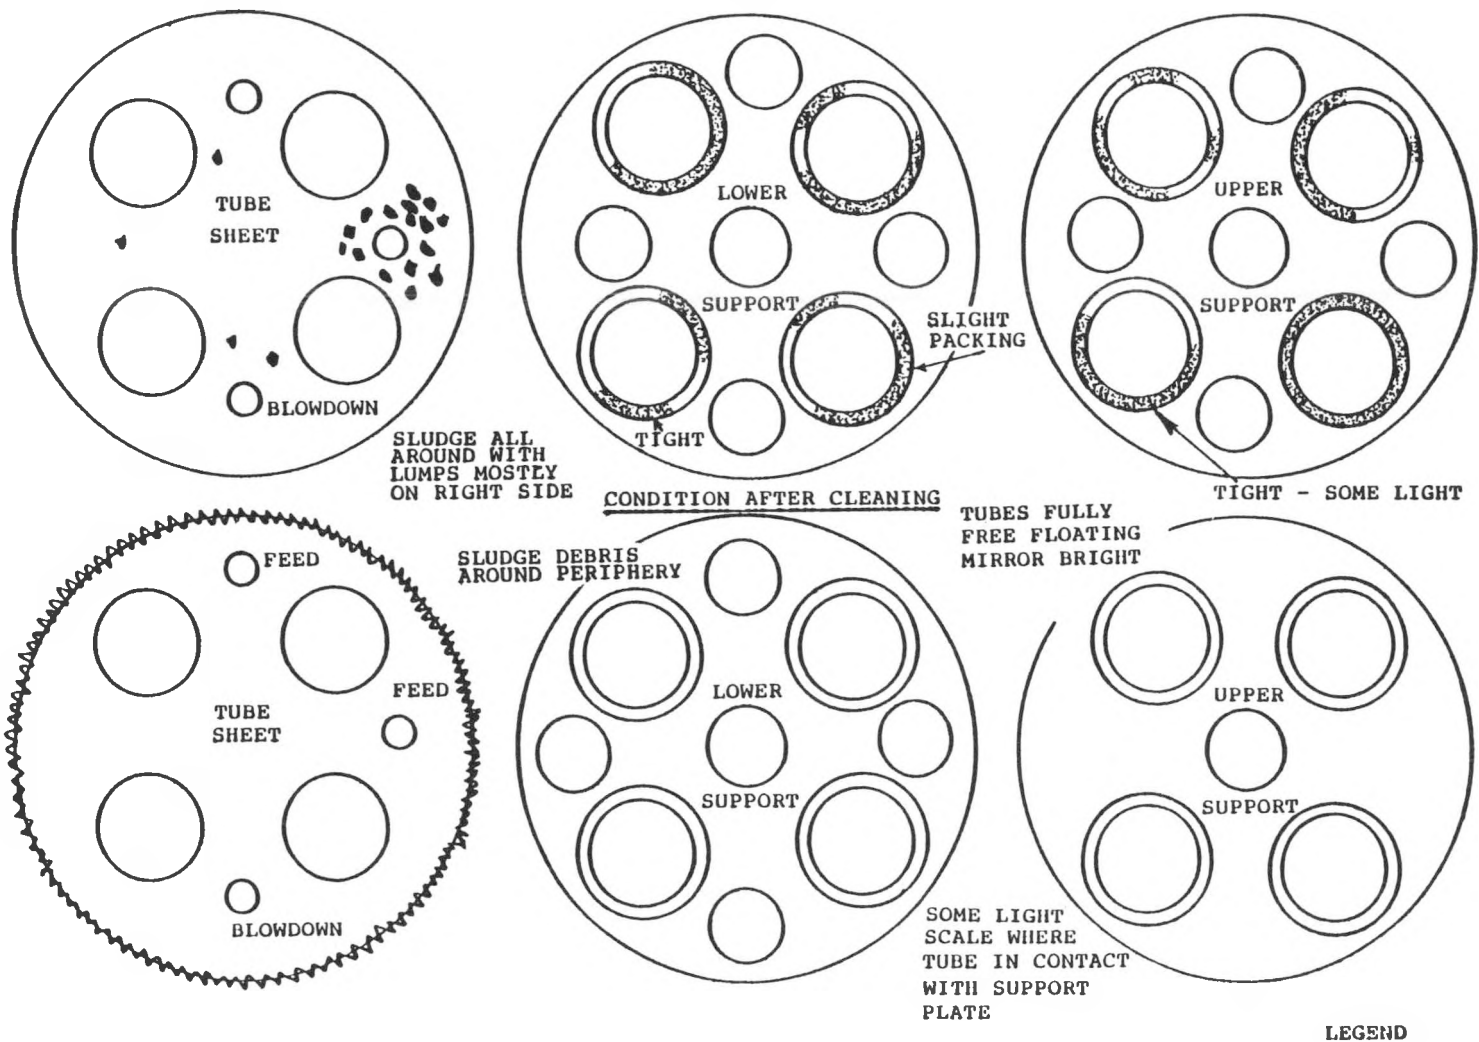
CONDITION BEFORE CLEANING 80-90% BLOCKED

FIGURE 4-22. Unit No. 5 Pre- and Post-Cleaning Comparison.
