Reduced Enrichment for Research and Test Reactors
1997 International Meeting
Jackson, Wyoming
USA

**Assessment Results of the South Korea TRIGA
SNF to be Shipped to INEEL**

October 9, 1997

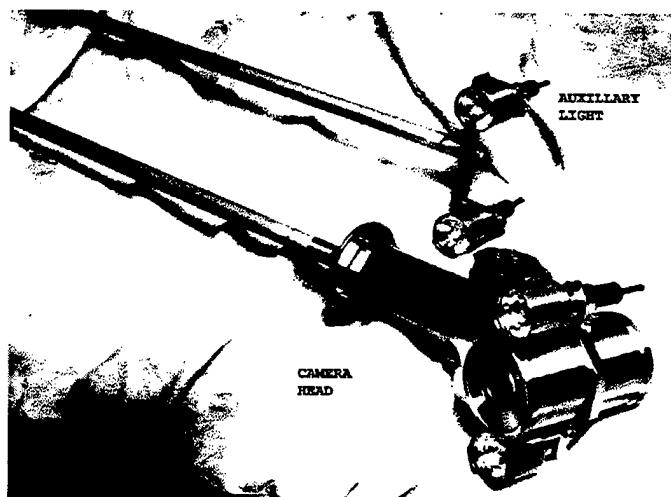
Figure 1 - Underwater Camera Head Assembly and Auxiliary Lighting

The selected camera system incorporates a moderate telephoto capability and a pan and tilt option. This allows positioning the camera head to zoom for closeup focus and still allow full sequential coverage of the fuel. Resolution of the SVHS equipment allowed viewing of pits less than 1/16 inch diameter to be identified approximately six feet from the camera head. Figure 1 shows the camera head and auxiliary lighting.

To provide contrast to surface areas, the camera was fitted with two adjustable lights with a second light source containing two adjustable lights were mounted on a separate pole and positioned independently to provide additional back lighting and contrast control.

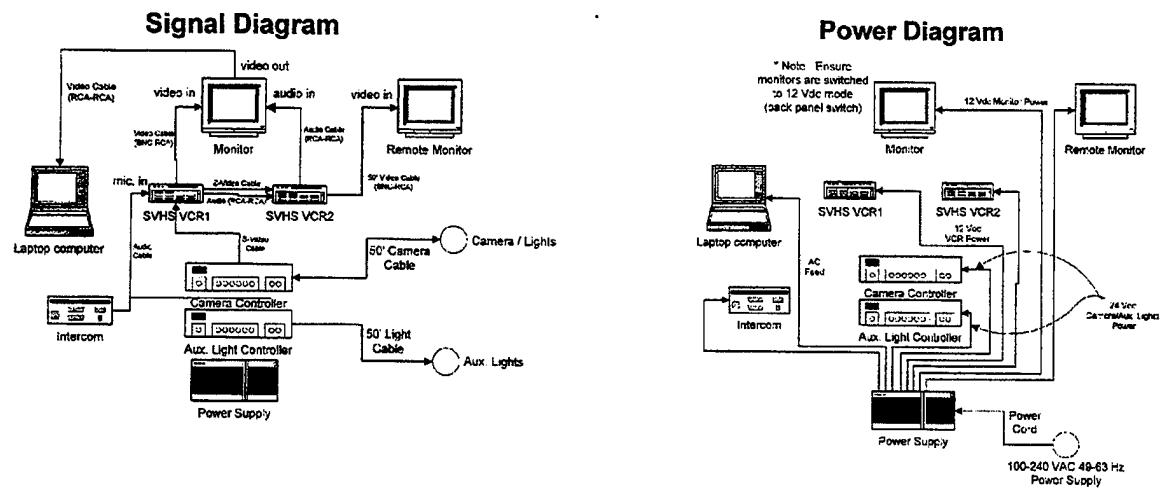
Figure 2 - Signal Diagram

SVHS recorder, to provide communication between members of the team. These features provide for independent verification of visual observations by allowing two team members to view the examination. Figures 2 and 3 are representations of the signal and power diagrams for equipment hookups.

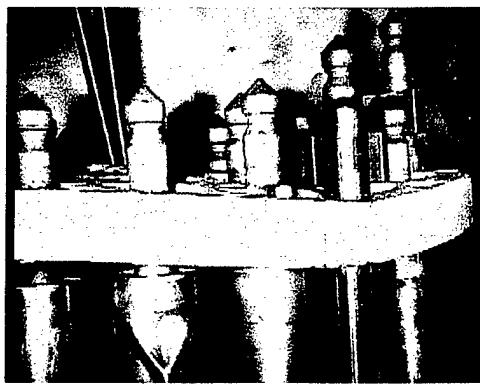
Figure 9 - Deformed Cask Basket
with deformed SS TRIGA Fuel

Figure 9 shows the aluminum basket and fuel from the cask in Taejon. The deformed stainless steel fuel elements are a result of inadvertent over pressurization using nitrogen as a cover gas. Figures 10 and 11 are typical examples of deformed fuel elements and fuel follower control rods from the over pressurization. Figure 12 is an example of the type of can in which the broken fuel rods and debris are stored and handled
