ORNL/TM-8385

## Evaluation of Tubular Ceramic Heat Exchanger Materials in Basic Coal Ash from Coal-Oil-Mixture Combustion

M. K. Ferber  
V. J. Tennery

Date Published - October 1982

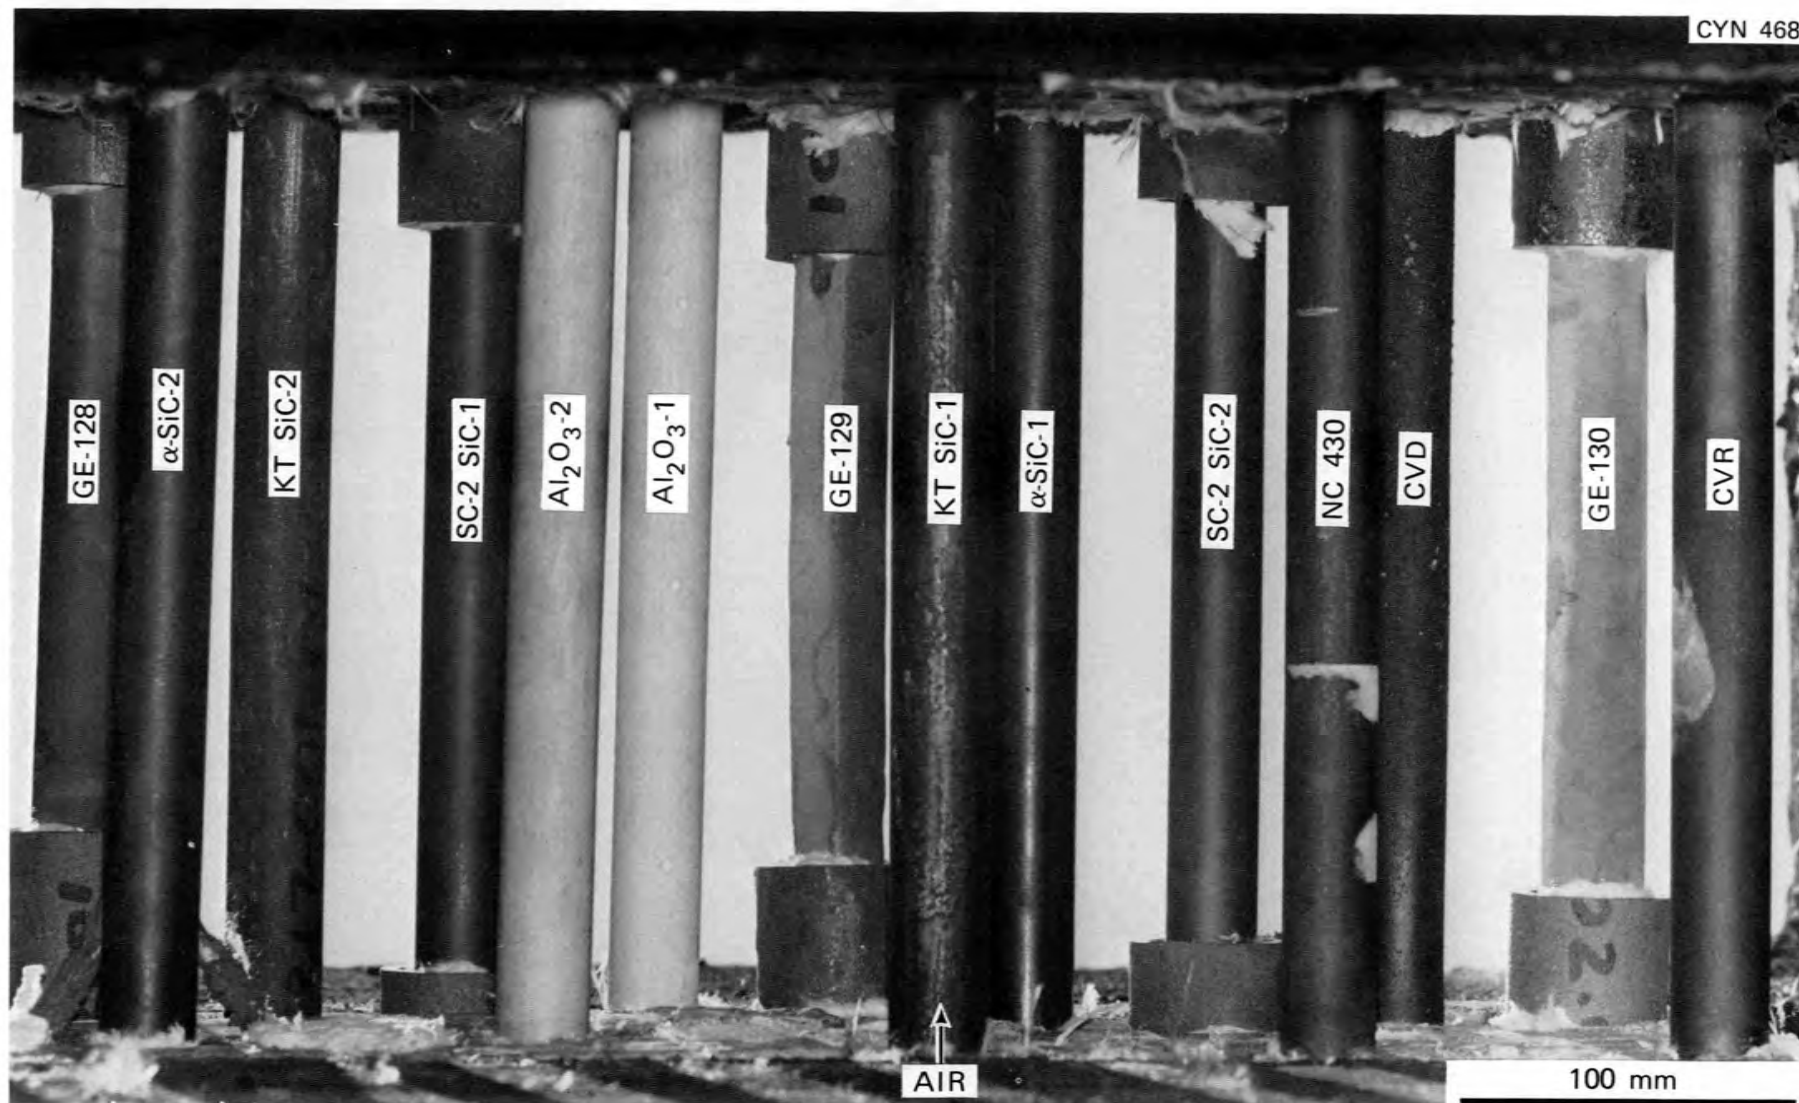
Fig. 5. Upstream surface of pretest ceramic tubes mounted in flue gas duct on the Refractory Test Facility. Flue gas flow direction into the page.

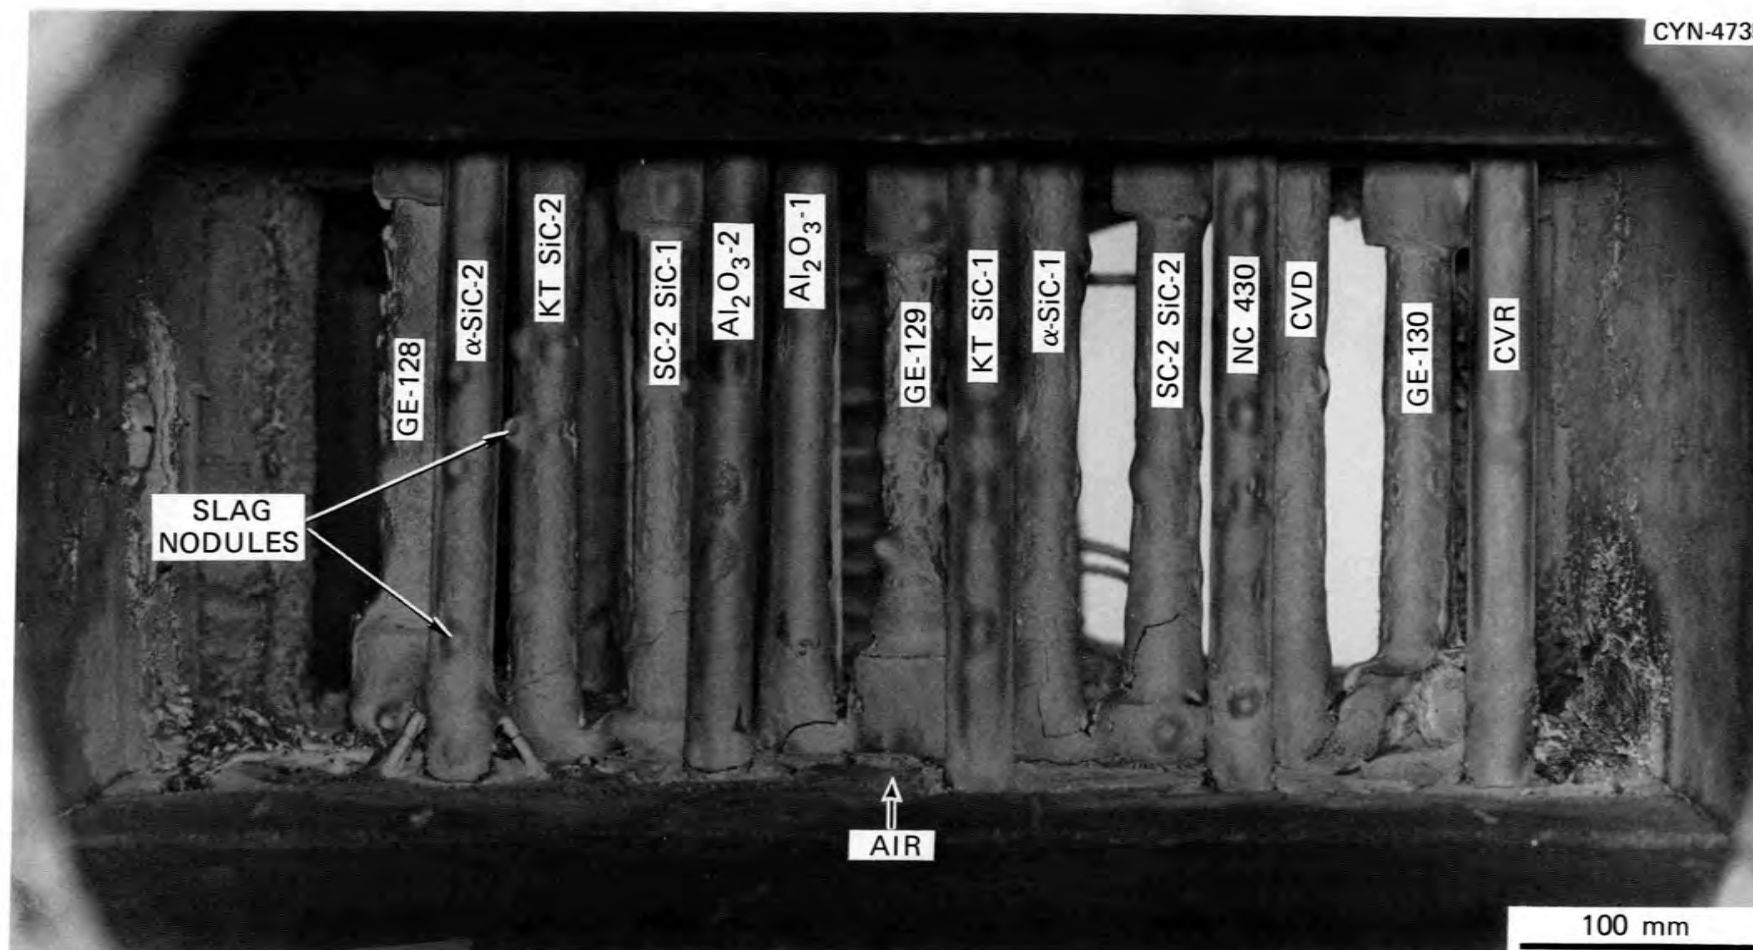
Fig. 14. Post-test tube array illustrating residual slag nodules on upstream surfaces of ceramic tubes after long-term exposure.

The tube-header array was visually examined following the exposure and subsequent cool down to ambient temperature. The upstream view of the tube-header array in Fig. 14 clearly shows the residual slag nodules that formed during the exposure (Figs. 10 and 11). For most tubes, these nodules which were located in the upstream surface region were displaced slightly toward the tube sides. This effect was apparently due to the combined effects of the aerodynamic forces exerted by the flue gas upon the fluid coal slag nodules and the gravitational effects. Figure 15, which illustrates the downstream view of the tubes in the header blocks, indicates that for most post-test tubes the residual, downstream-slag layer was considerably more uniform than that on the upstream side. As previously stated, this behavior was probably due to the fact that, during

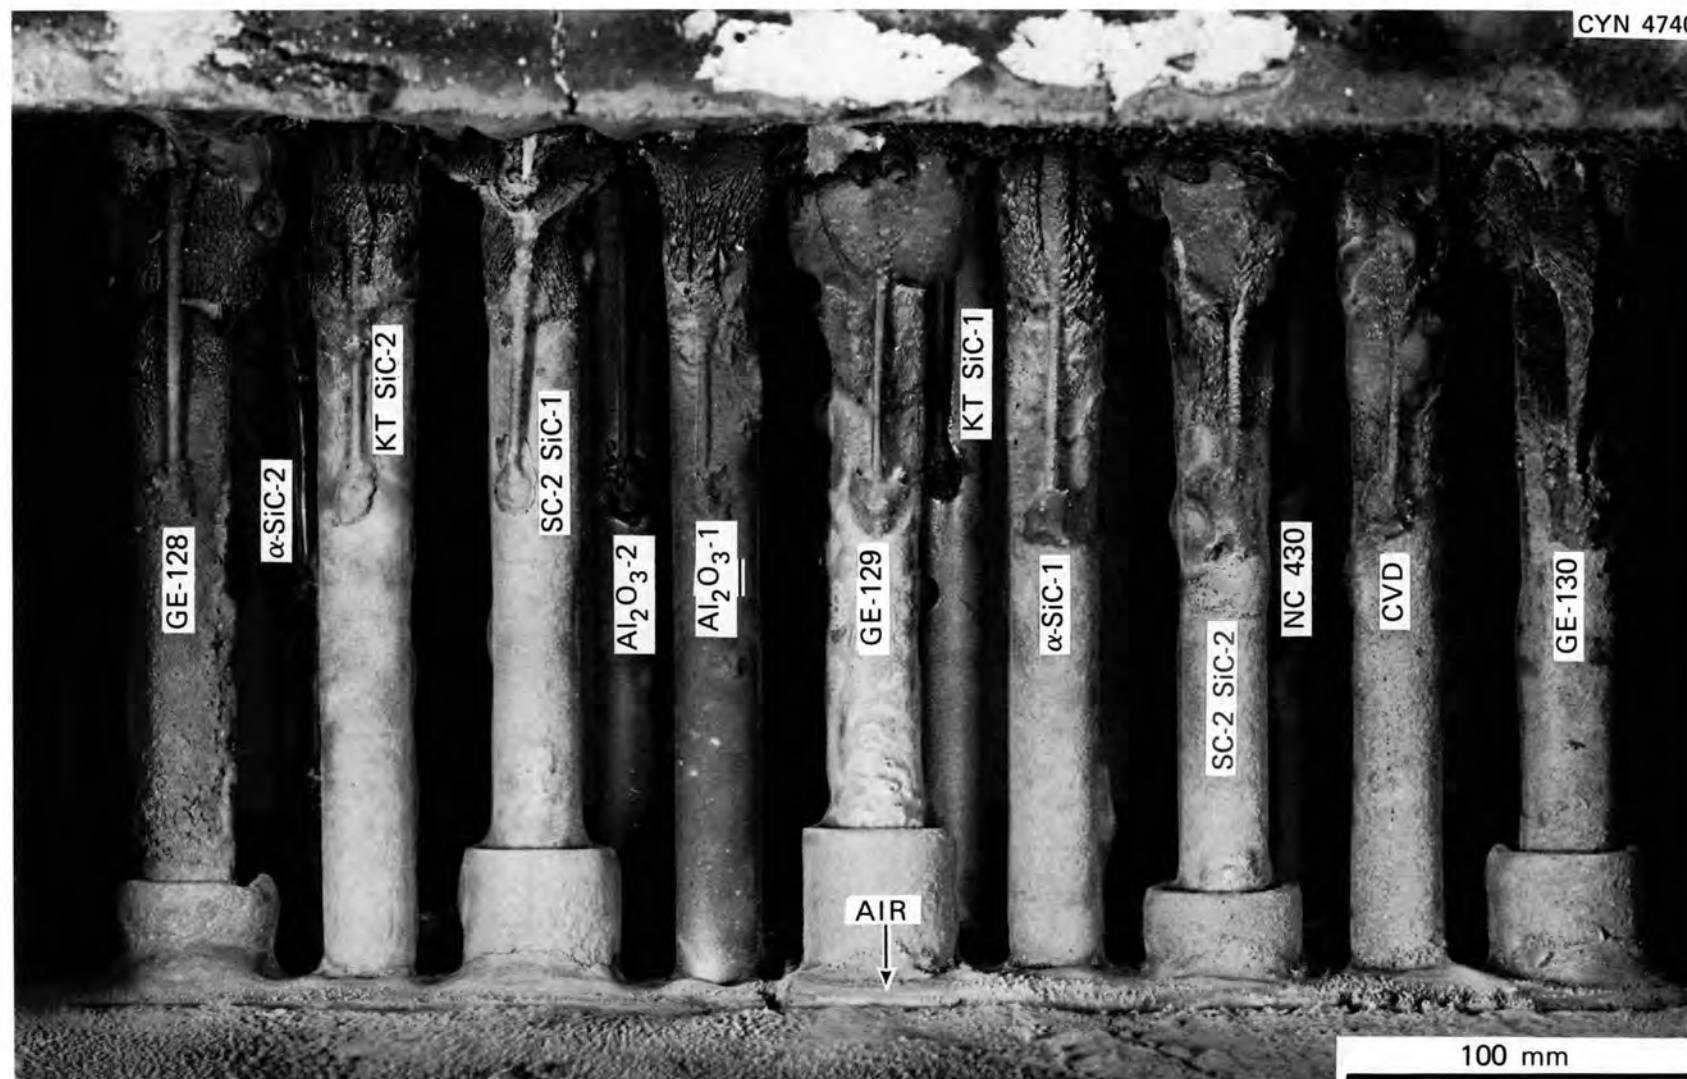
Fig. 15. Post-test tube array illustrating condition of downstream surfaces of ceramic tubes after long-term exposure.

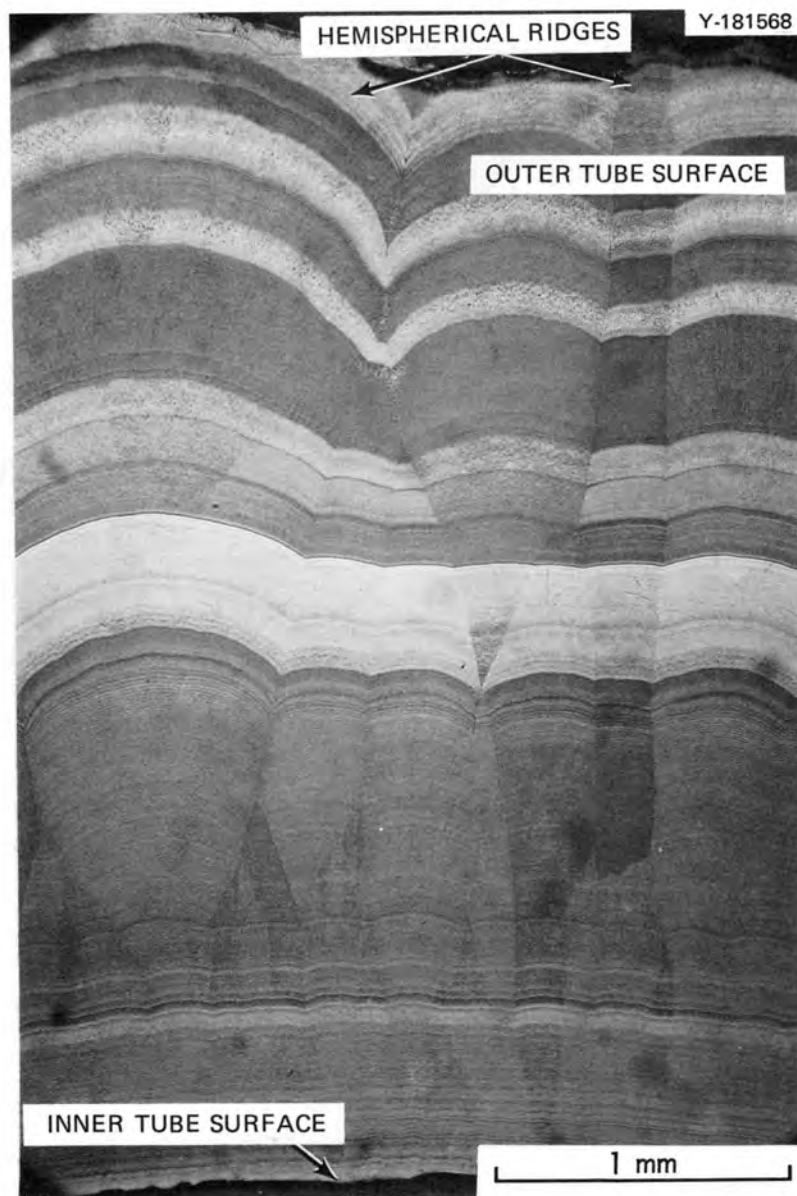
Fig. 25. Micrograph of as-received CVD SiC illustrating lack of uniformity along outer surface.
