EFFECT OF MECHANICAL CLEANING ON SEAWATER CORROSION
OF CANDIDATE OTEC HEAT EXCHANGER MATERIALS.

PART 1. TESTS WITH M.A.N. BRUSHES

ANL/OTEC-BCM-013

September 1980

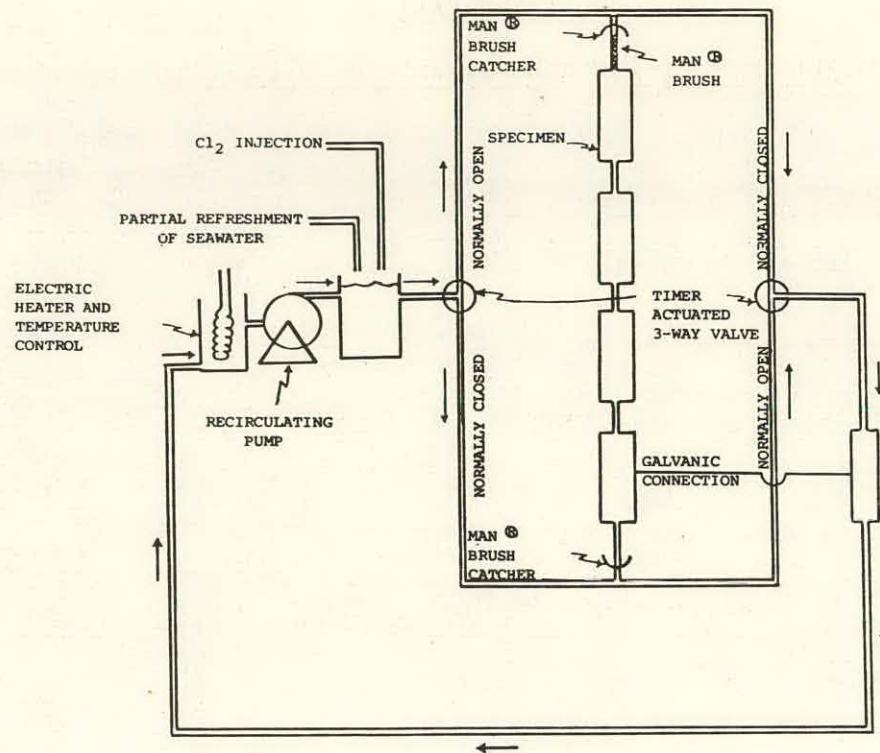
Figure 1. Schematic of M.A.N. brush cleaning system with partial seawater refreshment, chlorination, and temperature control. Neg. No. S-1836

Figure 1 shows a schematic diagram of the test facility. All piping, pumps, and other equipment in contact with the seawater environment were non-metallic or titanium (e.g., primary pump impeller) to avoid metal ion contamination.

As indicated in Figure 1, the test specimens were connected end to end to allow passage of the flowing seawater and the M.A.N. brush in series for each test loop. Figure 3 shows the details of specimen tube connections. A PVC spacer ring, machined to the approximate I.D. and O.D. size of the test specimens, was used to eliminate galvanic contact between test specimens. The spacer also provided for a smooth transition for the action of the M.A.N. brush from specimen to specimen minimizing the inevitable I.D. discontinuities at connection points.

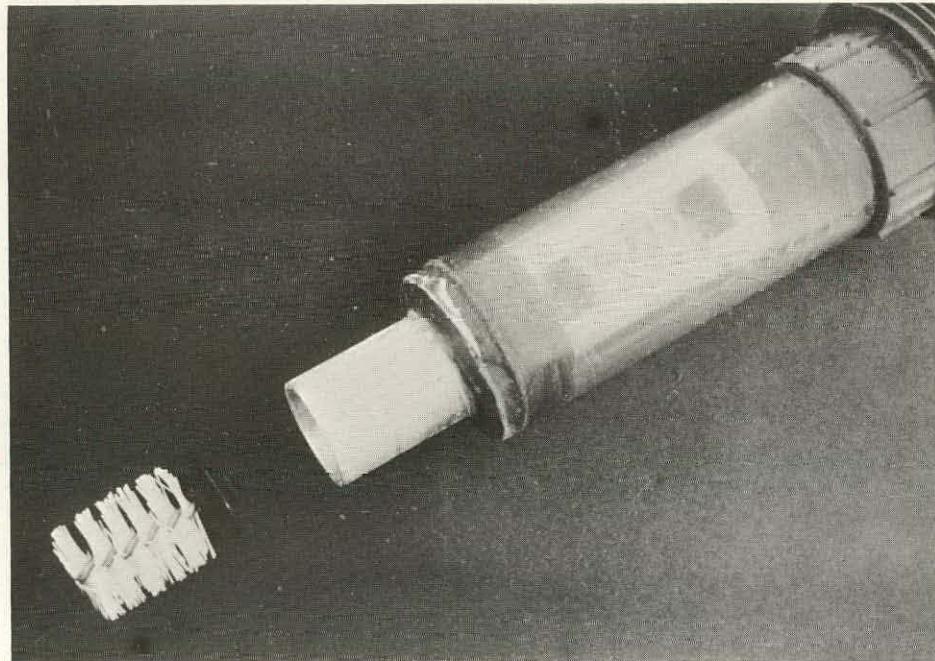
Figure 2. M.A.N. brush catcher assembly and M.A.N. brush. 0.6X Magnification. Neg. No. S-1837

Figure 2 shows a photograph of a M.A.N. brush catcher assembly located at either end of a test section. The plastic catcher basket was attached to a short length of tubing of each respective material in a given loop so that no specimen would be subjected to possible end effects arising from the catcher basket. Over the catcher basket, a section of clear PVC (polyvinyl chloride) was used for containment and allowed visual inspection of the operation of the brushes during flow reversal.

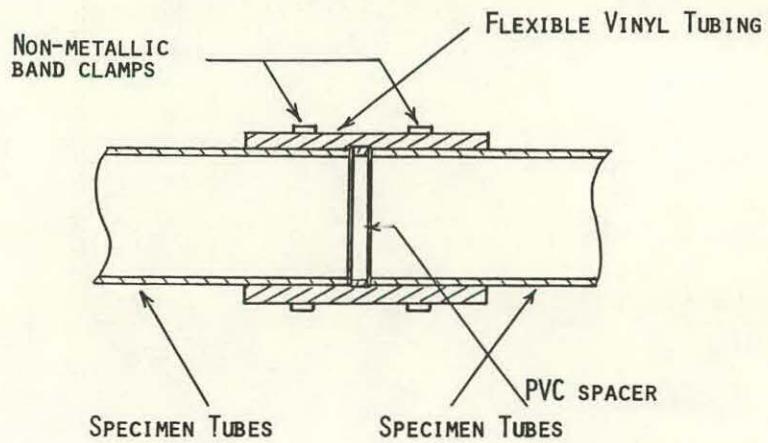
DETAIL OF SPECIMEN TUBE CONNECTION

Figure 3. Detail of specimen tube connection.
Neg. No. S-1838

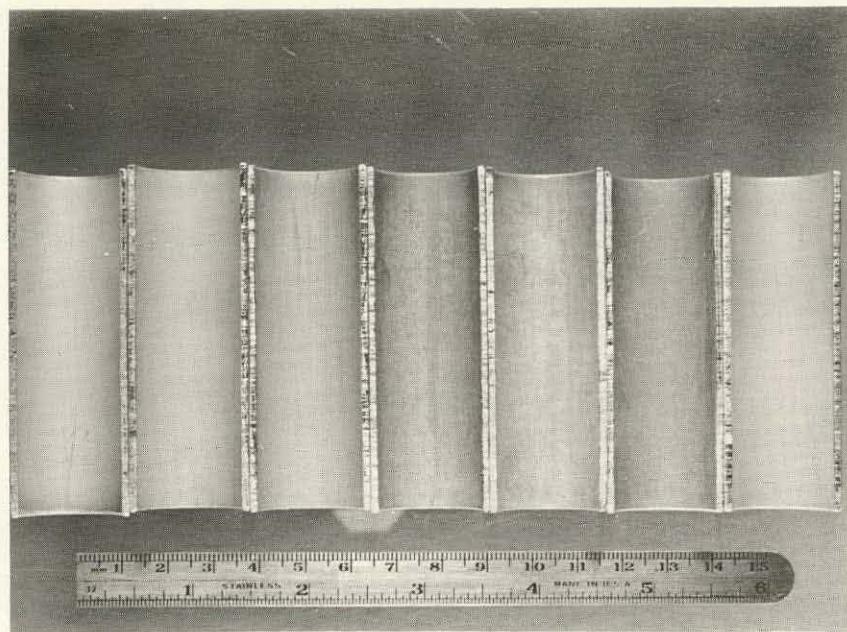
Figure 4. 3003 Alclad after exposure without cleaning for (left to right) 1, 2, 4, 8, 16, 32, and 64 days. Normal flow direction was top to bottom.
0.6X Magnification. Neg. No. 79158-6

Figures 4 and 5 show the I.D. surface appearance of 3003 Alclad tubing exposed in the control (no cleaning) environment and exposed to M.A.N. brush cleaning for 1 to 64 days. In both cases, the normal direction of flow through the tubes was from top to bottom in the photographs. In Figure 4, the specimens show a discoloration which is consistent with the normal growth of a corrosion film on aluminum alloys in flowing seawater. No localized corrosion was observed.

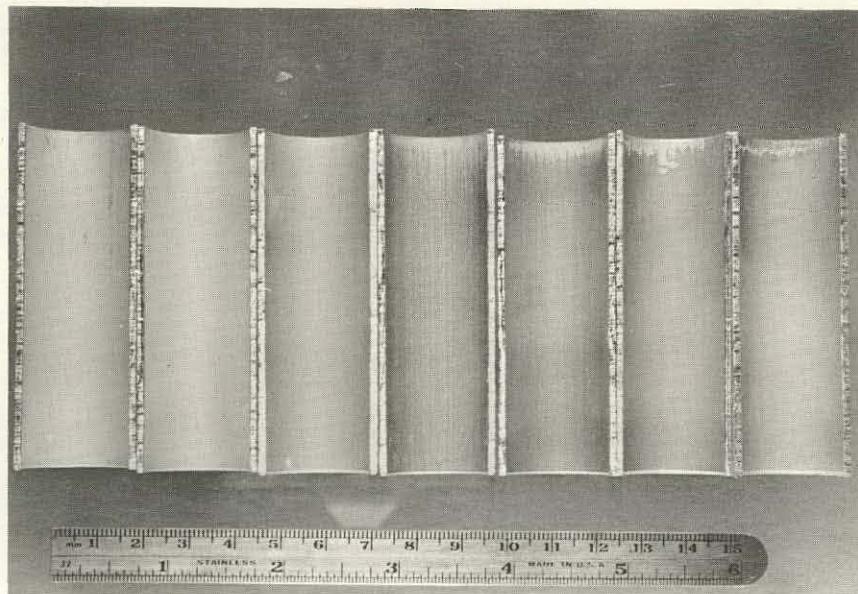
Figure 5. 3003 Alclad after exposure to M.A.N. brush cleaning for (left to right) 1, 2, 4, 8, 16, 32, and 64 days. Normal flow direction was top to bottom.
0.6X Magnification. Neg. No. 79158-11

In Figure 5, the specimens show the erosion-corrosion effects of M.A.N. brushing. Starting at 8 days exposure, streaks in the corrosion product film and a lighter color at the inlet (top) end began to appear. After 32 to 64 days a significant amount of localized corrosion had occurred at the inlet ends.

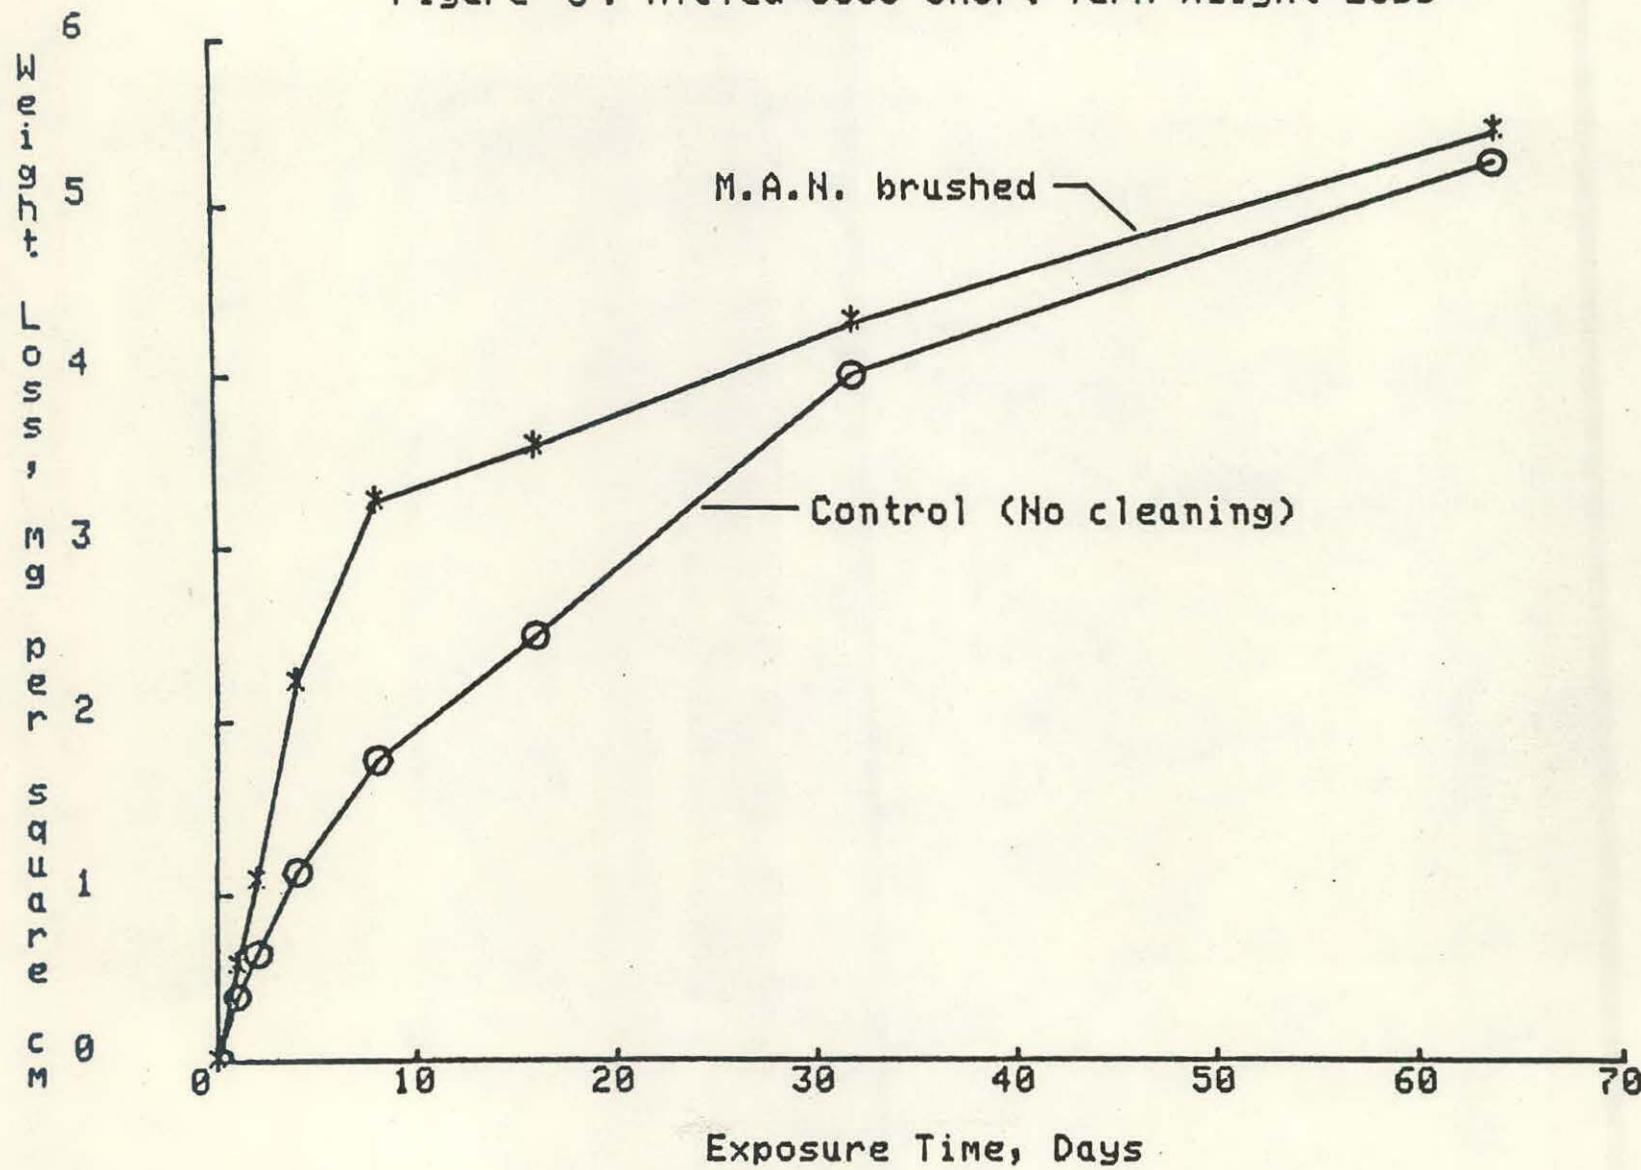
Figure 6. Alclad-3003 Short Term Weight Loss

Table IV summarizes the weight loss data from the short term specimens. Figure 6 gives the weight loss per unit surface area as a function of exposure time. In contrast with the surface appearances in Figures 4 and 5, the weight losses in the two environments converge after 32 days exposure. Based on overall weight loss for exposures up to 64 days, there is very little difference in the corrosion of 3003 Alclad in seawater with or without M.A.N. brush cleaning. Observation of the I.D. surface, however, revealed that the bulk of the corrosion attack in the M.A.N. brushed environment was localized corrosion at the inlet end, while corrosion in the control environment, without M.A.N. brushing, was uniform, general corrosion.

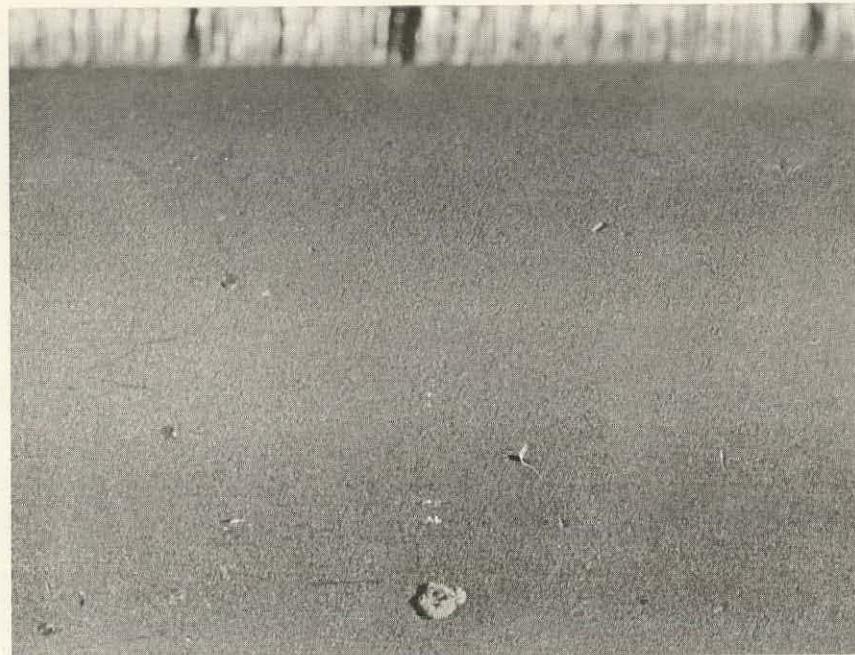
Figure 7. I.D. surface of 3003 Alclad control specimen (no cleaning) after a 3-month exposure. Note pitting corrosion.

Figures 7, 8 and 9 show the I.D. appearance of Alclad specimens from the three environments. Note the pitting corrosion in all environments and extensive erosion-corrosion in the brushed environments. Localized corrosion of 3003 Alclad in natural seawater is well documented.¹⁻⁴ The limited depths of pitting of 3003 Alclad tubing has also been observed in shipboard cooling system experiments.⁴

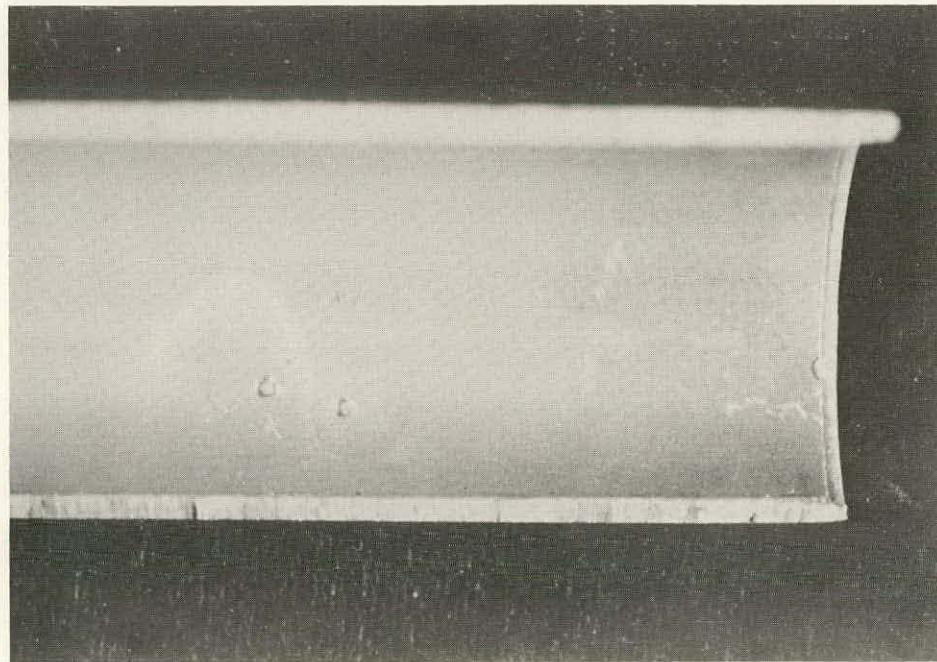
Figure 8. I.D. surface of 3003 Alclad M.A.N. brush cleaned specimen after a 7-month exposure.

Several M.A.N. brushes were briefly examined after three months of service. Figures 21 and 22 show the brush from the 3003 Alclad loop (without chlorination) compared with a similar size unused brush. (Figure 8 shows the I.D. surface of a tube specimen through which this brush passed during the test.) Although precise measurements of bristle length and overall brush diameter could not be made, Figure 21 shows that some bristle wear may have occurred. Note that the lengths of the bristles appear to be more uneven in the exposed brush. Also, the overall diameter seems to have decreased somewhat as determined by the length of bristle which is visible outside the end plate of the brush.

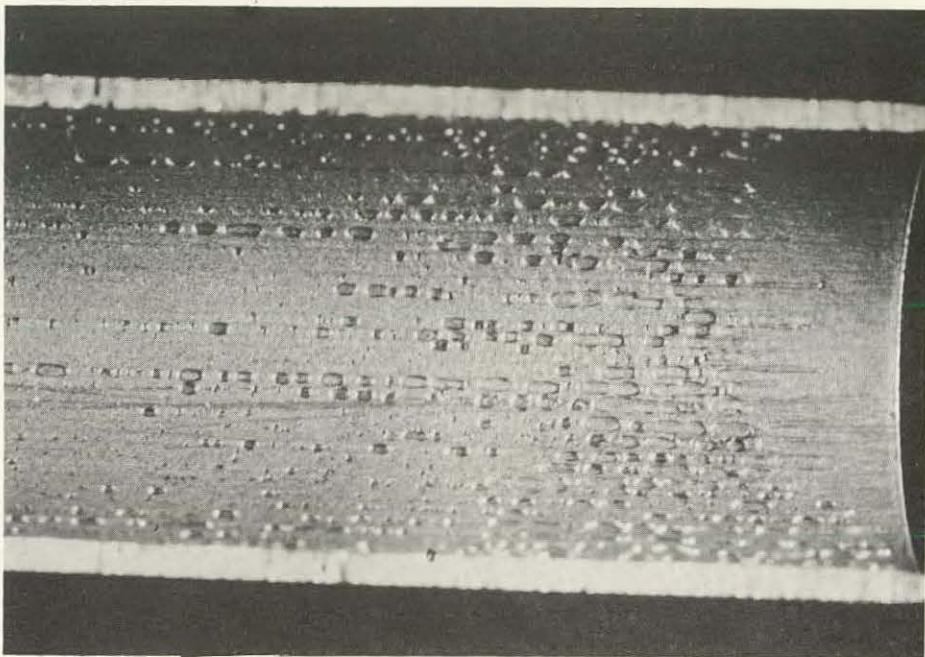
Figure 9. I.D. surface of 3003 Alclad M.A.N. brush cleaned + 0.1 mg/L chlorination specimen after a 7-month exposure. Note erosion-corrosion attack. 2.7X Magnification. Neg. No. S-1842

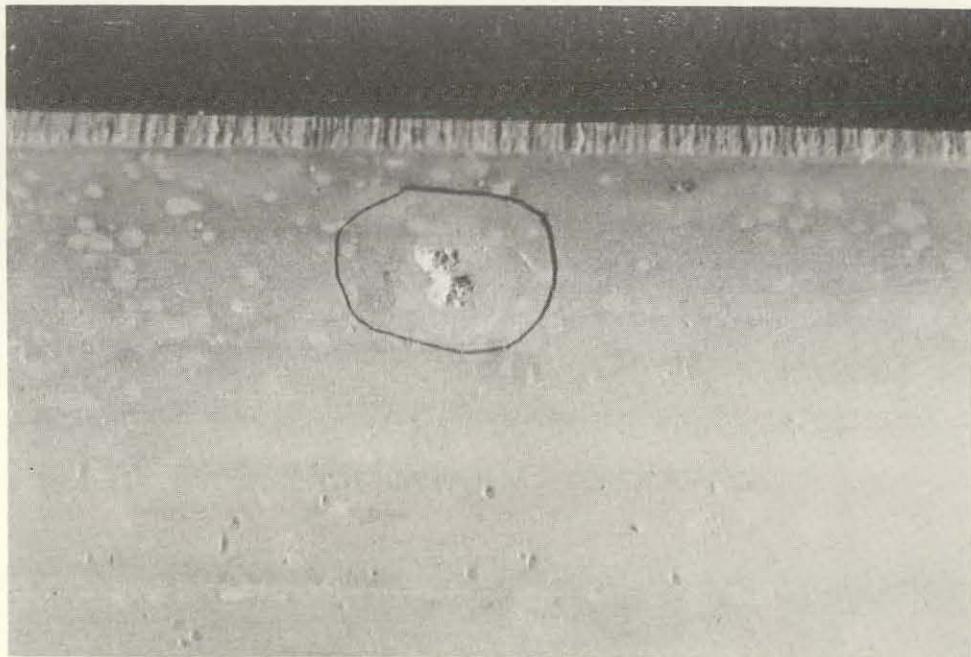
Figure 10. I.D. surface of 5052 aluminum control specimen (no cleaning) after a 7-month exposure. Note pitting corrosion. 3X Magnification. Neg. No. 80166-7

5052 showed localized attack similar to Alclad. Figures 10, 11, and 12 show the I.D. appearance of 5052 specimens from the three environments. Pitting corrosion is evident in all environments. In the brushed environments, the pitting morphology is more elongated, or striated, showing the erosion-corrosion influence of the brush cleaning. Pitting of 5052 aluminum has also been documented in the literature.^{1,2,5} The effect of various seawater variables on pitting of 5052 has been reported by Dexter.⁵

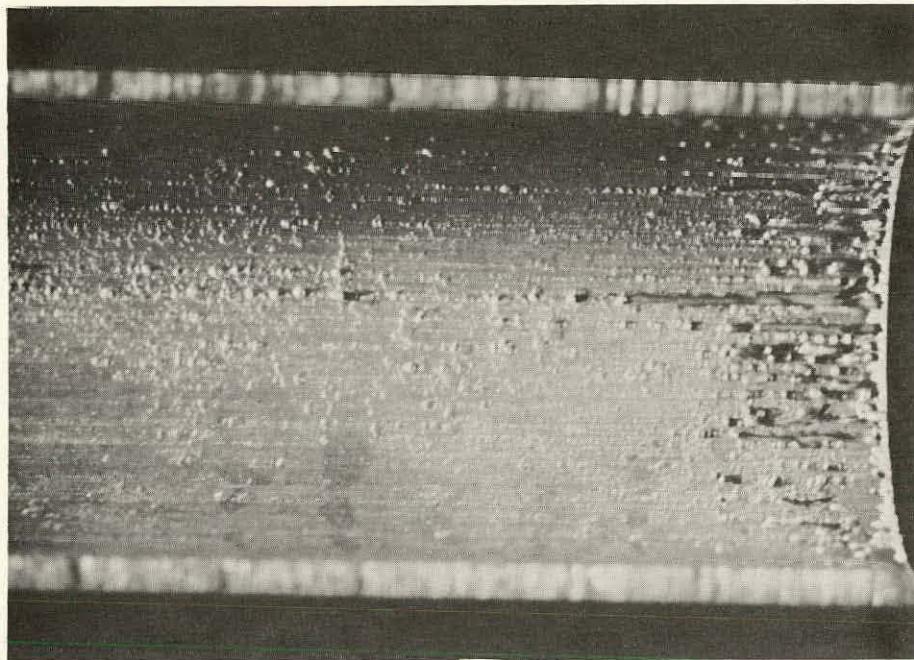
Figure 11. I.D. surface of 5052 aluminum M.A.N. brush cleaned specimen after a 7-month exposure.
Note erosion-corrosion attack.
2.7X Magnification. Neg. No. S-1845

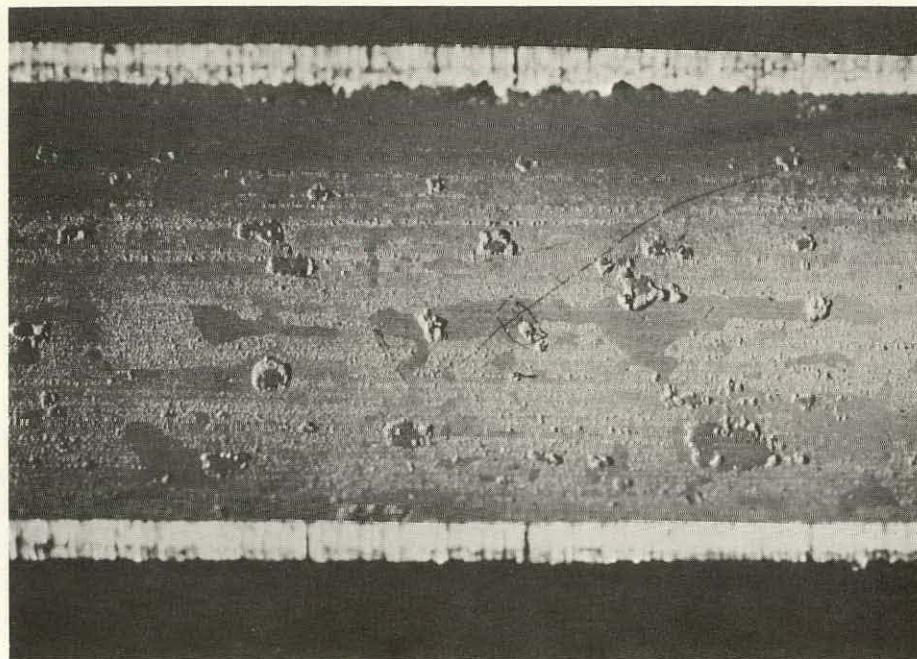
Figure 12. I.D. surface of 5052 aluminum M.A.N. brush cleaned + 0.1 mg/L chlorination specimen after a 7-month exposure. Note erosion-corrosion and pitting attack.
2.7X Magnification. Neg. No. S-1847

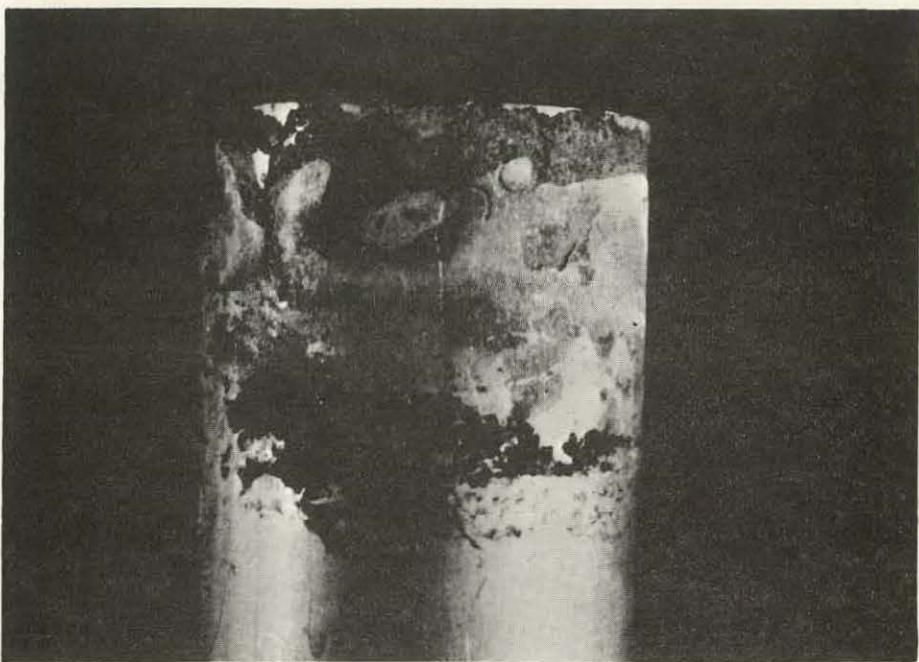
Figure 13. O.D. surface of 5052 aluminum control specimen (no cleaning) after a 7-month exposure, showing crevice corrosion under flexible connector.
2.4X Magnification. Neg. No. S-1844

Figure 13 shows crevice corrosion of 5052 on the O.D. under the flexible vinyl tubing connector to a maximum depth of over 20% of the wall thickness. Only one case of crevice corrosion was observed, but like pitting corrosion, crevice corrosion of 5052 is also well documented.^{1,2}

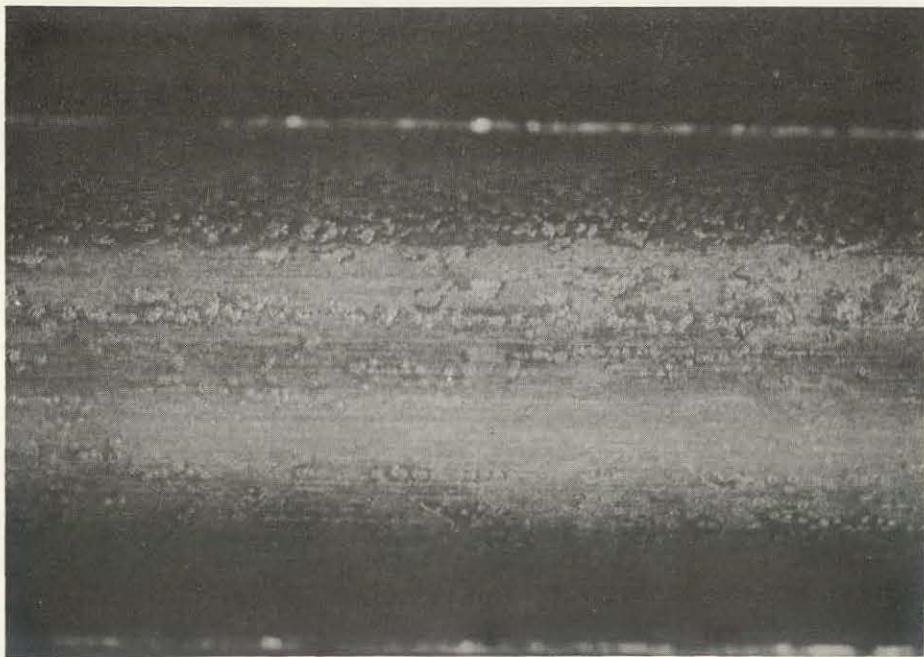
Figure 14. I.D. surface of C70600 control specimen (no cleaning) after a 7-month exposure.
2.8X Magnification. Neg. No. S-1848

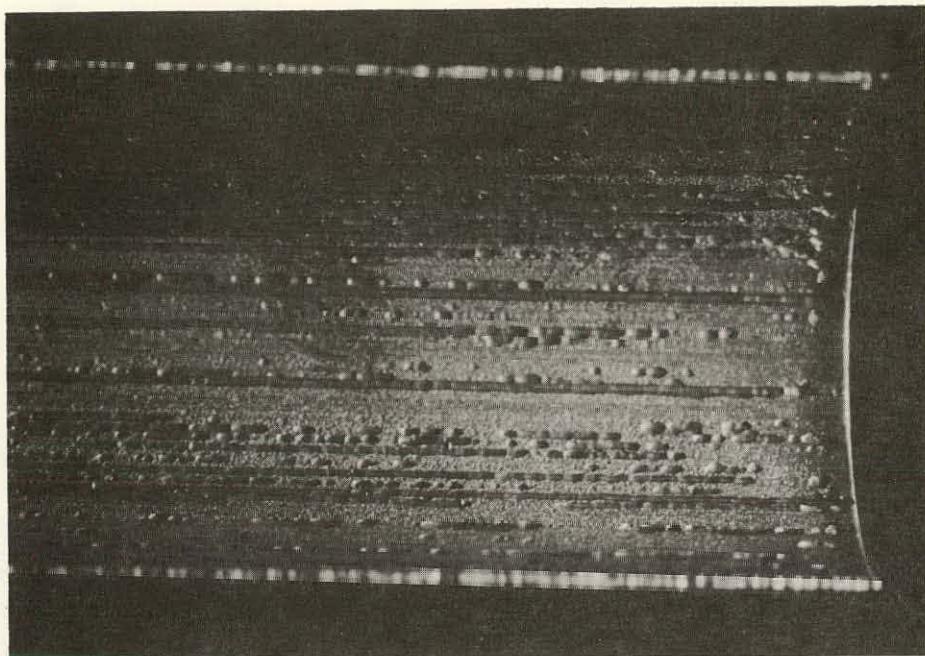
Figure 15. I.D. surface of C70600 M.A.N. brush cleaned specimen after a 7-month exposure. Note erosion-corrosion attack.

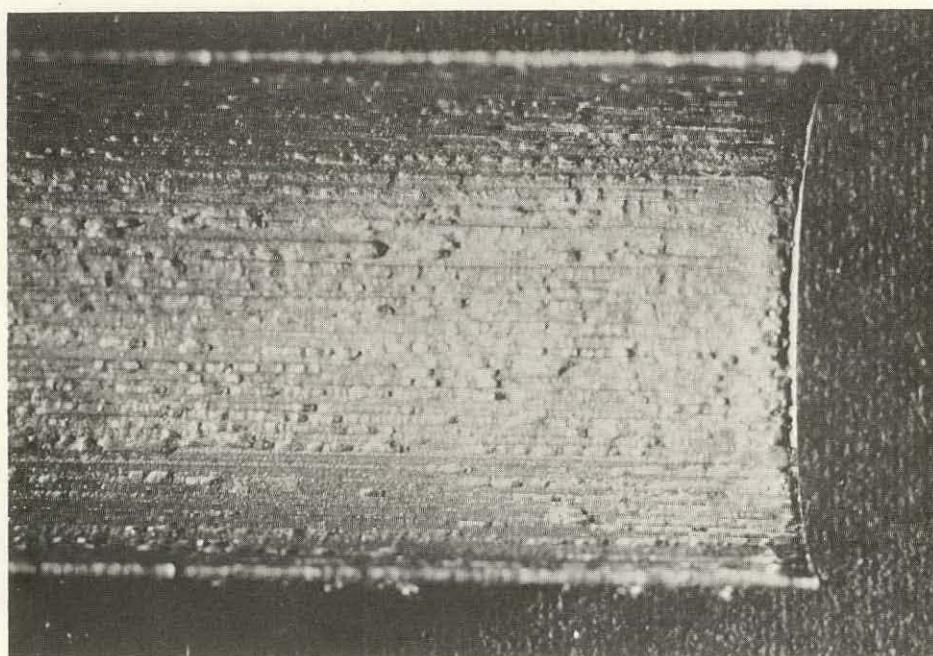
Figure 16. I.D. surface of C70600 M.A.N. brush cleaned + 0.1 mg/L chlorination specimen after a 7-month exposure. Note somewhat less attack than Figure 15.

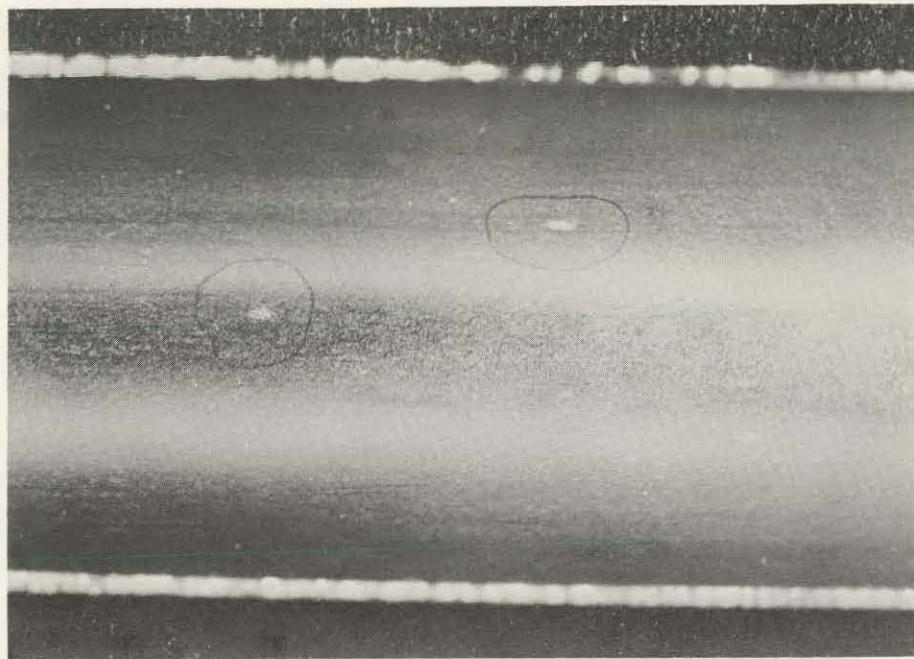
Figure 17. I.D. surface of AL-6X M.A.N. brush
cleaned + 0.1 mg/L chlorination specimen
after a 7-month exposure, showing typical
limited pitting nucleation.
2.7X Magnification. Neg. No. S-1855

As indicated in Tables V and VI, AL-6X showed only slight pitting on the tube I.D. Figure 17 shows the typical appearance of this very limited pitting. This attack was observed in all three environments and is, therefore, not related to the brush cleaning.

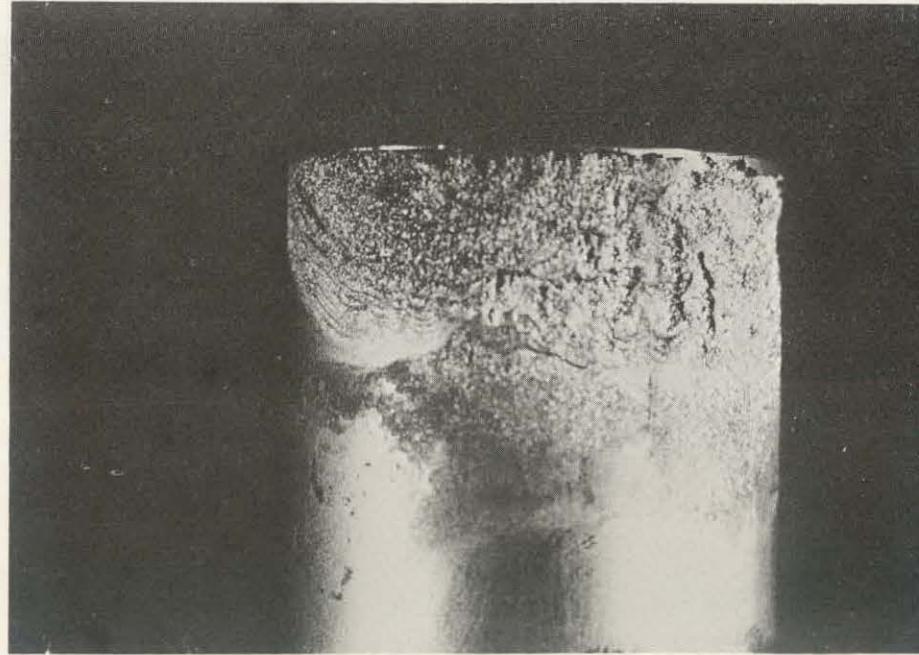
Figure 18. O.D. surface of AL-6X control specimen (no
cleaning) after a 7-month exposure, showing
severe crevice corrosion under flexible
connector.
2.5X Magnification. Neg. No. S-1852

Like 5052 aluminum, discussed earlier, AL-6X was subject to extensive crevice corrosion on the O.D. The crevice was created by the flexible vinyl tubing connection. This crevice, with a very small gap and a large depth, can create local conditions of low oxygen and low pH that can result in a corrosion attack. Figure 18 shows the most severe case of crevice corrosion observed of which perforated the tube wall. It should be pointed out that this crevice geometry represents a very severe condition may not be encountered in a heat exchanger. Crevice corrosion, to some extent, was observed on the O.D. surfaces of all six specimens of AL-6X exposed for 7 months. The other crevice sites were much less severely attacked than that shown in Figure 18. Figure 19 is representative of these less severely attacked sites.

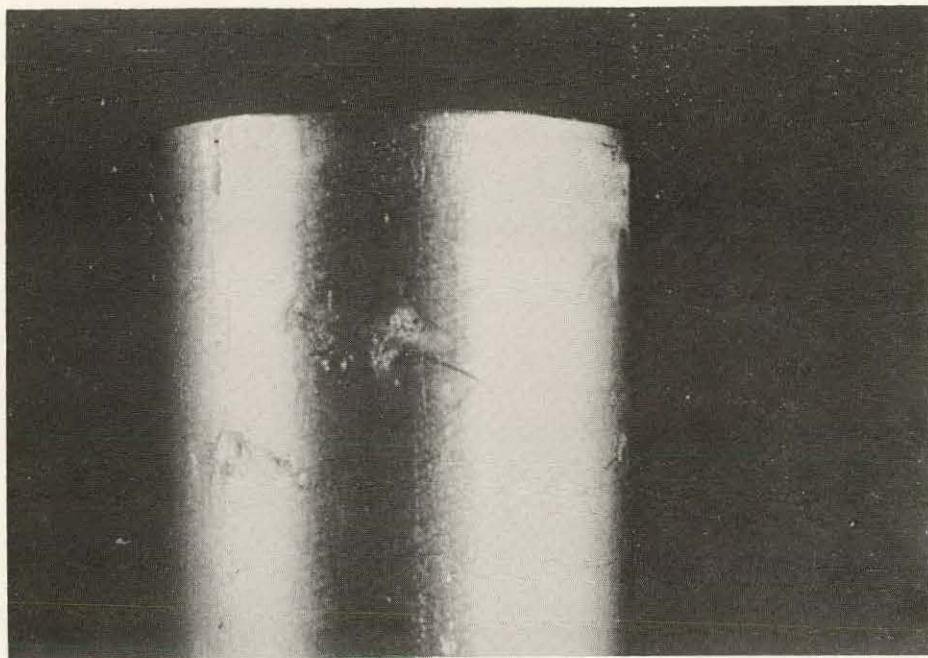
Figure 19. O.D. surface of AL-6X M.A.N. brush cleaned
after a 7-month exposure, showing typical
crevice corrosion under flexible connector.
2.5X Magnification. Neg. No. S-1854

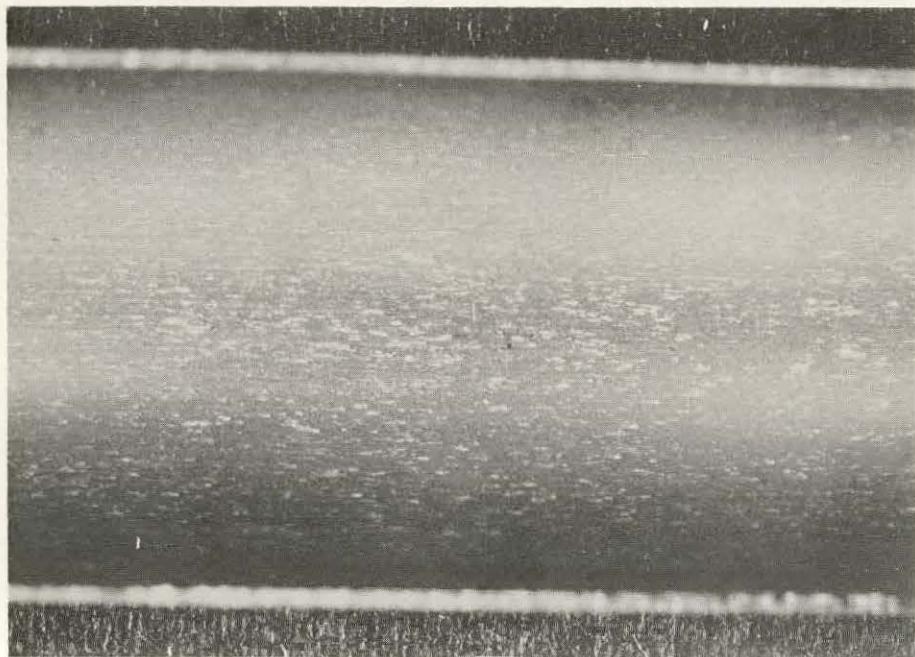
Figure 20. Typical titanium specimen after test exposure.
Light areas are pre-existing artifacts and not
corrosion attack.
2.8X Magnification. Neg. No. S-1856

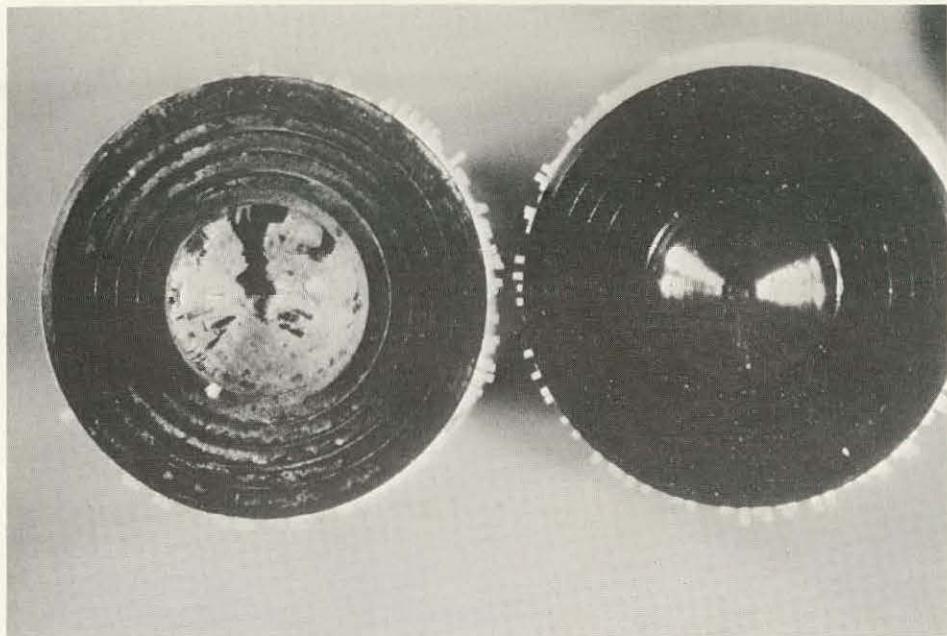
Figure 21. End view of M.A.N. brush from 3003 Alclad loop (no Cl_2) after a 3-month operation (left) and similar unused brush (right).

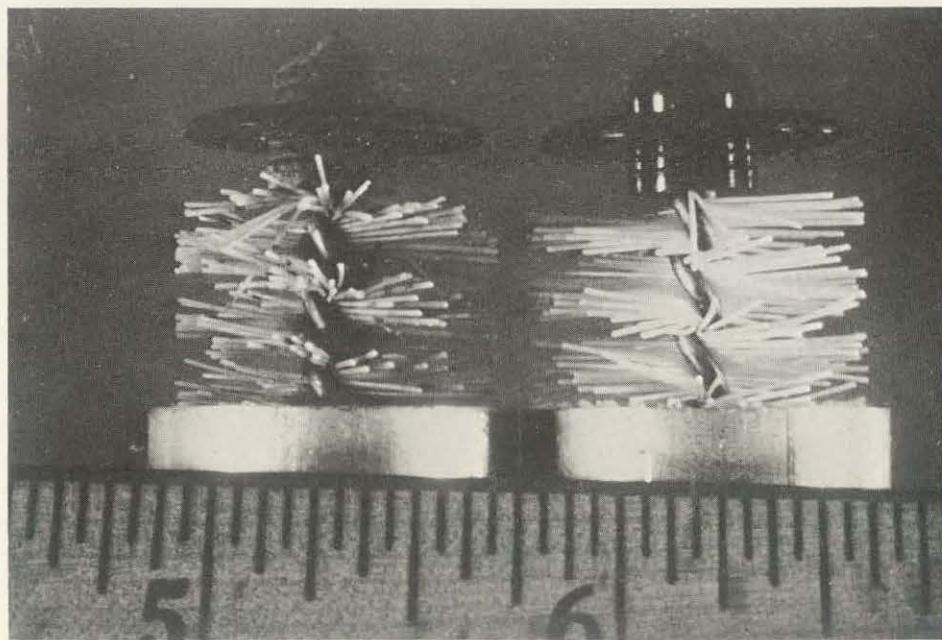
Figure 22. Same as Figure 21 but side view.

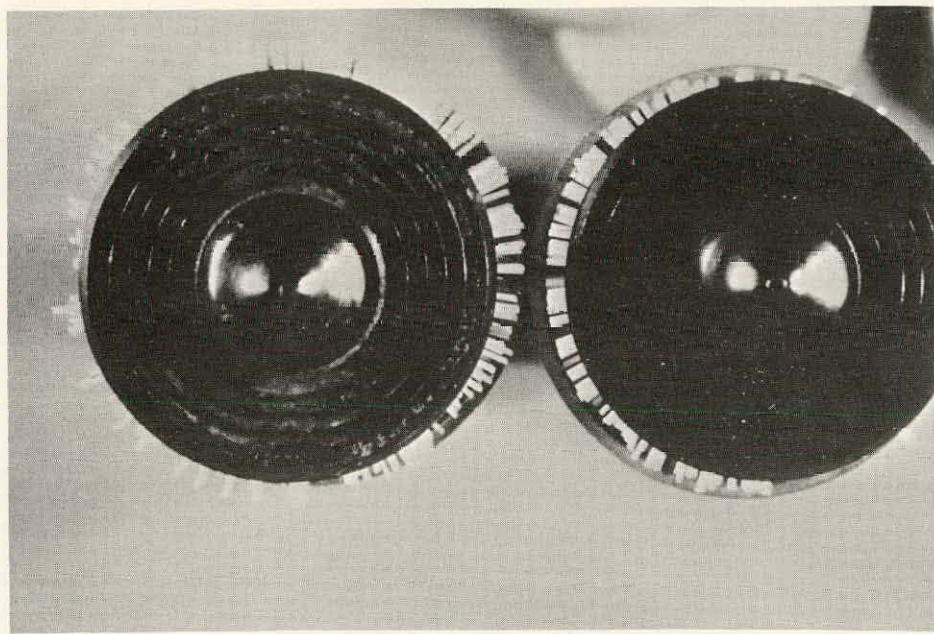
Figure 23. End view of M.A.N. brush from C70600 loop
(no Cl_2) after 3 months operation (left) and
similar unused brush (right).

Figure 23 shows the brush from the C70600 loop (without chlorination) compared with a similar size unused brush. In contrast with the 3003 Alclad brush in Figure 21 and 22, the brush in Figure 23 appears to have grown in overall diameter during the test. This increase in overall diameter is apparently due to the bristles being pulled from the spiral wire core by excessive mechanical/frictional forces imposed upon the brush bristles by the very rough tubing I.D. surfaces. As shown in Figure 15, the I.D. surface of the tube specimens contacted by this brush have been roughened by erosion-corrosion.
