# Characterization of Irradiated Zircaloys: Susceptibility to Stress Corrosion Cracking

NP-1557  
Research Project 1027

Final Report, October 1980

ARGONNE NATIONAL LABORATORY  
9700 South Cass Avenue  
Argonne, Illinois 60439

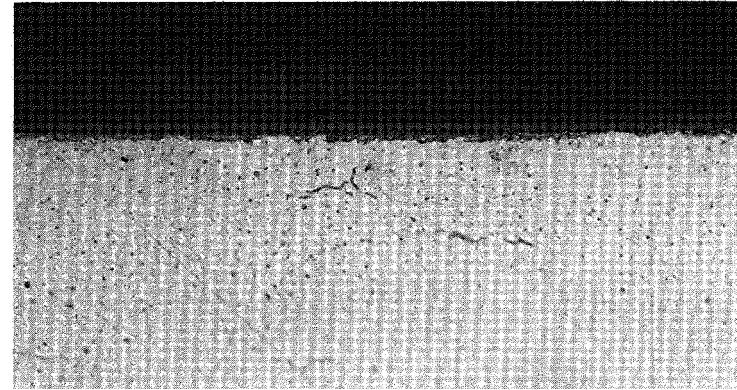
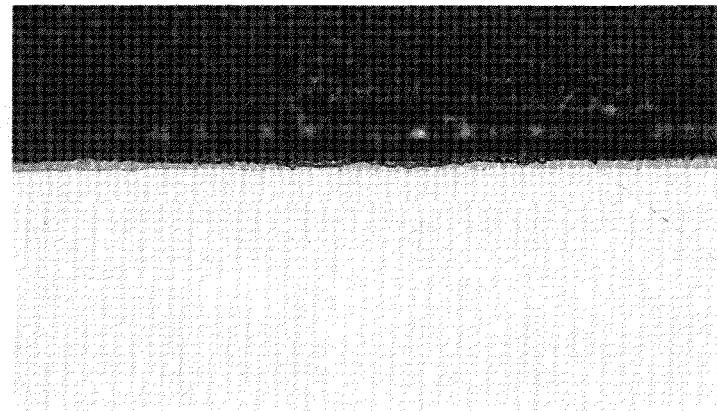
Fig. 2-1. Inner-surface oxide on high burnup BRP cladding: (a) ID oxide on low-fission-gas-release rod 165E, (b) ID oxide on high-fission-gas-release rod 165F.

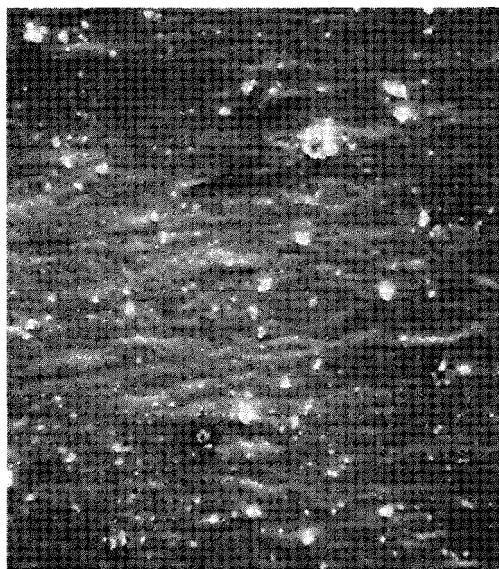
Fig. 2-2. Typical surface appearance of BRP cladding from low-gas-release rod 165U.

The cladding from rod 165U (low gas release) exhibited relatively clean areas as well as areas covered by particles composed of uranium and zirconium, as shown in Fig. 2-2. Wormlike growths were observed in isolated areas. In contrast, cladding from rod 165AG (high gas release) exhibited a wide range of deposit formations and compositions. Typical features of the surface are shown in Fig. 2-3. Figure 2-3a shows beads at the edge of a smooth film that covers much of the surface. This film is composed primarily of uranium, with small amounts of zirconium, cesium, and possibly tellurium. Figure 2-3b shows the wormlike growths that are observed in most irradiated samples. Several types of deposits containing iodine were also observed on the inner surface, as shown in Fig. 2-4. The deposit shapes are elongated (Fig. 2-4a), spherical (Fig. 2-4b), needlelike (Fig. 2-4c), and rodlike (Fig. 2-4d). The elemental composition of these deposits is primarily cesium and iodine with smaller amounts of zirconium and uranium.

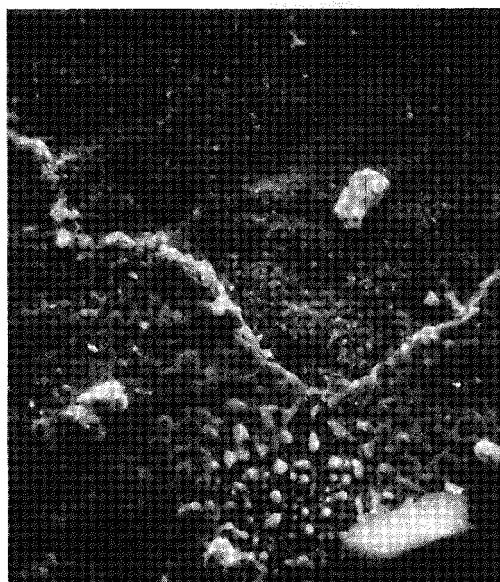
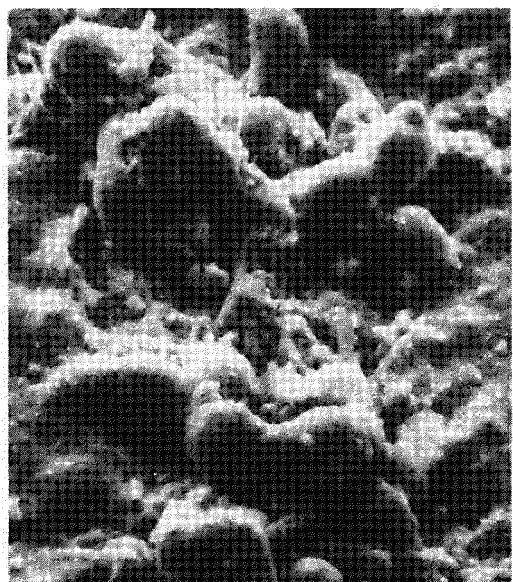
Fig. 2-3. Inner-surface appearance of BRP cladding from high-gas-release rod 165AG.

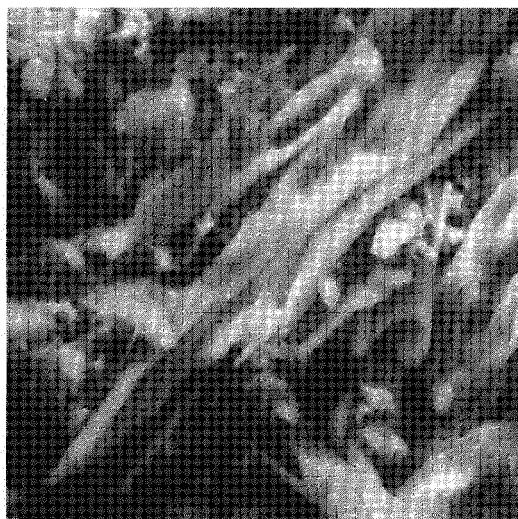
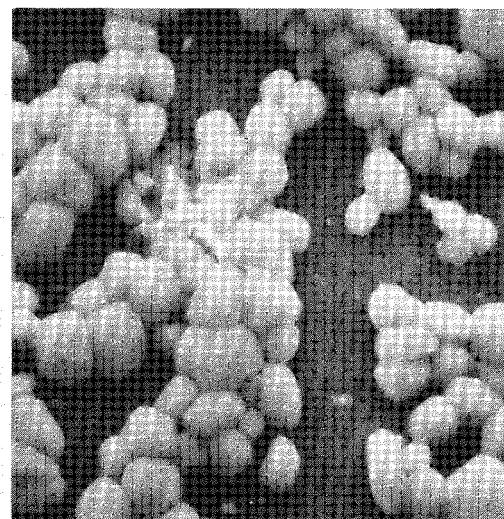
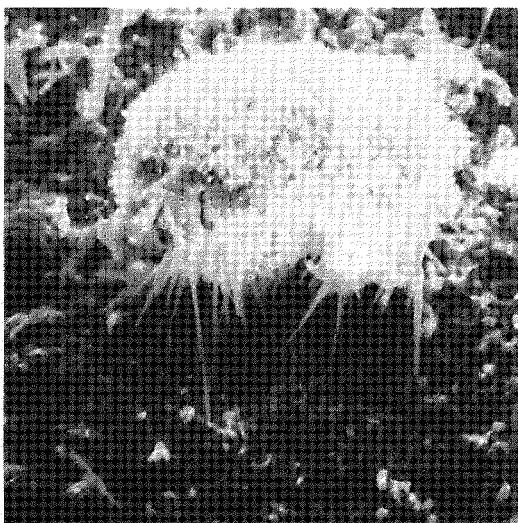
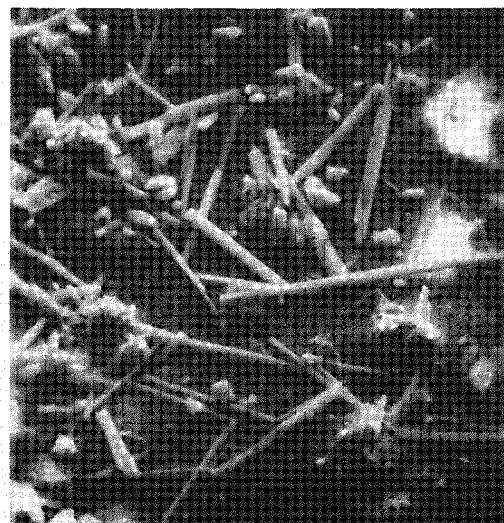
Fig. 2-4. Iodine-cesium deposits observed on inner-surface of BRP cladding from high-gas-release rod 165AG. (a) elongated, (b) spherical, (c) needle-like, and (d) rod-like.

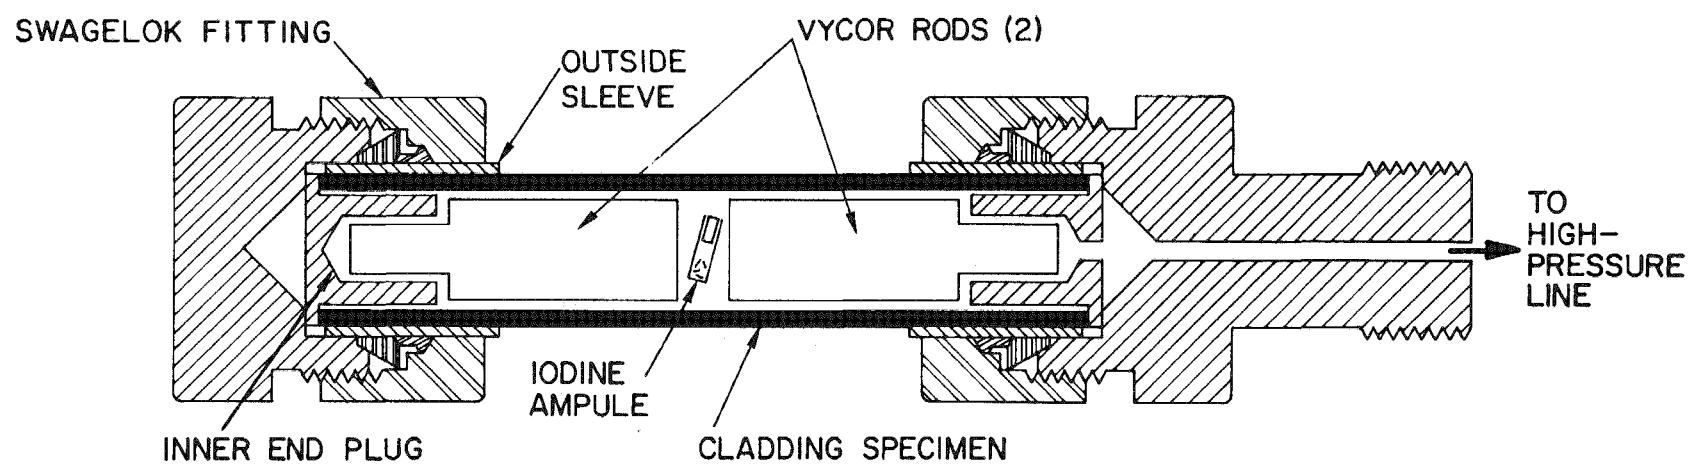
Fig. 3-1. Cutaway schematic drawing of specimen-sealing method and location of internal specimen components.

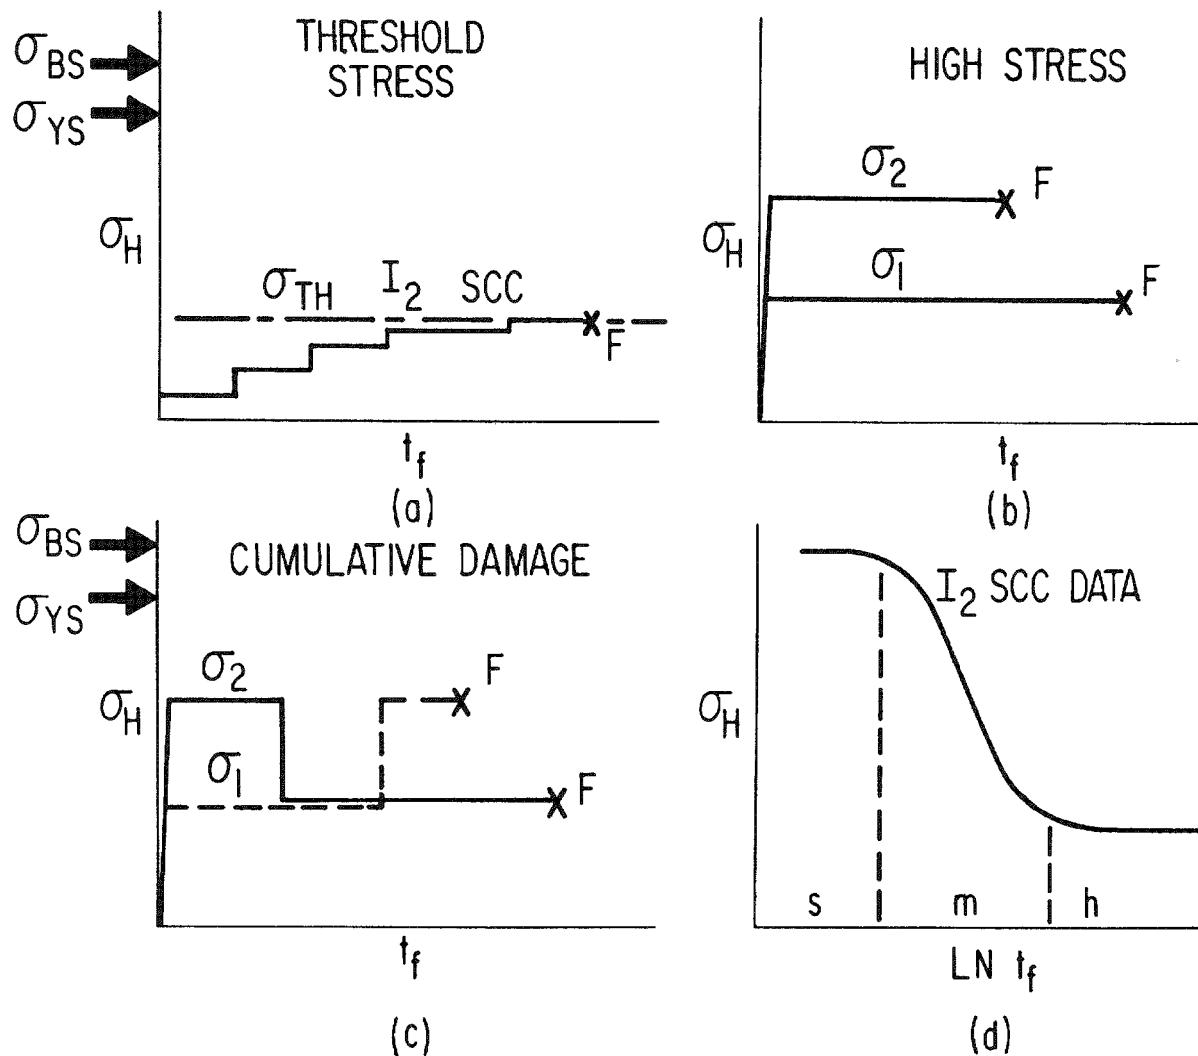
Fig. 3-2. Schematic representations of pressurizing sequences used in SCC tests and the resultant data plot: (a) pressure-step tests to determine  $\sigma_{th}$ . (b) tests to determine steep portion of  $I_2$  SCC curve. (c) tests to determine damage accumulated in upward and downward power ramps, (d) complete  $I_2$  SCC curve.

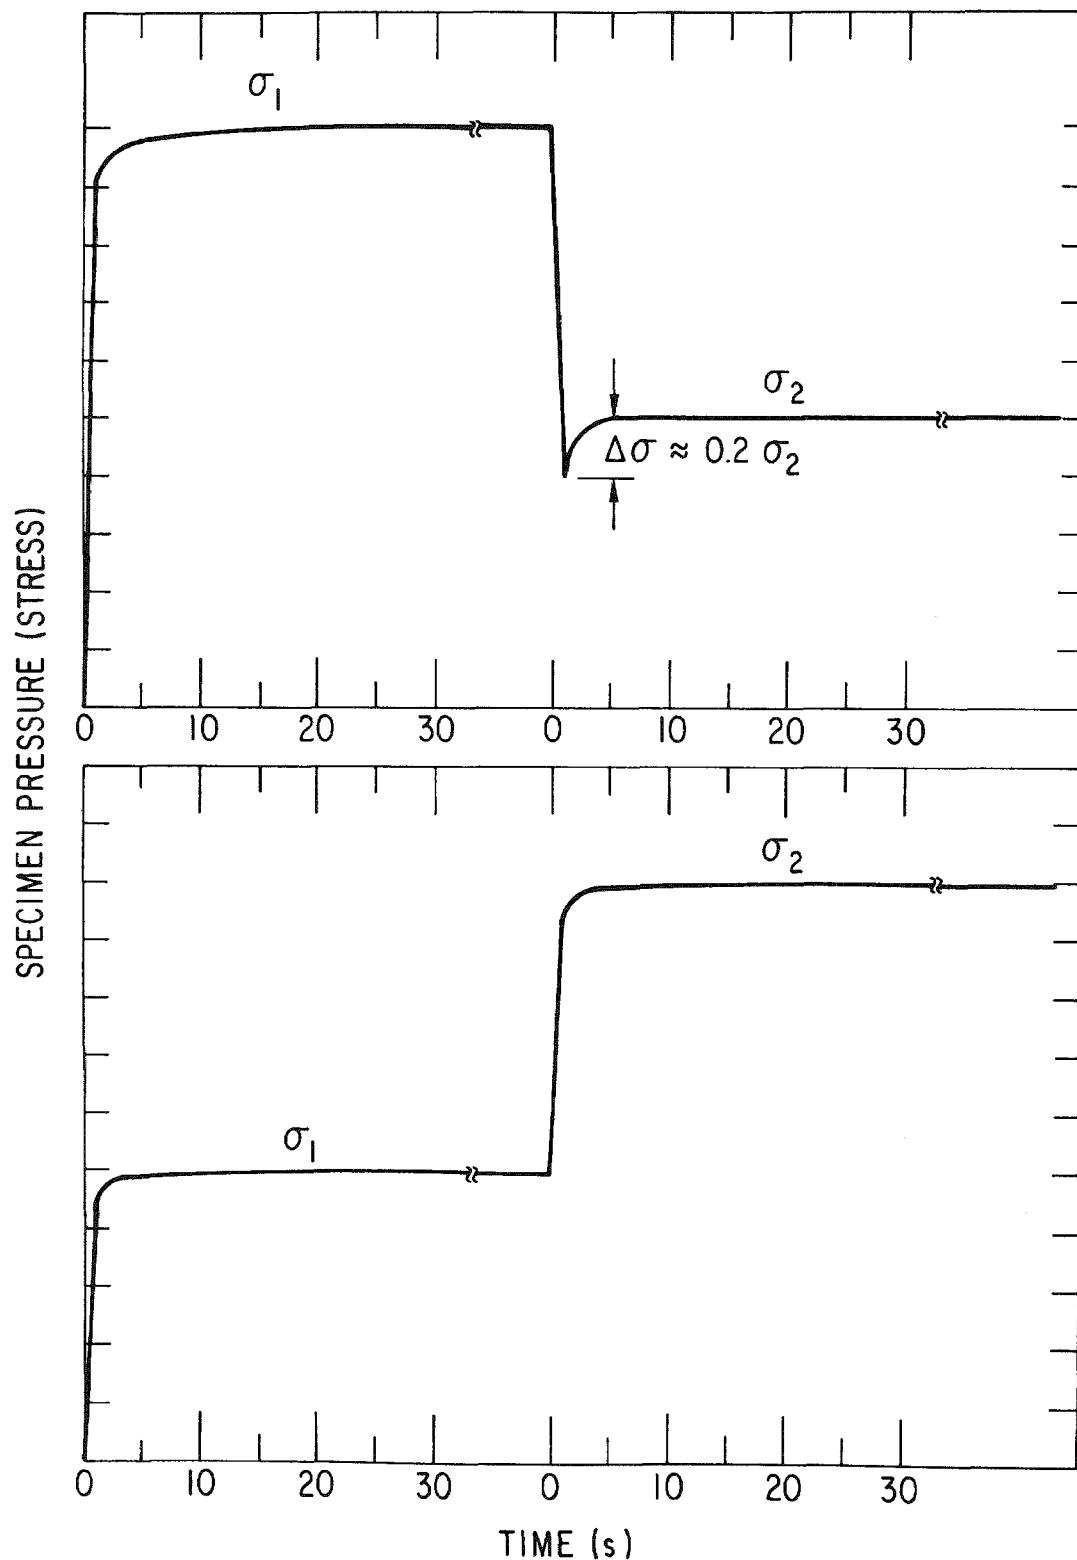
Fig. 3-3. Schematic representation of experimentally achieved stress (pressure) decrements and increments in cumulative-damage tests. (a) top-stress decrement. (b) bottom-stress increment.

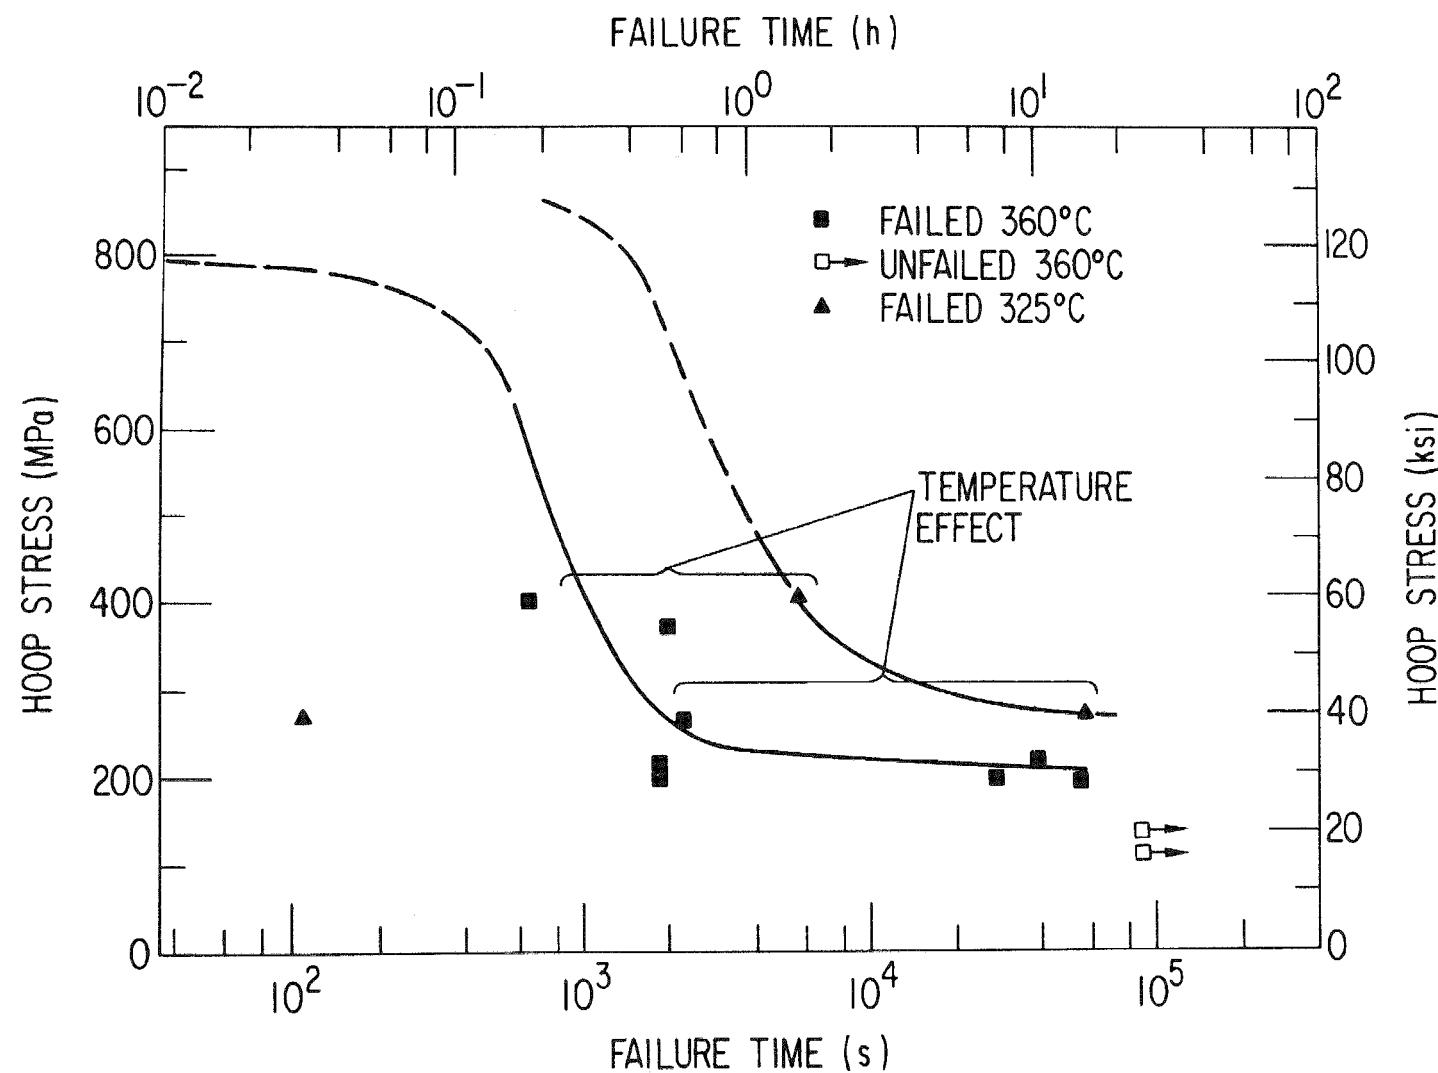
Fig. 4-1. Results of Iodine SCC Tests on Irradiated HBR Cladding at 598 and 633 K.

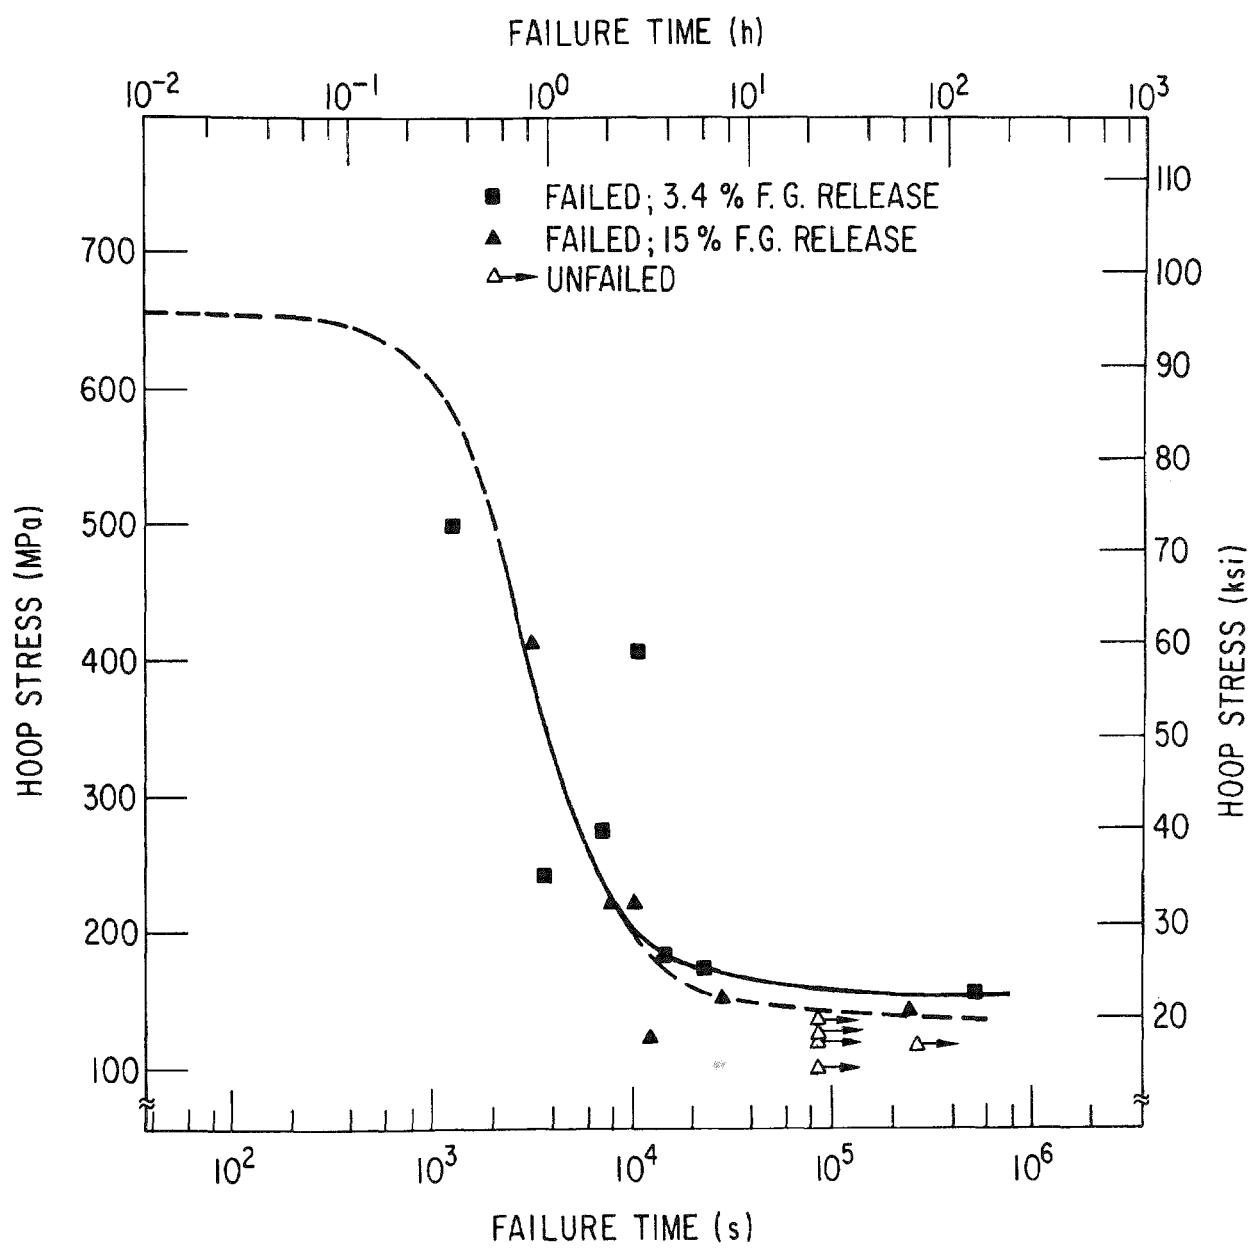
Fig. 4-2. Results of iodine SCC tests at 598 K on high-burnup BRP cladding from high- and low-fission-gas-release fuel rods.

Figure 4-2 also indicates that the SCC curves for high- and low-fission-gas-release cladding from high-burnup BRP fuel rods tend to merge into one SCC curve for hoop stresses above 221 MPa (32.1 ksi). The stress level at which a merger of the two SCC curves appears to occur is established by the SCC test results for duplicate specimens 165AG-19 and -20 given in Table 4-3. Both specimens were tested at a hoop stress of 221 MPa, and their corresponding failure times were  $1.06 \times 10^4$  and  $8.10 \times 10^3$  s (2.95 and 2.25 h).

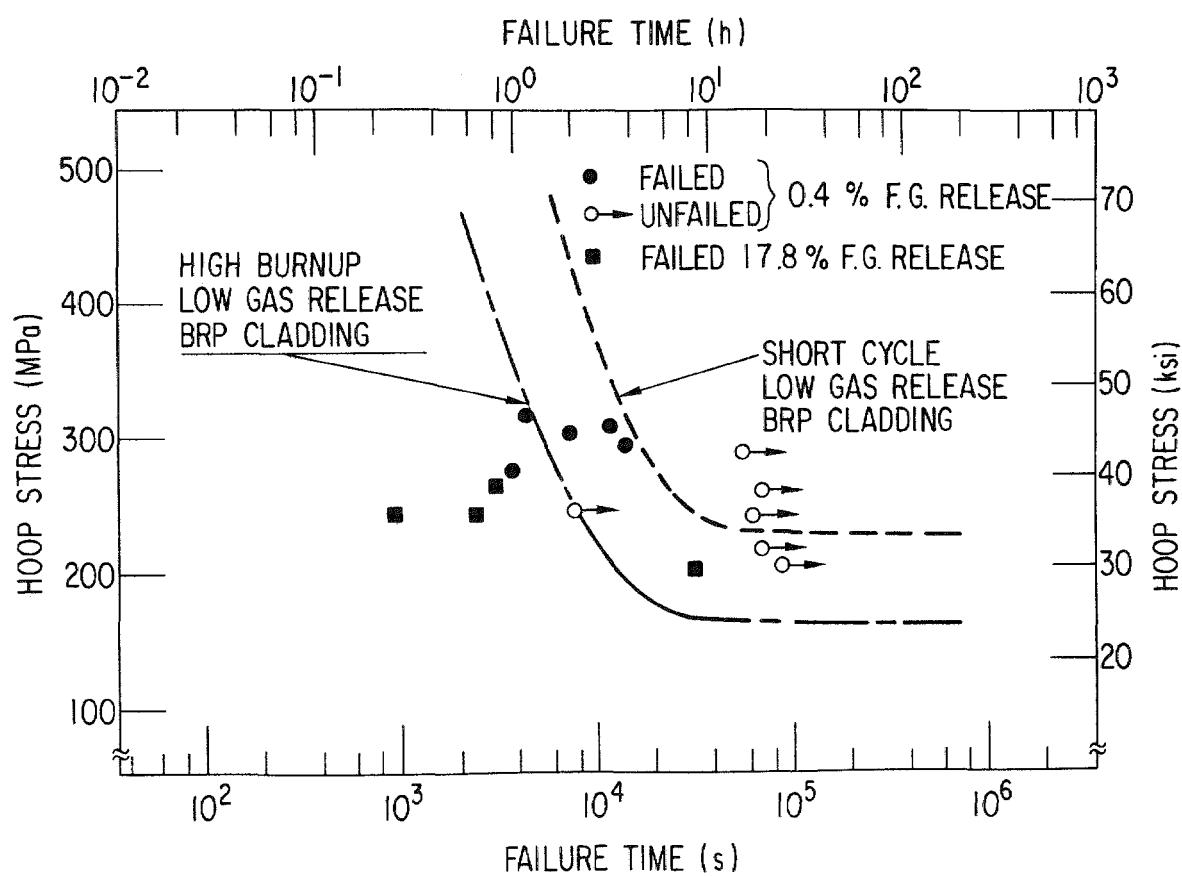
Fig. 4-3. Results of iodine SCC tests on medium-burnup BRP cladding at 598 K.

The finding of the fission-product release effect on the high-burnup BRP cladding prompted the limited testing of cladding from high-gas-release, medium-burnup rod JJ400002, to determine the threshold-stress value, the test results at 598 K (325°C) are listed in Table 4-5. The cladding fluence is estimated to be between 0.6 and  $1.0 \times 10^{21}$  n/cm<sup>2</sup> ( $E > 0.1$  MeV) at a reported burnup of  $\sim 8$  MWd/kg U. Fission-gas release was calculated to be about 17.8%. Data points for the four SCC tests conducted on this cladding (specimens 165F-7, -9, -10, and -11) are plotted as the solid squares in Fig. 4-3.

The four data points for this cladding indicate that the threshold stress is indeed lowered by the presence of extensive fission-product deposition on the cladding surface. The threshold stress appears to be in the vicinity of 200 MPa (29 ksi), compared with 280 MPa (40.6 ksi) for the low-gas-release cladding. This difference is significantly greater than what was found for low and high-gas-release high-burnup cladding, suggesting that the effect is either minimized at higher burnup or that different mechanisms are responsible for the effects. Note also that the high-stress regime of the curve would have shorter times to failure than the low-gas-release cladding.

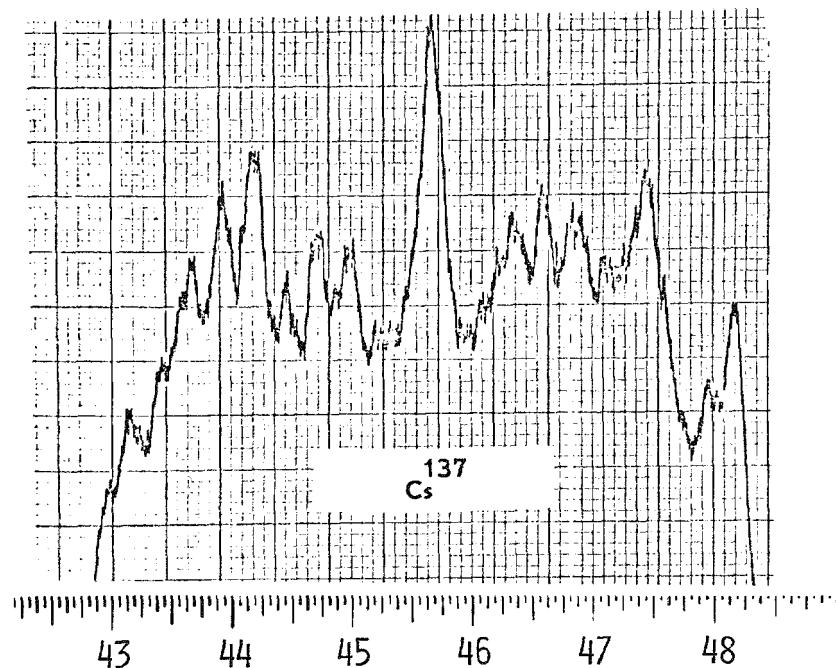
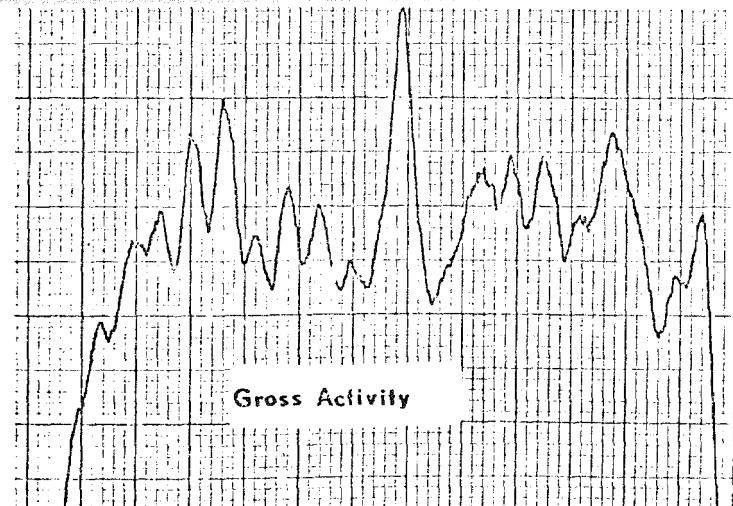
Fig. 4-4.  $\text{Cs}^{137}$  Profile in specimen 165F-9 from a medium-burnup, high-gas-release BRP fuel rod.

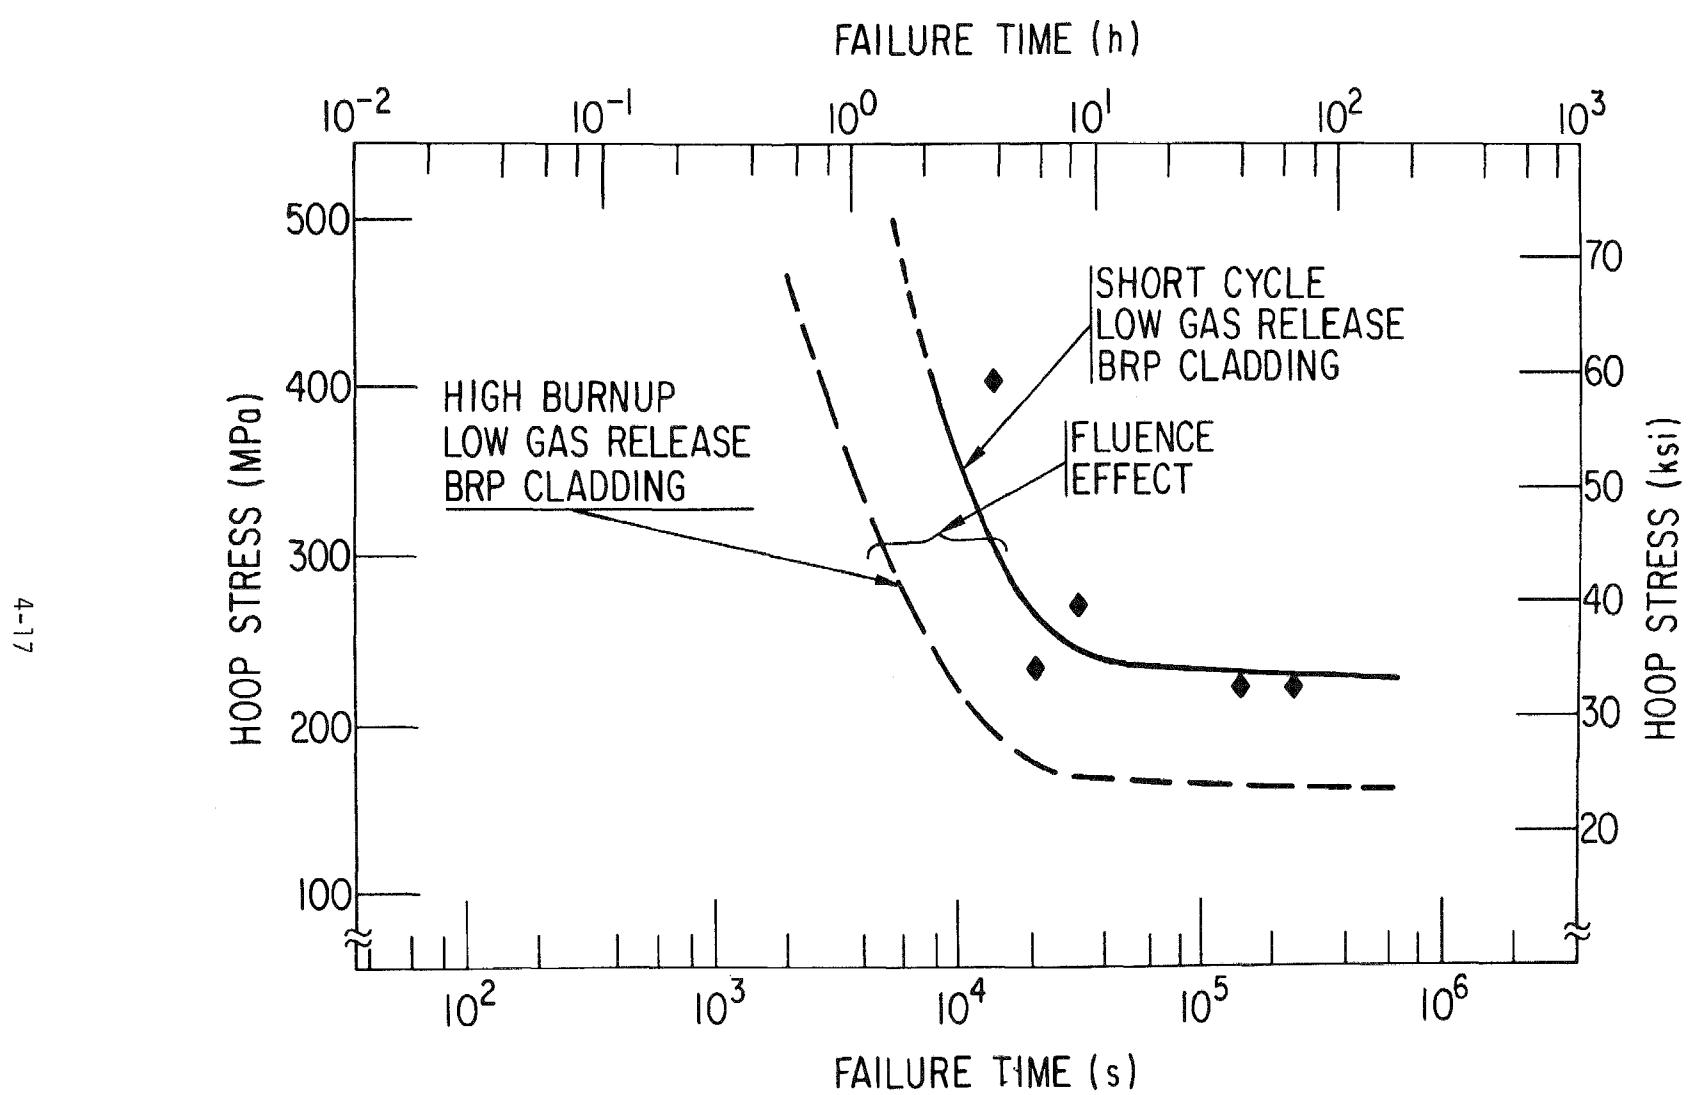
Fig. 4-5. Results of iodine SCC tests on low-burnup BRP cladding at 598 K.

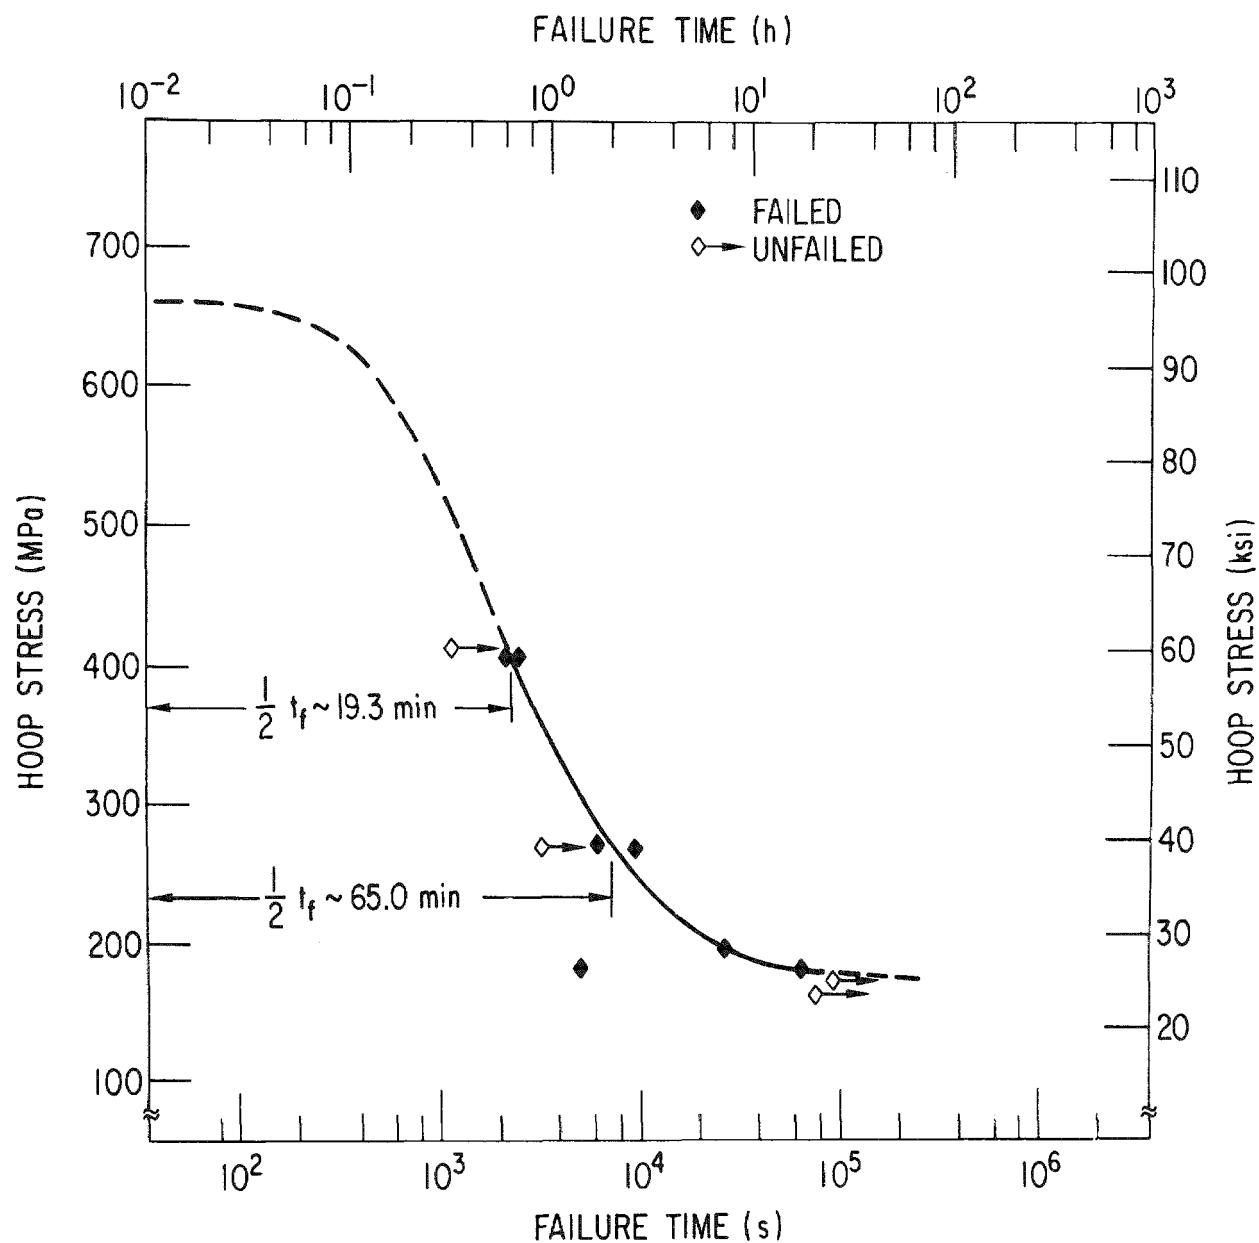
Fig. 4-6. Results of iodine SCC tests on irradiated QC cladding at 598 K illustrating the manner in which cumulative-damage-test parameters were established.

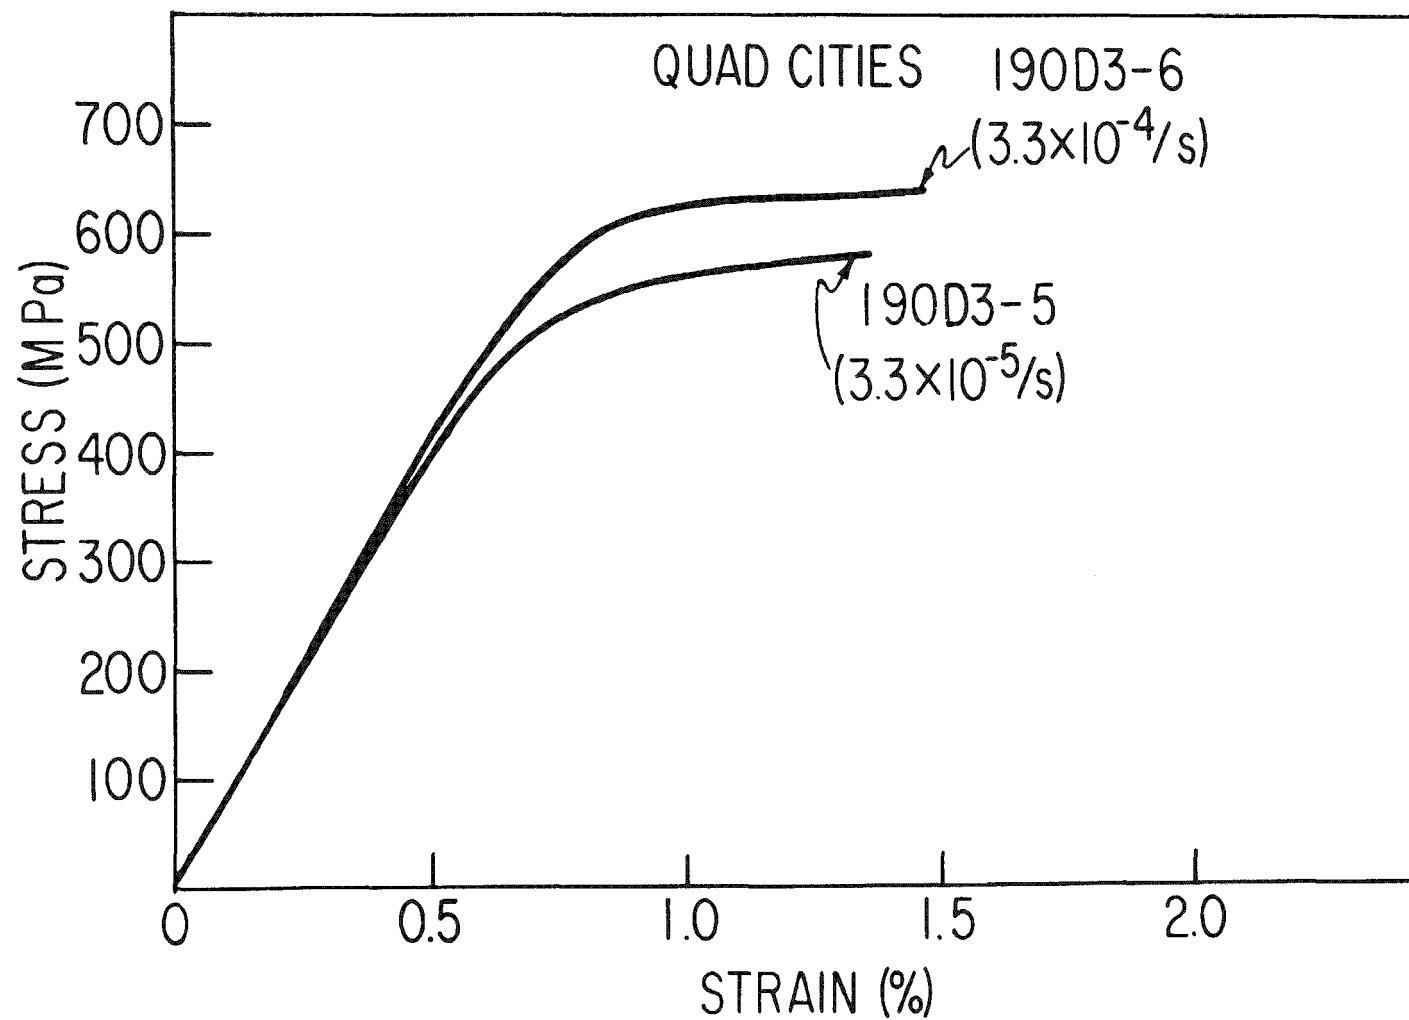
Fig. 4-7. Stress-strain curves for QC specimens tested at 325°C.

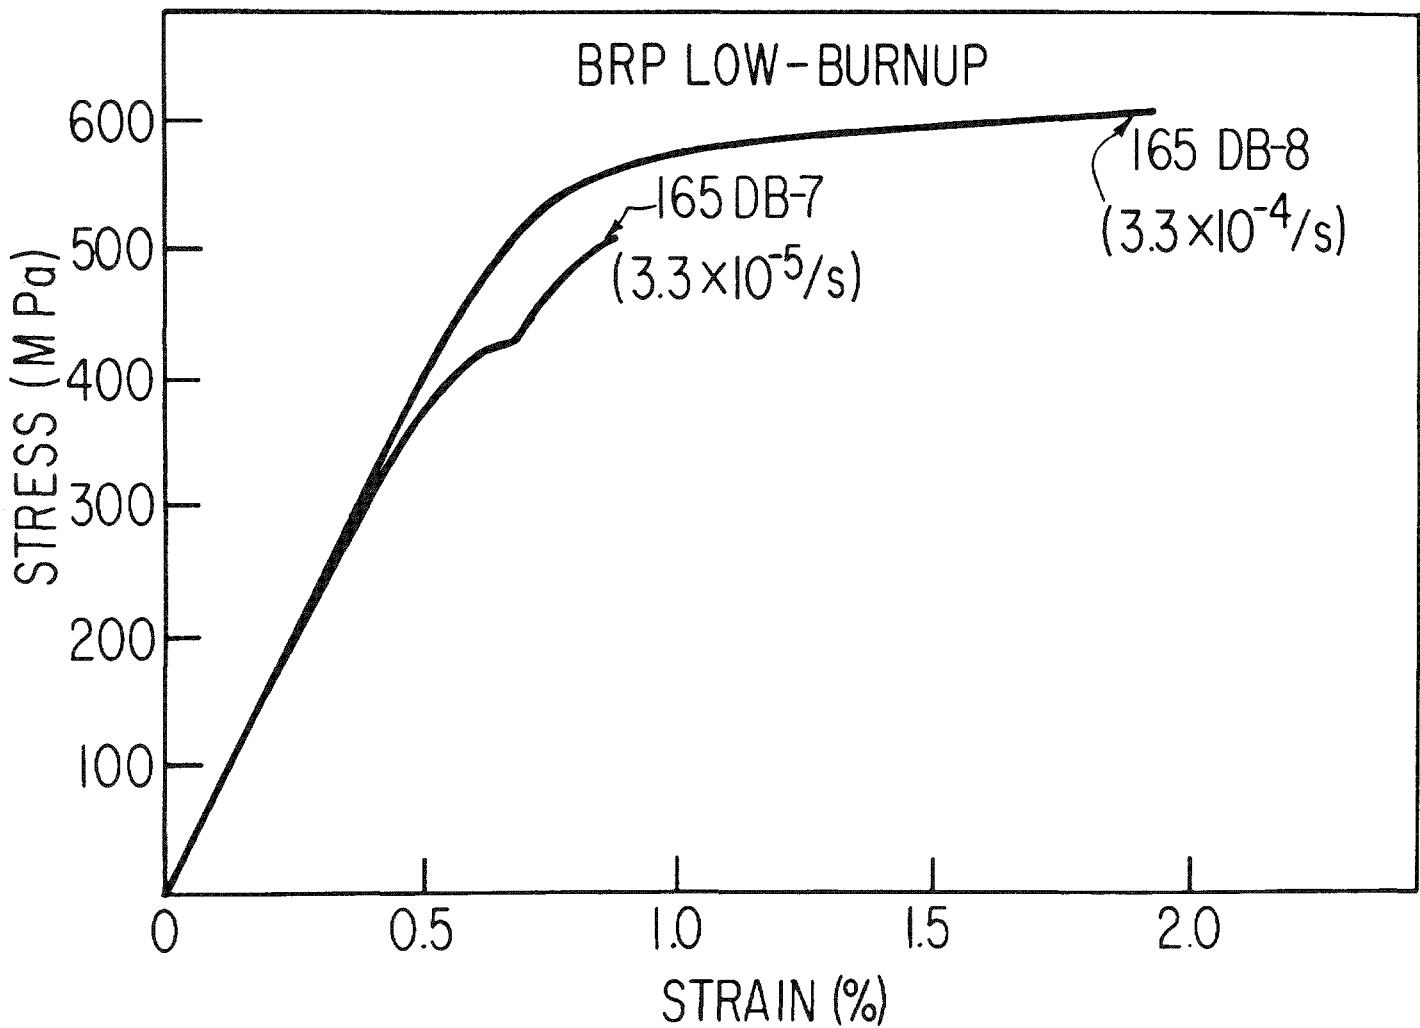
Fig. 4-8. Stress-strain curves for low-burnup BRP specimens tested at 325°C.

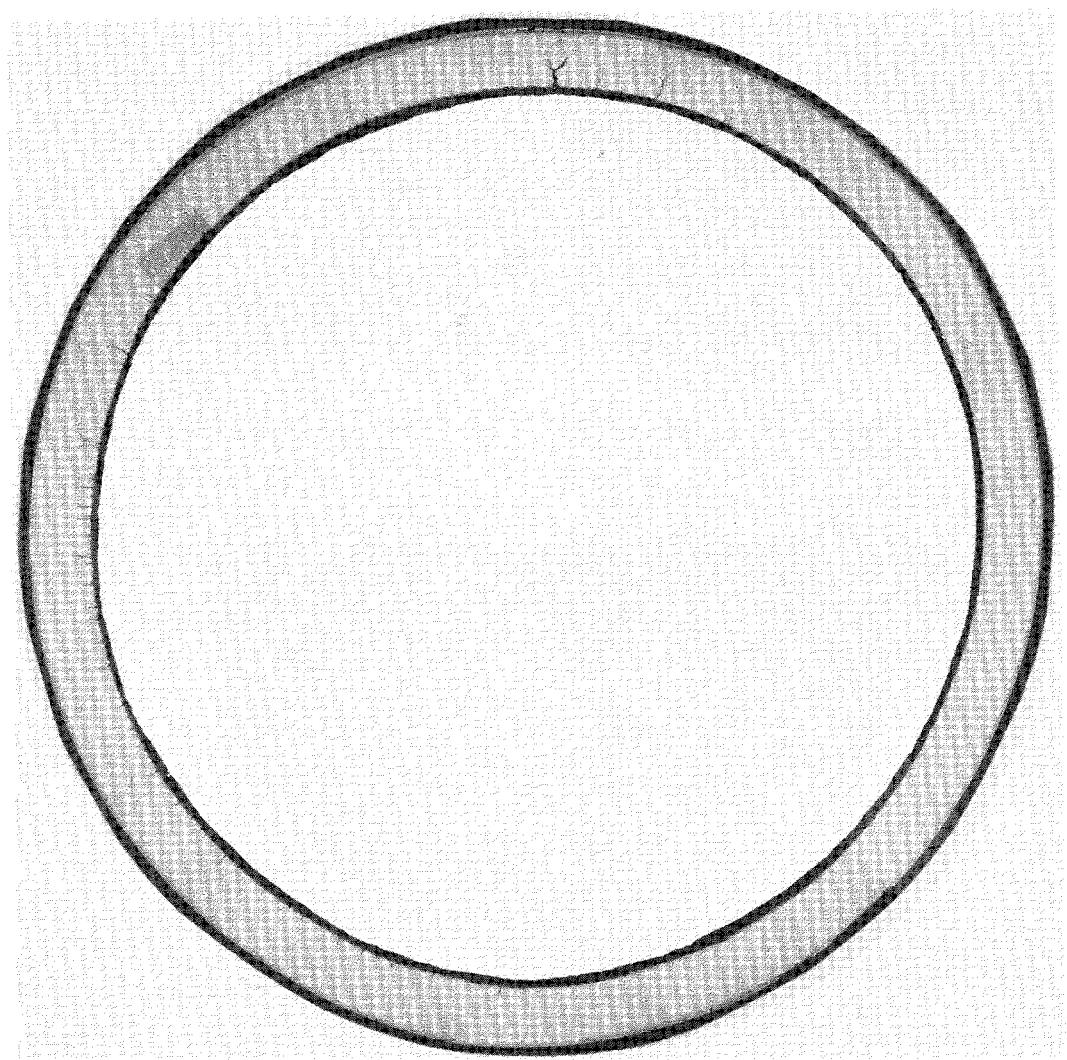
Fig. 4-9. Cross section of HBR specimen 155BC7 showing SCC cracks (15X).

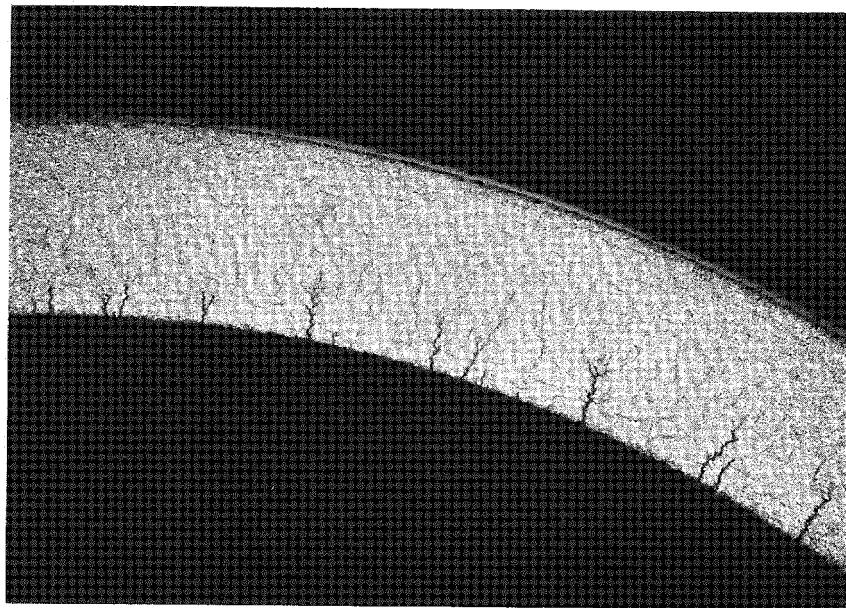
Fig. 4-10. Cross section of HBR specimen 155BC7 showing SCC cracks (50X).

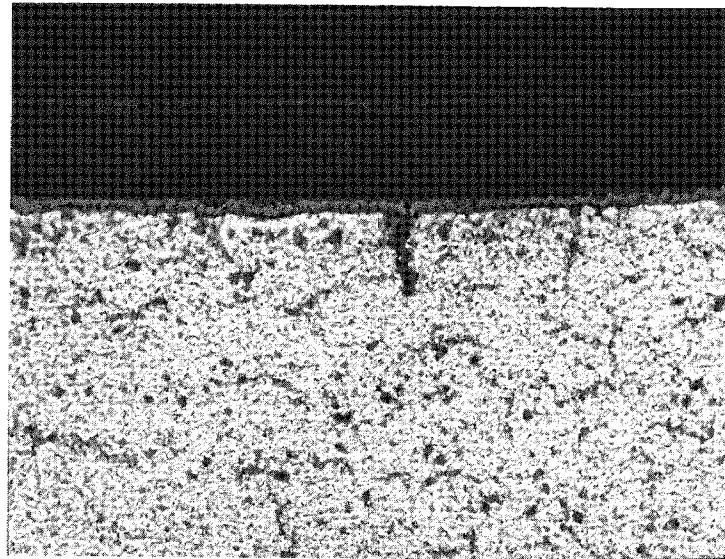
Fig. 4-11. SCC crack at location of oxide crack on inner surface of HBR specimen 155BC7 (250X).

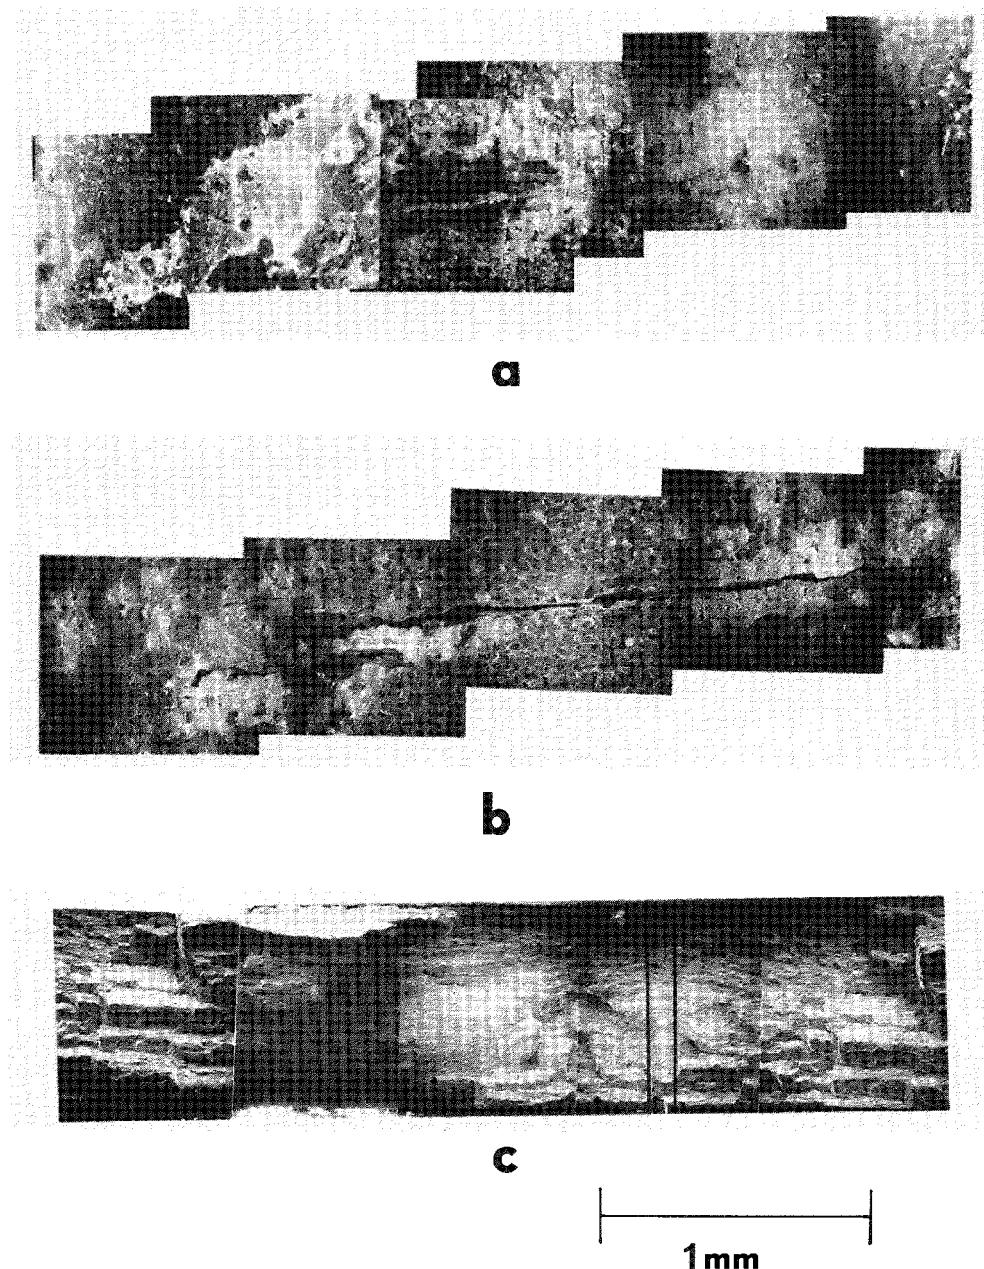
Fig. 4-12. SCC failure in HBR specimen 155BC5 (composite). (a) as tested, (b) after ultrasonic cleaning, (c) after three-point bending.

The SCC failure in specimen 155BC5 [325°C, 414 MPa (60.0 ksi), 5.38 ks (1.49 h)] was also examined in the SEM. The failure on the inner surface was first examined in the as-tested condition and then was ultrasonically cleaned and reexamined. The fracture surface was exposed by three-point bending and then examined. Figure 4-12 shows the composite photographs of the failure. The crack was ~2.5 mm long and was almost completely covered by corrosion product (Fig. 4-12a).
