# Characterization of Irradiated Zircaloys: Susceptibility to Stress Corrosion Cracking

NP-1557  
Research Project 1027

Final Report, October 1980

ARGONNE NATIONAL LABORATORY  
9700 South Cass Avenue  
Argonne, Illinois 60439

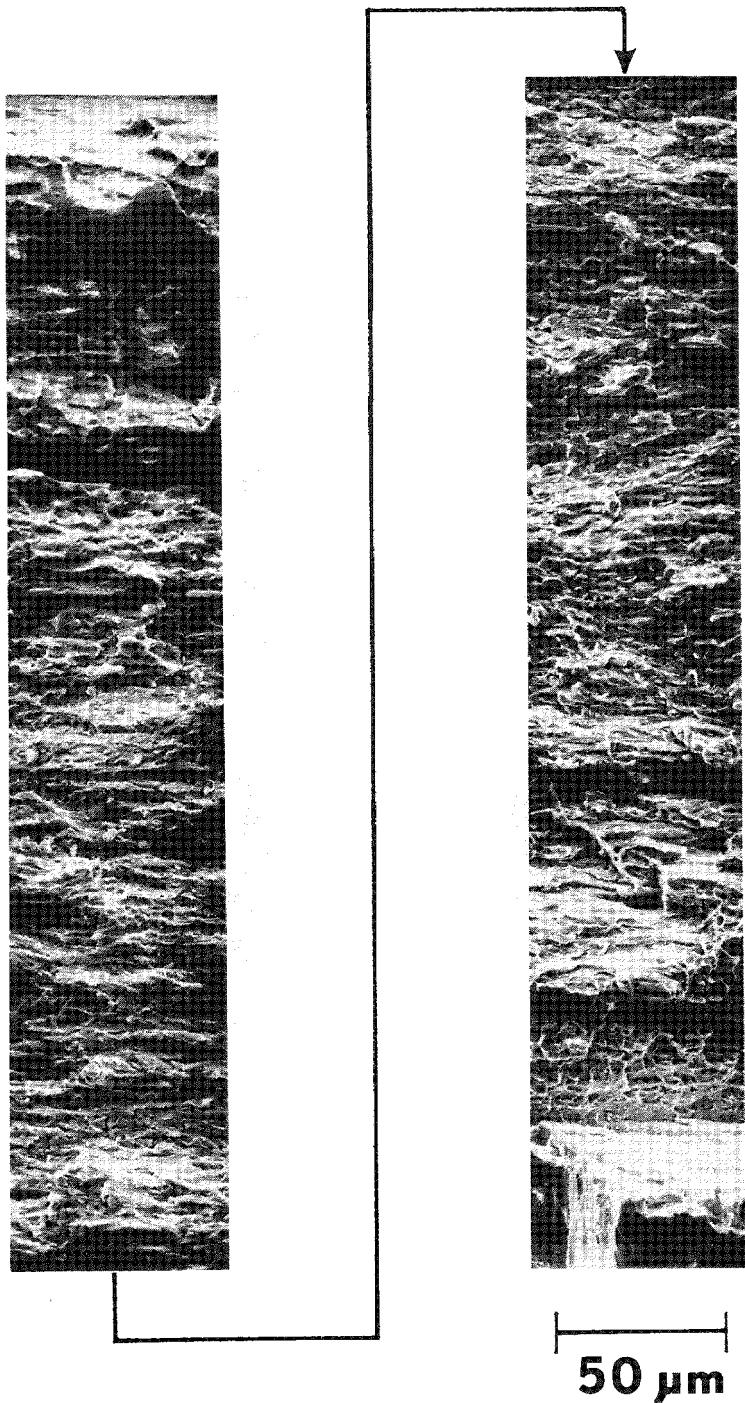
Fig. 4-13. High-magnification composite of fracture surface of HBR specimen 155BC5 located between vertical lines in Fig. 4-12c.

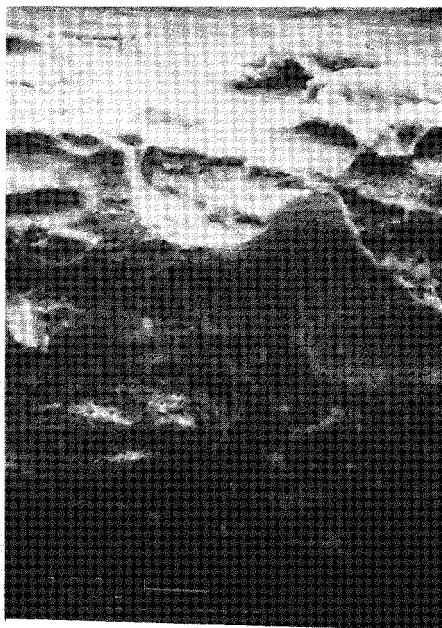
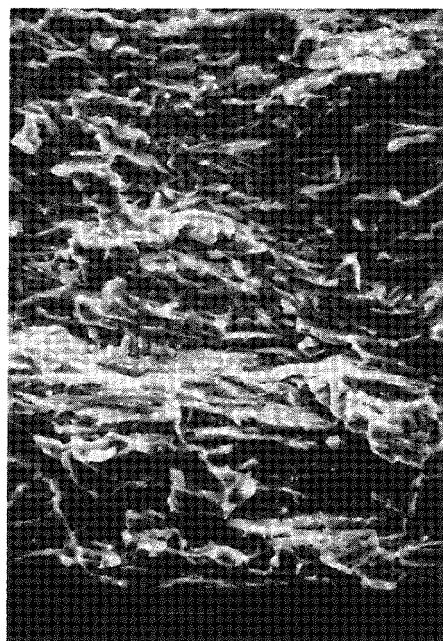
Fig. 4-14. Fracture surface of SCC failure in HBR specimen 155BC5. (a) area of chemical attack, (b) area showing cleavage fracture.

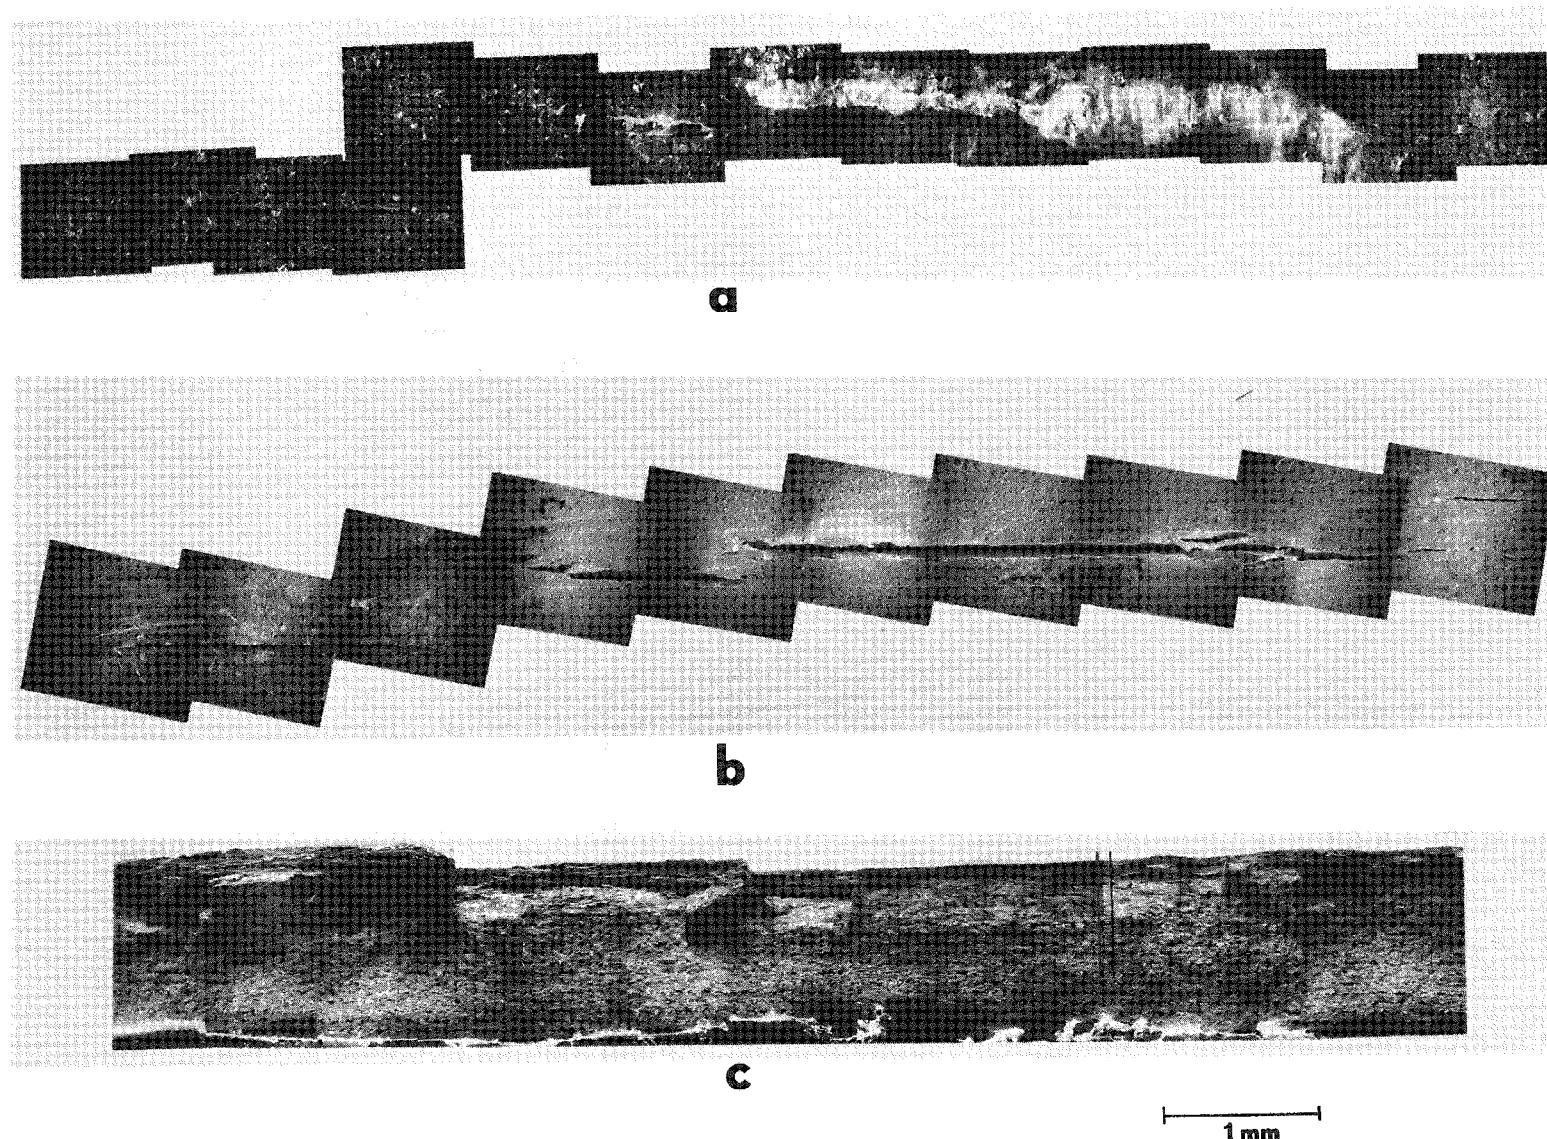
Fig. 4-15. Fracture surface of SCC failure in HBR specimen 165AB1 (composite).  
(a) as tested, (b) after ultrasonic cleaning, (c) after three-point bending.

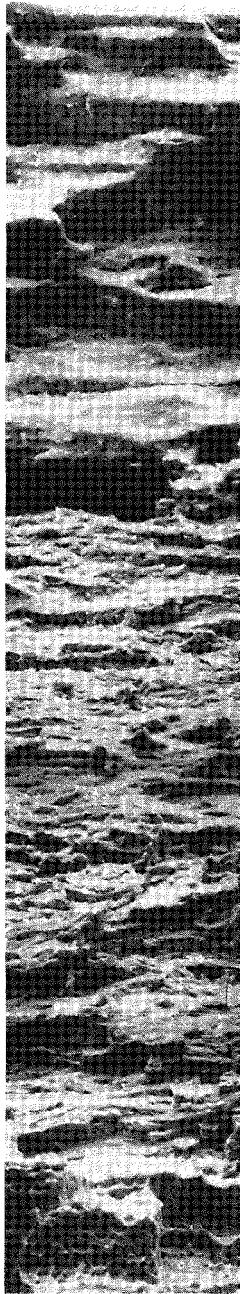
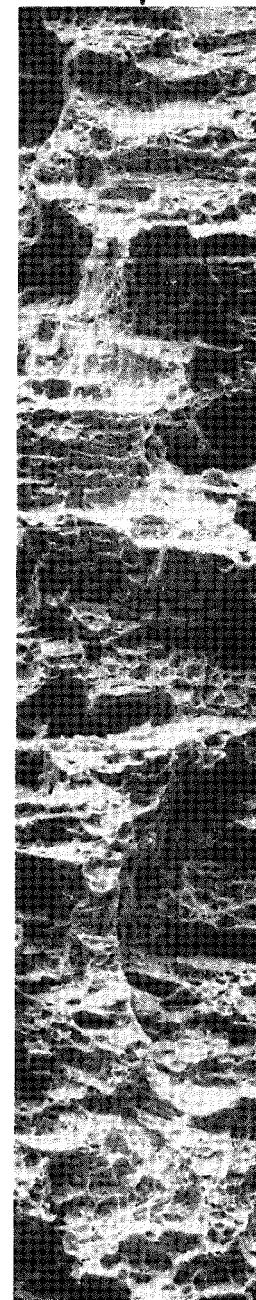
Fig. 4-16. High-magnification composite of fracture surface of BRP specimen 165AB1 located between vertical lines in Fig. 4-15c.

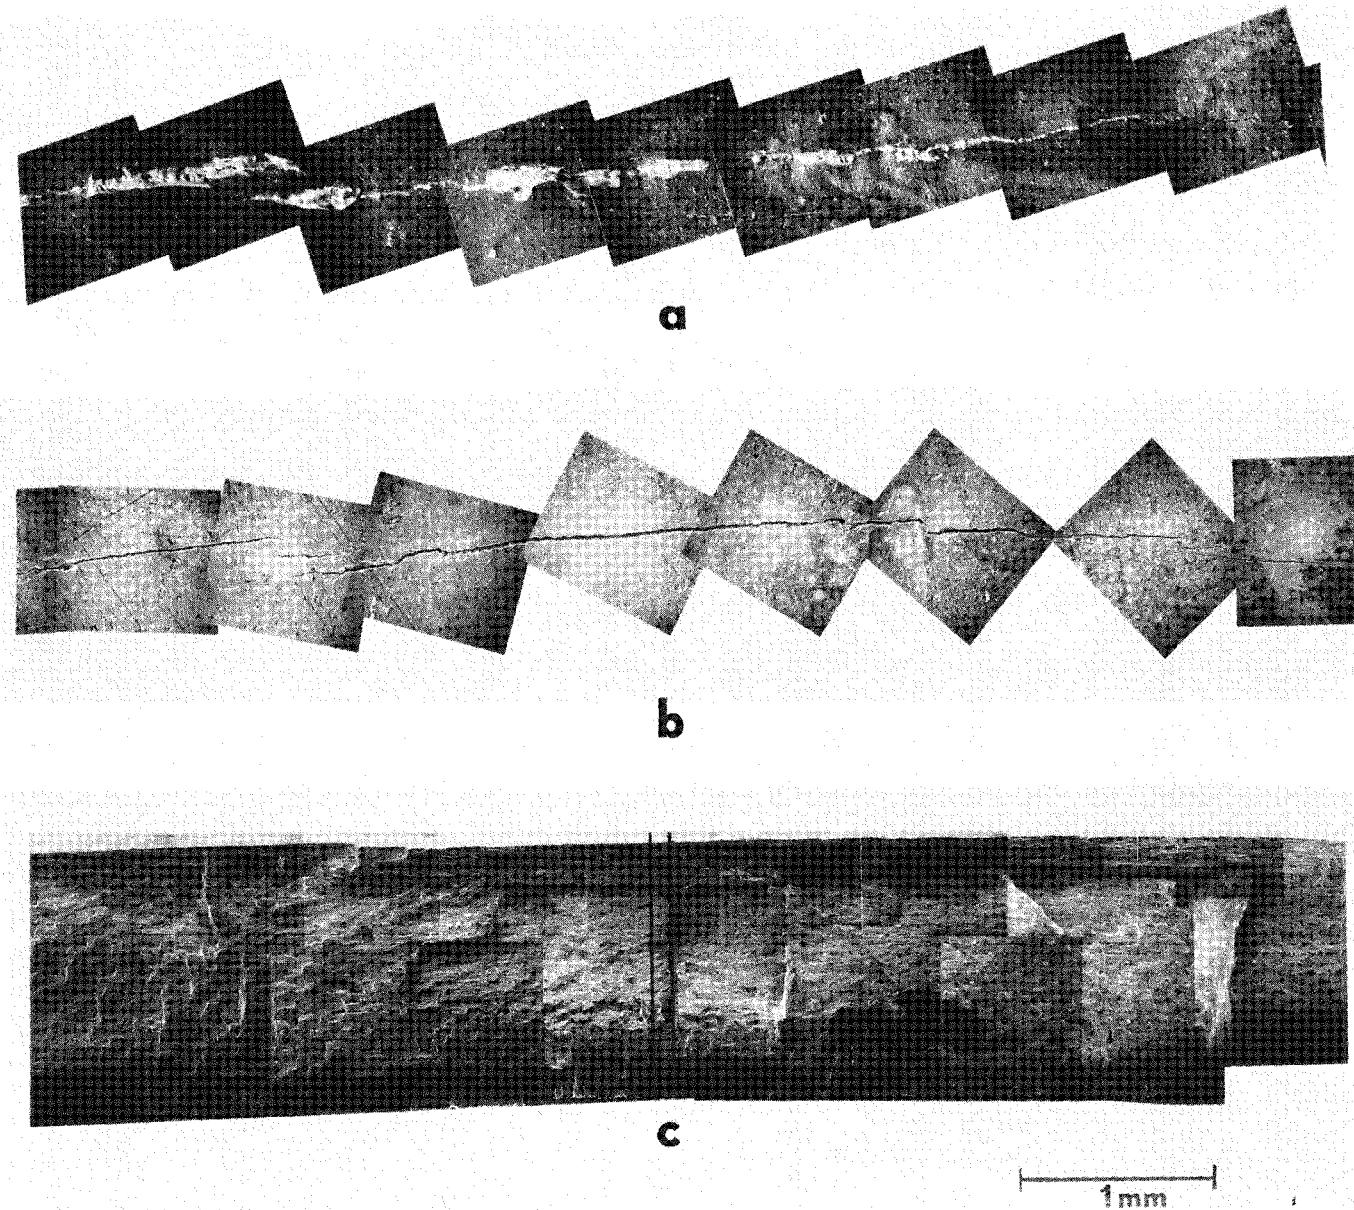
Fig. 4-17. SCC failure in BRP specimen 165AA10. (a) as tested, (b) after ultrasonic cleaning, (c) after three-point bending.

The failure in specimen 165AA10 [325°C, 275 MPa (39.9 ksi), 30.2 ks (8.4 h)] is shown in Fig. 4-17 as tested, after ultrasonic cleaning, and after three point bending. Again, multiple cracks are observed along the failure, but the cracks are narrower than those in 165AB1. Corrosion product is seen along the cracks, but there is little evidence of gross chemical attack. The exposed fracture surface reveals that crack branching occurred at ~250  $\mu\text{m}$  from the inner surface and that

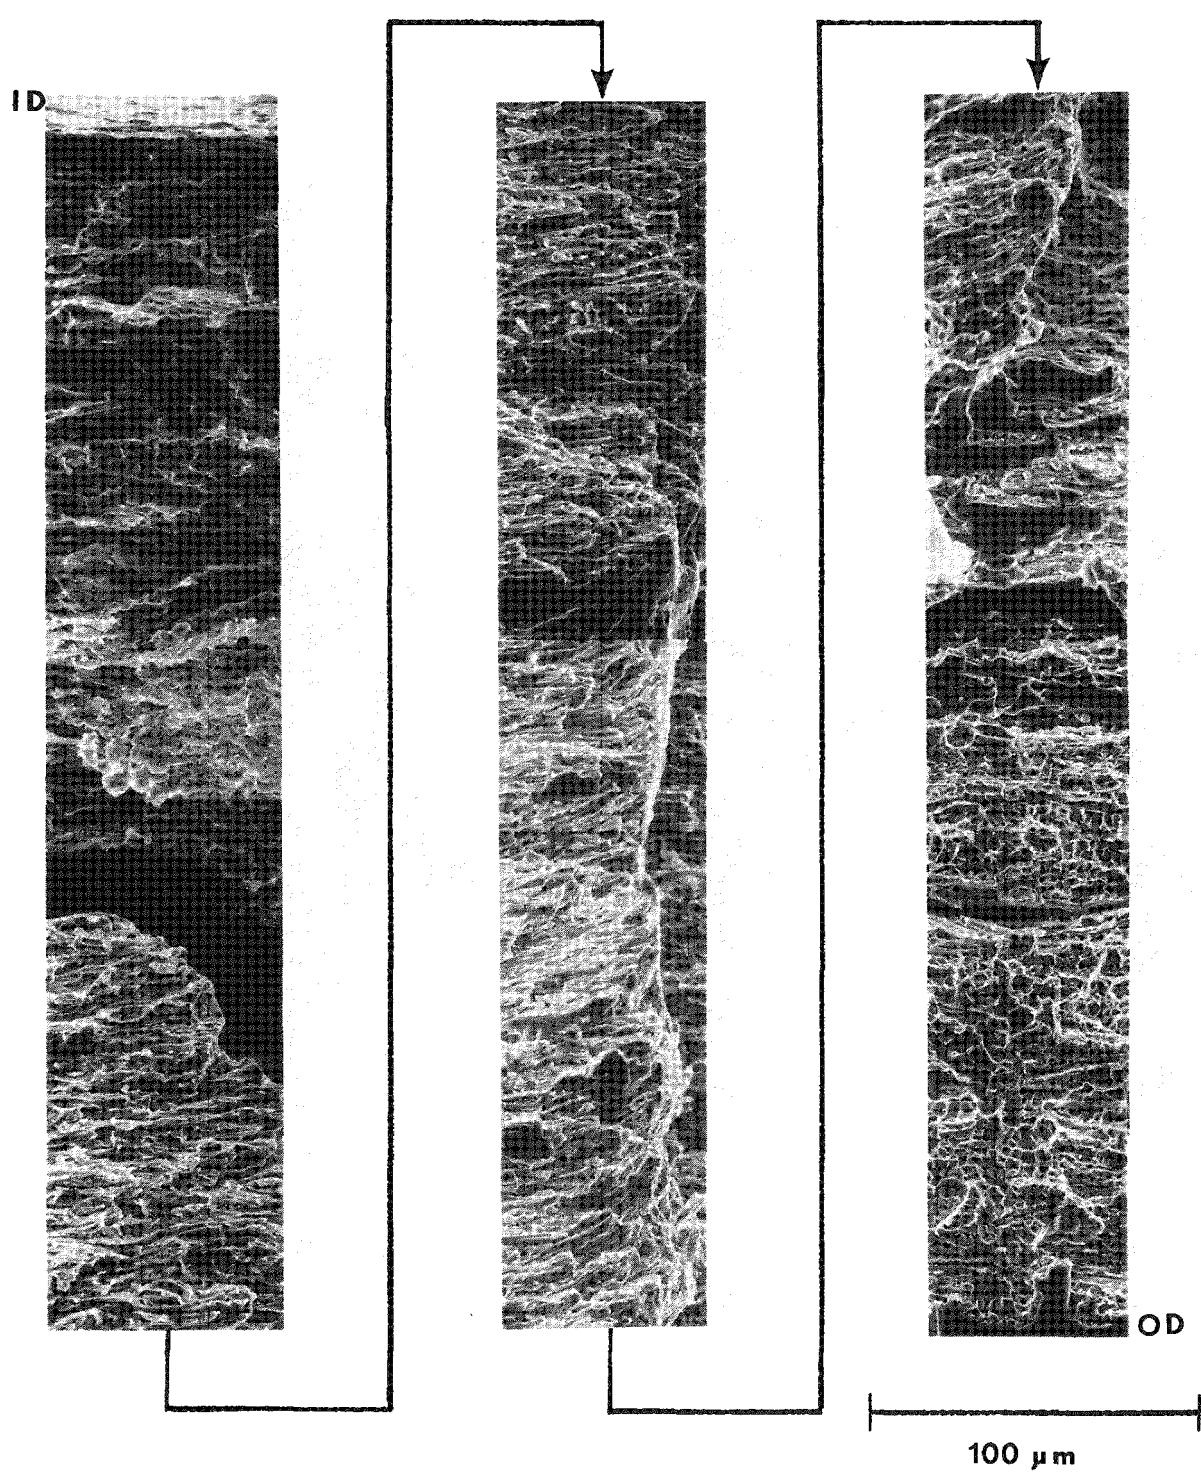
Fig. 4-18. High-magnification composite of fracture surface of BRP specimen 165AA10 located between vertical lines in Fig. 4-17c.

the crack length-to-depth ratio is  $\sim 7$ . At high magnification (Fig. 4-18), evidence of chemical attack can be seen up to the point of crack branching. This is followed by an area of cleavage-like failure for the next  $\sim 700 \mu\text{m}$ , which is then followed by ductile cup-cone fracture. Again, as with specimen 165AB1, the final failure mode was ductile rupture, but the depth of the SCC portion of the failure is much greater in specimen 165AB10.

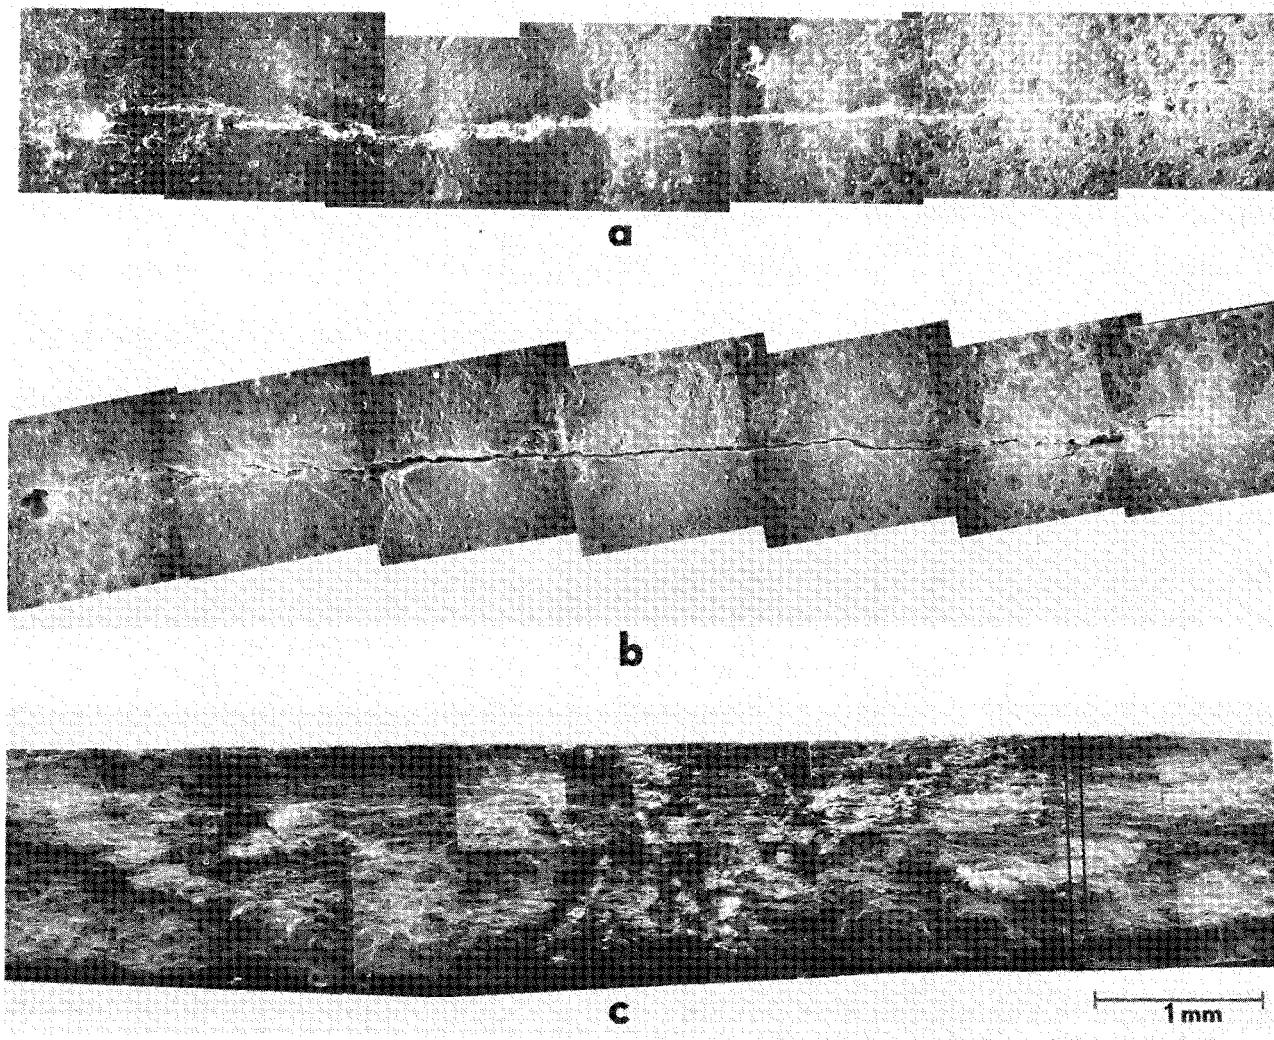
Fig. 4-19. SCC failure in BRP specimen 165AB12. (a) as tested, (b) after ultrasonic cleaning, (c) after three-point bending.

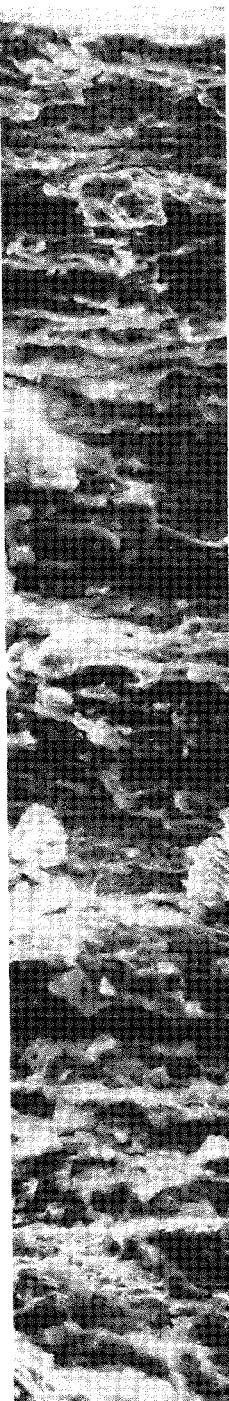
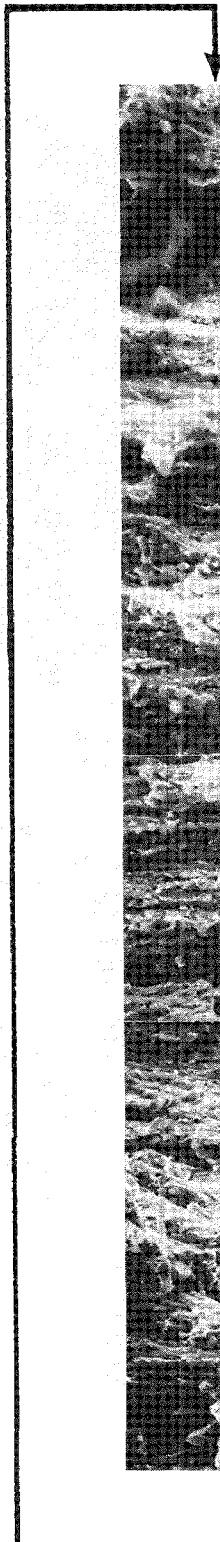
Fig. 4-20. High-magnification composite of fracture surface of BRP specimen 165ABI2 located between vertical lines in Fig. 4-19c.

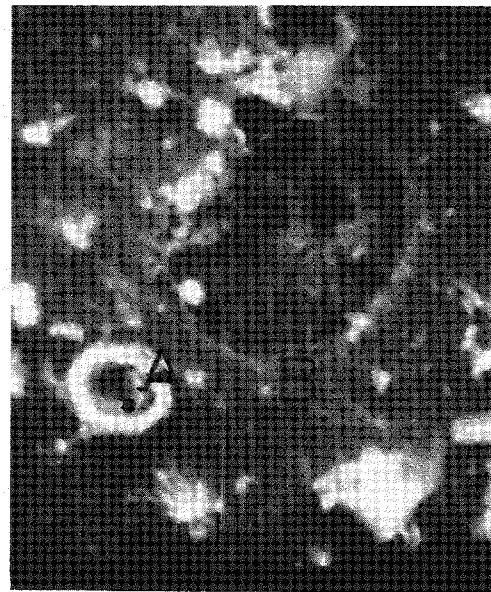
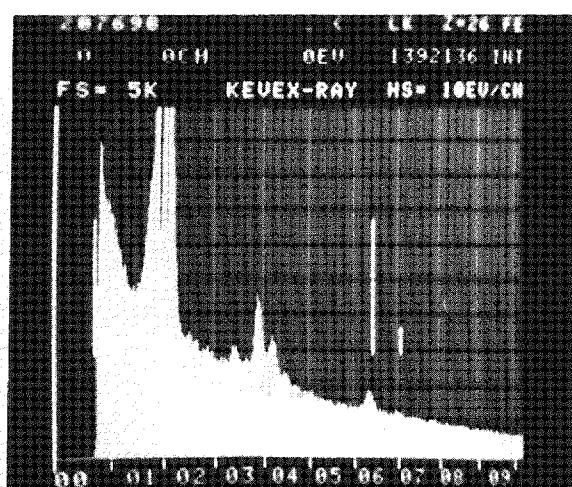
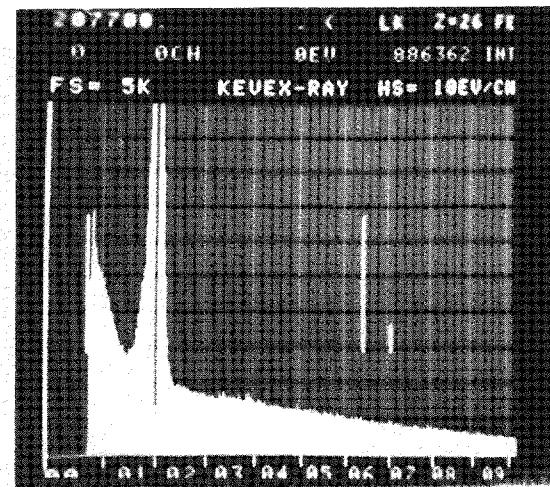
Fig. 4-21. Photos of SEM examination of inner-surface of BRP specimen 165AB12. (a) pits on inner surface after SCC testing, (b) X-ray spectra from point A showing the presence of iodine and iron, (c) X-ray spectra from point B showing only the Zirconium peak.

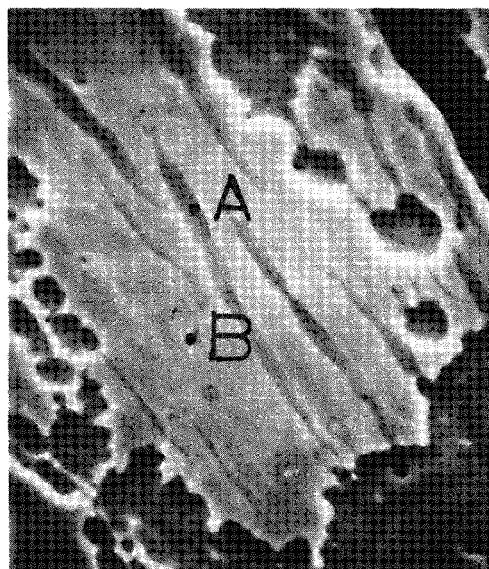
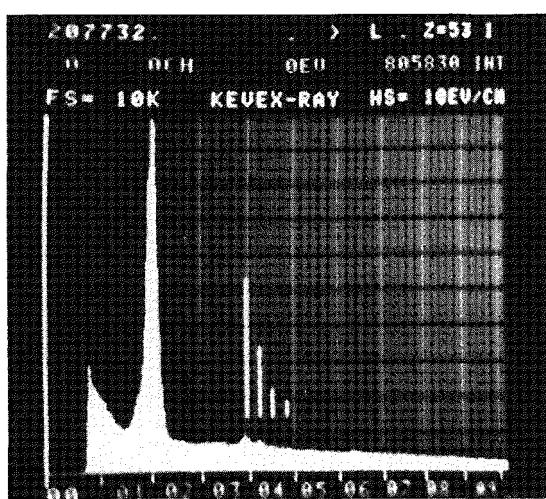
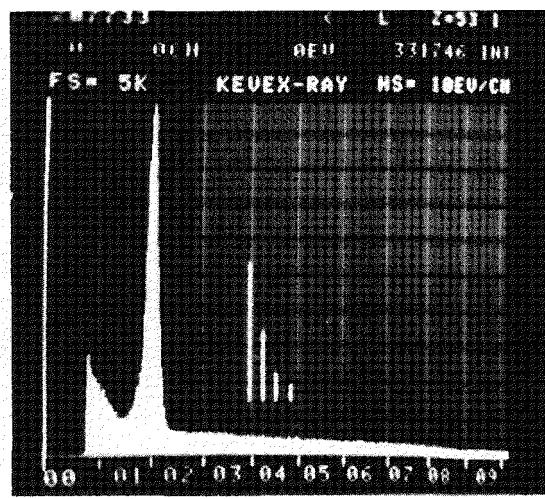
Fig. 4-22. Photos of SEM examination of inner-surface oxide on BRP specimen 165AB12. (a) oxide patch on inner surface after SCC testing, (b) X-ray spectra of point A showing presence of iodine, (c) X-ray spectra of point B showing no iodine.

A unique feature was observed on the inner surface of specimen 165AB12 following ultrasonic cleaning. This feature consisted of axial hairline cracks as shown in Fig. 4-22, in patches of oxide that were not removed by ultrasonic cleaning or chemical attack. The hairline cracks are surrounded on either side by dark areas,  $\sim 0.75 \mu\text{m}$  wide. X-ray analysis of the dark areas indicated the presence of iodine along with zirconium, whereas X-ray analysis of another section of the oxide indicated only the presence of zirconium. This feature is of interest because it could be a precursor to an SCC crack. The axial alignment of the hairline cracks implies an interaction with the applied hoop stress, and the presence of iodine after vigorous ultrasonic cleaning suggests a strong bond between the iodine and the oxide layer.

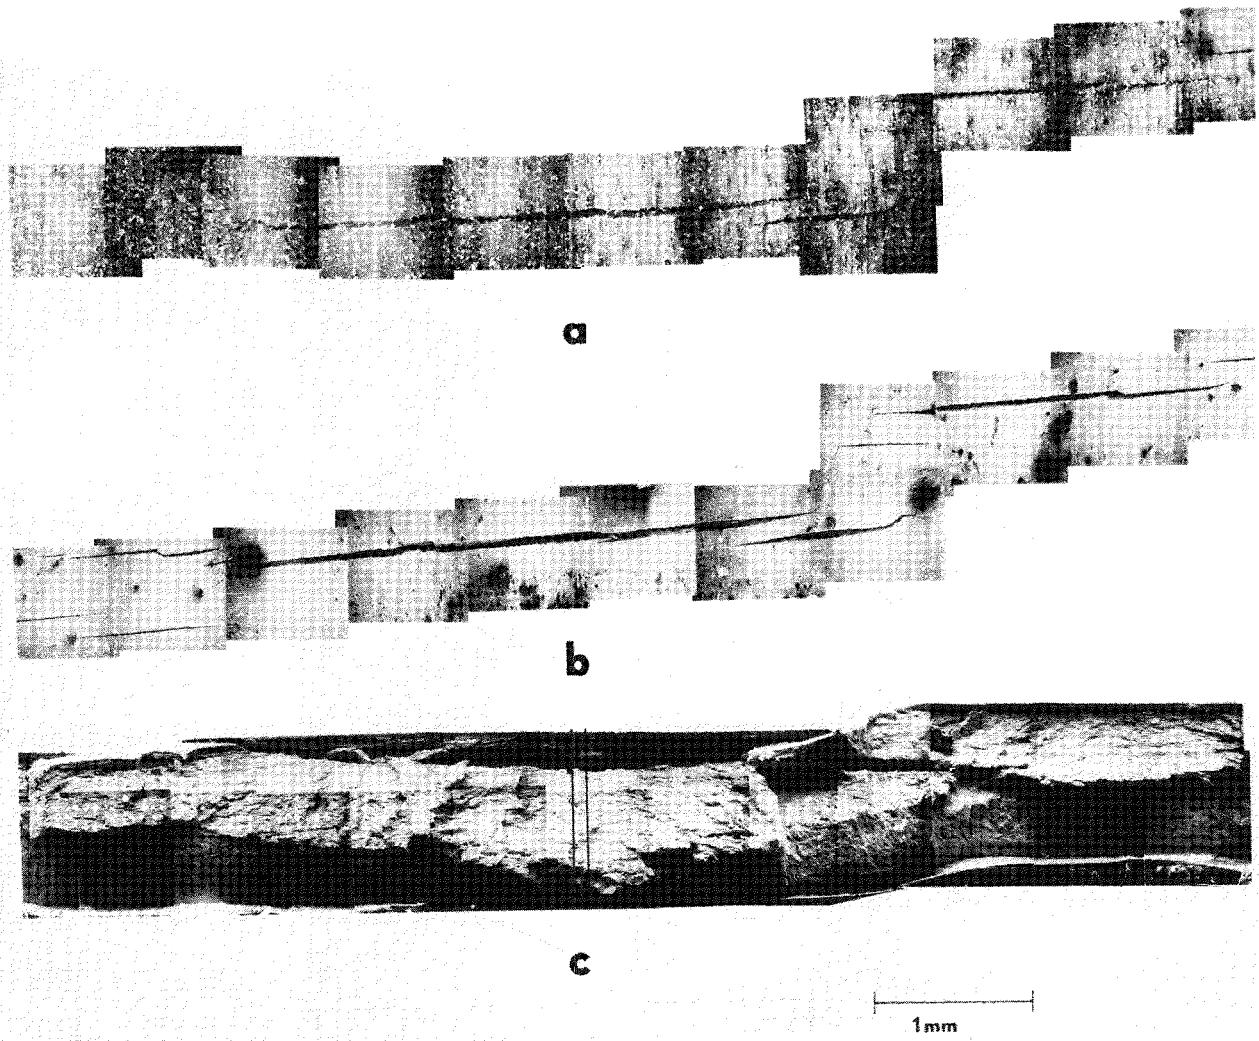
Fig. 4-23. SCC failure in BRP specimen 165E4. (a) as tested, (b) after ultrasonic cleaning, (c) after three-point bending.

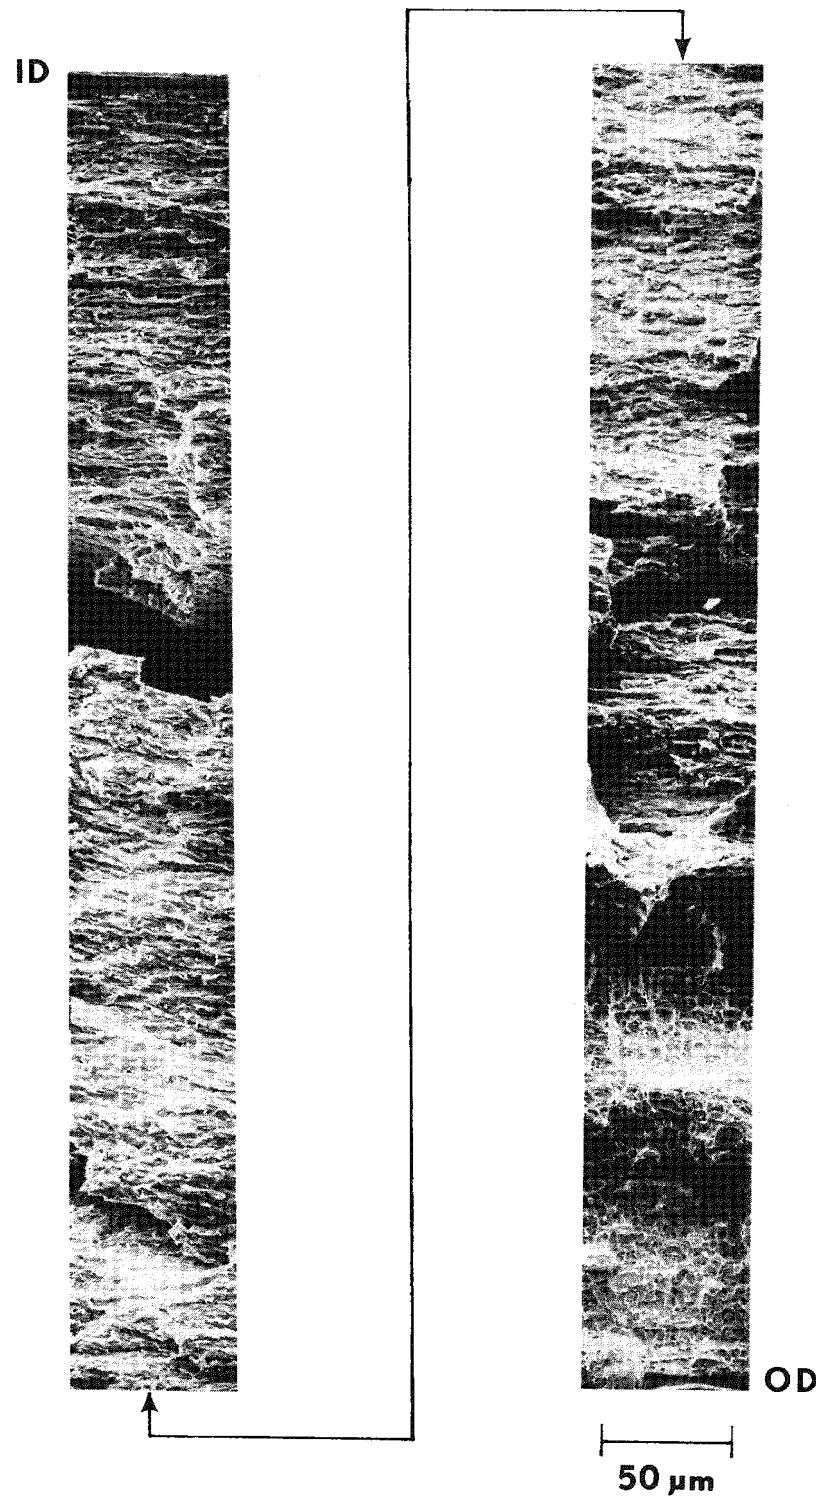
Fig. 4-24. High-magnification composite of fracture surface in BRP specimen 165E4 located between vertical lines in Fig. 4-23c.

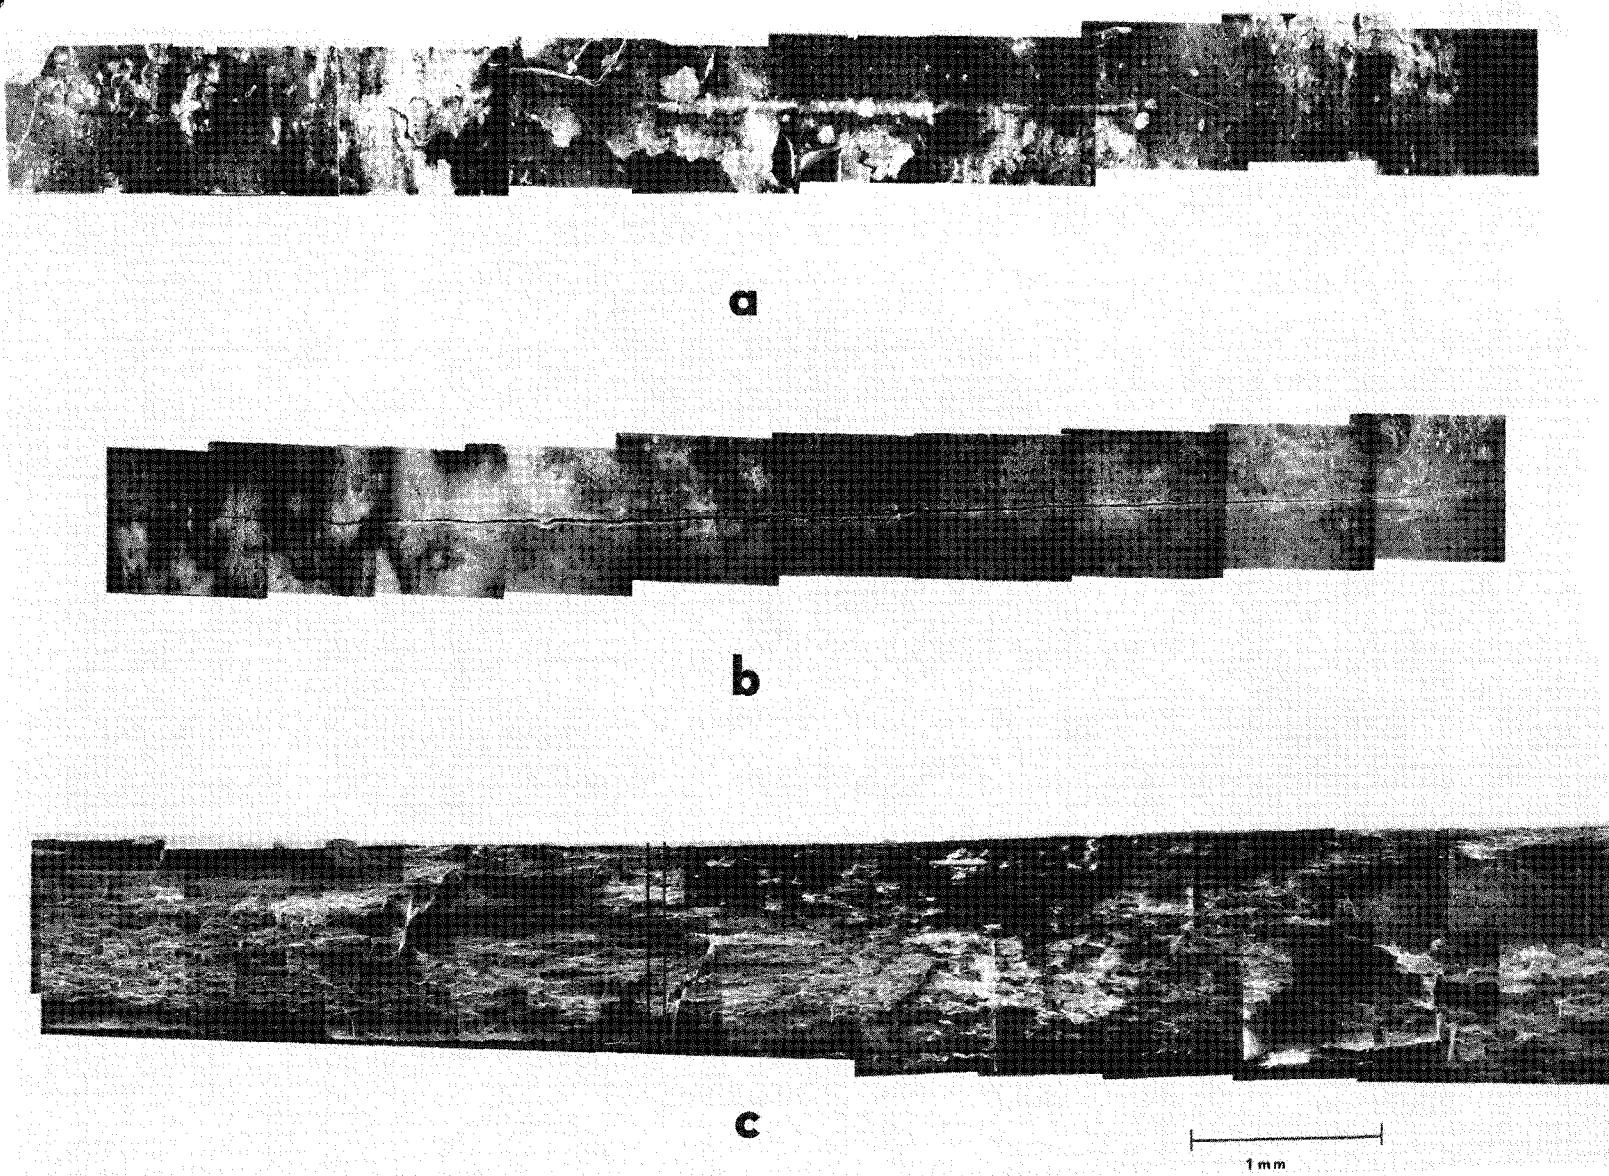
Fig. 4-25. SCC failure in BRP specimen 165T18A. (a) as tested, (b) after ultrasonic cleaning, (c) after three-point bending.

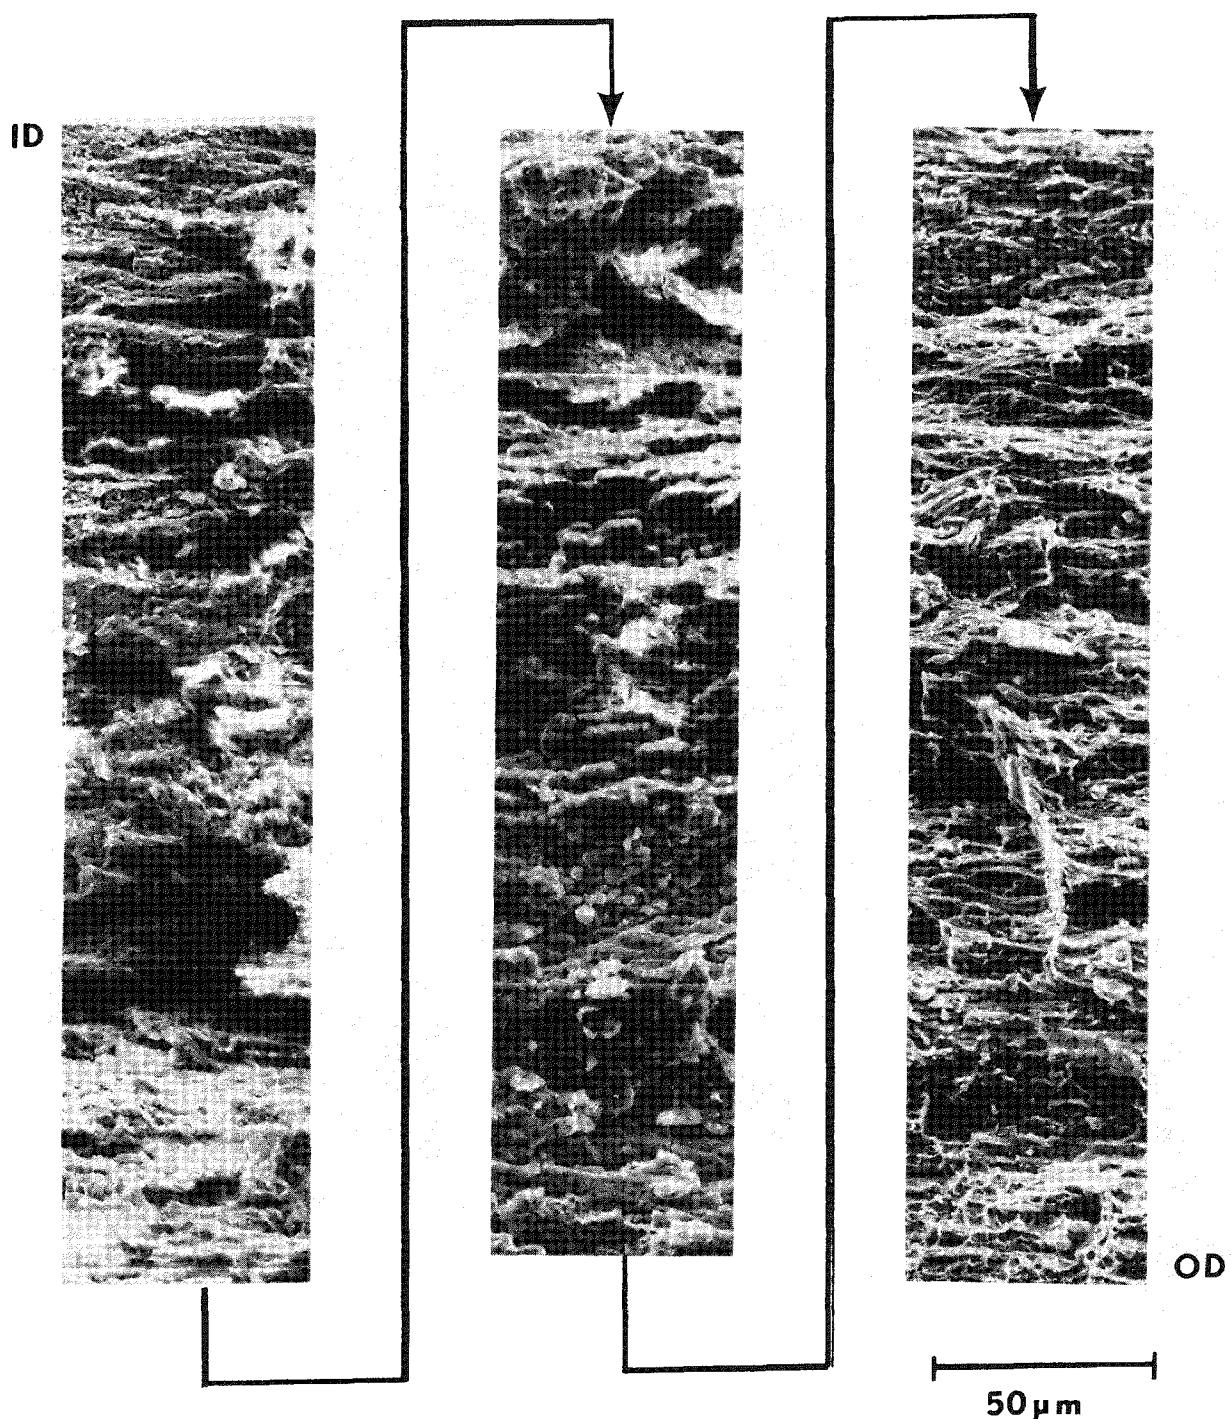
Fig. 4-26. High-magnification composite of fracture surface in BRP specimen 165T18A located between vertical lines in Fig. 4-25c. Chemical attack is observed to the bottom of the middle composite.

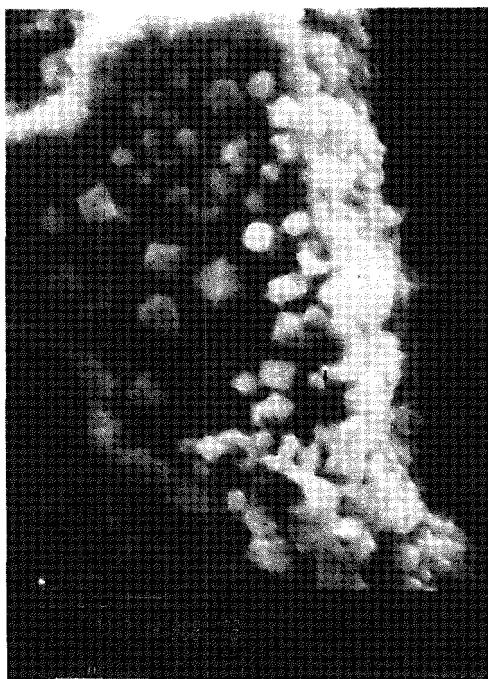
Fig. 4-27. Crystals containing cesium and iodine located along and on crack surface in BRP specimen 165T18A.

What apparently are CsI crystals were found on some areas along the crack and on the fracture surface. These octahedron-appearing crystals are shown in Fig. 4-27. The presence of cesium and iodine, in approximately equal quantities, was determined by energy-dispersive X-ray analysis. The presence of these crystals on the fracture surface is evidence that the iodine inserted for the test reacted with fission-product cesium on the inner surface. This finding, however, is not necessarily evidence that CsI was the corroding specie. Rather, it may simply indicate that the amount of iodine added was far in excess of that required to initiate cladding attack.

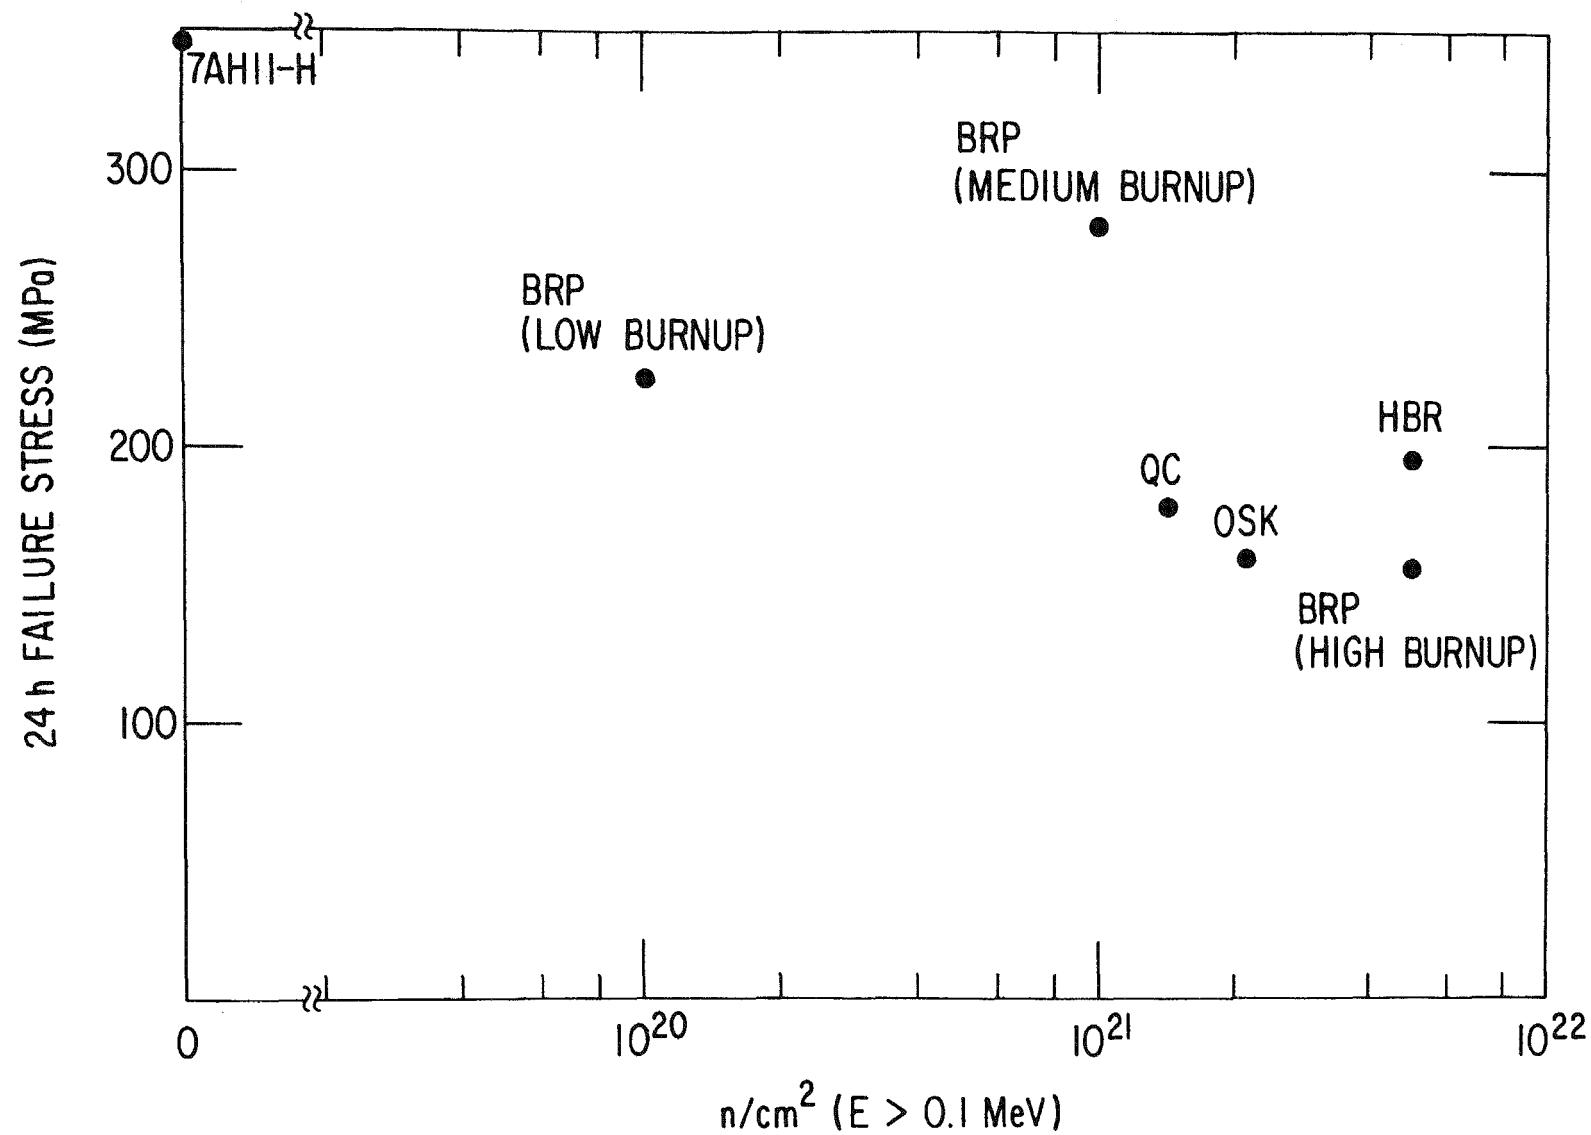
Fig. 5-1. Effect of fluence on the 24-h failure stress of irradiated Zircaloy cladding.

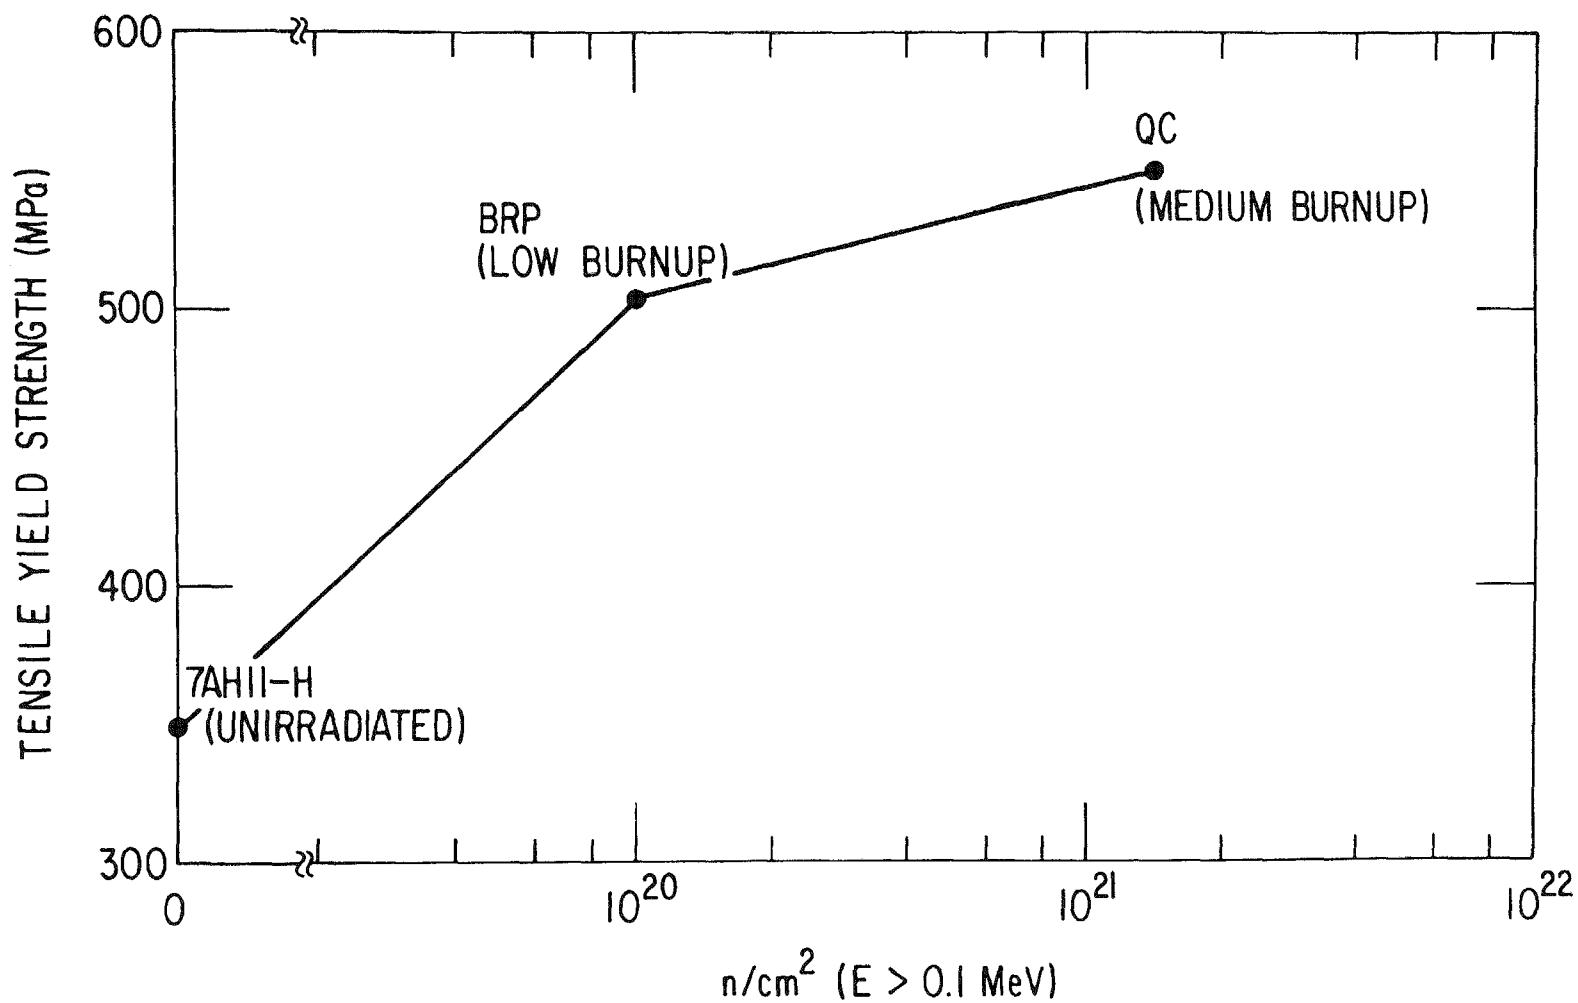
Fig. 5-2. Effect of fluence on the 0.2% yield strength of irradiated Zircaloy cladding.
