# Characterization of Irradiated Zircaloys: Susceptibility to Stress Corrosion Cracking

NP-1557  
Research Project 1027

Final Report, October 1980

ARGONNE NATIONAL LABORATORY  
9700 South Cass Avenue  
Argonne, Illinois 60439

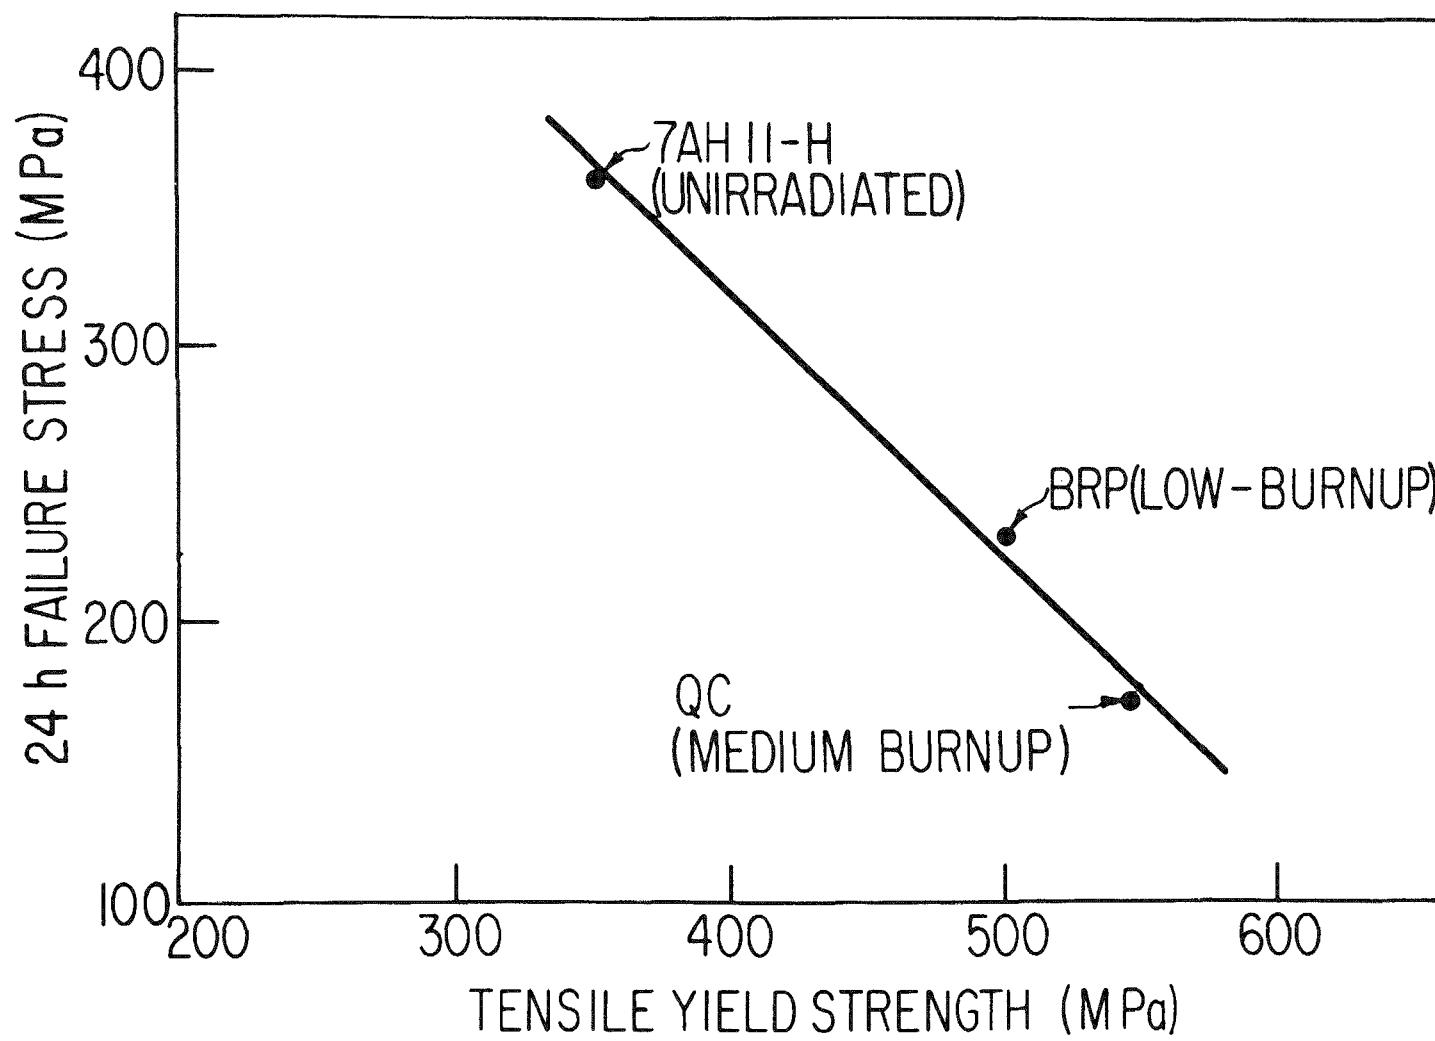
Fig. 5-3. Comparison of 0.2% yield strength and 24-h failure stress for 7AH11-H, QC, and low-burnup BRP cladding.

The primary effect of irradiation on the bulk properties of Zircaloy cladding from low-gas-release rods is to increase the strength and decrease the ductility (18). The effect of irradiation on the cladding tensile strength is illustrated in Fig. 5-2, which compares the yield strength of 7AH11-7 (17), low-burnup BRP, and QC cladding. Although the number of data points is limited, the trend of a higher yield stress with fluence is clearly evident. The results of Figs. 5-1 and 5-2 can be combined to examine the relationship of the cladding yield stress and the 24-h failure stress. As shown in Fig. 5-3, the limited data indicate that the SCC

failure stress decreases linearly with an increasing yield stress. Such a relationship between yield stress and stress-corrosion susceptibility is not unexpected, since similar relationships have been observed in other alloy systems (19). The effect of yield stress on stress-corrosion susceptibility is discussed more completely in the section describing the SCC model.

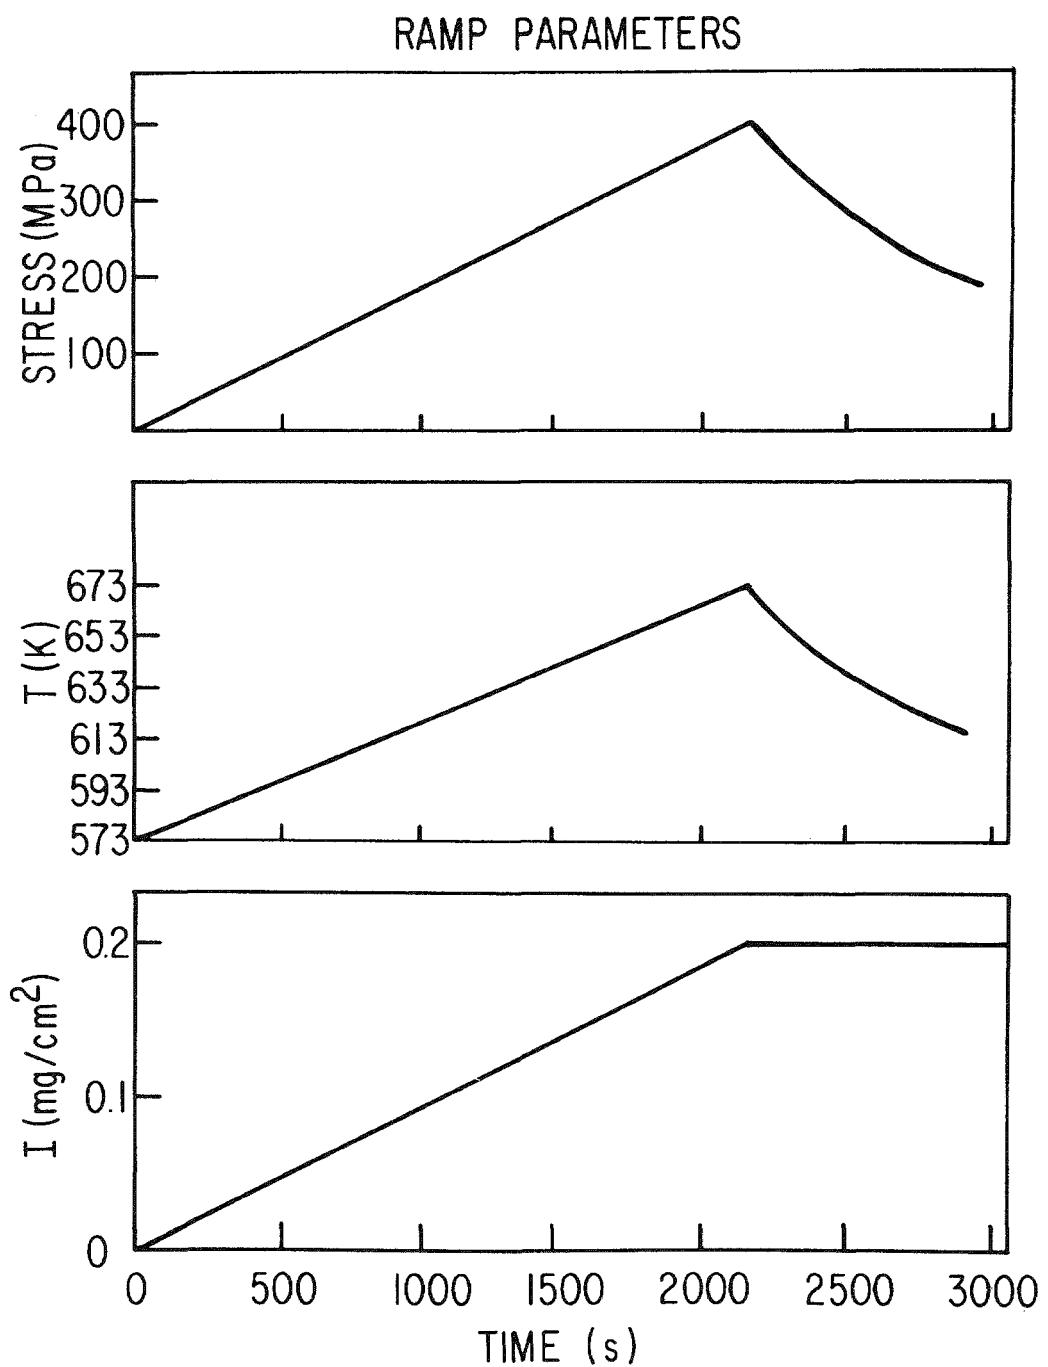
Fig. 5-4. Change in variables with time for a hypothetical power ramp.

As an illustration, the crack growth in unirradiated and irradiated cladding has been modeled for a hypothetical power ramp (Fig. 5-4). In this power ramp, the cladding temperature, hoop stress, and iodine concentration are allowed to increase with time up to 0.6 h. The crack growth has been calculated using the above relationships with the additional assumption that iodine attack of the

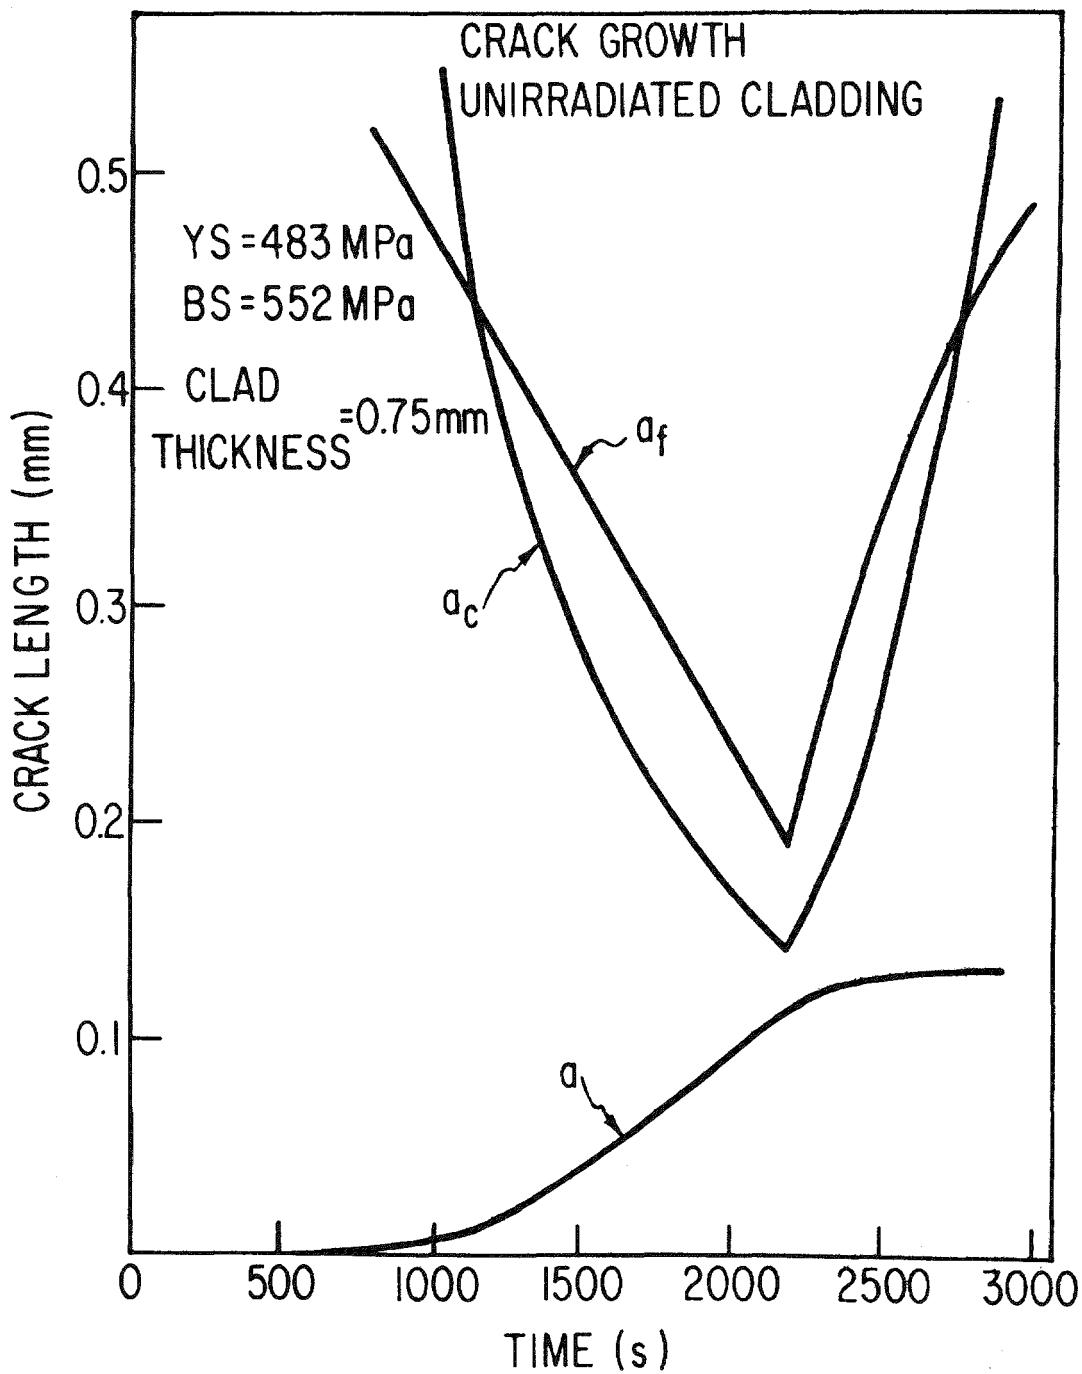
Fig. 5-5. Change in crack length in unirradiated Zircaloy cladding for the power-ramp conditions illustrated in Fig. 5-4. Also shown are the critical crack lengths where cleavage and fluting begin ( $a_c$ ) and where failure occurs by stress rupture ( $a_f$ ).

cladding cannot occur until the inner-surface oxide has cracked. The stress level chosen as that necessary for oxide cracking is 135 MPa. The results of crack-growth calculations for unirradiated cladding ( $\sigma_{ys} = 483$  MPa,  $\sigma_B = 550$  MPa) and irradiated cladding ( $\sigma_{ys} = 620$  MPa,  $\sigma_B = 690$  MPa) are shown in Figs. 5-5 and 5-6, respectively. For the unirradiated cladding, crack growth by chemical attack begins at 0.2 h and continues during the ramp. However, the crack length never reaches the critical length,  $a_c$ , for the initiation of cleavage and fluting. In the irradiated cladding, chemical attack occurs in the same way, but the critical length,  $a_c$ , is reached after  $\sim 0.48$  h. Failure occurs shortly thereafter because of the rapid crack growth by cleavage and fluting. About 85% of the time to failure for this illustration is spent chemically growing a crack to  $< 10\%$  of the cladding thickness. The predictions of the cumulative-damage tests shown in Table 5-1 have been calculated with these techniques.

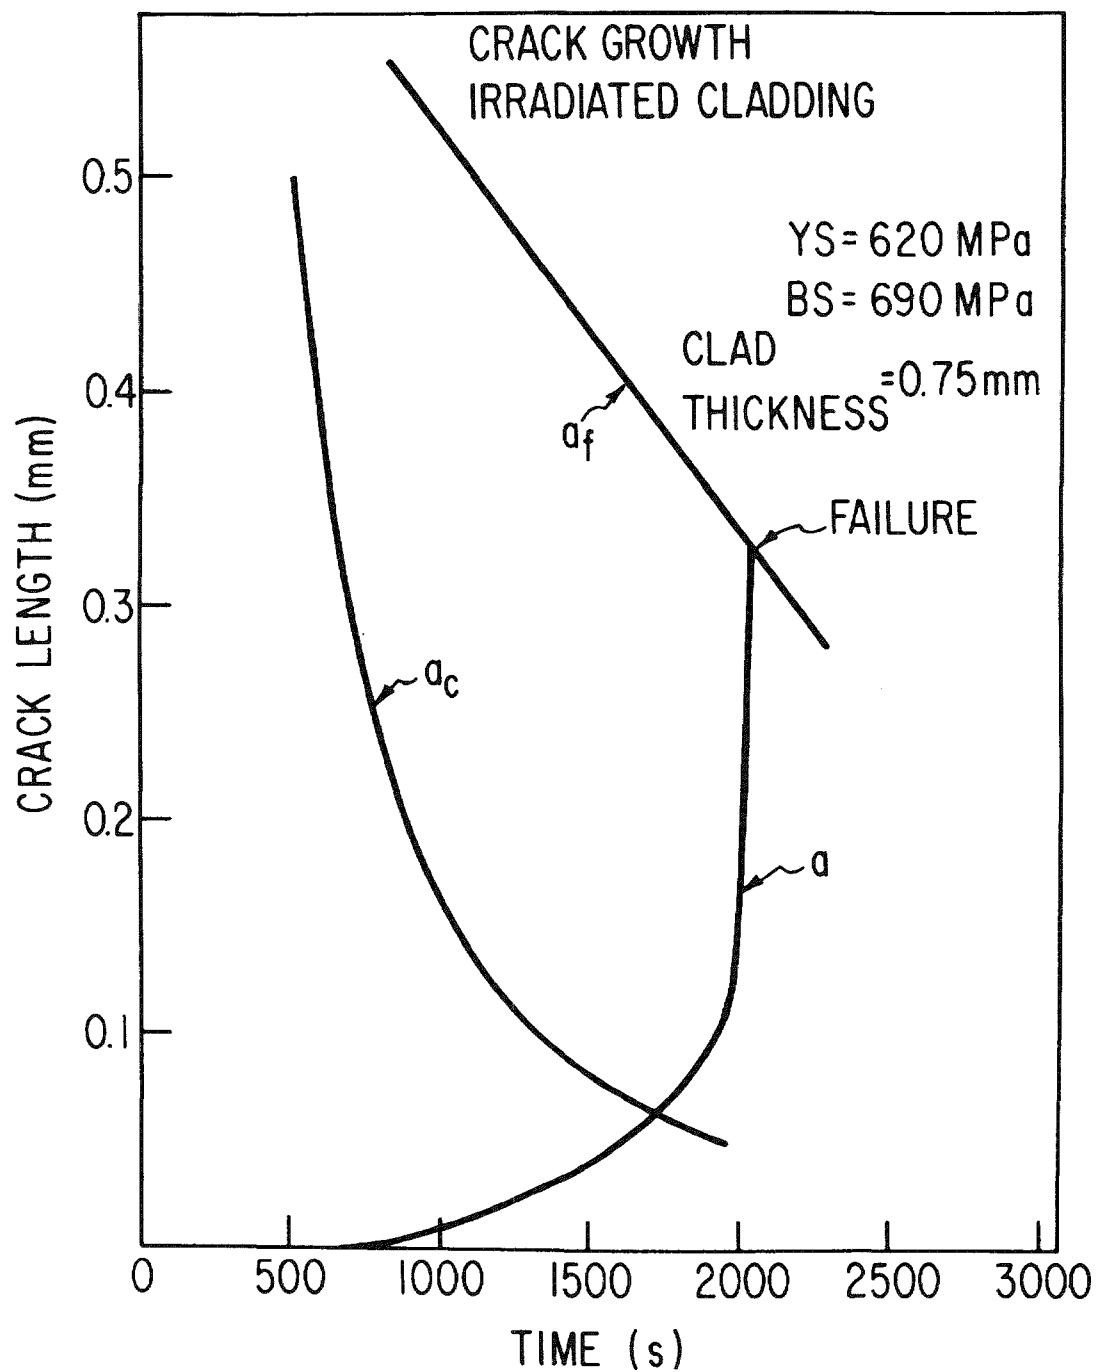
Fig. 5-6. Change in crack length,  $a$ , in irradiated cladding for the power ramp conditions illustrated in Fig. 5-2. Also shown are the critical crack lengths where cleavage and fluting begin ( $a_c$ ) and where failure occurs by stress rupture ( $a_f$ ).
