A Final Report
MAY 1990

EVALUATE FUNDAMENTAL APPROACHES TO LONGWALL DUST CONTROL SUBPROGRAM C - STAGELOADER DUST CONTROL

Contract J0318097
Foster-Miller, Inc.

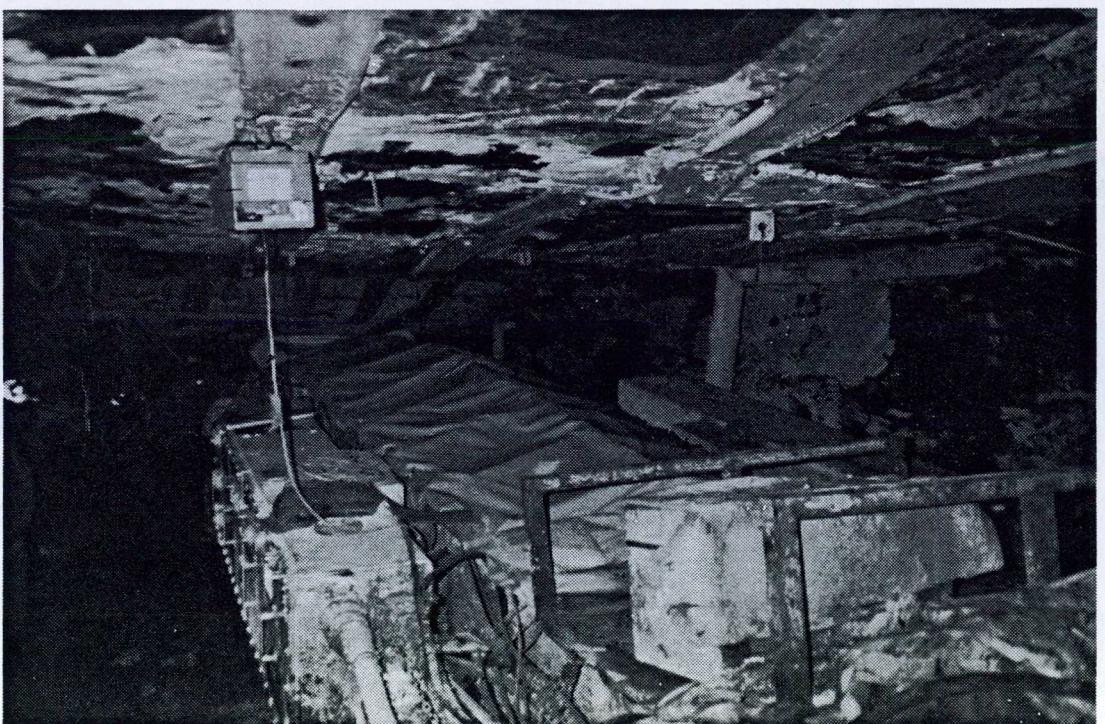
FIGURE 23. - Stageloader both uncovered and covered.

a) PHOTO OF OPEN STAGELOADER

b) PHOTO OF COVERED STAGELOADER

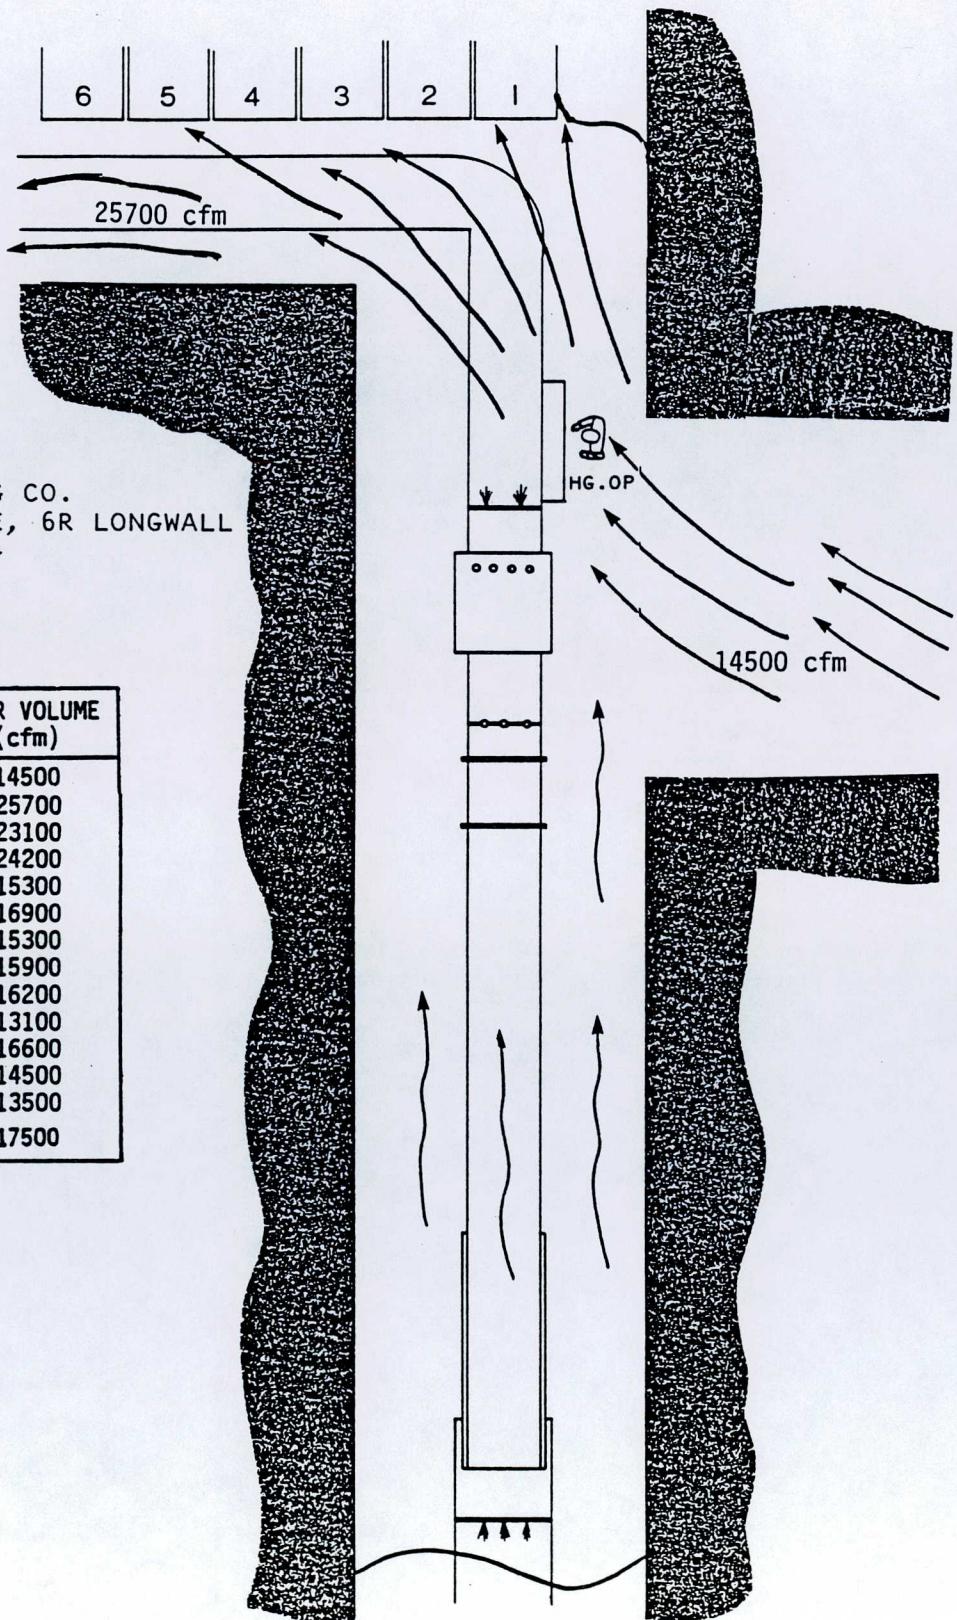
EMERY MINING CO.
WILBERG MINE, 6R LONGWALL
JUNE 19 1984

LOCATION	AIR VOLUME (cfm)
INTAKE	14500
SHIELD #5	25700
SHIELD #10	23100
SHIELD #20	24200
SHIELD #30	15300
SHIELD #40	16900
SHIELD #50	15300
SHIELD #60	15900
SHIELD #70	16200
SHIELD #80	13100
SHIELD #90	16600
SHIELD #100	14500
SHIELD #110	13500
FACE AVERAGE	17500
