LOS ALAMOS NATIONAL LABORATORY CASE STUDIES ON
DECOMMISSIONING OF RESEARCH REACTORS AND A SMALL
NUCLEAR FACILITY

**LOS ALAMOS NATIONAL LABORATORY CASE STUDIES
ON THE DECOMMISSIONING OF RESEARCH REACTORS
AND A SMALL NUCLEAR FACILITY**

This training-course material presented at Argonne National Laboratory on March 26, 1998, as part of the International Atomic Energy Agency and Argonne National Laboratory Training Course on Decommissioning.

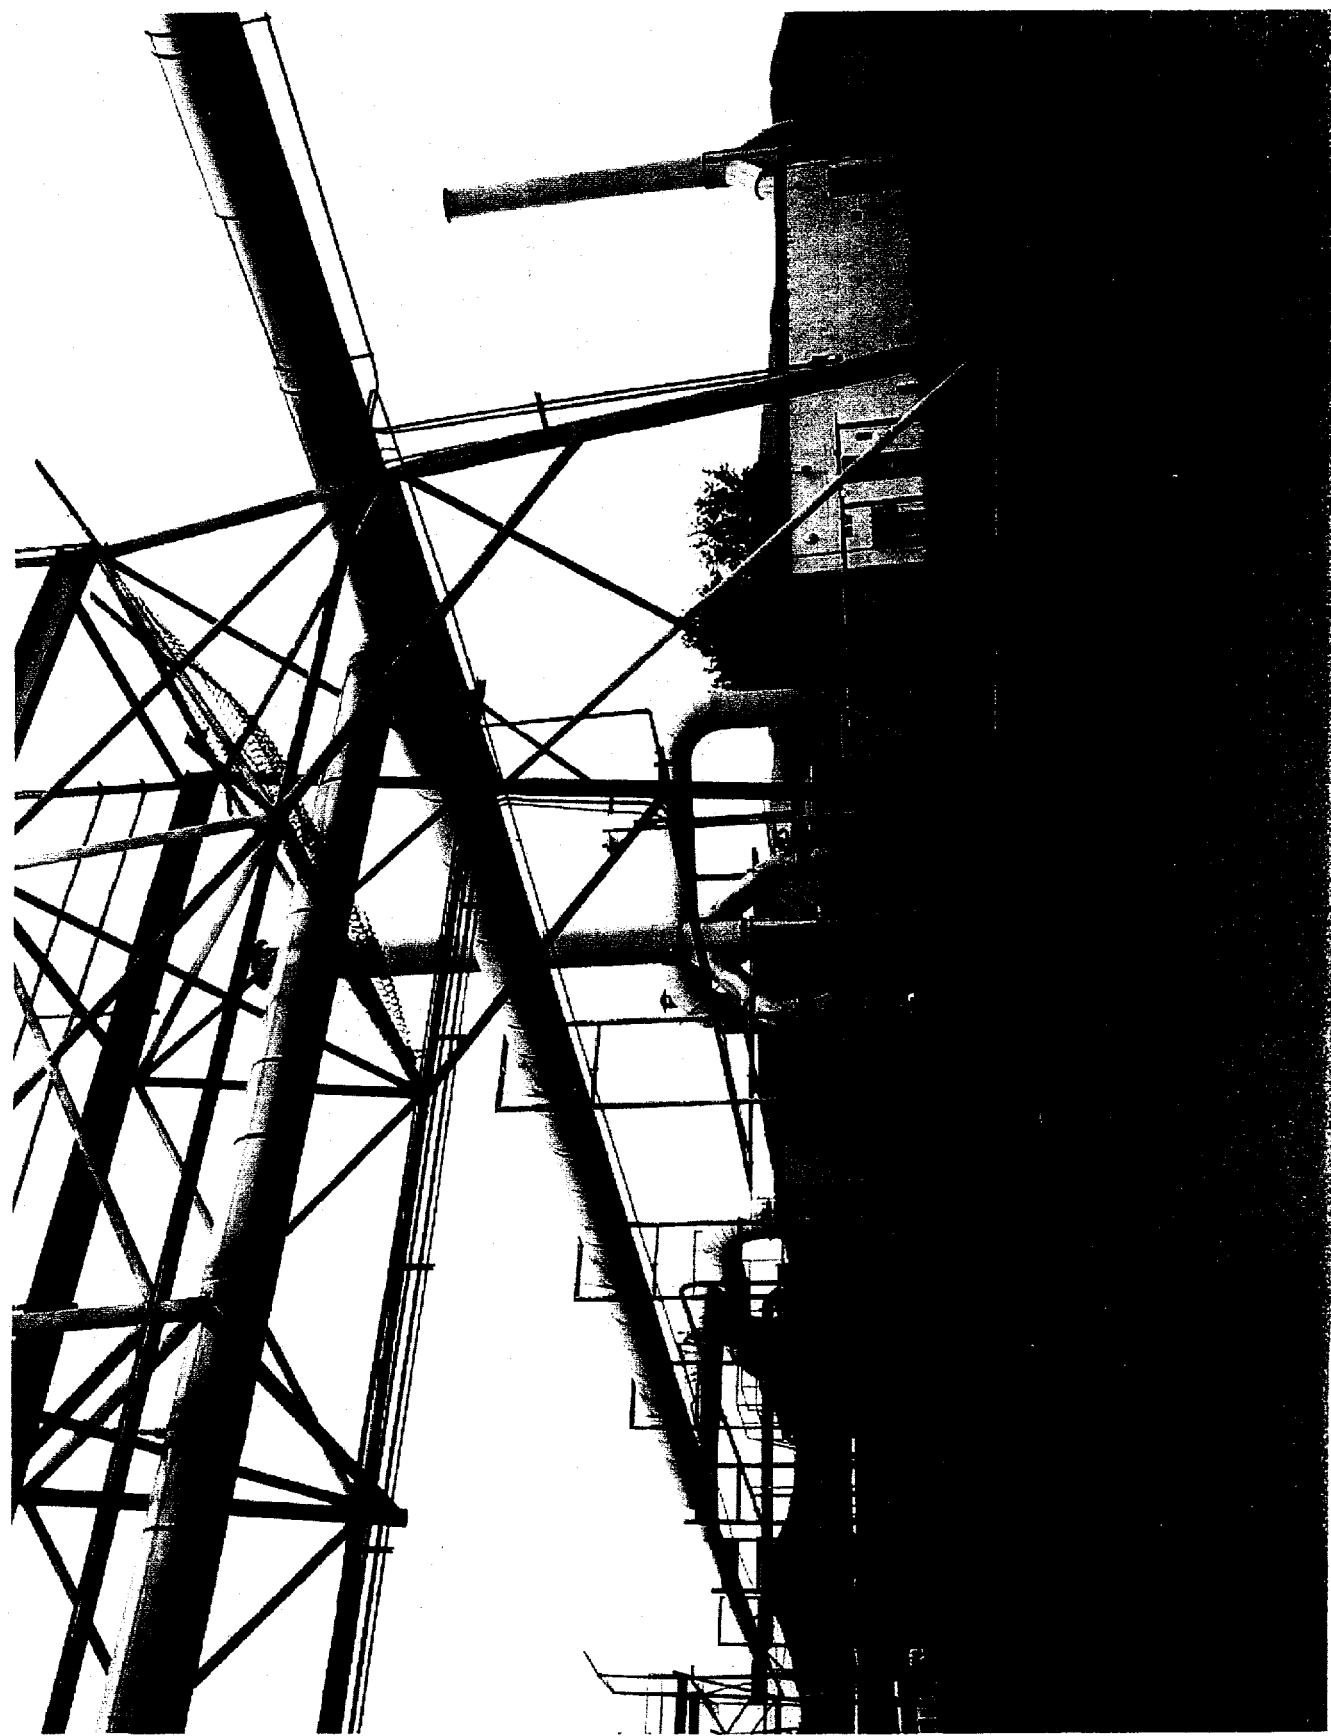
Fig. 2. Building 329, 146, and 324.

Initial air flow passed through the fire-screen plenum in Building 329 into the plenum in Building 146. This plenum contained a large, drum-shaped HEPA filter system. The drum diameter was approximately 92 in. (2.3 m), with a length of 96 in. (2.4 m). It contained 24 filters, with 3 filters arranged along each side of the 8-sided drum. The air flow then went to Building 324, which provided a second stage

of filtration. The flow in Building 324 passed through 20 parallel HEPA filters and exited the stack (Fig. 2).

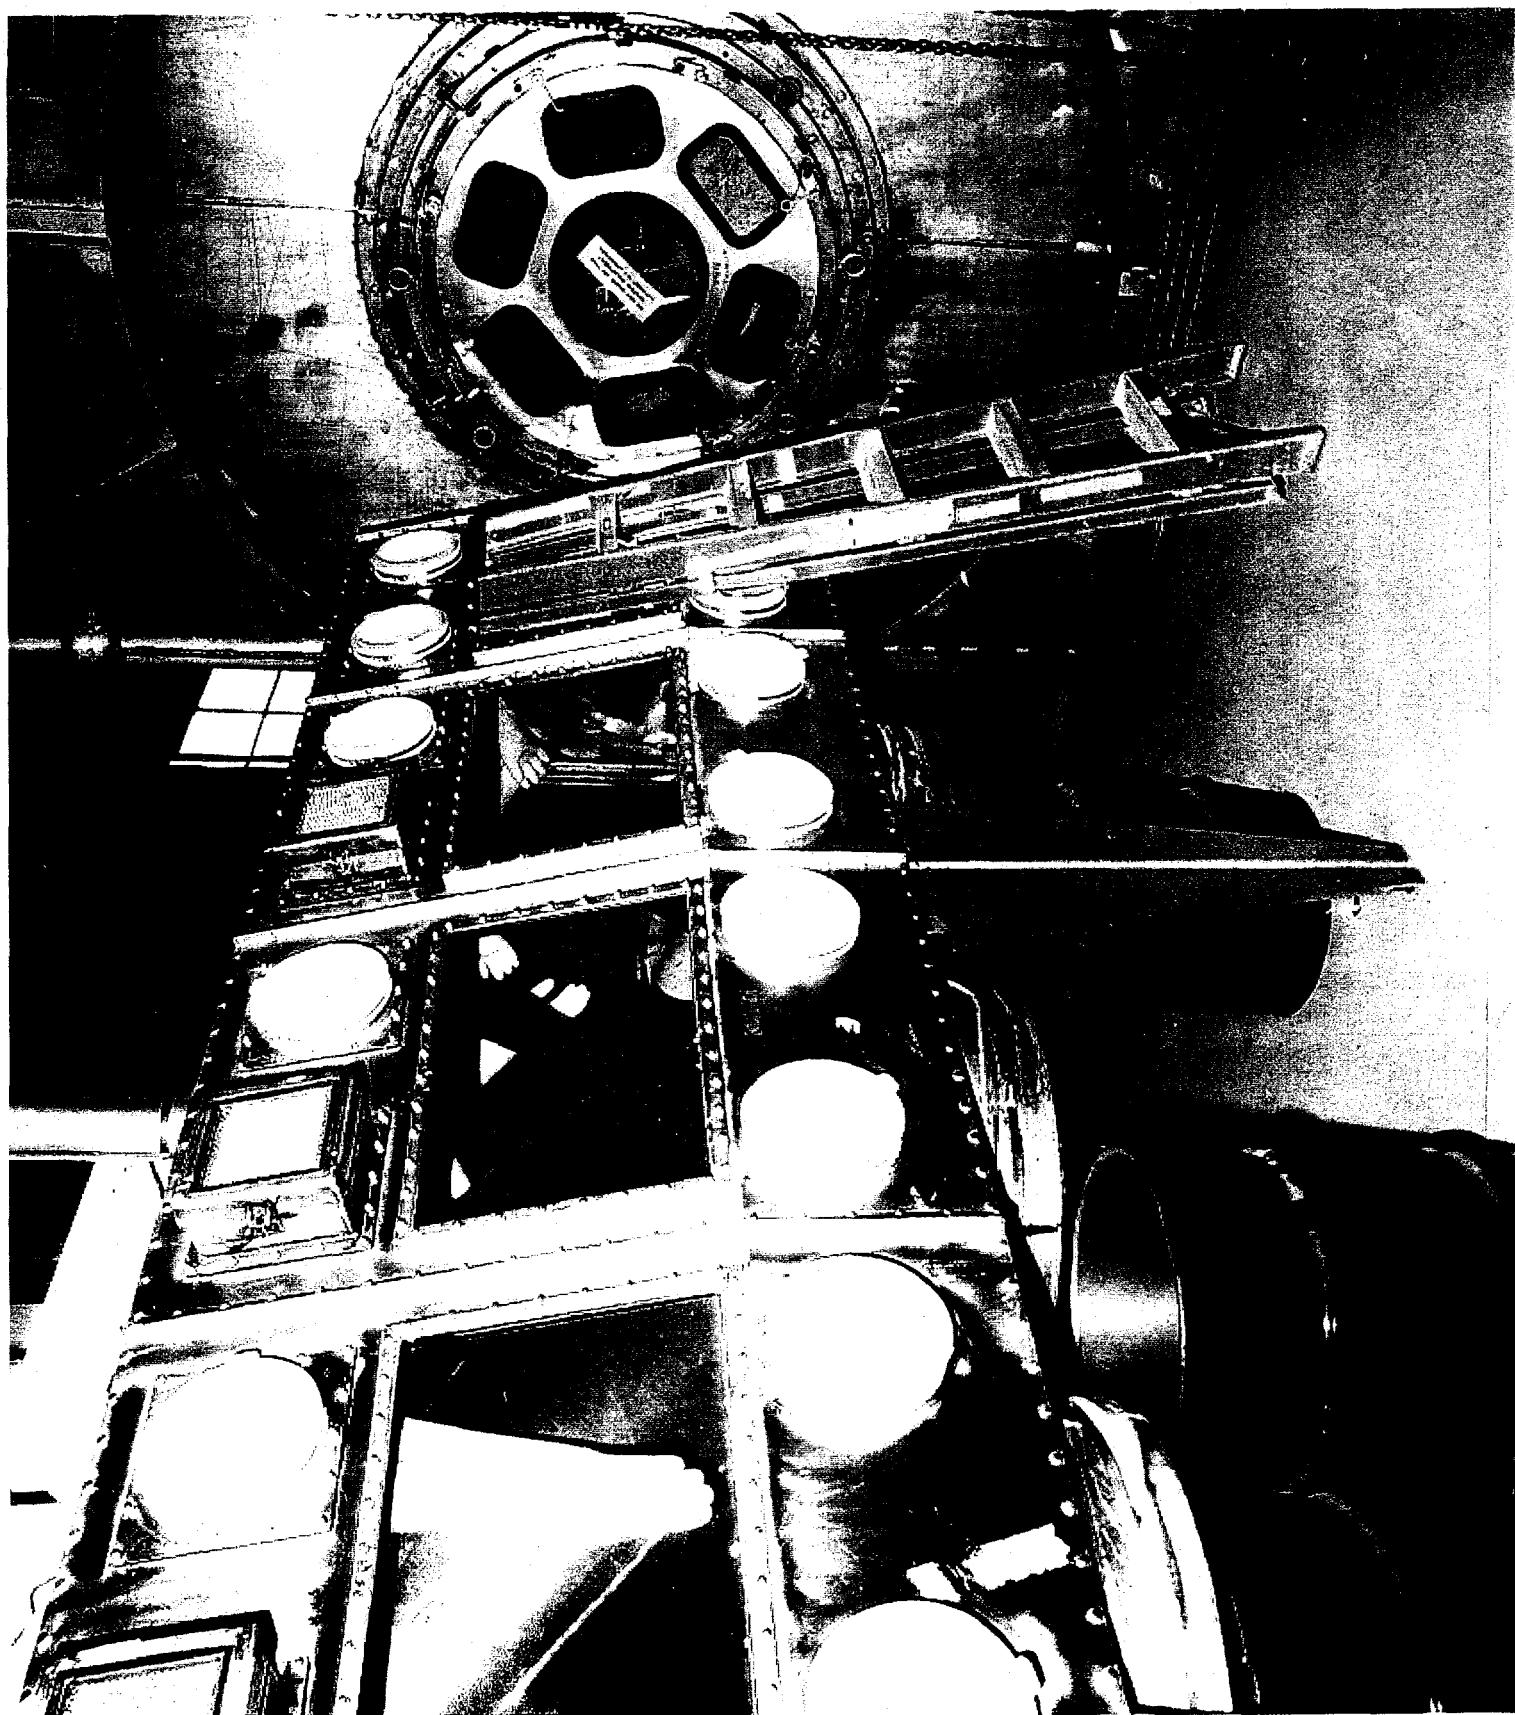
Fig. 3. Building 146, rotary plenum and glove boxes.

Building 146 consisted of a concrete-block structure that measured 18 x 40 ft, with a height of 13 ft (5.5 x 12.2 x 4 m). Equipment in the building consisted of a stainless-steel rotary filter plenum, recovery dry boxes, loading hood, wall exhaust fan, electric unit heater, and two 30-hp electric exhaust fan motors and fans coupled to a 36-in- (91-cm-) diameter stack (Fig. 3).

The existing glove-box system was used to remove the filters inside the rotary drum. Fixative was sprayed onto the filters, which were then wrapped and placed inside TRU-standard-waste boxes. The glove box was modified by removing the east end plate and fabricating a bag-out system to transfer the filters to the waste box.

Using supplied-air respirator protection, workers entered the main plenum to apply fixative and lock down any removable contamination. Radiological surveys were performed to confirm that the plenum was below the TRU waste threshold.

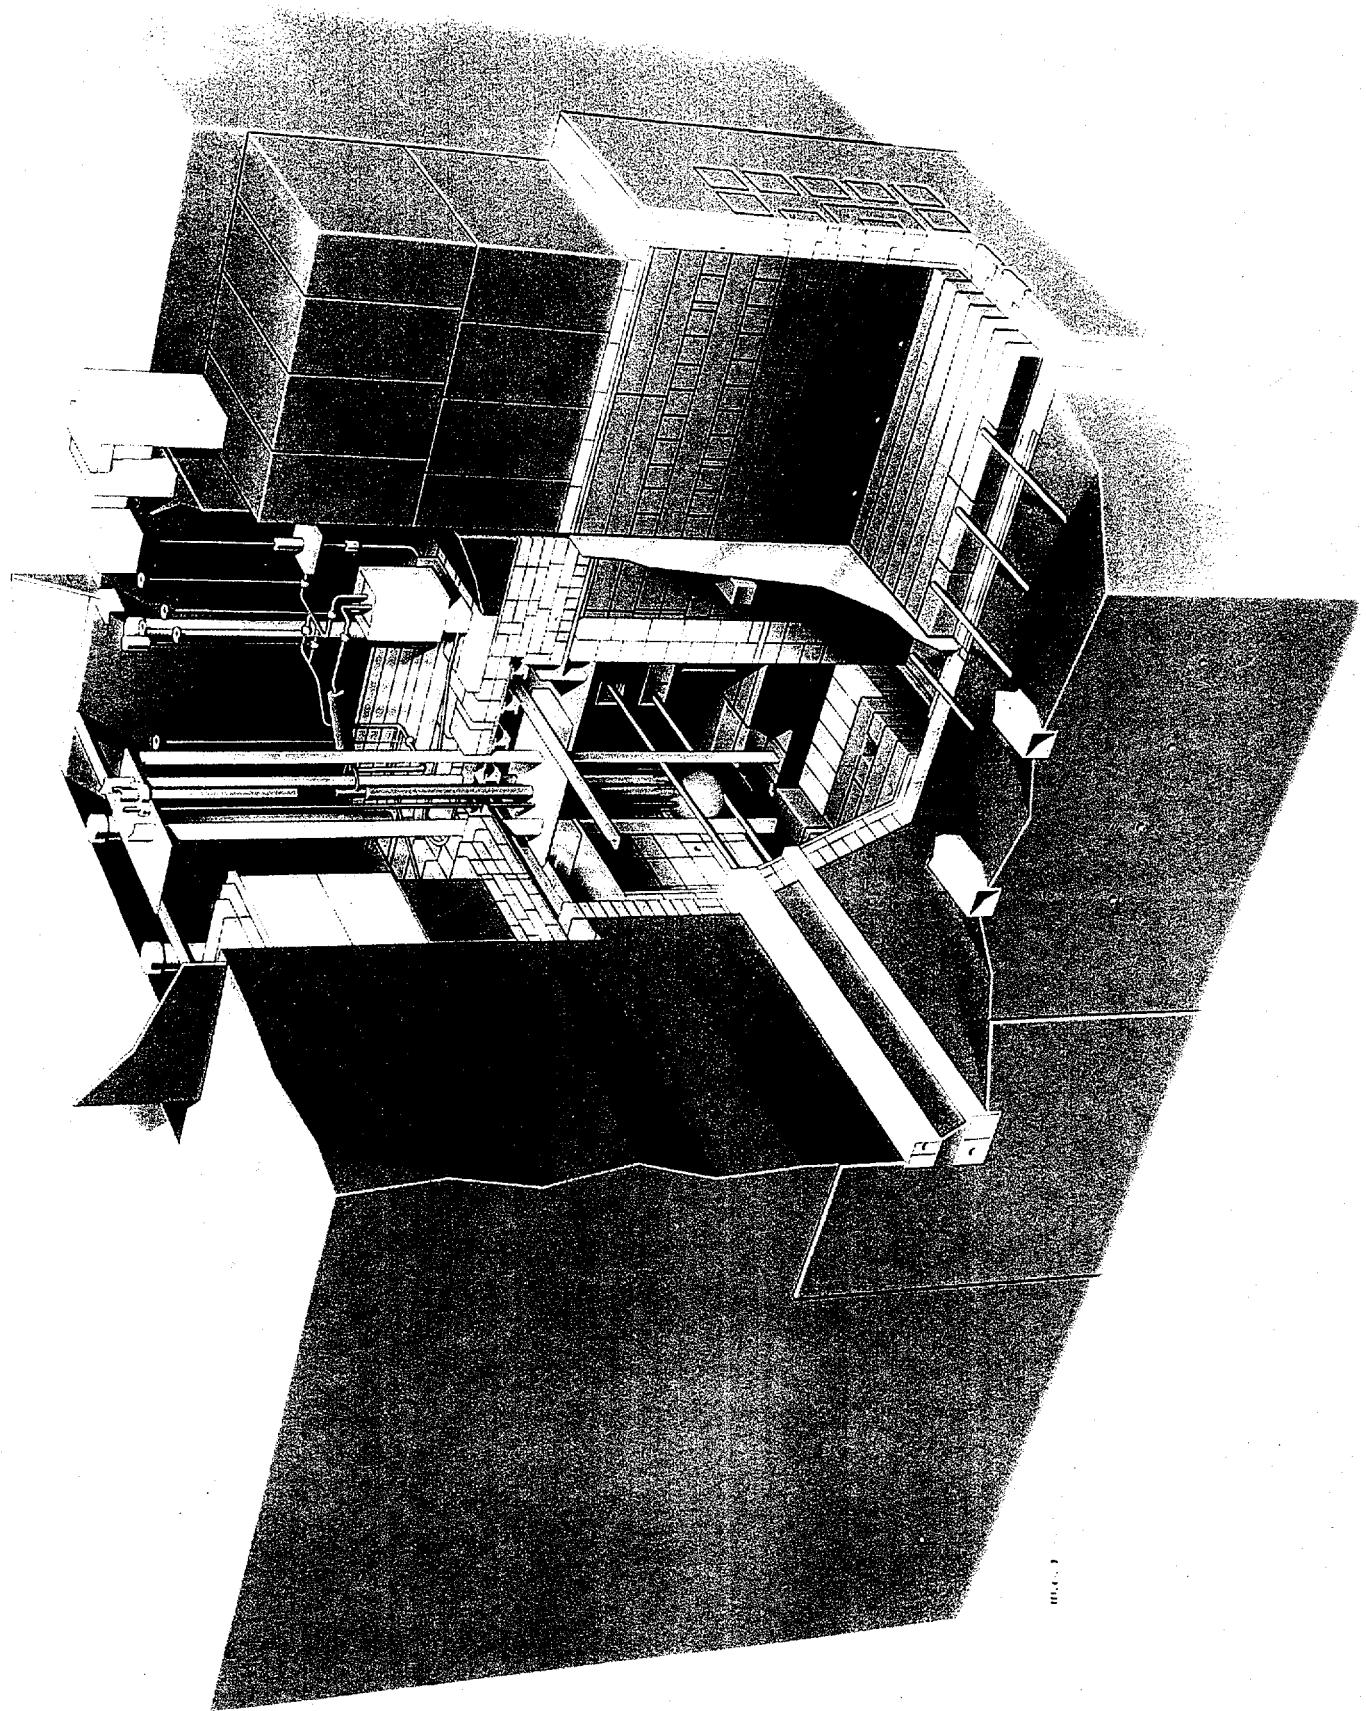
Fig. 7. Water Boiler reactor prior to decommissioning.

A recombination system was added in 1951 to recombine hydrogen and oxygen radiolytically dissociated by reactor operations. The system reduced the hydrogen-explosion hazard, as well as the quantity of radioactivity contaminated gas requiring discharge to the atmosphere (Figs. 6 and 7). The gases flowed through an underground line to a 150-ft (46-m) stack.

Fig. 6. Water Boiler reactor.

In 1985 and 1986, decommissioning activities consisted of dismantling of the exterior facilities associated with the stack line. In 1989, the reactor, its biological shield, and some remaining piping were removed. Detailed engineering for the physical decommissioning for the project began in July 1988; it was completed in June 1989. The on-site subcontractor conducted the decommissioning operations under the management, direction, and support of Laboratory's Waste Management Group.

At first, a physical, chemical, and radiological assessments of the site were conducted. Decommissioning operations included removing the contaminated filter plenum and unstacking the pier in the graphite thermal columns, as well as removing borax paraffin cans, paraffin, and 4-in lead. The recombiner assembly, reactor vessel, and remaining shielding materials were then removed.

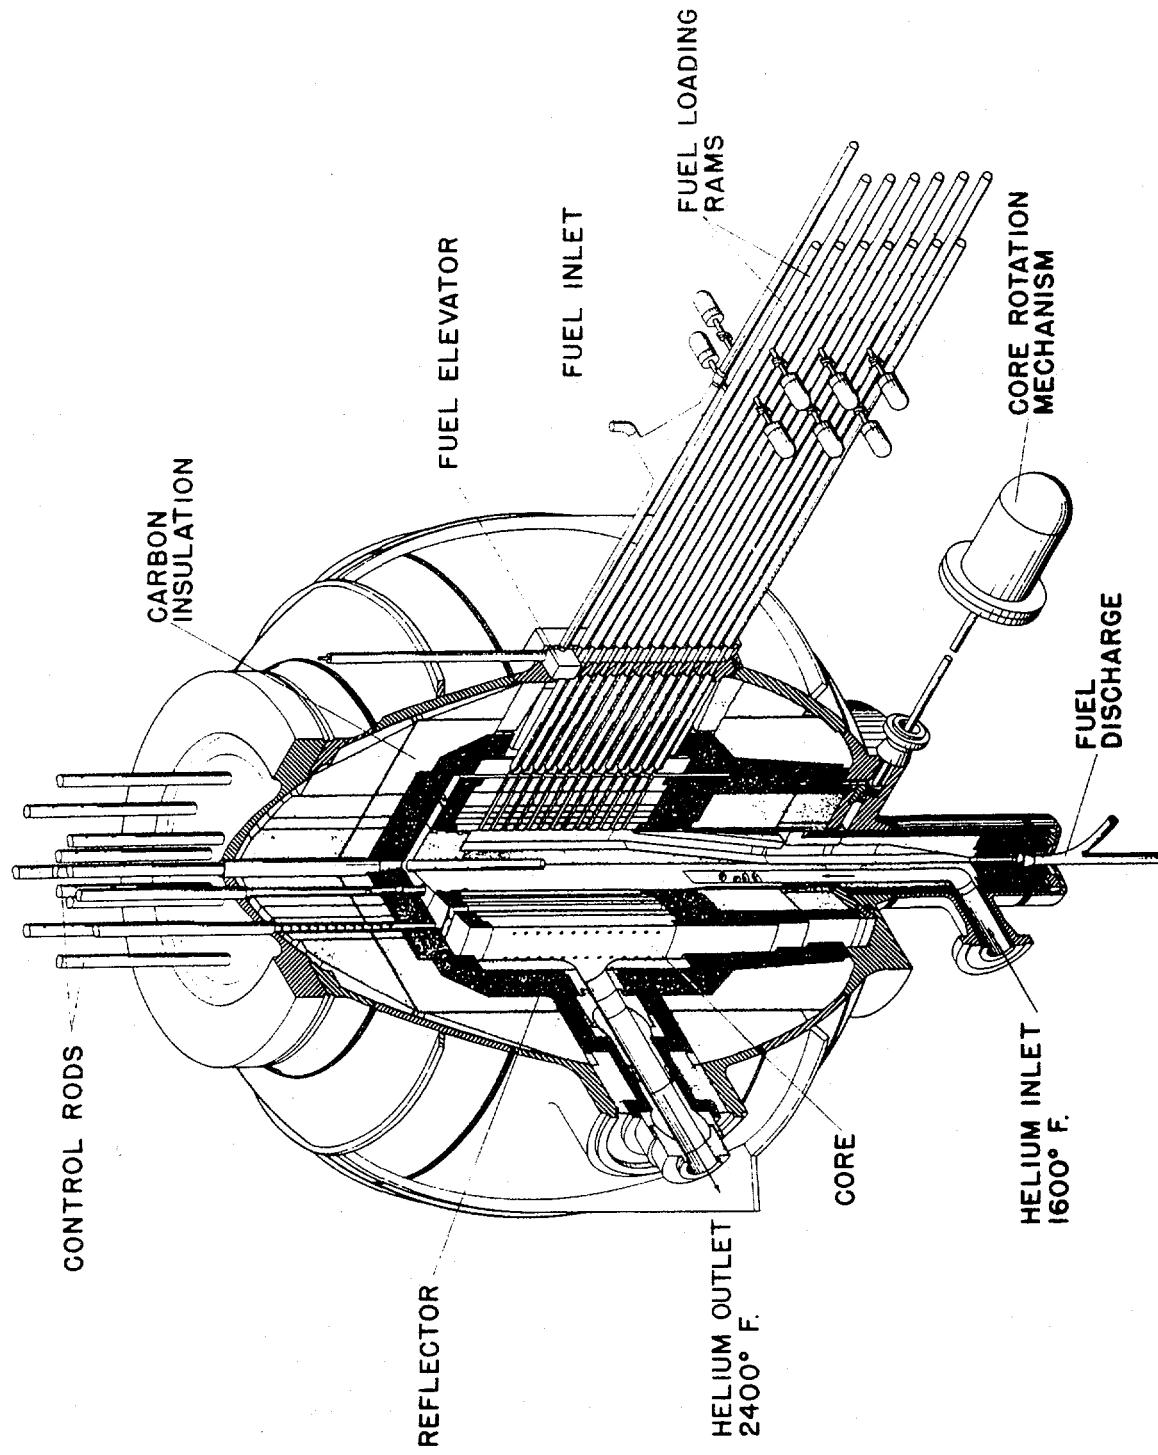
Fig. 9. UHTREX reactor.

Constructed for the Atomic Energy Commission in the late 1960s, the UHTREX reactor operated for approximately one year. The 3-MW reactor was graphite moderated. Helium was used in the primary and secondary cooling loops.

A rotating reactor core could be fueled with enriched uranium while in operation.

Operating temperatures ranged from 871 to 1316°C, with pressures from 475 to 500 psi (3.3 to 3.4x10⁶ Pa). The reactor was shut down in 1970 and defueled (Fig. 9).

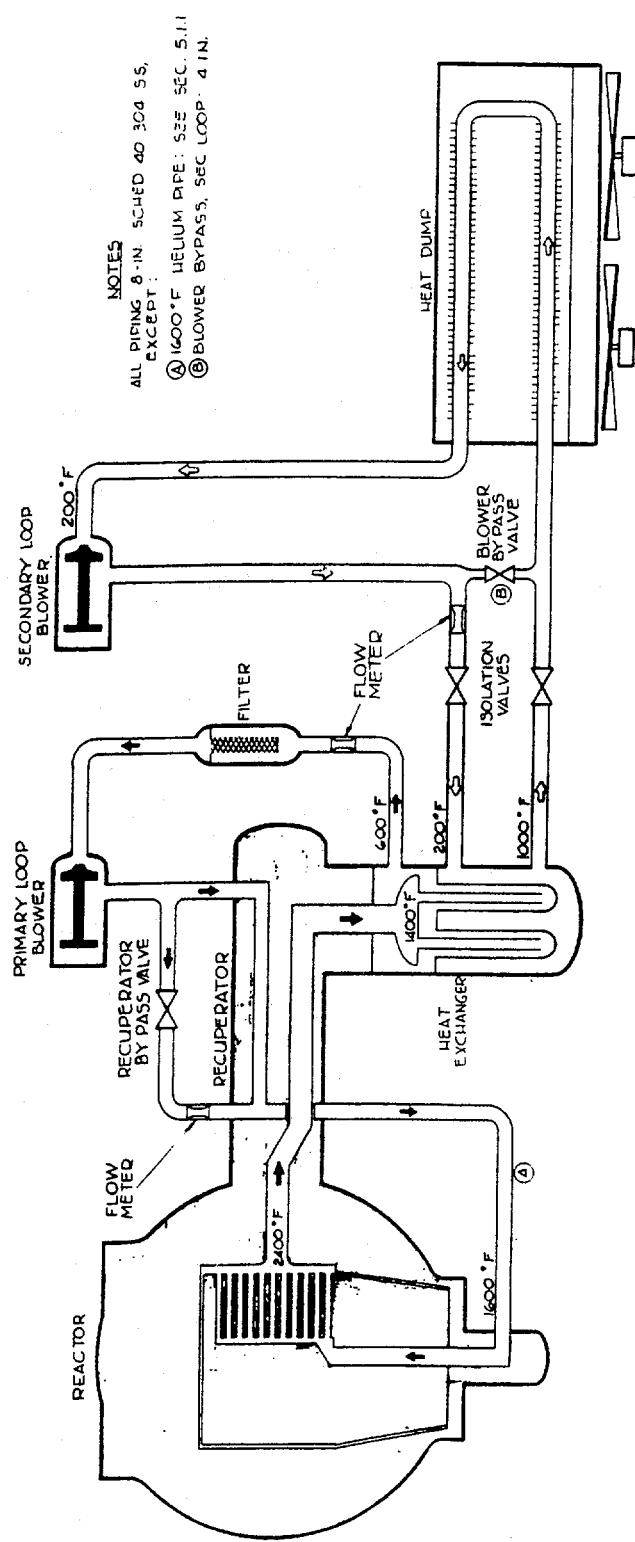
Fig. 10. UHRTREX reactor coolant system.

Housed in room 310, the reactor consisted of a spherical carbon-steel vessel 4 m in diameter with a minimal wall thickness of 4.5 cm. Dense carbon and graphite formed the inner core. It weighted approximately 100 metric tons. The loading rams and core motor drive were located in different rooms. Twelve control rods entered the core vertically from a high-bay room above. The primary and secondary loops were fabricated of 20-cm-diameter stainless-steel piping. The cylindrical recuperator and heat exchanger were also in room 310 (Figs. 10 and 11).
