Examination of Stainless Steel-Clad Connecticut Yankee Fuel Assembly S004 After Storage in Borated Water

September 1982

EXAMINATION OF STAINLESS STEEL-CLAD
CONNECTICUT YANKEE FUEL ASSEMBLY 5004
AFTER STORAGE IN BORATED WATER

Pacific Northwest Laboratory
Richland, Washington 99352

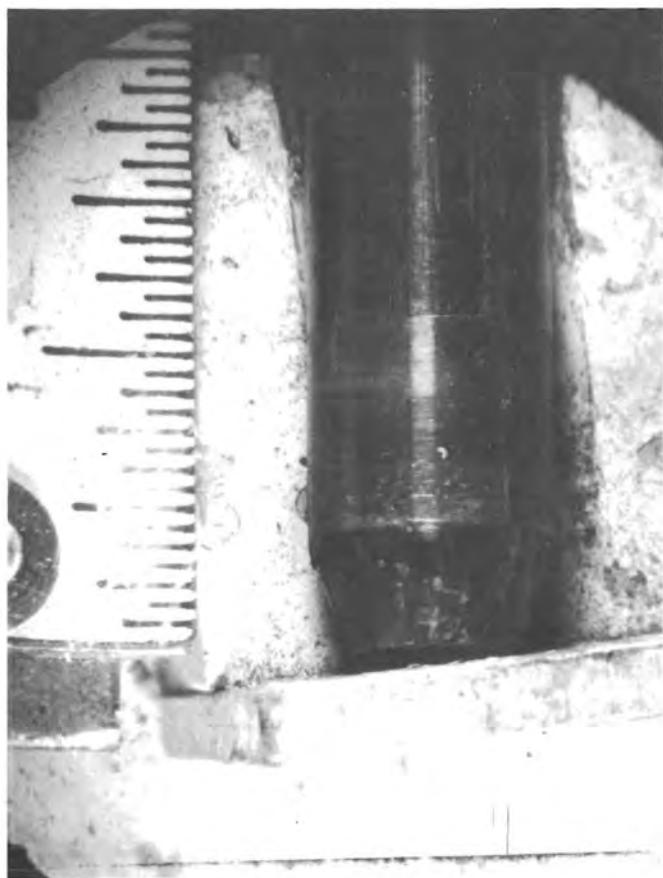
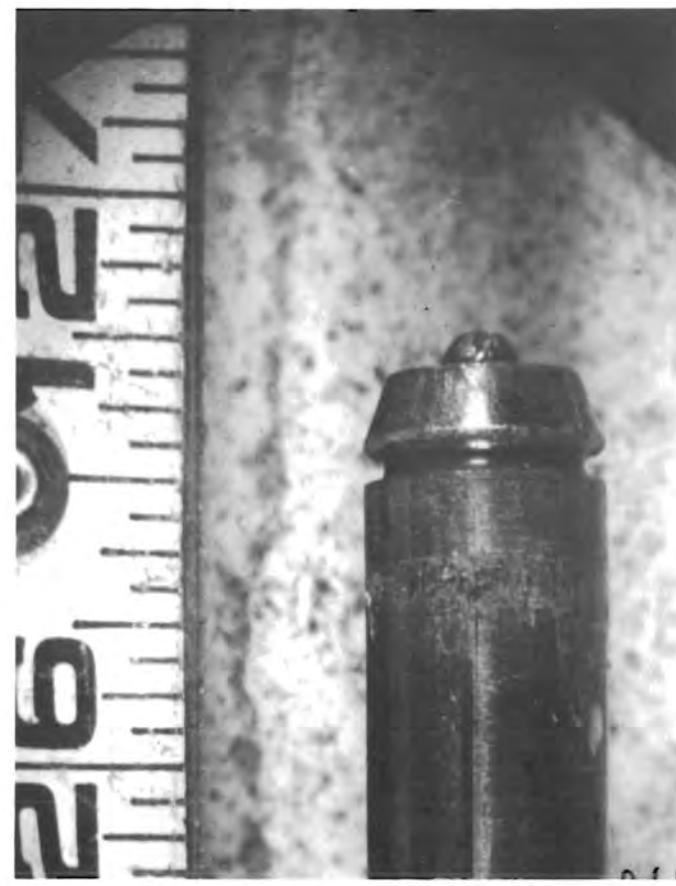
FIGURE 16. Upper and Lower End Caps and End Cap Weld Areas from S004 Fuel Rods Showing the Machined Area at the Lower End Cap and Handling Marks

indicated that surface deposits were very thin. The fuel rod end cap welds showed no indication of exterior corrosion either in the visual examinations (Figure 16) or in the metallographic examinations (Figure 17). Axial scratches, attributed to abrasion at spacer contacts, were observed when the fuel rods were inserted into or removed from the assembly, and some shallow indentations at cladding-grid spacer spring contact were noted (see Figures 16 and 18). None of the anomalies observed during the underwater periscope examination were discernible. The fuel rods were dry during the visual

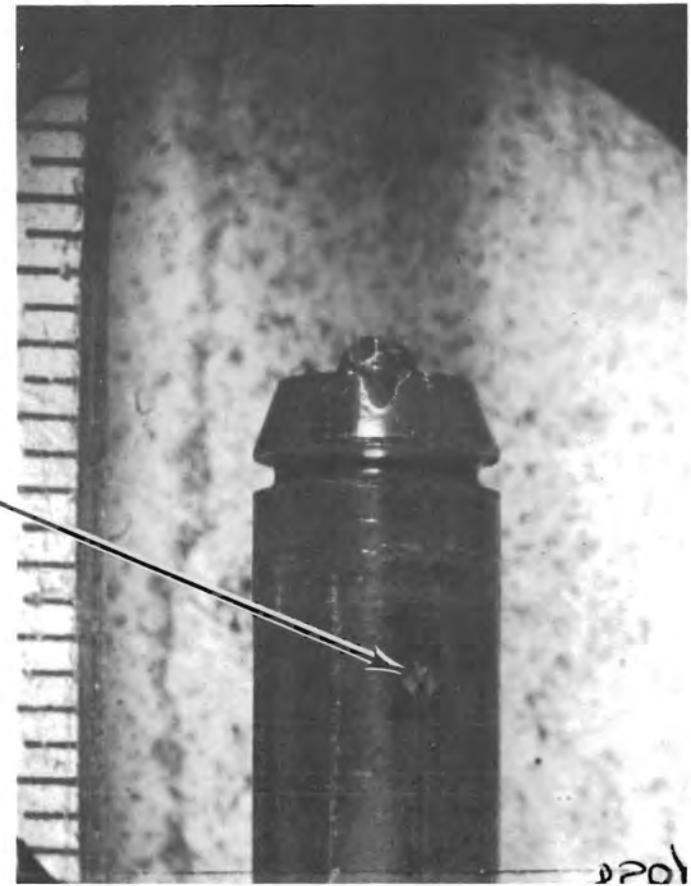
FIGURE 18. Shallow Indentation on Cladding at Grid Spacer Contact Point That was Observed During Visual Examination

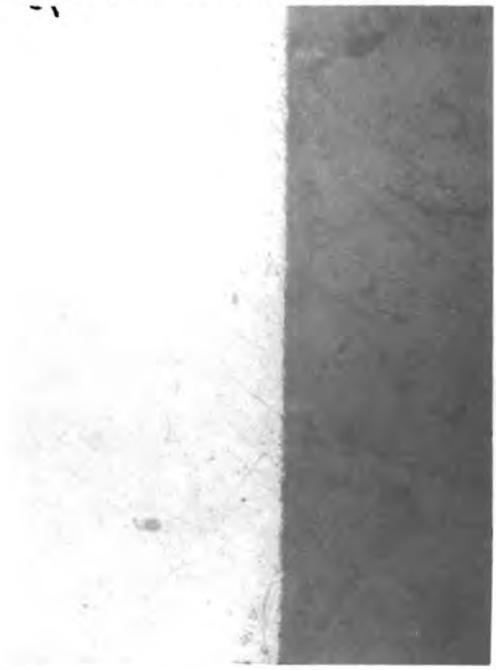
FIGURE 43. Metallography of ID and OD Surface Condition of Cladding from Connecticut Yankee Fuel Rods

The cladding surface condition was generally very smooth with no measurable surface layers in the fuel rods examined from the three assemblies (Figures 43 through 47). However, the light brown cladding surface appearance suggested the presence of a thin surface oxide. There were no apparent differences in corrosion between the cladding or base material, the weld area, and the weld heat-affected zone.

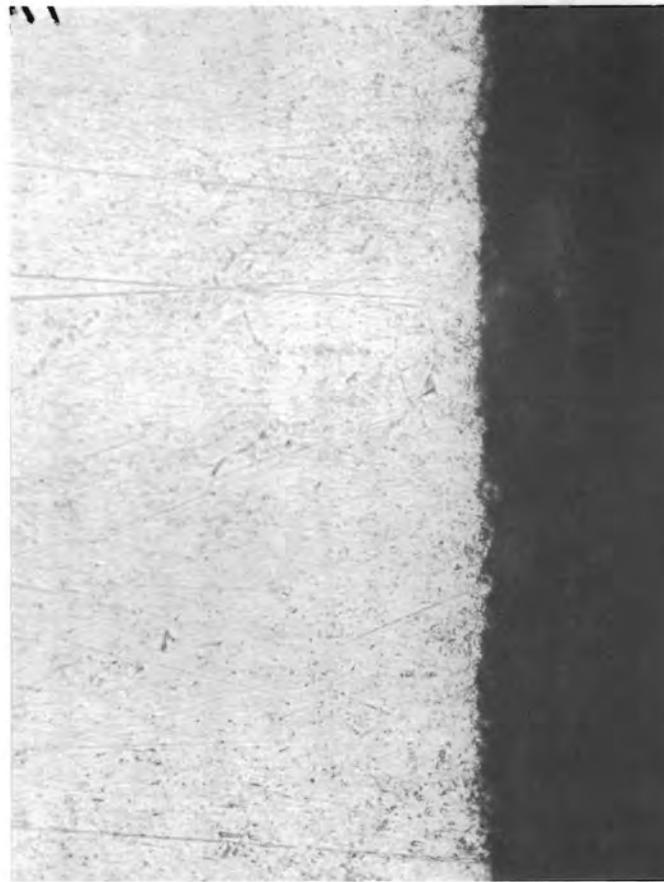
OD 50 μ m

FIGURE 47. Metallography of Surface Condition of Cladding Near Lower End Cap on S004 Fuel Rod AHR

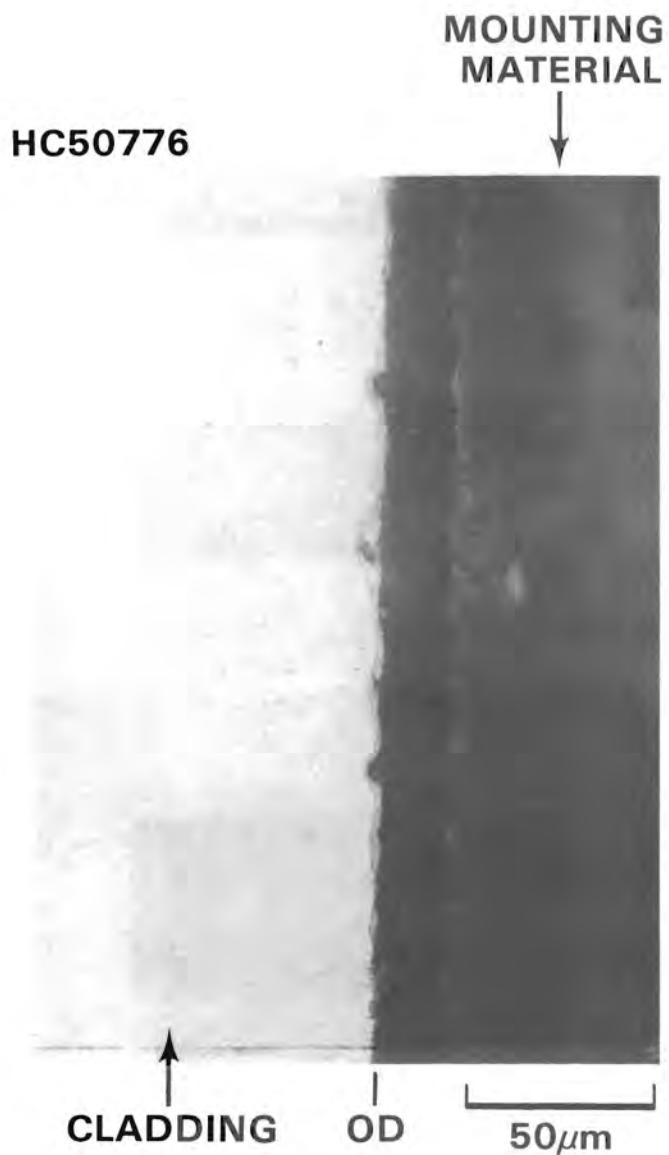
FIGURE 48. Metallography of Surface Layer on Cladding from S004 Fuel Rod AHR
