Steam Generator Group Project

Task 13 Final Report: Nondestructive Examination Validation

Prepared by
E. R. Bradley, P. G. Doctor, R. H. Ferris, J. A. Buchanan

Pacific Northwest Laboratory
Richland, WA 99352

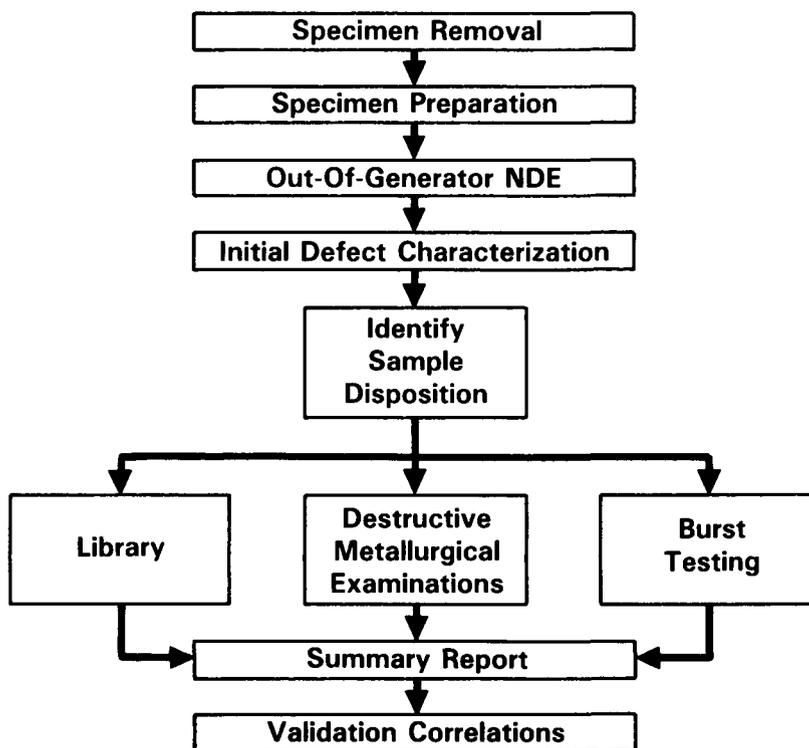
FIGURE 2.1. Flow Diagram for NDE Validation

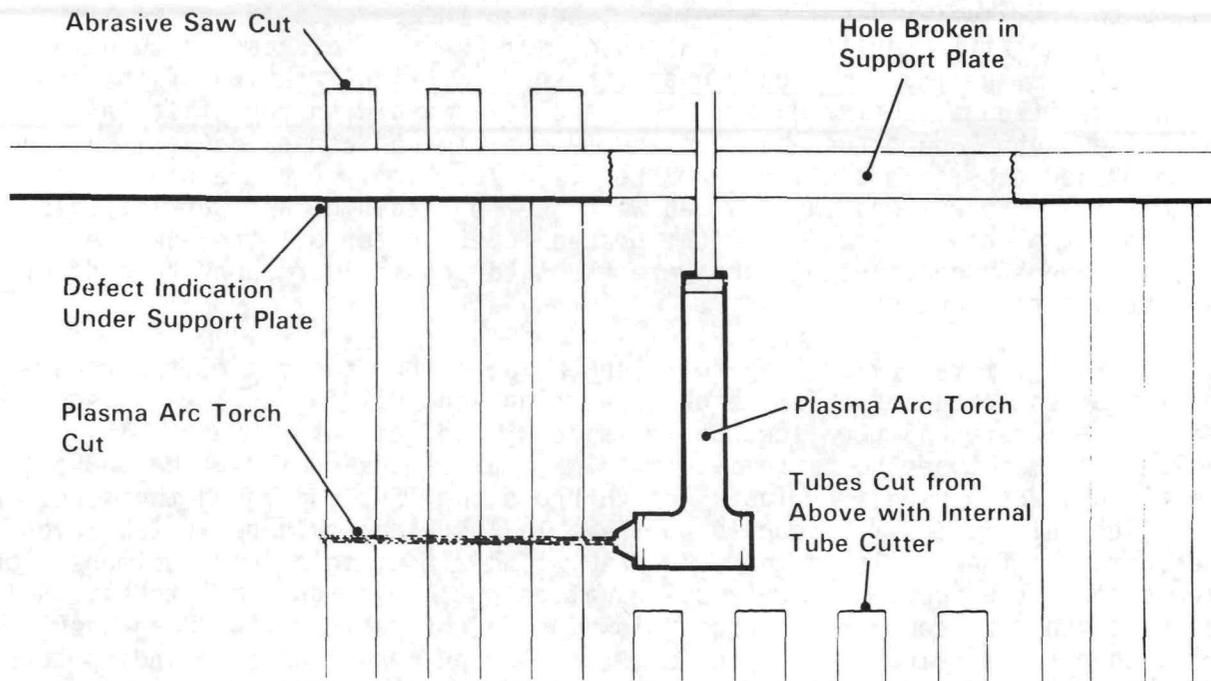
FIGURE 2.5. Technique for Removing Tube Specimens with Indicated Defect at Seventh TSP

Specimens that included the seventh TSP intersection were removed concurrently with or immediately after removal of the U-bends. The technique used for their removal is illustrated in Figure 2.5. The specimen tube and the adjacent tubes were cut ~6 in. above the seventh TSP with the abrasive saw, and the U-bend portion of the tube was removed. The sample tube was then positively identified by inserting a probe from the channel head where its location could be determined. As the probe emerged from the cut tube at the seventh

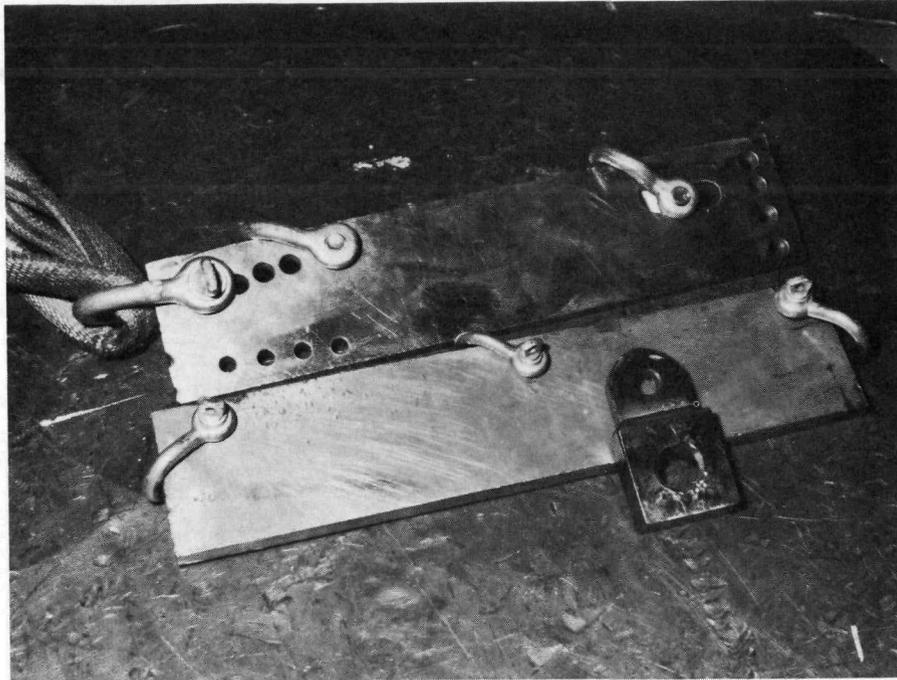
FIGURE 2.6. Gripping Devices for Pulling Tubes from Above

To keep removal rates acceptably high and simultaneously minimize damage to the specimens, the following approach was adopted. For hot leg tubes where direct pulling forces were lower than 5,000 lb, two or three adjacent tubes were pulled before removing the specimen tube, lowering the pulling forces to <1,500 lb. Four to six cold leg tubes were pulled before retrieving a specimen tube, which generally kept pulling forces under 7,000 lb.

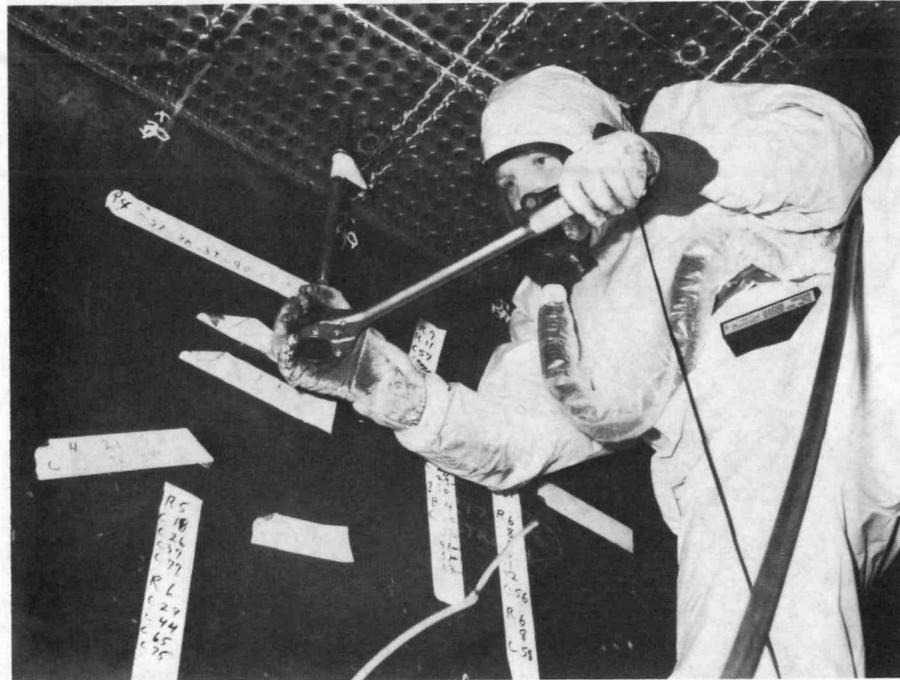
FIGURE 2.8. Cutting TTS Specimen Above the Sludge Pile

specimen to be removed was cut above the sludge pile from the inside with a rotary hand cutter as shown in Figure 2.8. A completely cut tube was essential for reducing the pulling forces and minimizing tube damage; the cut tubes were then inspected using a video probe before tube removal. An offset was generally observed in a completely severed tube, as shown by the video image in Figure 2.9. Additional cuts were made if the video inspection indicated an incomplete cut. The tube-to-tube sheet fillet weld was milled off as shown in Figure 2.10. A fixture was used to hold the air motor and cutting tool in proper alignment against the tube sheet. The fillet weld was then removed by raising the motor and single-blade cutting tool using the lever device of the holding fixture. After the fillet weld had been removed, the roll-expanded region was heated with an oxyacetylene torch, which reduced the force required to pull the tube from the tube sheet. A threaded mandrel or pulling spear was then inserted into the tube end. A 2-ton hydraulic jack was positioned over the mandrel, and the specimen tube was pulled out as the jack operated on the

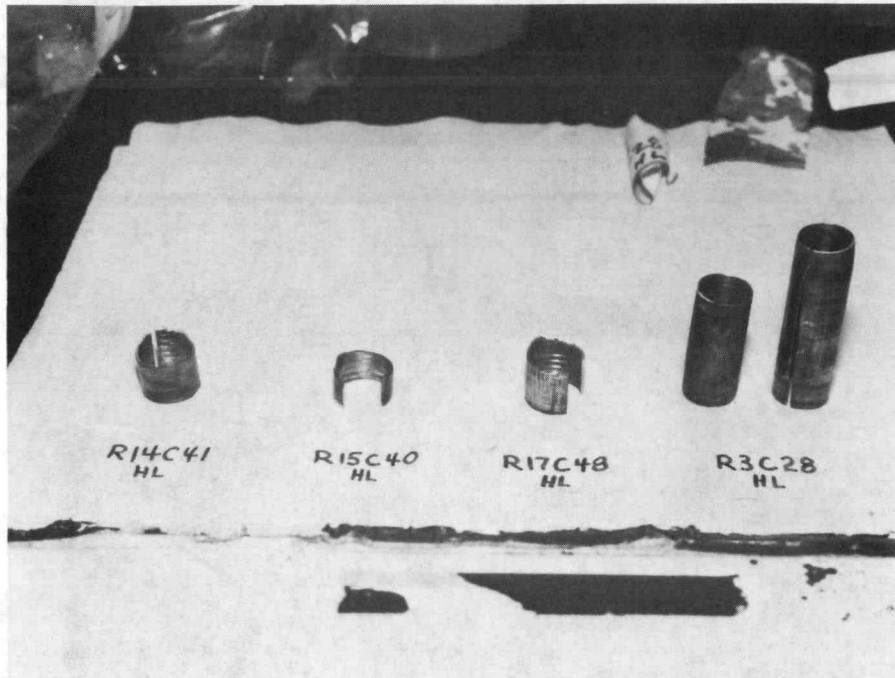
FIGURE 2.12. Examples of Failed Tube Ends. These sections failed during pulling of previously plugged tubes.

Some specimens that had been plugged during service, in which the plugs had subsequently been removed by drilling (Wheeler et al. 1984), fractured during the tube-pulling operation. Four examples of tube ends that failed in this manner are shown in Figure 2.12. The fractures usually occurred in the roll-expanded region, although some failures occurred above the roll transition but within the region drilled out to remove the plugs. These specimen tubes were removed by repetitive insertion and jacking of mandrels with various diameters and lengths until the complete specimen was removed. Up to five repetitions of the procedure were required for some of the more difficult-to-remove specimens.

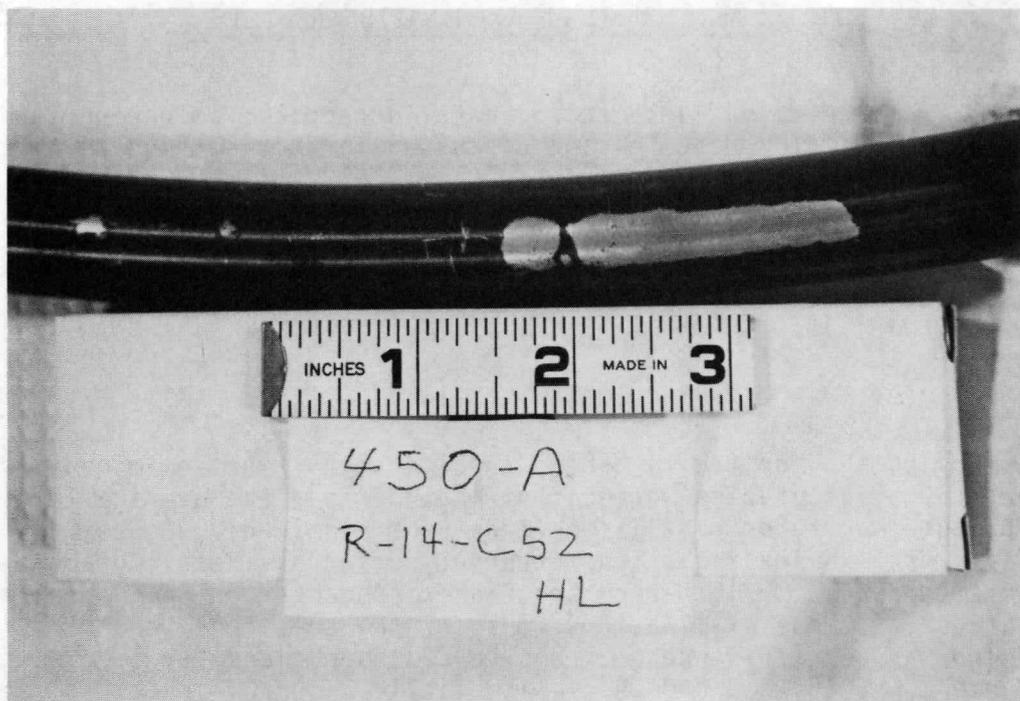
FIGURE 3.1. U-Bend Specimen 450A (R14 C52 HL) Showing Discontinuities in the Copper-Rich OD Surface Deposit

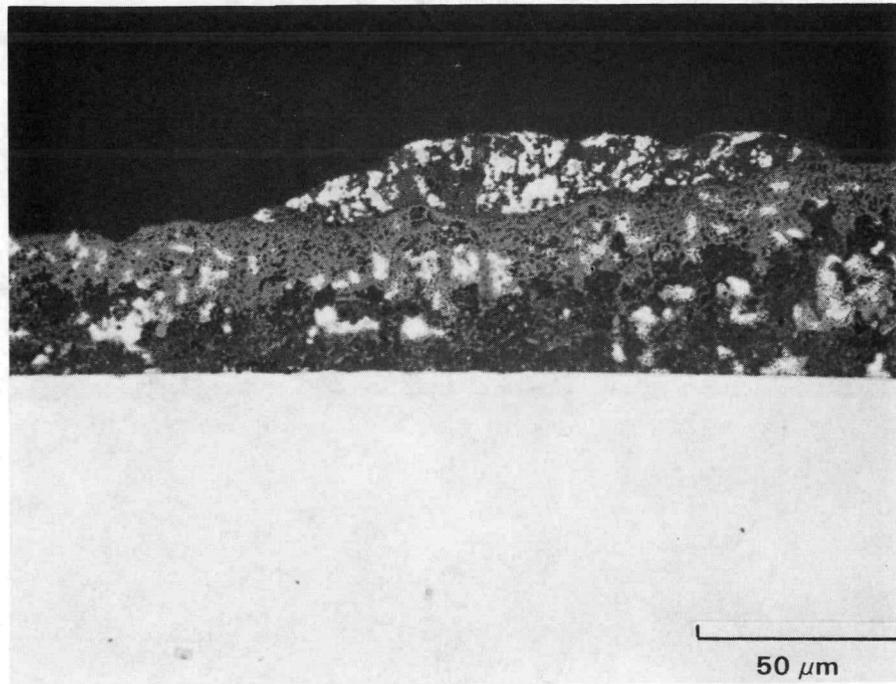
FIGURE 3.2. Optical Micrograph Showing Deposits on the OD Surface of U-Bend Specimen 430B (R35 C56)

The microstructure of the deposits can be generally characterized as a layered structure with multiple phases and granular features as illustrated by the optical micrographs in Figures 3.2 through 3.5. The relative amount and distribution of the different phases varied from sample to sample and also around the circumference of each sample. Variations in phase distribution were especially evident for the bright phase that was identified as metallic Cu by EDS and x-ray diffraction. Copper particles were observed throughout the thicker areas of the deposits but were concentrated in discrete layers, suggesting periodic intrusion of large concentrations of Cu into the secondary water. The relative amount of the metallic Cu phase was greater in the thinner areas of the deposits as can be seen by comparing Figures 3.2 and 3.3, which

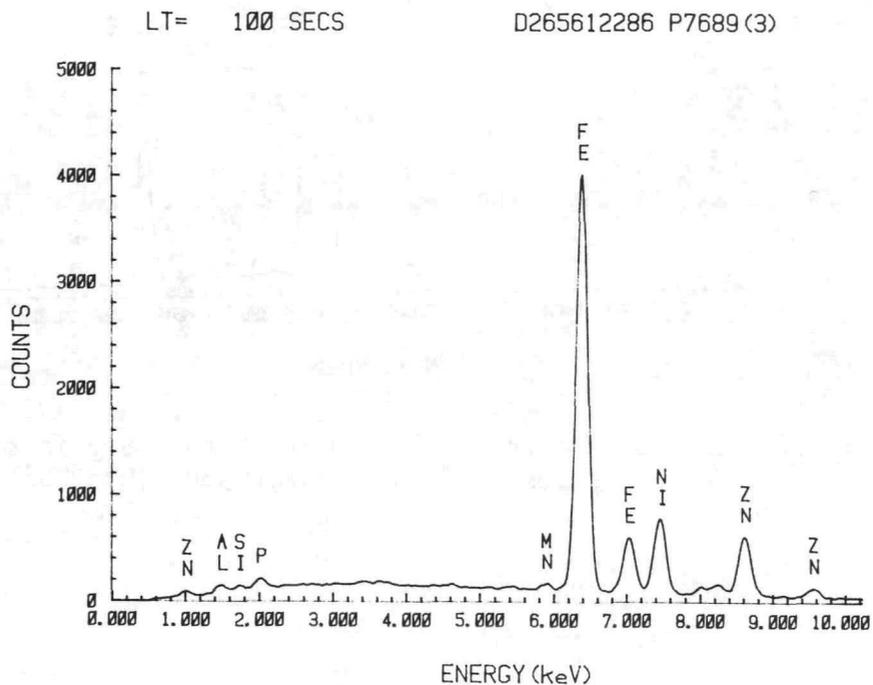
FIGURE 3.6. Typical EDS Spectra from an Iron-Rich Phase in the OD Surface Deposits from Specimen 430B (R35 C56)

Two additional phases were identified by EDS analysis of the deposits on the surface of Specimen 430B. The predominant phase was rich in Fe with lesser amounts of Ni and Zn as shown by a typical EDS spectra in Figure 3.6. This phase was distributed throughout the deposit in the form of individual particles or discrete layers of particles, and the composition remained relatively constant throughout the deposit. It was assumed to be primarily magnetite, although a positive phase identification was not made.

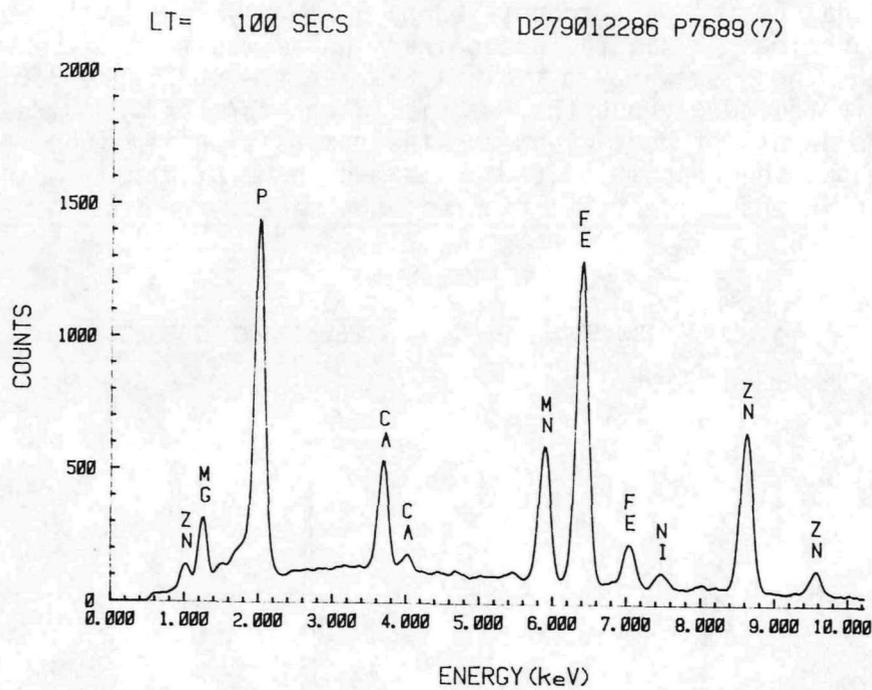
FIGURE 3.7. EDS Spectra from a Phosphorus-Rich Phase in the OD Surface Deposits from Specimen 430B (R35 C56)

The other noncopper phase was observed in the thicker regions of the deposits and appeared to provide a binder material for the discrete magnetite particles. This phase was found in a layer adjacent to the tube surface; the thickness of the layer ranged up to $\sim 40 \mu\text{m}$. Analysis using EDS showed that the phase generally contained P, Ca, Mn, Fe, and Zn with smaller amounts of Mg and Ni (see Figure 3.7). The relative concentration of the various elements varied within the deposit, and some regions were found to be particularly high in Ca and P. The consistently high P content suggests that this phase is a metal phosphate with the cation concentration varying locally within the deposit. Although SEM/EDS examinations were not conducted on the deposits from Specimen 561A, similar phases would be expected but with possible different distributions.

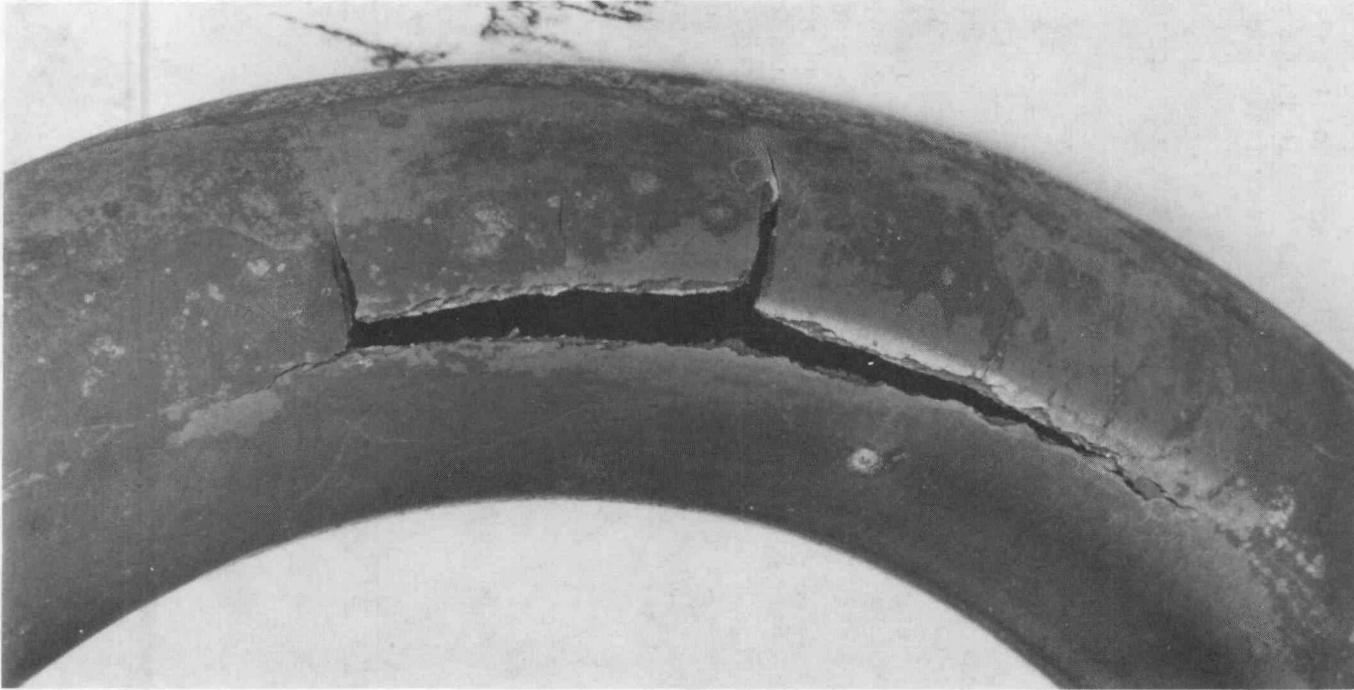
FIGURE 3.8. Row 1 U-Bend Showing Severe Cracking and Rupture

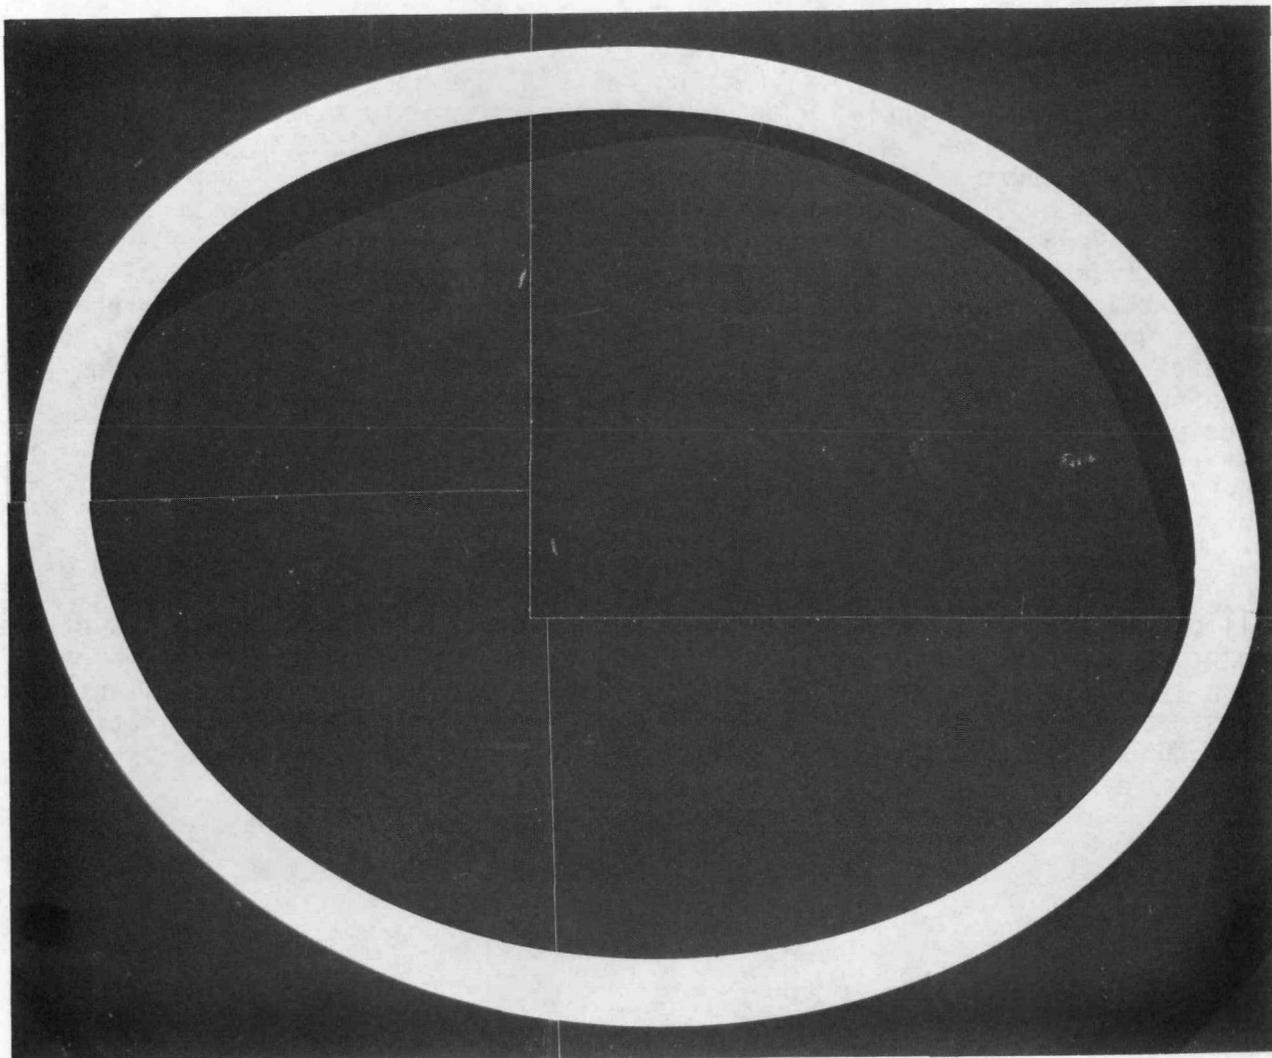
FIGURE 3.10. Optical Micrograph Showing Tube Ovalization and OD Stress Corrosion Cracking of U-Bend Specimen 1049B (R2 C27 at Apex)

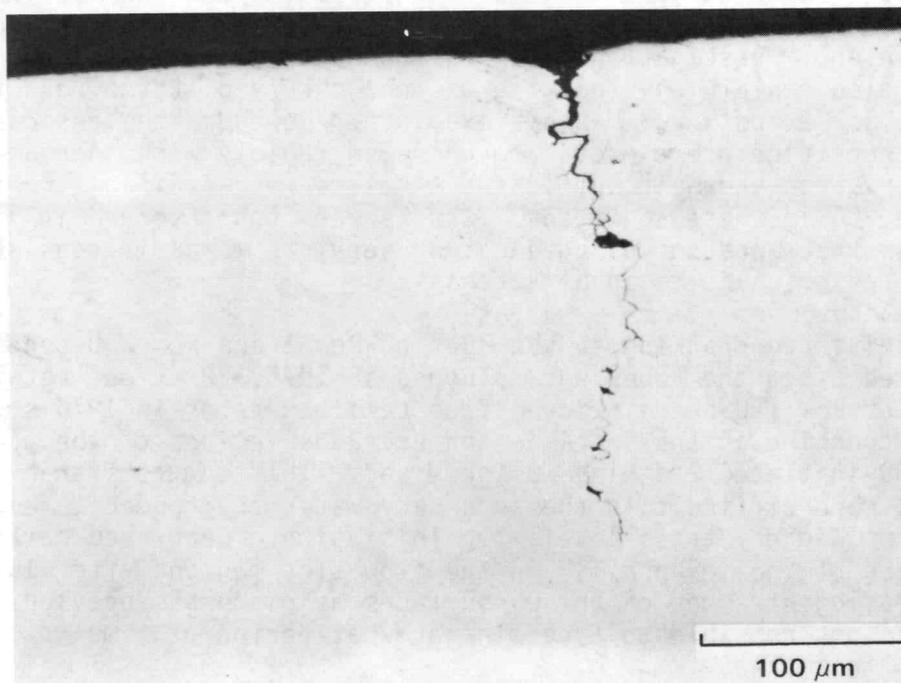
FIGURE 3.13. Optical Micrograph Showing a Circumferential SCC Initiated at a Shallow Surface Scratch on the OD Surface of U-Bend Specimen 1049B (R2 C27)

The observed SCC at the apex of the inner row U-bends is consistent with the stress distributions produced by tube ovalization from the inward movement of the U-bend legs that was caused by corrosion of the seventh TSP and resulted in partial closure of the flow slots. Under these conditions of tube ovalization, tensile hoop stresses would be expected on the OD surfaces at the sides

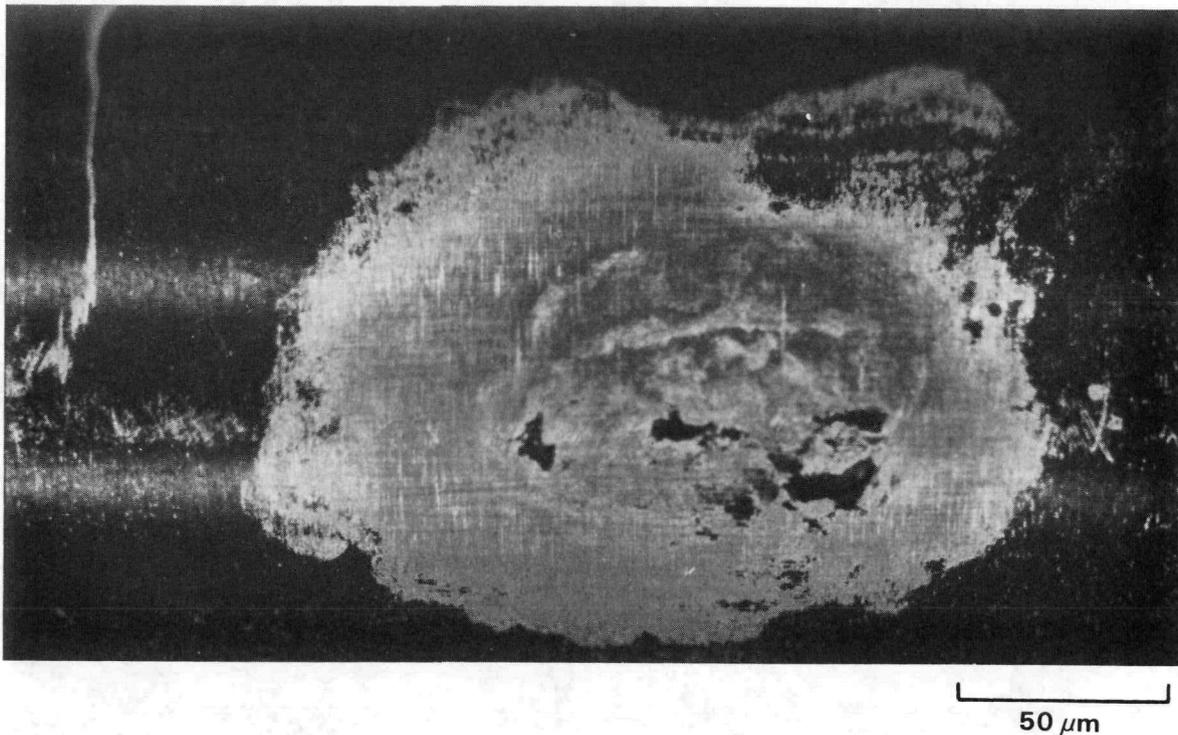
FIGURE 3.14. Photograph of Typical AVB Contact Area Showing Little Evidence of Wear or Corrosion; Specimen 491A (R13 C29)

A typical AVB contact area from Specimen 491A (R13 C29) is shown in Figure 3.14. The contact areas were marked by the absence of the thin dark oxide coating on the tube surface and occasional deposits that were not removed by chemical cleaning. Shallow circumferential scratches produced during tube fabrication were often observed in the contact areas, which shows the lack of significant abrasion or corrosion.

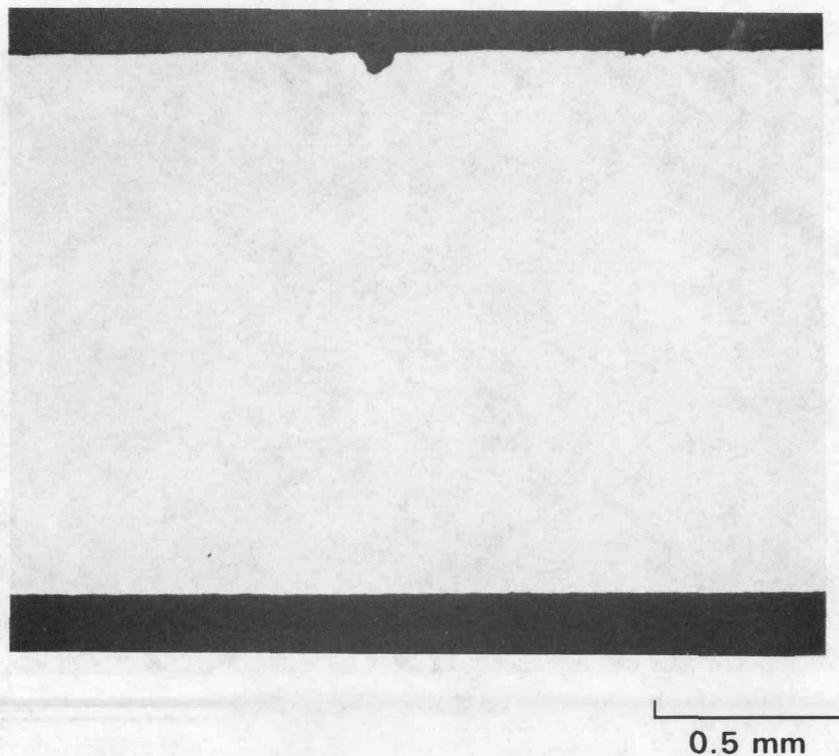
FIGURE 3.15. Optical Micrograph Showing an Isolated Pit at an AVB Contact Area on U-Bend Specimen 497A (R10 C29 HL)

Evidence of wear and corrosion under the AVB contact areas was found on seven of the contact areas examined. The wear marks were generally rectangular in shape and often contained linear features that were filled with corrosion products or deposits as illustrated in Figure 3.16. A pit-like depression filled with corrosion products or deposits was also observed near the center of a wear mark on Specimen 435C (R31 C58 HL) as shown in Figure 3.17. The shape

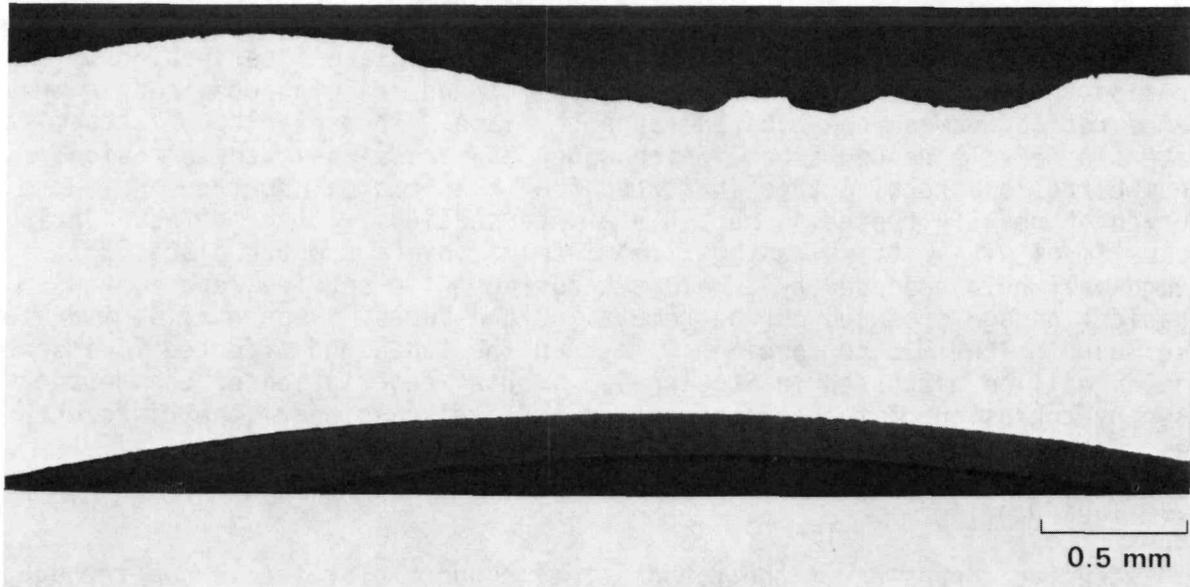
FIGURE 3.18. Optical Micrograph Showing AVB Contact Wear and Corrosion on U-Bend Specimen 435C (R31 C58 HL)

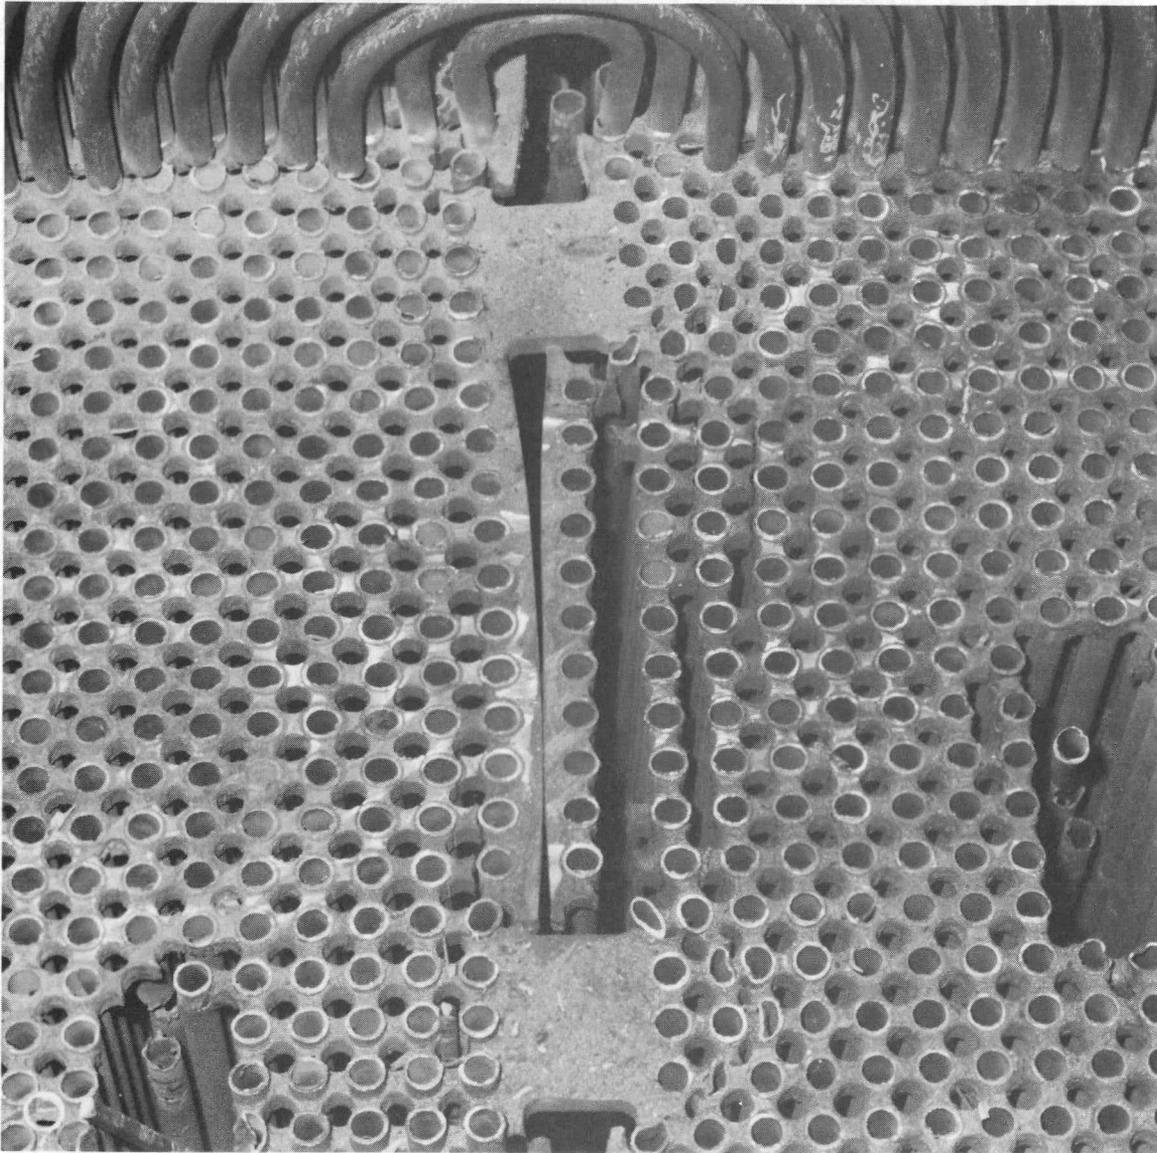
FIGURE 3.19. Seventh TSP After U-Bend Removal Showing Support Plate Cracking and Tube Denting

Increased support plate corrosion and denting on the hot leg side are consistent with the higher operating temperatures in this region. Corrosion rates increase dramatically with increasing temperature, and observations regarding support plate breakup during full-length tube removal are in general agreement with expected temperature variations. All seven support plates on the hot leg side broke apart during tube removal, indicating extensive support

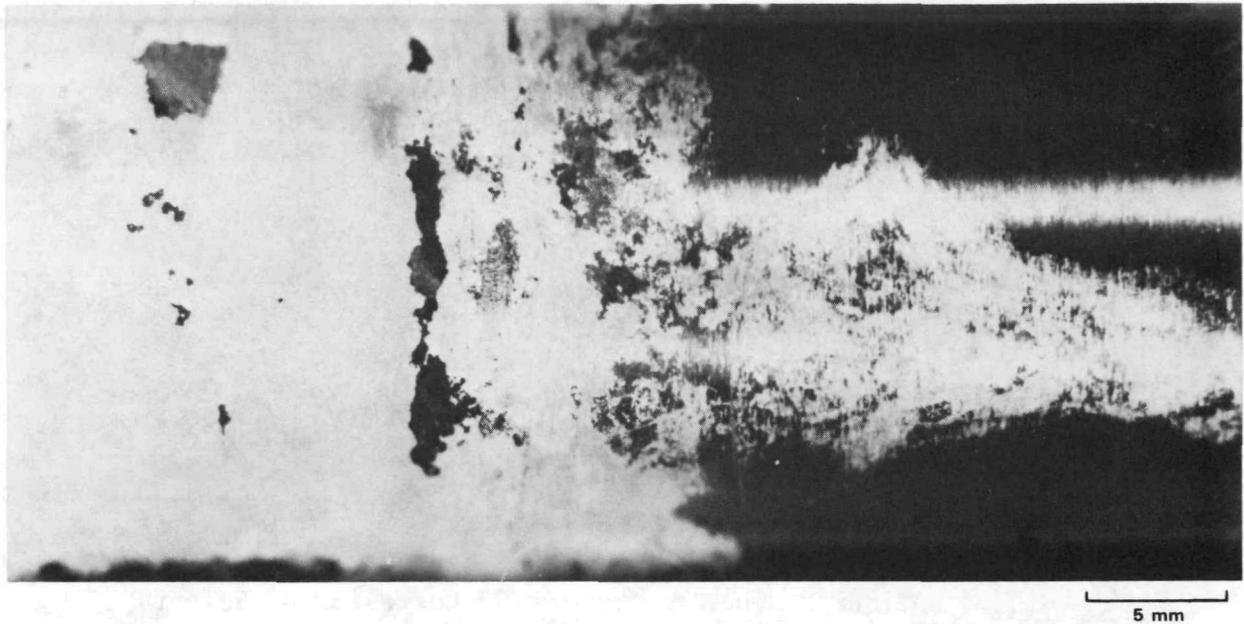
FIGURE 3.20. Typical TSP Intersection; Specimen 665 (R7 C57 HL)

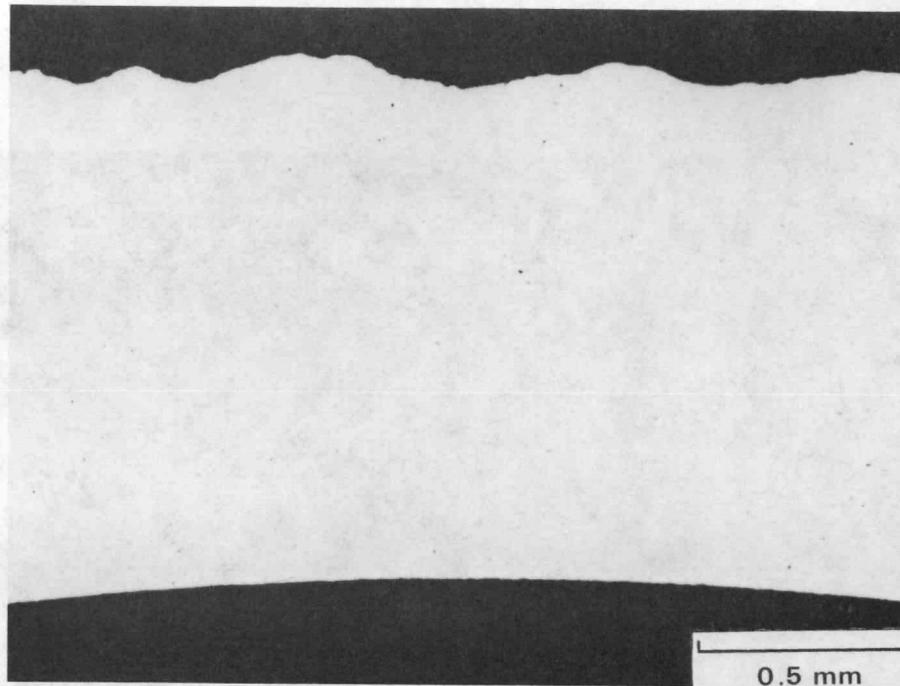
FIGURE 3.21. Optical Micrograph Showing OD Corrosion of Seventh TSP Specimen 455 (R9 C47 HL7)

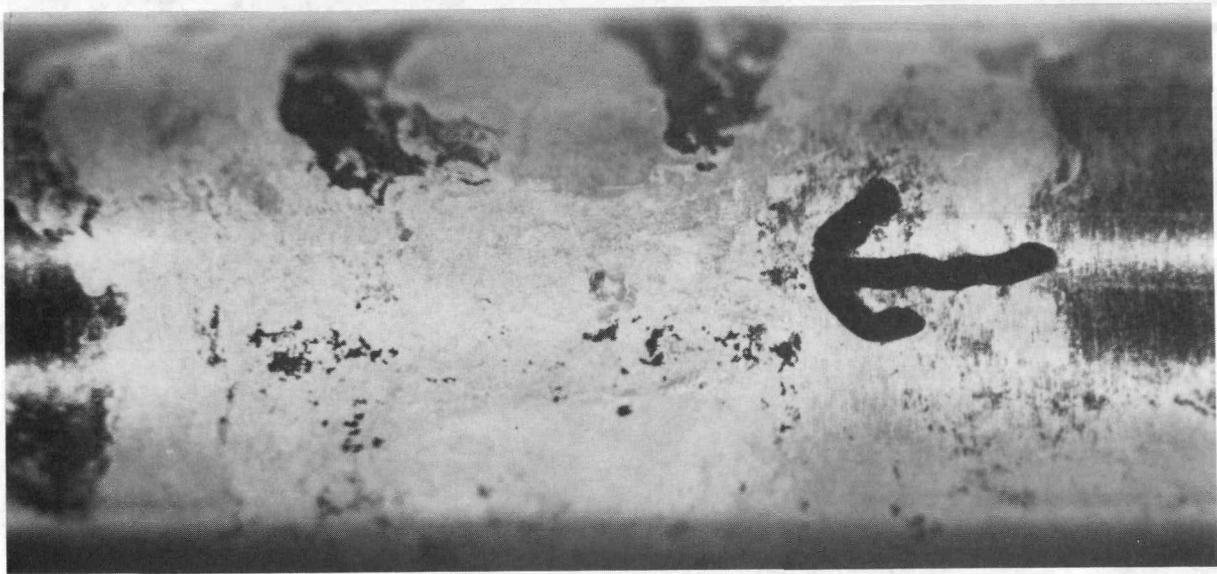
FIGURE 3.22. Photograph Showing OD Surface Corrosion of Fifth TSP Specimen 935 (R45 C52 HL) (17.1% strain)

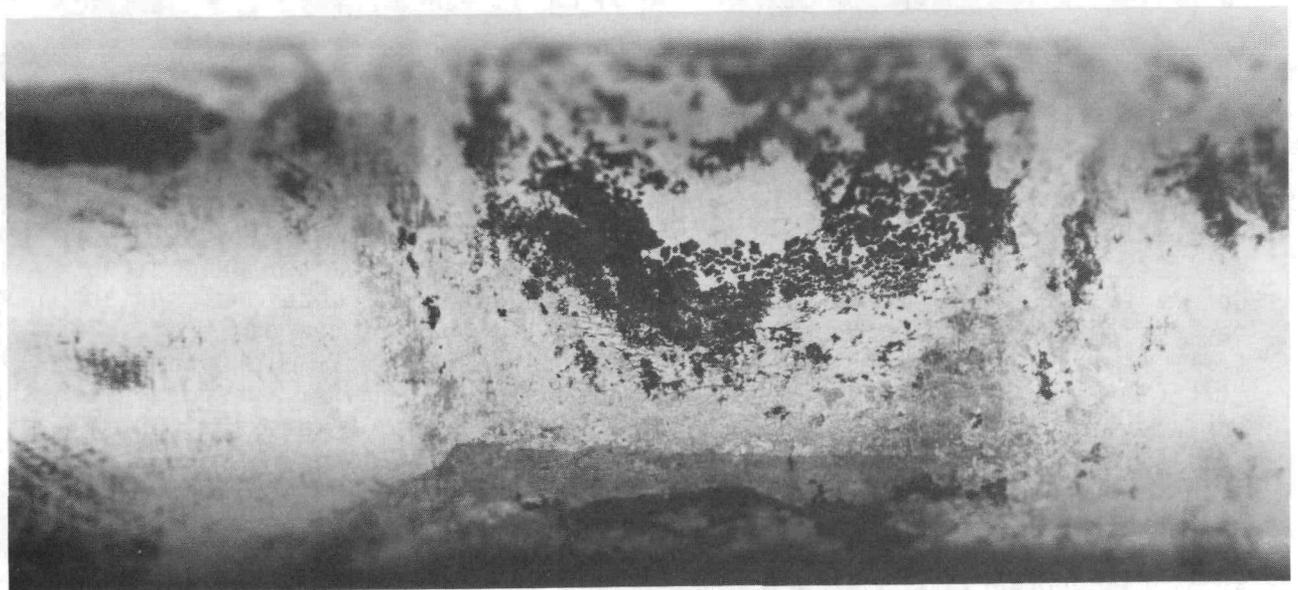
FIGURE 3.23. Photograph Showing OD Surface Corrosion of First TSP Specimen 1041 (R4 C51 HL) (26.9% strain)

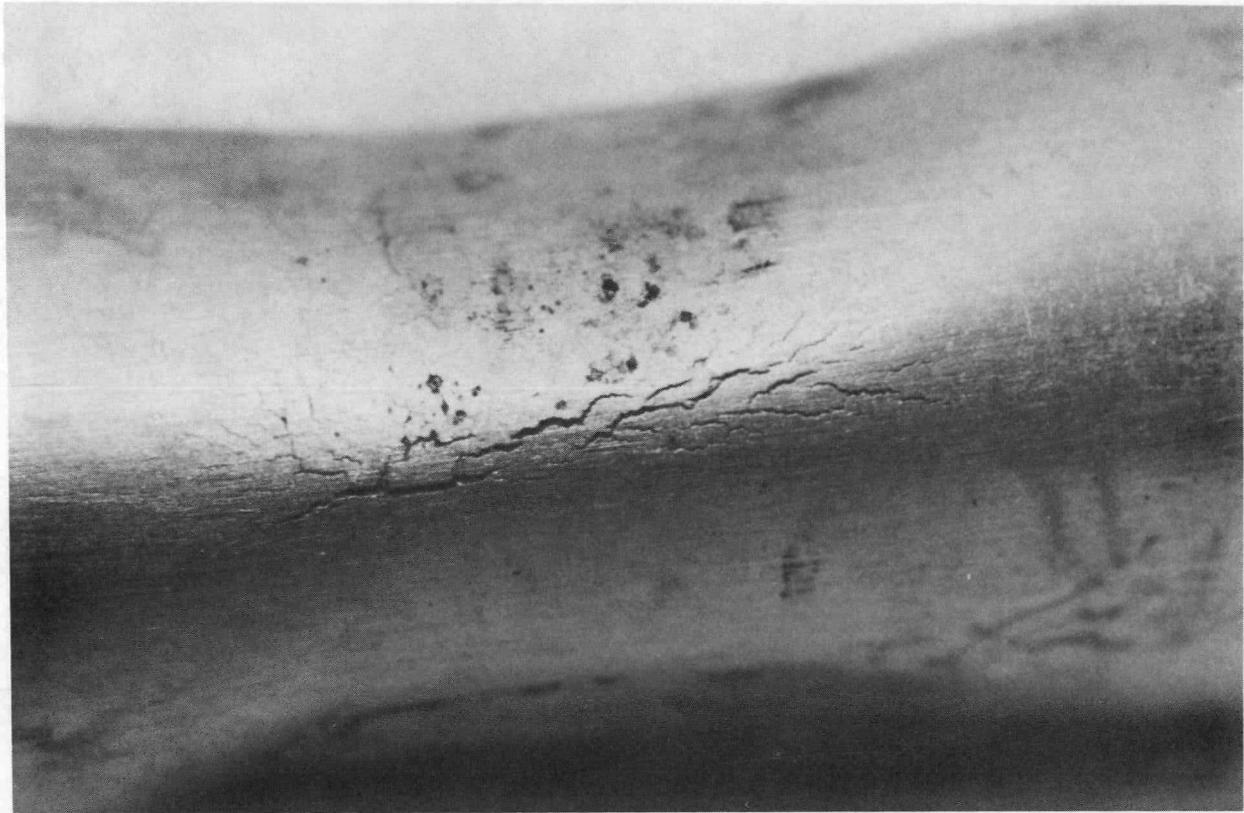
FIGURE 3.24. Photograph Showing Axial Cracking of Seventh TSP Specimen 451 (R45 C50 HL7) (79.8% strain)

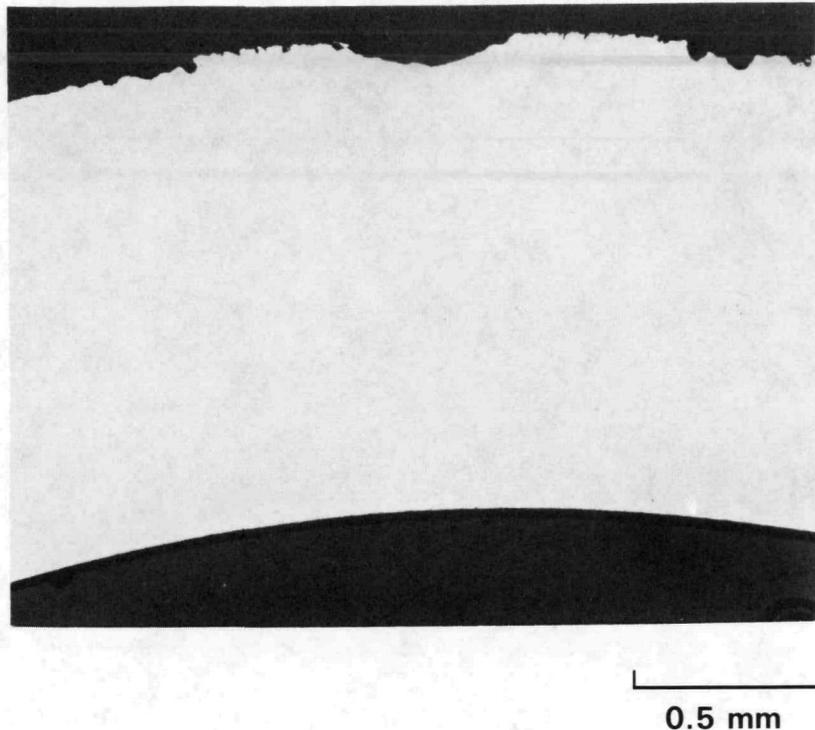
FIGURE 3.25. Optical Micrograph Showing OD Corrosion of Fifth TSP Specimen 935 (R45 C52 HL5)

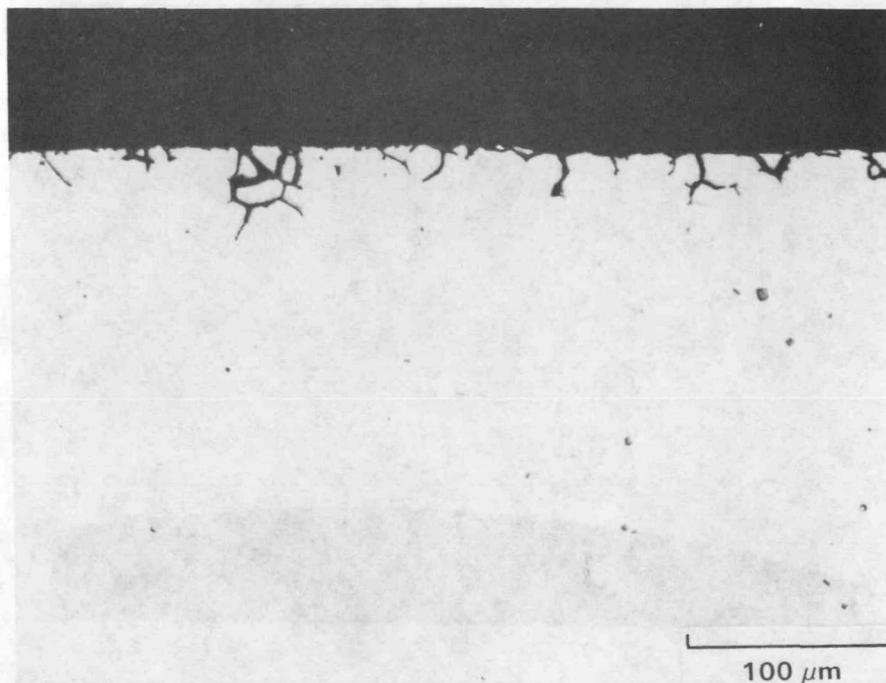
FIGURE 3.26. Optical Micrograph Showing Shallow IGA on the OD Surface of Fifth TSP Specimen 909 (R10 C39 HL5)

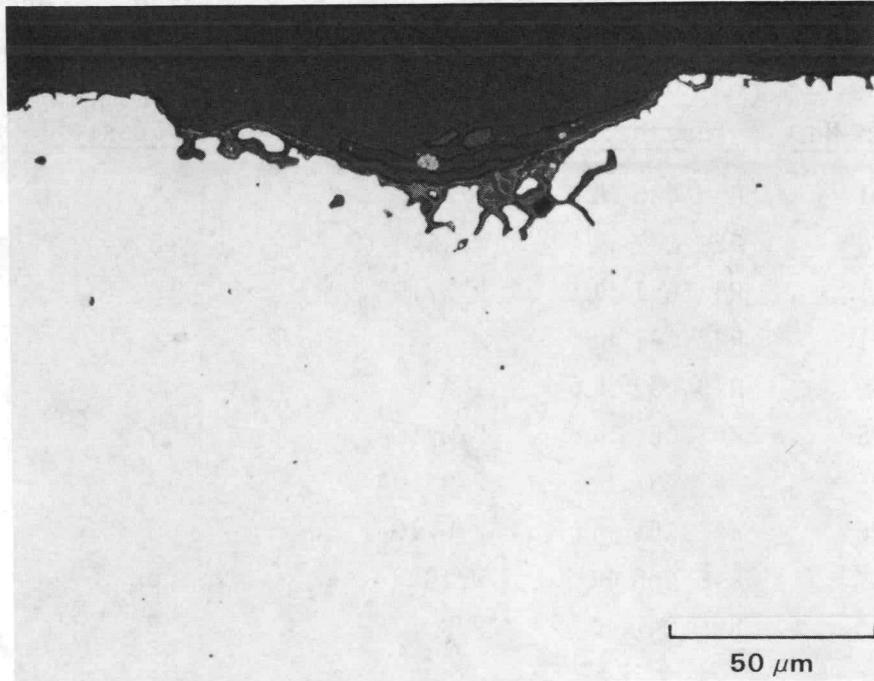
FIGURE 3.27. Optical Micrograph Showing IGA at the Base of Corroded Areas in Sixth TSP Specimen 926 (R4 C51 HL6)

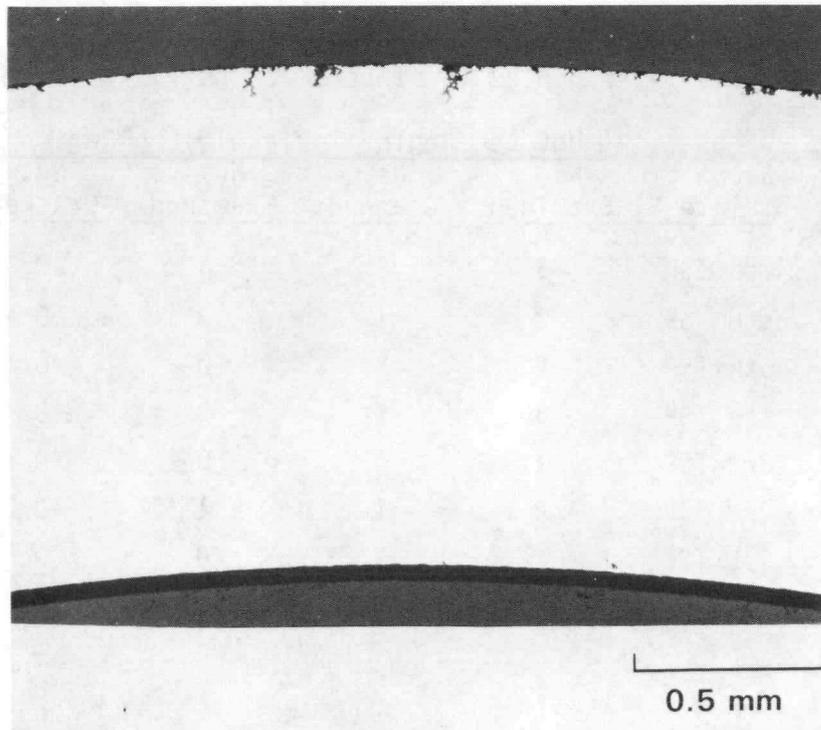
FIGURE 3.28. Optical Micrograph Showing Intergranular Penetrations of First TSP Specimen 1041 (R4 C51 HL1)

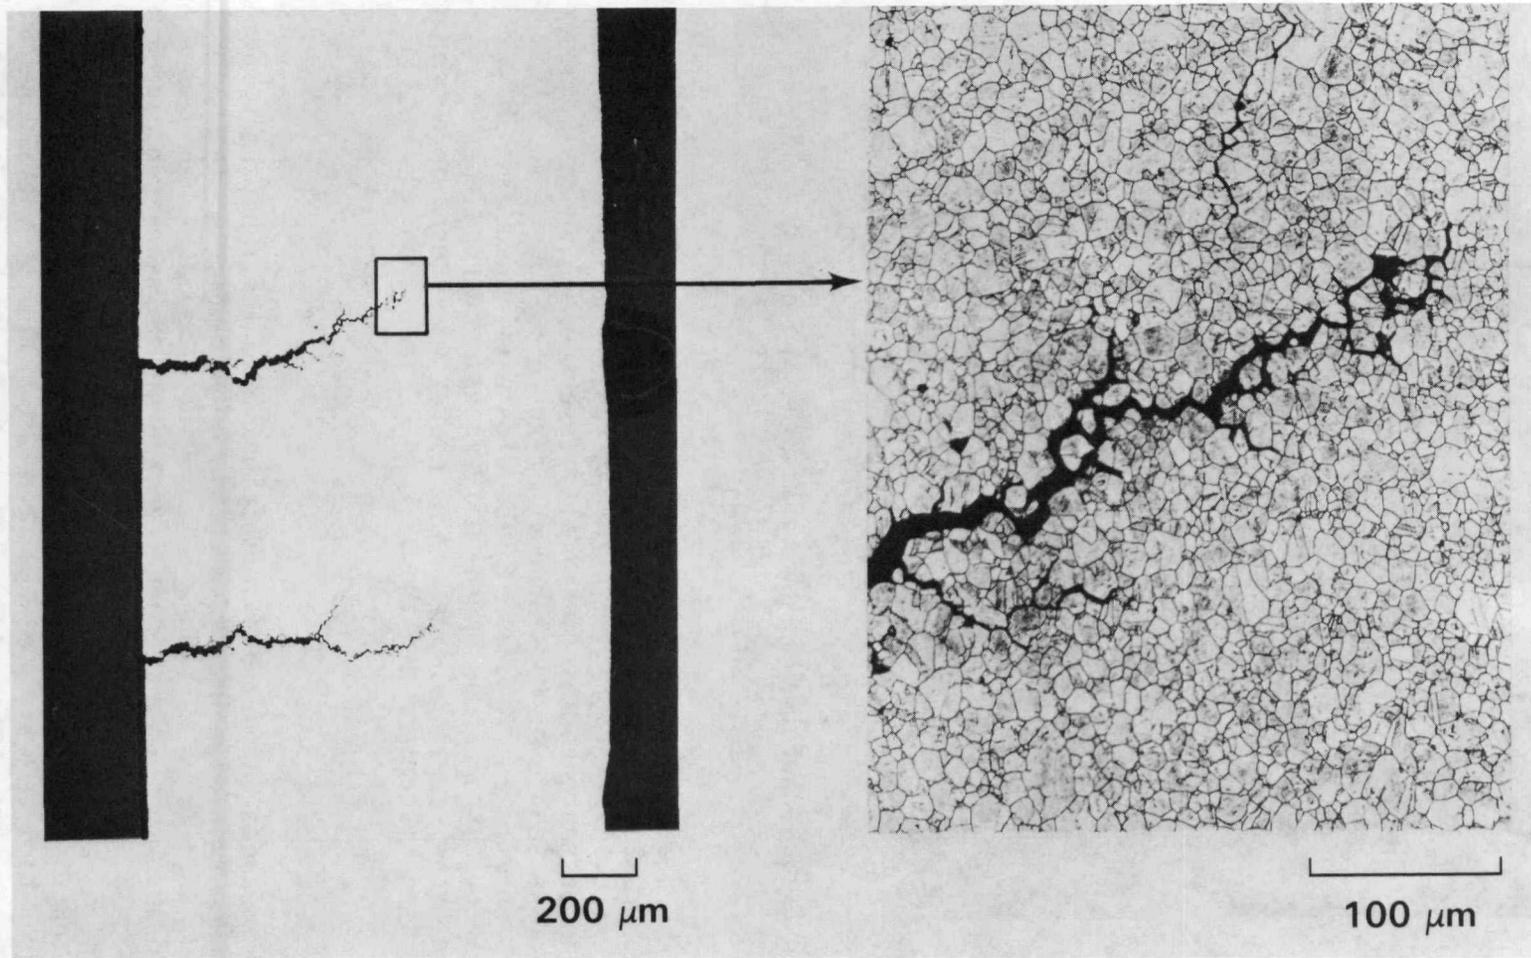
FIGURE 3.30. Optical Micrographs Showing ID Axial Cracking of Fifth TSP Specimen 935 (R45 C52 HL5)
