Steam Generator Group Project

Task 13 Final Report: Nondestructive Examination Validation

Prepared by
E. R. Bradley, P. G. Doctor, R. H. Ferris, J. A. Buchanan

Pacific Northwest Laboratory
Richland, WA 99352

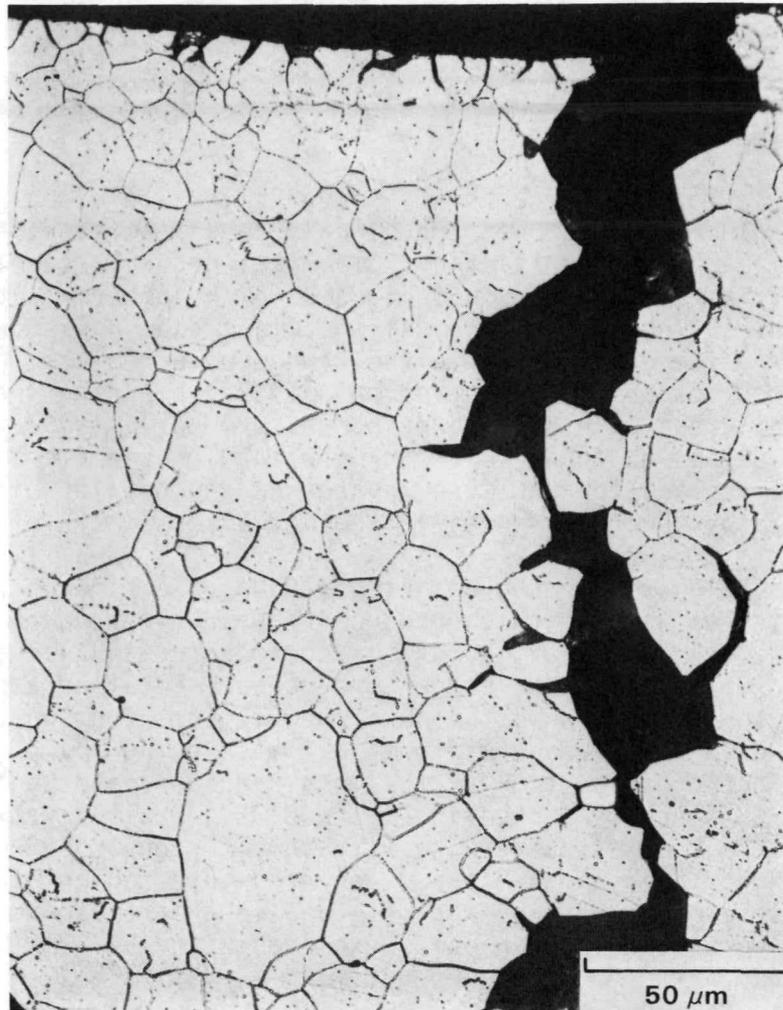
FIGURE 3.31. Optical Micrograph Showing the Intergranular Nature of the ID Cracking; Specimen 921 (R42 C47 HL4)

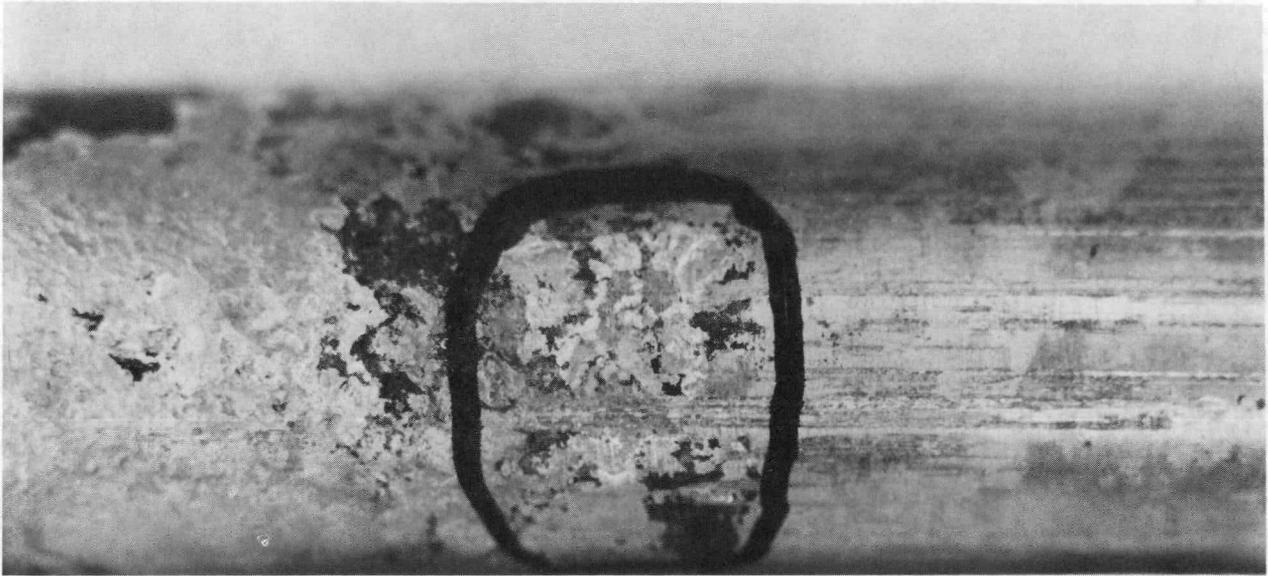
FIGURE 3.33. Photograph Showing Pitting and Wastage on Cold Leg TTS Specimen 678C (R7 C27 CL)

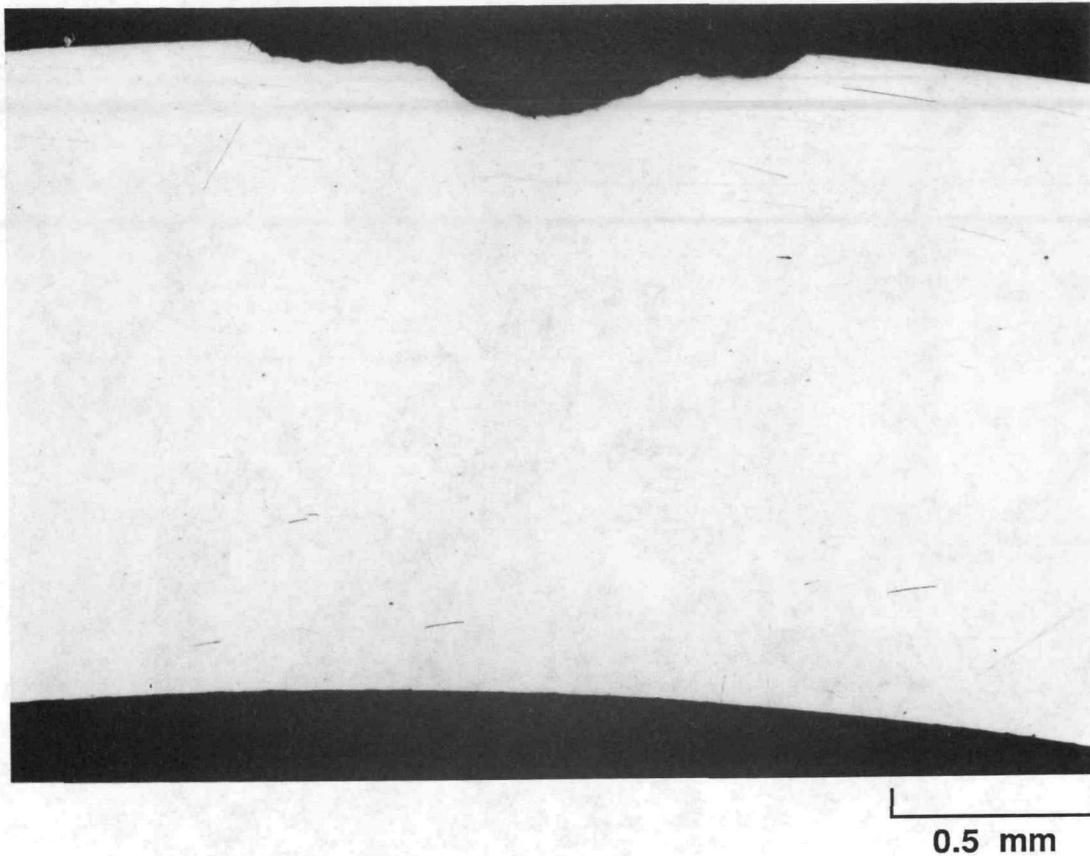
FIGURE 3.35. Optical Micrograph Showing Pitting on Cold Leg TTS Specimen 743C (R16 C37 CL)

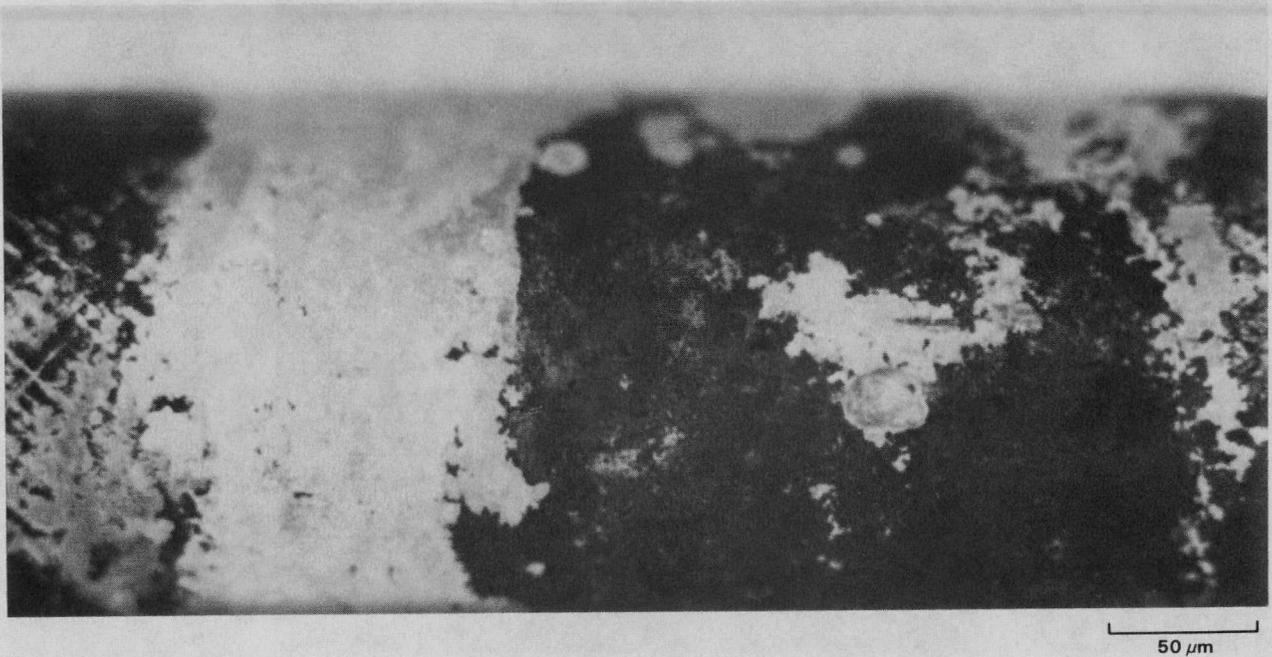
FIGURE 3.41. Photograph Showing Isolated Pitting on Hot Leg TTS Specimen 587C (R6 C65 HL)

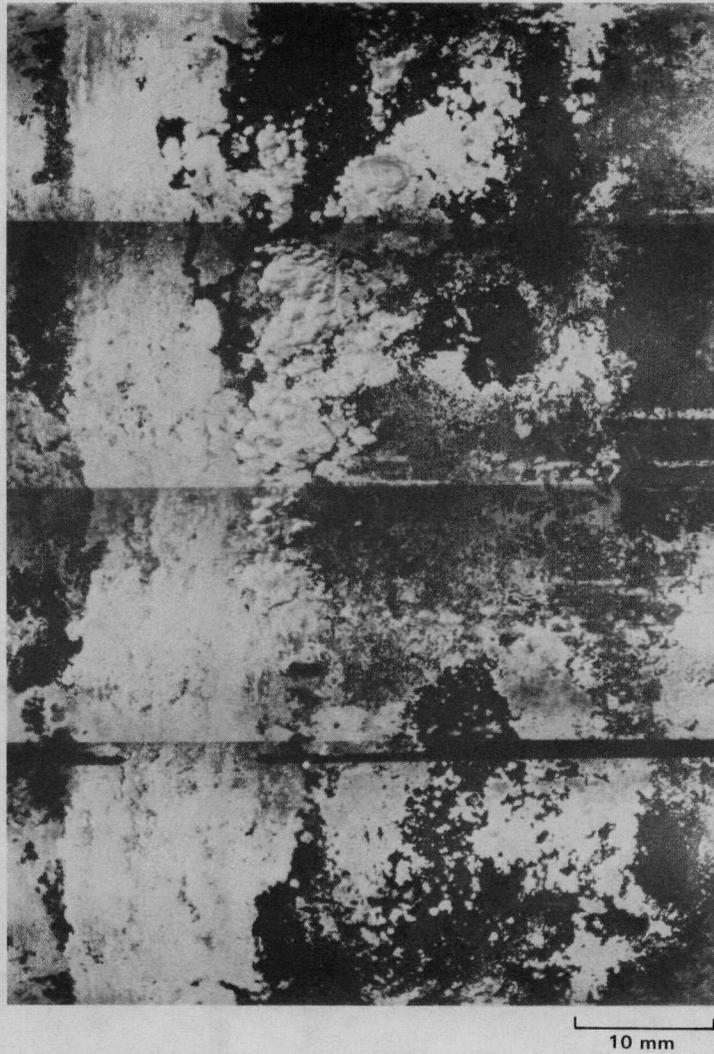
FIGURE 3.43. Composite Photographs Showing the Distribution of Pitting/Wastage Type Degradation on Hot Leg TTS Specimen 657C (R17 C62 HL)

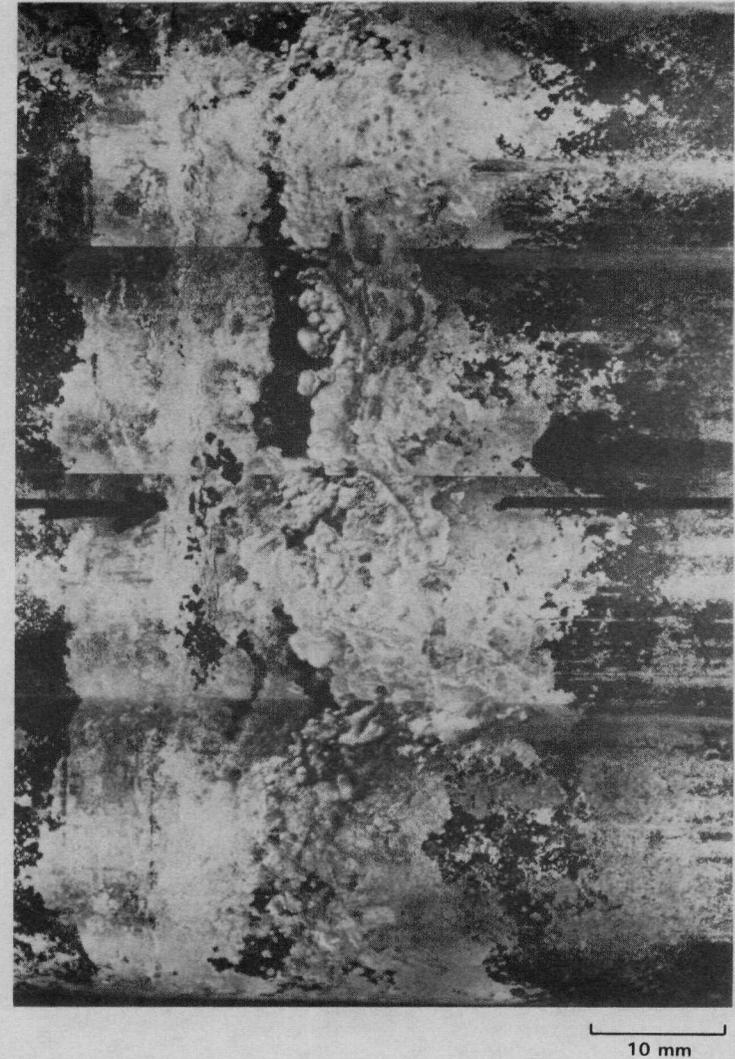
FIGURE 3.44. Composite Photographs Showing the Distribution of Pitting/Wastage Type Degradation on Hot Leg TTS Specimen 794C (R16 C57 HL)

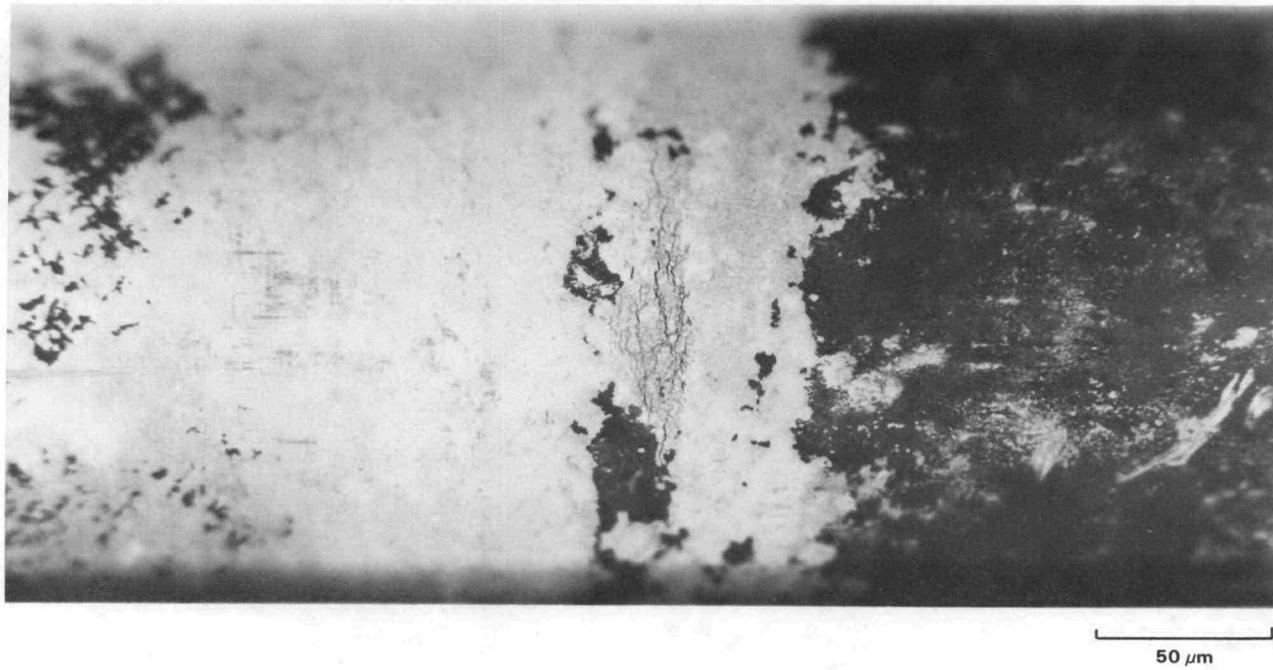
FIGURE 3.52. Photograph of TTS Specimen 660 (R15 C49 HL) Showing Wastage and Localized Circumferential Corrosion

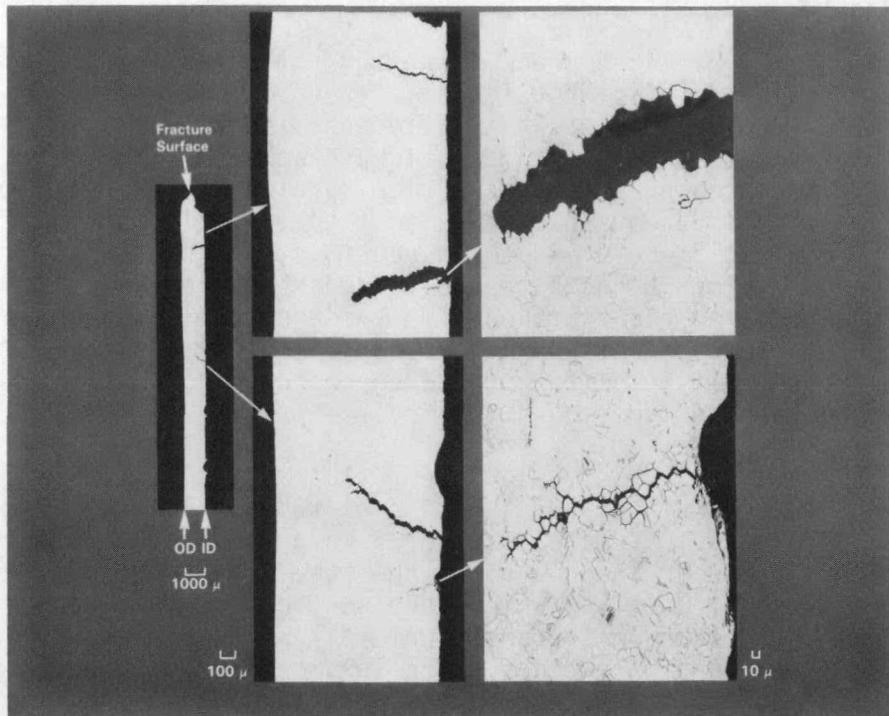
FIGURE 3.57. Optical Micrographs Showing Circumferential IGSCC in Roll Expanded Region of Specimen 547 (R17 C48 HL)

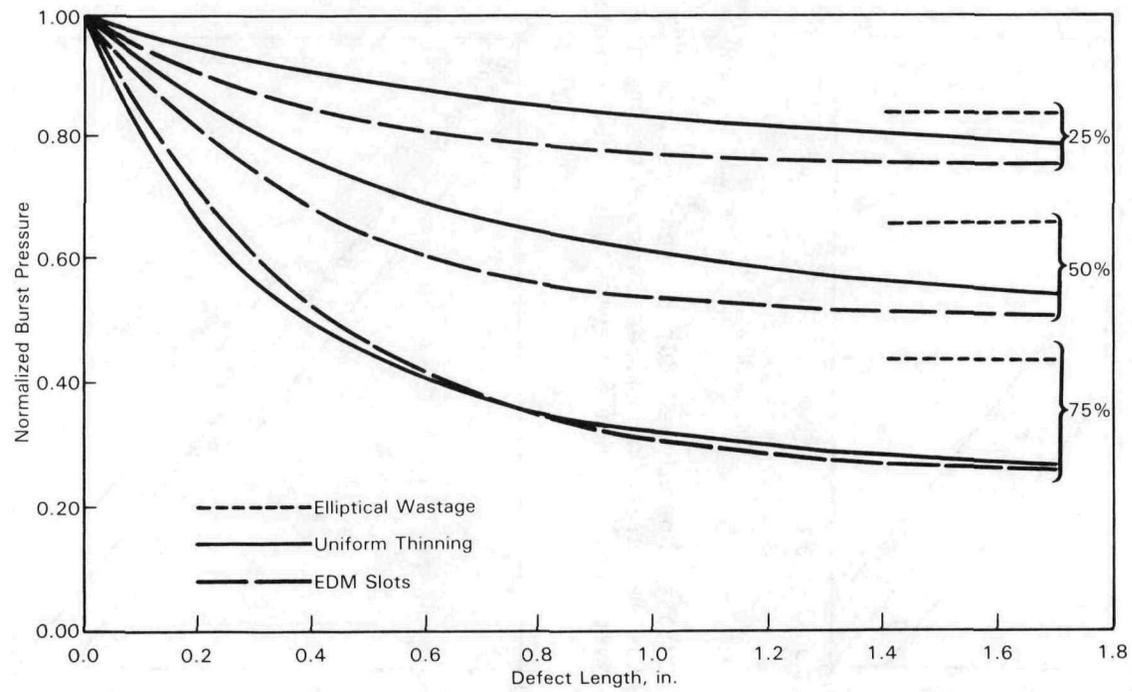
FIGURE 3.59. Comparison of Burst Pressure Equations for Elliptical Wastage, Uniform Thinning, and EDM Slots

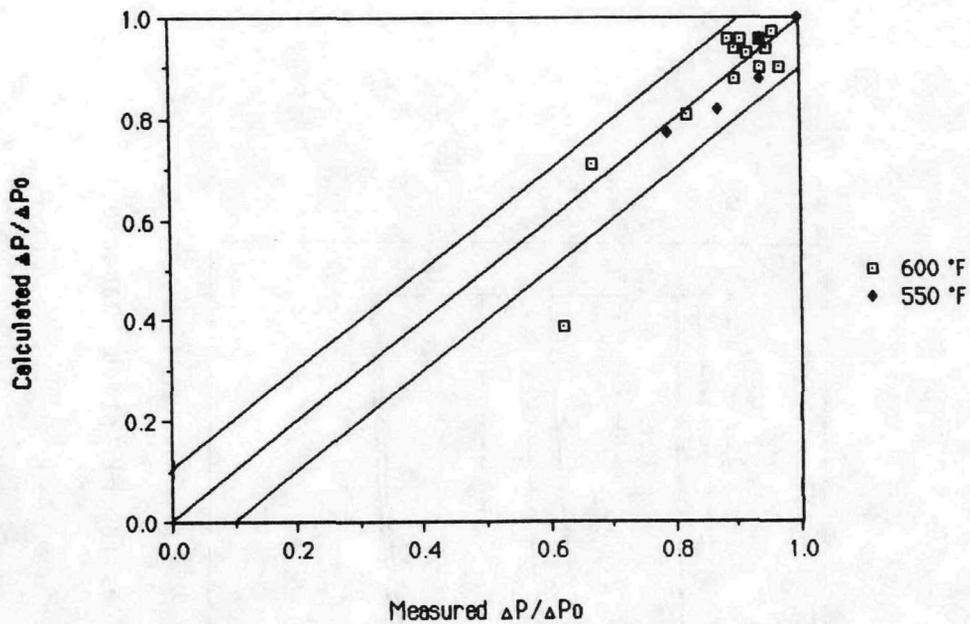
FIGURE 3.60. Calculated Normalized Burst Pressure from EDM Slot Equation Versus Measured Normalized Burst Pressure for Tubes Removed from the HLTTS Region with P/W Defects

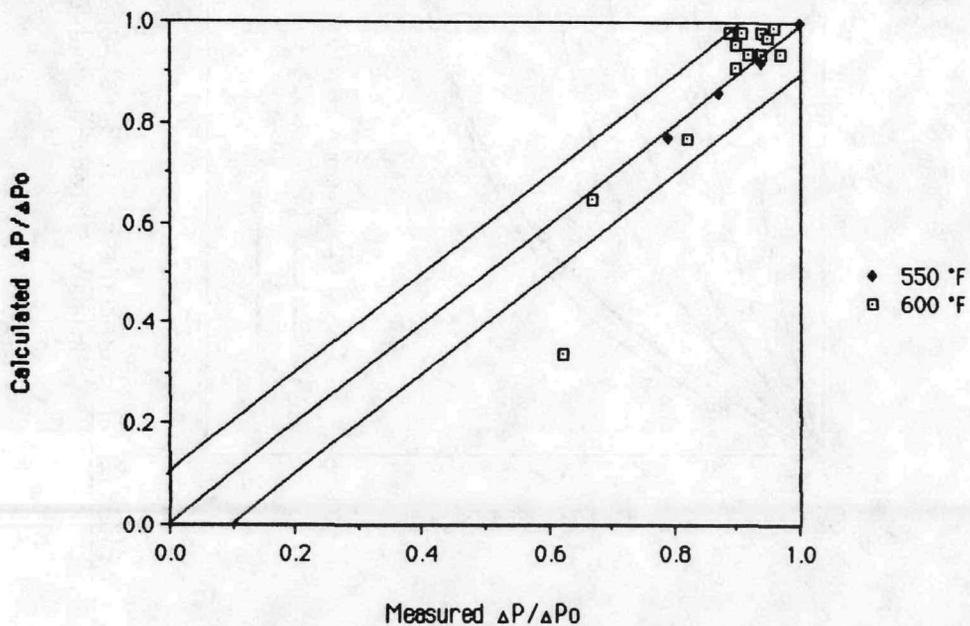
FIGURE 3.61. Calculated Normalized Burst Pressure from Uniform Thinning Equation Versus Measured Normalized Burst Pressure for Tubes Removed from the HLTTS Region with P/W Defects

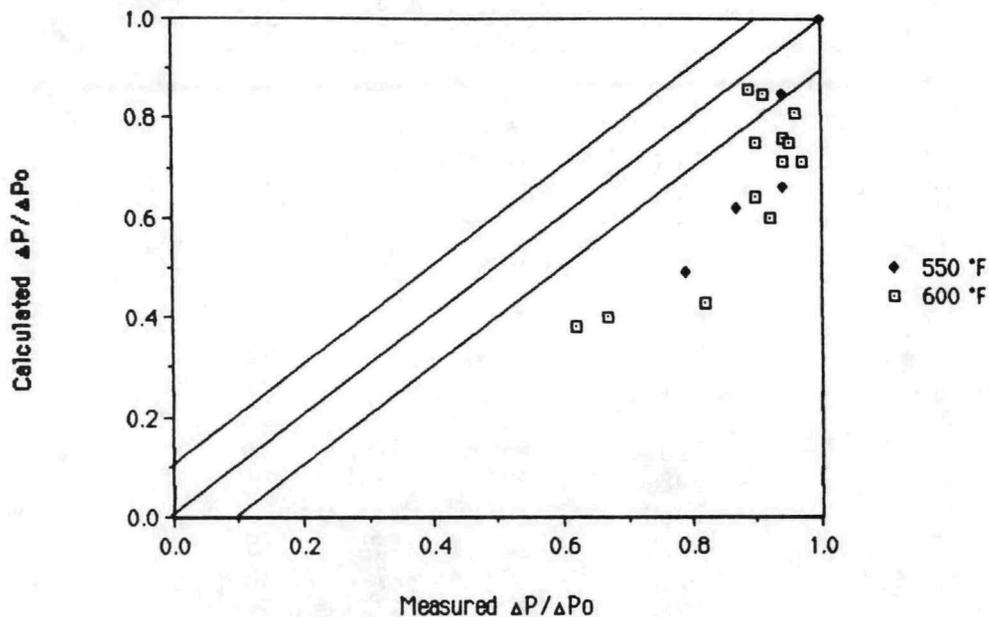
FIGURE 3.62. Calculated Normalized Burst Pressure from Elliptical Wastage Equation Versus Measured Normalized Burst Pressure for Tubes Removed from the HLTTs Region with P/W Defects

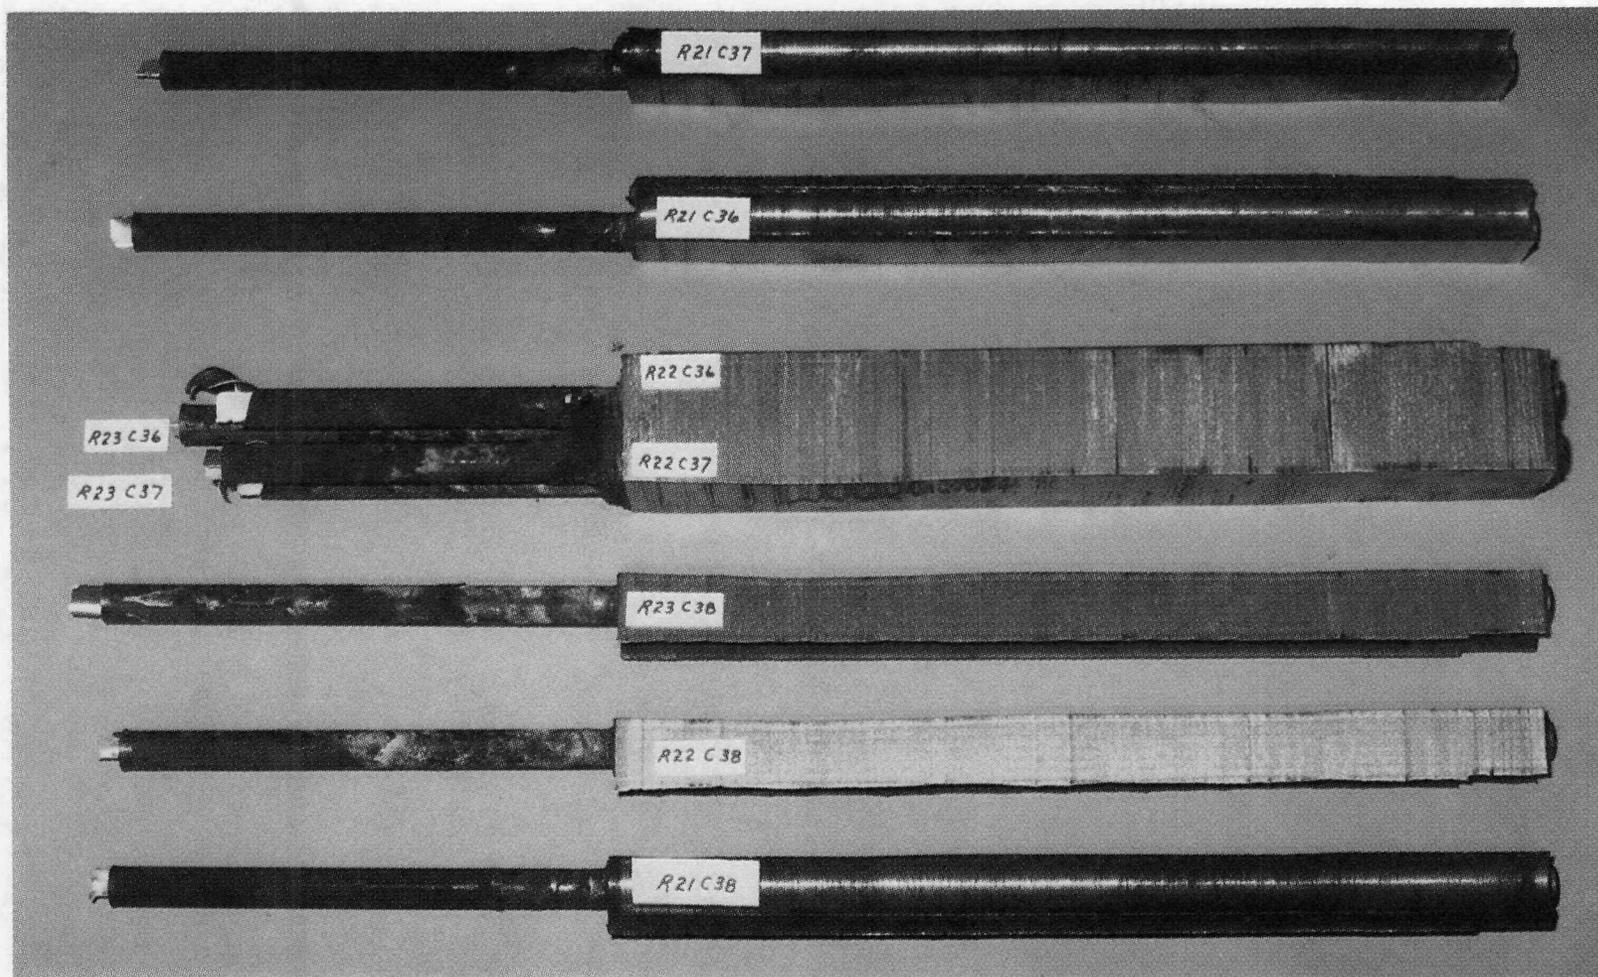
FIGURE 3.67. Tube Sheet Specimen 355 After Sectioning

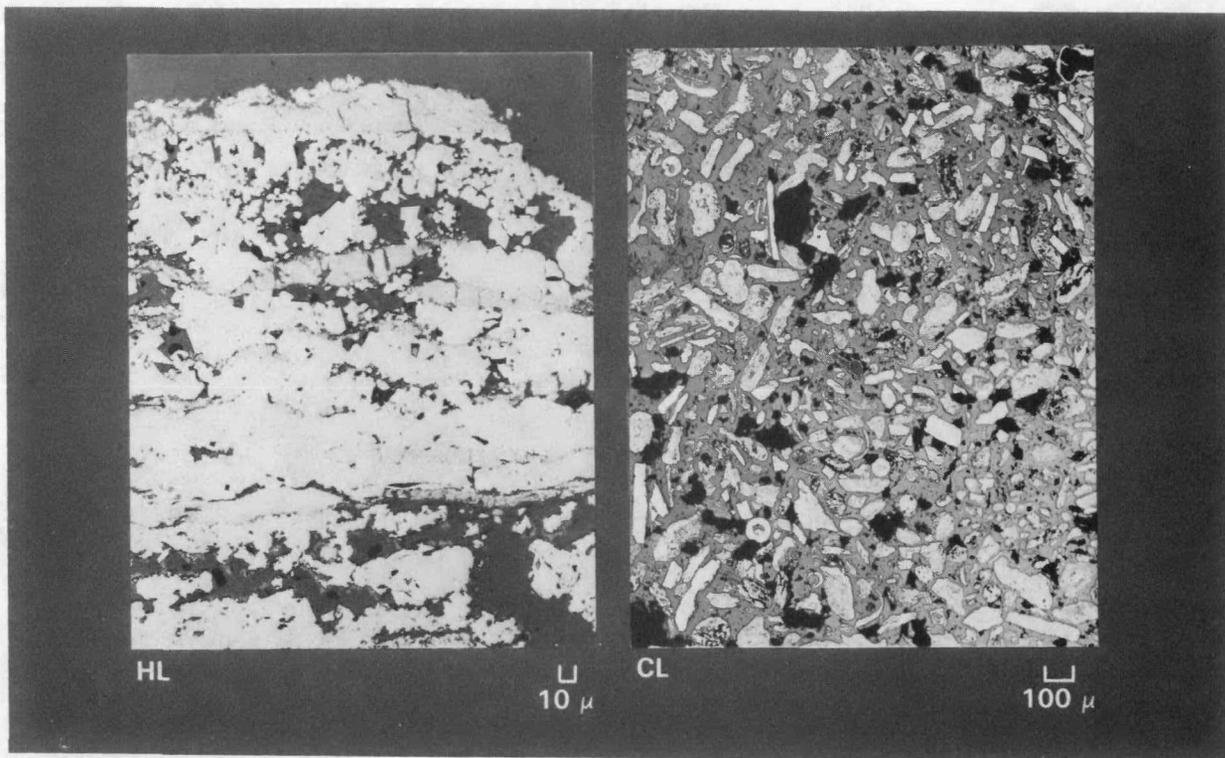
FIGURE 3.70. Microstructure of Compact Sludge from Hot Leg (355) and Cold Leg (354) Tube Sheet Section

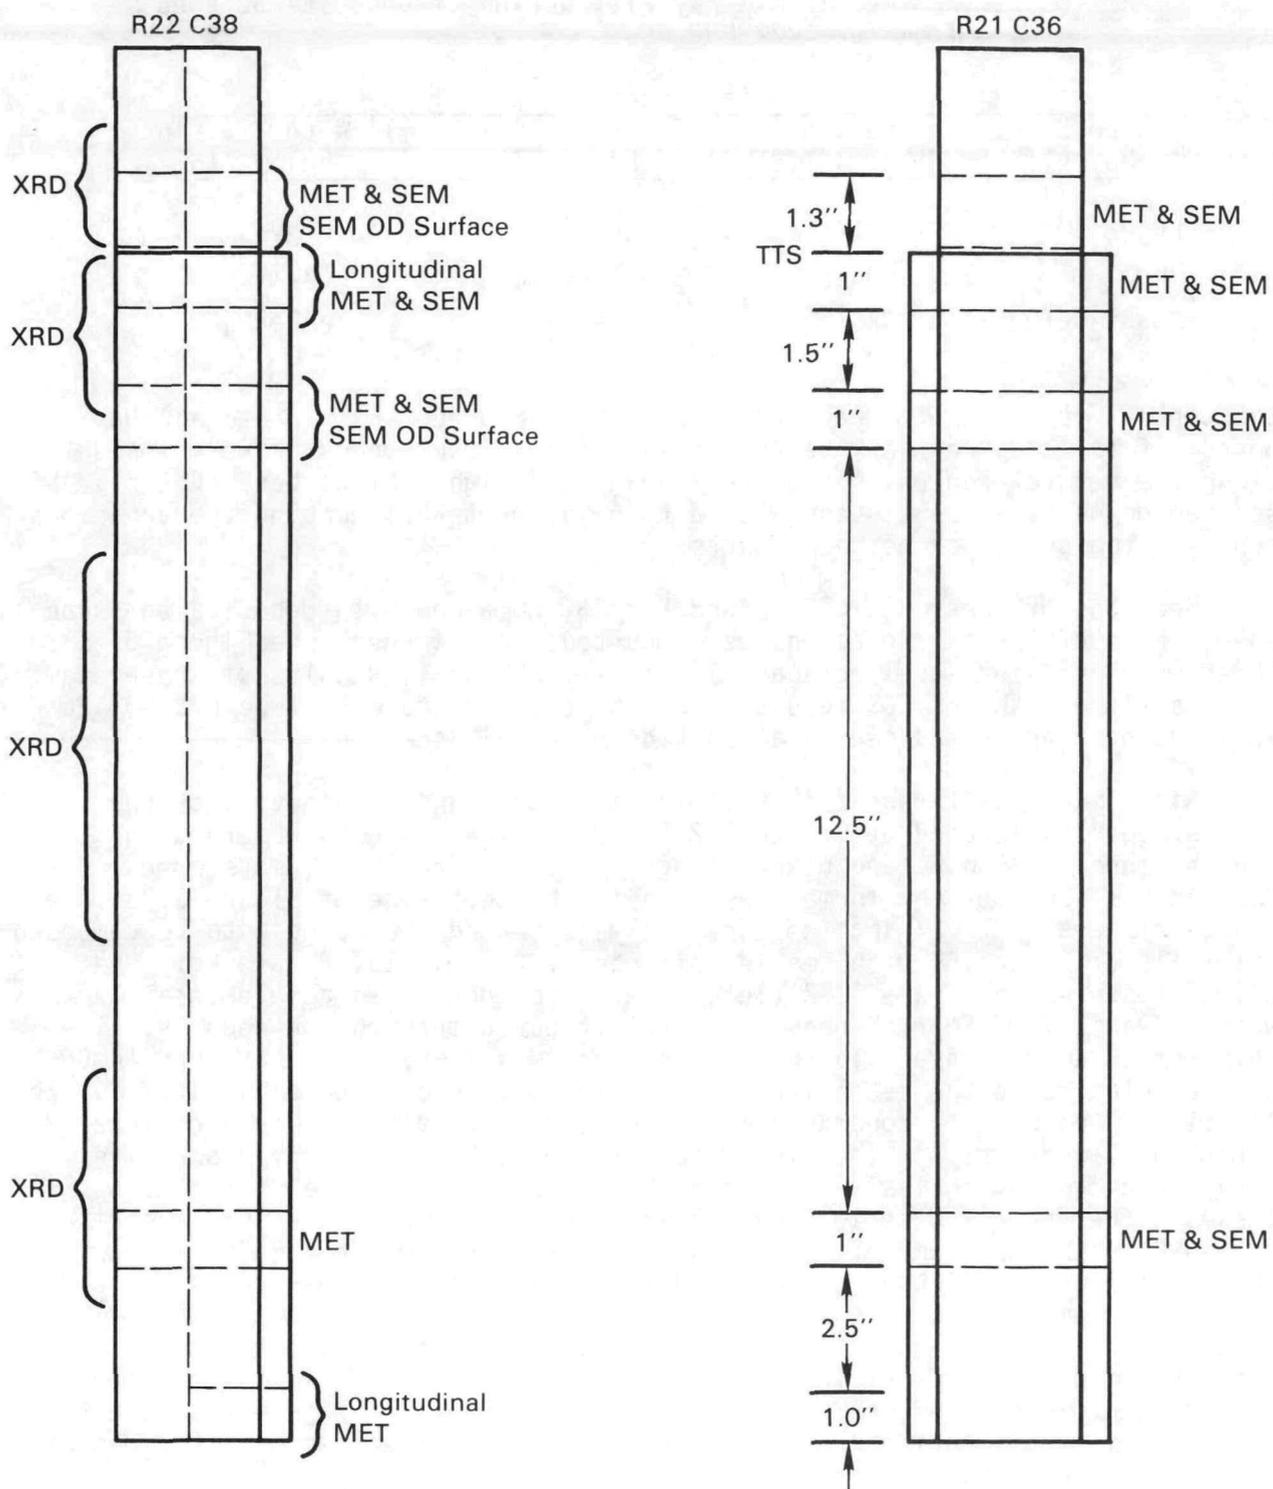
FIGURE 3.71. Location of Metallurgical Examinations Conducted on Hot Leg Tubes R21 C36 and R22 C38

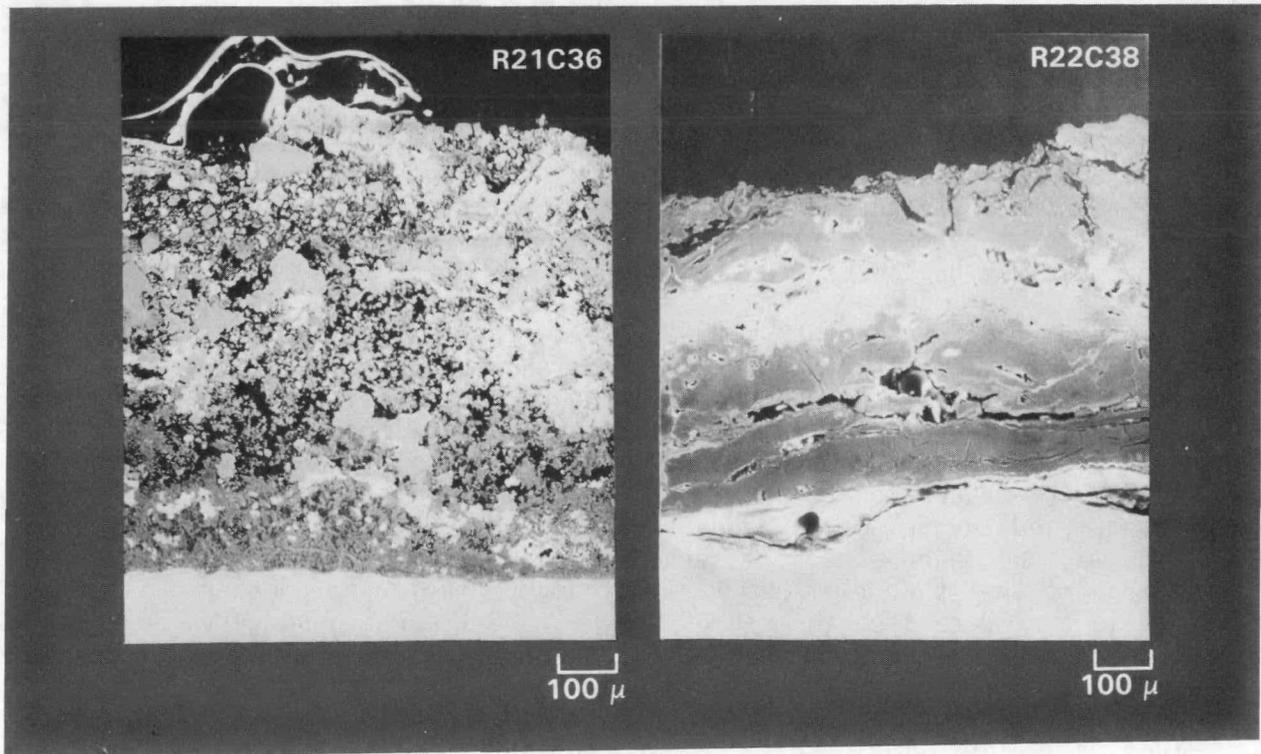
FIGURE 3.72. Electron Micrographs Comparing the Scale/Deposits on Hot Leg Tube R21 C36 and R22 C38

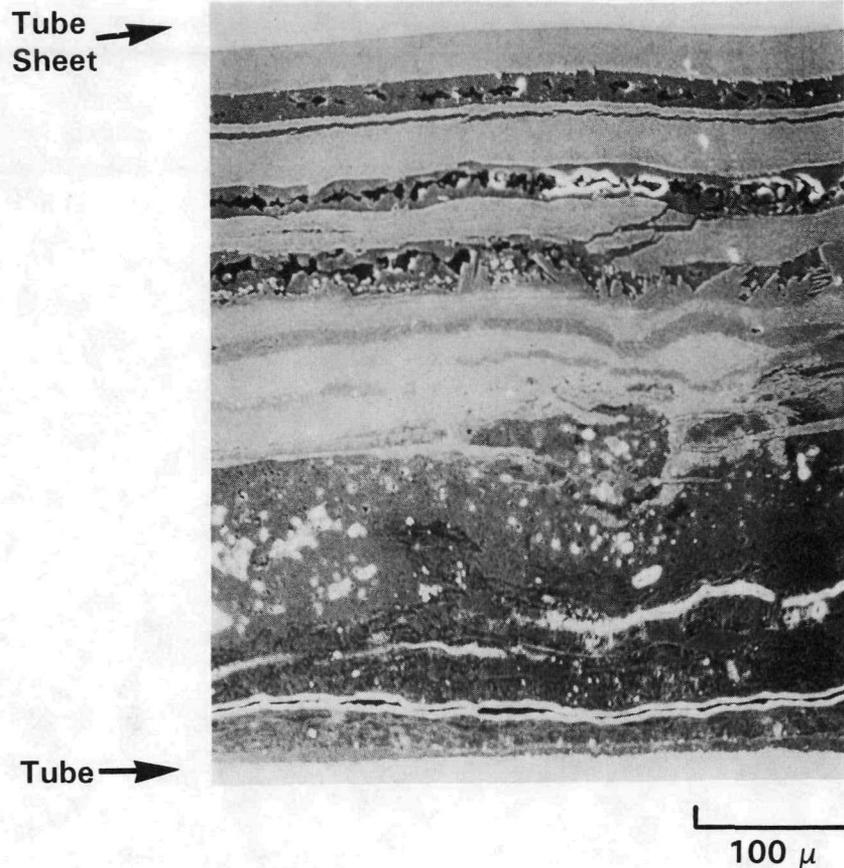
FIGURE 3.73. Microstructure of Crevice Deposits and Corrosion Products from Hot Leg Tube/Tube Sheet Specimen R21 C36 (~0.05 in. below TTS)

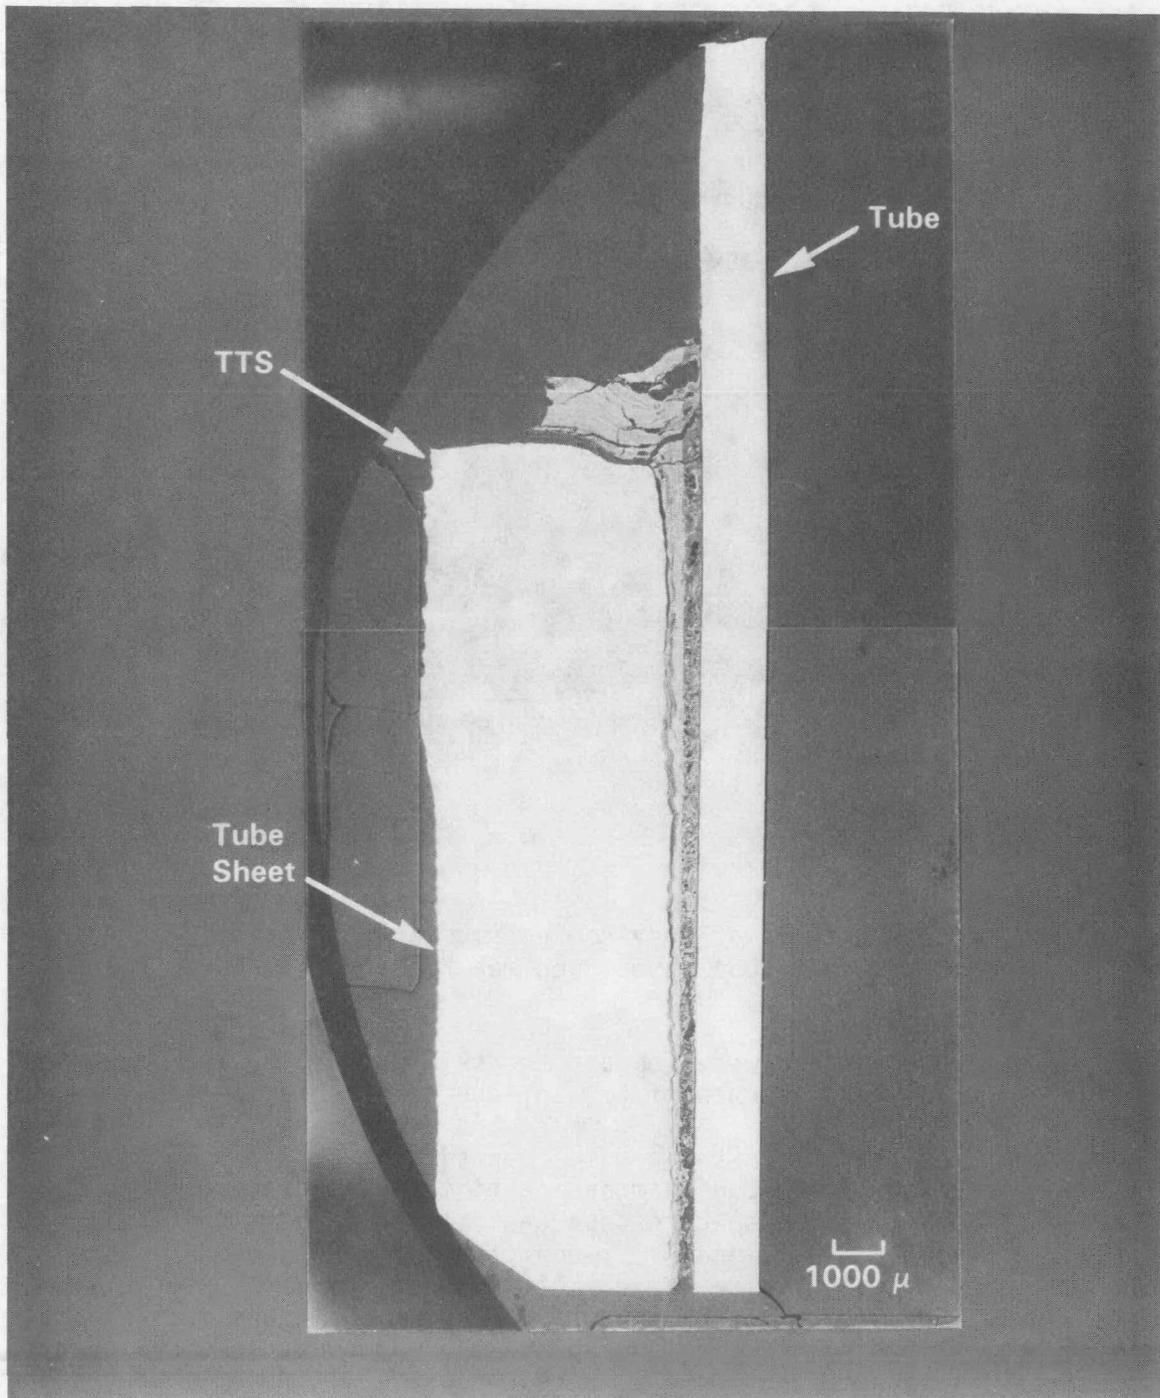
FIGURE 3.74. View of Longitudinal Metallographic Section Through the TTS of Hot Leg Tube/Tube Sheet Specimen R22 C38

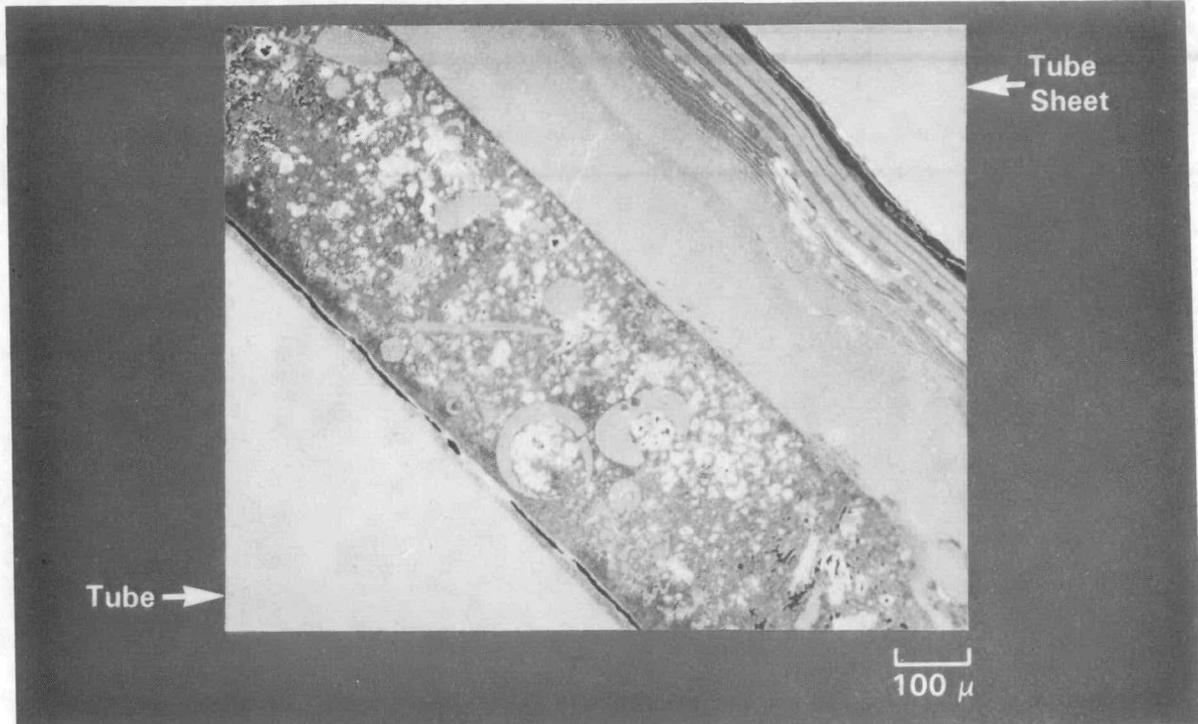
FIGURE 3.75. Microstructure of Crevice Deposits and Corrosion Products from Hot Leg Tube/Tube Sheet Specimen R22 C38 (~0.1 in. below TTS)

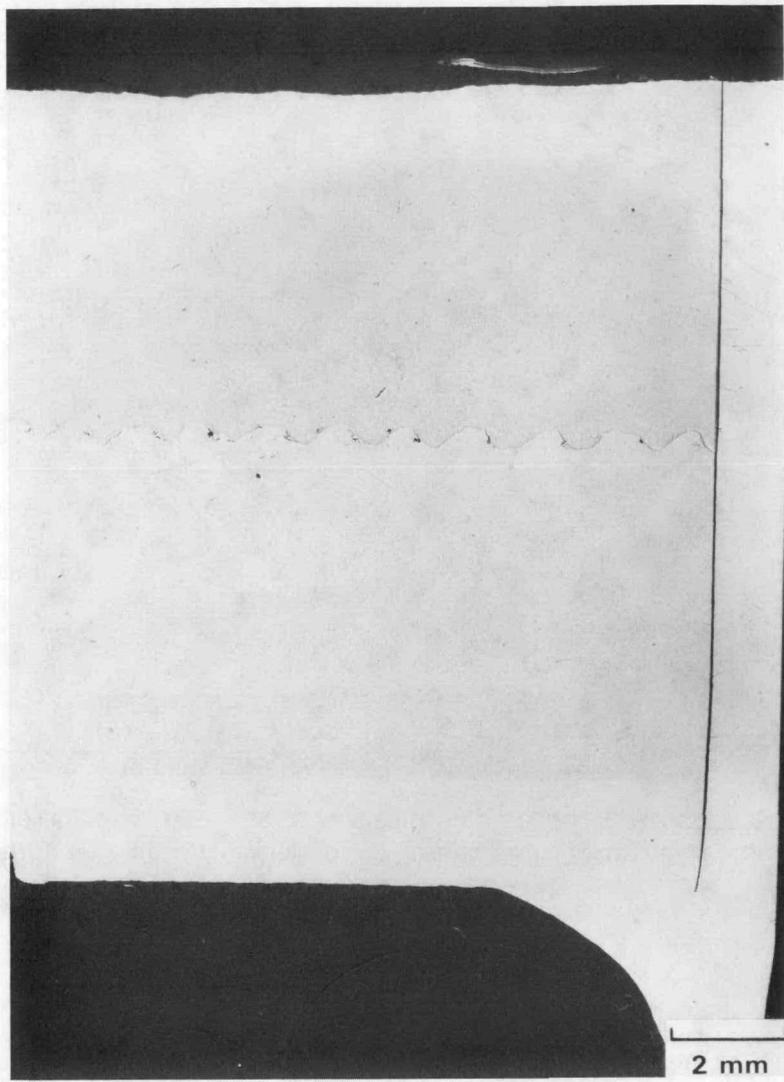
FIGURE 3.78. Optical Micrograph Showing the Interface Between the Tube Sheet and Cladding at the Bottom of Specimen R22 C38 HL

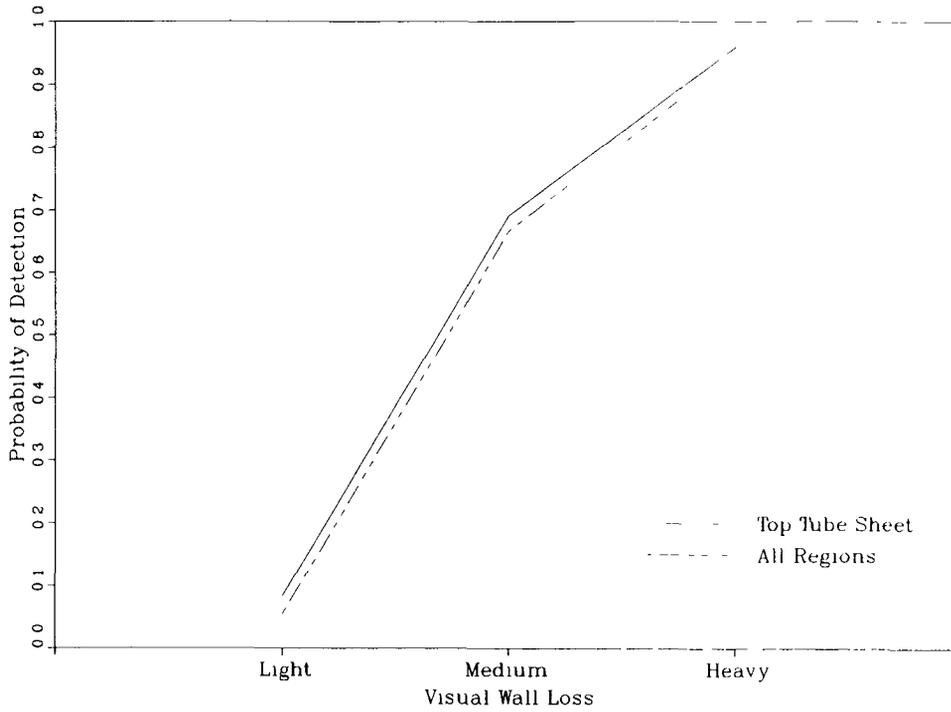
FIGURE 4.1. POD Curve for Team A Based on Visual Wall Loss Data

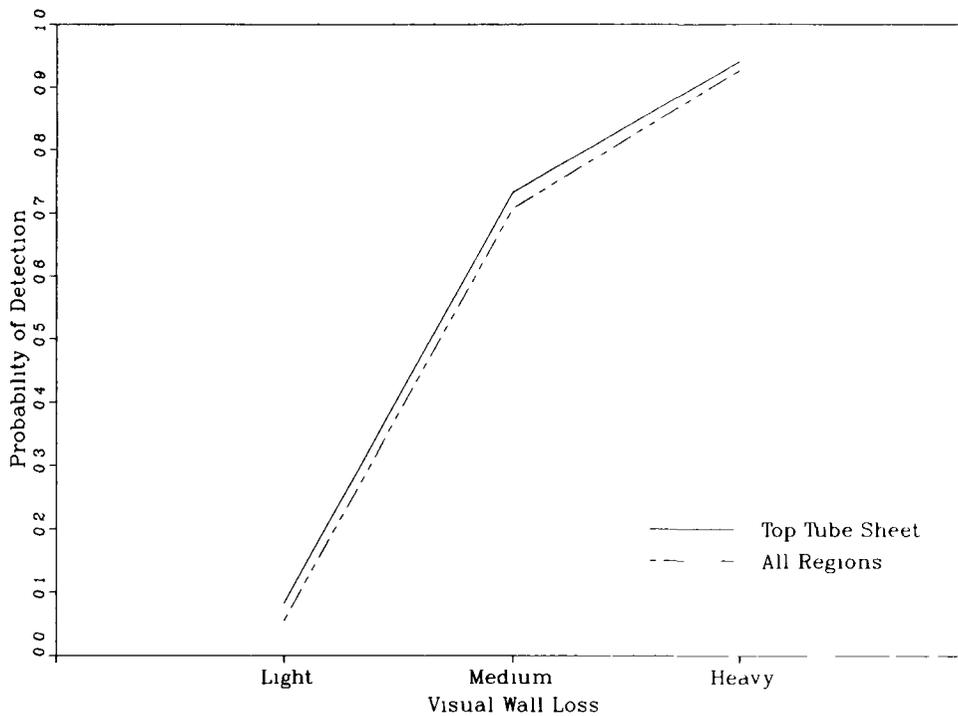
FIGURE 4.8. Median POD Curve for DAARR and Baseline Teams Based on Visual Wall Loss Data

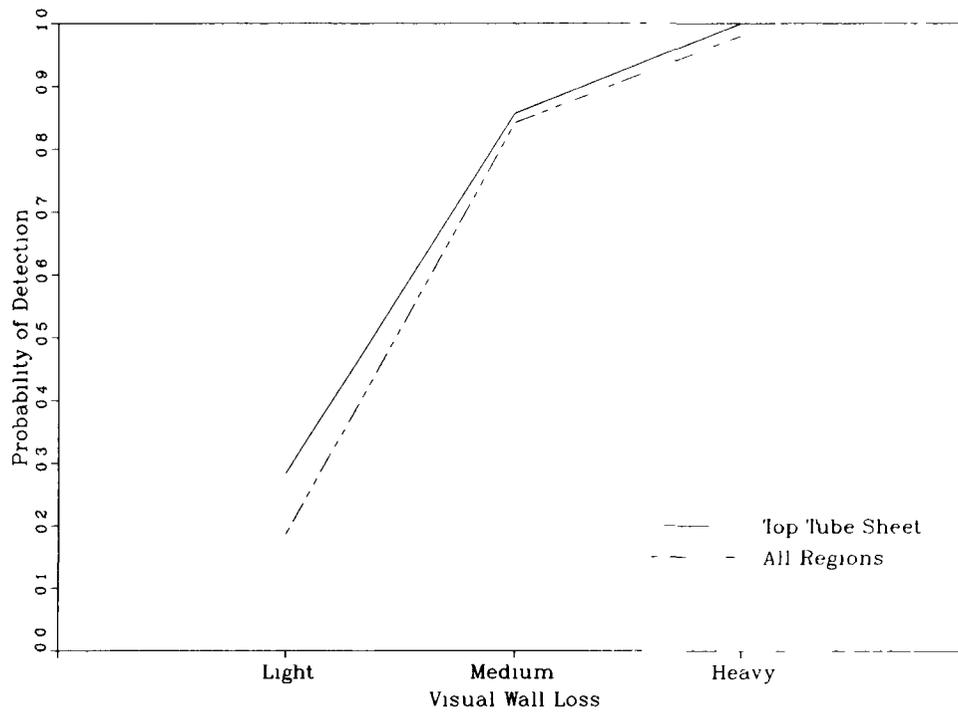
FIGURE 4.9. POD Curve for Team V Based on Visual Wall Loss Data

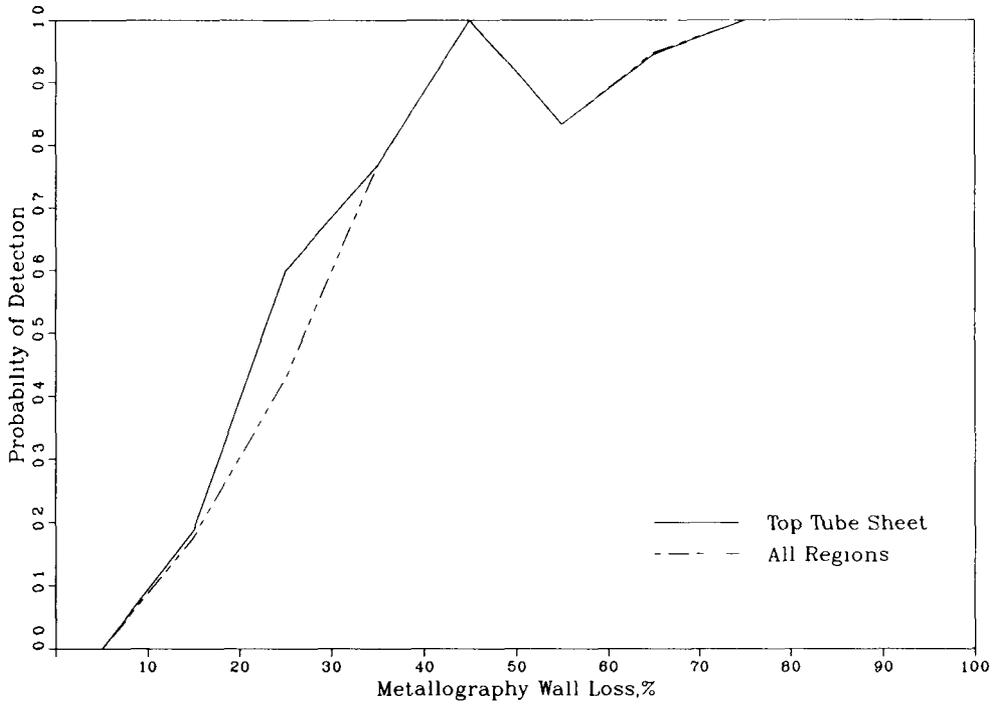
FIGURE 4.10. POD Curve for Team A Based on Metallographic Wall Loss Data
