Steam Generator Group Project

Task 13 Final Report: Nondestructive Examination Validation

Prepared by
E. R. Bradley, P. G. Doctor, R. H. Ferris, J. A. Buchanan

Pacific Northwest Laboratory
Richland, WA 99352

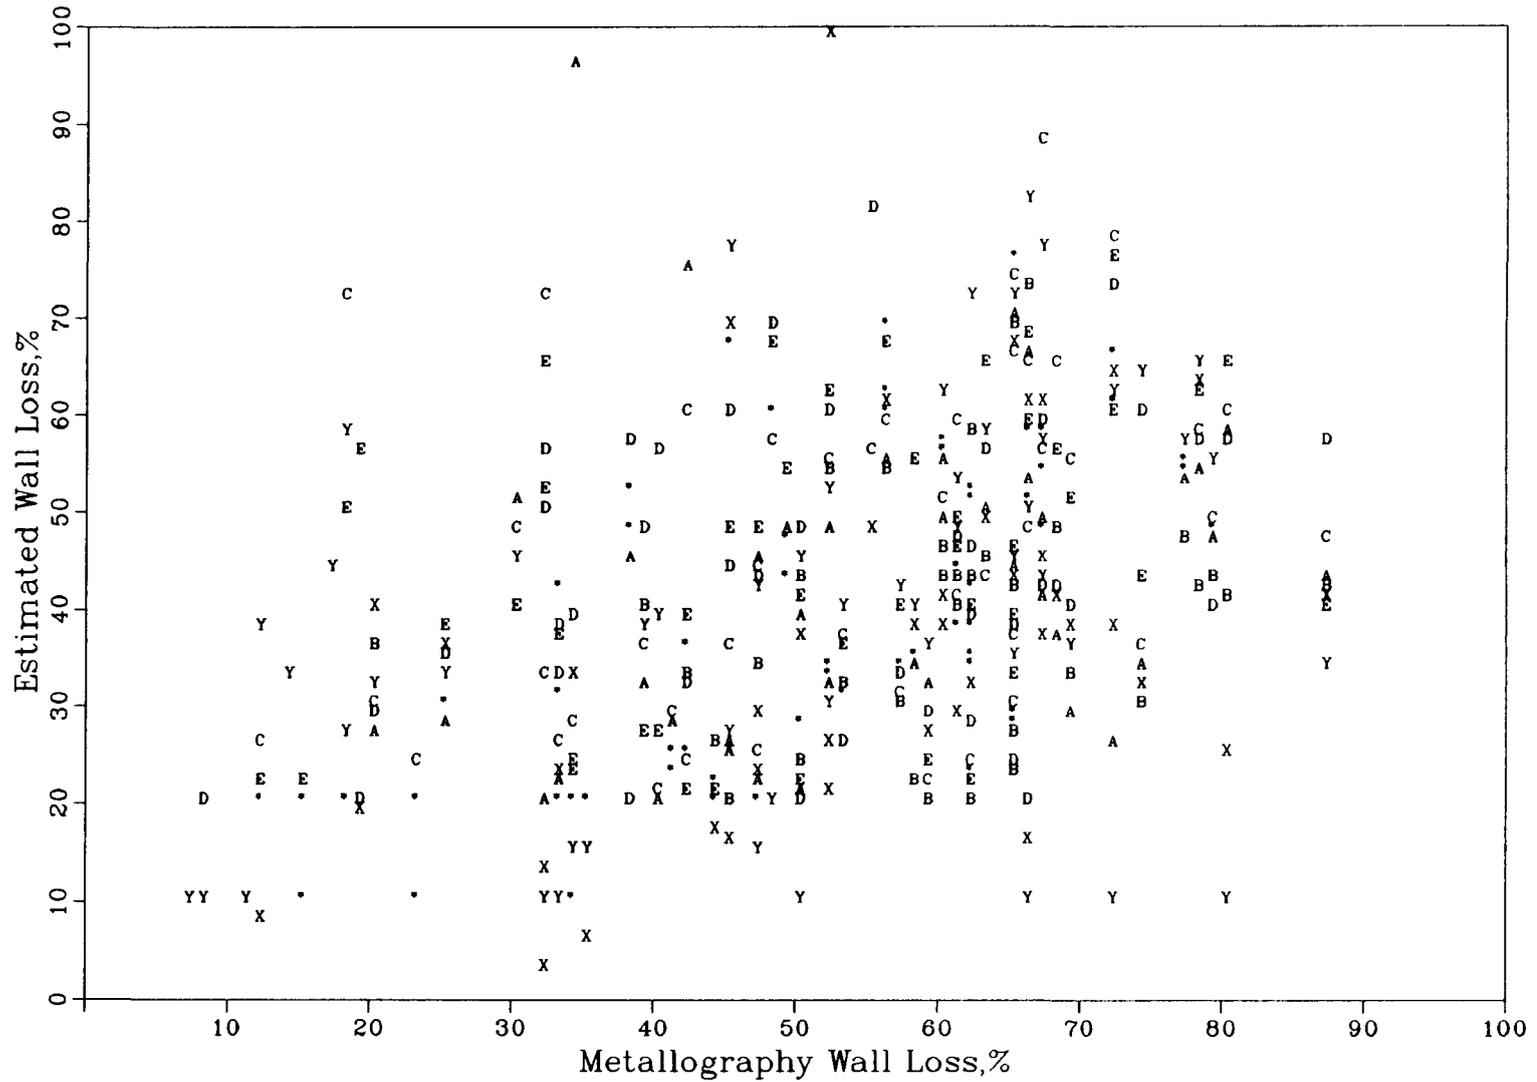
FIGURE 4.32. Plot of Estimated Defect Depth for DAARR and Baseline Teams Versus Depth from Metallographic Analysis

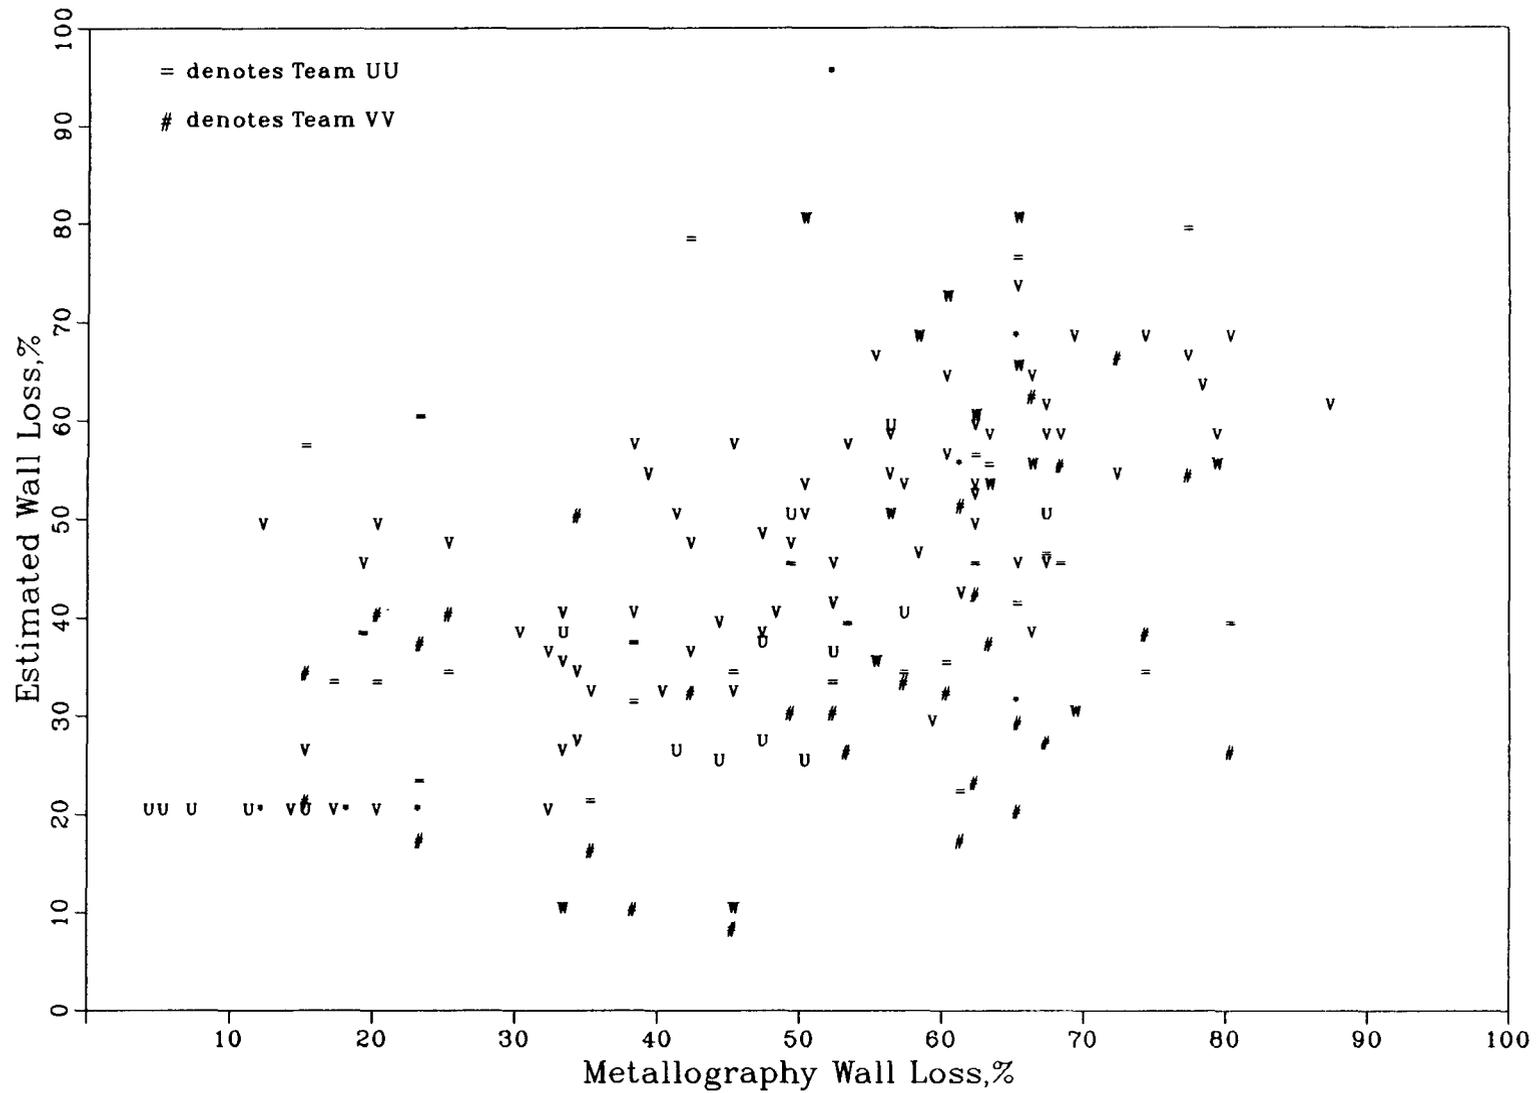
FIGURE 4.33. Plot of Estimated Defect Depth for AATTR Teams Versus Depth from Metallographic Analysis

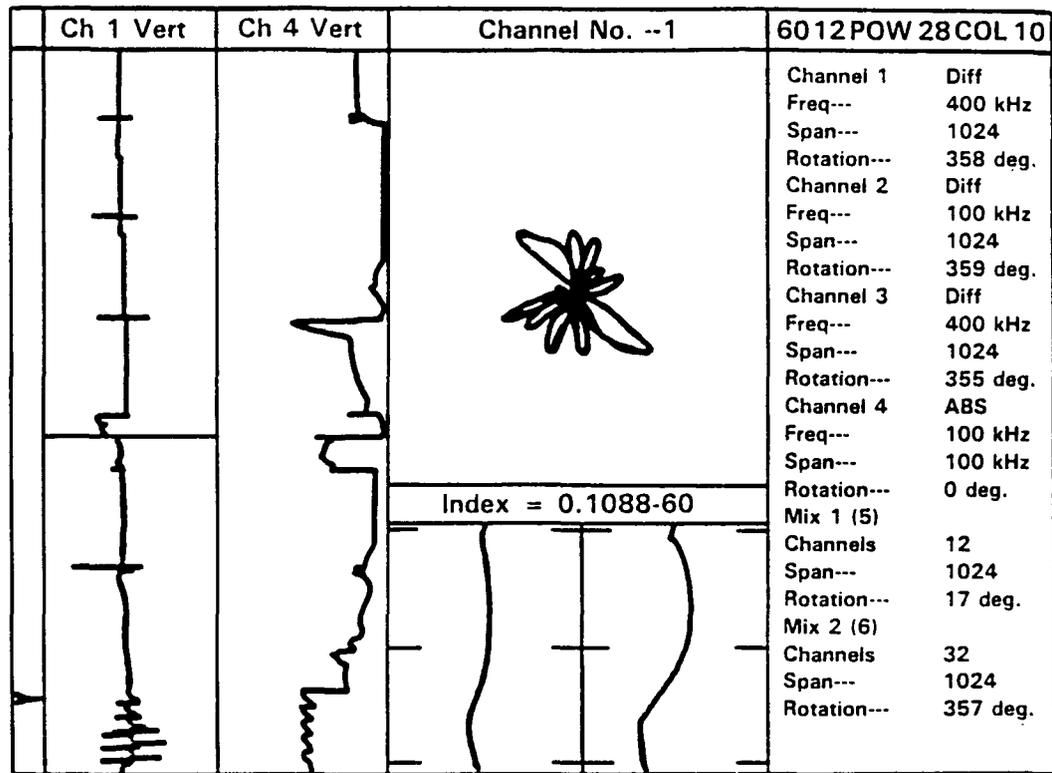
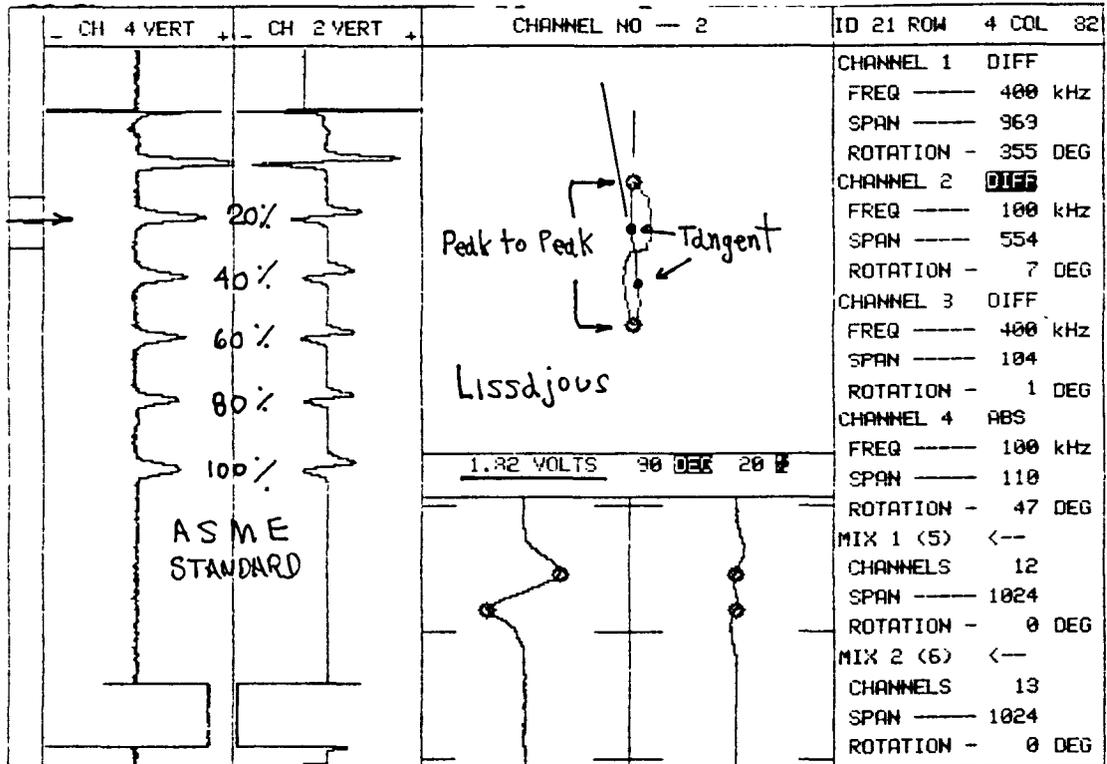
FIGURE 4.34. ASME Standard Used for Defect Detection and Sizing

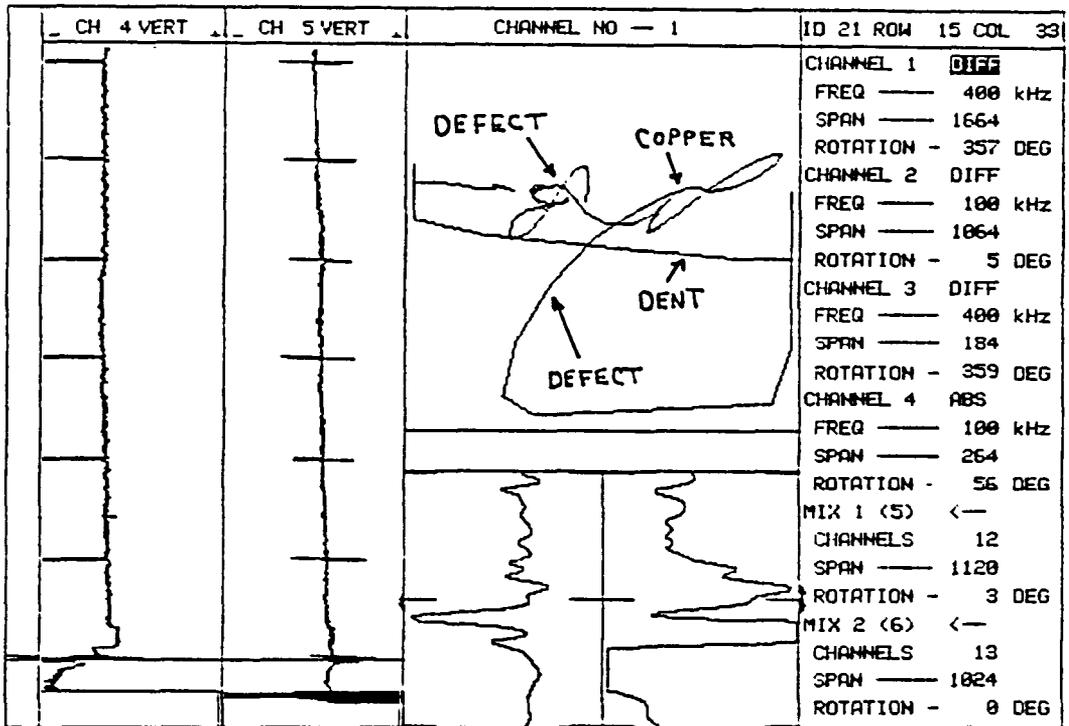
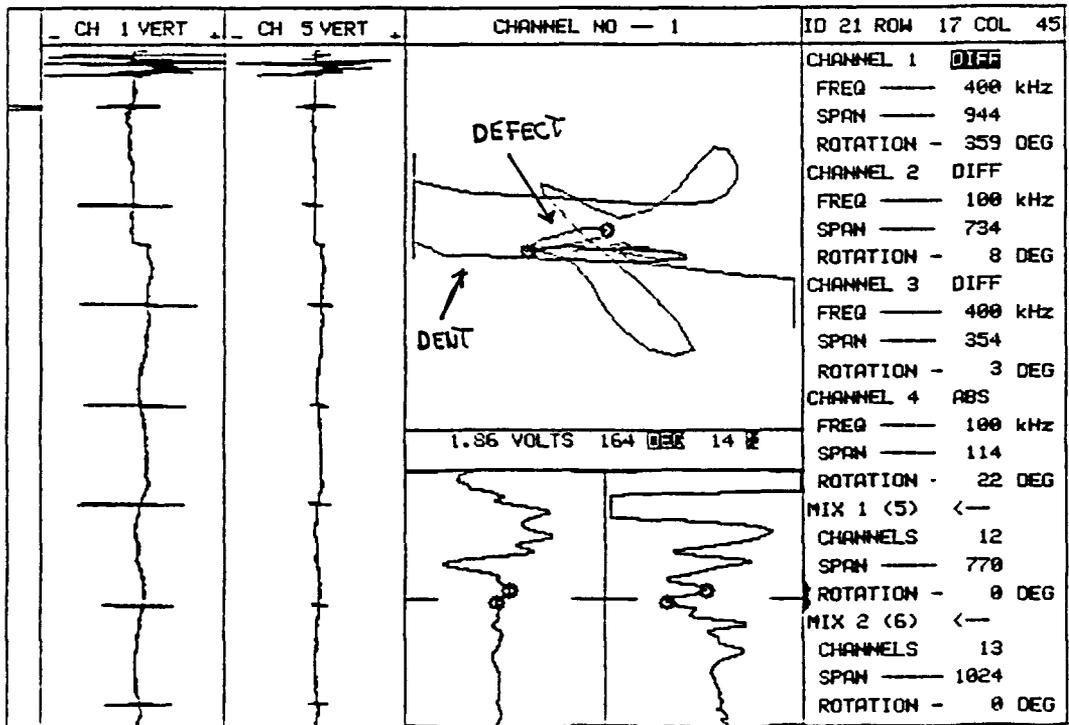
FIGURE 4.35. Complex Signals from TTS Specimens 658C (R15 C33 HL) and 655C (R17 C45 HL) Showing Defects and Effects of Copper and Dent

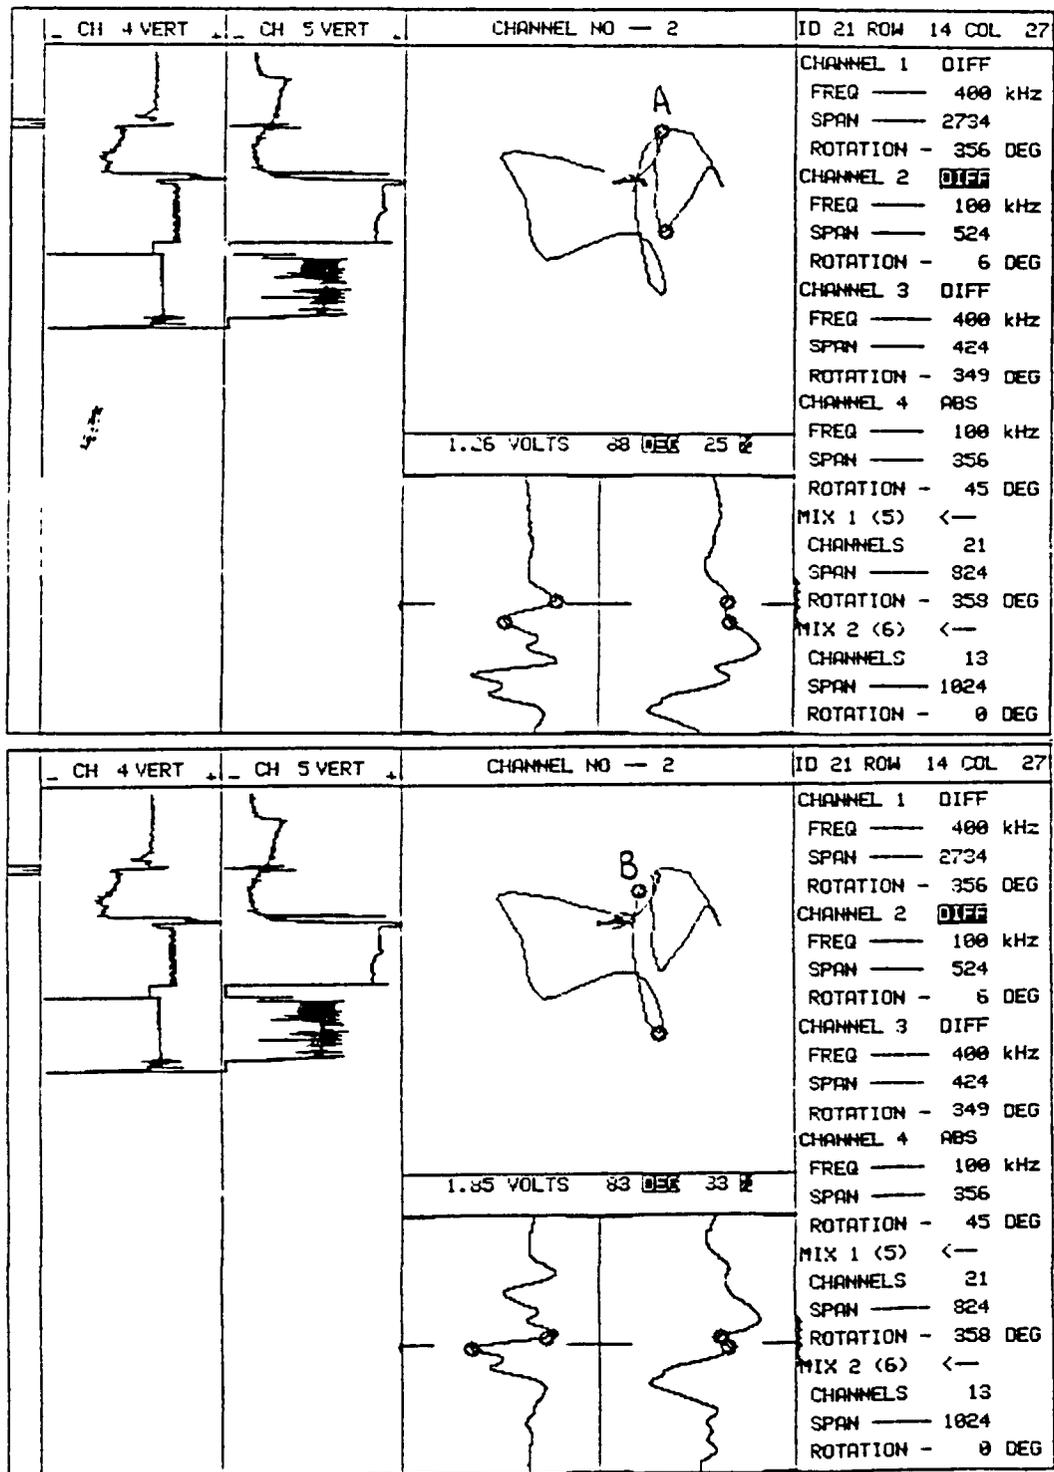
FIGURE 4.36. Complex Defect Signals from TTS Specimen 636C Showing More Than One Defect with a Dent Present

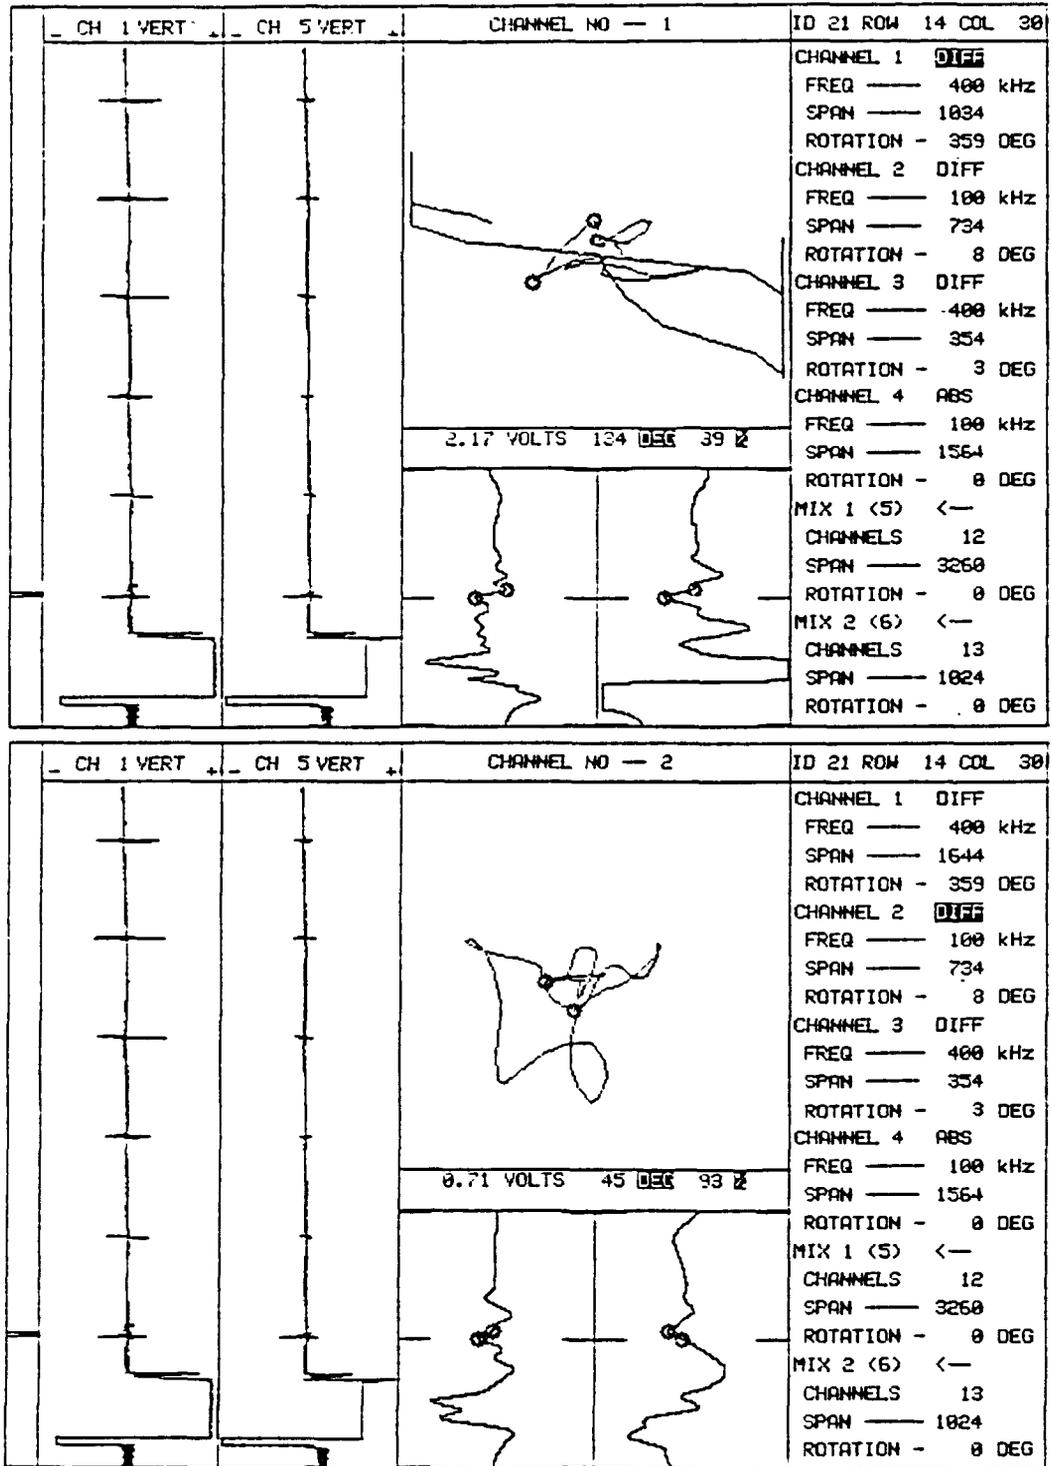
FIGURE 4.44. Defect Signal from Specimen 637C (R14 C30 HL) Showing Phase Relation Which Relates to an OD Defect at 400 kHz and an ID Defect at 100 kHz

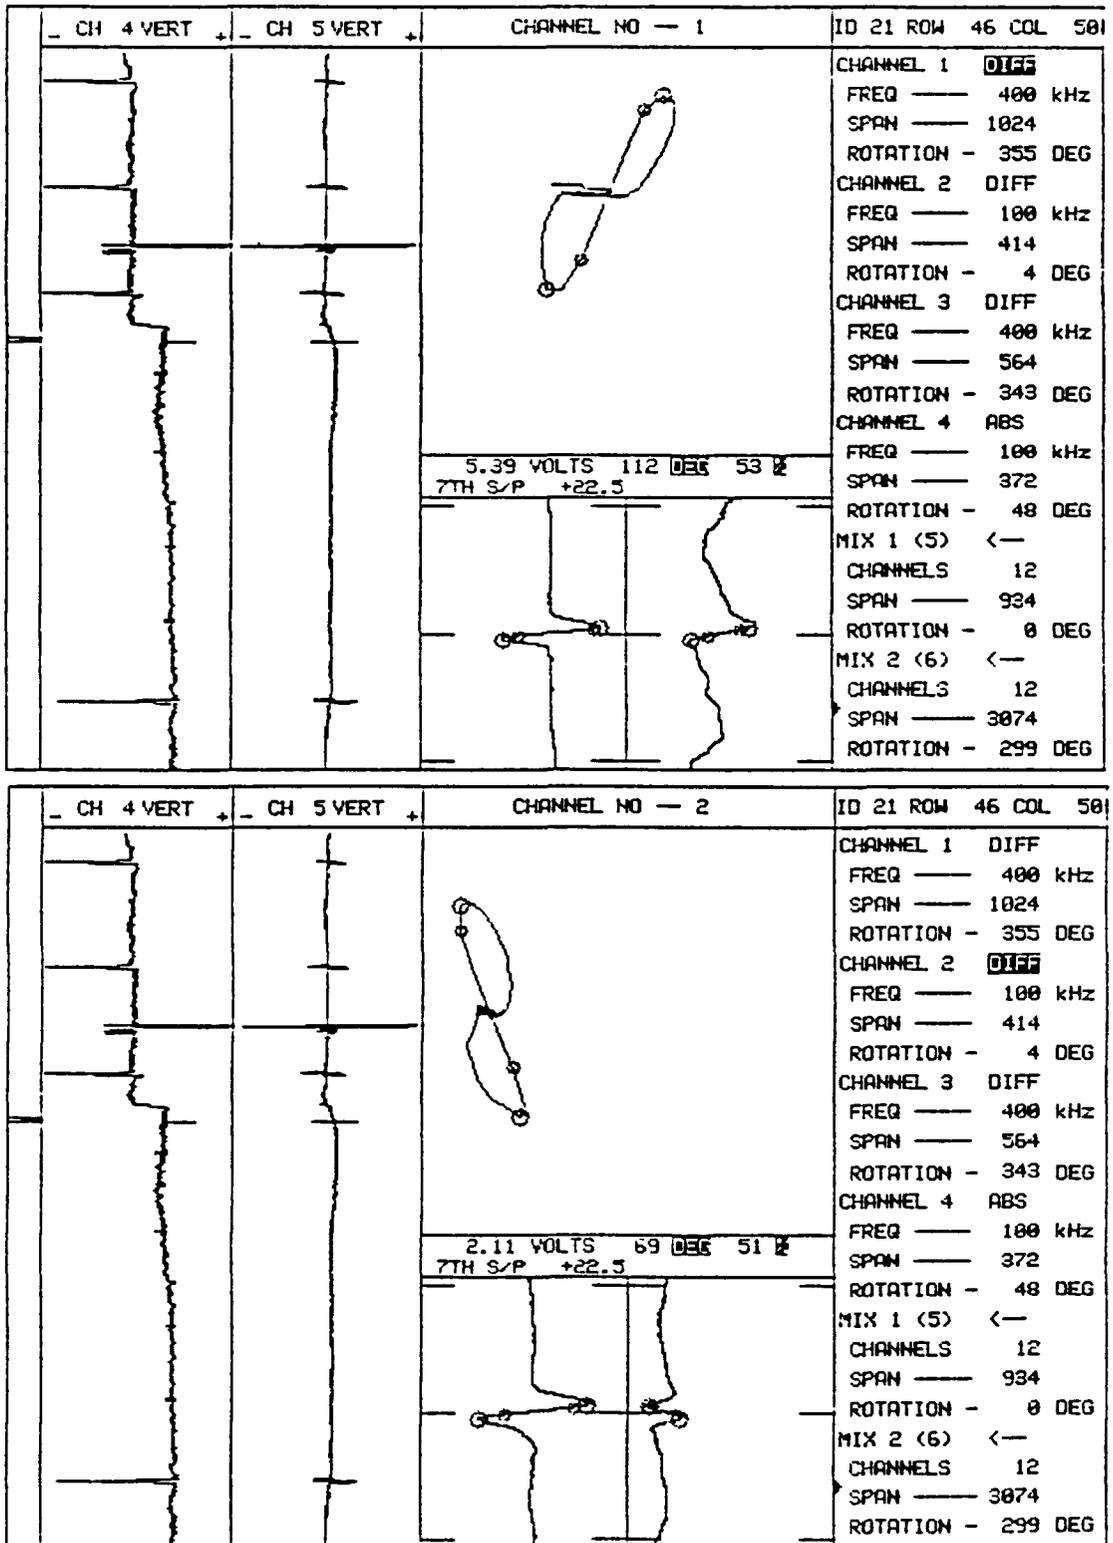
FIGURE 4.45. Eddy Current Signals from Grinder Mark on U-bend Specimen 429A (R46 C50 HL)

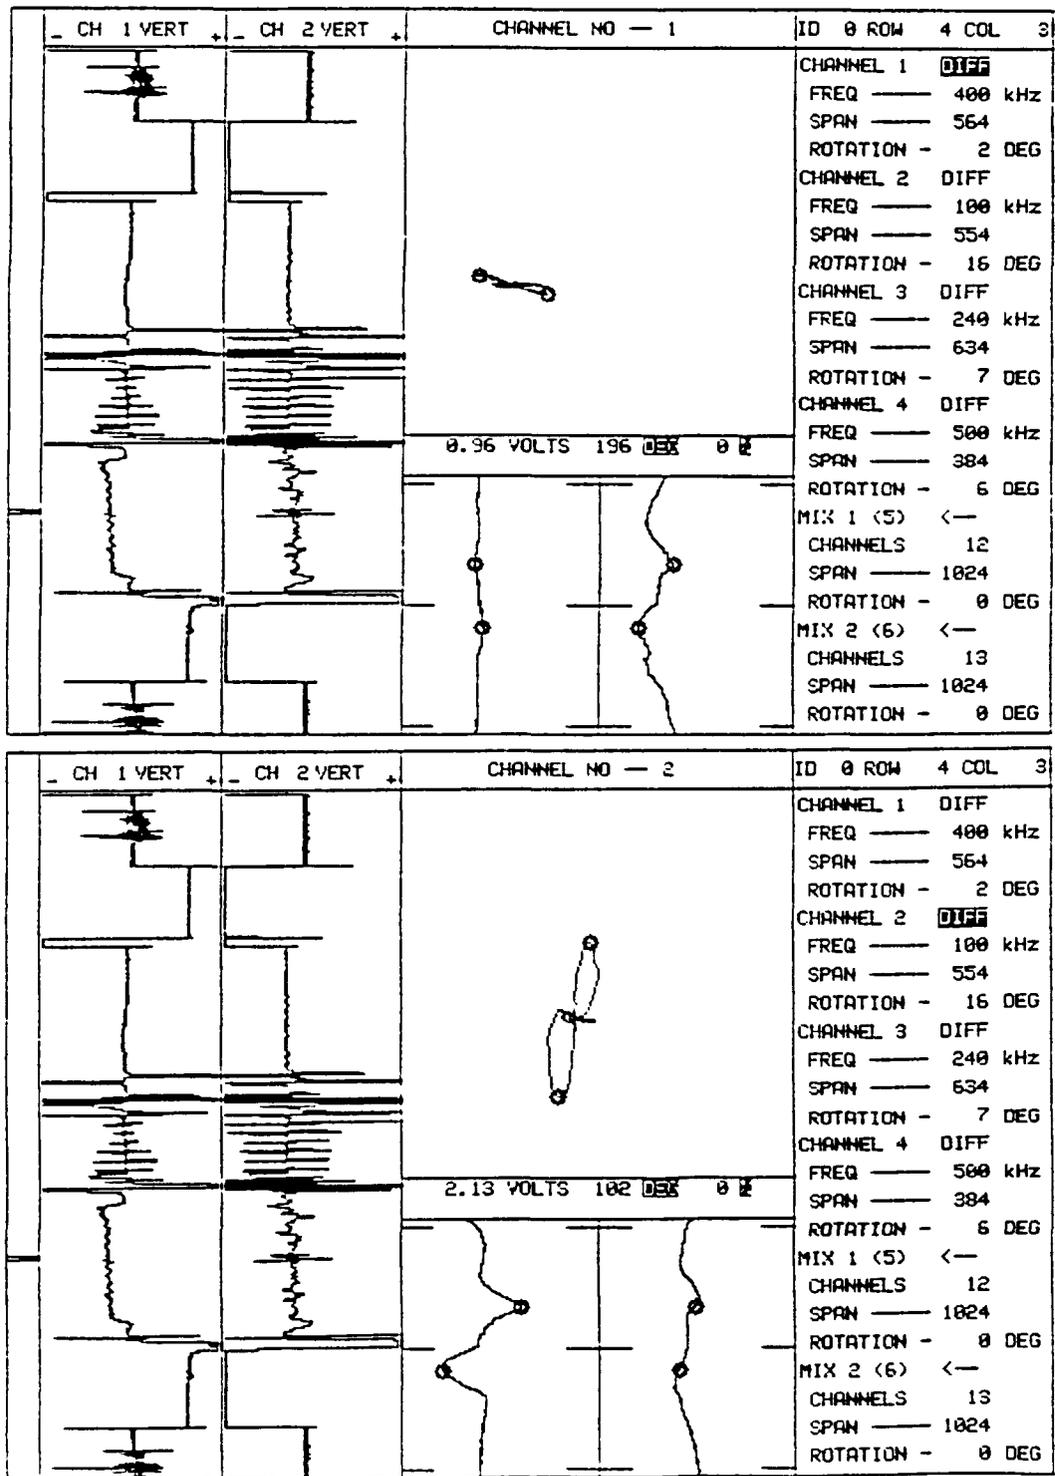
FIGURE 4.46. U-bend Specimen 568 (R4 C3) Showing a Defect Called Signal in U-bend Area Which Turned Out to Be Lack of Copper

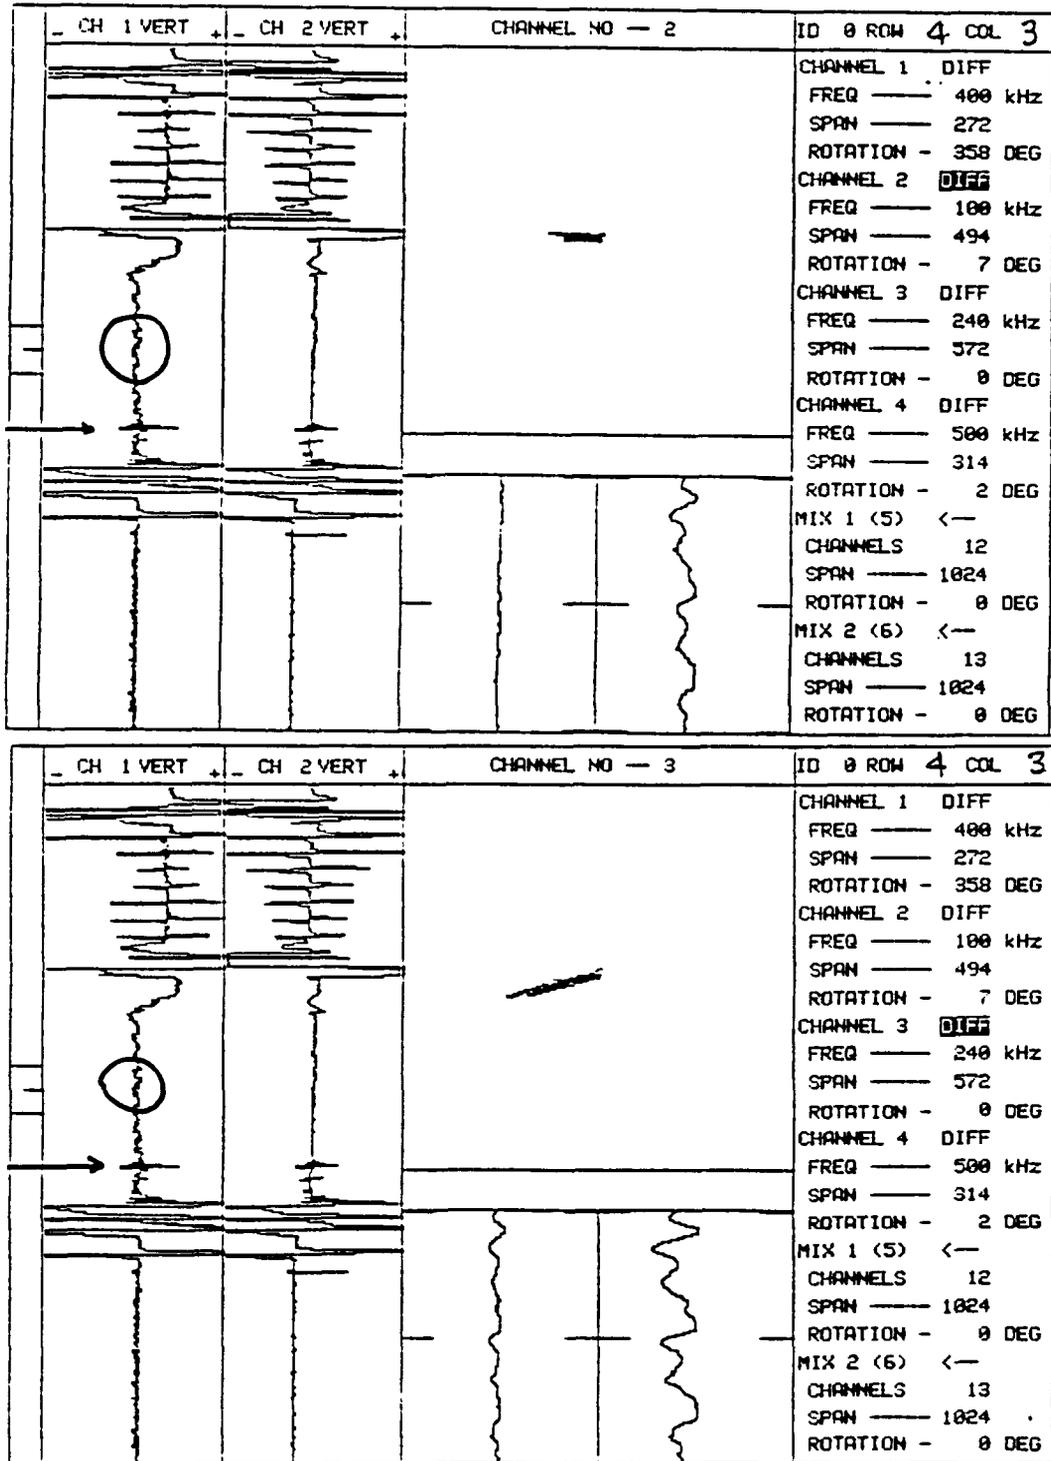
FIGURE 4.47. Specimen 568 (R4 C3) After Cleaning

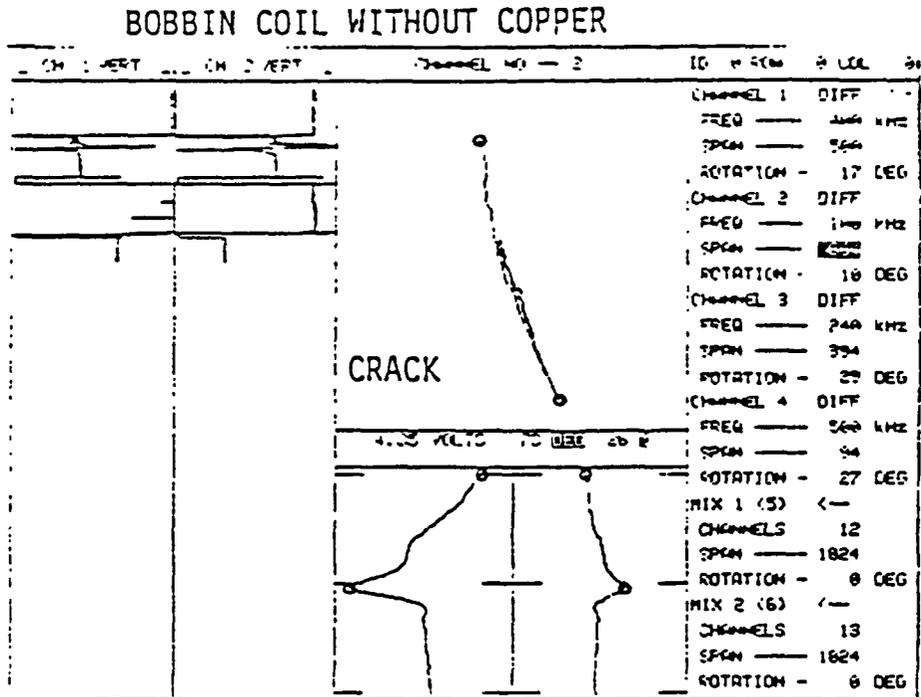
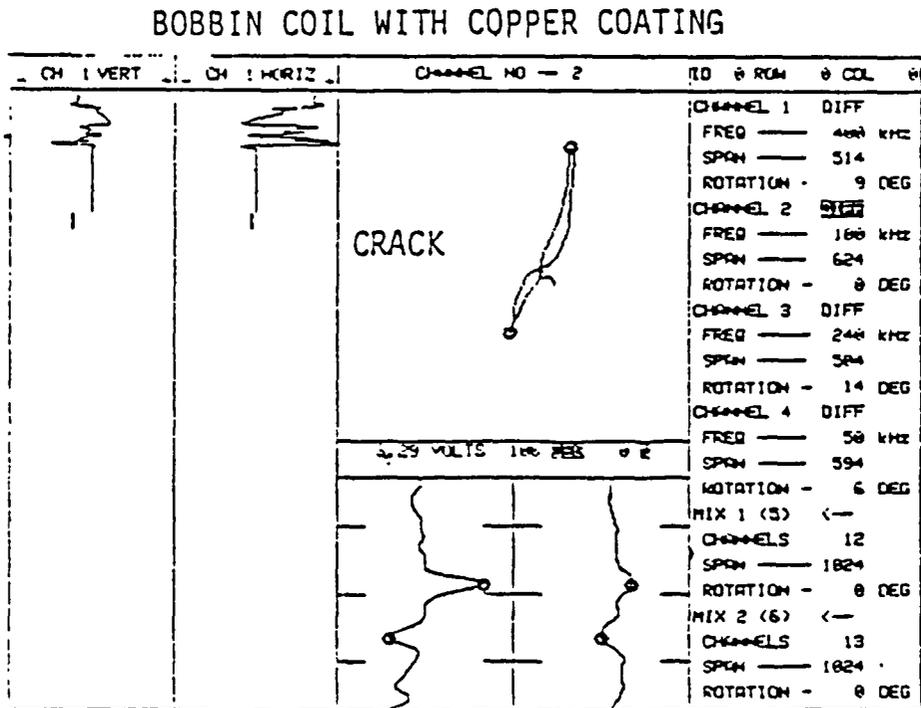
FIGURE 4.49. Changes in EC Signals from a One-Inch Crack (38% deep) Before and After Copper Plating
